# **GEOTECHNICAL REPORT**

## **St. James Street Reconstruction – Portage Avenue to Maroons Road – Sub Surface Investigation**

**RE: Sub-Surface Investigation Report for  
St. James Reconstruction – Portage Avenue to Maroons Road**

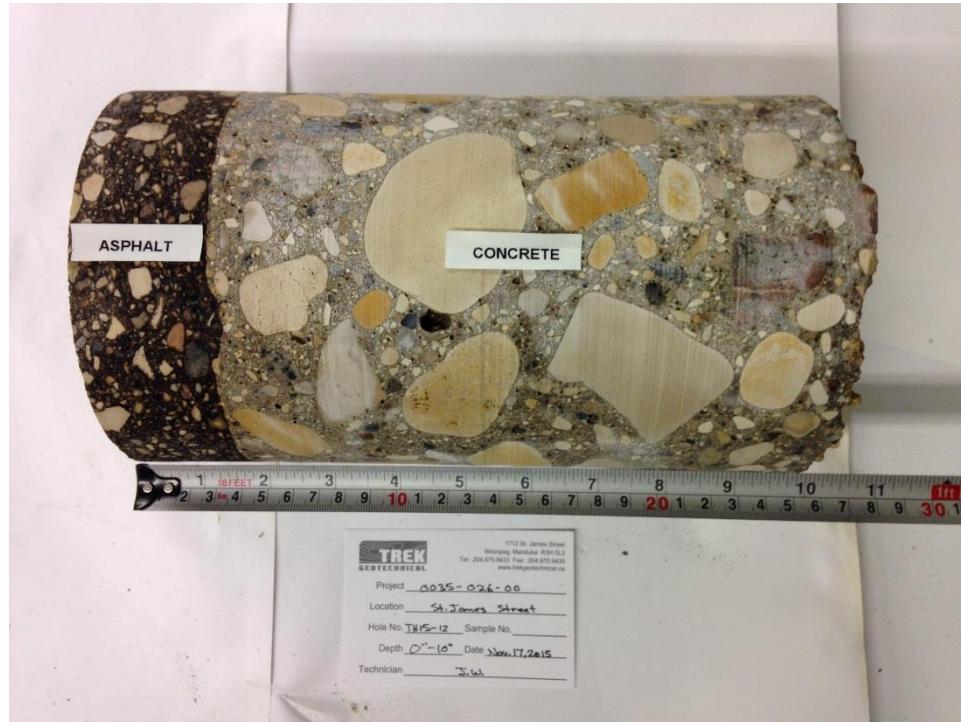
Photo 12: Concrete Core Sample From Test Hole TH15-12
