# **GEOTECHNICAL REPORT**

**Regarding: Local Streets Package 16-R-05 – Contract 2 – Pavement Coring Summary**

This report summarizes the results of the pavement coring investigation completed for the proposed 2016 Local Street Renewals of Kilkenny Drive and Markham Road. The objective of the investigation is to provide information related to the existing pavement.

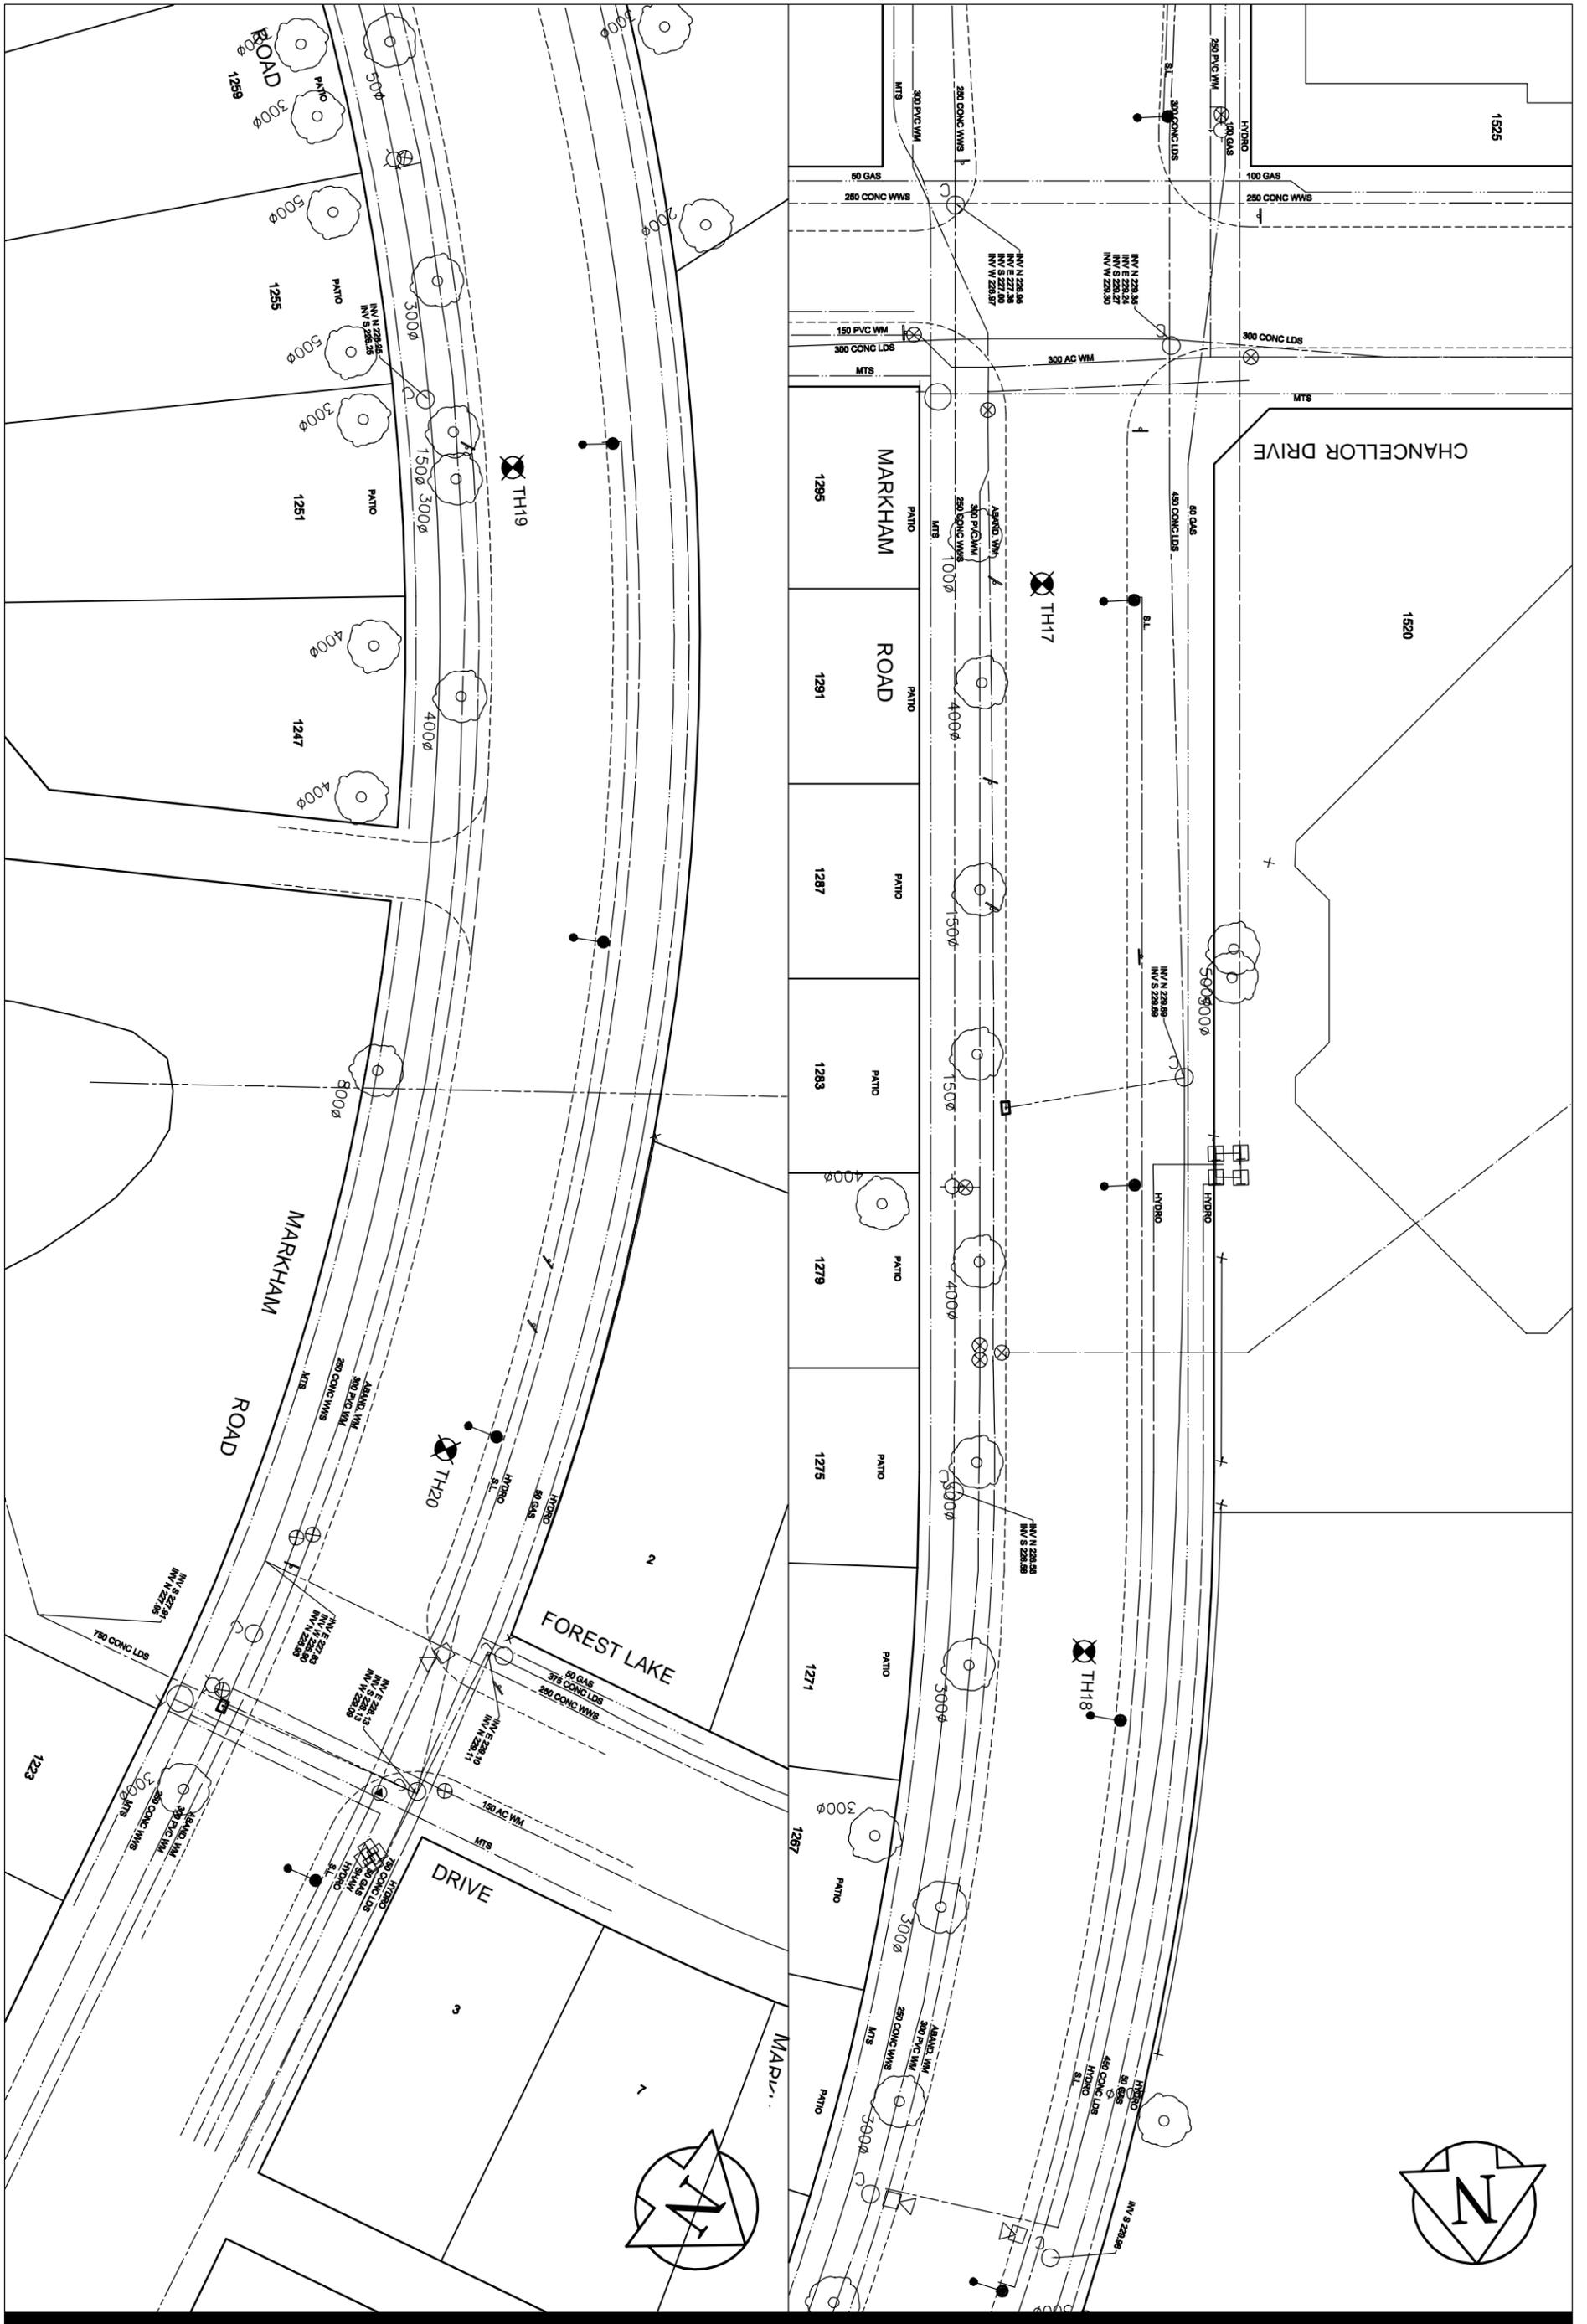
FIGURE 02: TEST HOLES LOCATION PLAN

Eight pavement cores (TH16-11 to TH16-18) were collected on Kilkenny Drive and four pavement cores (TH16-17 to TH16-20) were collected on Markham Road. The approximate location of pavement core holes are shown on Figures 01 and 02 in Appendix A.

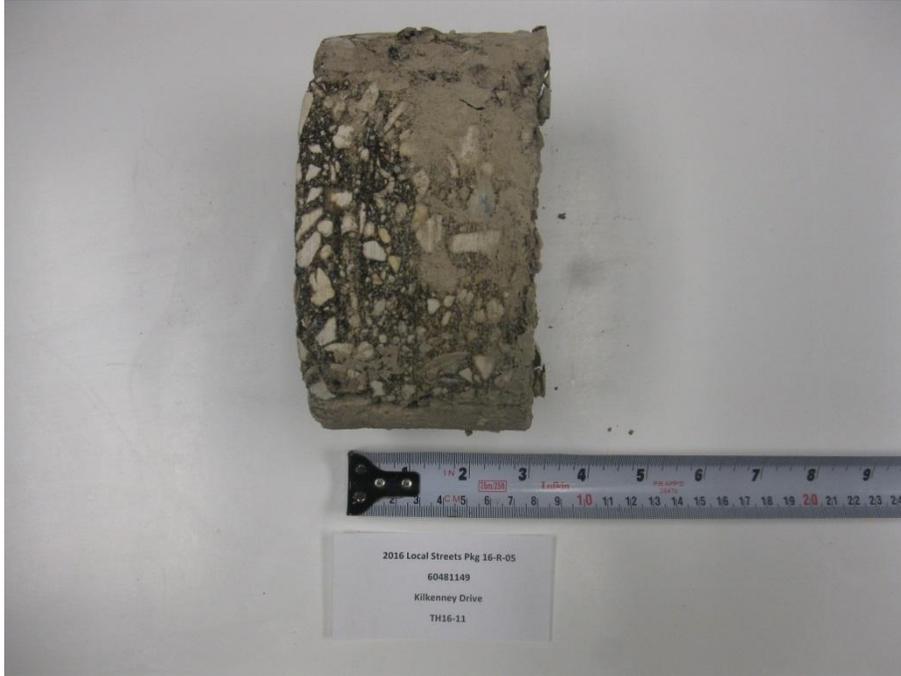
**Photograph 1. Kilkenny Drive – TH16-11**

Test Hole No.	Testhole Location	Pavement Surface	
		Type	Thickness (mm)
TH16-11	Kilkenny Drive; 50 m E of Patricia Avenue, eastbound traffic lane, #733 Kilkenny	Asphalt	75
		Concrete	N/A
TH16-12	Kilkenny Drive; 50 m E of Patricia Avenue, westbound traffic lane, #733 Kilkenny	Asphalt	200
		Concrete	N/A
TH16-13	Kilkenny Drive; 110 m E of Patricia Avenue, westbound traffic lane, #717 Kilkenny	Asphalt	75
		Concrete	N/A
TH16-14	Kilkenny Drive; 170 m E of Patricia Avenue, westbound traffic lane, #685 Kilkenny	Asphalt	75
		Concrete	N/A
TH16-15	Kilkenny Drive; 170 m E of Patricia Avenue, eastbound traffic lane, #685 Kilkenny	Asphalt	75
		Concrete	N/A

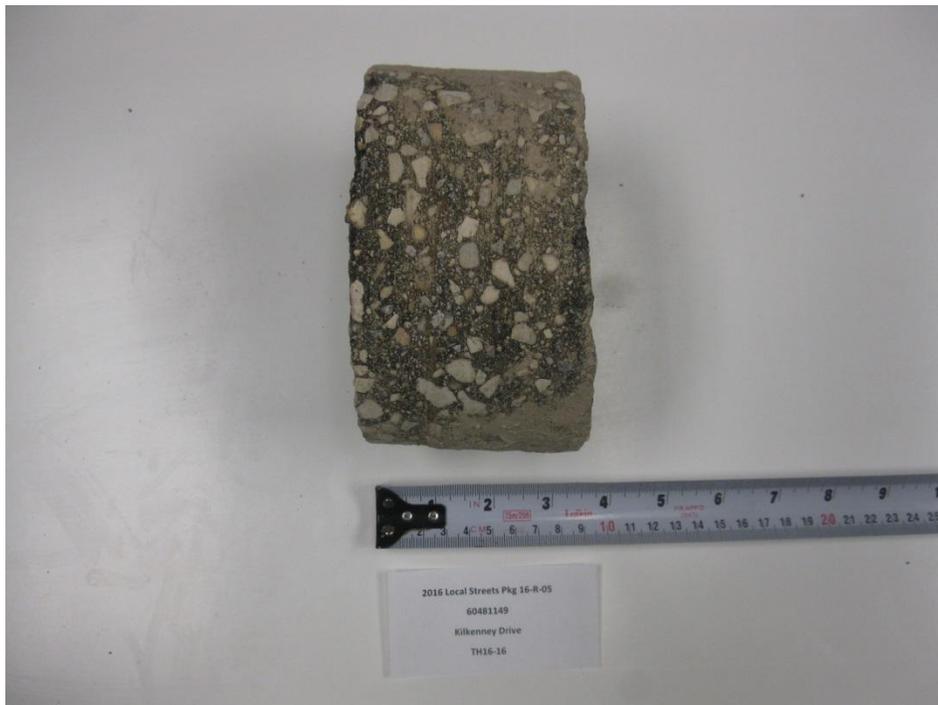
**Photograph 6. Kilkenny Drive – TH16-16**

Test Hole No.	Testhole Location	Pavement Surface	
		Type	Thickness (mm)
TH16-16	Kilkenny Drive; 270 m E of Patricia Avenue, westbound traffic lane, #643 Kilkenny	Asphalt	75
		Concrete	N/A
TH16-17	Kilkenny Drive; 120 m W of Kings Drive, westbound traffic lane, #617 Kilkenny	Asphalt	75
		Concrete	N/A
TH16-18	Kilkenny Drive; 10 m W of Kings Drive, eastbound traffic lane, #603 Kilkenny	Asphalt	75
		Concrete	N/A
TH16-17	Markham Road; 15 m N of Chancellor Drive, northbound traffic lane, #1295 Markham	Asphalt	100
		Concrete	N/A
TH16-18	Markham Road; 100 m N of Chancellor Drive, southbound traffic lane, #1271 Markham	Asphalt	150
		Concrete	N/A

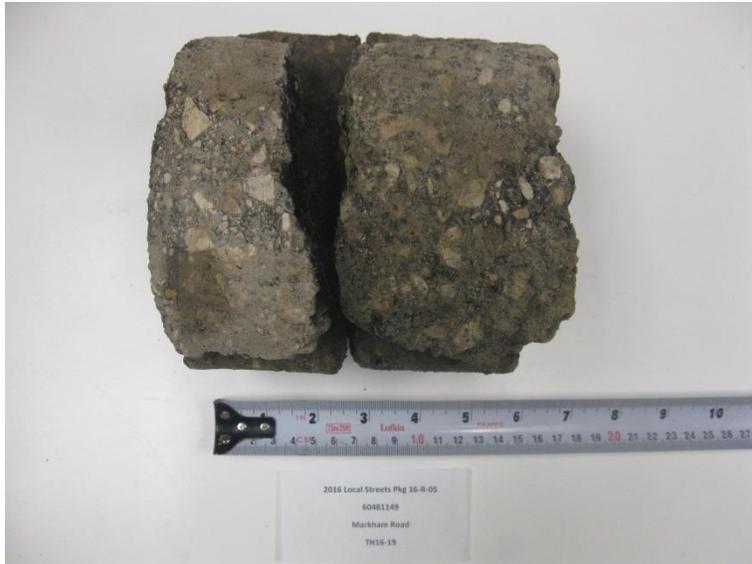
**Photograph 11. Markham Road – TH16-19**

Test Hole No.	Testhole Location	Pavement Surface	
		Type	Thickness (mm)
TH16-19	Markham Road; 100 m S of Forest Lake Road, northbound traffic lane, #1251 Markham	Asphalt	150
		Concrete	N/A
TH16-20	Markham Road; 10 m S of Forest Lake Road, southbound traffic lane, #2 Forest Lake Road	Asphalt	180
		Concrete	N/A
