Public City Architecture Inc
Cornish Library Addition
Riverbank Stabilization Measures
Hydraulic Engineering and Assessment

**RE: Cornish Library Addition Riverbank Stabilization Measures
Hydraulic Engineering and Assessment**

TREK Geotechnical Inc. is pleased to submit our Final Report for the Hydraulic Engineering Assessment for the above noted project. This report will include recommendations for rock riprap sizing, layout and extent on the riverbank located at the Cornish Library in Winnipeg, MB.

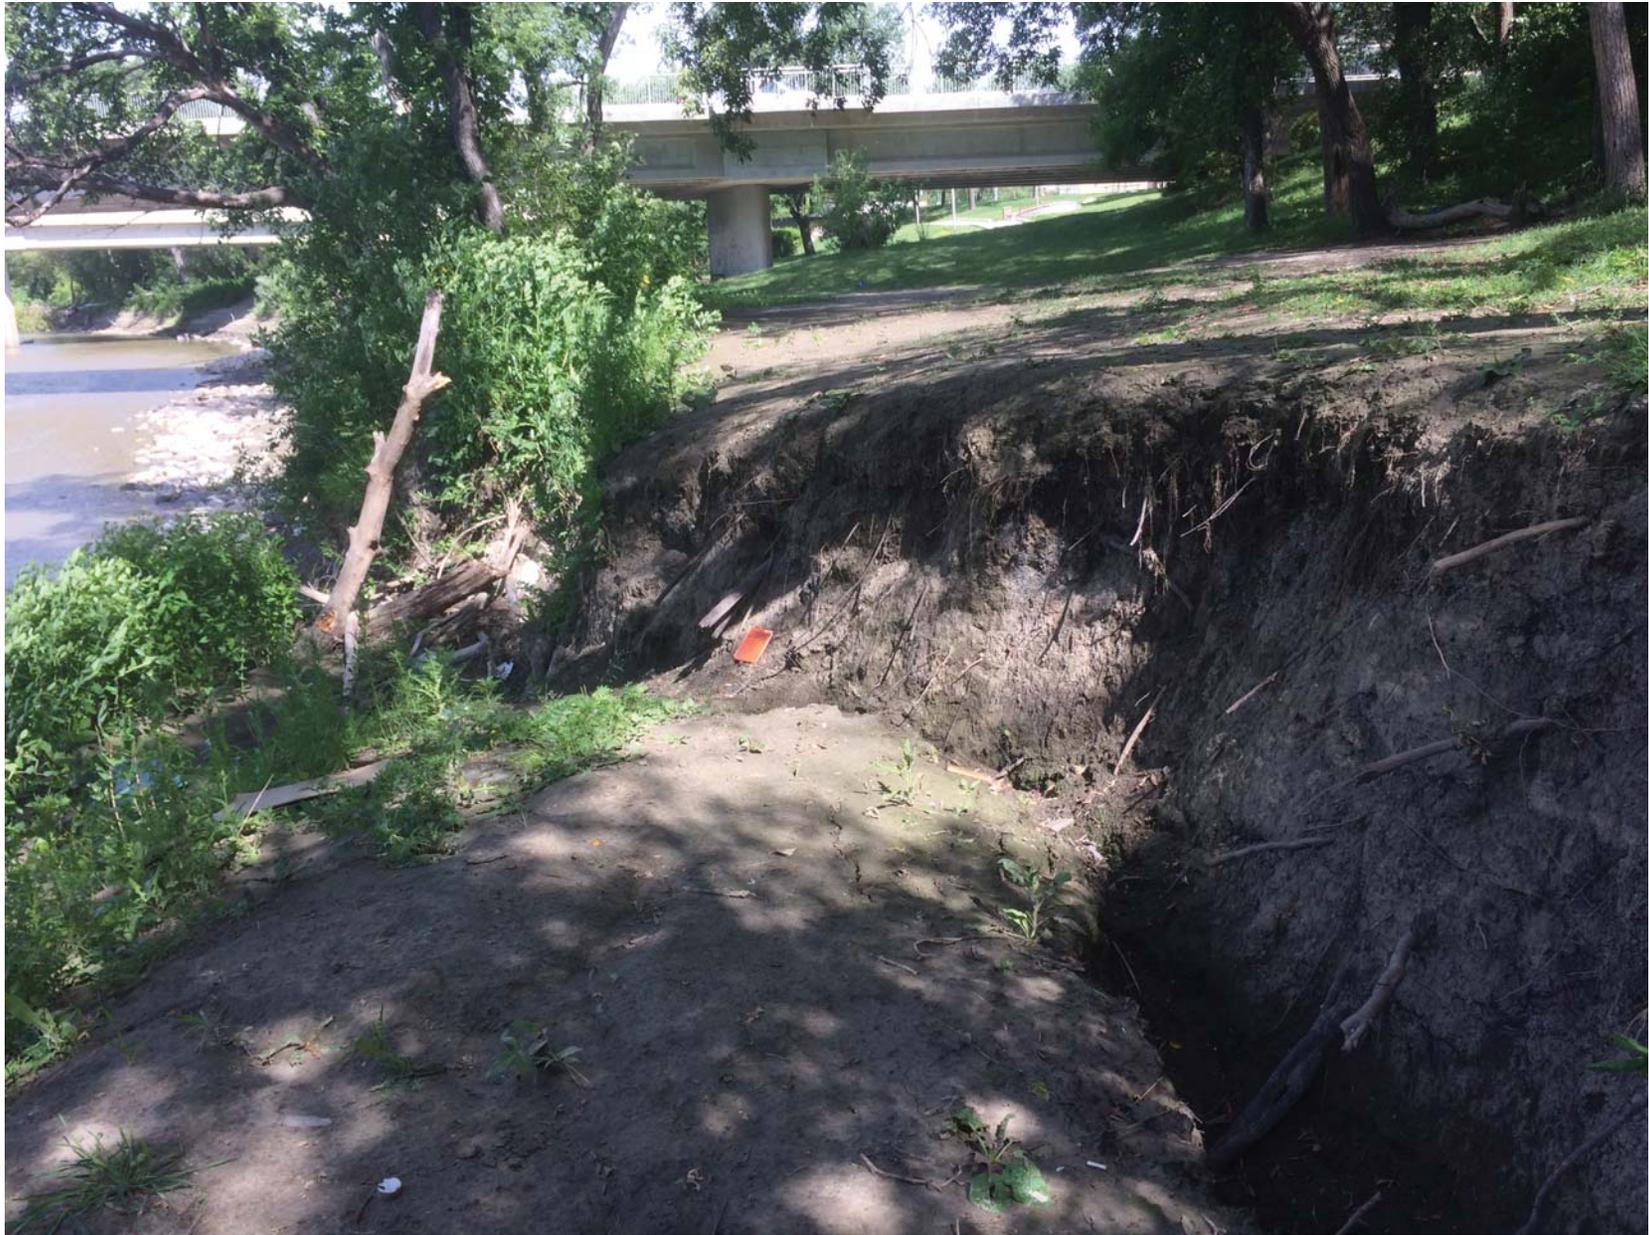
Figure 01
Riverbank Slope Failure at Cornish Library

In the time between TREK's site visit to determine subsurface conditions in December 2015 and site visits in 2017, the river bank experienced a slope failure on the east side of the property. This riverbank slope failure occurred before construction of the addition, further demonstrating the need for local geotechnical stabilization measures that could be provided by bank toe rock ballast or a rock riprap blanket. The area of the riverbank failure is shown in Figure 01.

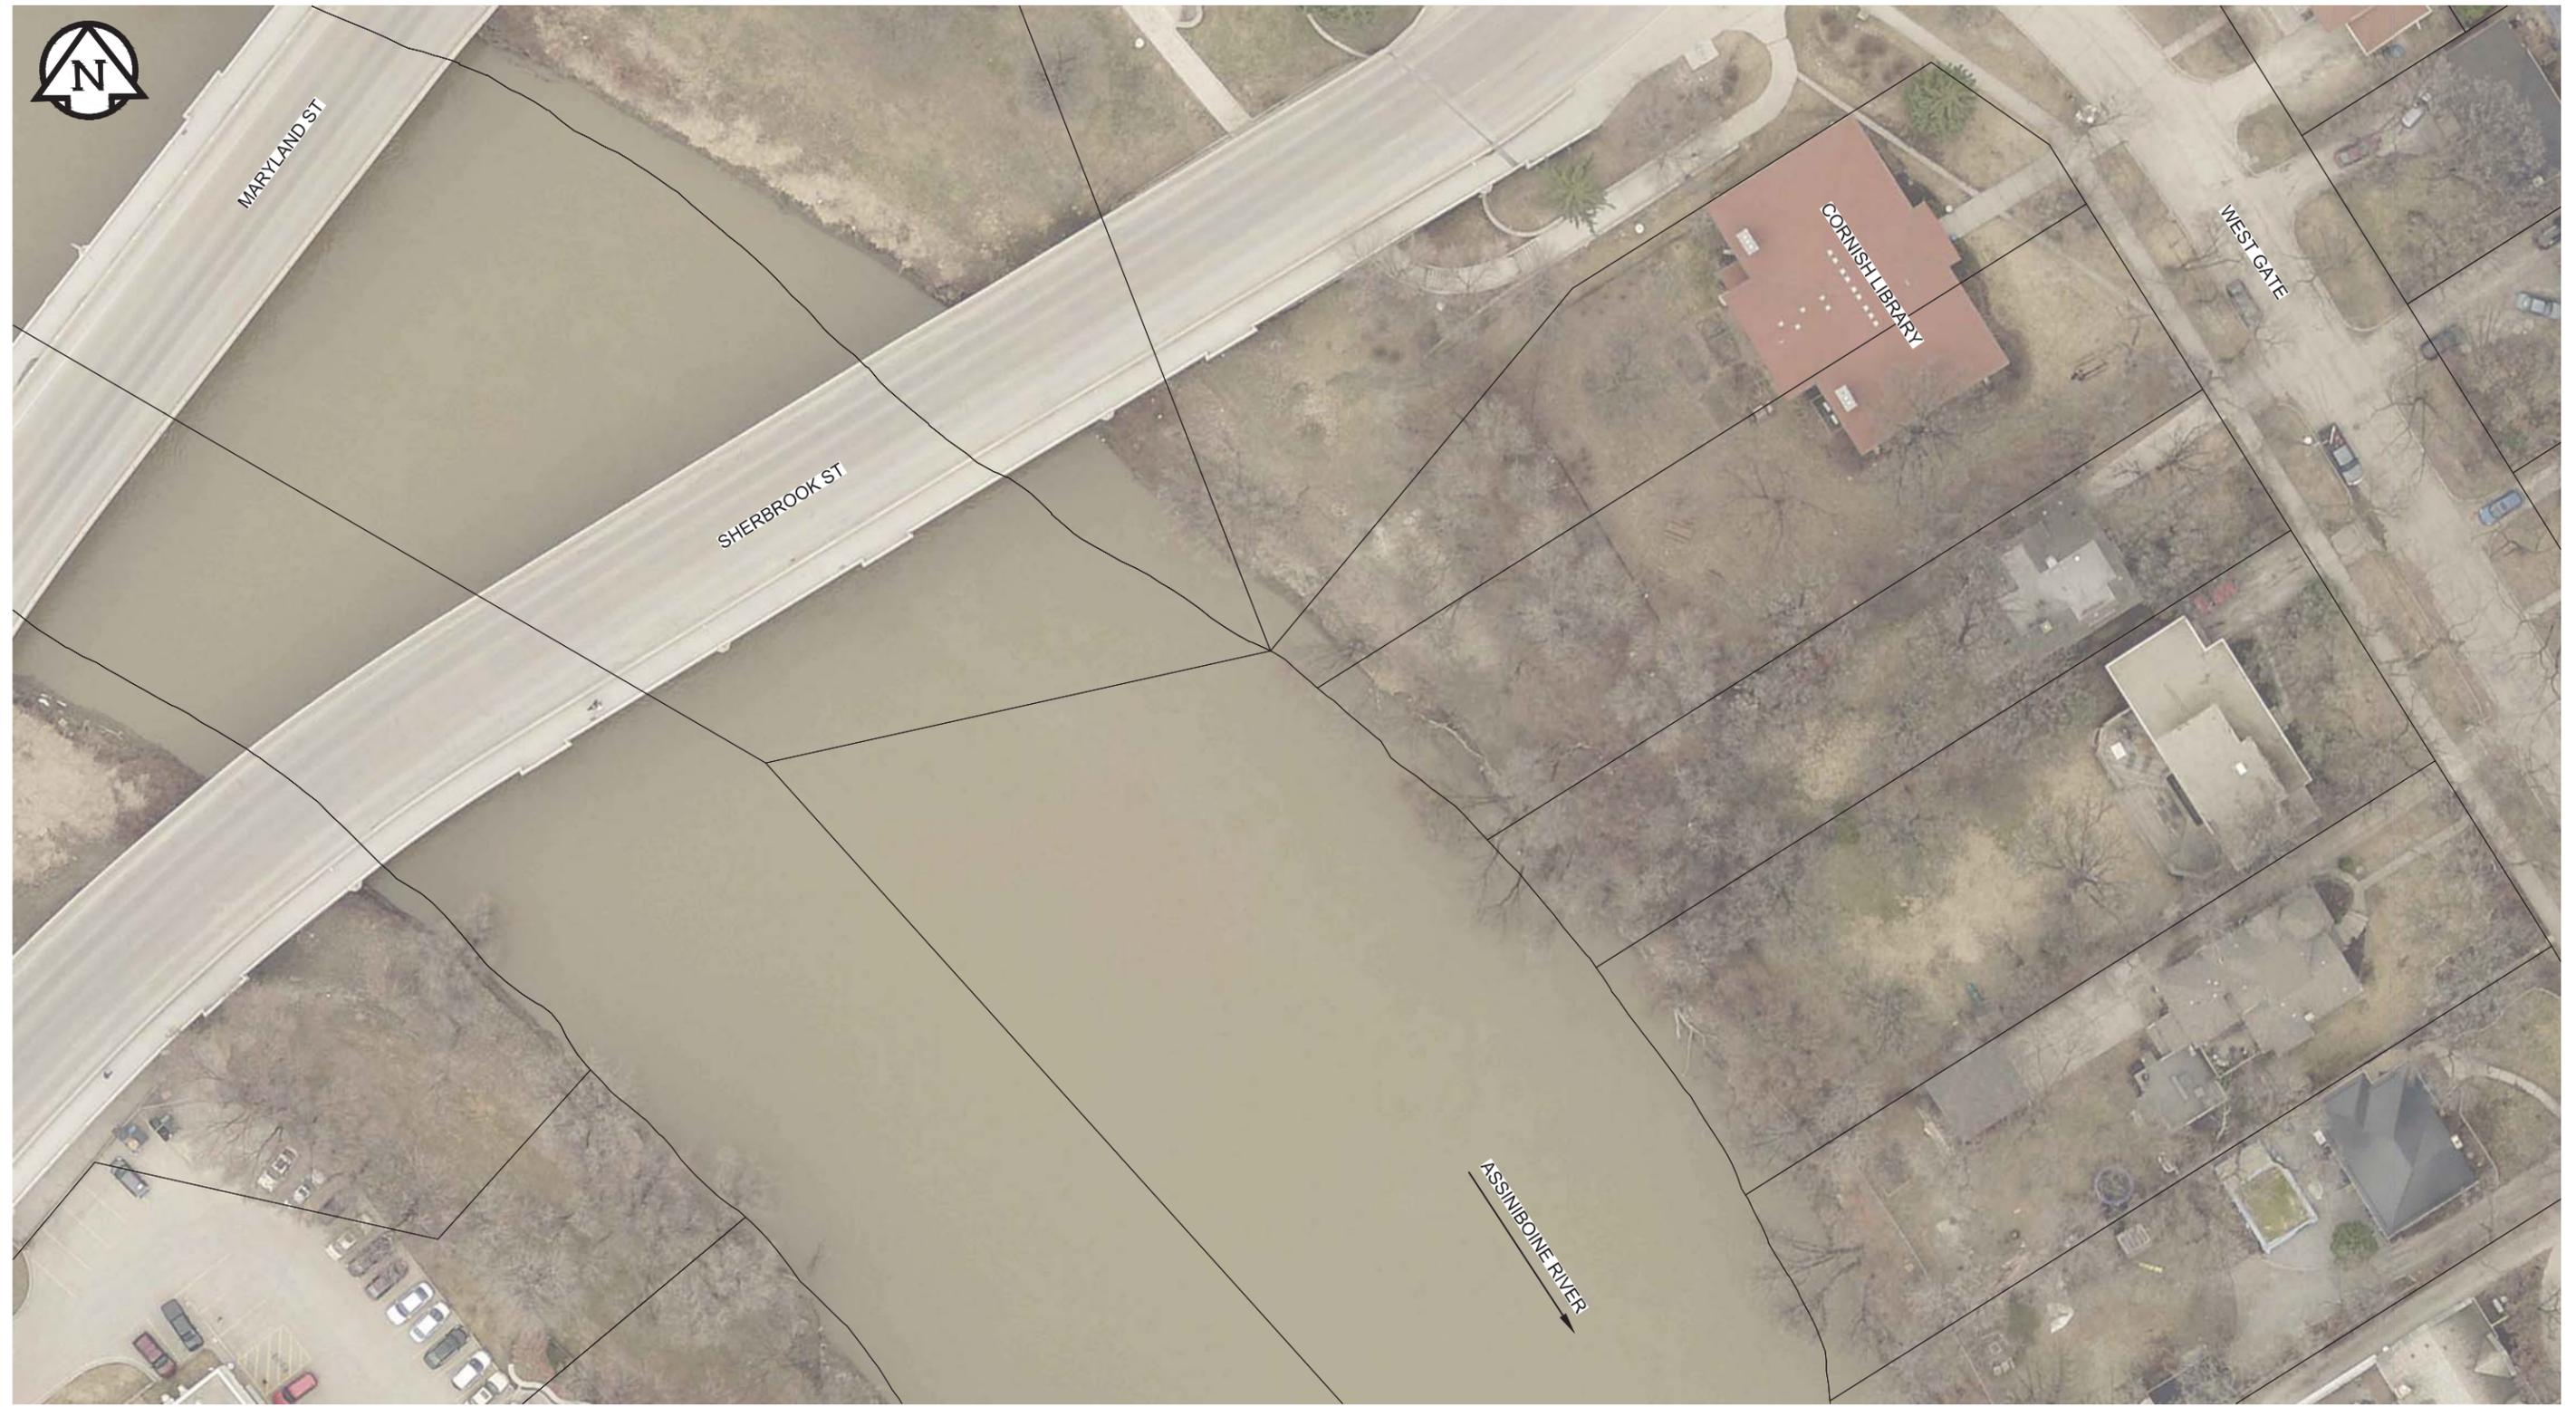
Figure 02
General Site Plan

The hydraulic conditions within the Assiniboine River were assessed to establish the baseline hydraulic regime. A steady-state backwater model of the Assiniboine River within the study reach was developed using the US Army Corps of Engineers Hydrologic Engineering Centre - River Analysis System (HEC RAS) model. The HEC RAS model is a one dimensional hydraulic model, which is considered to be the universal standard for computing steady-state water surface profiles. The backwater model extends along the Assiniboine River from the Red River (Forks) upstream to Headingly. The Cornish Library's project area is located approximately 3700 m upstream from the Red River at the Forks, extending from the Maryland Bridge for approximately 50 m downstream of the bridge. A plan of the study area is shown on Figure 02.

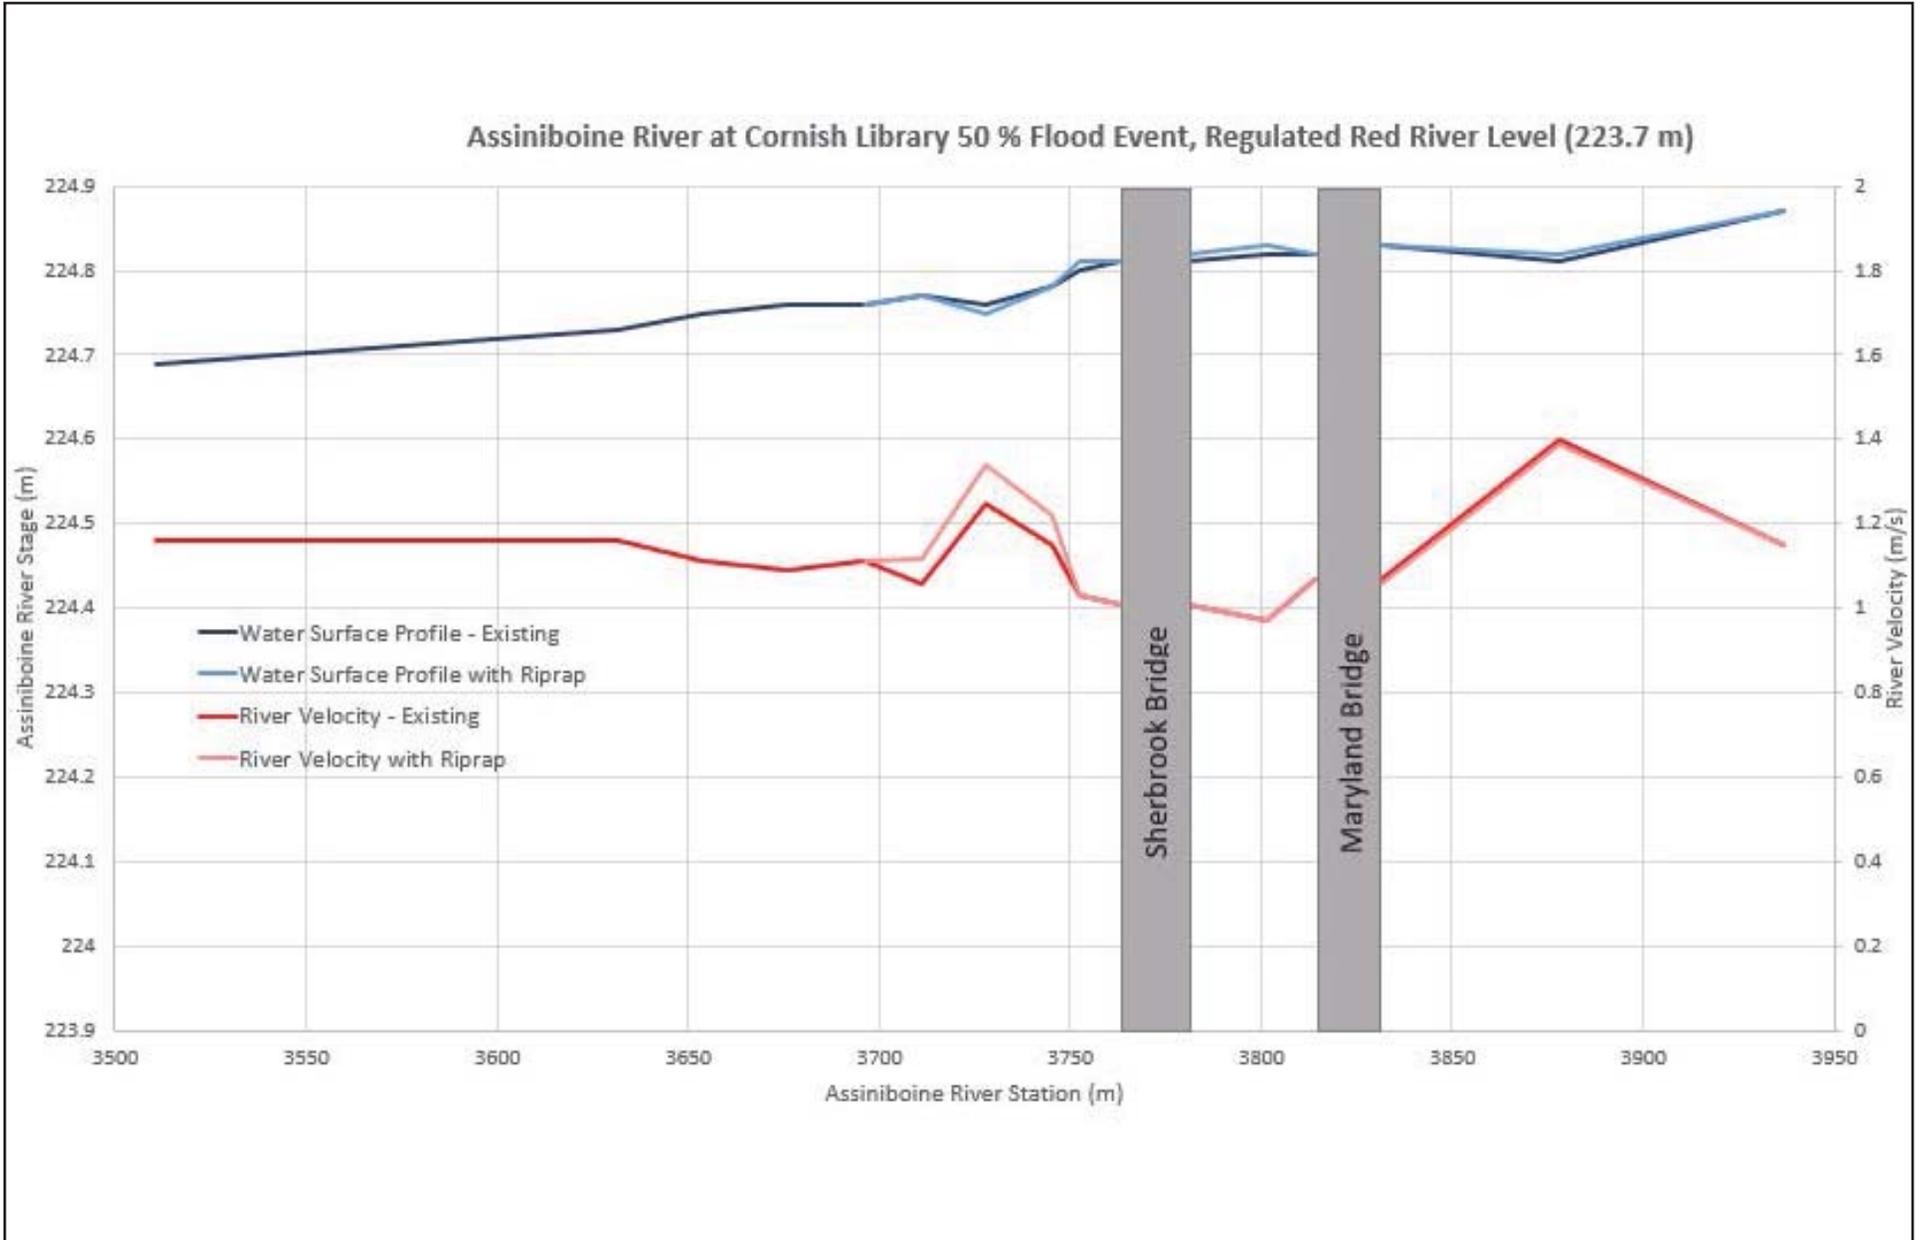
Figure 03
50% Flood Event

The estimated water surface profiles and channel velocity profile on the Assiniboine River for existing conditions are shown in Table 2 and Figures 03-05 at selected discharges throughout a range of downstream boundary conditions.

The estimated water surface profiles and channel velocity on the Assiniboine River for existing and design conditions, are shown in Figures 03-05 at selected discharges and downstream conditions. The addition of the rock riprap without embedment into the riverbank will cause minimal changes to the average local velocity of the river and water levels. The change to river velocity is negligible, with less than a 0.06 m/s increase locally. Changes to the water surface profile would be imperceptible (less than 1 cm).

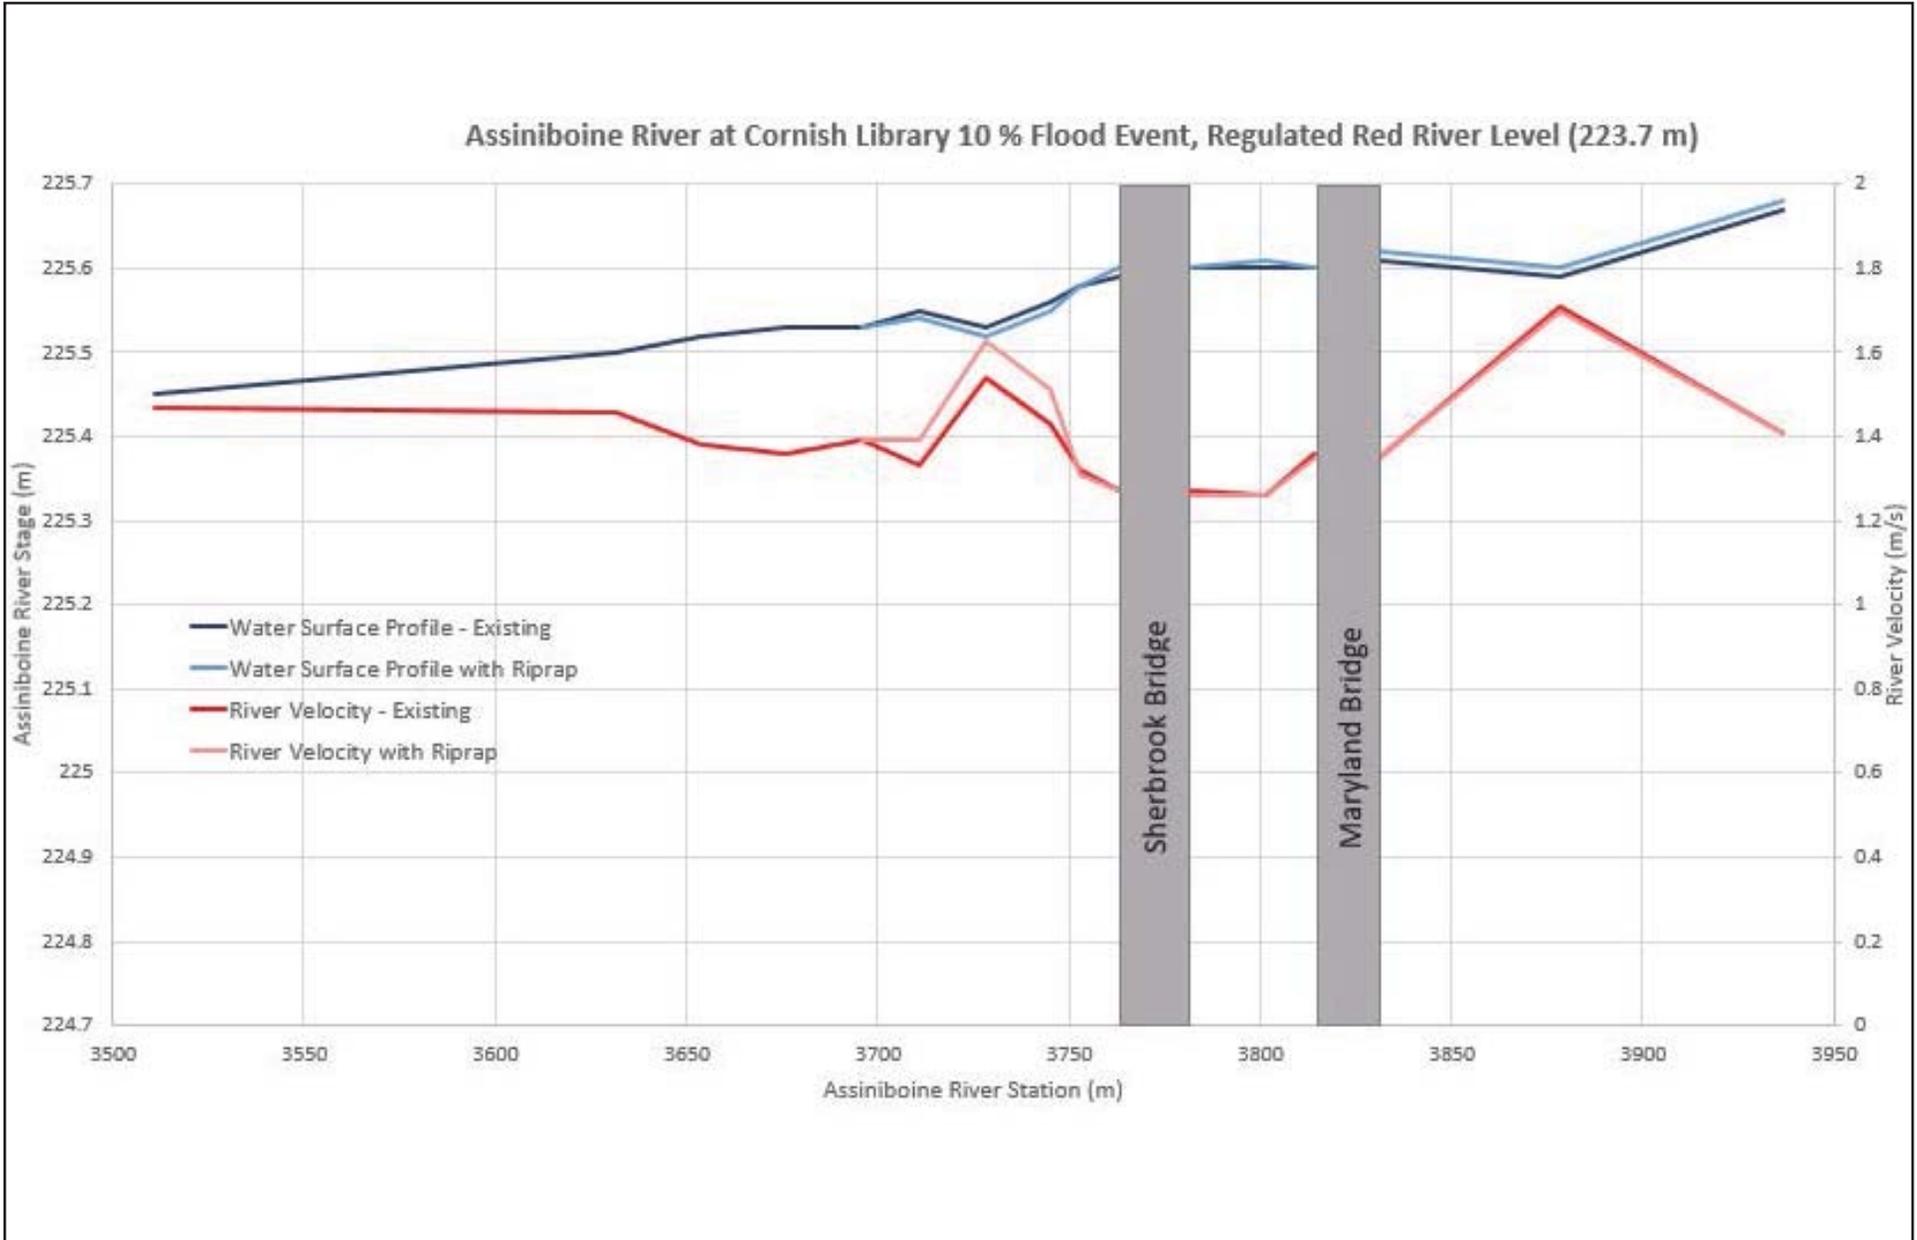
Figure 04
10% Flood Event

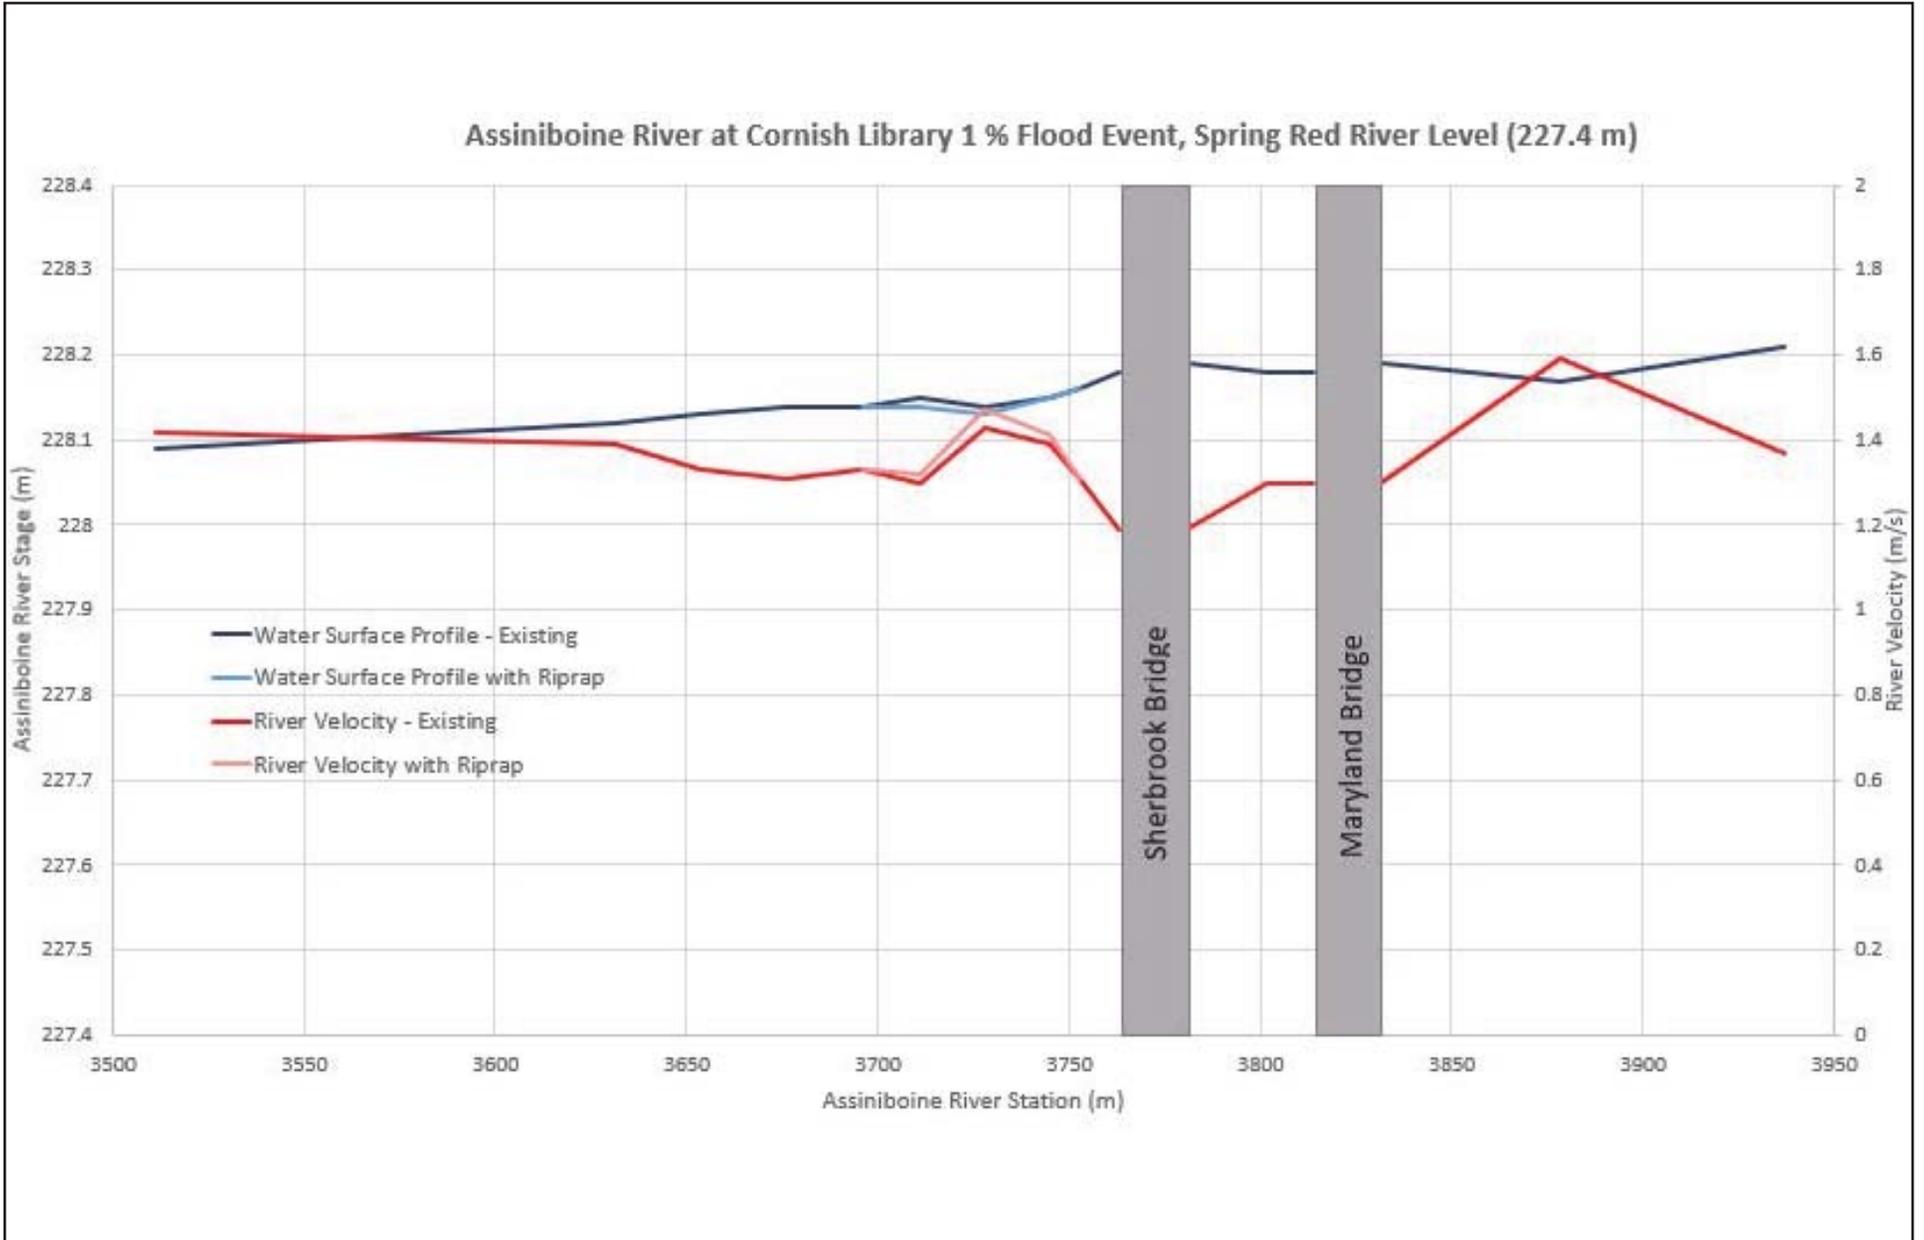
Figure 05
1% Flood Event

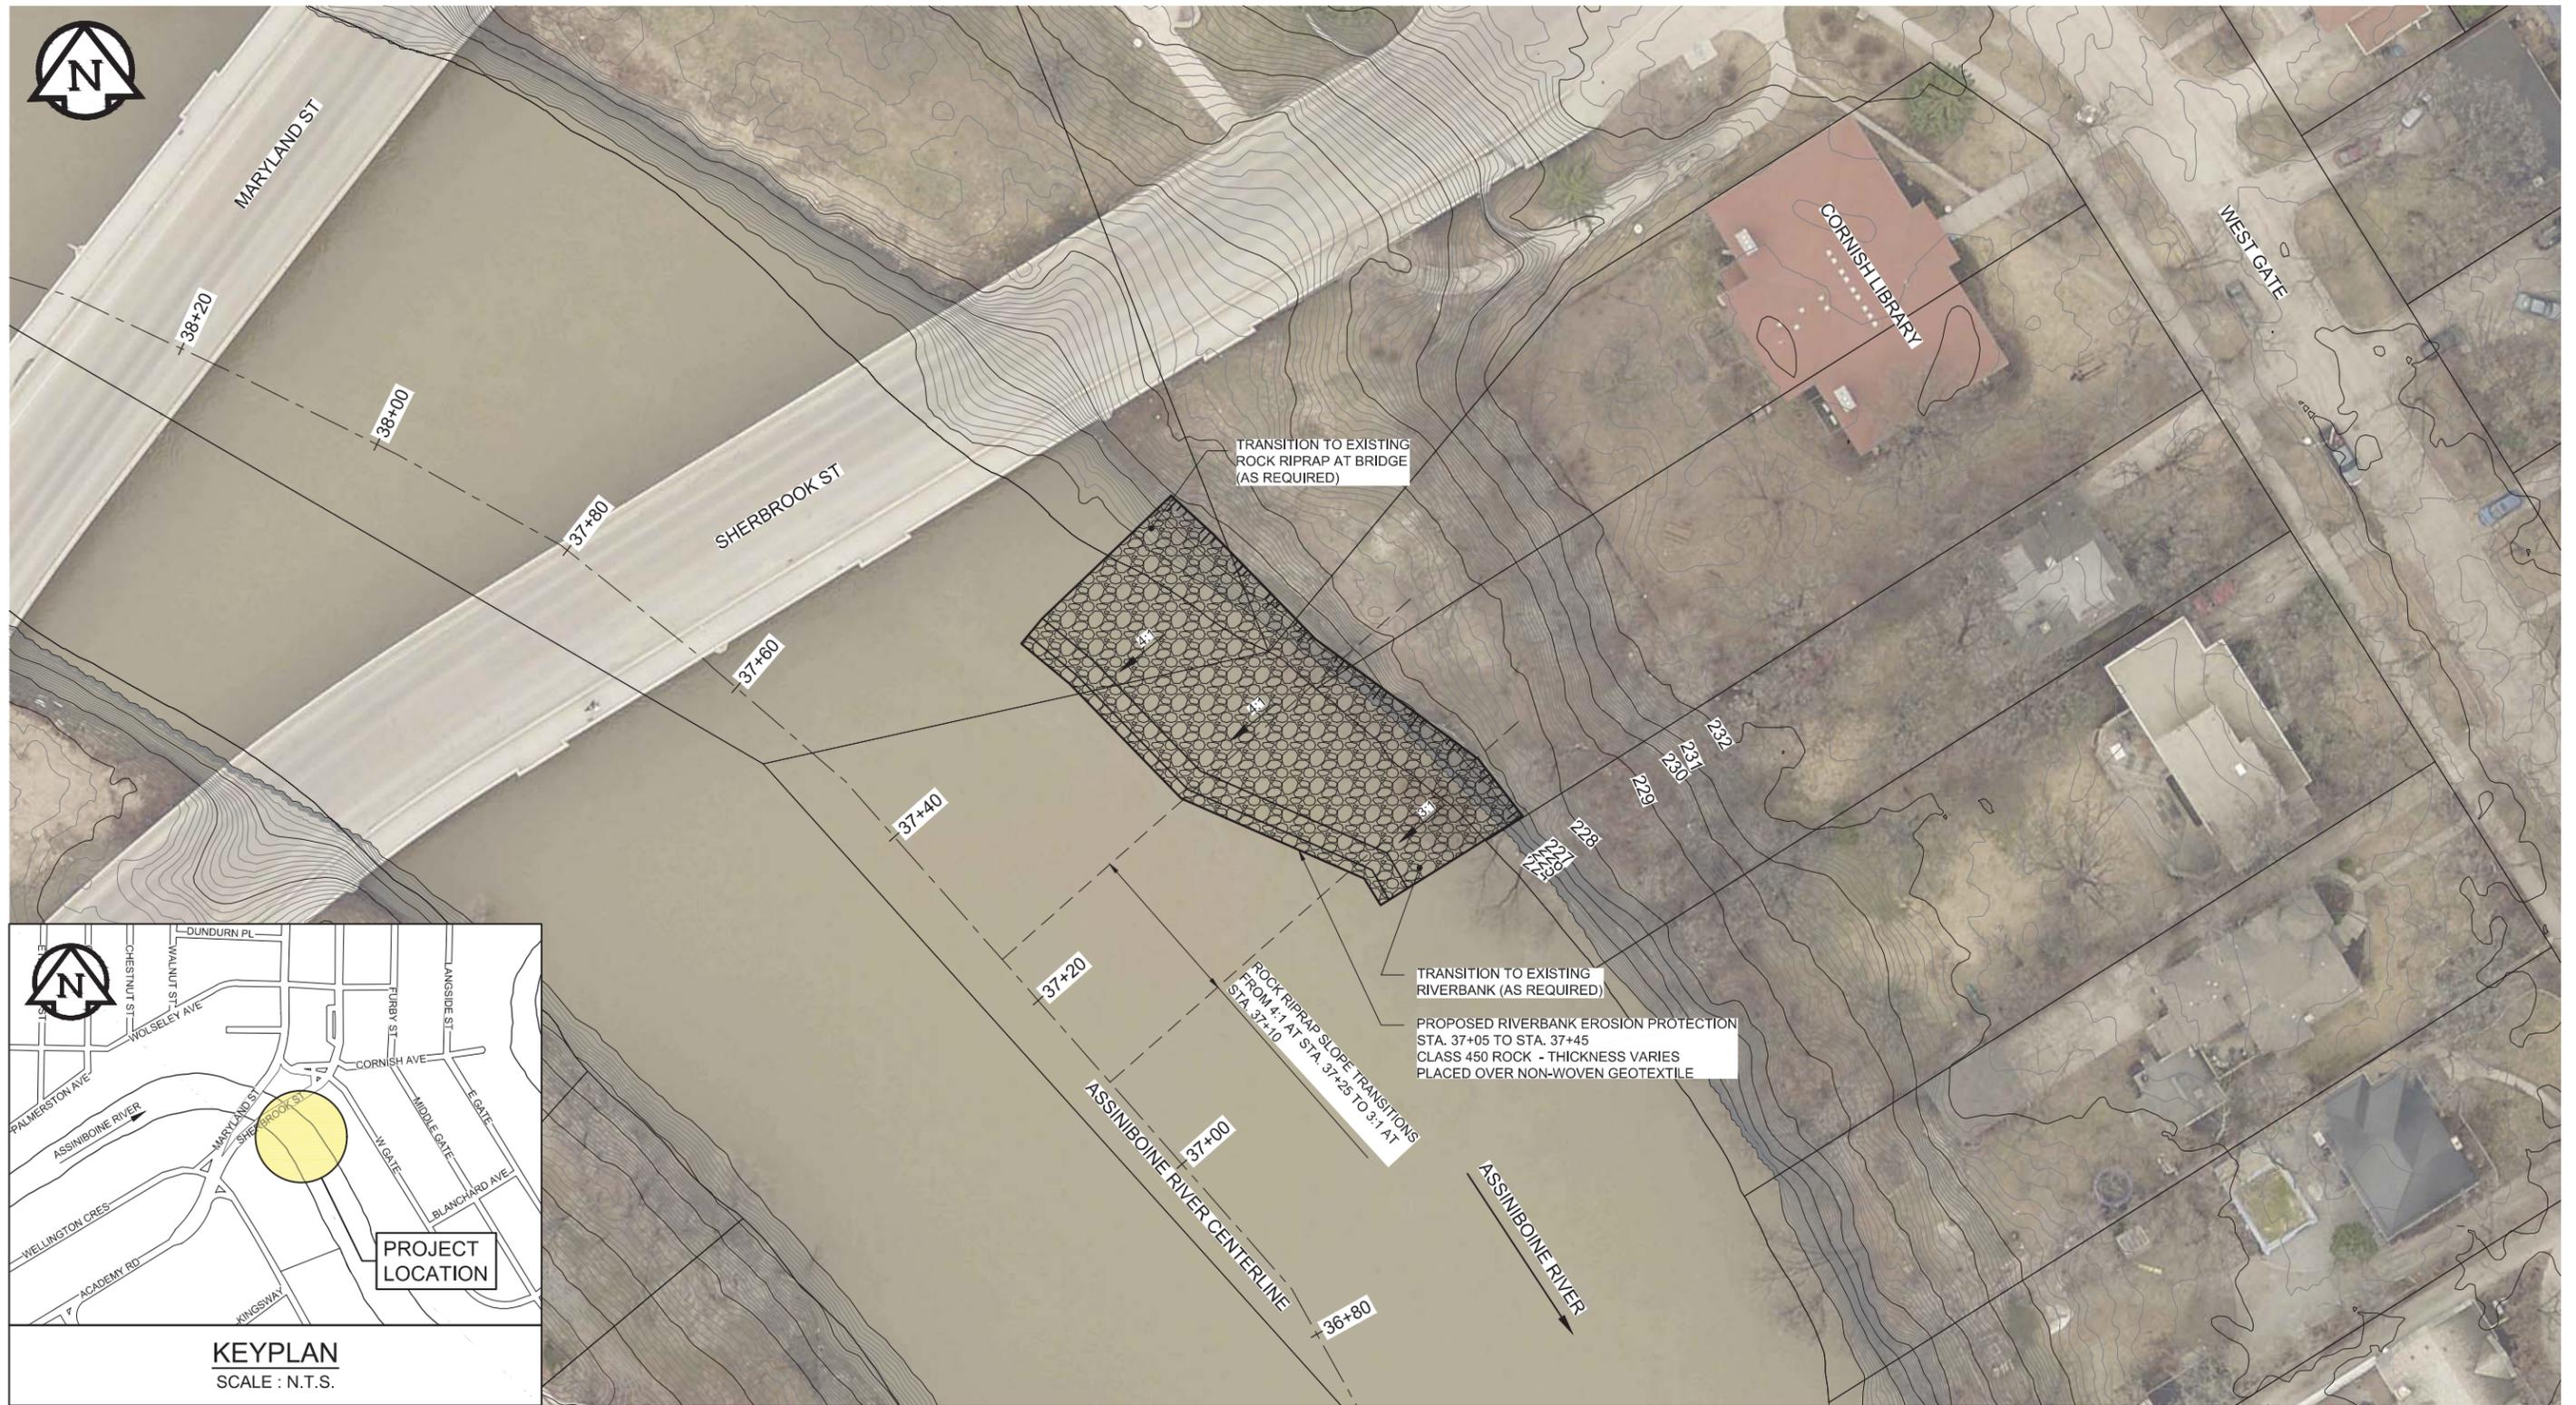
Figure 06
General Site Plan

The top of rock elevation has been chosen at an elevation of 226 m to fill in the existing head scarps and smooth the curvature of the slope. This height of protection is slightly above the minimum City of Winnipeg requirements which state the top of rock elevation should be at the Normal Summer Controlled Level of 223.75 plus 1.0 m which yields an elevation of 224.75. The proposed layout of the erosion protection measures are presented in plan view on Figure 06, and typical sections are shown on Figure 07.

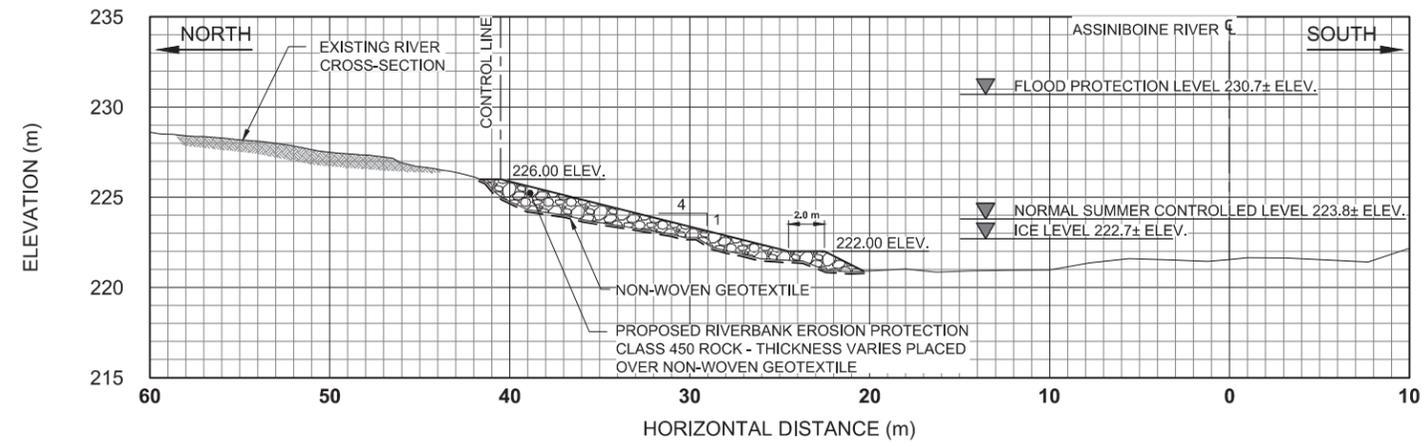
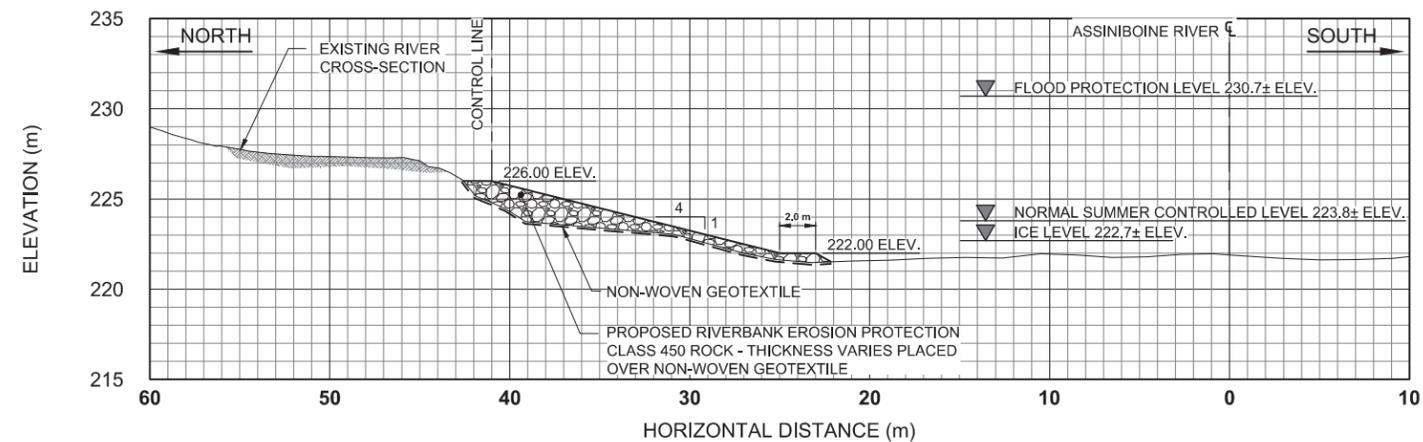
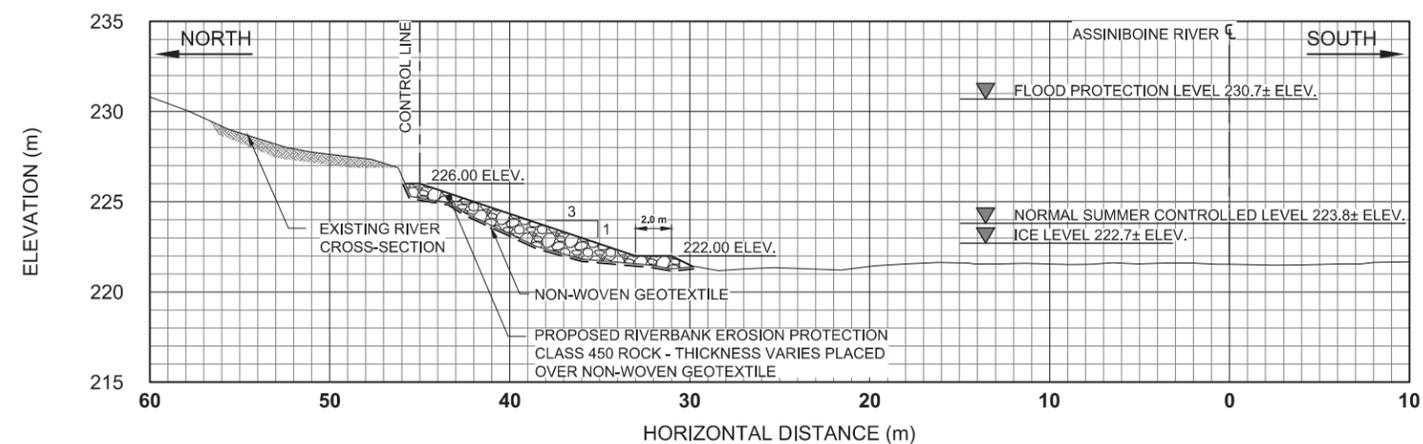
Figure 07
Cross Sections

01. CROSS SECTION A (STA. 37+45)

02. CROSS SECTION B (STA. 37+28)

03. CROSS SECTION C (STA. 37+11)
