Project
Cornish Library Renovation

Drawing
Details

Reviewed By
PS
Drawing No.
A-603

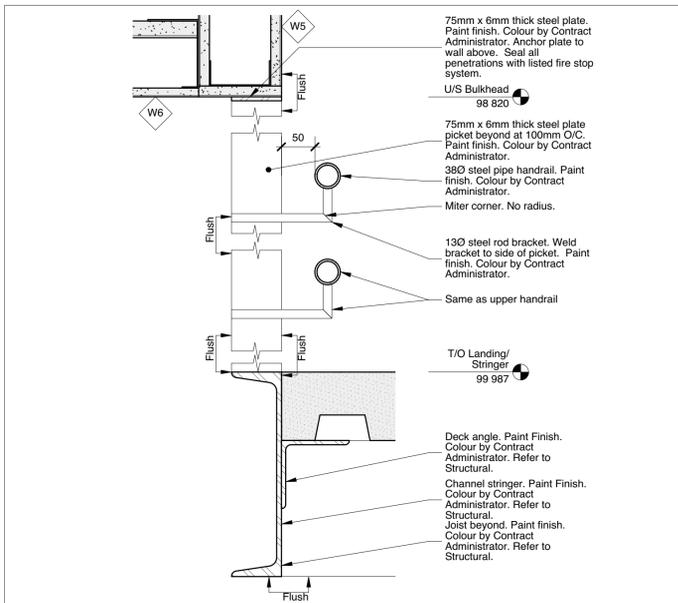
5 Section Detail - Exit Stair 001 Guardrail/Handrail
A-603 1:5
