4.19 ROLAND FLOOD PUMP STATION

KGS GROUP CONSULTING ENGINEERS	THE CITY OF WINNIPEG WATER & WASTE DEPARTMENT
	ROLAND FLOOD PUMP STATION
ELECTRICAL EXISTING SINGLE LINE DIAGRAM	
JUNE/2010	FIGURE 18-1

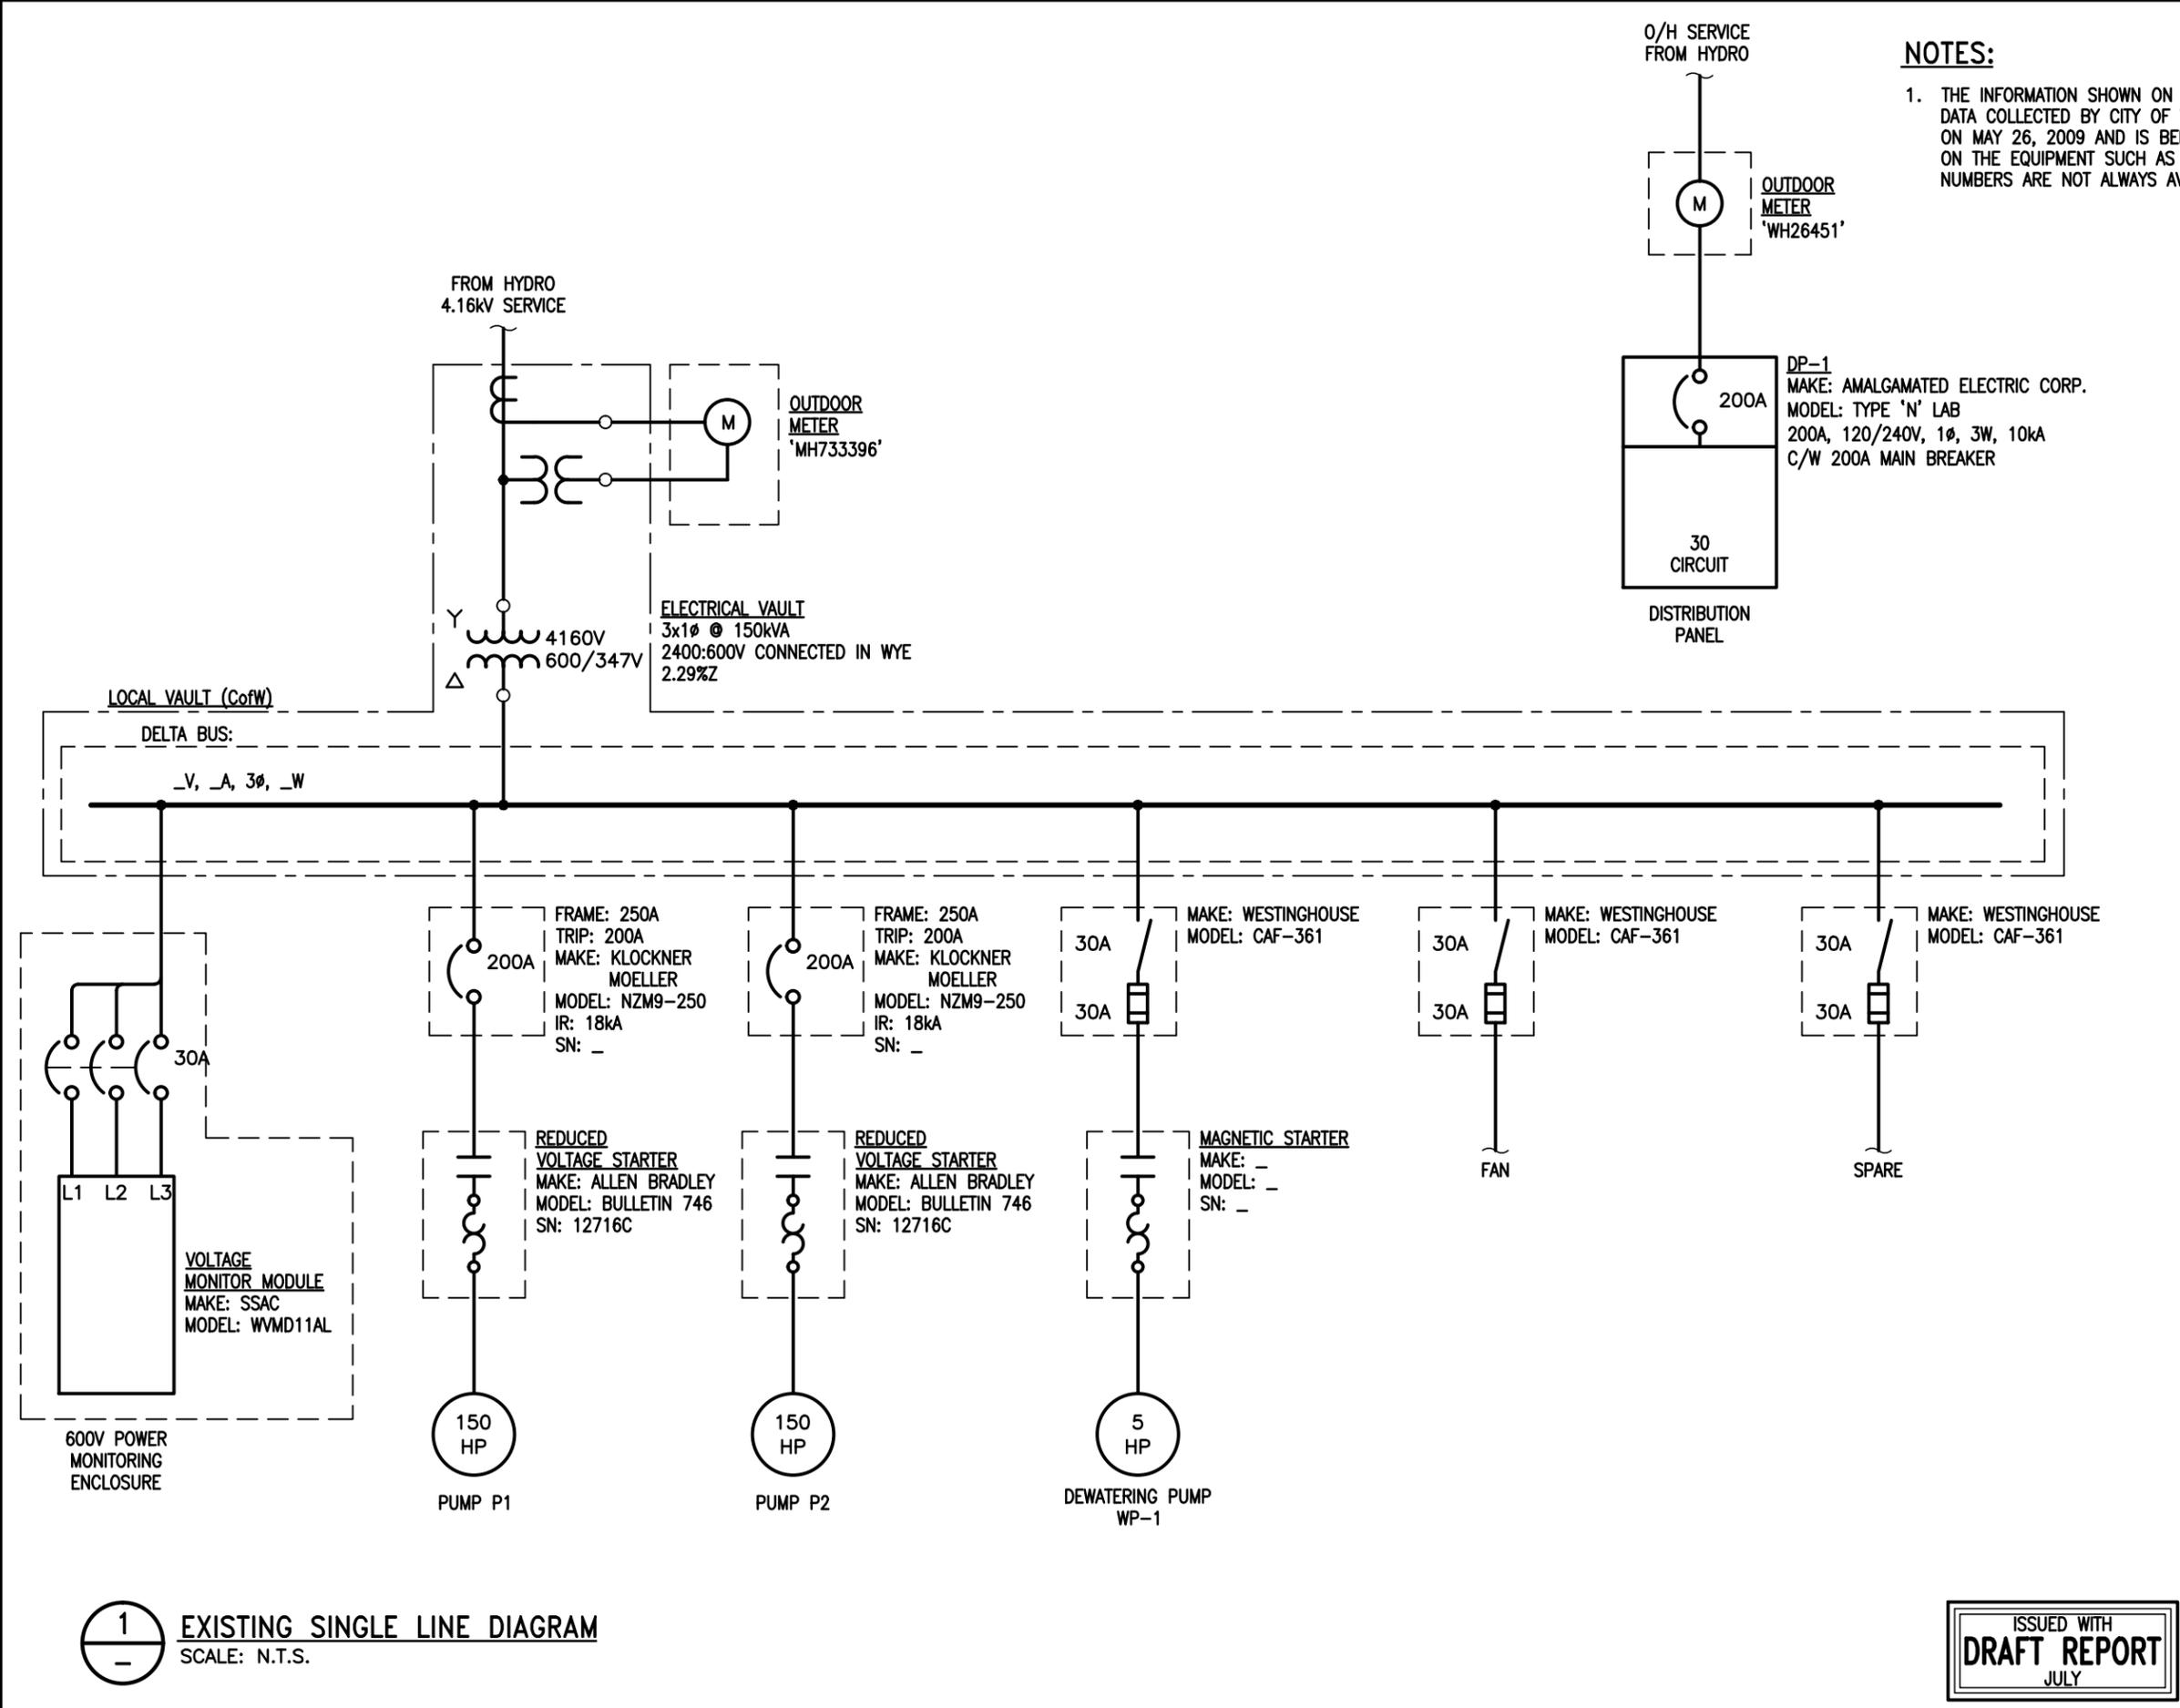
1
EXISTING SINGLE LINE DIAGRAM
 SCALE: N.T.S.

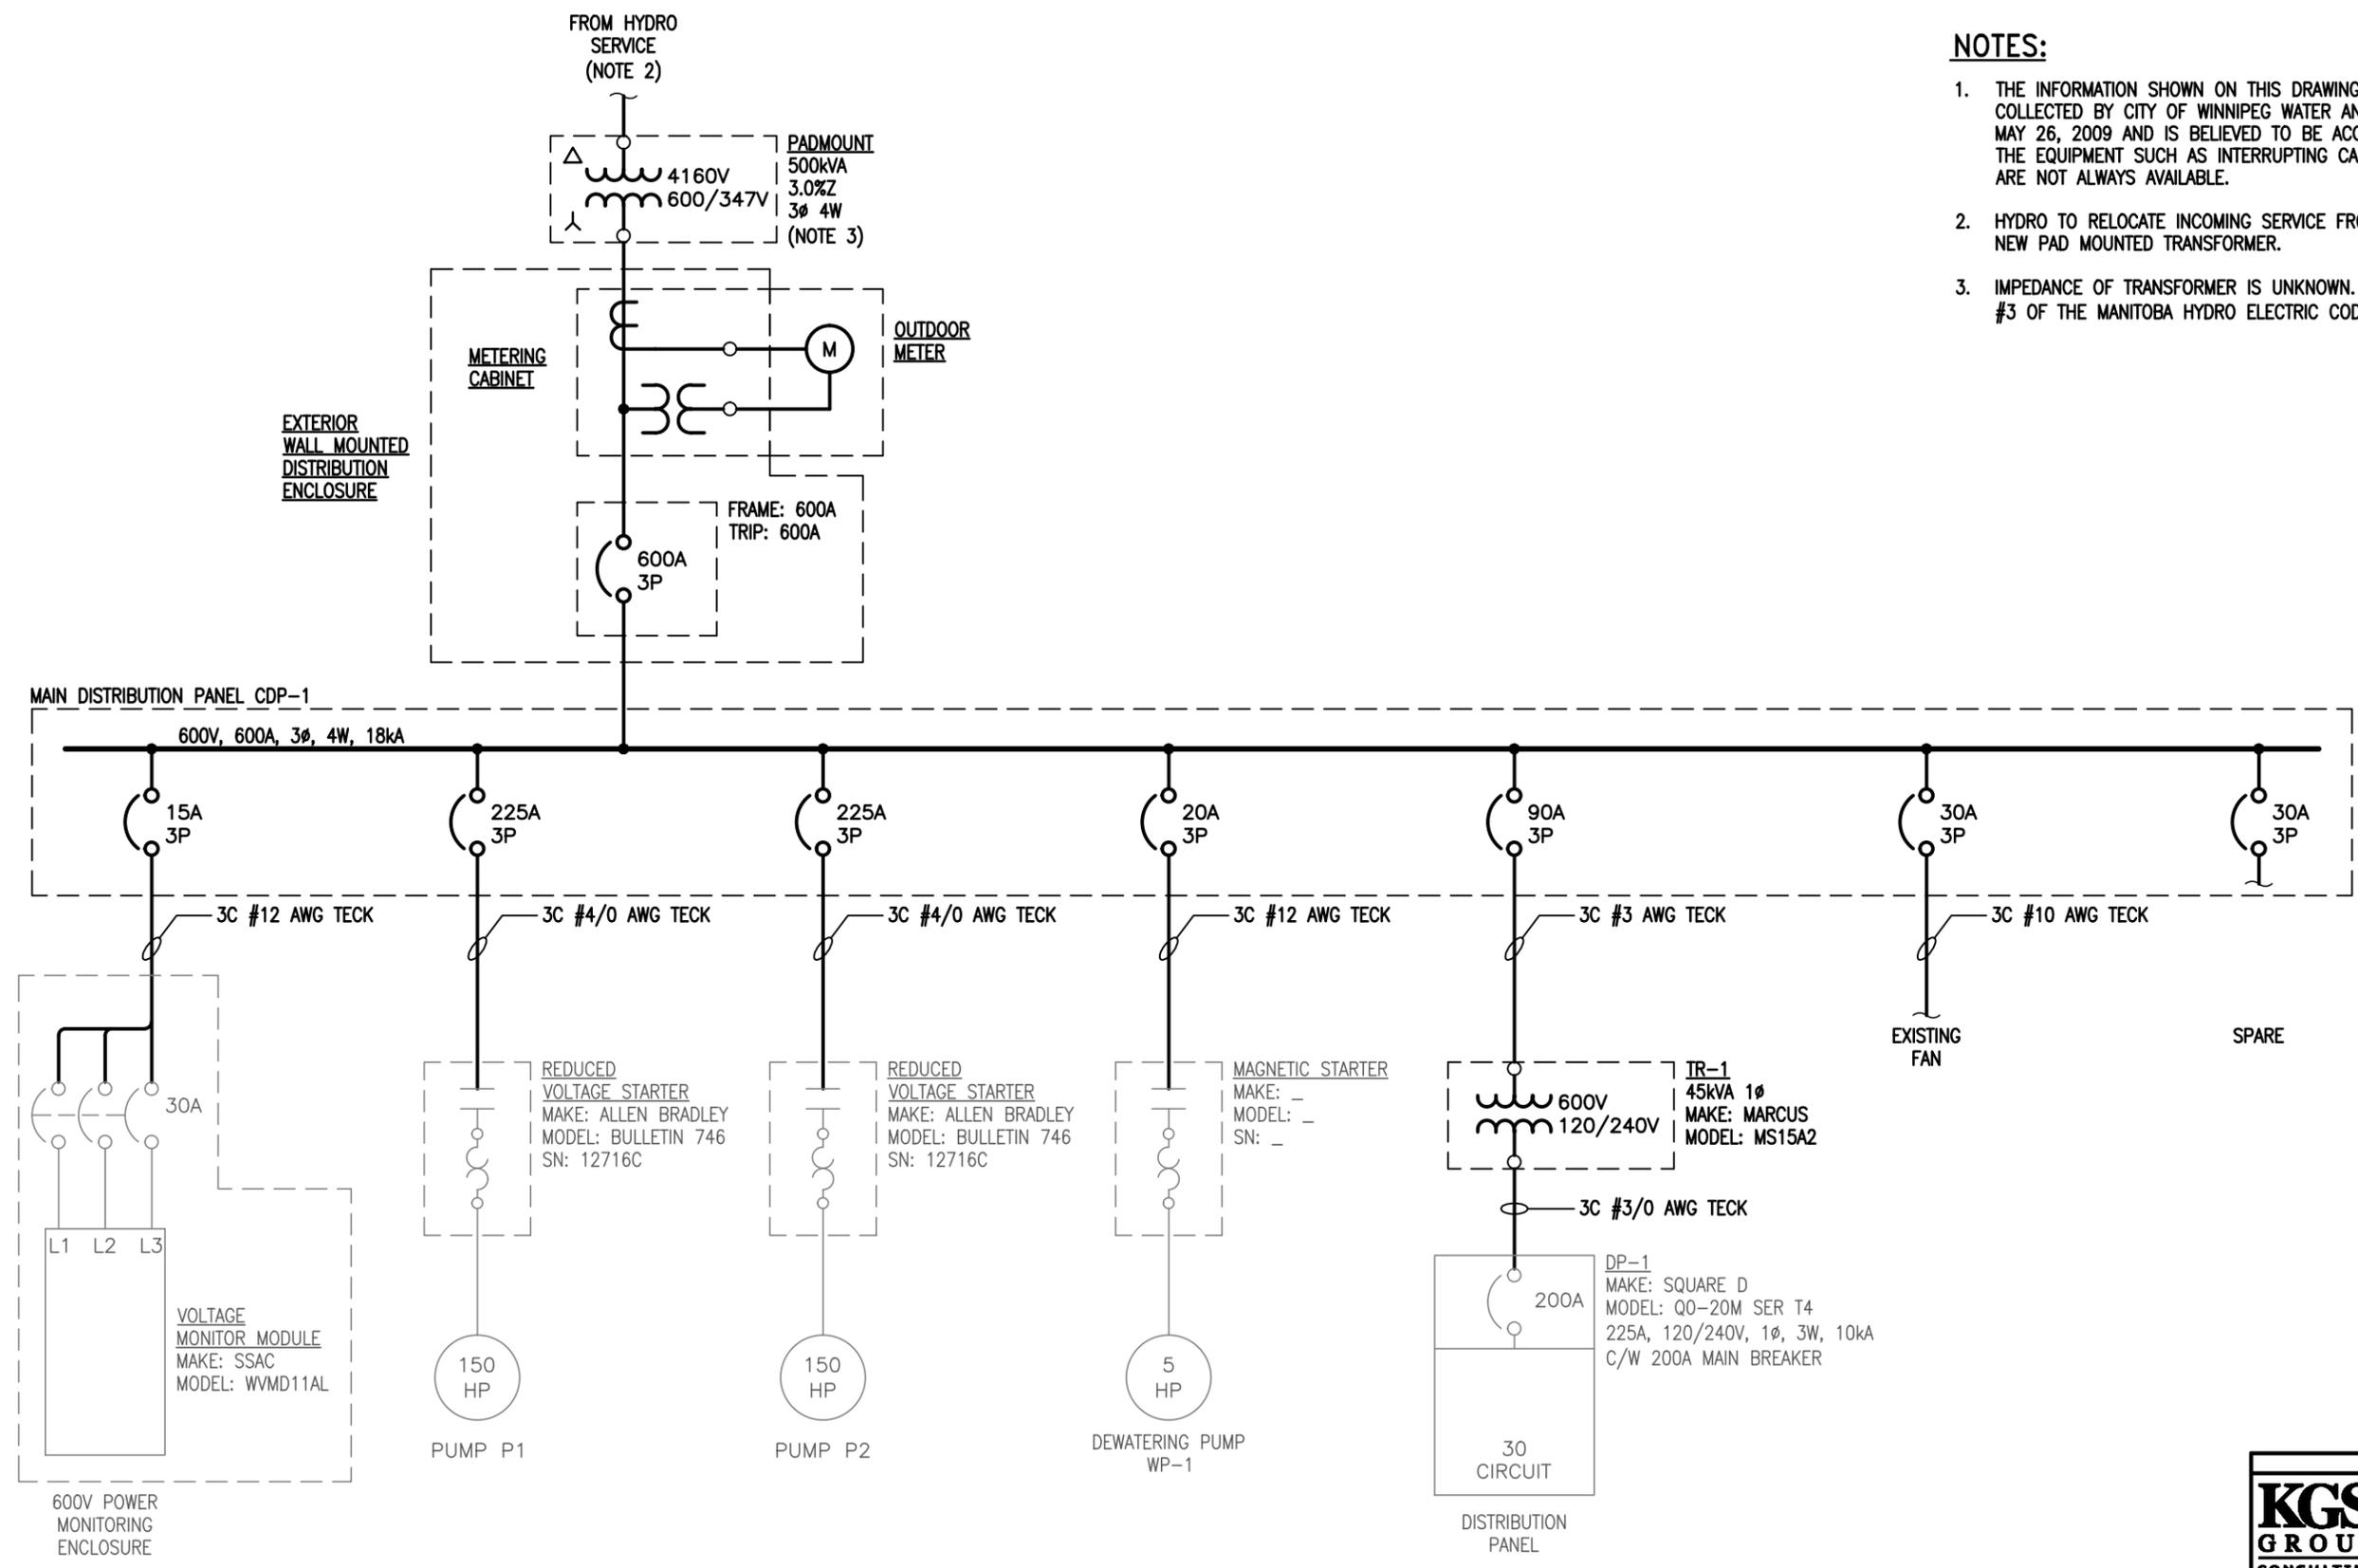
KGS GROUP CONSULTING ENGINEERS	 THE CITY OF WINNIPEG WATER & WASTE DEPARTMENT
ROLAND FLOOD PUMP STATION	
ELECTRICAL PROPOSED SINGLE LINE DIAGRAM - OPTION 'A'	
JULY/2010	FIGURE 18-2A

1
PROPOSED SINGLE LINE DIAGRAM - OPTION 'A'
 SCALE: N.T.S.

For the 600V distribution equipment, refurbishing (Option1) or replacing (Option 2) the existing ITE breakers would involve retaining the 600V delta bus. Accordingly we recommend that the existing three feeder breakers be removed and that a new 600 Amp CDP type panel c/w a main breaker and Hydro CT cabinet sections. Due to the complexity of upgrading the Hydro service and the stations 600V distribution equipment, we have provided two options. Figures 18-3a and 18-3b show the different installation location options for all the equipment. The corresponding single line diagram options of the refurbished station are shown on Figure 18-2a to 18-2c.

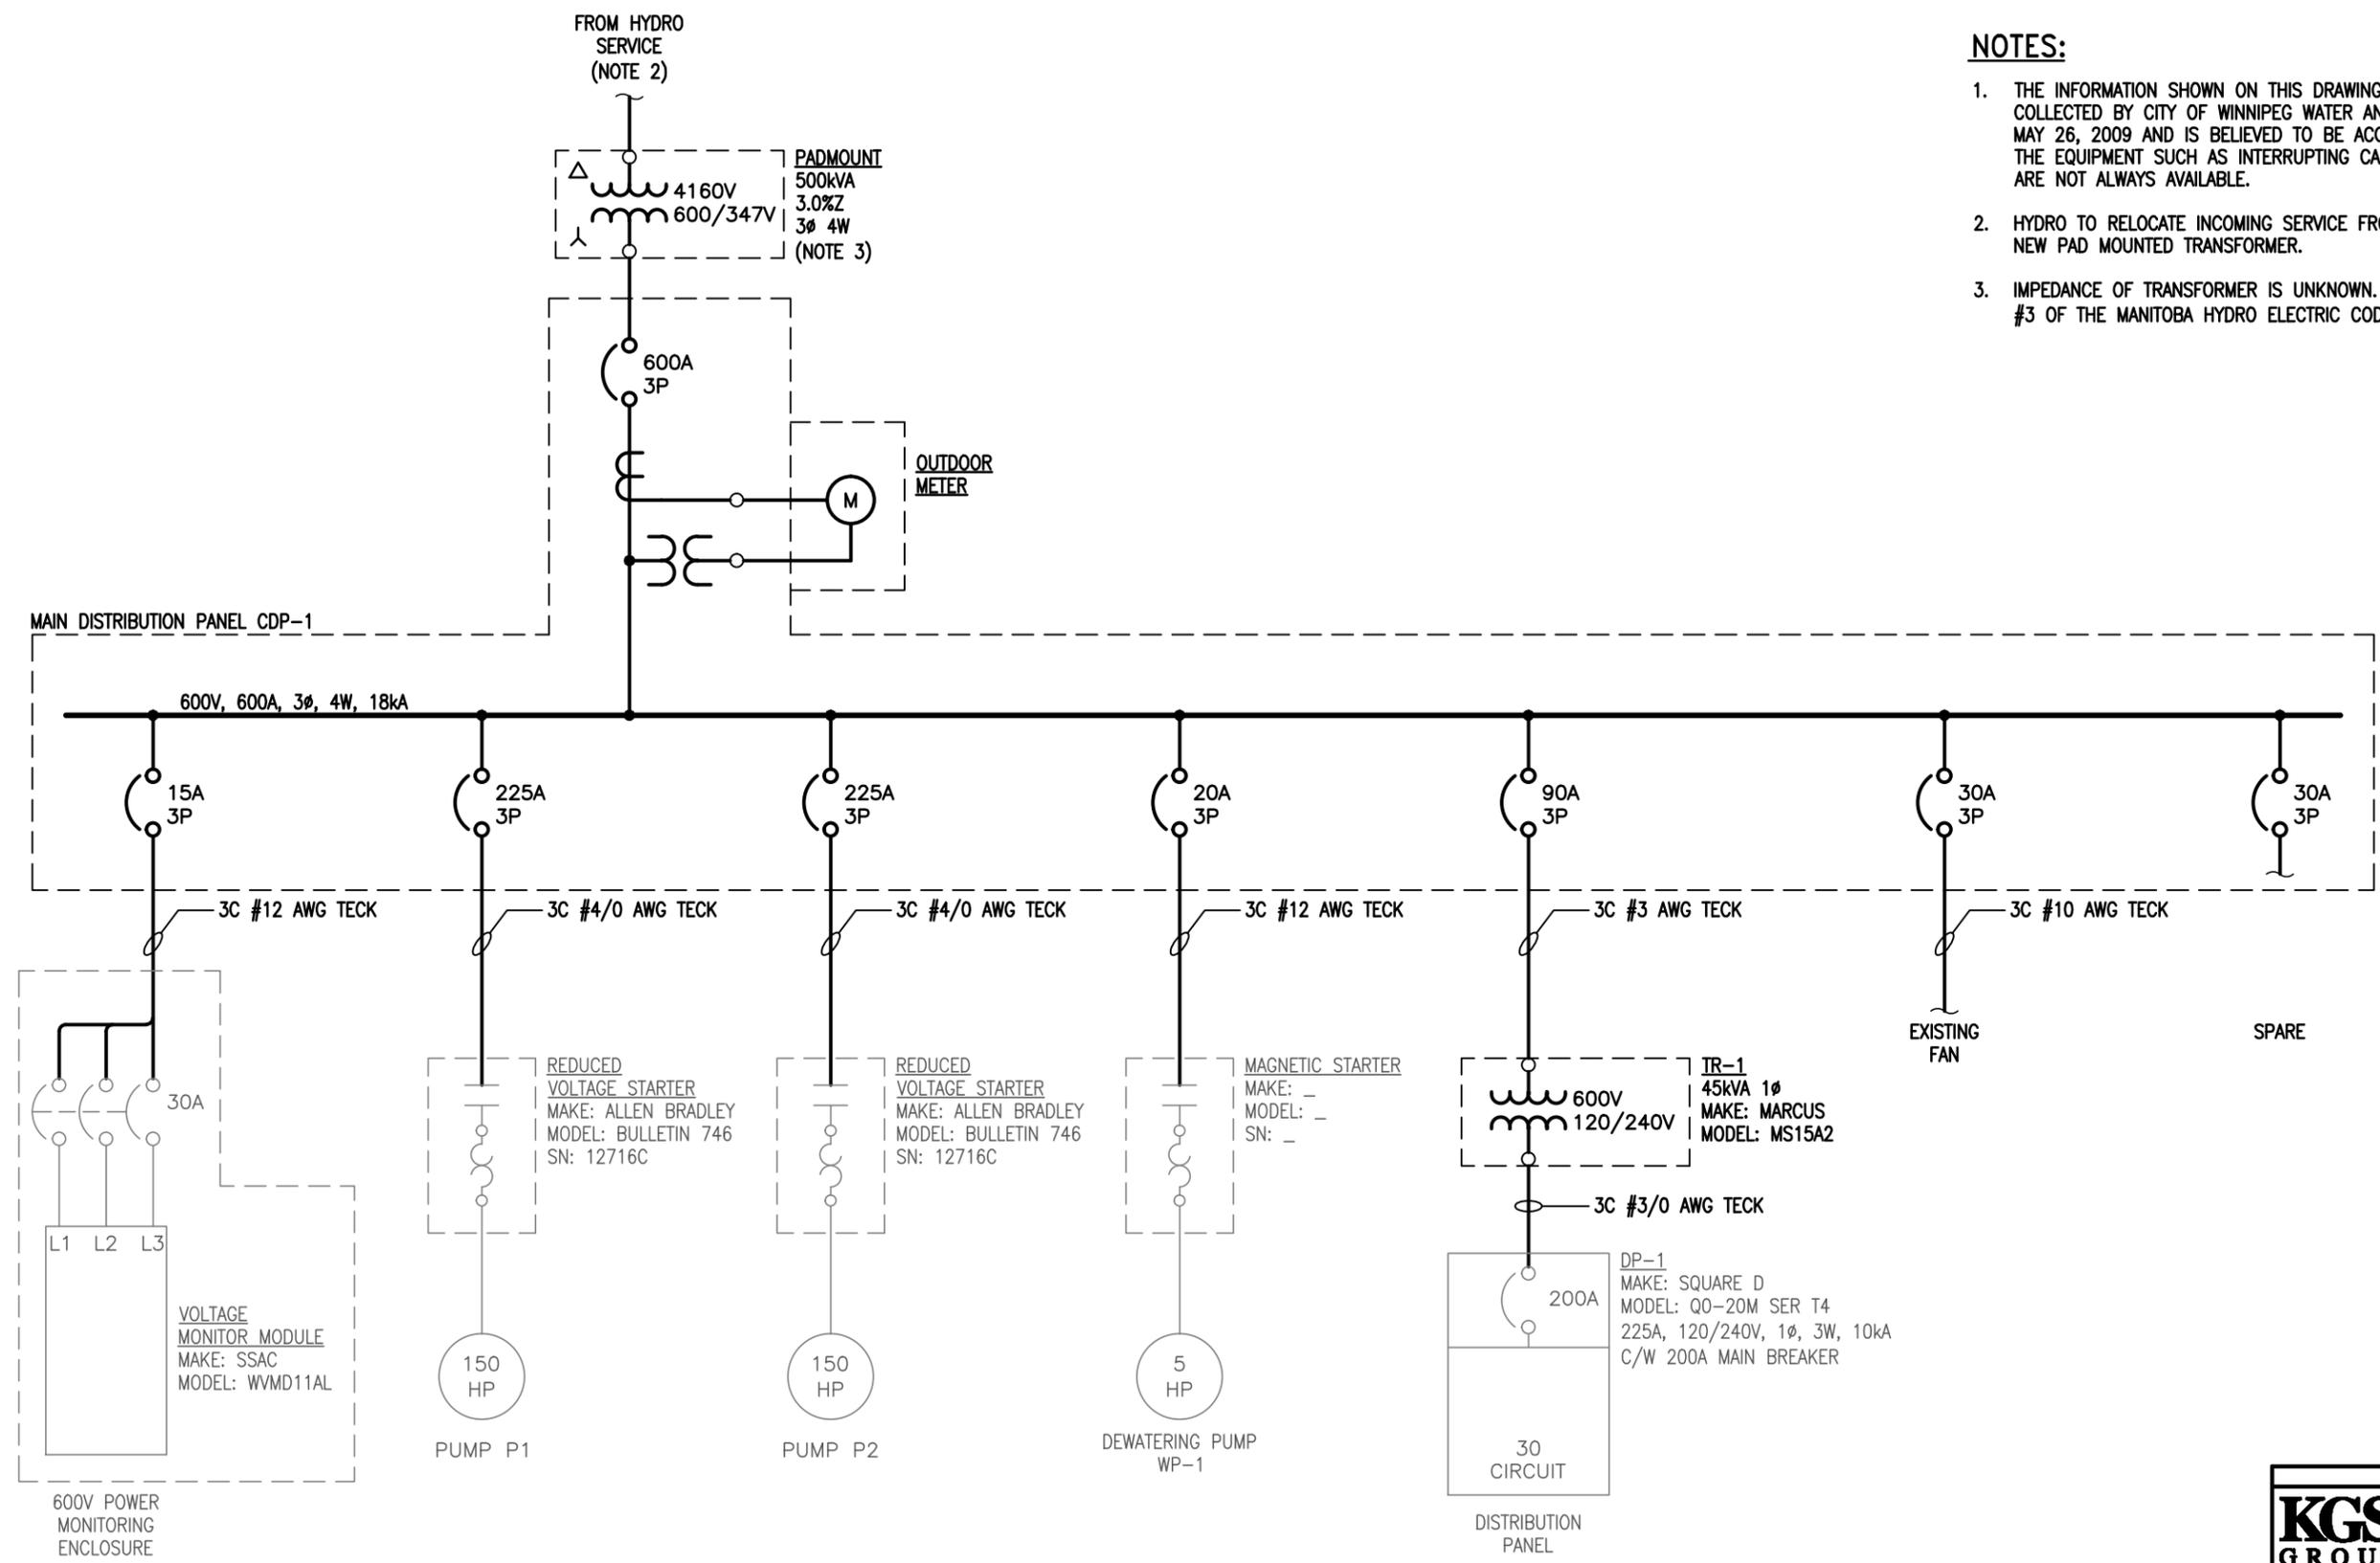
ROLAND FLOOD PUMP STATION
ELECTRICAL PROPOSED SINGLE LINE DIAGRAM - OPTION 'B'	
JULY/2010	FIGURE 18-2B

PROPOSED SINGLE LINE DIAGRAM - OPTION 'B'
 SCALE: N.T.S.

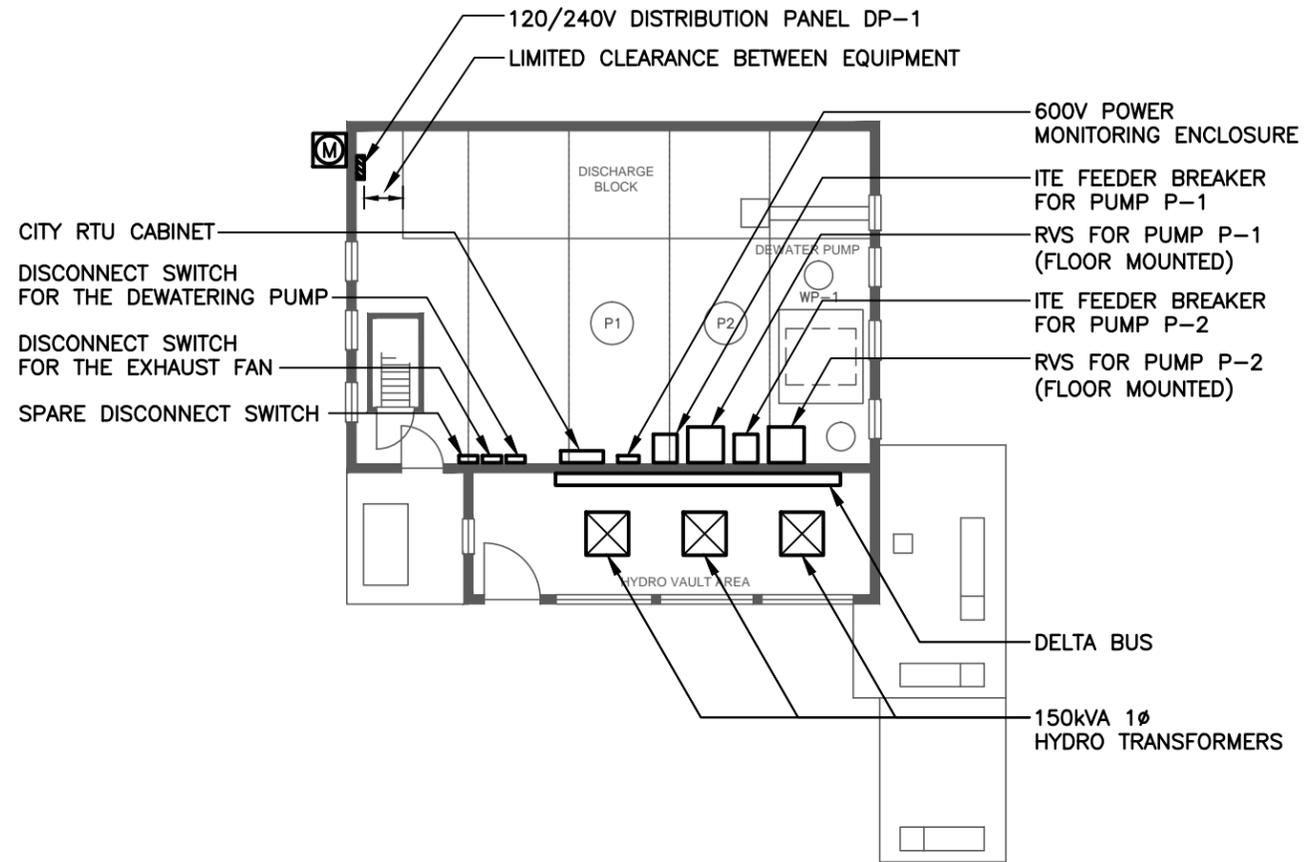
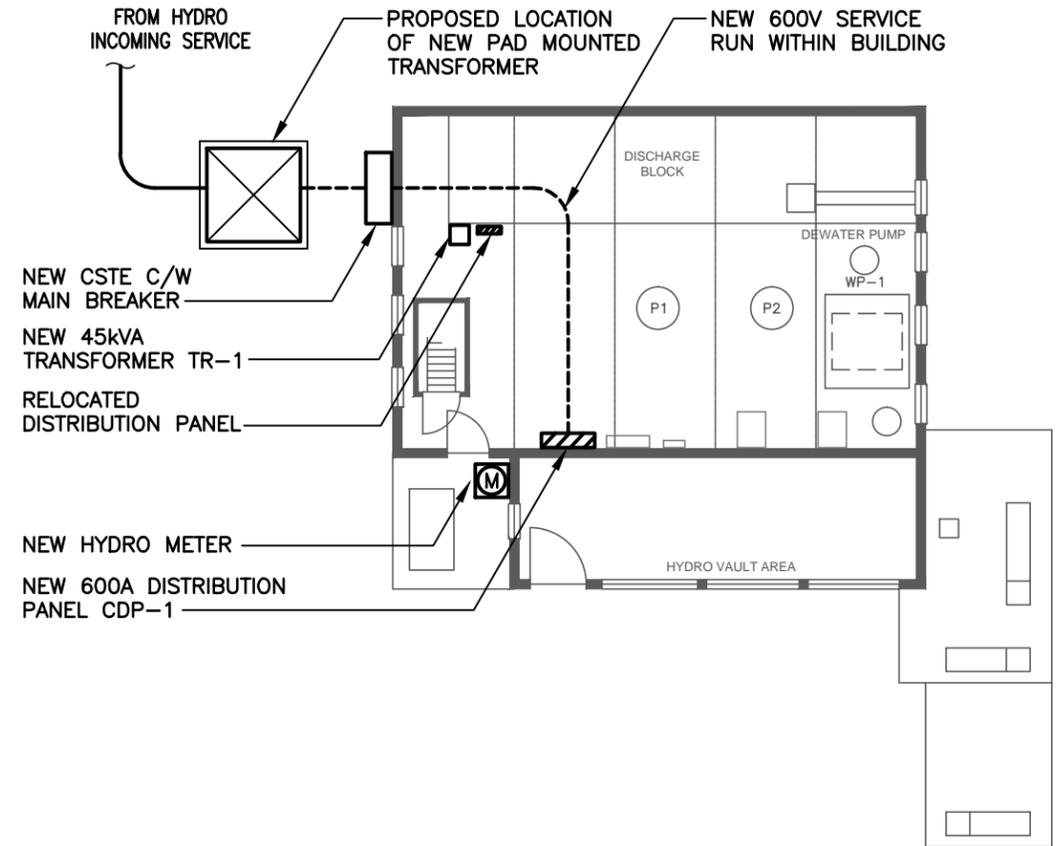
KGS GROUP CONSULTING ENGINEERS	
ROLAND FLOOD PUMP STATION	
ELECTRICAL EXISTING AND PROPOSED OPTION 'A' PLANS	
JULY/2010	FIGURE 18-3A

1
 EXISTING PLAN
 1 0 1 2 3 4 5m
 Scale: 1:150 Metric

2
 PROPOSED PLAN - OPTION 'A'
 1 0 1 2 3 4 5m
 Scale: 1:150 Metric

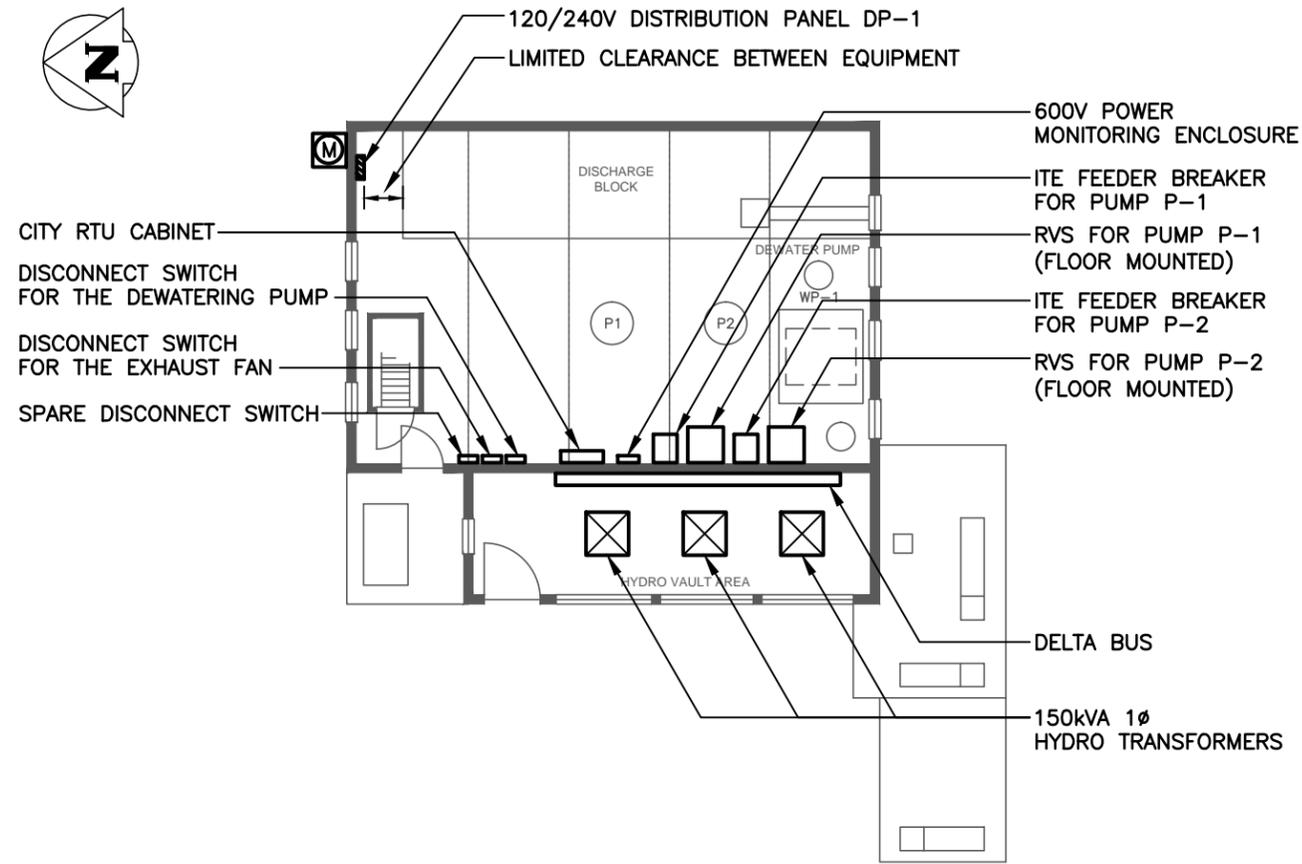
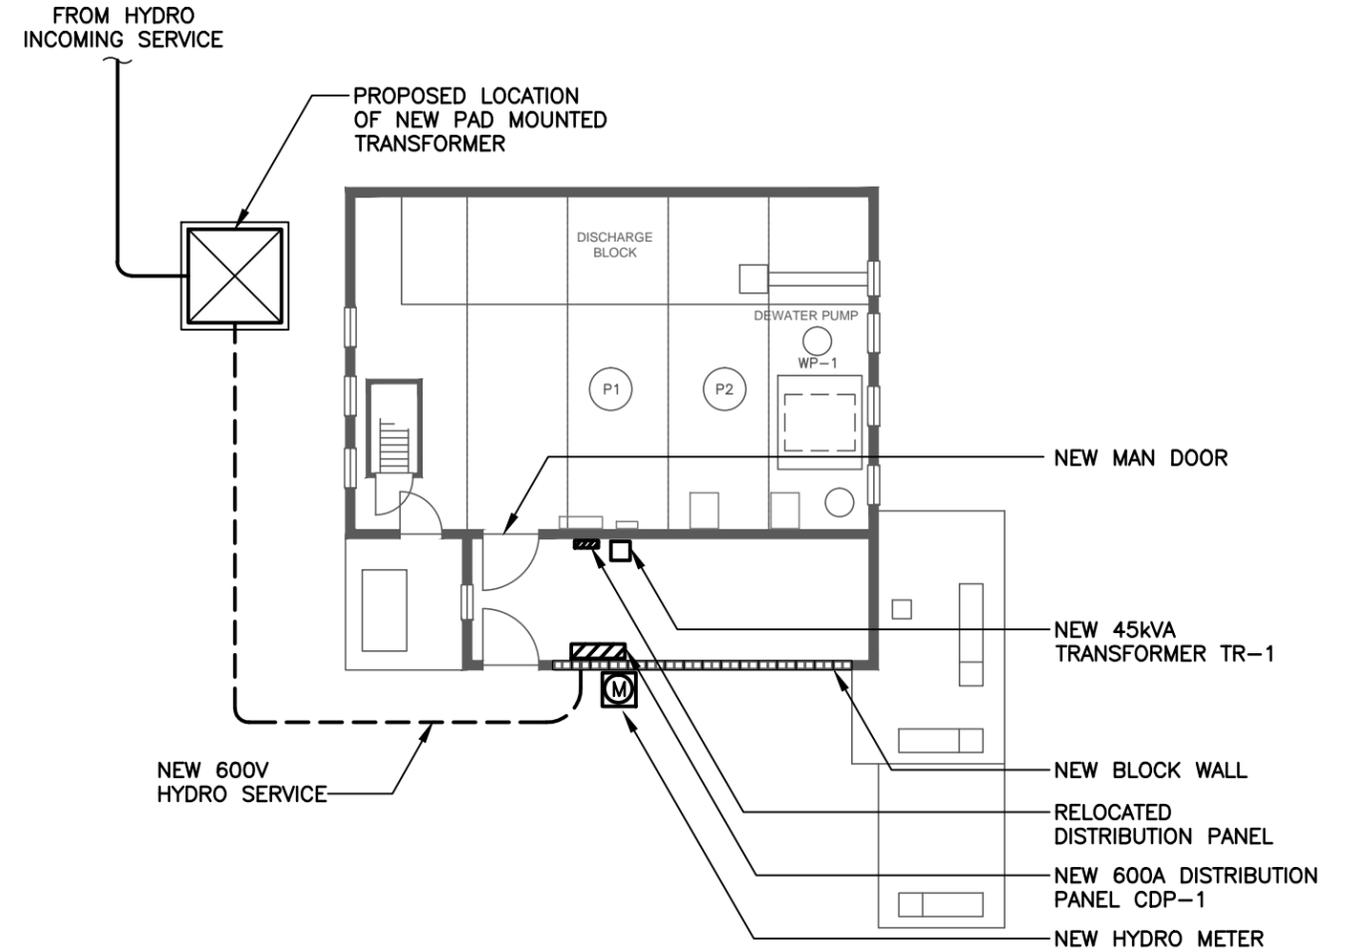
JULY/2010 FIGURE 18-3B -

1
 EXISTING PLAN
 1 0 1 2 3 4 5m
 Scale: 1:150 Metric

3
 PROPOSED PLAN - OPTION 'B'
 1 0 1 2 3 4 5m
 Scale: 1:150 Metric

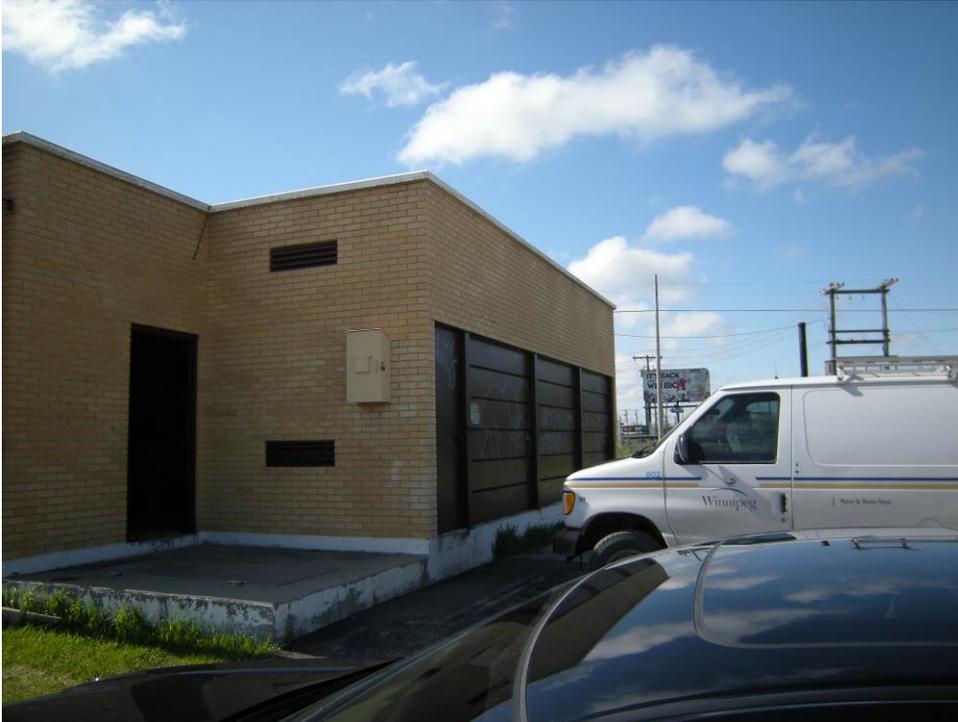
Photograph: 18-3
Description: West elevation of the pumping station
Date: May 26, 2009

This station contains an old Winnipeg Hydro service vault located in the southwest corner of the building. 5kV Manitoba Hydro service feeders entering into the old Winnipeg Hydro vault and terminates to a bank of floor mounted transformers. This vault contains three 2400V to 600V, 150kVA single phase transformers connected in a wye/delta configuration. The secondary side of the transformers terminate to a 600V delta bus. The delta bus provides individual 600V, 3 ph, 3-wire services to each of the two flood pump feeder breakers. (Refer to Photographs 18-3 to 18-7).

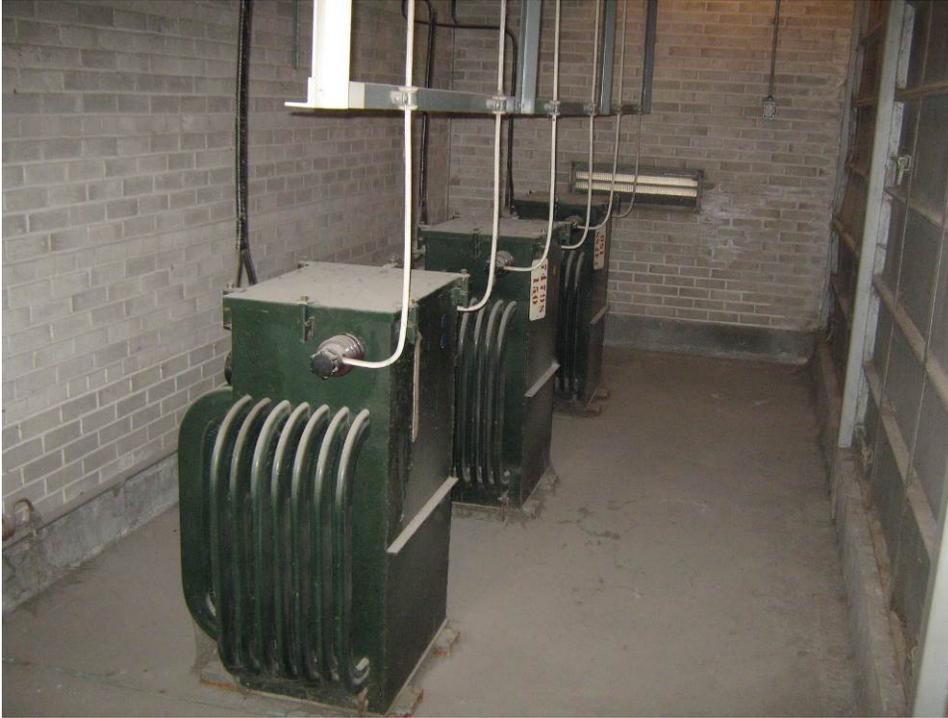
Photograph: 18-5
Description: 2400V/600V, 150kVA single phase transformers within the vault.
Date: May 26, 2009

The existing interior service entrance equipment configuration has been phased out from a number of other stations. This station is one of a select few that still contains this type of installation. We recommend that the existing service equipment be removing and replaced with an exterior Hydro owned pad mounted transformer.

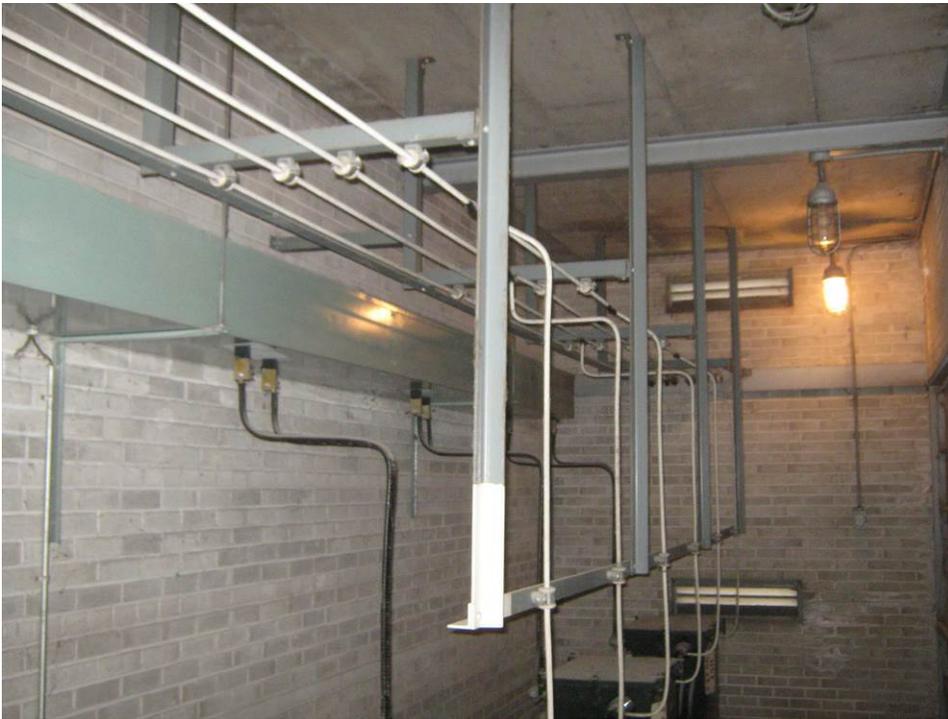
Photograph: 18-6
Description: 2400V/600V, 150kVA single phase transformers connected to the delta bus.
Date: May 26, 2009

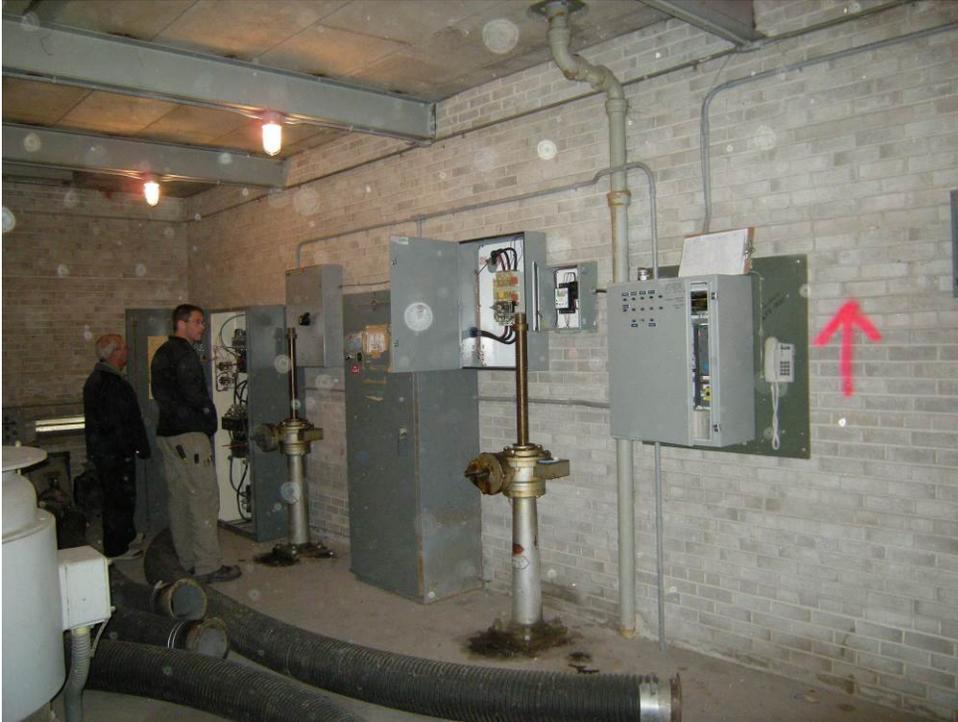
The two flood pump feeder breakers are mounted on the stations west interior wall. There are no ITE feeder breakers in this station. The two resistance type reduced voltage starters (RVS) are also original and are floor mounted up against the west wall next to their corresponding feeder breaker. (Refer to Photograph 18-5).

Photograph: 18-7
Description: Pump feeder breaker, RVS and RTU cabinet mounted on the stations west wall
Date: May 26, 2009

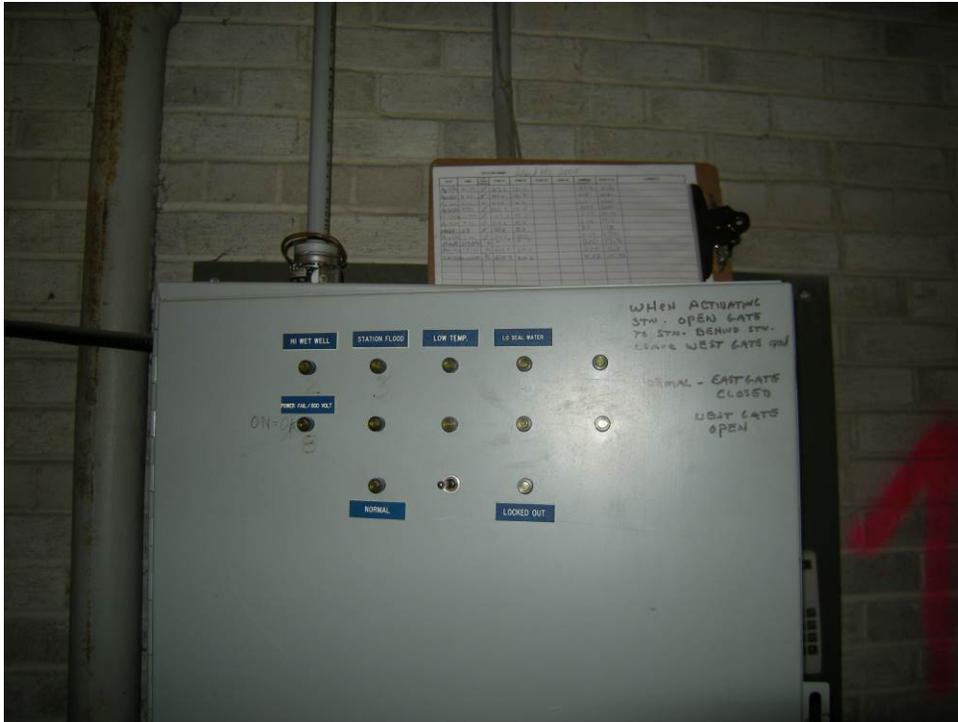
Photograph: 18-9
Description: Station's RTU cabinet mounted on the west wall
Date: May 26, 2009

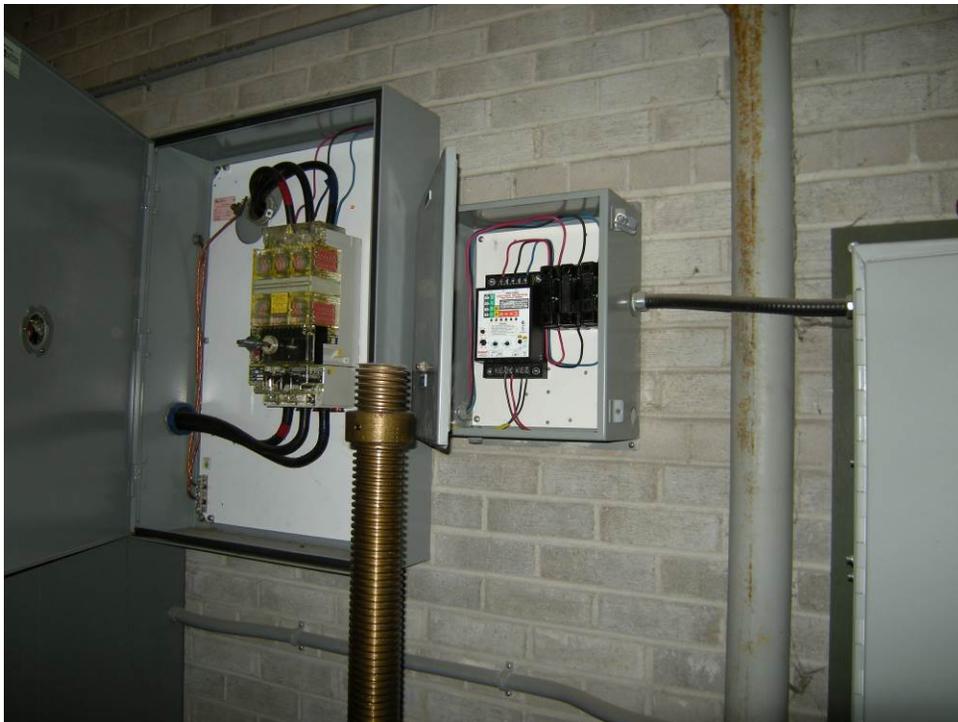
This distribution contains voltage-monitoring equipment. The power monitoring equipment consists of an ABB model SSAC-WVM011AL relay.

Photograph: 18-10
Description: Pump feeder breaker and 600V power monitoring cabinet mounted on west wall
Date: May 26, 2009

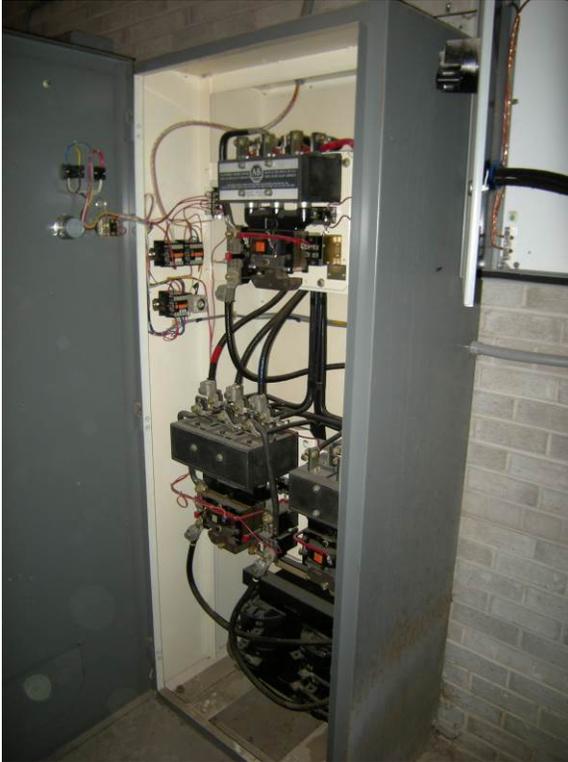
Photograph: 18-11
Description: RVS cabinet mounted on west wall
Date: May 26, 2009

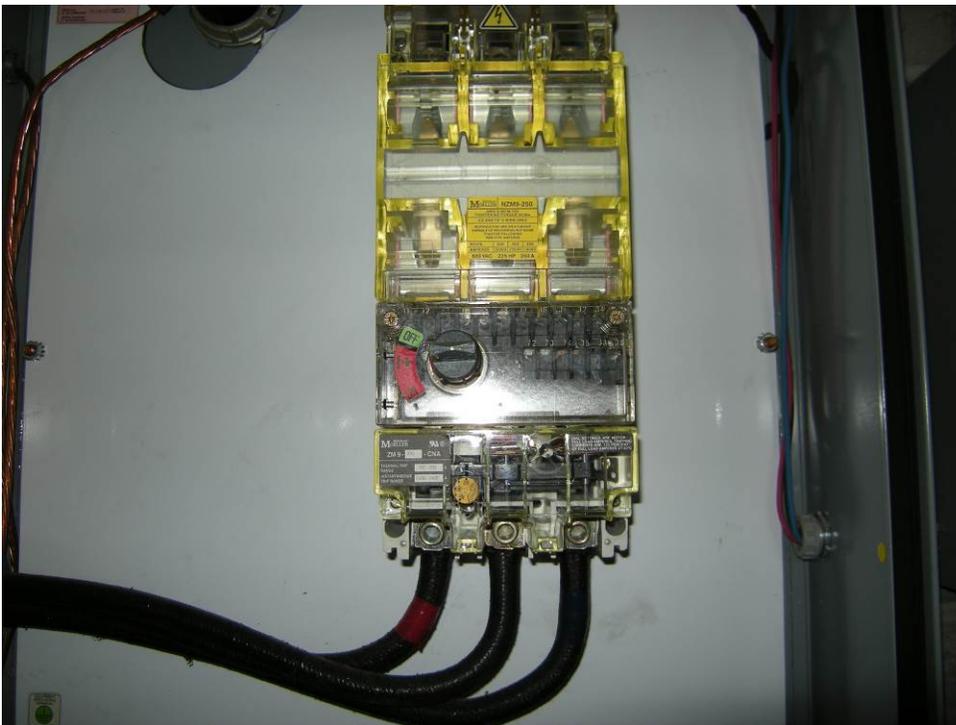
Photograph: 18-12
Description: Pump feeder breaker in the enclosure
Date: May 26, 2009

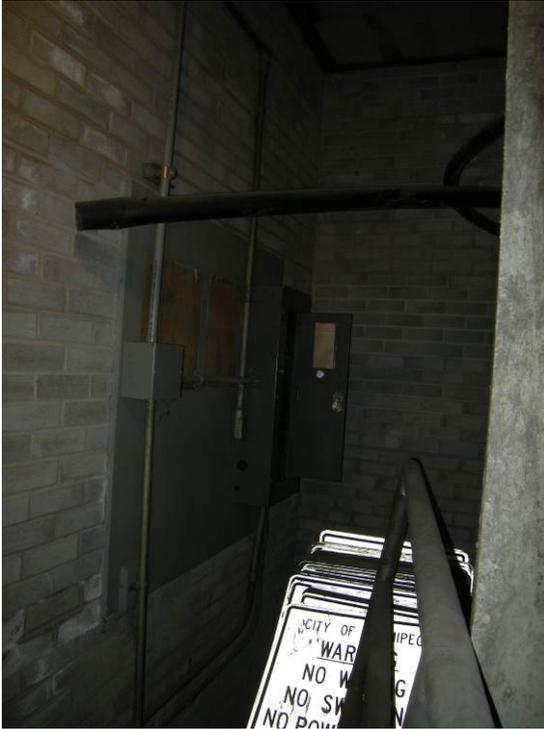
In addition, this station contains a 120/240V Manitoba Hydro service. This service is overhead and enters the building on the northeast corner and connects to a 200A, 40 circuit, 120/240V distribution panel c/w a 200A main breaker. There is insufficient clearance in front of the panel to meet CEC requirements for 1m clear working space in front of the equipment. (Refer to Photograph 18-11).

Photograph: 18-13
Description: 120/240V distribution mounted on the north wall
Date: May 26, 2009

This station currently has a second additional service. We recommend that at this time the second 120/240V service be removed and relocated the loads to the new 600V service via a new 15kVA transformer.

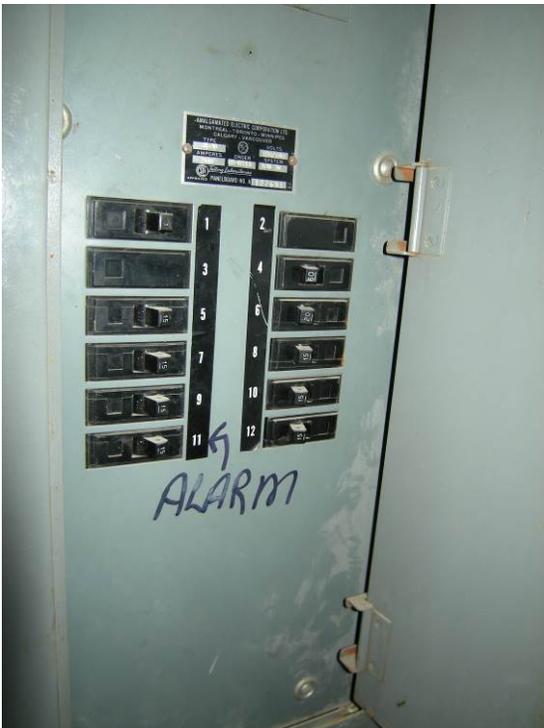
Photograph: 18-14
Description: 120/240V distribution panel
Date: May 26, 2009
