4.19 ROLAND FLOOD PUMP STATION

KGS GROUP CONSULTING ENGINEERS	THE CITY OF WINNIPEG WATER & WASTE DEPARTMENT
	ROLAND FLOOD PUMP STATION
ELECTRICAL EXISTING SINGLE LINE DIAGRAM	
JUNE/2010	FIGURE 18-1

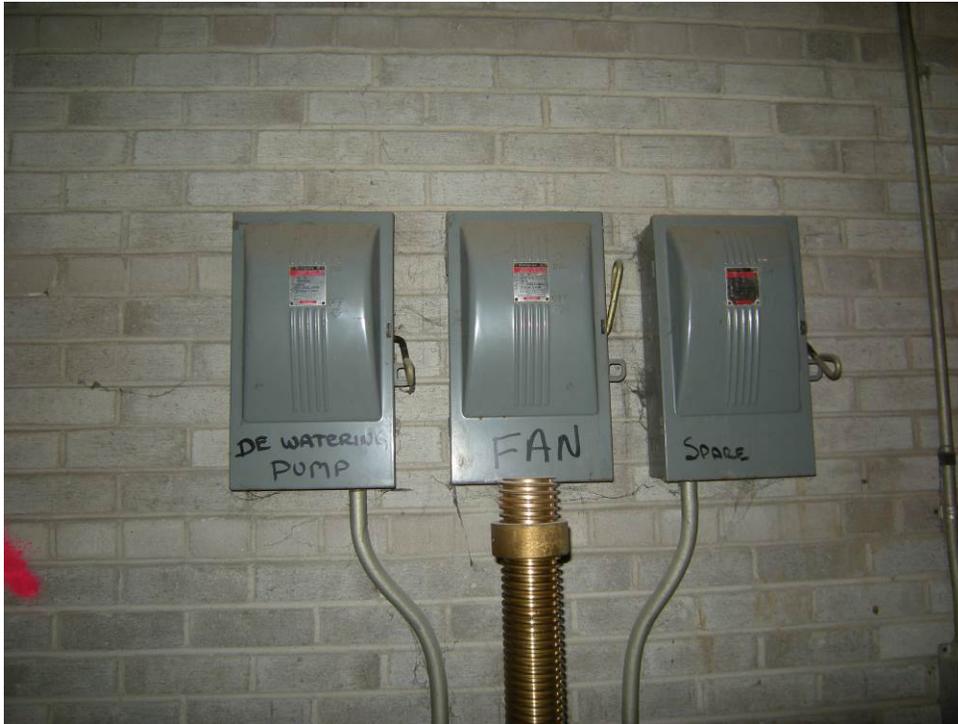
Photograph: 18-15
Description: 600V disconnect switches mounted on the west wall
Date: May 26, 2009
