Project
ST. JAMES CENTENNIAL POOL
STEEL COLUMNS REPAIR

Sheet Title
SECTIONS AND TYPICAL REPAIR DETAILS

File	2018-0383	Date	2018-07-02
Design	SMC	Drawn	MAH
Revision	2	Sheet No.	S2.1

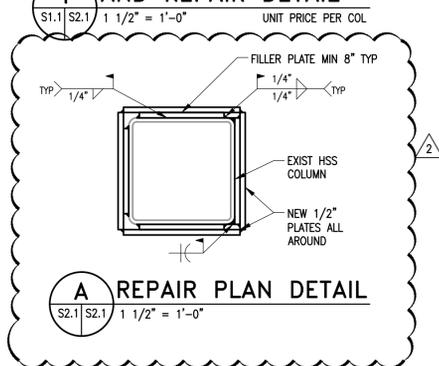
1 COLUMN REINFORCING AND REPAIR DETAIL

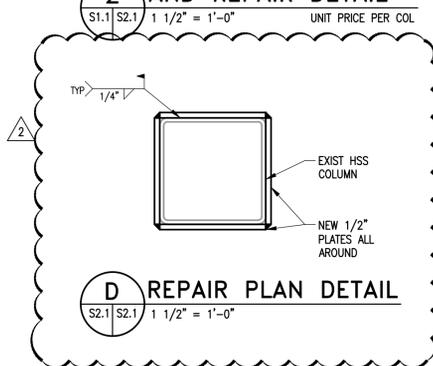
2 COLUMN REINFORCING AND REPAIR DETAIL

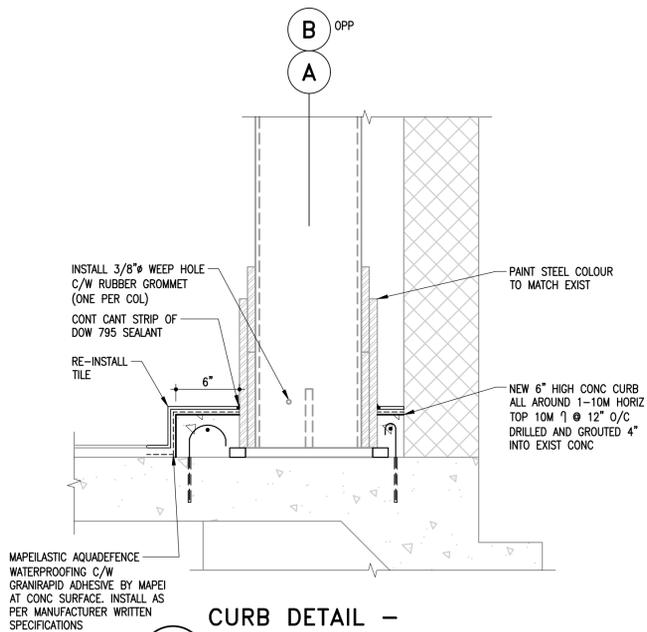
4 CURB DETAIL - OPTION A & B

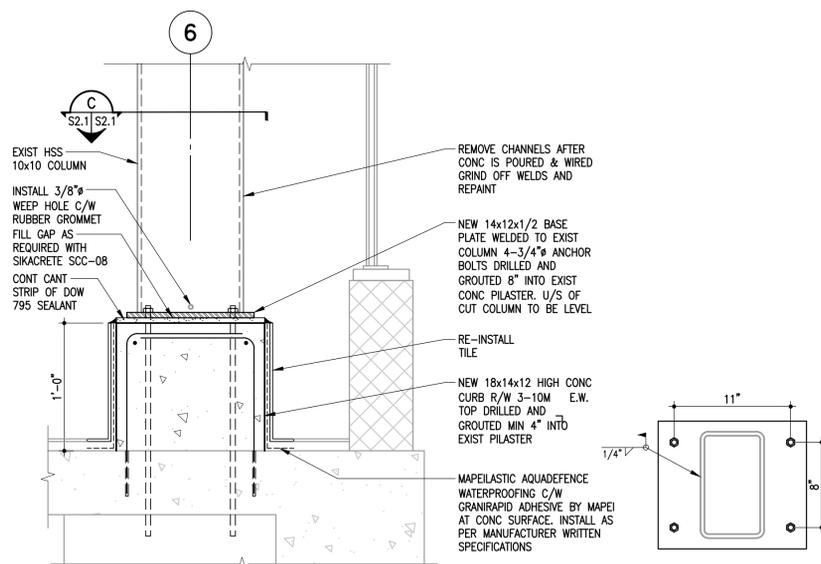
5 CURB DETAIL - OPTION C
