**THE CITY OF WINNIPEG**  
PUBLIC WORKS DEPARTMENT  
ENGINEERING DIVISION

**EMPRESS STREET PROJECT**  
OVERPASS REHABILITATION WORKS  
SUBSTRUCTURE  
NORTH PIER CAP DEFECT MAP  
AND SURFACE REPAIRS

CITY DRAWING NUMBER  
P-3494-91  
SHEET 91 OF 168  
DRAWING No. REV  
91 D

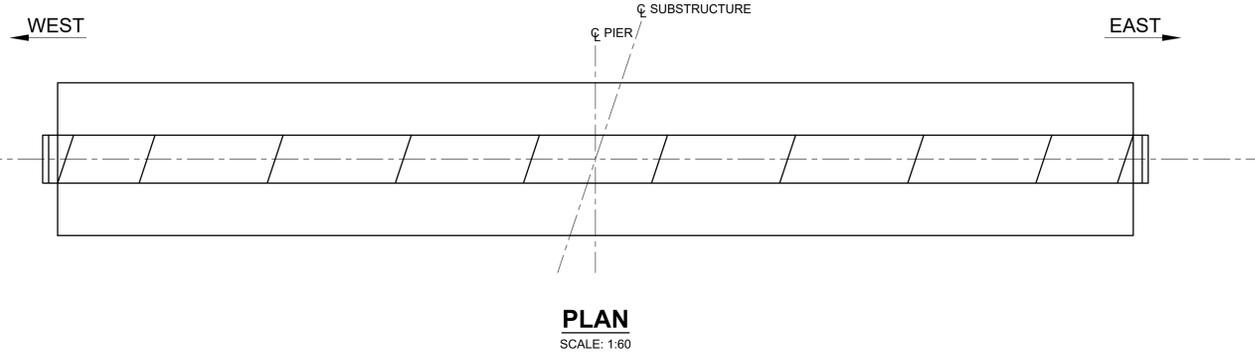
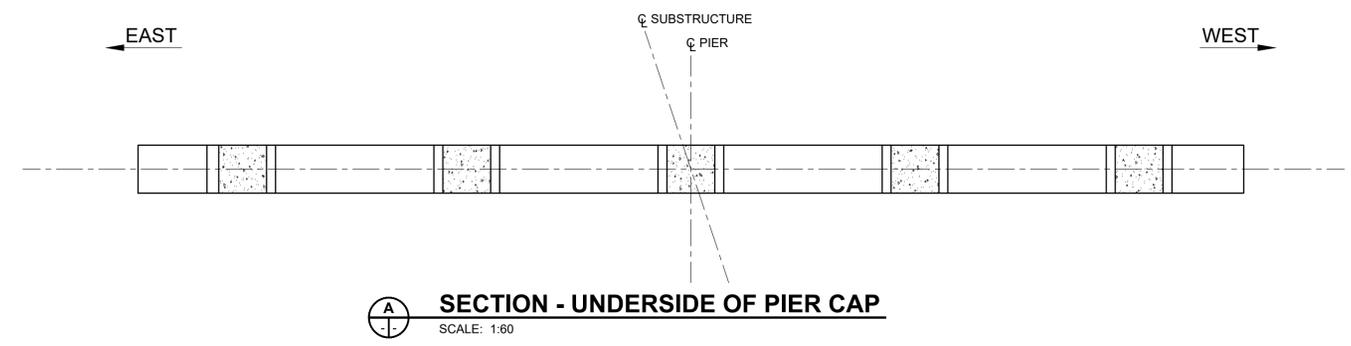
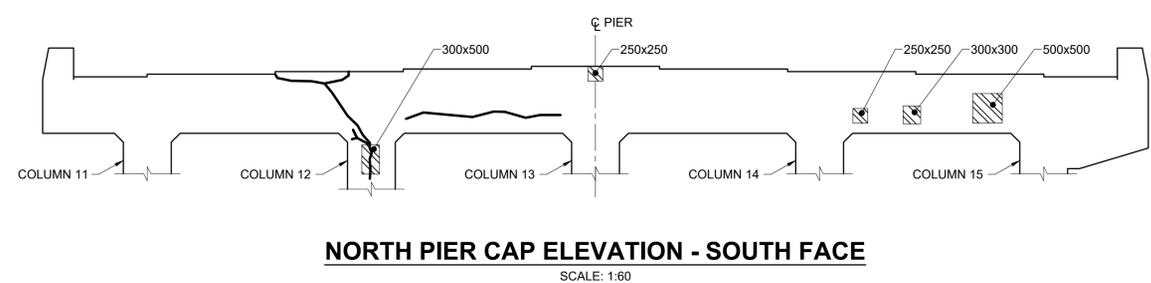
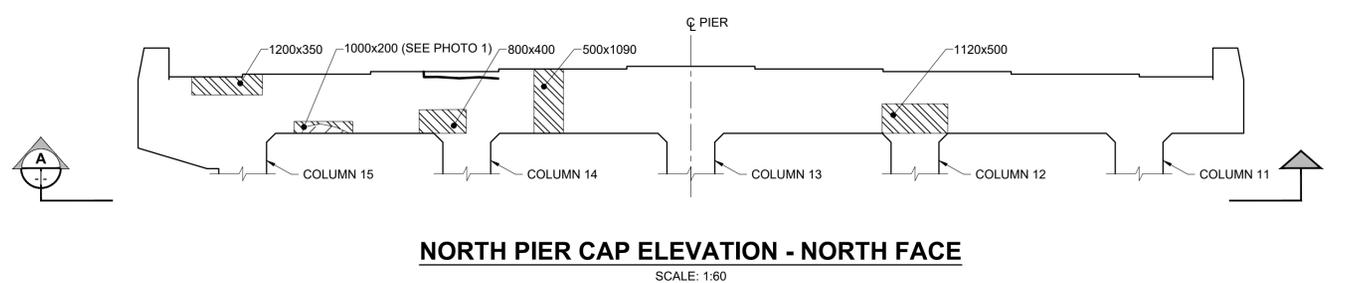
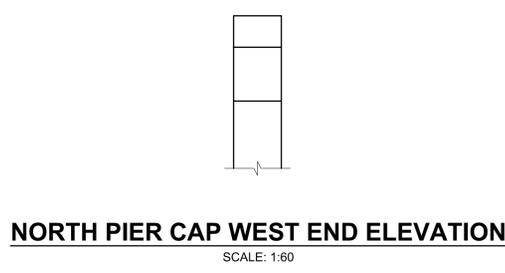
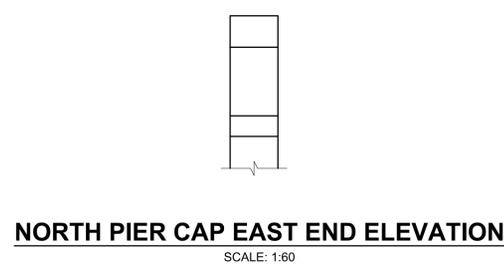
- LEGEND:**
- LOSS OF MORTAR SURFACE REPAIR
  - DELAMINATION
  - SPALL
  - CRACK

- GENERAL NOTES:**
- CLOSE INSPECTION OF CAP ABOVE COLUMN 11 TO THE WEST EDGE ON NORTH FACE NOT COMPLETED AS IT WAS INACCESSIBLE.
  - DEFECTS MAPPED OCTOBER 5, 2017.
  - CONTRACTOR TO UNDERTAKE DELAMINATION SURVEY WITH RESIDENT ENGINEER TO CONFIRM EXTENTS OF DEFECTS.
  - REPAIRS TO BE COMPLETED TO DELAMINATED, SPALLED, AND CRACKED CONCRETE PRIOR TO INSTALLING AND APPLYING ECE TREATMENT. REFER TO SHEET 99 FOR REPAIR DETAILS.
  - SEE SHEET 92 FOR COLUMN DEFECT MAPS.
