# **APPENDIX 'A'**

# **GEOTECHNICAL REPORTS**

File No. 19-0535-002

RE: 2019 City of Winnipeg Alleys Package  
Clifton, Garfield, Ingersoll, Victor and Sherbrook Alleys  
Geotechnical Investigation – Final

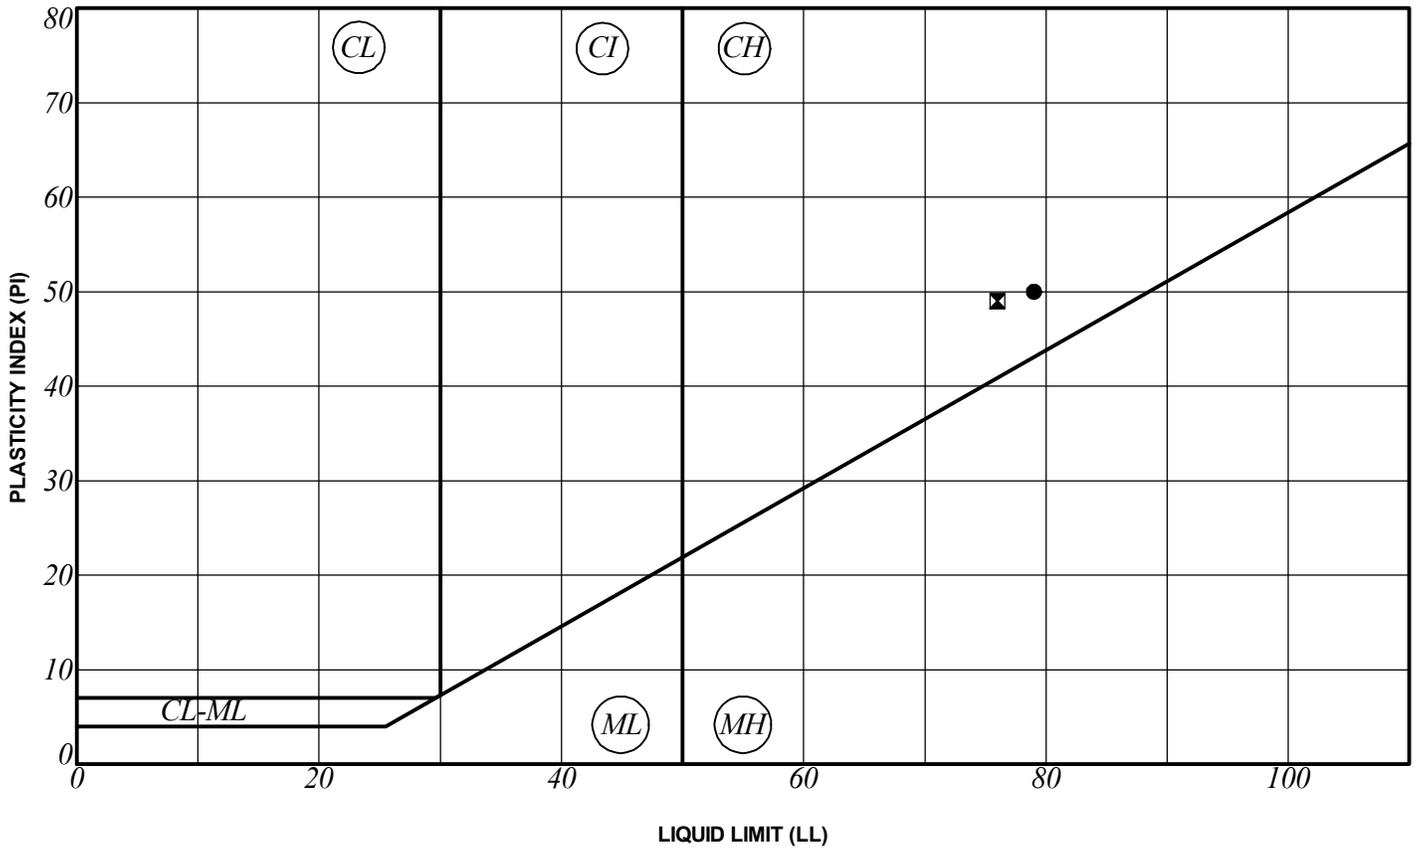
SYMBOL	HOLE	DEPTH (m)	SAMPLE #	LL	PL	PI	% SAND	% SILT	% CLAY	% MC	CLASSIFICATION
●	TH19-103	0.3	S2	79	29	50	6.9	27.4	65.7	44.2	CH
⊠	TH19-104	0.6	S3	76	27	49	5.5	34.8	59.6	41.1	CH

The moisture content of the fat clay generally ranged from 21 to 47%, as measured from 39 samples. Atterberg limits on two (2) fat clay samples at depths of 0.3 m to 0.6 m measured a liquid limit of 76 to 79, a plastic limit of 27 to 29 and a plasticity index of 49 to 50, classifying the material as fat clay (CH). Grain size analyses completed on the same samples measured 60 to 66% clay sized particles, 27 to 35% silt sized particles, 6 to 7% sand sized particles and 0 to 0.1% gravel sized particles.

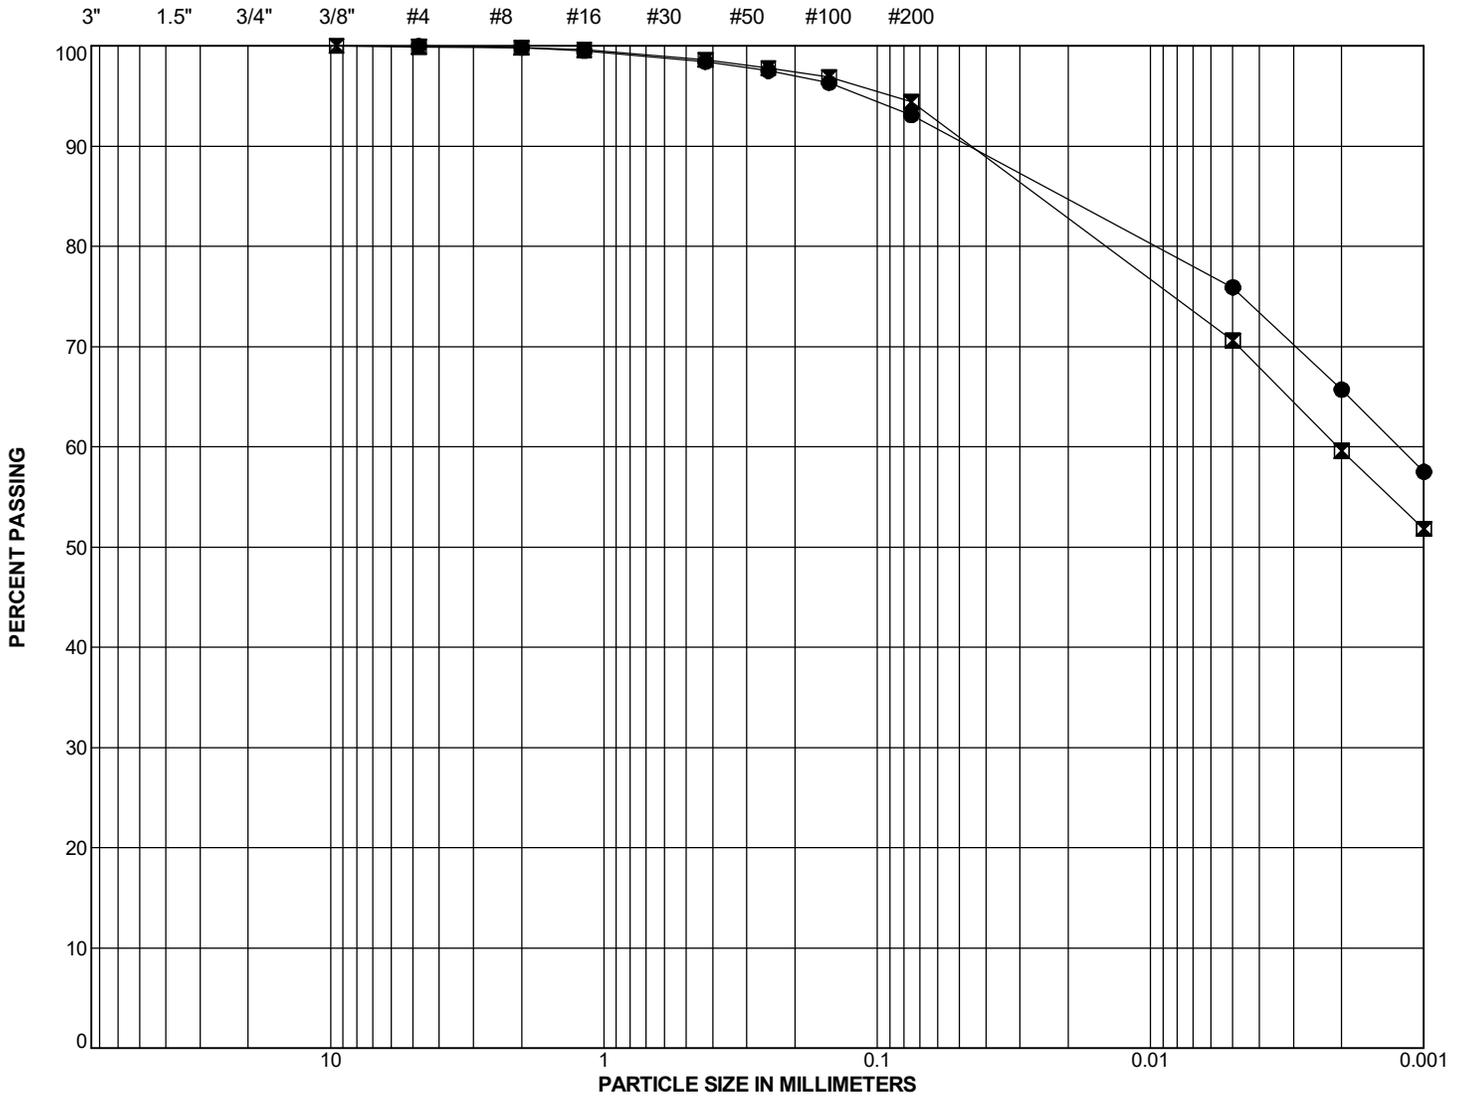
HYDROMETER ANALYSIS

SYMBOL	HOLE	DEPTH (m)	SAMPLE #	% GRAVEL	% SAND	% SILT	% CLAY	% SILT & CLAY	Cu	Cc	CLASSIFICATION
●	TH19-103	0.3	S2	0.0	6.9	27.4	65.7	93.1			CH
⊠	TH19-104	0.6	S3	0.1	5.5	34.8	59.6	94.4			CH

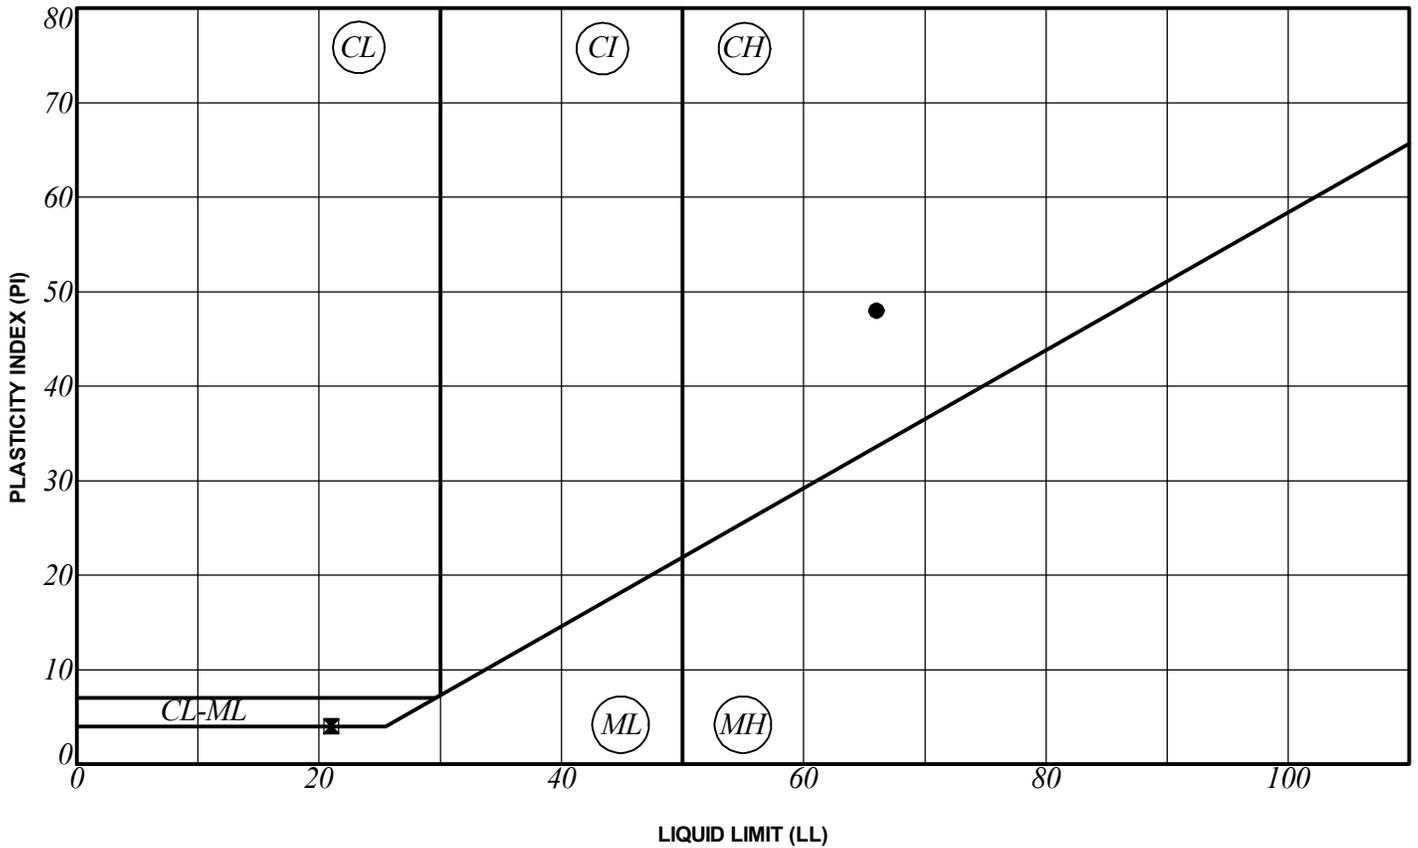
SYMBOL	HOLE	DEPTH (m)	SAMPLE #	LL	PL	PI	% SAND	% SILT	% CLAY	% MC	CLASSIFICATION
●	TH19-206	0.3	S2	66	18	48	12.2	26.5	61.3	29.7	CH
⊠	TH19-206	1.2	S5	21	17	4	5.2	76.2	18.5	19.5	CL-ML

The moisture content of the fat clay generally ranged from 27 to 62%, as measured from thirty-nine (39) samples. Atterberg limits completed on one (1) fat clay sample at a depth of 0.3 m measured a liquid limit of 66, a plastic limit of 18 and a plasticity index of 48, classifying

The moisture content of the silty clay generally ranged from 20 to 23%, as measured from two (2) samples. Atterberg limits completed on one (1) silt clay sample at a depth of 1.2 m measured a liquid limit of 21, a plastic limit of 17 and a plasticity index of 4, classifying the material as silty clay (CL-ML). Grain size analysis completed on the same sample measured 19% clay sized particles, 76% silt sized particles, 5% sand sized particles and 0% gravel sized particles.

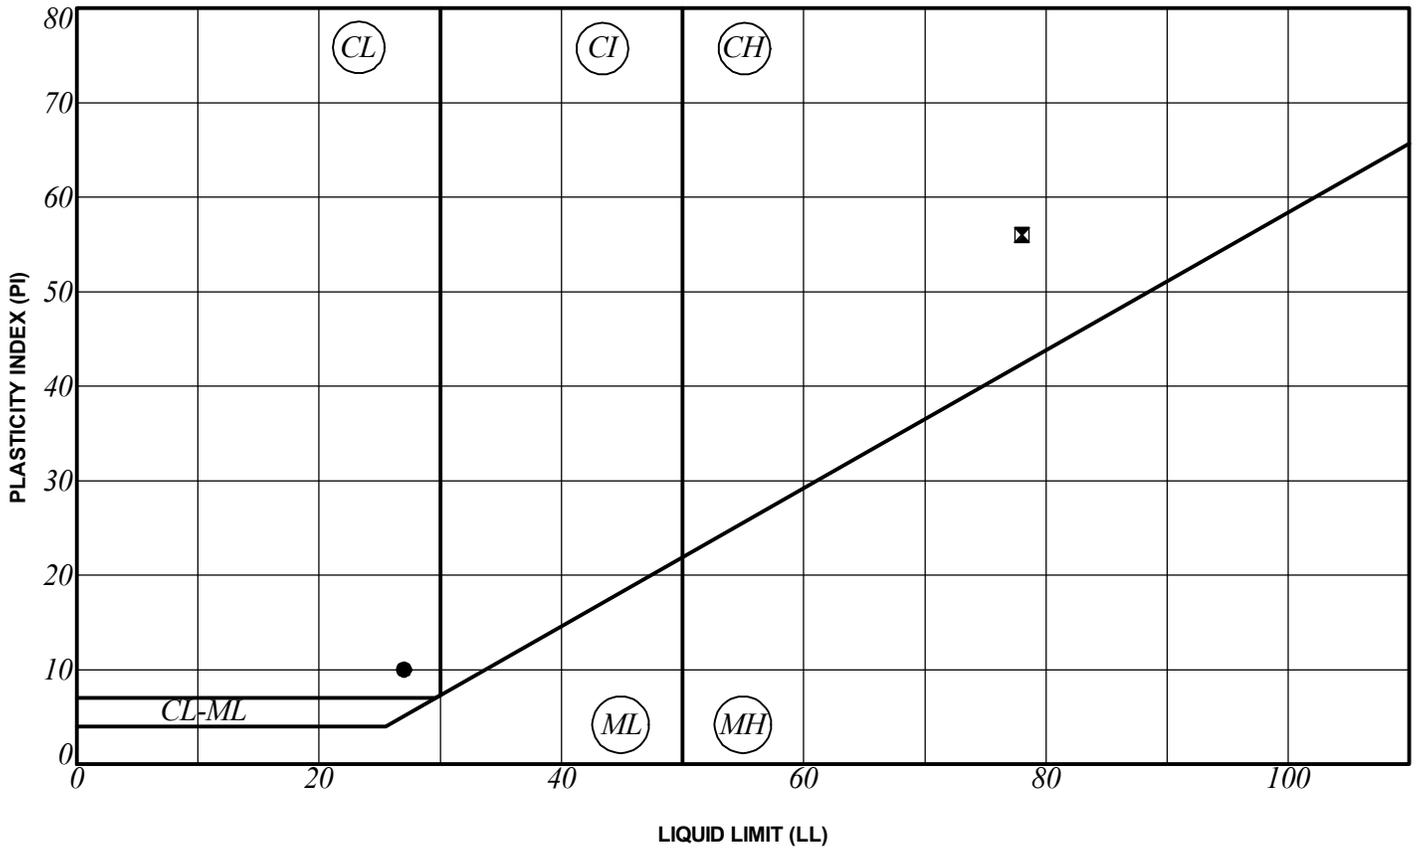
SYMBOL	HOLE	DEPTH (m)	SAMPLE #	LL	PL	PI	% SAND	% SILT	% CLAY	% MC	CLASSIFICATION
●	TH19-302	0.6	S3	27	17	10	5.3	68.0	26.7	27.6	CL
⊠	TH19-304	0.9	S4	78	22	56	3.6	17.1	79.3	31.6	CH

The moisture content of the fat clay generally ranged from 22 to 51%, as measured from thirty-one (31) samples. Atterberg limits completed on one (1) fat clay sample at a depth of 0.9 m measured a liquid limit of 78, a plastic limit of 22 and a plasticity index of 56, classifying the material as fat clay (CH). Grain size analysis completed on the same sample measured 79% clay sized particles, 17% silt sized particles, 4% sand sized particles and 0% gravel sized particles.

The moisture content of the lean clay ranged from 24 to 28%, as measured from two (2) samples. Atterberg limits completed on one (1) lean clay sample at a depth of 0.6 m measured a liquid limit of 27, a plastic limit of 17 and a plasticity index of 10, classifying the material as lean clay (CL). Grain size analysis completed on the same sample measured 27% clay sized particles, 68% silt sized particles, 5% sand sized particles and 0% gravel sized particles.

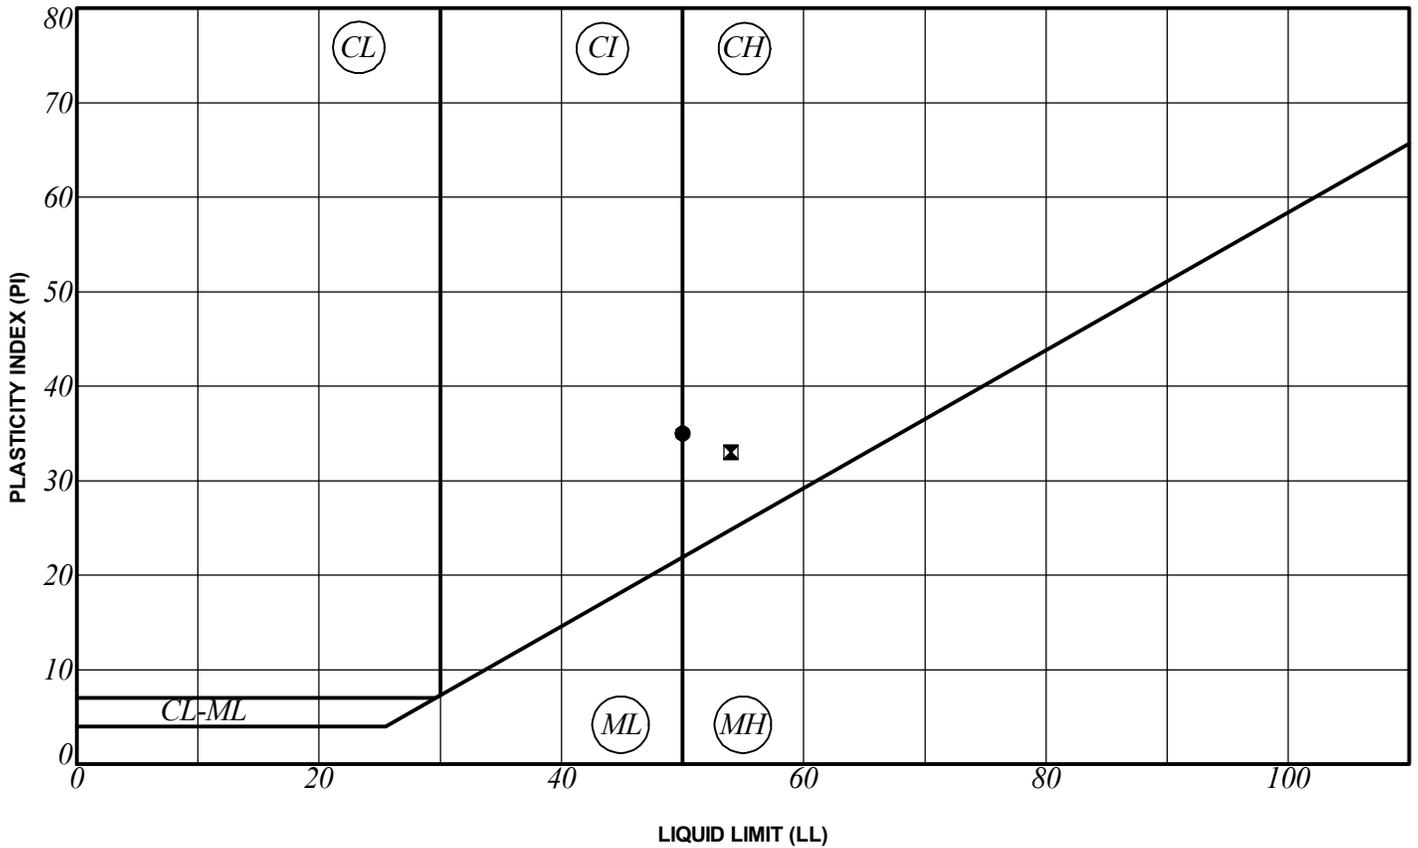
SYMBOL	HOLE	DEPTH (m)	SAMPLE #	LL	PL	PI	% SAND	% SILT	% CLAY	% MC	CLASSIFICATION
●	TH19-404	0.3	S2	50	15	35	23.5	30.3	46.1	36.4	CH
⊠	TH19-406	0.3	S2	54	21	33	24.1	35.9	39.5	46.9	CH

The moisture content of the fat clay generally ranged from 30 to 55%, as measured from forty-four (44) samples. Atterberg limits completed on one (1) fat clay sample at a depth of 0.3 m measured a liquid limit of 50, a plastic limit of 15 and a plasticity index of 35, classifying the material as fat clay (CH). Grain size analysis completed on the same sample measured 46% clay sized particles, 30% silt sized particles, 24% sand sized particles and 0.1% gravel sized particles.

The moisture content of the clay fill generally ranged from 47 to 50%, as measured from two (2) samples. Atterberg limits completed on one (1) clay fill sample at a depth of 0.3 m measured a liquid limit of 54, a plastic limit of 21 and a plasticity index of 33, classifying the material as fat clay (CH). Grain size analysis completed on the same sample measured 40% clay sized particles, 36% silt sized particles, 24% sand sized particles and 1% gravel sized particles.

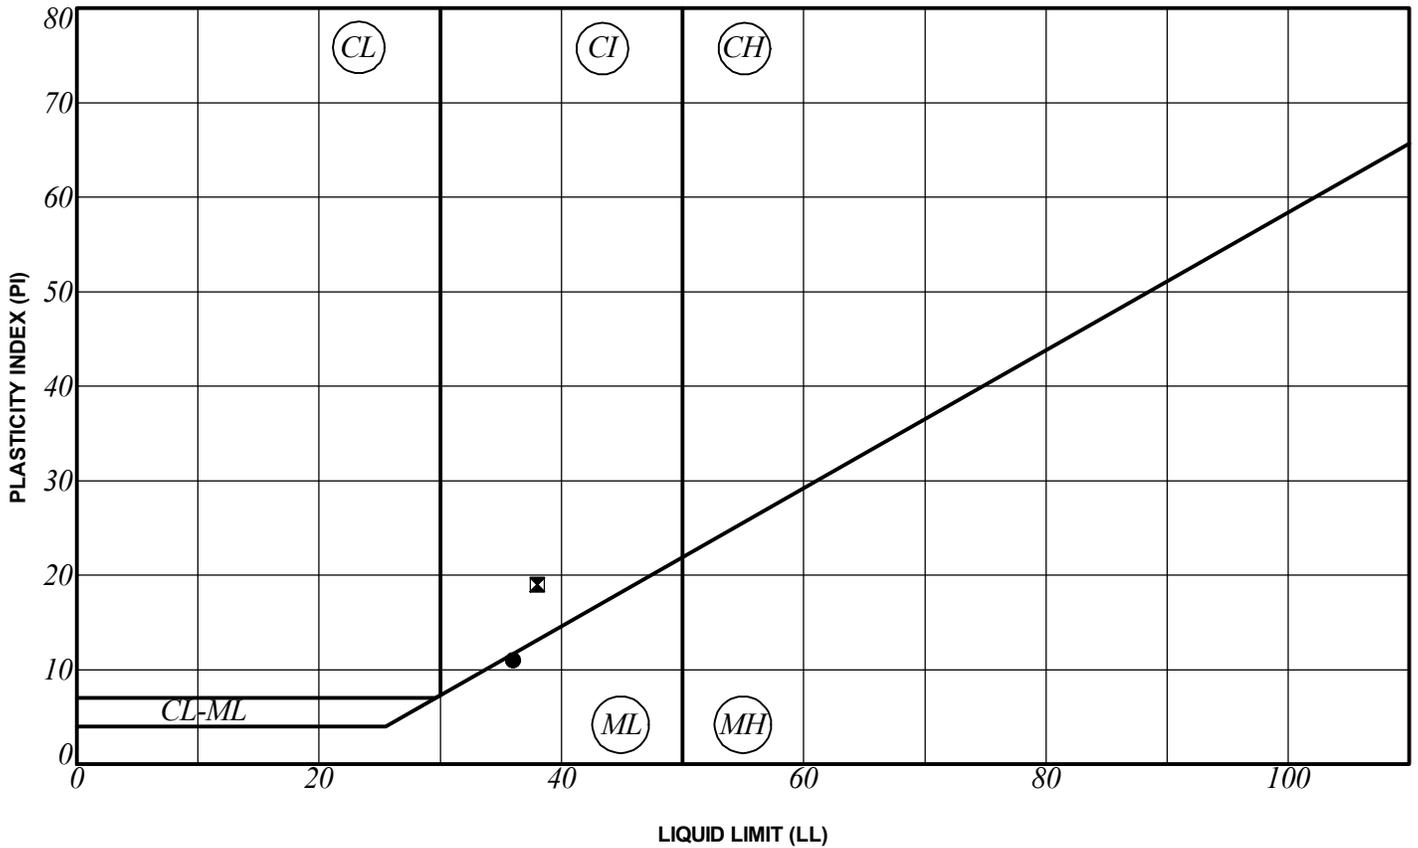
SYMBOL	HOLE	DEPTH (m)	SAMPLE #	LL	PL	PI	% SAND	% SILT	% CLAY	% MC	CLASSIFICATION
●	TH19-505	0.3	S2	36	25	11	57.4	31.3	10.3	40.0	ML
⊠	TH19-507	0.9	S4	38	19	19	5.5	56.8	37.7	59.9	CI

The moisture content of the sandy silty was 40%, as measured from one (1) sample. Atterberg limits completed on one (1) sandy silt sample at a depth of 0.5 m measured a liquid limit of 36, a plastic limit of 25 and a plasticity index of 11, classifying the material as low plasticity silt (ML). Grain size analysis completed on the same sample measured 10% clay sized particles, 31% silt sized particles, 57% sand sized particles and 1% gravel sized particles.

The moisture content of the lean clay ranged from 22 to 60%, as measured from three (3) samples. Atterberg limits completed on one (1) sample at a depth of 0.9 m measured a liquid limit of 38, a plastic limit of 19 and a plasticity index of 19, classifying the material as intermediate clay (CI). Grain size analysis completed on the same sample measured 38% clay sized particles, 57% silt sized particles, 6% sand sized particles and 0% gravel sized particles.

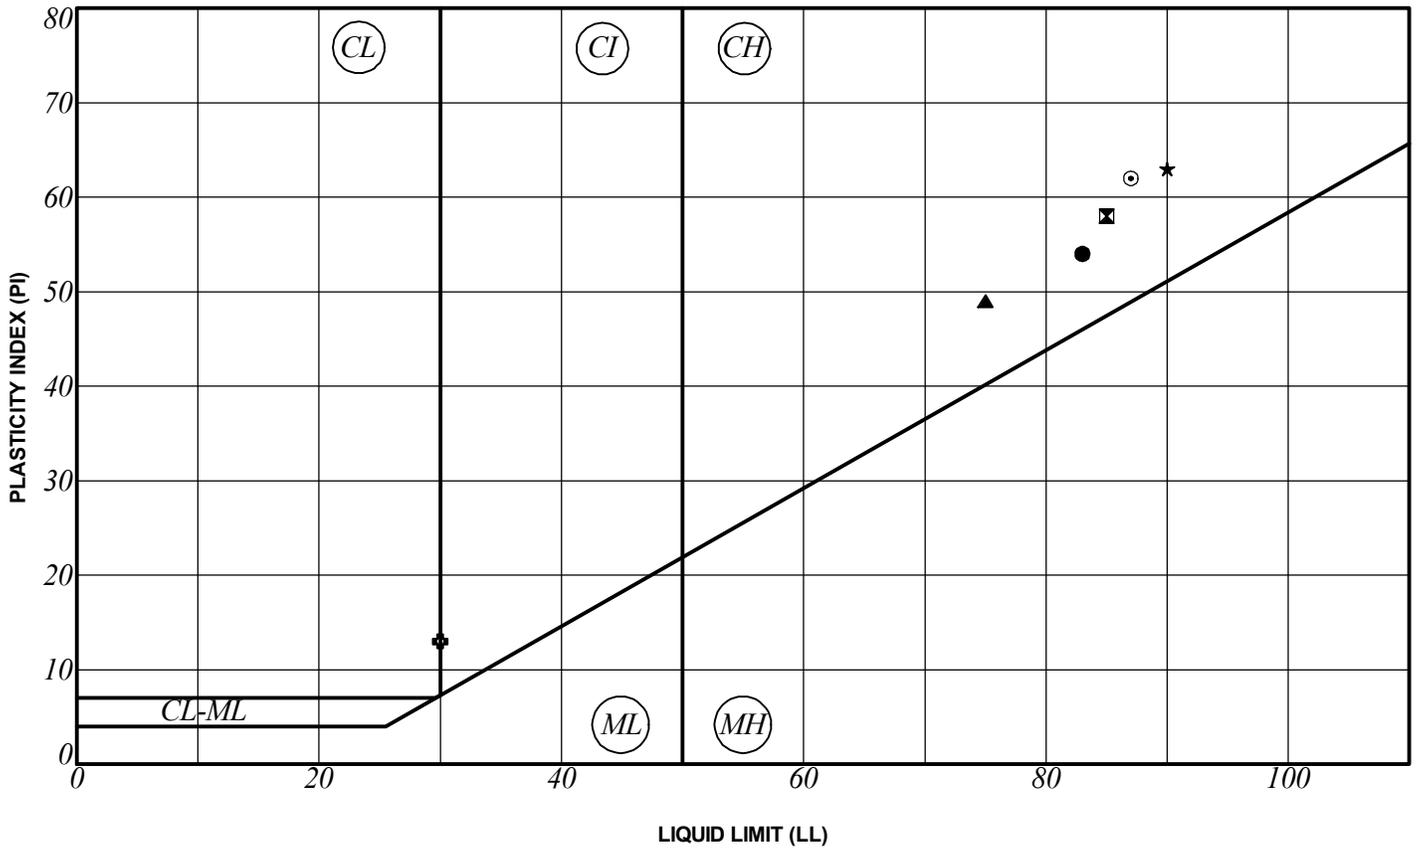
Laboratory Test Results

SYMBOL	HOLE	DEPTH (m)	SAMPLE #	LL	PL	PI	% SAND	% SILT	% CLAY	% MC	CLASSIFICATION
●	TH19-11	0.6	S3	83	29	54	4.0	47.2	48.8	32.5	CH
■	TH19-12	0.9	S4	85	27	58	1.4	37.6	61.0	36.3	CH
▲	TH19-21	0.6	S3	75	26	49	13.1	34.6	52.3	34.8	CH
★	TH19-22	0.9	S4	90	27	63	1.9	38.9	59.2	36.7	CH
⊙	TH19-31	0.9	S4	87	25	62	1.5	47.6	50.9	37.0	CH
⊕	TH19-31	1.7	S6	30	17	13	3.3	64.6	32.1	26.2	CL
