# **GEOTECHNICAL REPORT**

**Re: 2022 City of Winnipeg Local and Industrial Street and Alley Renewal Program  
Report of Geotechnical Investigation and Test Results**

This letter summarizes KGS Group's geotechnical results for the 2022 City of Winnipeg (COW) Local and Industrial Street and Alley Renewal Program in Winnipeg, Manitoba. KGS Group's scope of services for this project was outlined in our proposal no. 21-000-1988 titled "2022 COW Local and Industrial Street and Alley Renewal Program - Geotechnical" dated January 11, 2022.

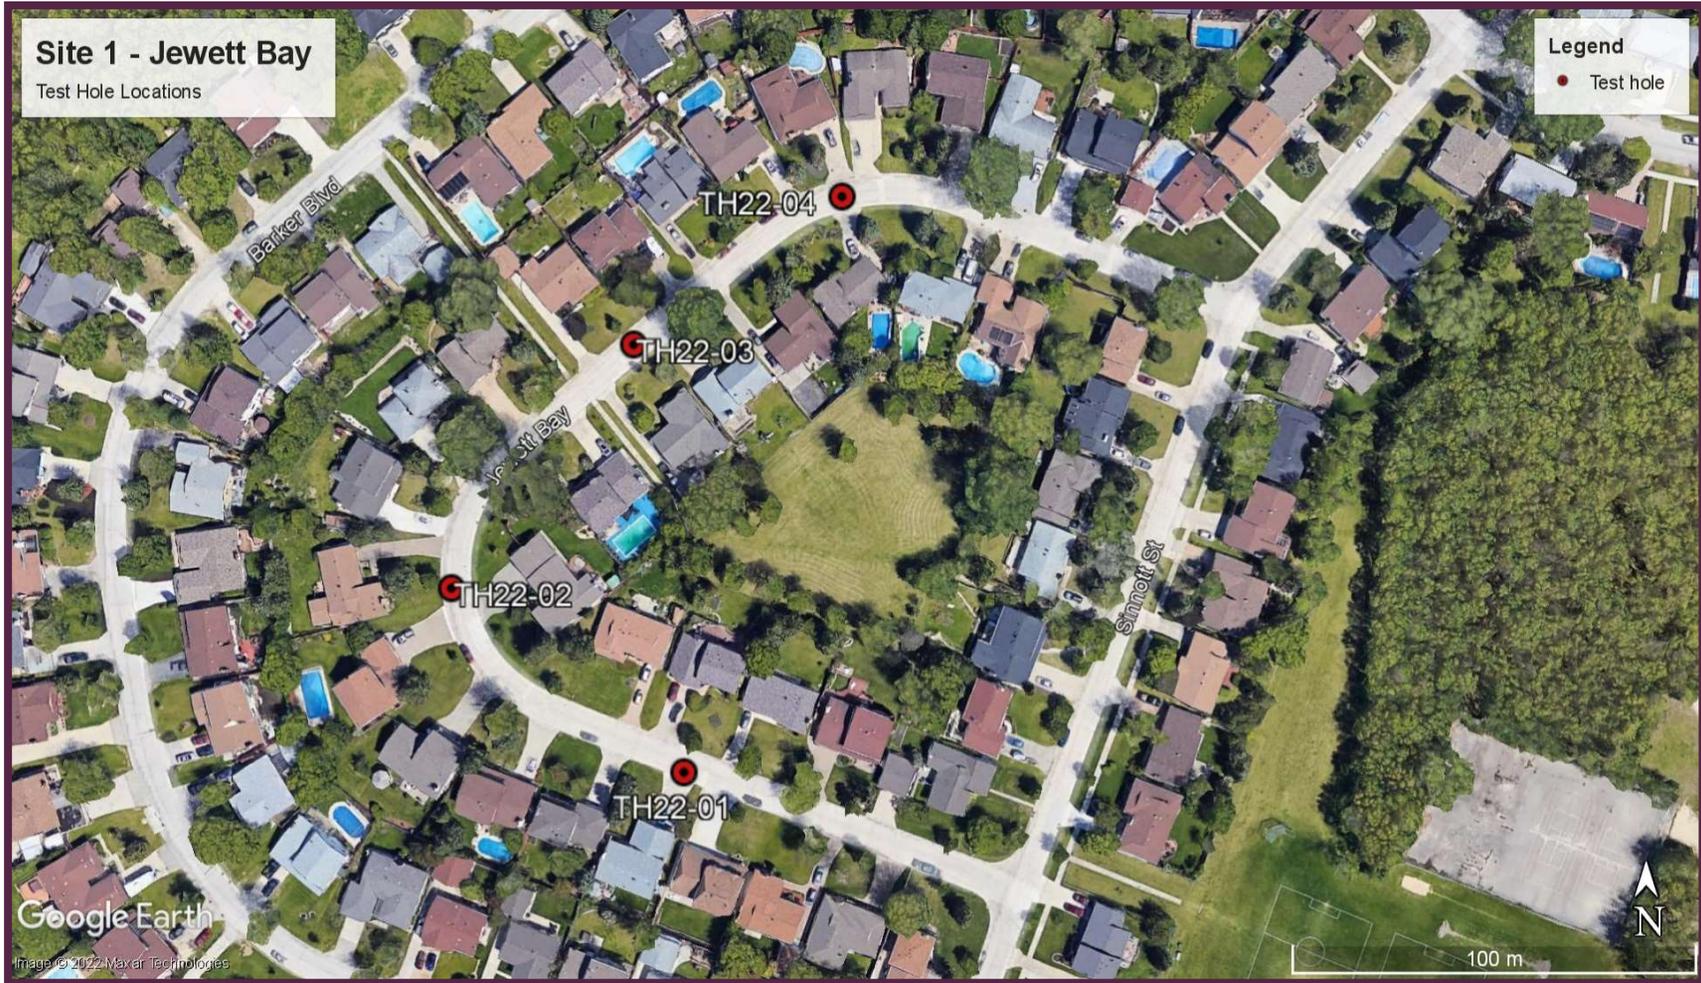
FIGURE 1: Test Hole Locations for Site 1 - Jewett Bay

Four (4) cores were completed along Jewett Bay. The pavement surfacing consisted concrete ranging in thickness from 160 to 180 mm (6 to 7 in). The granular base material ranged in thickness from 100 to 300 mm (4 to 12 in). Core locations can be viewed on the attached Figure 1.

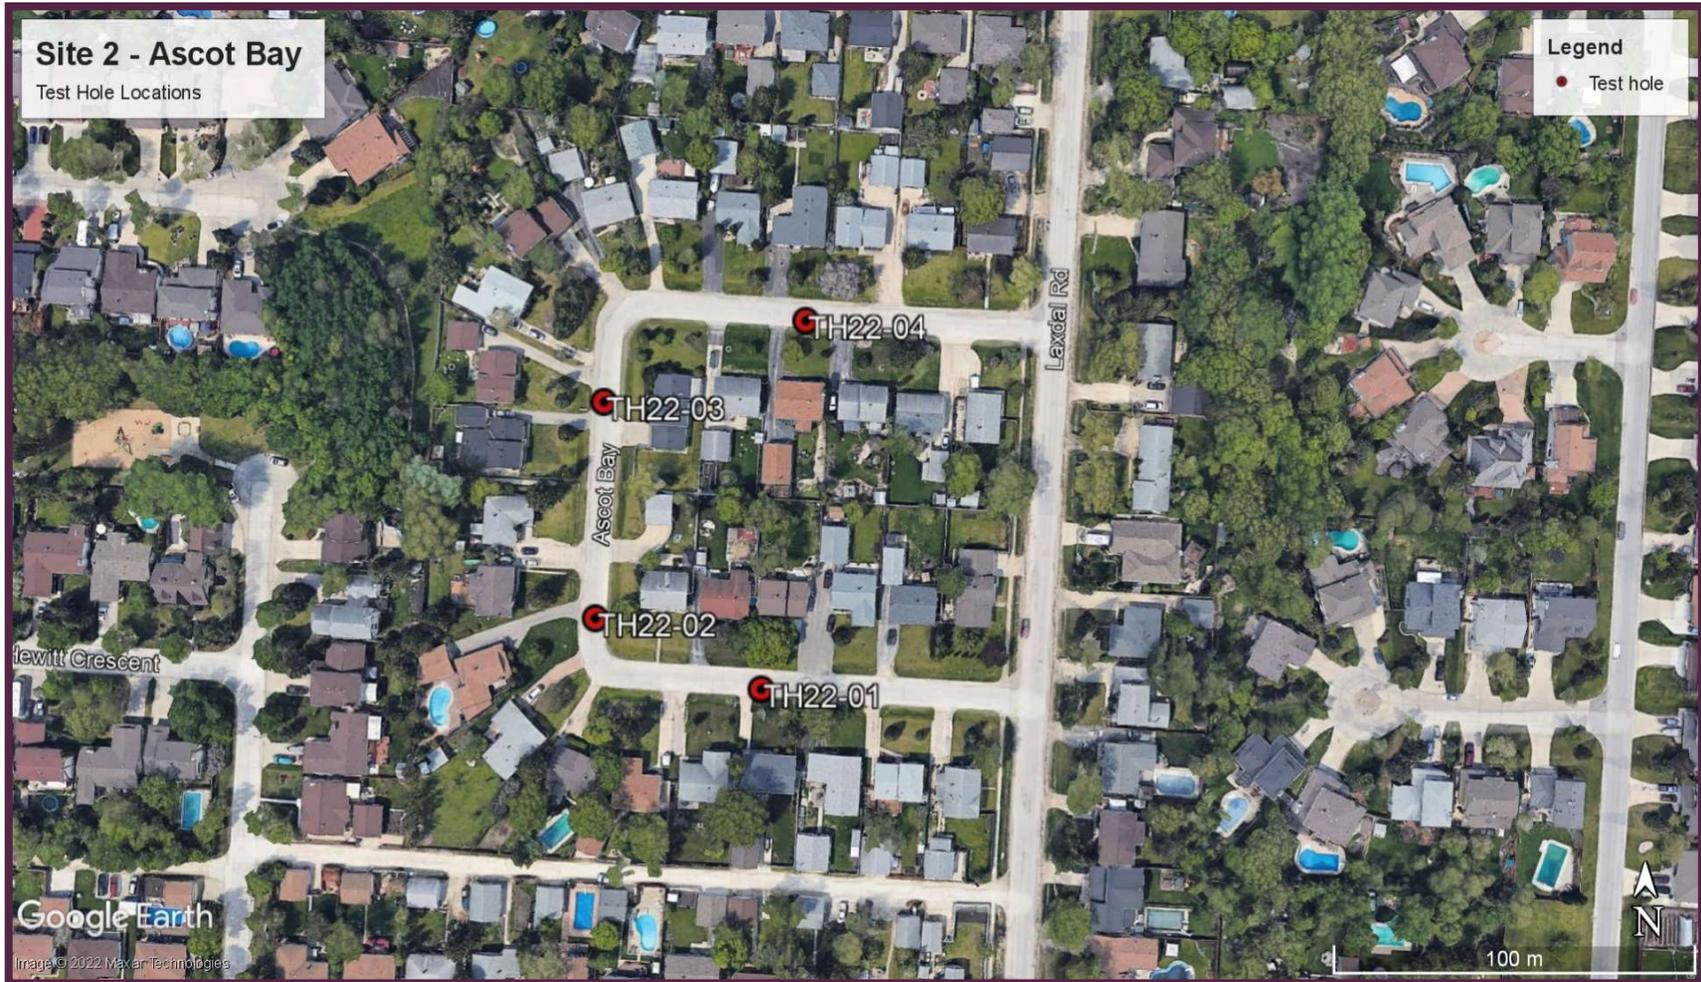
FIGURE 2: Test Hole Locations for Site 2 - Ascot Bay

Four (4) cores were completed along Ascot Bay. The pavement surfacing consisted of asphalt material ranging in thickness from 60 to 100 mm (2.4 to 4.0 in). Granular base material below the pavement ranged in thickness from 290 to 300 mm (11.4 to 11.8 in). Core locations can be seen on Figure 2 attached.

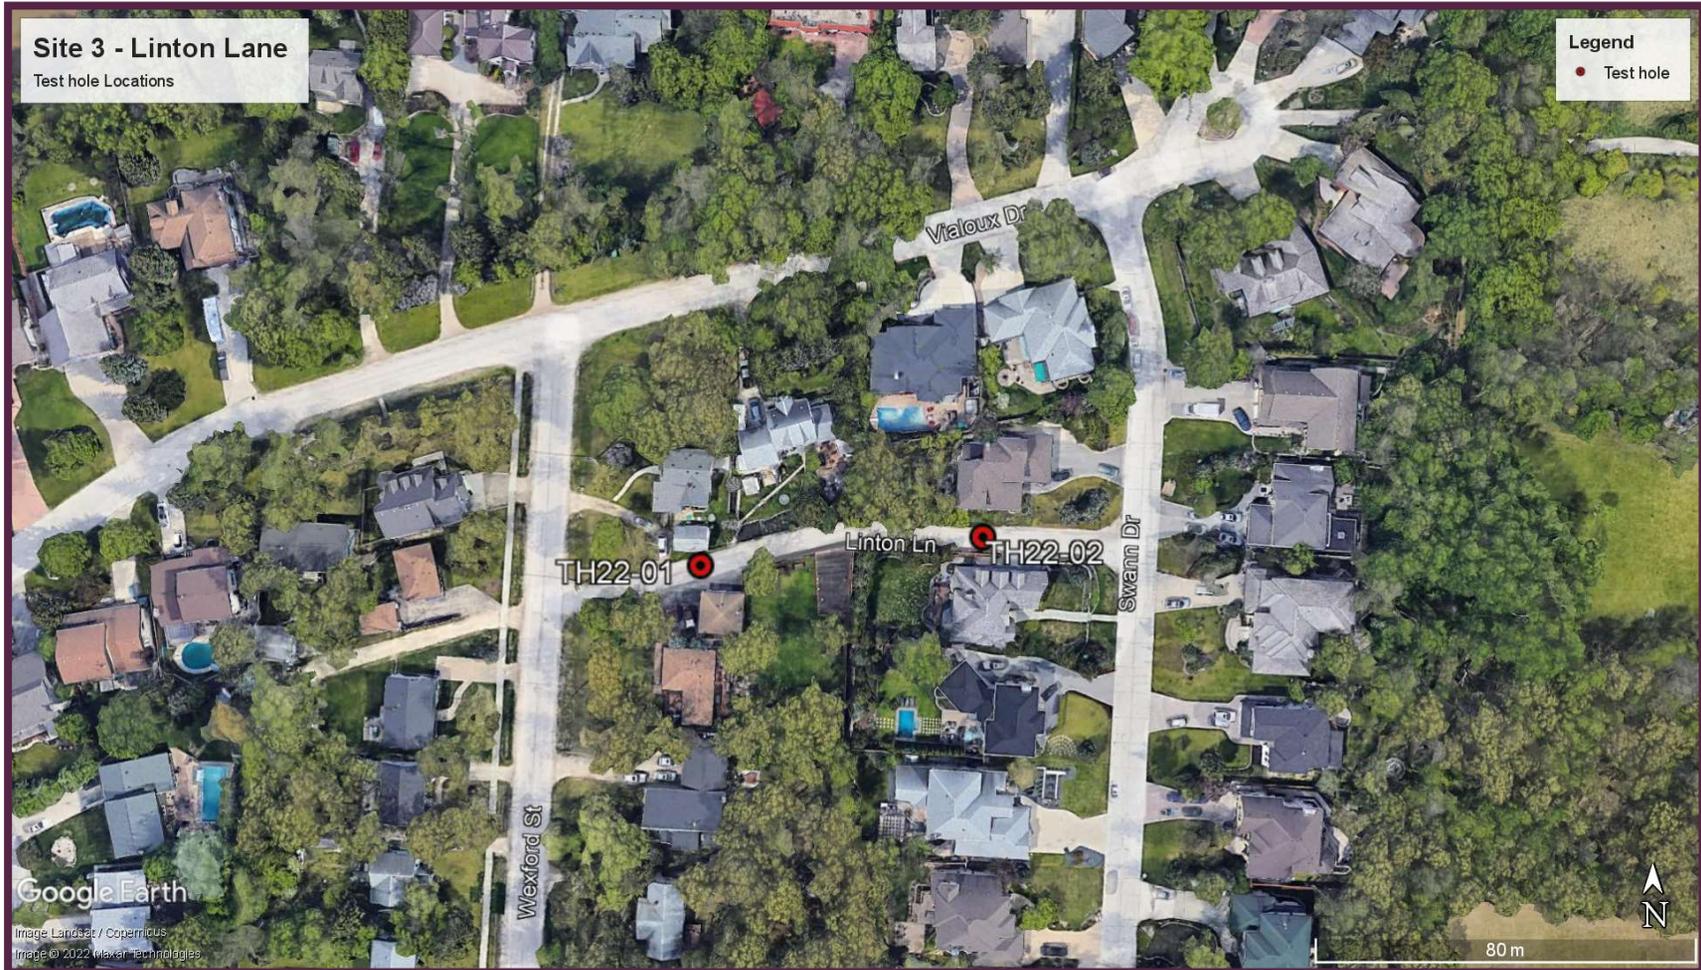
## FIGURE 3: Test Hole Locations for Site 3 - Linton Lane

Two (2) cores were completed along Linton Lane. The pavement surfacing consisted of asphalt material ranging in thickness from 70 to 90 mm (2.8 to 3.5 in). Base material was 300 mm (11.8 in) thick and consisted of crushed limestone. Core locations can be viewed on Figure 3 attached.

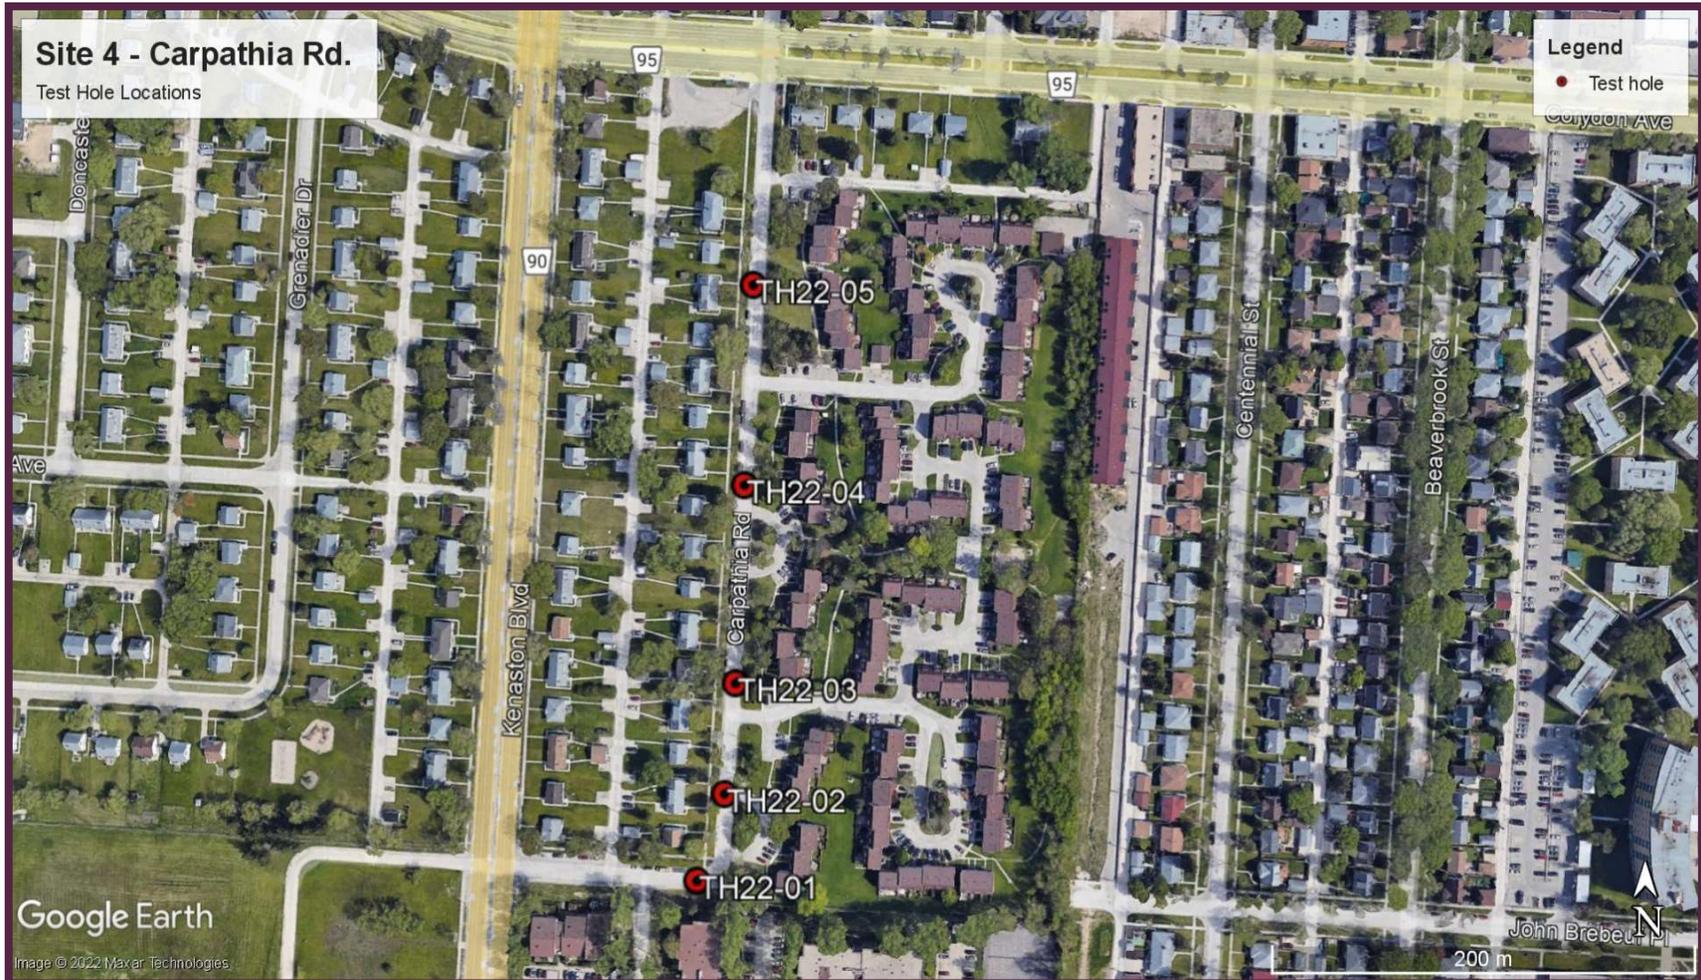
FIGURE 4: Test Hole Locations for Site 4 - Carpathia Road

Five (5) cores were completed along Carpathia Road. The pavement surfacing consisted of asphalt material ranging in thickness from 20 to 60 mm (1 to 2.5 in) overlying 150 to 300 mm (6.0 to 11.8 in) of concrete. Granular base material was 300 to 350 mm (11.8 to 13.8 in) thick at locations TH22-01, TH22-02 and TH22-04 and the clay subgrade was encountered immediately below the pavement at locations TH22-03 and TH22-05. Locations are shown in Figure 4 attached.

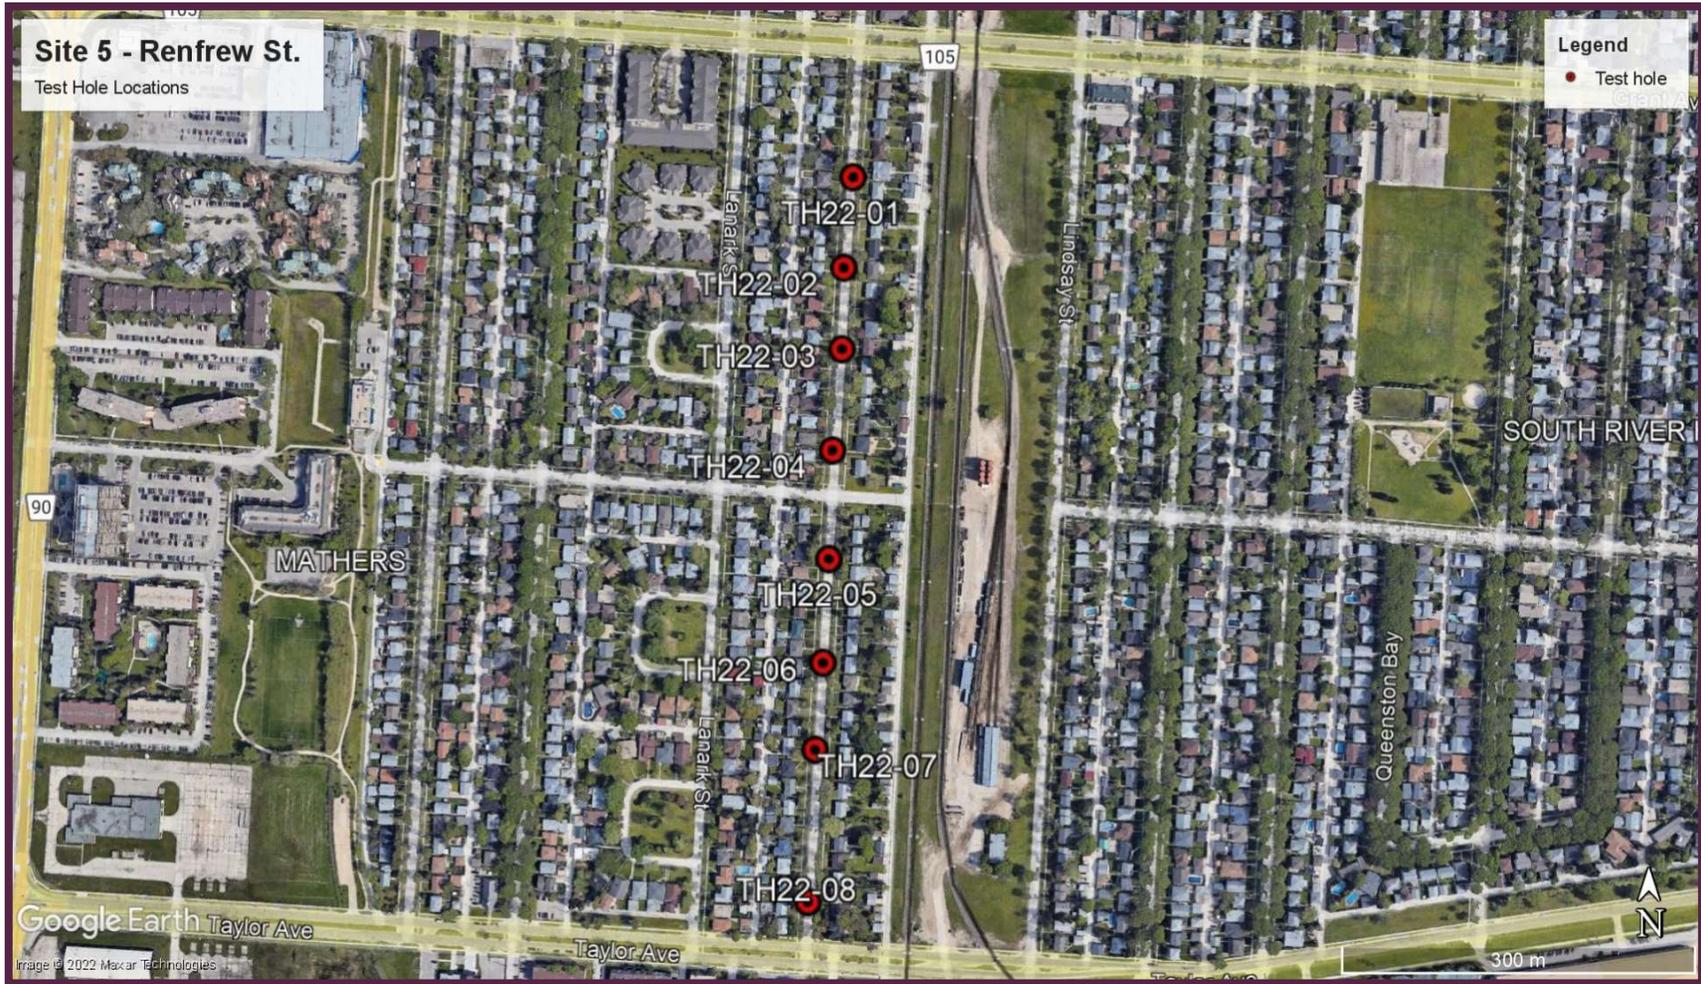
FIGURE 5: Test Hole Locations for Site 5 - Renfrew Street

Eight (8) cores were completed along Renfrew Street. The pavement surfacing consisted of 160 to 210 mm (6.3 to 8.3 in) of concrete. Granular base material ranged from 80 to 300 mm (3.1 to 11.8 in) thick in core holes TH22-01 to TH22-03, and clay subgrade was encountered below the pavement at locations TH22-04 to TH22-08. Core locations can be viewed in Figure 5 attached.

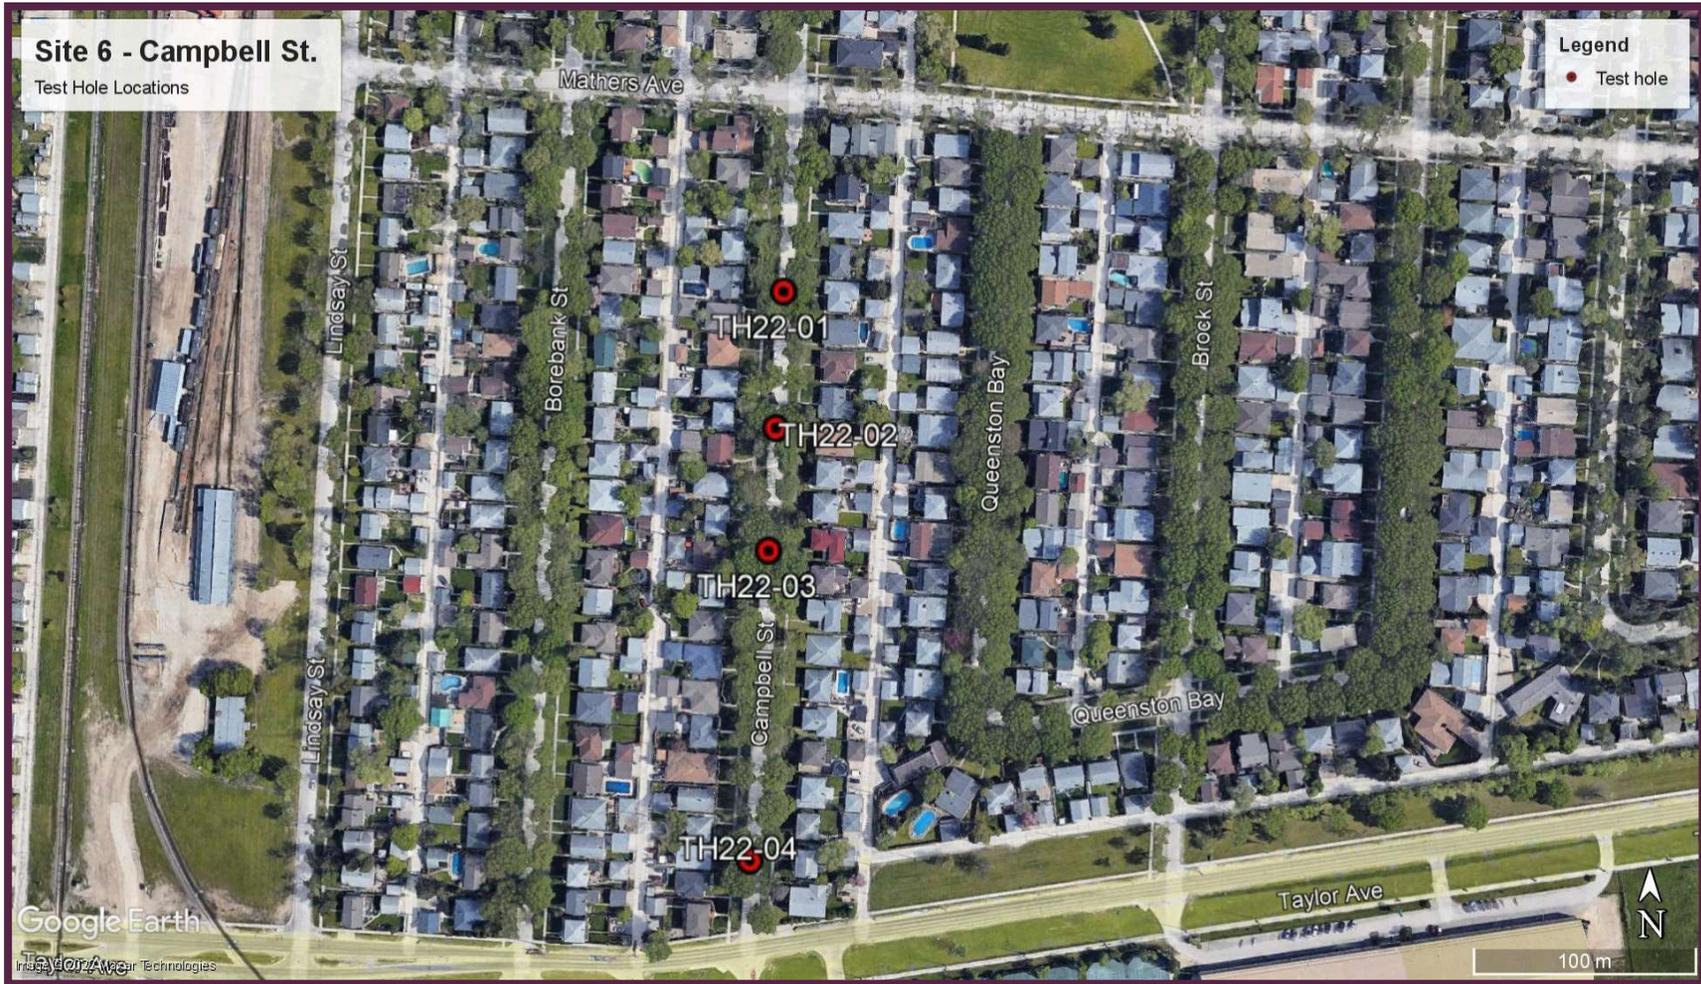
FIGURE 6: Test Hole Locations for Site 6 - Campbell Street

Four (4) cores were completed along Campbell Street. The pavement surfacing consisted of 140 to 190 mm (5.5 to 7.4 in) of concrete. The granular base material ranged from 80 to 300 mm (3.1 to 11.8 in). Core locations are shown on the attached Figure 6.

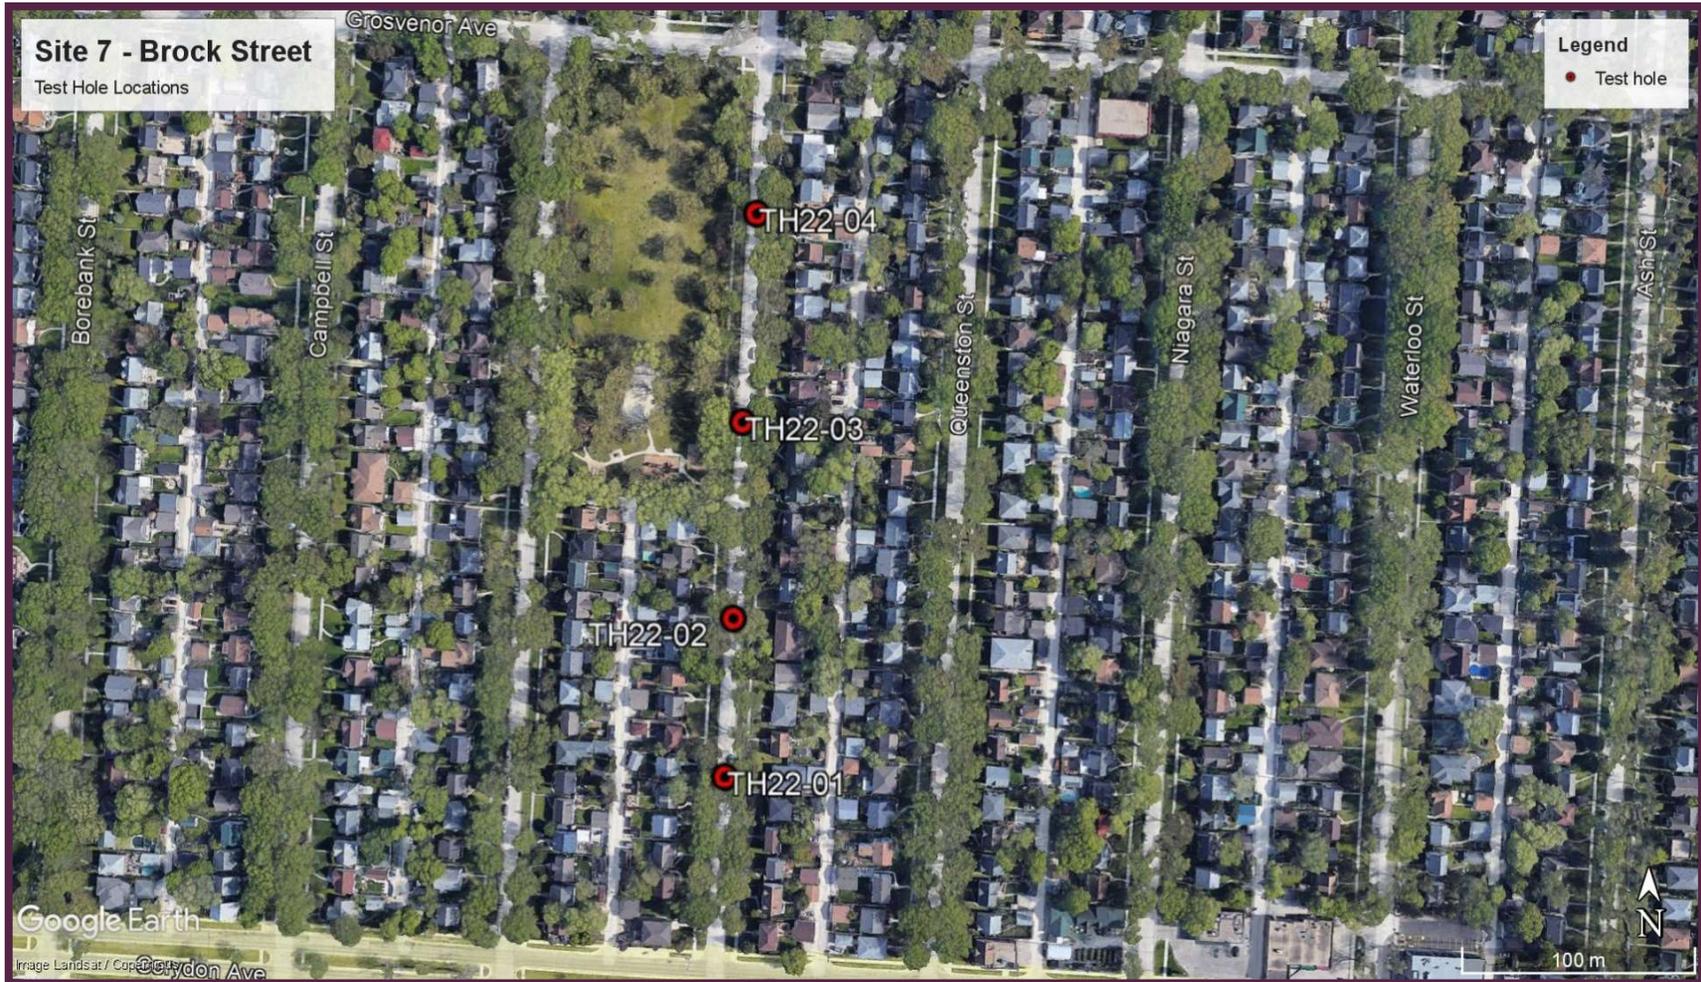
FIGURE 7: Test Hole Locations for Site 7 - Brock Street

Four (4) cores were completed along Brock Street. The pavement surfacing consisted of 100 to 110 mm (3.9 to 4.3 in) of asphalt with 300 mm (11.8 in) of crushed limestone base. Of the total pavement thickness, there was a notable initial layer with an overlay. Coring hole locations can be viewed in Figure 7 attached.

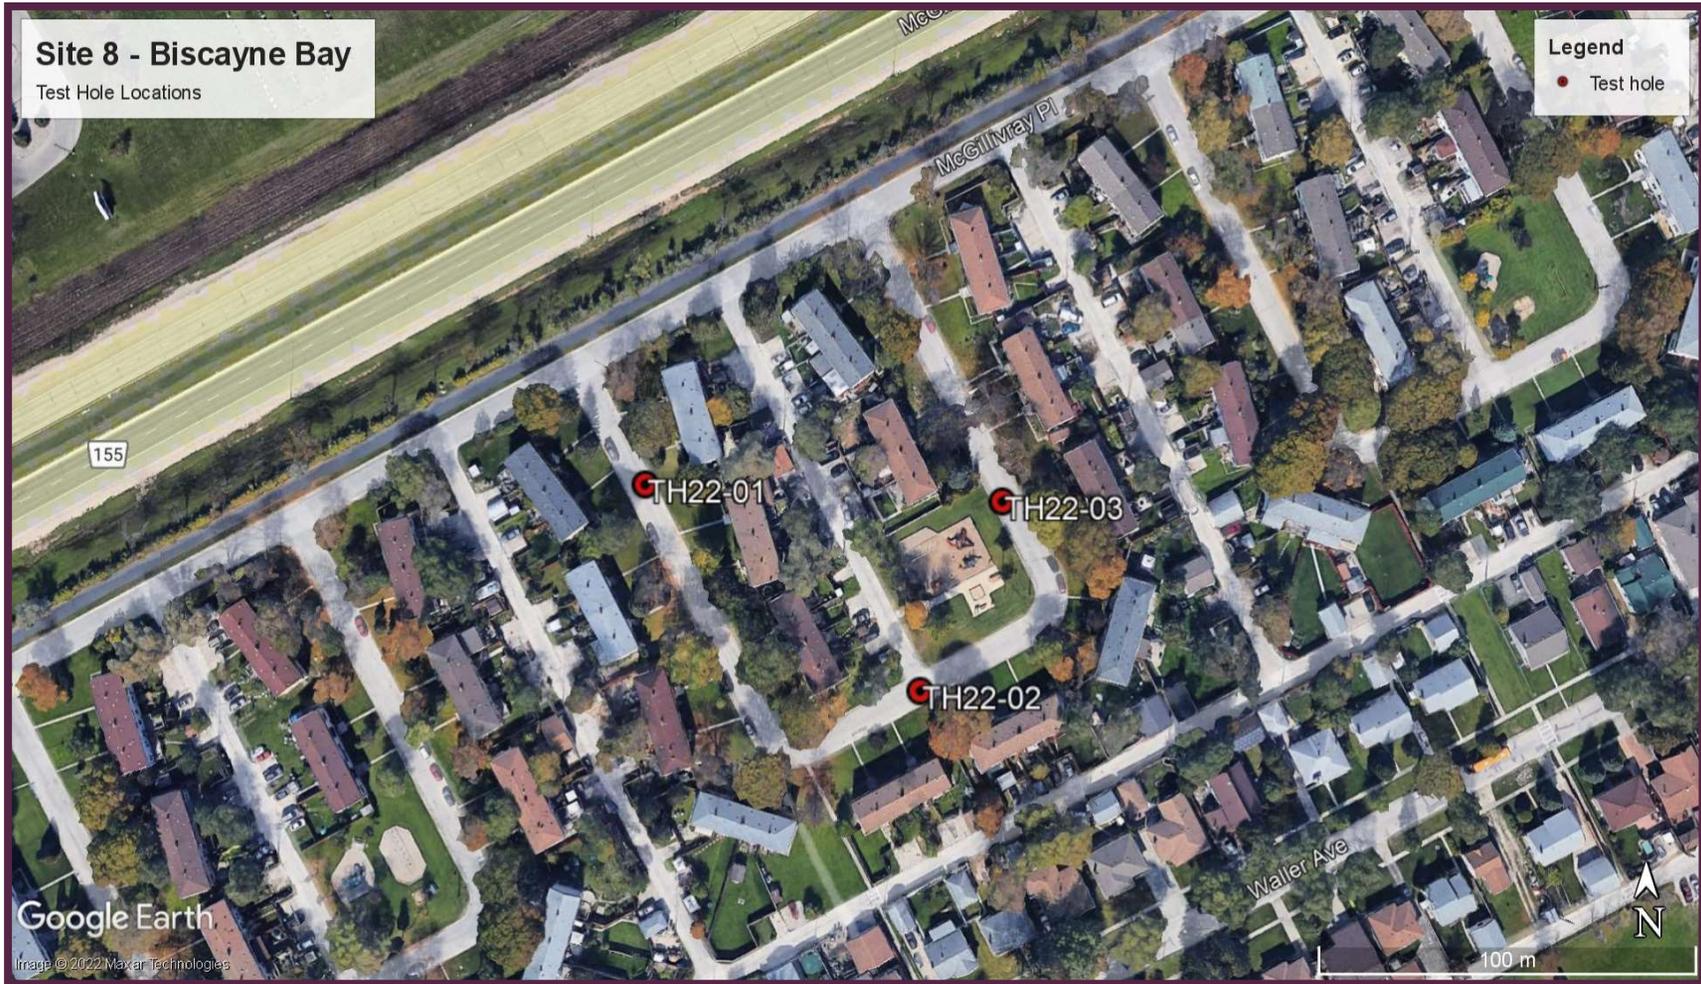
## FIGURE 8: Test Hole Locations for Site 8 - Biscayne Bay

Three (3) cores were completed along Biscayne Bay. The pavement surfacing consisted of 50 mm (2 in) of asphalt and 300 mm (11.8 in) of granular base. Core hole locations can be viewed in Figure 8 attached.

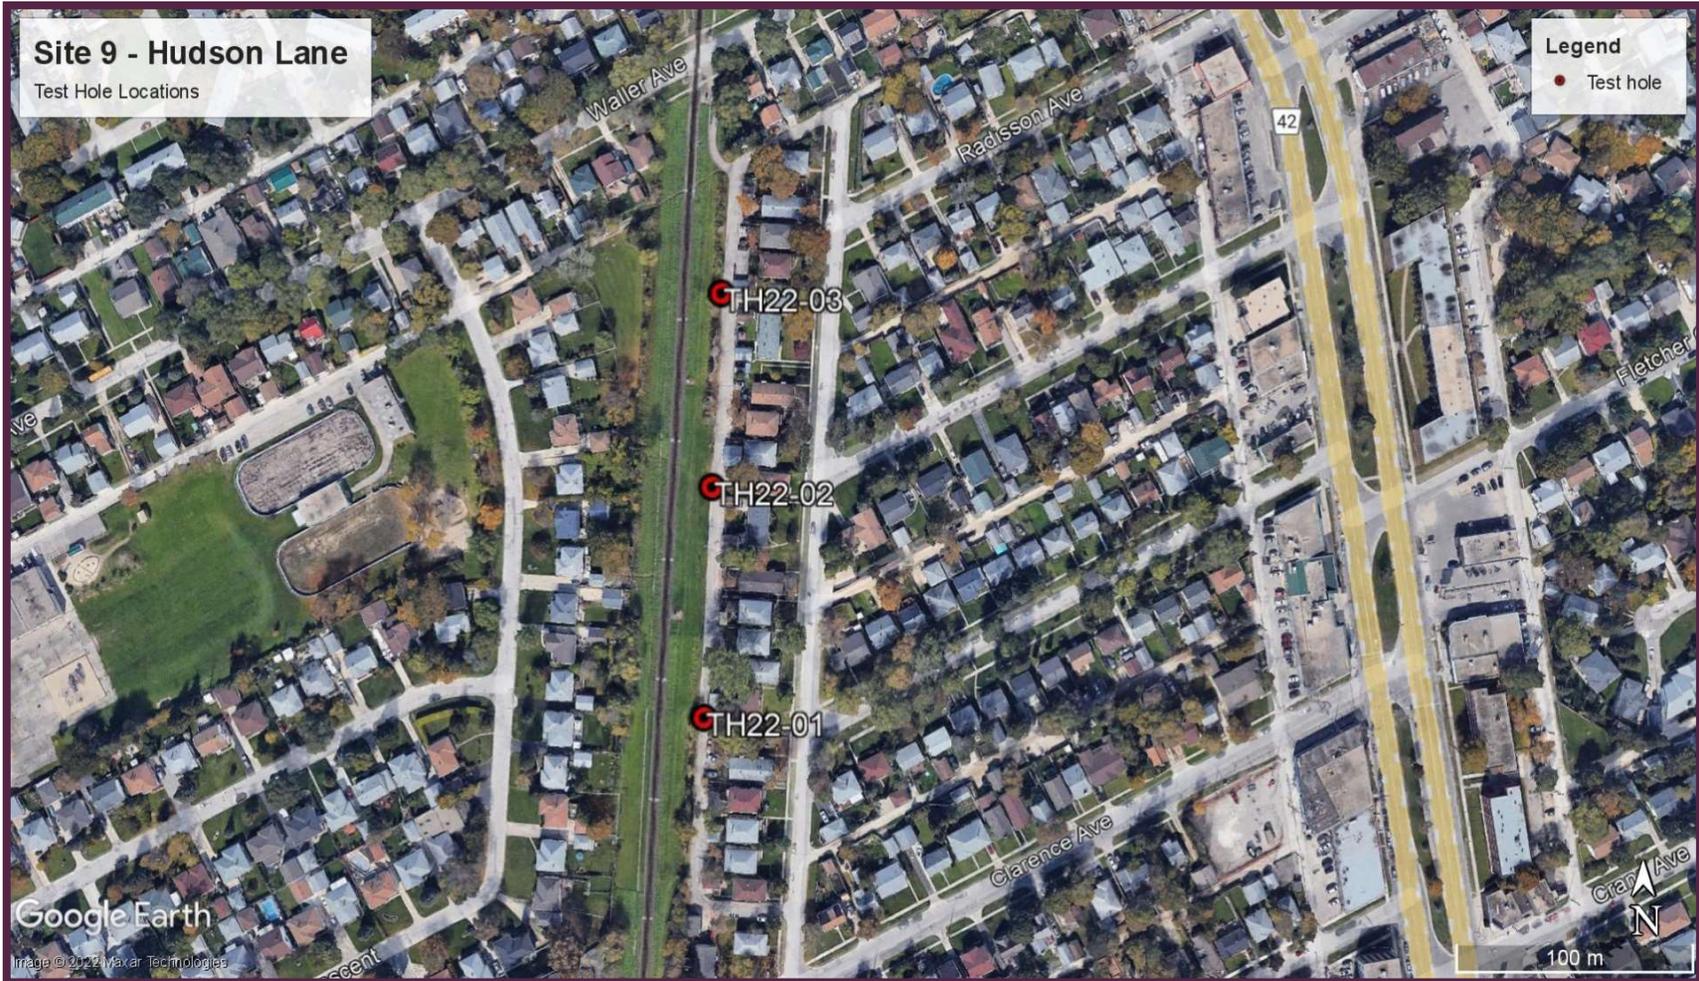
FIGURE 9: Test Hole Locations for Site 9 - Hudson Lane

Three (3) test holes were completed along Hudson Lane to a depth of 2.3m (7.5 ft). The general stratigraphy encountered in the test holes is summarized below.

**Asphalt** – The pavement surfacing consisted of 50 mm of asphalt. The asphalt was black with 20 mm (max) diameter sub-rounded aggregate.

**Poorly Graded Gravel (GP)** – 100 to 200mm (4.0 to 7.9 in) of poorly graded gravel base was observed underlying the asphalt pavement surfacing. The gravel was brown in colour, damp, compact, frozen.

**Clay (CH)** - High plasticity clay was encountered below the gravel base and extended the full depth of explored of 2.3 m (7.5 ft). The clay was dark grey in colour, moist, frozen to depths of 1.1 to 1.2m (3½ to 4 ft) and stiff below the frost.

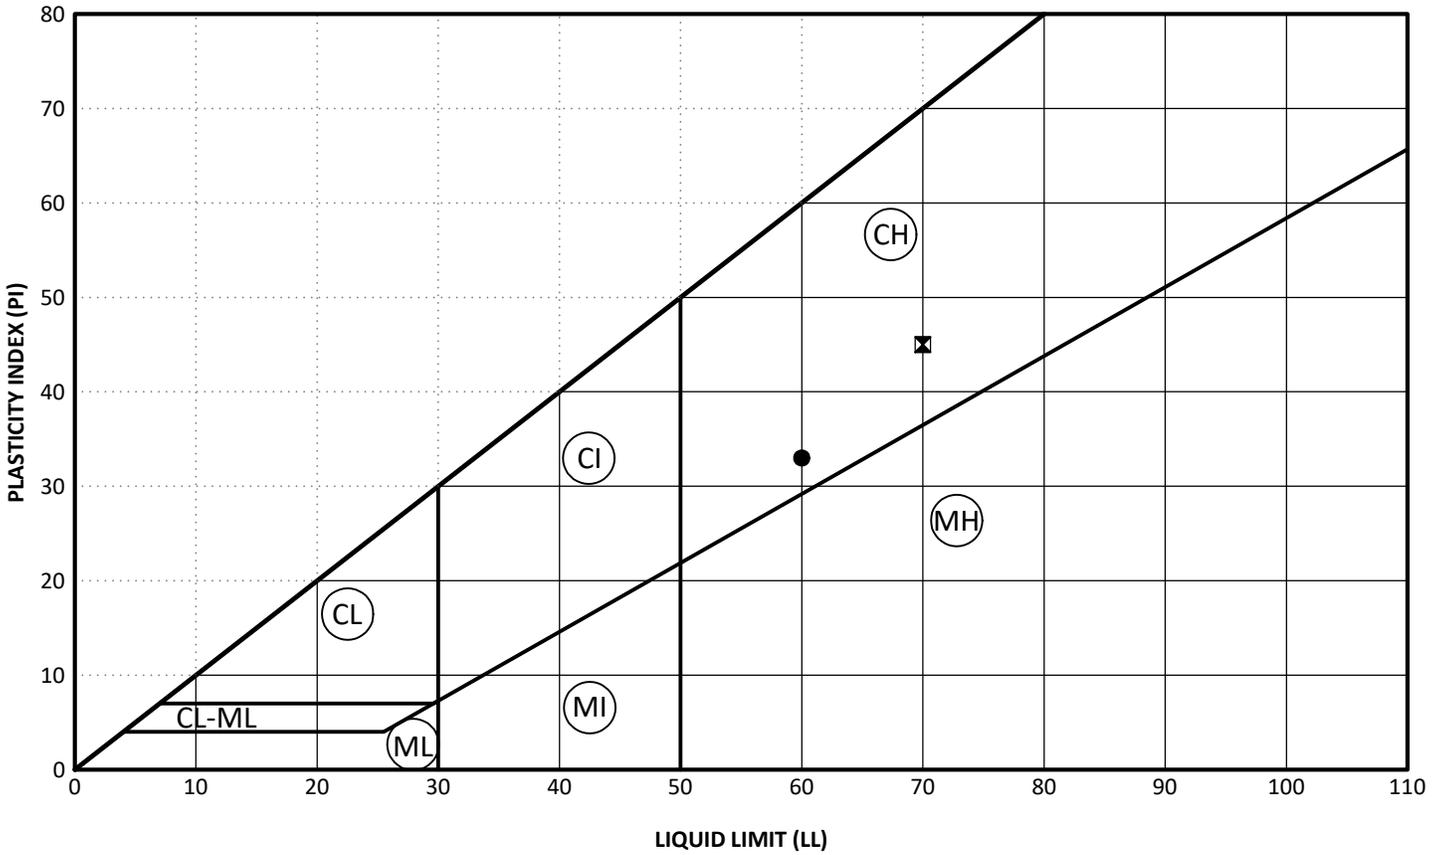
# ATTERBERG LIMITS

Undrained shear strength of the clay was estimated in the field during drilling using a handheld Torvane and ranged from 80 to 65 kPa. Two (2) Atterberg limit tests completed on clay soil samples at a depth of 0.6m (2 ft) classified the material as high plasticity clay. Grain size analysis tests completed on the same samples indicated 0 to 1% gravel, 3 to 17% sand, 59 to 61% silt and 23 to 37% clay. Moisture contents ranged from 33 to 40% and generally increased with depth.

HOLE	DEPTH (m)	SAMPLE #	LL	PL	PI	SAND (%)	SILT (%)	CLAY (%)	SILT & CLAY (%)	MC (%)	CLASSIFICATION
● TH22-01	0.6	S3	60	27	33	17	59	23	82	33	CH
✕ TH22-03	0.6	S5	70	25	45	3	61	37	97	36	CH

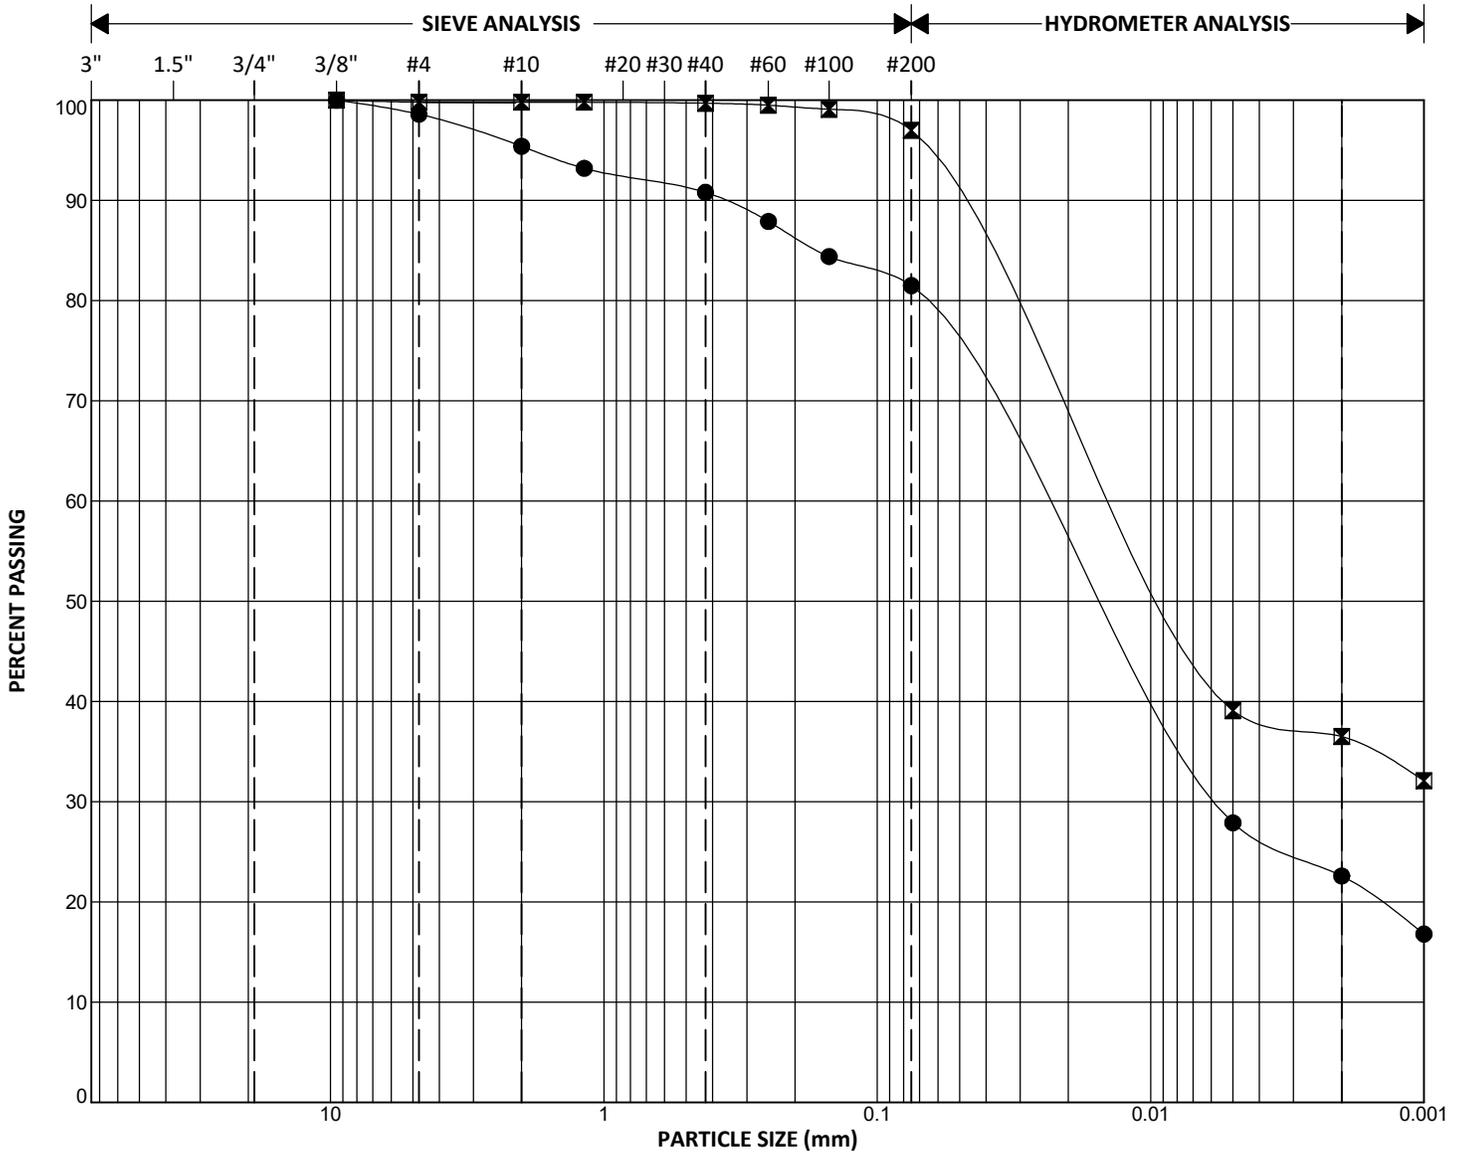
# GRAIN SIZE DISTRIBUTION

HOLE	DEPTH (m)	SAMPLE #	GRAVEL (%)	SAND (%)	SILT (%)	CLAY (%)	SILT & CLAY (%)	Cu	Cc	CLASSIFICATION
●	TH22-01	0.6	S3	1	17	59	23	82			CH
⊠	TH22-03	0.6	S5	0	3	61	37	97			CH

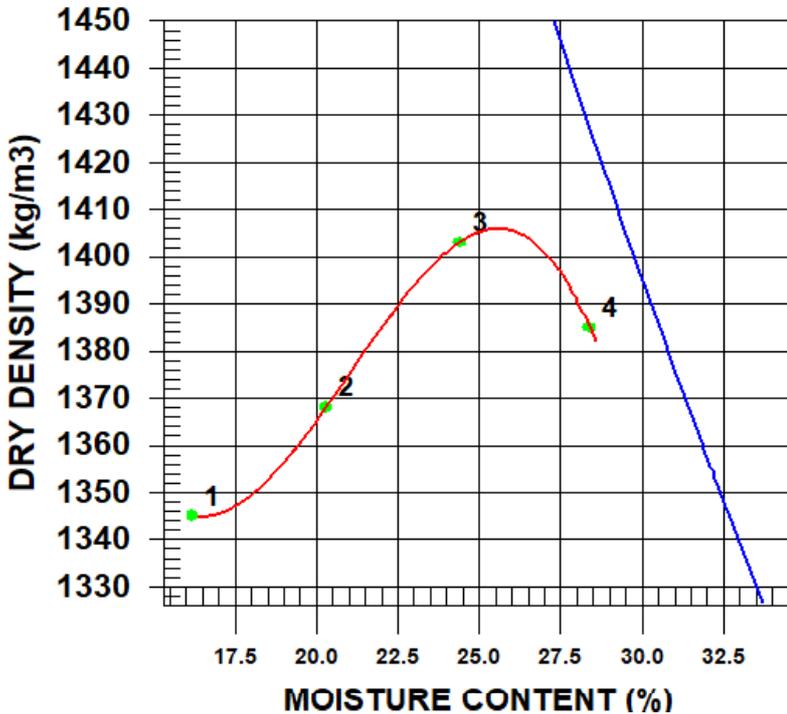
# PROCTOR TEST REPORT

A moisture-density relationship test (standard Proctor) was completed on the clay subgrade soil and resulted in a maximum dry density of 1410 kg/m<sup>3</sup> and an optimum moisture content of 25.5%. The CBR-value was measured to be 1.2 at 2.54 mm penetration-for the same sample. The laboratory Proctor and CBR-value test reports are attached in Appendix B, Laboratory Test Results.

TRIAL NUMBER	WET DENSITY (kg/m <sup>3</sup> )	DRY DENSITY (kg/m <sup>3</sup> )	MOISTURE CONTENT (%)
1	1563	1345	16.2
2	1646	1368	20.3
3	1745	1403	24.4
4	1778	1385	28.4

MAXIMUM DRY DENSITY (kg/m <sup>3</sup> )	OPTIMUM MOISTURE CONTENT (%)
CALCULATED	1410	25.5
OVERSIZE CORRECTED

Material tested was a composite sample of clay taken from TH22-01 & TH22-03. Samples were identified by the client as Site 9 Hudson Lane.

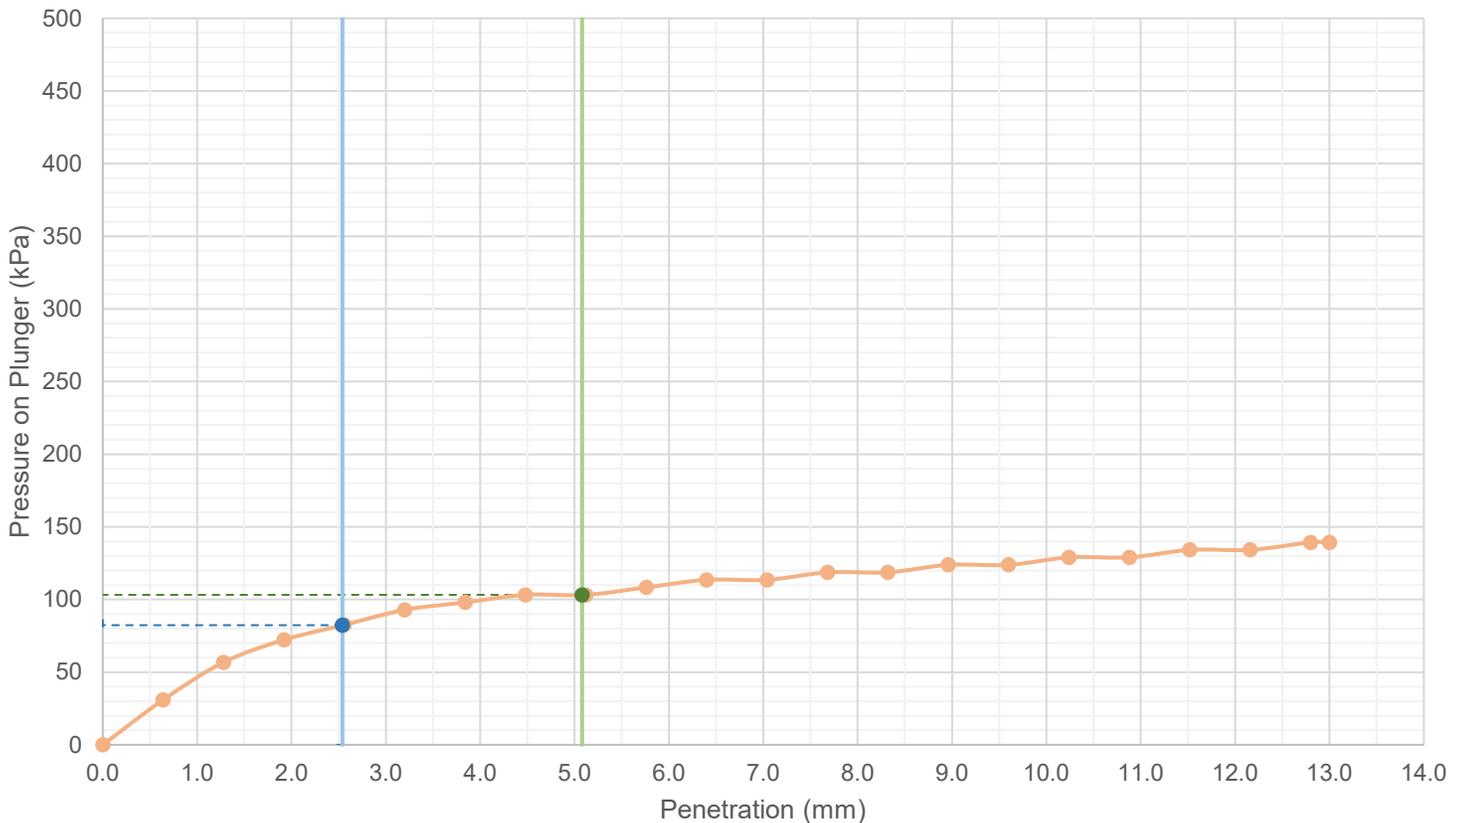
**LOAD PENETRATION CURVE**

IMMERSION PERIOD	96 ± 2 hr	TARGET MAX. DRY DENSITY	1410 kg/m <sup>3</sup>
CONDITION OF SAMPLE	Soaked	TARGET OPTIMUM MOISTURE	25.5 %
SURCHARGE MASS	4.54 kg	AS-COMPACTED MAX. DRY DENSITY	1342 kg/m <sup>3</sup>
SWELL OF SAMPLE	9.0%	AS-COMPACTED MOISTURE CONTENT	25.4 %
		POST-TEST MOISTURE CONTENT (TOP 25 mm)	49.3 %

CBR VALUE AT <b>2.54 mm</b> PENETRATION	<b>1.2</b>
CBR VALUE AT <b>5.08 mm</b> PENETRATION	<b>1.0</b>

Sample prepared to 95% of the maximum dry density at the optimum moisture content as determined from ASTM D698.  
 We appreciate the opportunity to assist you on this project. Please contact the undersigned if you have any questions regarding this report.
