# **APPENDIX 'A'**

## **GEOTECHNICAL REPORT**

**Re: 2024 City of Winnipeg Local Street Renewal Program  
Report of Geotechnical Investigations and Test Results – Rev 1**

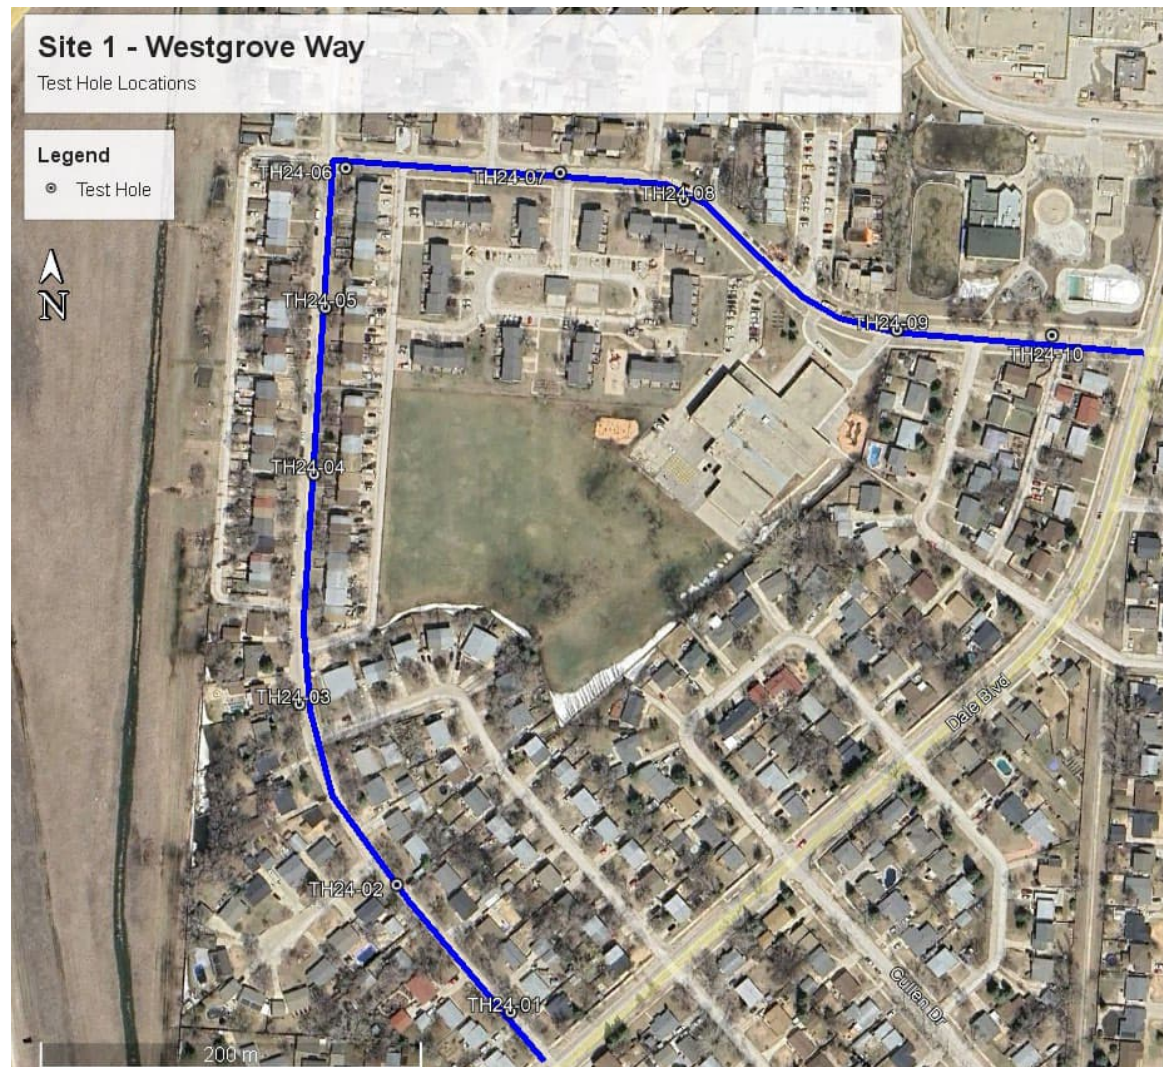
FIGURE 1: TEST HOLE LOCATIONS FOR WESTGROVE WAY

A core investigation was conducted along Westgrove Way, involving the extraction of 10 core: five (5) from mid-slab locations and five (5) from joint locations. The pavement surface was composed of concrete with thicknesses ranging from 140 to 203 mm. A granular base was identified at TH24-01, TH24-06, and TH24-07 with thicknesses varying between 38 and 51 mm, while the remaining cores revealed no base material, exposing a clay subgrade beneath the pavement. Detailed core locations are illustrated in Figure 1.

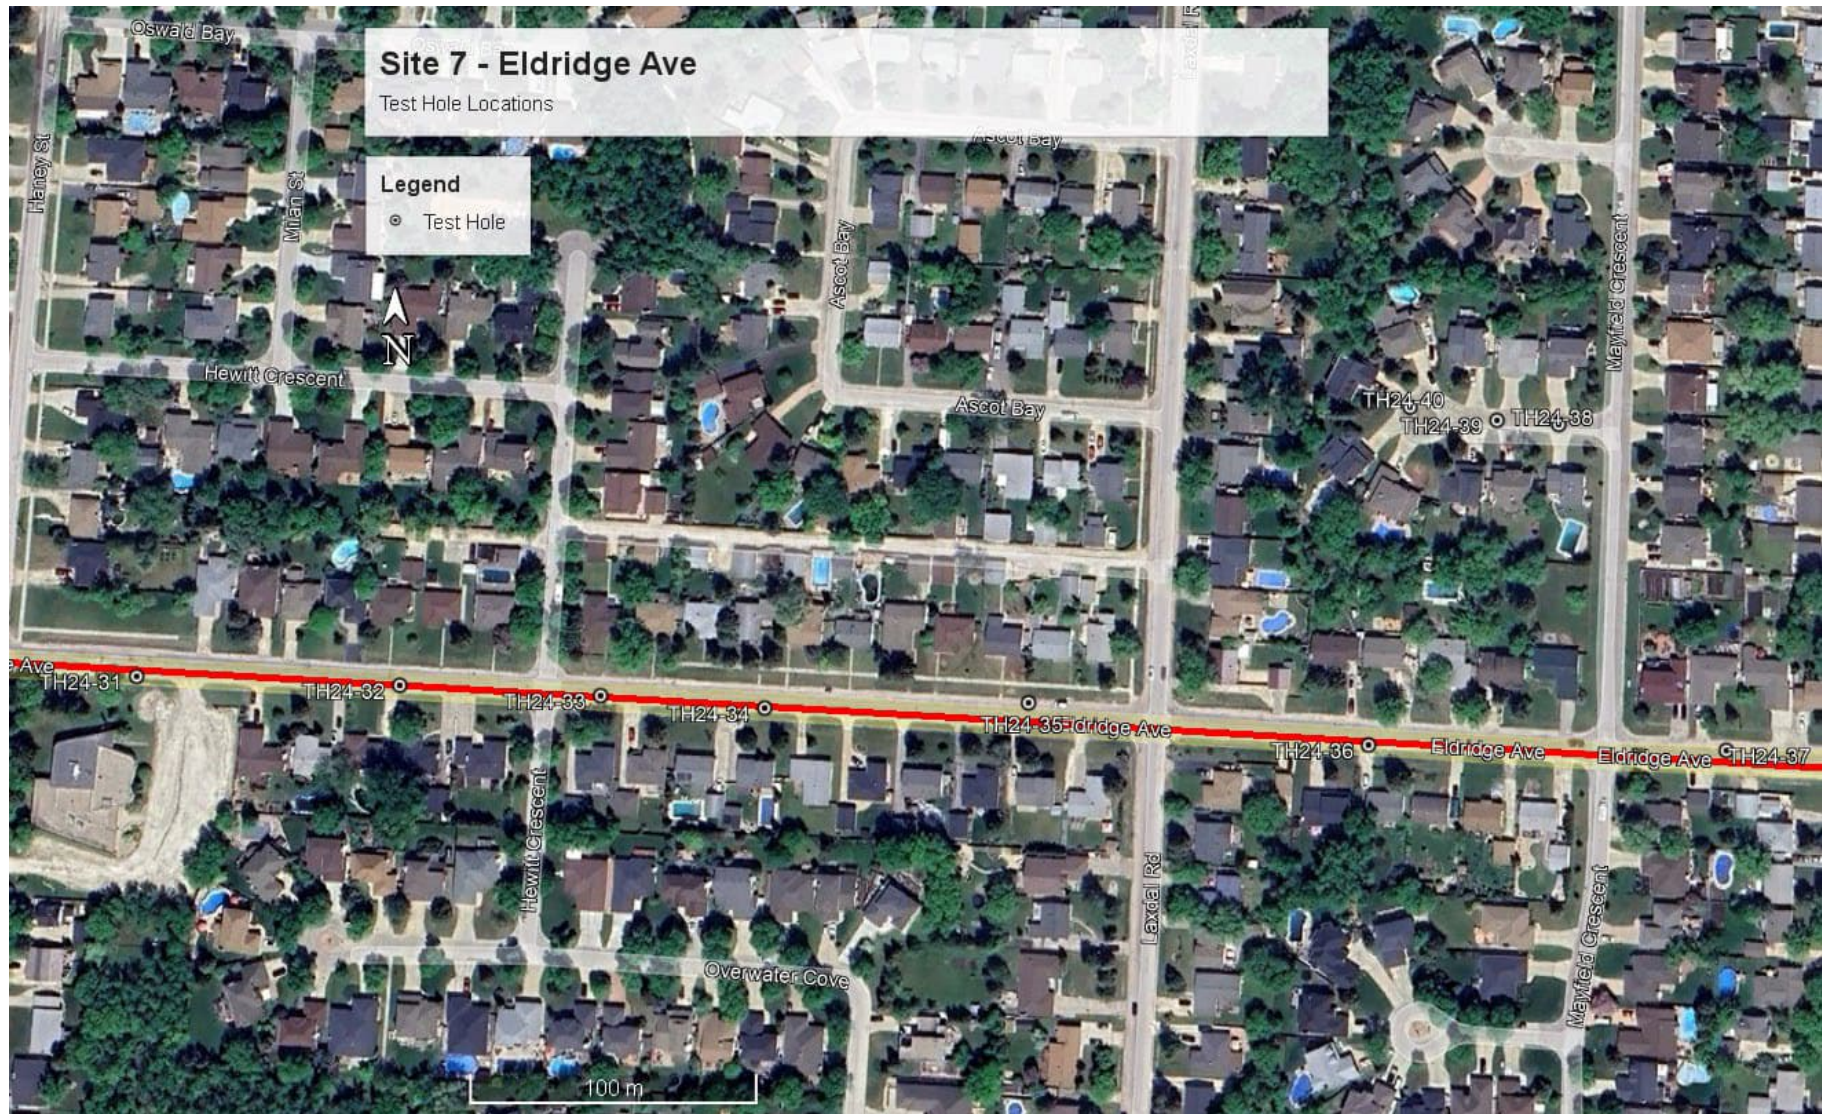
FIGURE 7: TEST HOLE LOCATIONS FOR ELDRIDGE AVEUNE

A core investigation was conducted along Eldridge Avenue, involving the extraction of six (6) core from exclusively mid-slab locations. The pavement surface was composed of asphalt with thicknesses ranging from 100 to 185 mm. Granular base was identified at TH24-32, TH24-33, TH24-34, TH24-35, and TH24-36 with thicknesses of 40 and 185 mm, while the remaining core revealed no base material, exposing a clay subgrade beneath the pavement. Detailed core locations are illustrated in Figure 7.

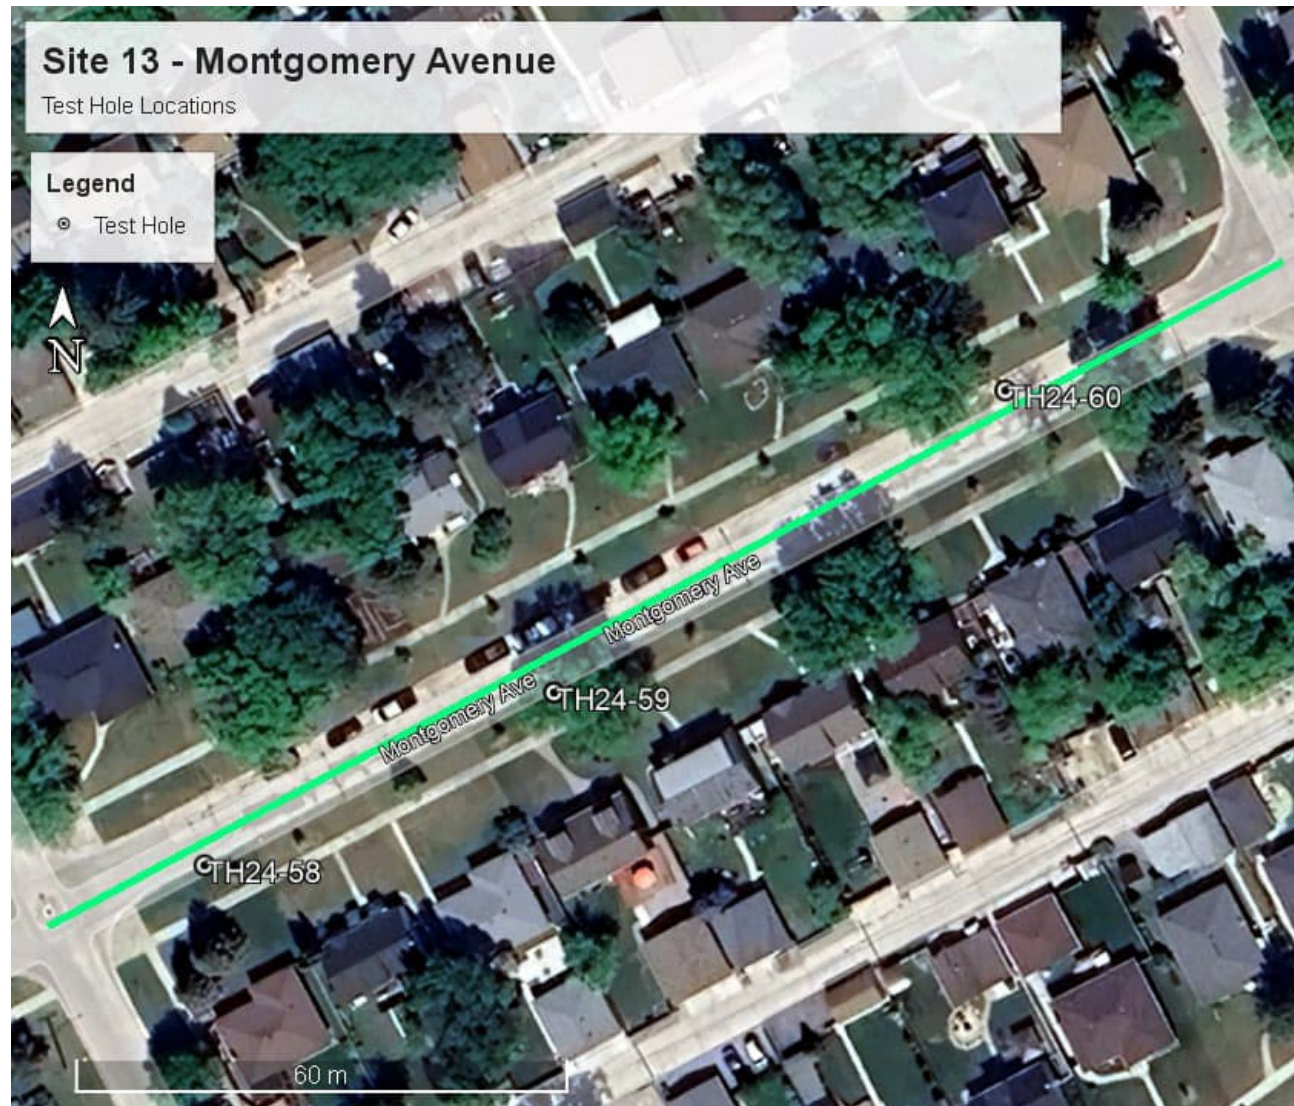
FIGURE 14: TEST HOLE LOCATIONS FOR MONTGOMERY AVENUE

A core investigation was conducted along Montgomery Avenue, involving the extraction of three (3) core: two (2) from mid-slab locations and one (1) from a joint location. The pavement surface was composed of concrete with thicknesses ranging from 180 to 195 mm. Crushed limestone base was identified at TH24-58 and TH24-59 with thicknesses of 55 and 90 mm, while the remaining core revealed no base material, exposing a clay subbase beneath the pavement. Detailed core locations are illustrated in Figure 14.
