GEOTECHNICAL REPORT

**Pembina Highway Overpass at Abinojii
Mikanah Rehabilitation RFP 975-2024**

**Geotechnical Investigation and Foundation
Report**

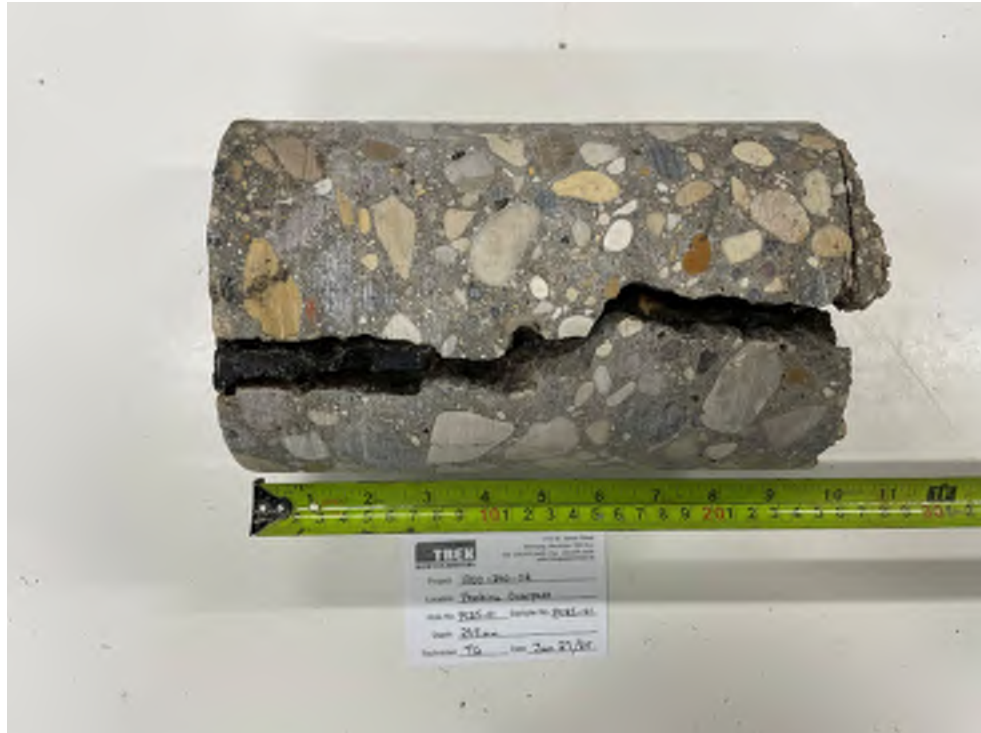
Photo 1: Pavement Core Sample at PC25-01

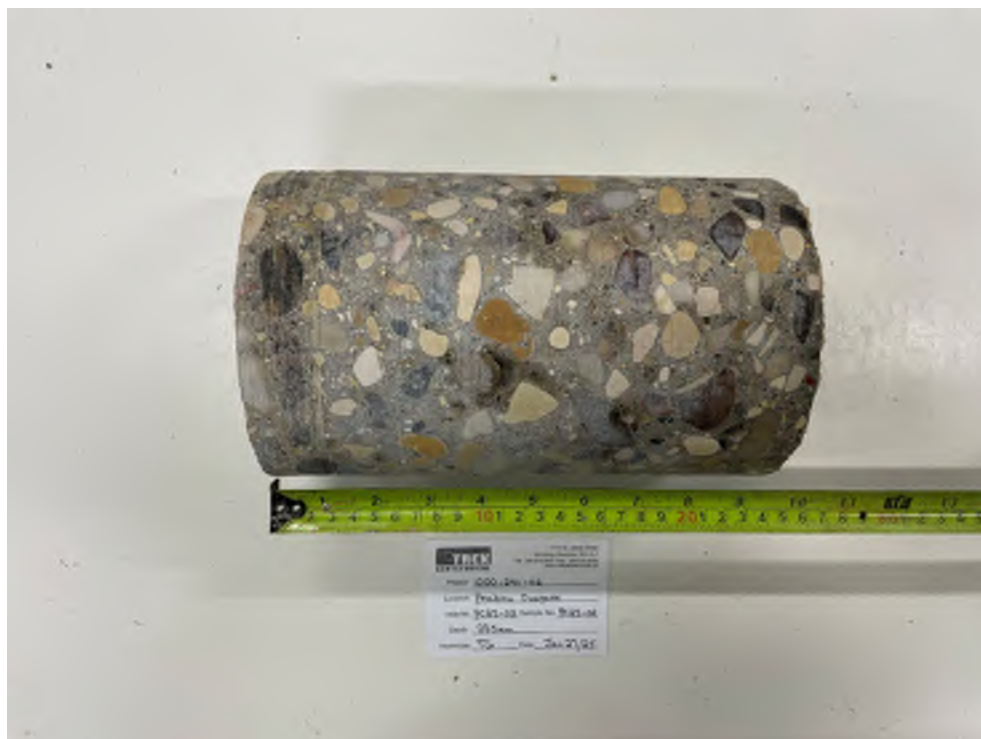
Photo 2: Pavement Core Sample at PC25-02

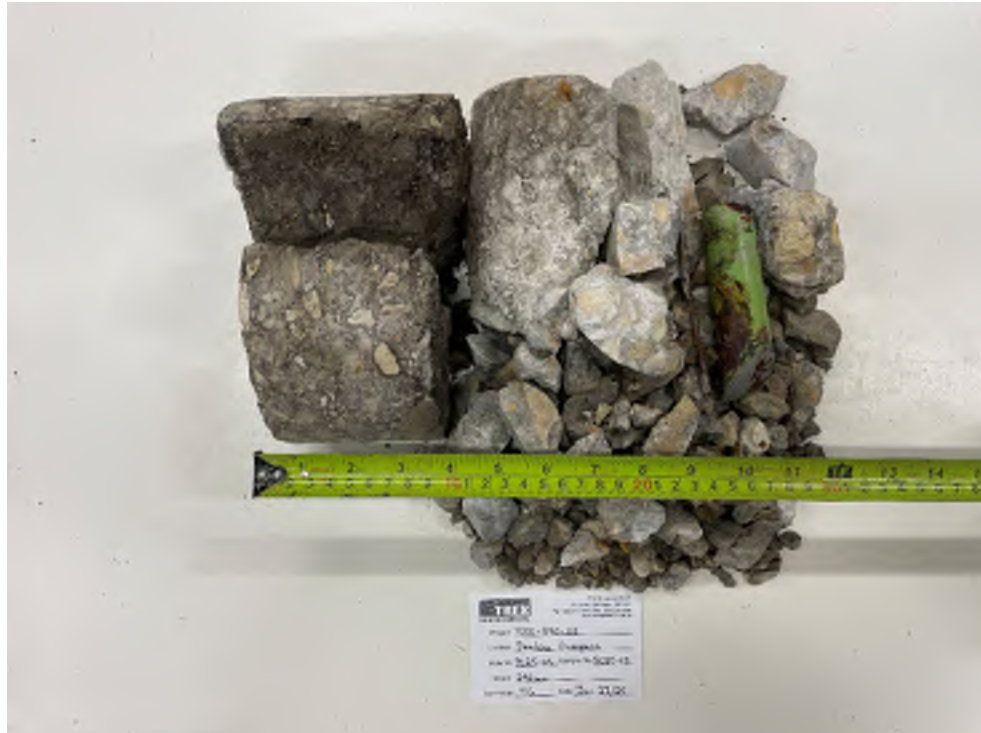
Photo 3: Pavement Core Sample at PC25-03

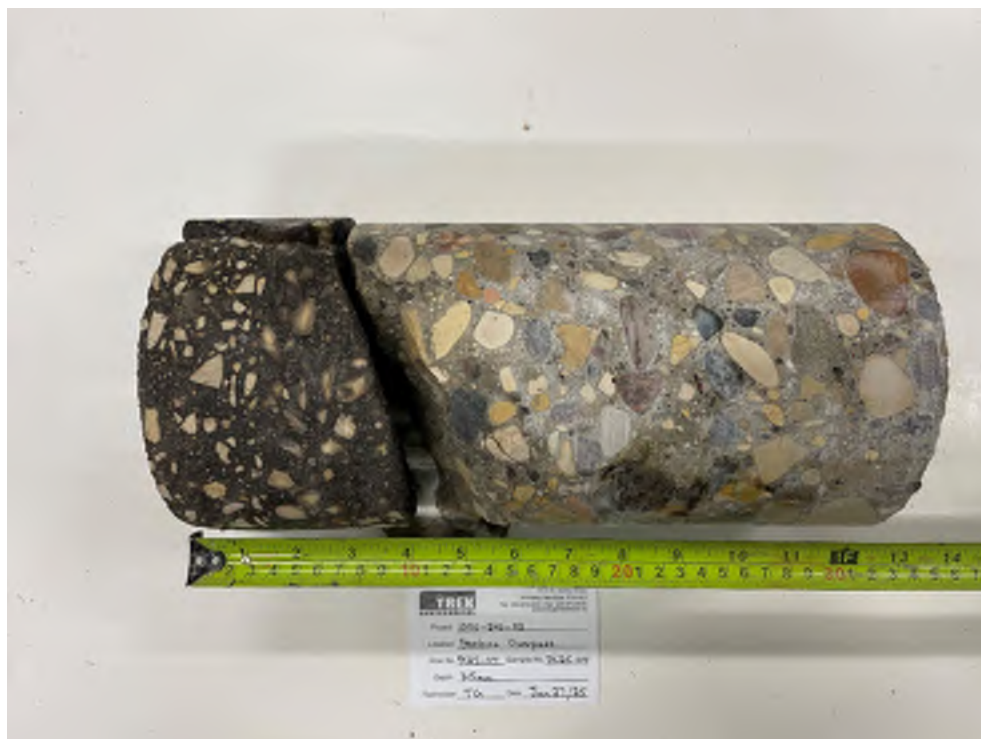
Photo 4: Pavement Core Sample at PC25-04

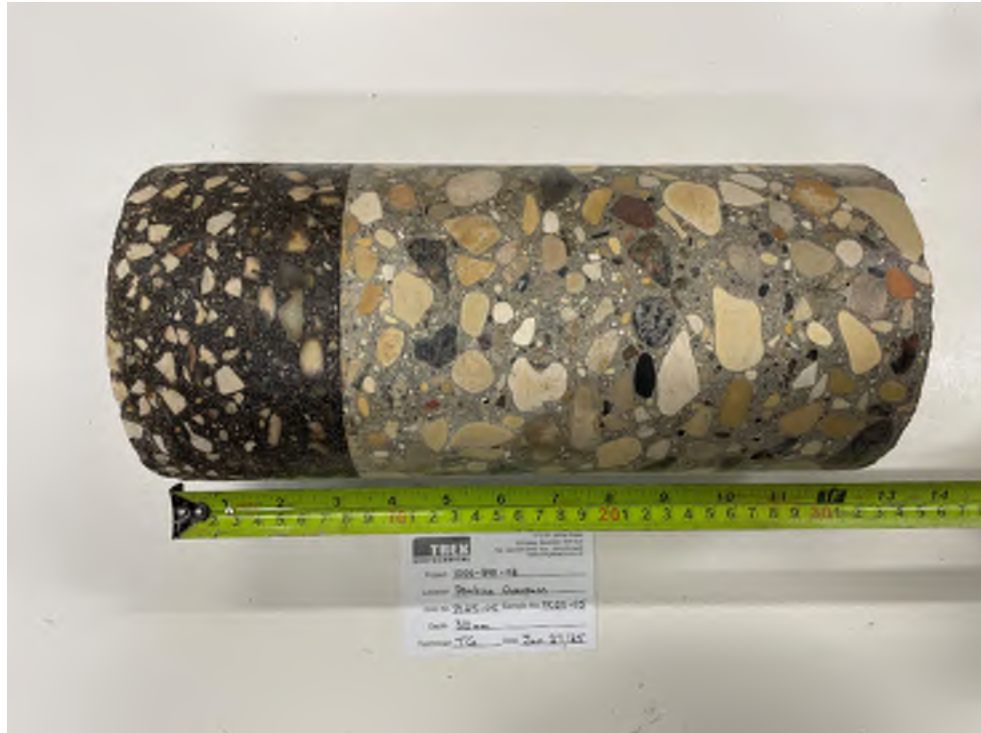
Photo 5: Pavement Core Sample at PC25-05

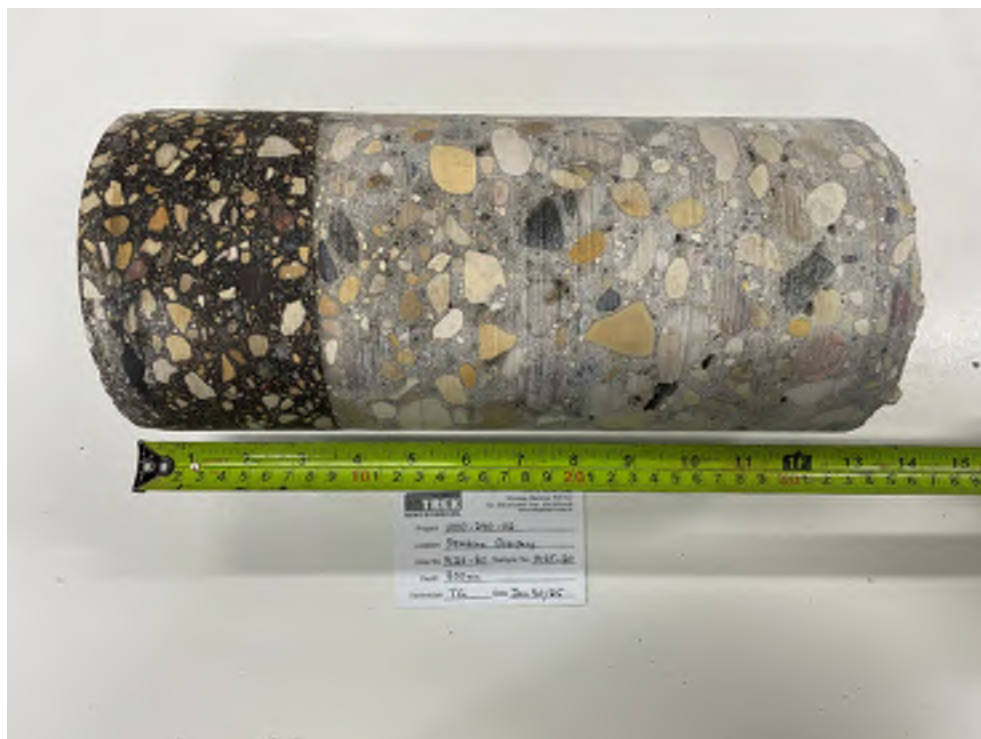
Photo 20: Pavement Core Sample at PC25-20

PC25-20	UTM : 5520414 m N, 633039 m E; Located on Pembina Overpass, Westbound Abinoojii Mikanah to Pembina Highway, 4.5 m South of North curb (Compressive Strength, Core #16)	Asphalt	90	Concrete	210	67.68	
PC25-21	UTM : 5520414 m N, 633010 m E; Located on Pembina Overpass, Westbound Abinoojii Mikanah to Pembina Highway, 1.7 m North of South curb (Joint, Core #17)	Asphalt	40	Concrete	220		
PC25-22	UTM : 5520501 m N, 632853 m E; Located at #1875 Pembina Highway, Southbound Curb Lane, 1.9 m East of West curb (Joint, Core #29)	Asphalt	70	Concrete	210		
PC25-23	UTM : 5520405 m N, 632875 m E; Located at #1921 Pembina Highway, Southbound Median Lane, 2.0 m West of East curb (Compressive Strength, Core #28)	Asphalt	65	Concrete	225	52.10	
PC25-24	UTM : 5520013 m N, 632919 m E; Located at Pembina Highway Bus Stop #60138, Southbound Curb Lane, 2.0 m East of West curb (Compressive Strength, Core #27)	Asphalt	115	Concrete	240	73.14
