APPENDIX A: GEOTECHNICAL REPORT

Lagimodiere Blvd Twin Overpass Rehabilitation Preliminary Design - (RFP No. 111-2022)

Project Number: 0002-130-00

**RE: Lagimodiere Blvd Twin Overpass Rehabilitation
Preliminary Design - (RFP No. 111-2022)
Geotechnical Report**

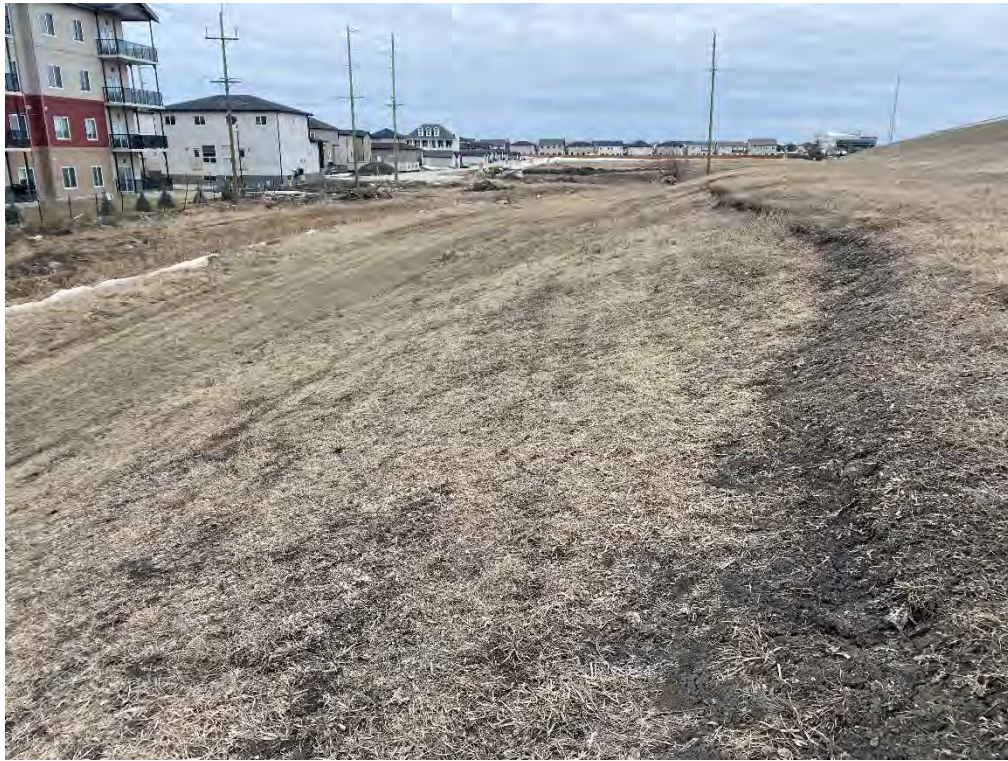
Photo 01: Shallow instabilities located on the lower east side of the south embankment.

A total of nine shallow slope instabilities have occurred on the side and head slopes of both north and south approach embankments for the overpass, five of which occurred in 1993 and four occurred in 2007. These shallow slope instabilities were repaired using a combination of excavating existing materials, replacing with rockfill, constructing clay berms, filling in tension cracks and regrading at flatter slopes. Instabilities observed in 2007 on the lower east side of the south embankment have since re-activated, indicating ongoing movement in the areas where tension cracks were observed (Photos 01 and 02).

Additionally, stabilization of the existing shallow slope instabilities along the lower east side of the south embankment is required. The observed instabilities are generally consistent with shallow, saturation induced instabilities which are commonly observed in cut or fill slopes during periods of high precipitation or water infiltration, in some cases several decades after construction. Further, record drawings from the 2007 slope repairs at other instability locations indicated the base of the slip surfaces coincided with the sand blanket that underlies the embankment fill. It is possible that the sand blanket has settled beneath the embankment and may not be properly draining. It may also be possible that the sand blanket has become blocked off and may not be able to drain water from beneath the embankment, concentrating excess porewater pressures in localized areas near the slope toe, where slope instabilities have been observed.
