THE CITY OF WINNIPEG PUBLIC WORKS DEPARTMENT ENGINEERING DIVISION</div>								
				DESIGNED BY	RL	REVIEWED BY	SA	LAGIMODIERE TWIN OVERPASSES OVER CPKC KEEWATIN REHABILITATION AND RELATED WORKS				CITY DRAWING NUMBER B123-25-2109				
				DRAWN BY	EV	APPROVED BY	KA					SHEET 9 OF 47				
				SCALE: AS NOTED		ACCEPTED BY DATE										
						CAM WARD, P.ENG. 25.08.07										
0	ISSUED FOR TENDER		25.08.07	SA					CONSULTANT DRAWING NO. 704-INF.MBI03007.01-DWG-S2109				SOUTHBOUND STRUCTURE PIER S-1 - REPAIR DETAILS		2109	
NO	REVISIONS		DATE	BY	DATE	25.08.07

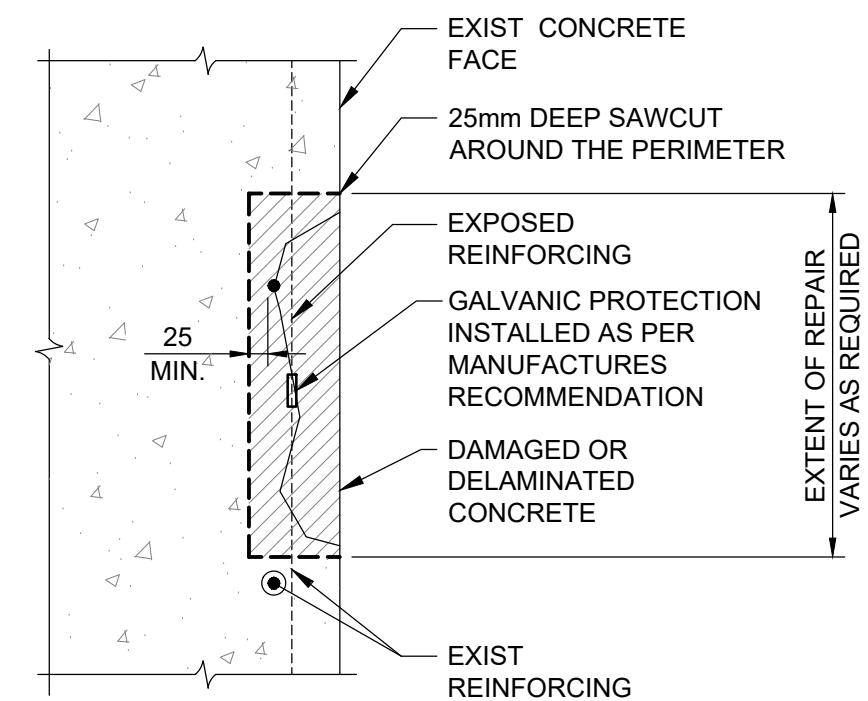
5 PARTIAL DEPTH REPAIR
1 : 10

NOTE:
REFER TO SHEET 1004 FOR TYPICAL REPAIR NOTES.
