# **GEOTECHNICAL REPORT**

Re: 2025 City of Winnipeg Local Street Program – 25-R-02  
Report of Geotechnical Investigations and Test Results – Rev 1

This letter summarizes KGS Group’s geotechnical investigation results for the 2025 City of Winnipeg (COW) Local Street Program – 25-R-02 in Winnipeg, Manitoba. KGS Group’s scope of service for this project was outlined in our proposal no. 25-000-0103 titled “City of Winnipeg 2025 Local Street Program 25-R-02 – Geotechnical Services” dated January 23, 2025.

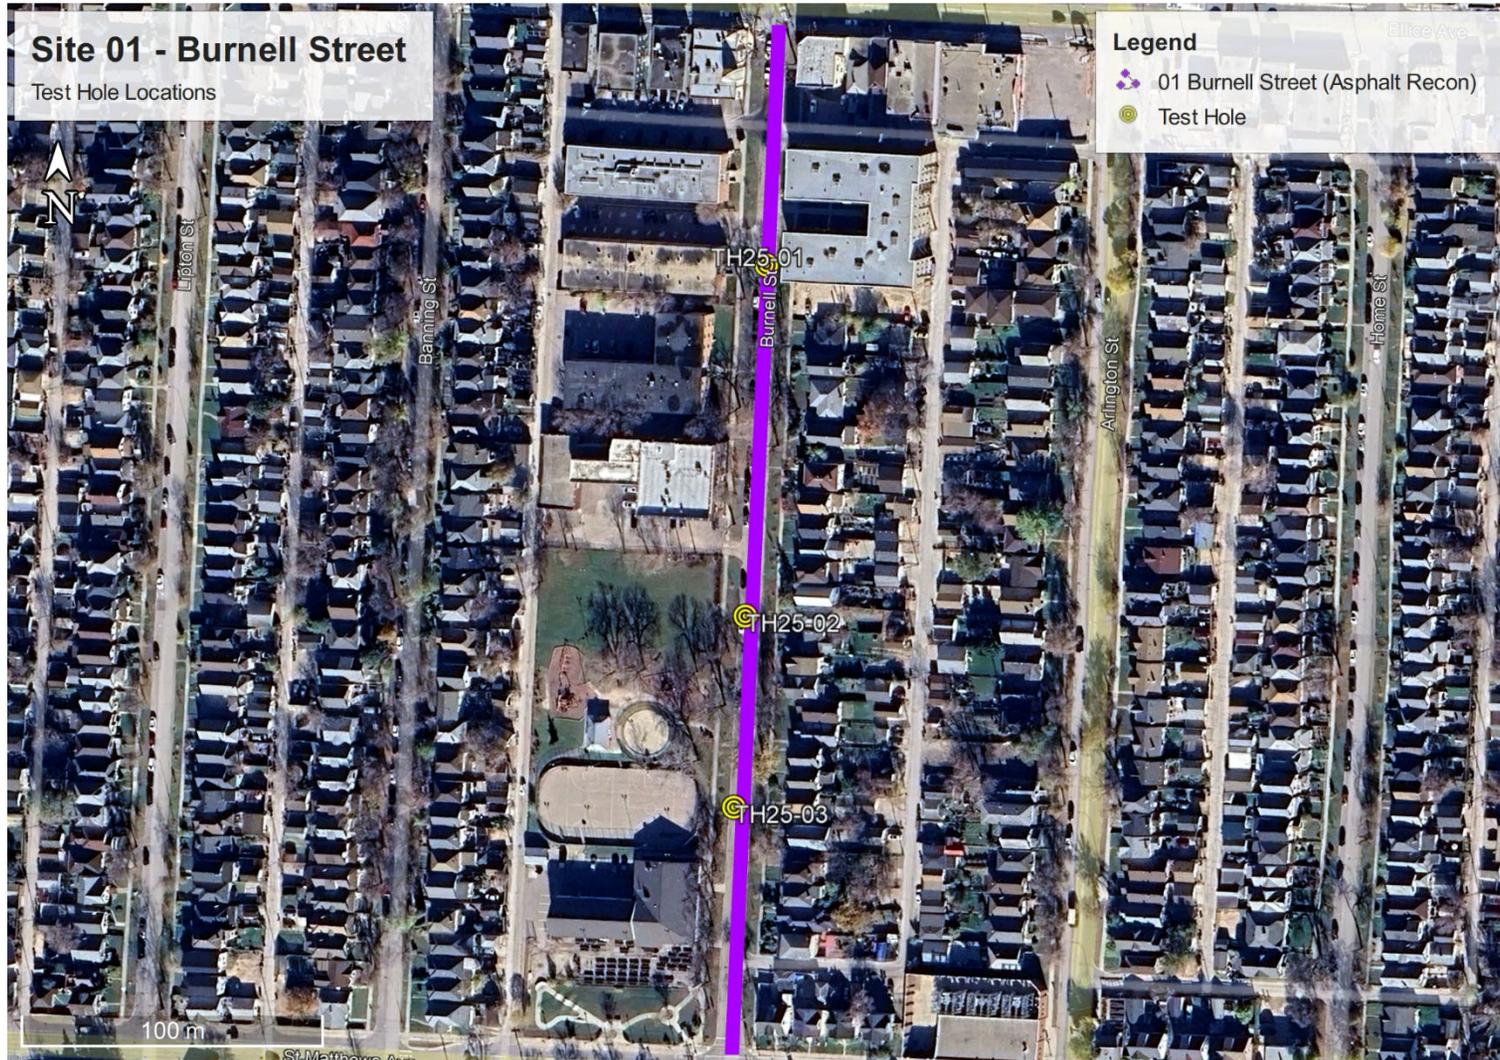
FIGURE 1: TEST HOLE LOCATIONS ON BURNELL STREET (SITE 01)

A core investigation was conducted along Burnell Street, involving the extraction of three (3) cores from mid-slab locations. Additional soil investigations were conducted at each of the test hole locations and were advanced to a depth of 3.0 m (10 ft) below pavement surface. The general stratigraphy encountered within the test holes consisted of asphalt pavement overlying concrete, with clay fill overlying fat clay. A further description of each layer is provided below, with test hole logs provided in Appendix B and test hole locations shown in Figure 1.

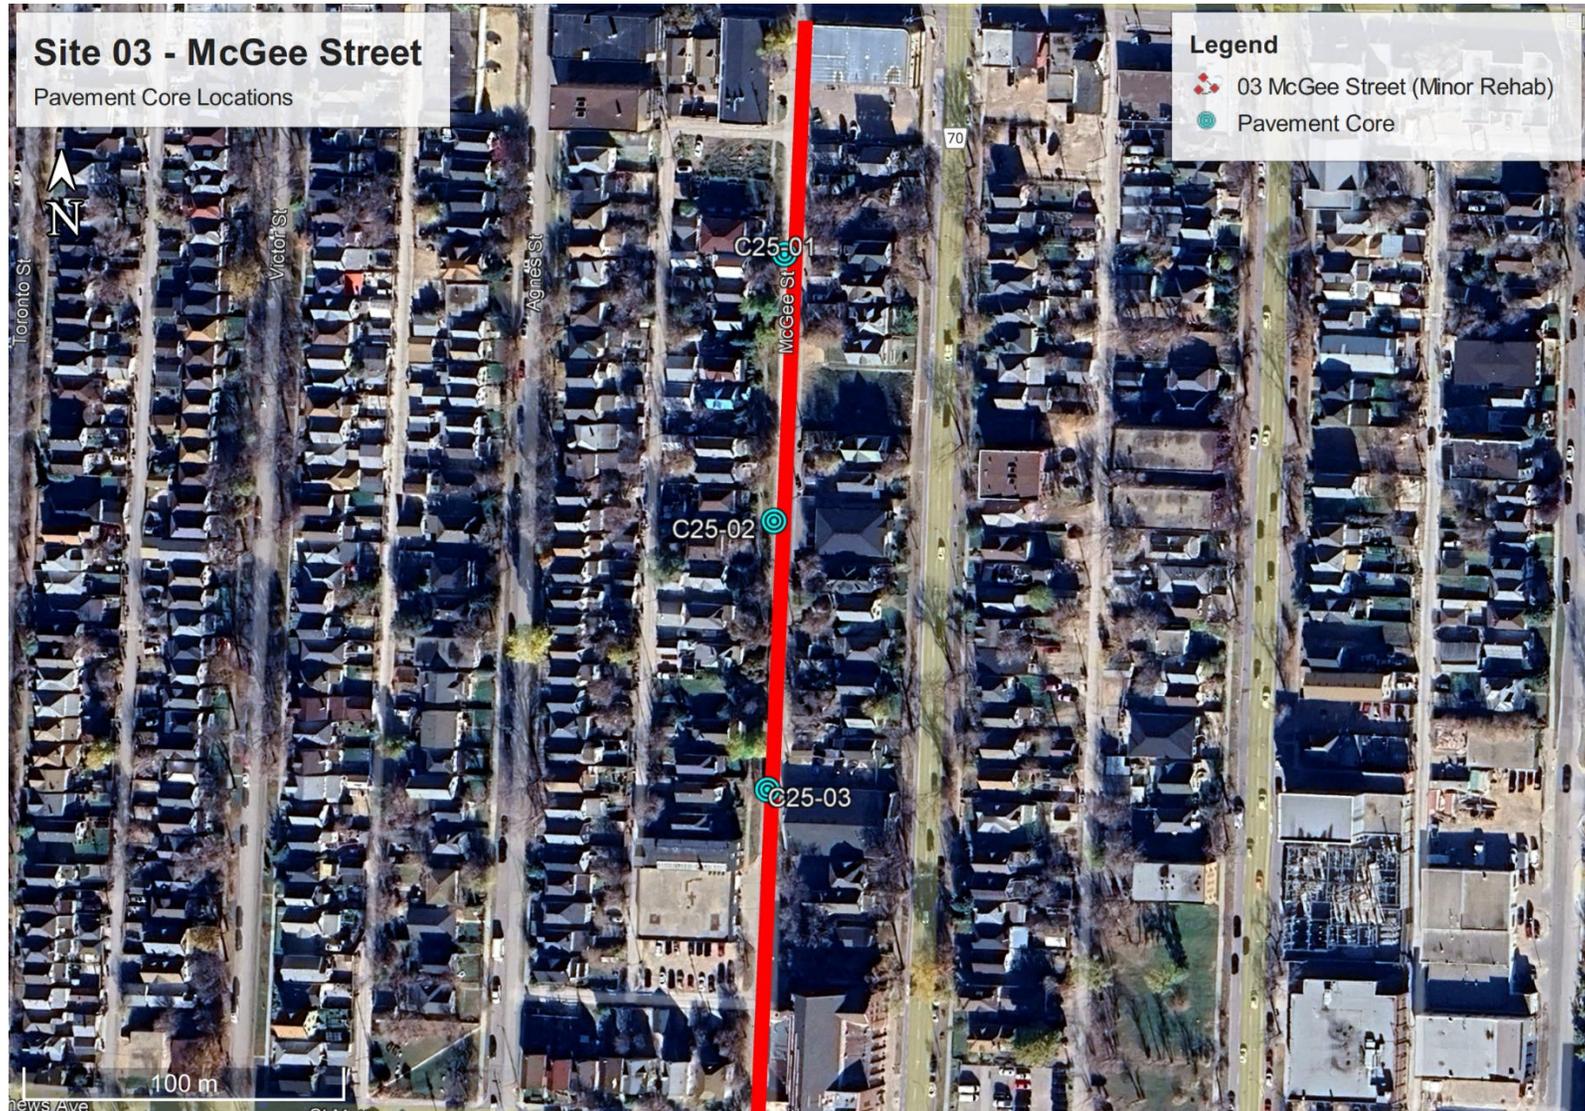
FIGURE 3: PAVEMENT CORE LOCATIONS ON MCGEE STREET (SITE 03)

A core investigation was conducted along McGee Street, involving the extraction of three (3) cores: two (2) from mid-slab locations and one (1) from a joint location. The pavement surface was composed of concrete with thicknesses ranging from 185 to 190 mm. Granular base was observed below the pavement structure at all core locations with thicknesses varying between 39 and 221 mm, generally increasing in thickness in the northbound direction. Dense, frozen conditions of the gravel base prevented observation of the underlying subgrade. Detailed core locations are illustrated in Figure 3.

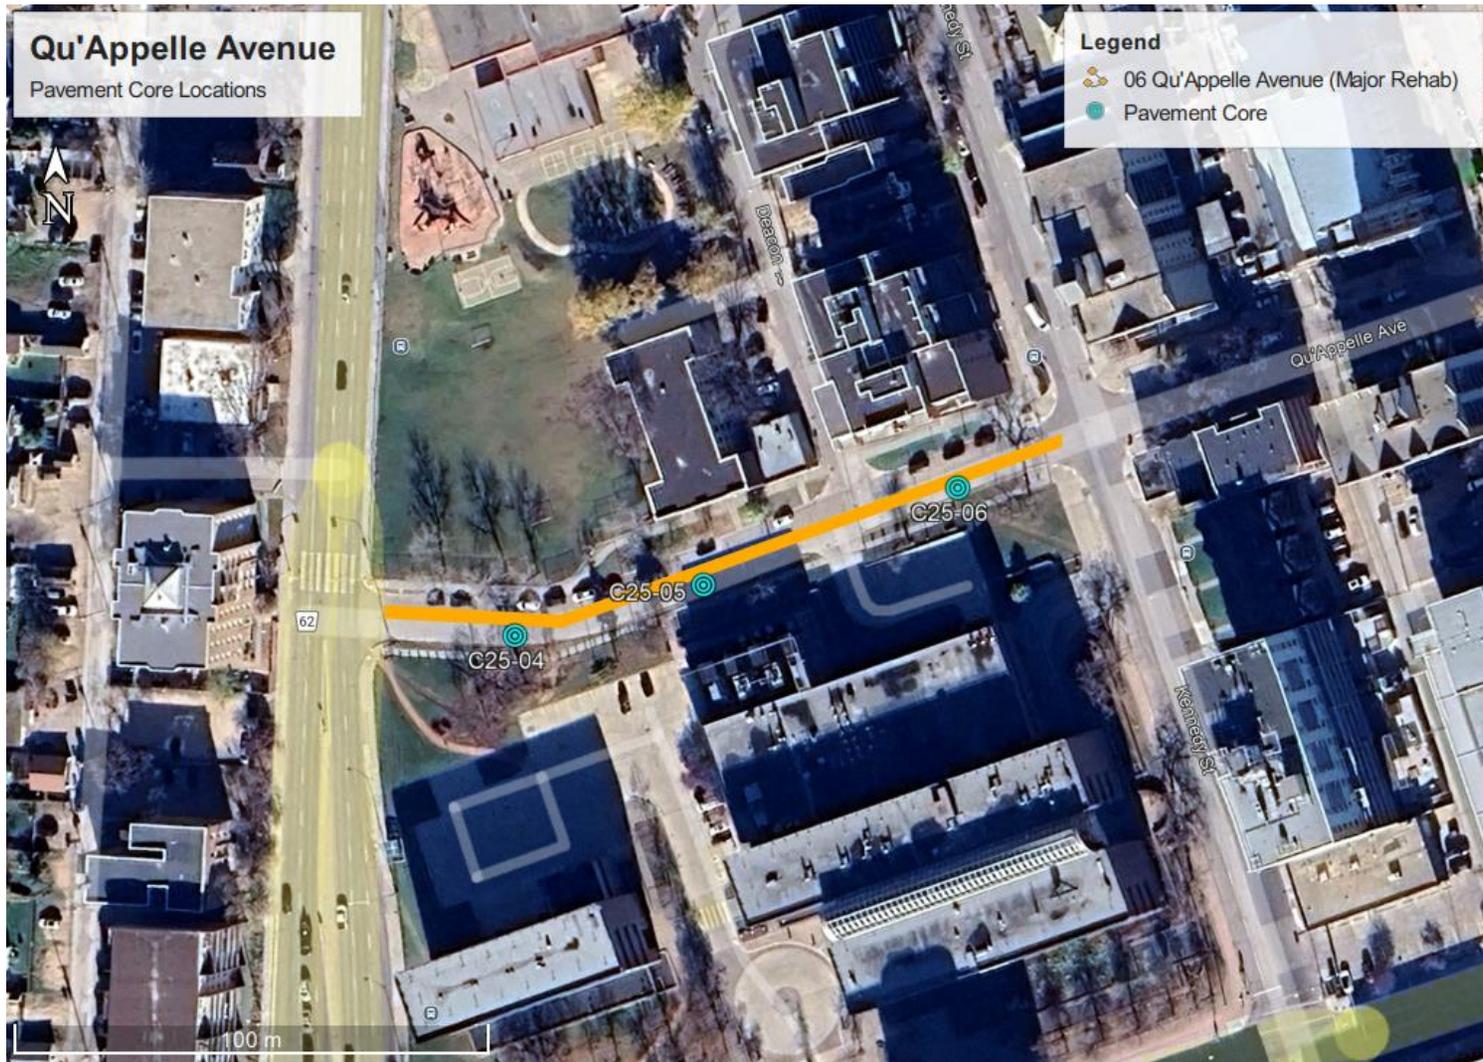
**FIGURE 6: PAVEMENT CORE LOCATIONS ON QU'APPELLE AVENUE (SITE 06)**

A core investigation was conducted along Qu'Appelle Avenue, involving the extraction of three (3) cores from mid-slab locations. Locations of joints were difficult to find due to thick snow and ice cover during the time of the investigation. The pavement surface was composed of concrete with thicknesses ranging from 200 to 220 mm. Granular base was observed below the pavement structure at C25-04 and C25-05, with observed thicknesses of 59 and 204 mm. Clay with some intermixed sand was observed below the pavement structure at C25-06. Dense, frozen conditions of the gravel base prevented observation of the underlying subgrade in C24-04 and C25-05. Detailed core locations are illustrated in Figure 6.

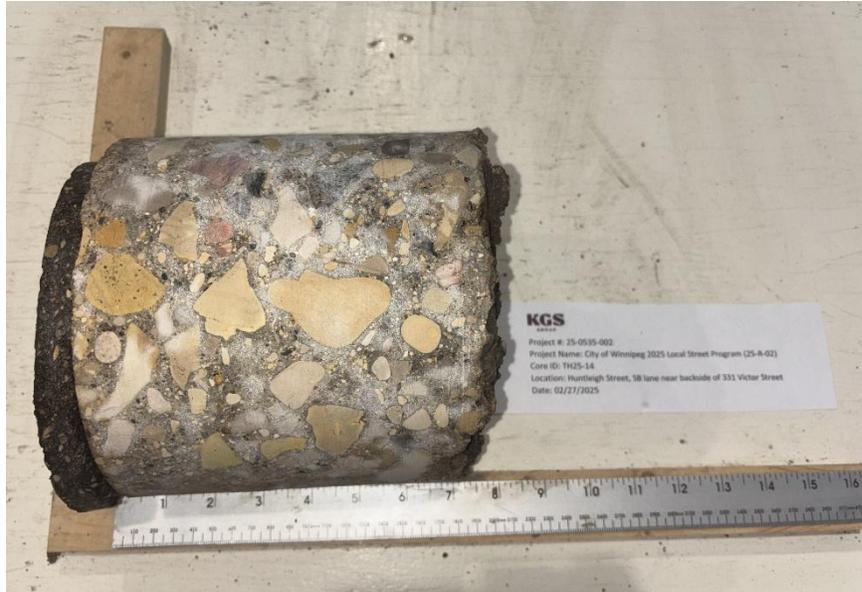
Photo 5: Huntleigh Street, TH25-14

*Huntleigh Street TH25-15 core not recoverable.*

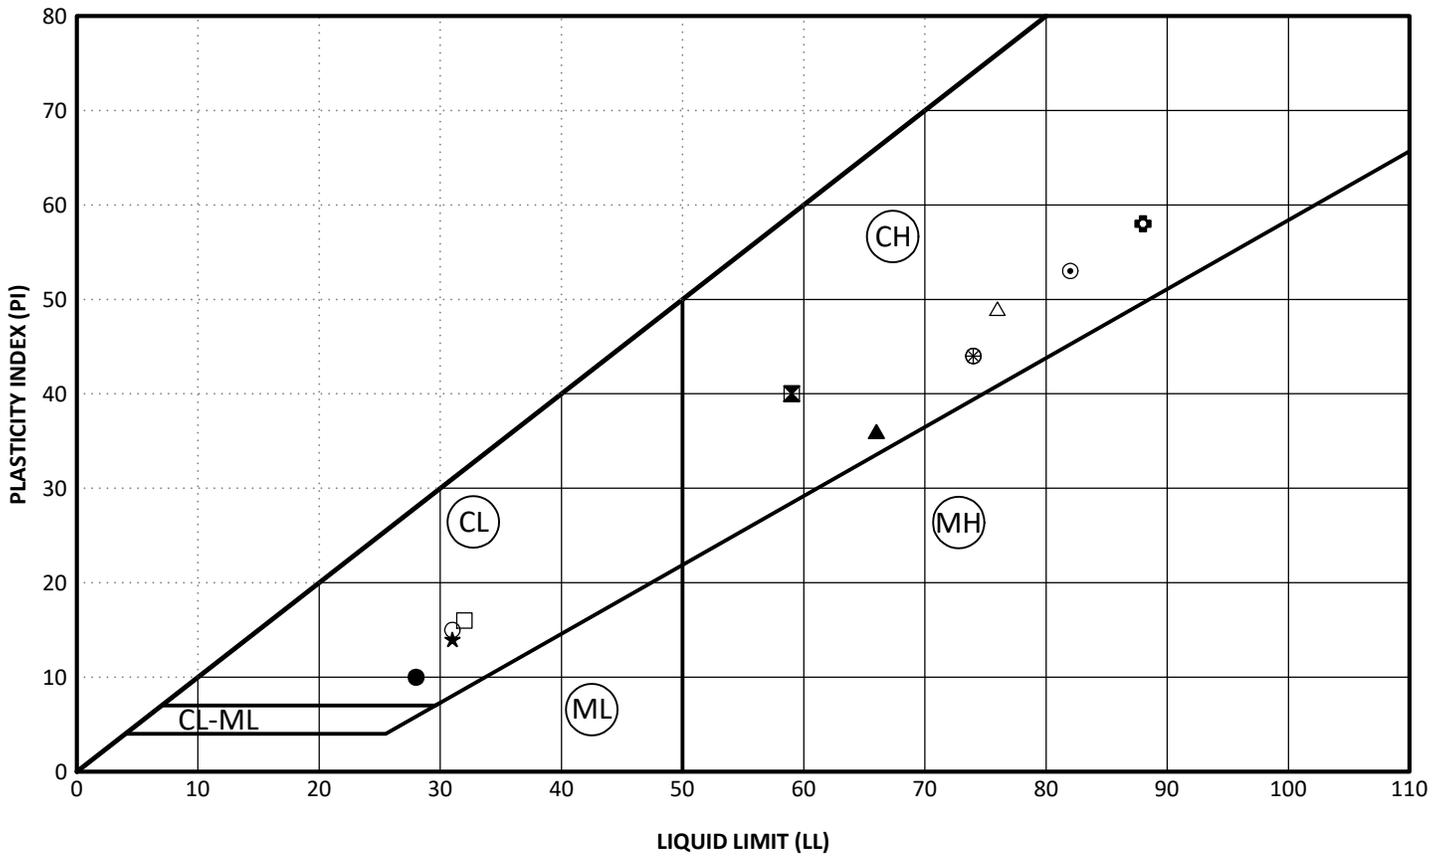
# ATTERBERG LIMITS

HOLE	DEPTH (m)	SAMPLE #	LL	PL	PI	SAND (%)	SILT (%)	CLAY (%)	SILT & CLAY (%)	MC (%)	CLASSIFICATION
●	TH25-01	0.6	S2	28	18	10	8	77	15	92	25	CL
☒	TH25-03	0.9	S2	59	19	40	3	39	58	97	27	CH
▲	TH25-04	0.6	S1	66	30	36	16	45	38	83	53	CH
★	TH25-07	0.6	S2	31	17	14	8	75	18	92	25	CL
⊙	TH25-08	0.9	S2	82	29	53	1	18	81	99	32	CH
⊕	TH25-09	0.8	S1	88	30	58	2	17	81	98	35	CH
○	TH25-10	0.9	S2	31	16	15	3	73	24	97	26	CL
△	TH25-11	0.9	S2	76	27	49	2	27	71	98	37	CH
⊗	TH25-12	0.6	S1	74	30	44	3	38	59	97	39	CH
⊕	TH25-13	0.9	S2	74	30	44	1	32	67	99	32	CH
□	TH25-15	0.6	S2	32	16	16	5	76	19	95	30	CL

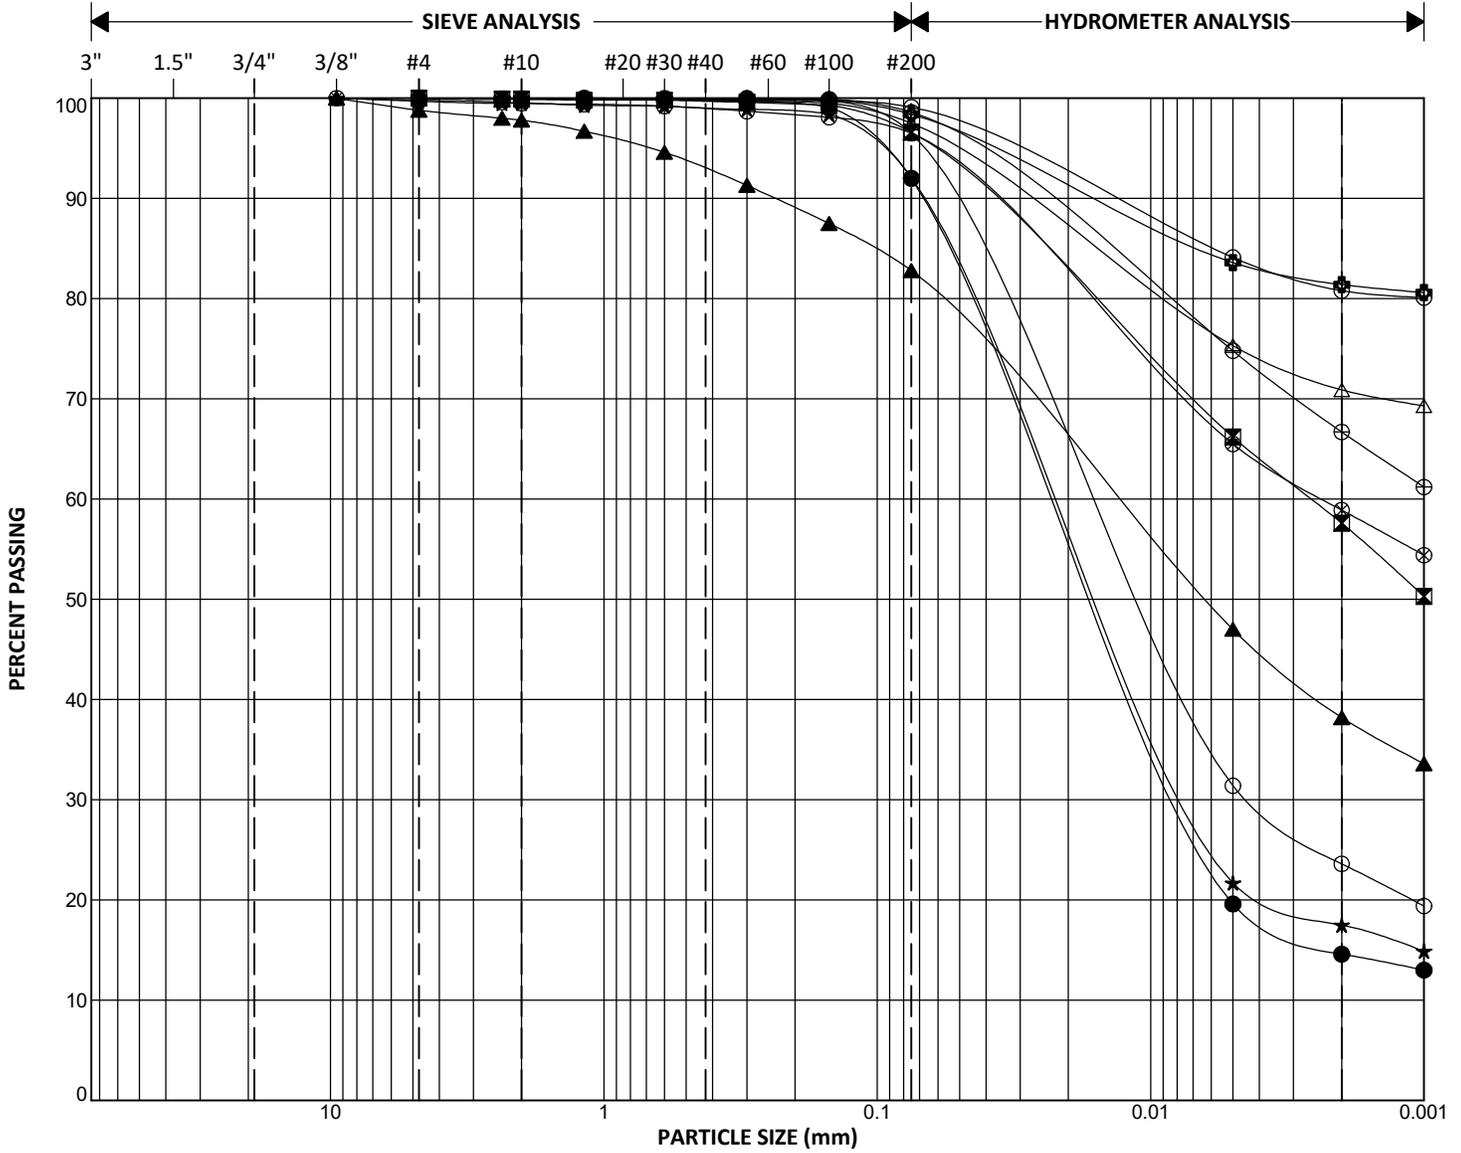
# GRAIN SIZE DISTRIBUTION

HOLE	DEPTH (m)	SAMPLE #	GRAVEL (%)	SAND (%)	SILT (%)	CLAY (%)	SILT & CLAY (%)	Cu	Cc	CLASSIFICATION
●	TH25-01	0.6	S2	0	8	77	15	92			CL
⊠	TH25-03	0.9	S2	0	3	39	58	97			CH
▲	TH25-04	0.6	S1	1	16	45	38	83			CH
★	TH25-07	0.6	S2	0	8	75	18	92			CL
⊙	TH25-08	0.9	S2	0	1	18	81	99			CH
⊕	TH25-09	0.8	S1	0	2	17	81	98			CH
○	TH25-10	0.9	S2	0	3	73	24	97			CL
△	TH25-11	0.9	S2	0	2	27	71	98			CH
⊗	TH25-12	0.6	S1	0	3	38	59	97			CH
⊕	TH25-13	0.9	S2	0	1	32	67	99			CH

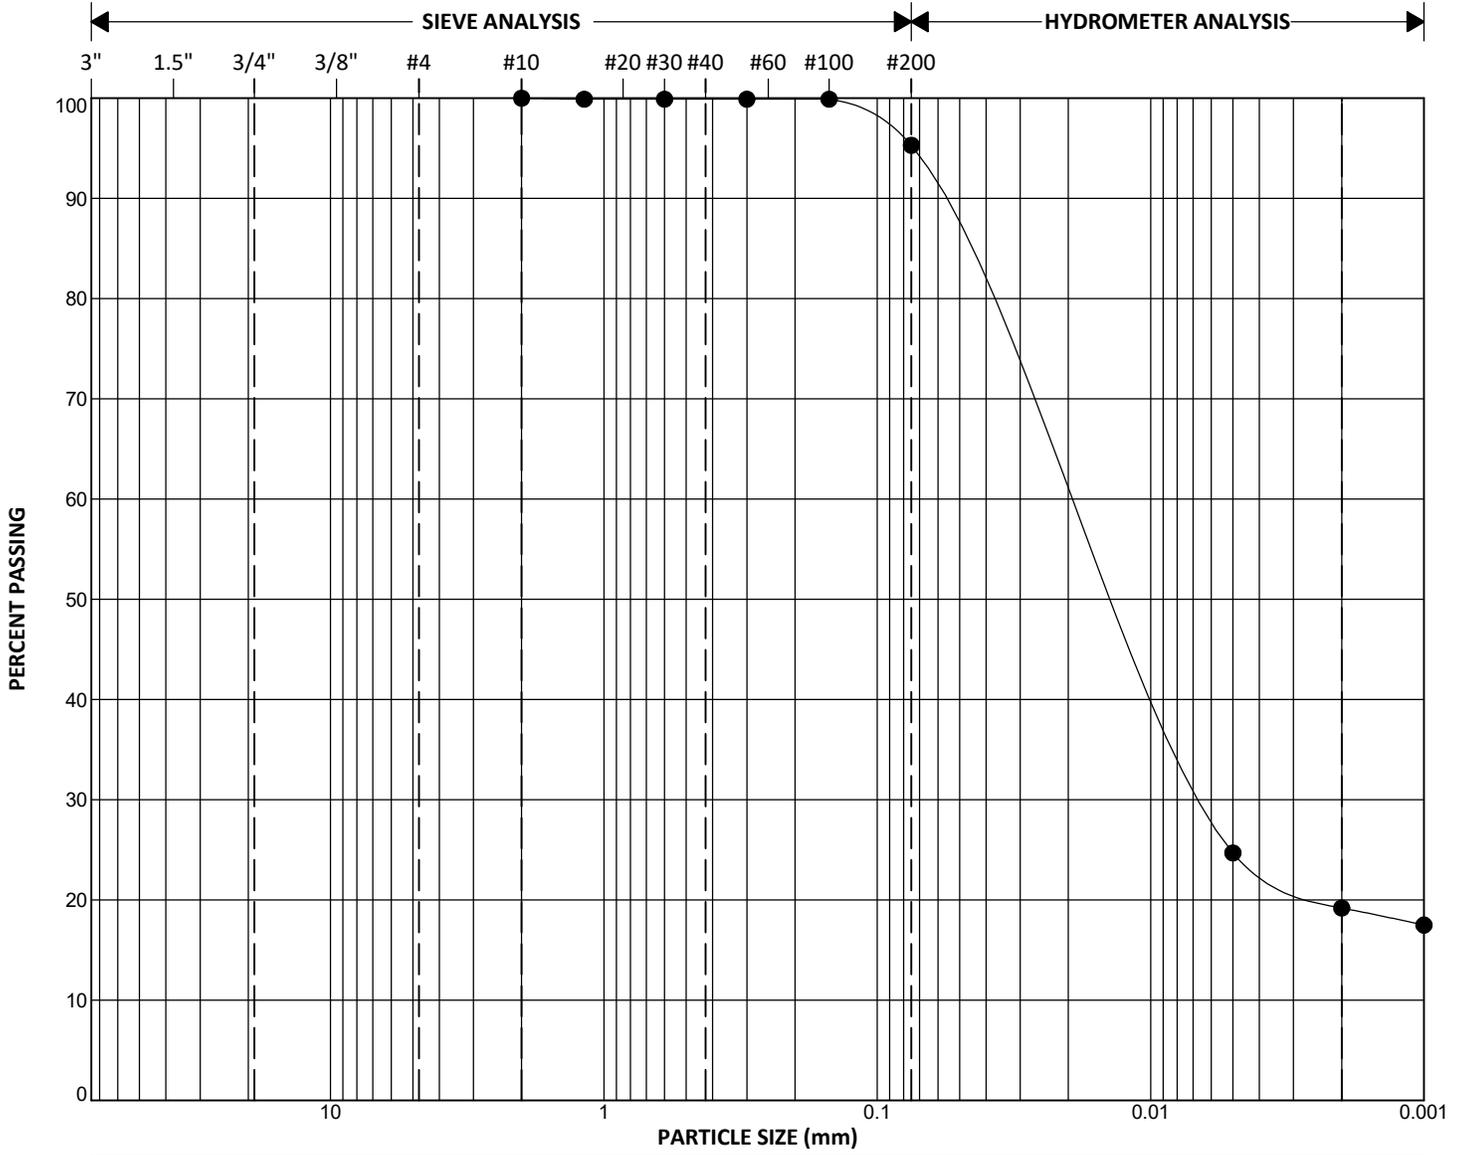
# GRAIN SIZE DISTRIBUTION

HOLE	DEPTH (m)	SAMPLE #	GRAVEL (%)	SAND (%)	SILT (%)	CLAY (%)	SILT & CLAY (%)	Cu	Cc	CLASSIFICATION
● TH25-15	0.6	S2	0	5	76	19	95			CL

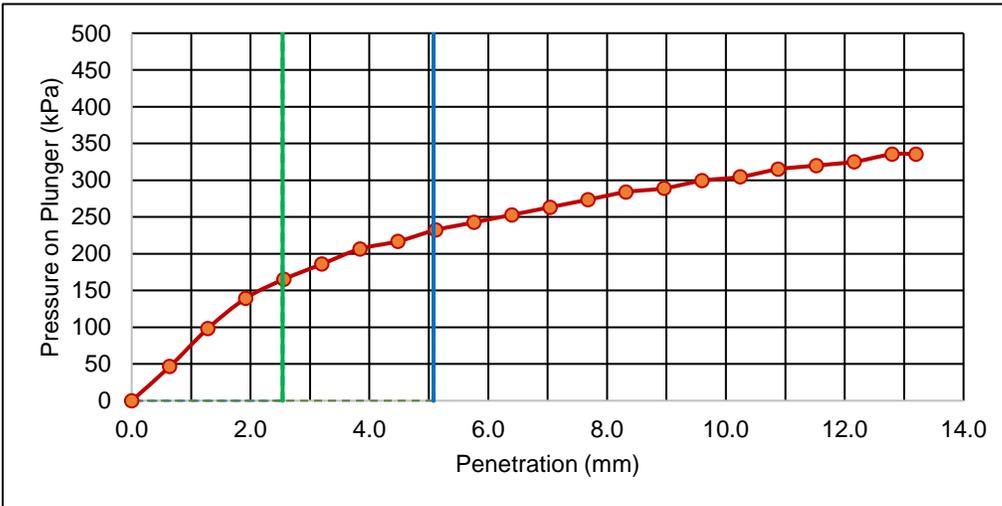
IMMERSION PERIOD	96 ± 2 hr	TARGET MAX. DRY DENSITY	1710 kg/m <sup>3</sup>
CONDITION OF SAMPLE	Soaked	TARGET OPTIMUM MOISTURE	18.5 %
SURCHARGE MASS	4.54 kg		
+19 mm OVERSIZE	0 %	AS-COMPACTED DRY DENSITY	1625 kg/m <sup>3</sup>
SWELL OF SAMPLE	4.47 %	AS-COMPACTED MOISTURE	18.4 %
POST-TEST MOISTURE	28.1 %	AS-COMPACTED % COMPACTION	95 %

**CBR VALUE AT 2.54 mm  
PENETRATION**  
2.4

**CBR VALUE AT 5.08 mm  
PENETRATION**  
2.3

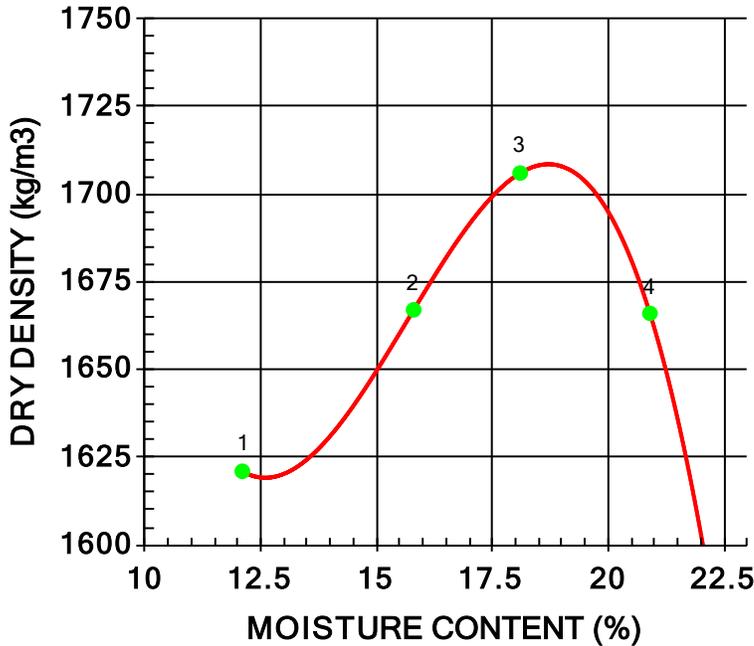
INSITU MOISTURE	26.9 %	COMPACTION STANDARD	Standard Proctor, ASTM
TESTED BY	Donald Eliazar		D698
MATERIAL IDENTIFICATION		COMPACTION PROCEDURE	A: 101.6mm Mold, Passing 4.75mm
MAJOR COMPONENT	Subgrade	RAMMER TYPE	Manual
SIZE	Clay	PREPARATION	Moist
DESCRIPTION		OVERSIZE CORRECTION METHOD	None
SUPPLIER	Existing Materials	RETAINED 4.75mm SCREEN	N/A %
SOURCE	TH 25-1,2 & 3 - Burnell Street

TRIAL NUMBER	WET DENSITY (kg/m³)	DRY DENSITY (kg/m³)	MOISTURE CONTENT (%)
1	1817	1621	12.1
2	1930	1667	15.8
3	2015	1706	18.1
4	2014	1666	20.9

*Additional Laboratory Testing* – One (1) moisture density relationship test (standard Proctor) and one (1) CBR test were completed on a composite sample consisting of clay collected from approximately 0.3 m to 0.9 m (1 ft to 3 ft) BGS in all test holes. Results indicated a maximum dry density of 1710 kg/m<sup>3</sup>, an optimum moisture content of 18.5%, and a CBR of 2.4 remolded to 95% of the SPDD at optimum moisture content. All laboratory test reports can be found attached in Appendix C.

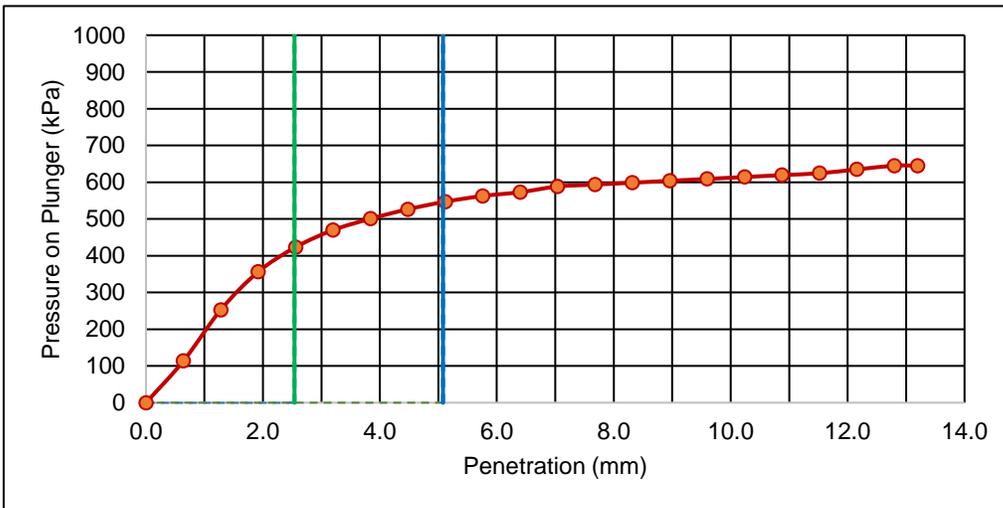
MATERIAL USE	Subgrade	SUPPLIER	Existing Material
MAX. NOMINAL SIZE	< 4.75 mm	SOURCE	McMicken Street
MATERIAL TYPE	Clay	SAMPLE LOCATION	TH25-04/05/06/07, 1'-3'
SPECIFICATION ID	Not Applicable	STANTEC SAMPLE NO.	5445
IMMERSION PERIOD	96 ± 2 hr	TARGET MAX. DRY DENSITY	1650 kg/m <sup>3</sup>
CONDITION OF SAMPLE	Soaked	TARGET OPTIMUM MOISTURE	20.0 %
SURCHARGE MASS	4.54 kg	AS-COMPACTED DRY DENSITY	1567 kg/m <sup>3</sup>
+19 mm OVERSIZE	0 %	AS-COMPACTED MOISTURE	20.1 %
SWELL OF SAMPLE	1.78 %	AS-COMPACTED % COMPACTION	95 %
POST-TEST MOISTURE	23.2 %

**CBR VALUE AT 2.54 mm PENETRATION**  
6.1

*Additional Laboratory Testing* – One (1) moisture density relationship test (standard Proctor) and one (1) CBR test were completed on a composite sample consisting of clay collected from approximately 0.3 m to 0.9 m (1 ft to 3 ft) BGS in all test holes. Results indicated a maximum dry density of 1650 kg/m<sup>3</sup>, an optimum moisture

content of 20.0%, and a CBR of 6.1 remolded to 95% of the SPDD at optimum moisture content. All laboratory test reports can be found attached in Appendix C.

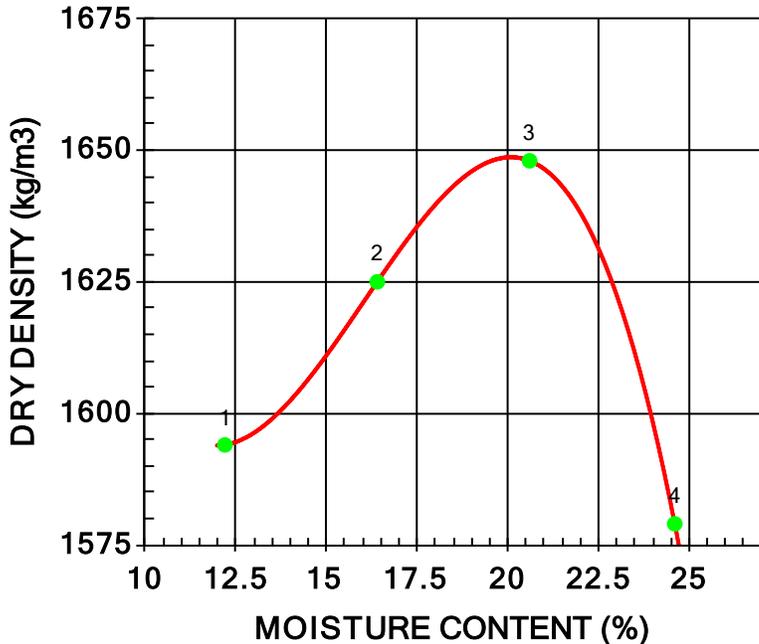
INSITU MOISTURE	36.0 %	COMPACTION STANDARD	Standard Proctor, ASTM
TESTED BY	Donald Eliazar		D698
MATERIAL IDENTIFICATION		COMPACTION PROCEDURE	A: 101.6mm Mold, Passing 4.75mm
MAJOR COMPONENT	Subgrade	RAMMER TYPE	Manual
SIZE	Clay	PREPARATION	Moist
DESCRIPTION		OVERSIZE CORRECTION METHOD	None
SUPPLIER	Existing Materials	RETAINED 4.75mm SCREEN	N/A %
SOURCE	TH 24-04 4,5,6 & 7 McMicken St

TRIAL NUMBER	WET DENSITY (kg/m³)	DRY DENSITY (kg/m³)	MOISTURE CONTENT (%)
1	1789	1594	12.2
2	1891	1625	16.4
3	1987	1648	20.6
4	1968	1579	24.6

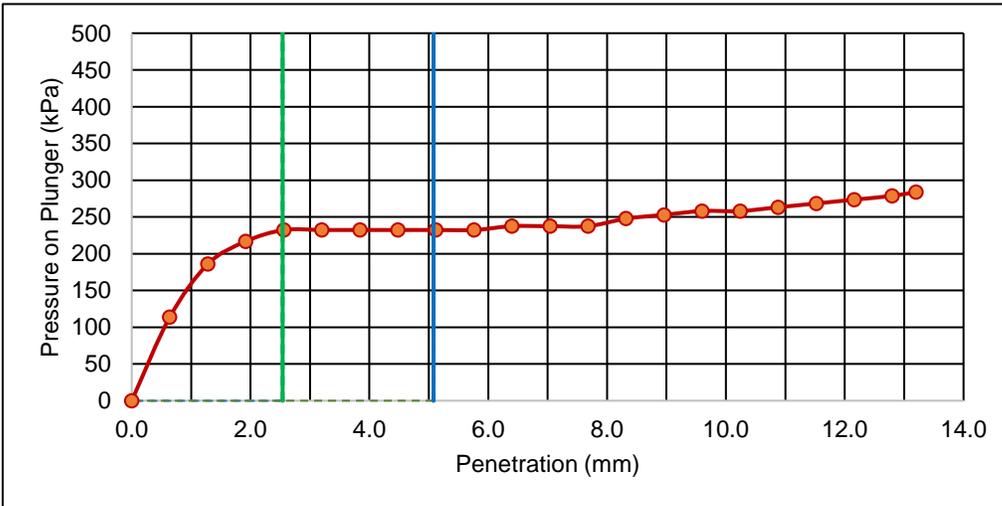
IMMERSION PERIOD	96 ± 2 hr	TARGET MAX. DRY DENSITY	1470 kg/m <sup>3</sup>
CONDITION OF SAMPLE	Soaked	TARGET OPTIMUM MOISTURE	28.0 %
SURCHARGE MASS	4.54 kg		
+19 mm OVERSIZE	0 %	AS-COMPACTED DRY DENSITY	1396 kg/m <sup>3</sup>
SWELL OF SAMPLE	3.36 %	AS-COMPACTED MOISTURE	28.0 %
POST-TEST MOISTURE	34.7 %	AS-COMPACTED % COMPACTION	95 %

**CBR VALUE AT 2.54 mm PENETRATION**  
3.4

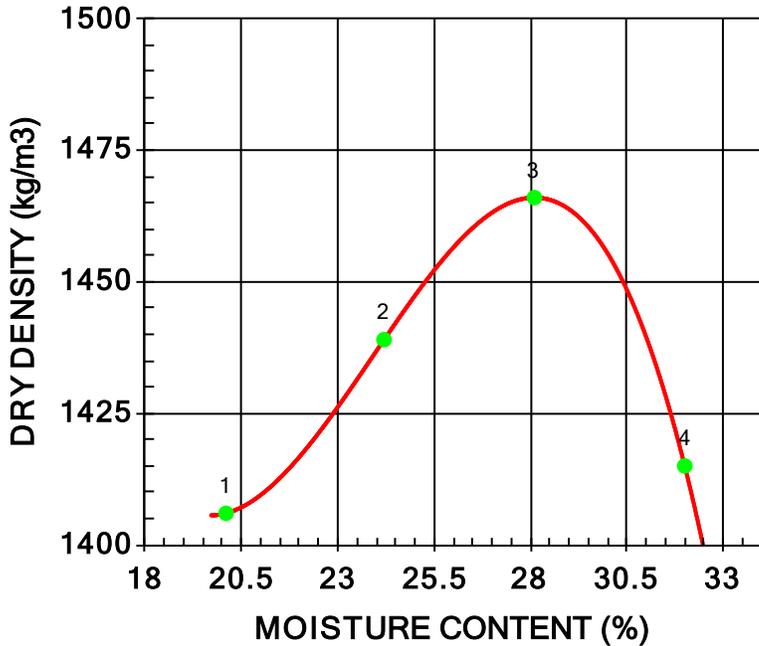
INSITU MOISTURE	32.5 %	COMPACTION STANDARD	Standard Proctor, ASTM
TESTED BY	Donald Eliazar		D698
MATERIAL IDENTIFICATION		COMPACTION PROCEDURE	A: 101.6mm Mold, Passing 4.75mm
MAJOR COMPONENT	Subgrade	RAMMER TYPE	Manual
SIZE	Clay	PREPARATION	Moist
DESCRIPTION		OVERSIZE CORRECTION METHOD	None
SUPPLIER	Existing Materials	RETAINED 4.75mm SCREEN	N/A %
SOURCE	BH 25 08 - 8,9&10 Langside St

TRIAL NUMBER	WET DENSITY (kg/m³)	DRY DENSITY (kg/m³)	MOISTURE CONTENT (%)
1	1689	1406	20.1
2	1787	1439	24.2
3	1878	1466	28.1
4	1868	1415	32.0

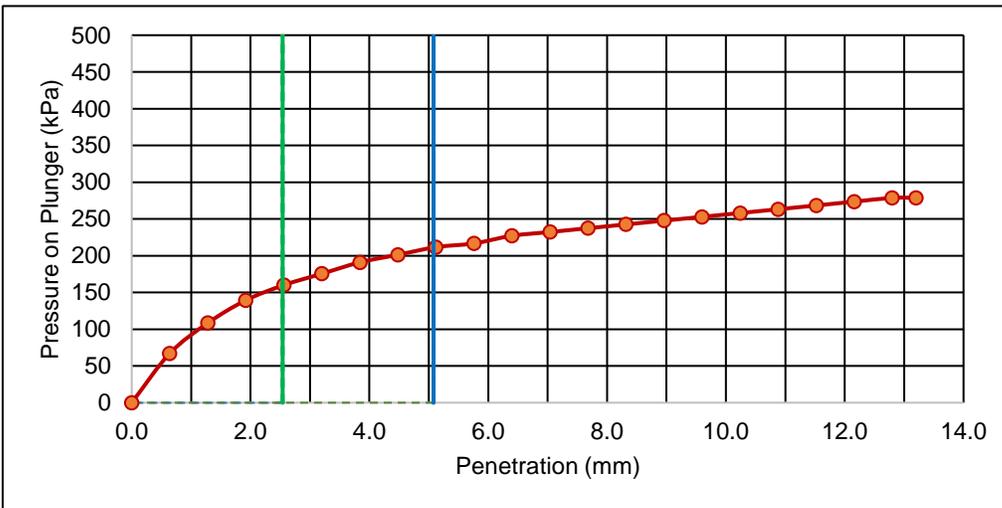
IMMERSION PERIOD	96 ± 2 hr	TARGET MAX. DRY DENSITY	1410 kg/m <sup>3</sup>
CONDITION OF SAMPLE	Soaked	TARGET OPTIMUM MOISTURE	25.5 %
SURCHARGE MASS	4.54 kg		
+19 mm OVERSIZE	0 %	AS-COMPACTED DRY DENSITY	1340 kg/m <sup>3</sup>
SWELL OF SAMPLE	4.75 %	AS-COMPACTED MOISTURE	25.5 %
POST-TEST MOISTURE	41.5 %	AS-COMPACTED % COMPACTION	95 %

**CBR VALUE AT 2.54 mm  
PENETRATION**  
2.3

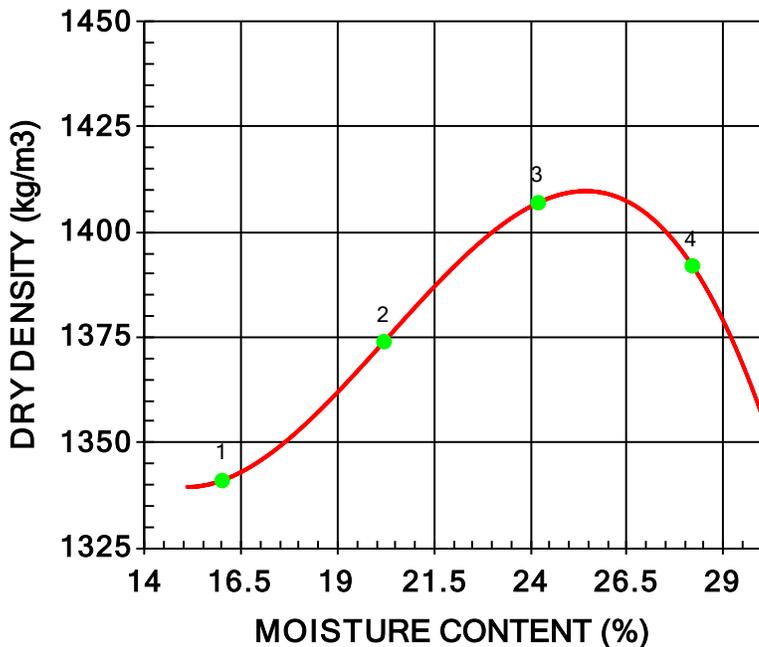
INSITU MOISTURE	33.7 %	COMPACTION STANDARD	Standard Proctor, ASTM
TESTED BY	Donald Eliazar		D698
MATERIAL IDENTIFICATION		COMPACTION PROCEDURE	A: 101.6mm Mold, Passing 4.75mm
MAJOR COMPONENT	Subgrade	RAMMER TYPE	Manual
SIZE	Clay	PREPARATION	Moist
DESCRIPTION		OVERSIZE CORRECTION METHOD	None
SUPPLIER	Existing Materials	RETAINED 4.75mm SCREEN	N/A %
SOURCE	BH 25-11 & 12 Kennedy/Edmonton

TRIAL NUMBER	WET DENSITY (kg/m³)	DRY DENSITY (kg/m³)	MOISTURE CONTENT (%)
1	1555	1341	16.0
2	1652	1374	20.2
3	1748	1407	24.2
4	1785	1392	28.2

*Additional Laboratory Testing* – One (1) moisture density relationship test (standard Proctor) and one (1) CBR test were completed on a composite sample consisting of clay collected from approximately 0.3 m to 0.9 m (1 ft to 3 ft) BGS in all test holes. Results indicated a maximum dry density of 1410 kg/m<sup>3</sup>, an optimum moisture content of 25.5%, and a CBR of 2.3 remolded to 95% of the SPDD at optimum moisture content. All laboratory test reports can be found attached in Appendix C.

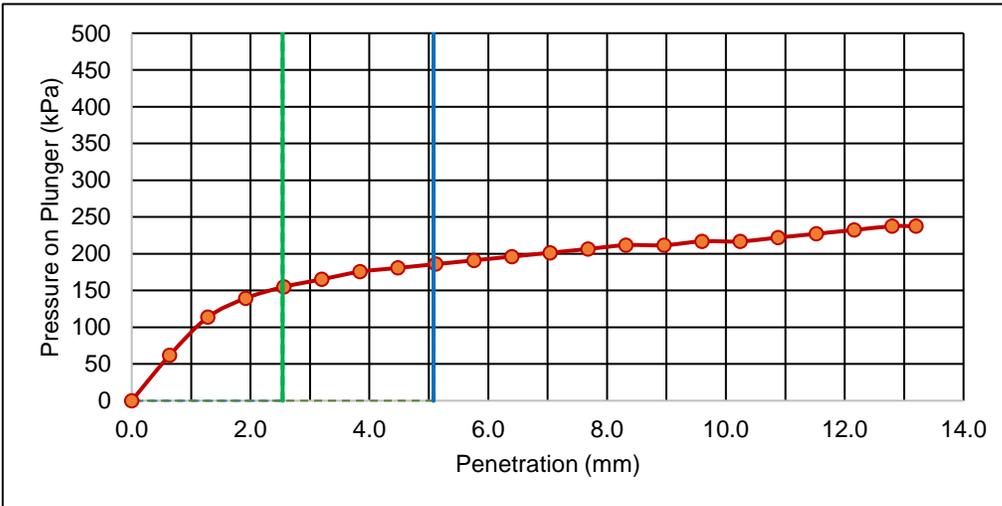
IMMERSION PERIOD	96 ± 2 hr	TARGET MAX. DRY DENSITY	1520 kg/m <sup>3</sup>
CONDITION OF SAMPLE	Soaked	TARGET OPTIMUM MOISTURE	21.5 %
SURCHARGE MASS	4.54 kg		
+19 mm OVERSIZE	0 %	AS-COMPACTED DRY DENSITY	1443 kg/m <sup>3</sup>
SWELL OF SAMPLE	5.74 %	AS-COMPACTED MOISTURE	21.6 %
POST-TEST MOISTURE	39.6 %	AS-COMPACTED % COMPACTION	95 %

**CBR VALUE AT 2.54 mm  
PENETRATION**  
2.2

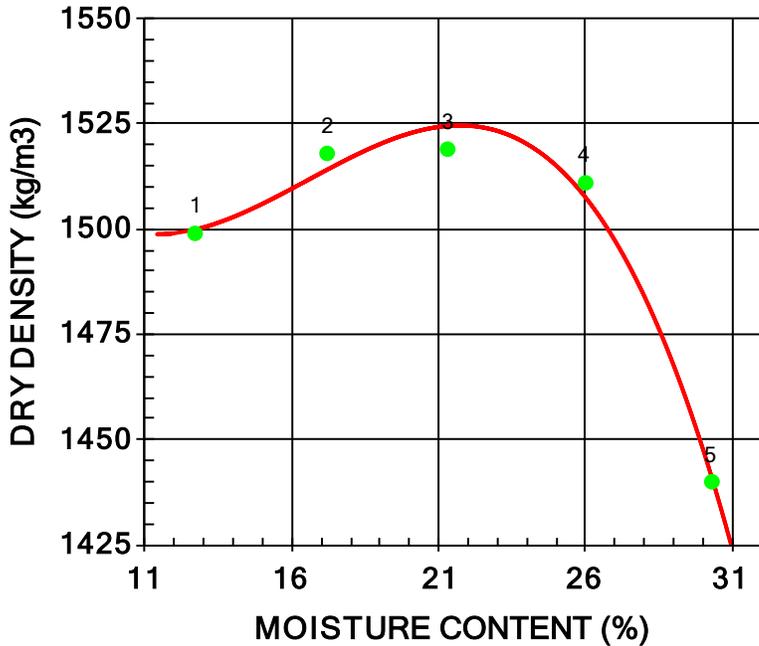
INSITU MOISTURE	29.1 %	COMPACTION STANDARD	Standard Proctor, ASTM
TESTED BY	Donald Eliazar		D698
MATERIAL IDENTIFICATION		COMPACTION PROCEDURE	A: 101.6mm Mold, Passing 4.75mm
MAJOR COMPONENT	Subgrade	RAMMER TYPE	Manual
SIZE	Clay	PREPARATION	Moist
DESCRIPTION		OVERSIZE CORRECTION METHOD	None
SUPPLIER	Existing Materials	RETAINED 4.75mm SCREEN	N/A %
SOURCE	TH 25-13,14&15 Huntleigh St

TRIAL NUMBER	WET DENSITY (kg/m³)	DRY DENSITY (kg/m³)	MOISTURE CONTENT (%)
1	1689	1499	12.7
2	1779	1518	17.2
3	1843	1519	21.3
4	1904	1511	26.0
5	1876	1440	30.3

*Additional Laboratory Testing* – One (1) moisture density relationship test (standard Proctor) and one (1) CBR test were completed on a composite sample consisting of clay collected from approximately 0.3 m to 0.9 m (1 ft to 3 ft) BGS in all test holes. Results indicated a maximum dry density of 1520 kg/m<sup>3</sup>, an optimum moisture content of 21.5%, and a CBR of 2.2 remolded to 95% of the SPDD at optimum moisture content. All laboratory test reports can be found attached in Appendix C.
