GEOTECHNICAL REPORT

April 7, 2025

Re: 2025 City of Winnipeg Local Street Program – 25-R-05
Report of Geotechnical Investigations and Test Results - Rev 0

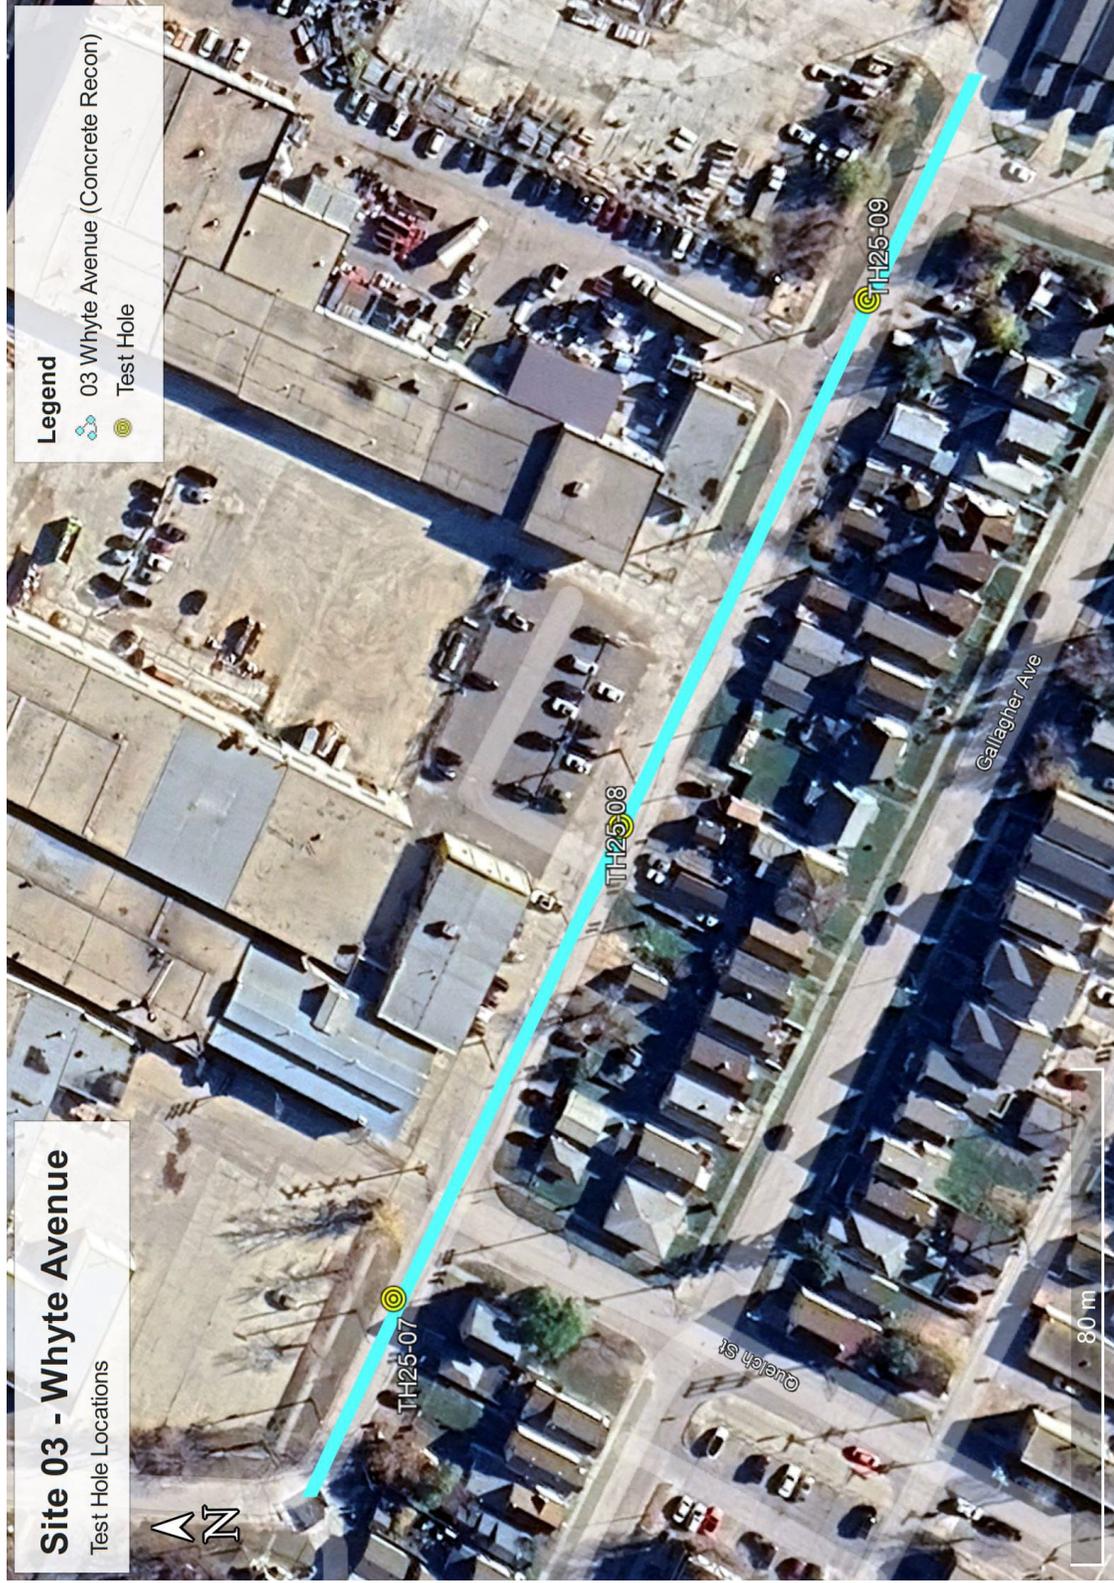
FIGURE 2: TEST HOLE LOCATIONS ON WHYTE AVENUE (SITE 03)

A core investigation was conducted along Whyte Avenue, involving the extraction of three (3) cores. Additional soil investigations were conducted at each of the test hole locations; one (1) advanced to a depth of 3.0 m (10 ft) below pavement surface, and two (2) advanced to a depth of 2.0 m (6.5 ft) below pavement surface. The general stratigraphy encountered within the test holes consisted of concrete pavement with clay fill base overlying lean and fat clay. A further description of each layer is provided below, with test hole logs provided in Appendix B and test hole locations shown in Figure 2.

Asphalt – The pavement surface consisted of asphalt with varying thicknesses of 60 to 140 mm.

Concrete – Concrete was encountered directly below the asphalt with varying thicknesses of 75 to 135 mm.

Gravel Fill – Gravel fill was encountered directly below the concrete in one test hole, TH25-09, with a thickness of 95 mm. The fill was frozen, fine grained, and with fine to coarse sand.

Clay Fill – Clay fill material was encountered directly below the concrete in two test holes and below the gravel fill in TH25-09. The thickness varied between 170 to 180 mm. The fill was dark grey, frozen, and intermixed with granular.

Lean Clay (CL) – Lean clay was encountered below the clay fill in all test holes, except TH25-09. The lean clay was light brown, frozen, silty, trace fine sand.

One (1) Atterberg limits test was completed on the lean clay with results indicating a liquid limit of 28, plastic limit of 17, and plasticity index of 11, classifying the material as low plasticity. One (1) particle size analysis test was completed and indicated 0% gravel, 9% sand, 75% silt, and 16% clay. Moisture contents within the clay ranged from 18 to 22%.

Fat Clay (CH) – Fat clay was generally encountered below the lean clay, except for TH25-09 where it was encountered below the clay fill and to the depth of exploration in all test holes. The fat clay was generally brown, frozen, trace to with silt, trace fine to coarse sand, and moist below frozen material.

Undrained shear strengths of the clay were estimated during drilling using a handheld Torvane and ranged from 15 kPa to 90 kPa, classifying the clay as soft to stiff in consistency. One (1) Atterberg limits test was completed on the fat clay with results indicating a liquid limit of 67, plastic limit of 24, and plasticity index of 43, classifying the material as high plasticity. One (1) particle size analysis test was completed and indicated 1% gravel, 7% sand, 74% silt, and 18% clay. Moisture contents within the clay ranged from 21 to 54% and generally increased with depth.

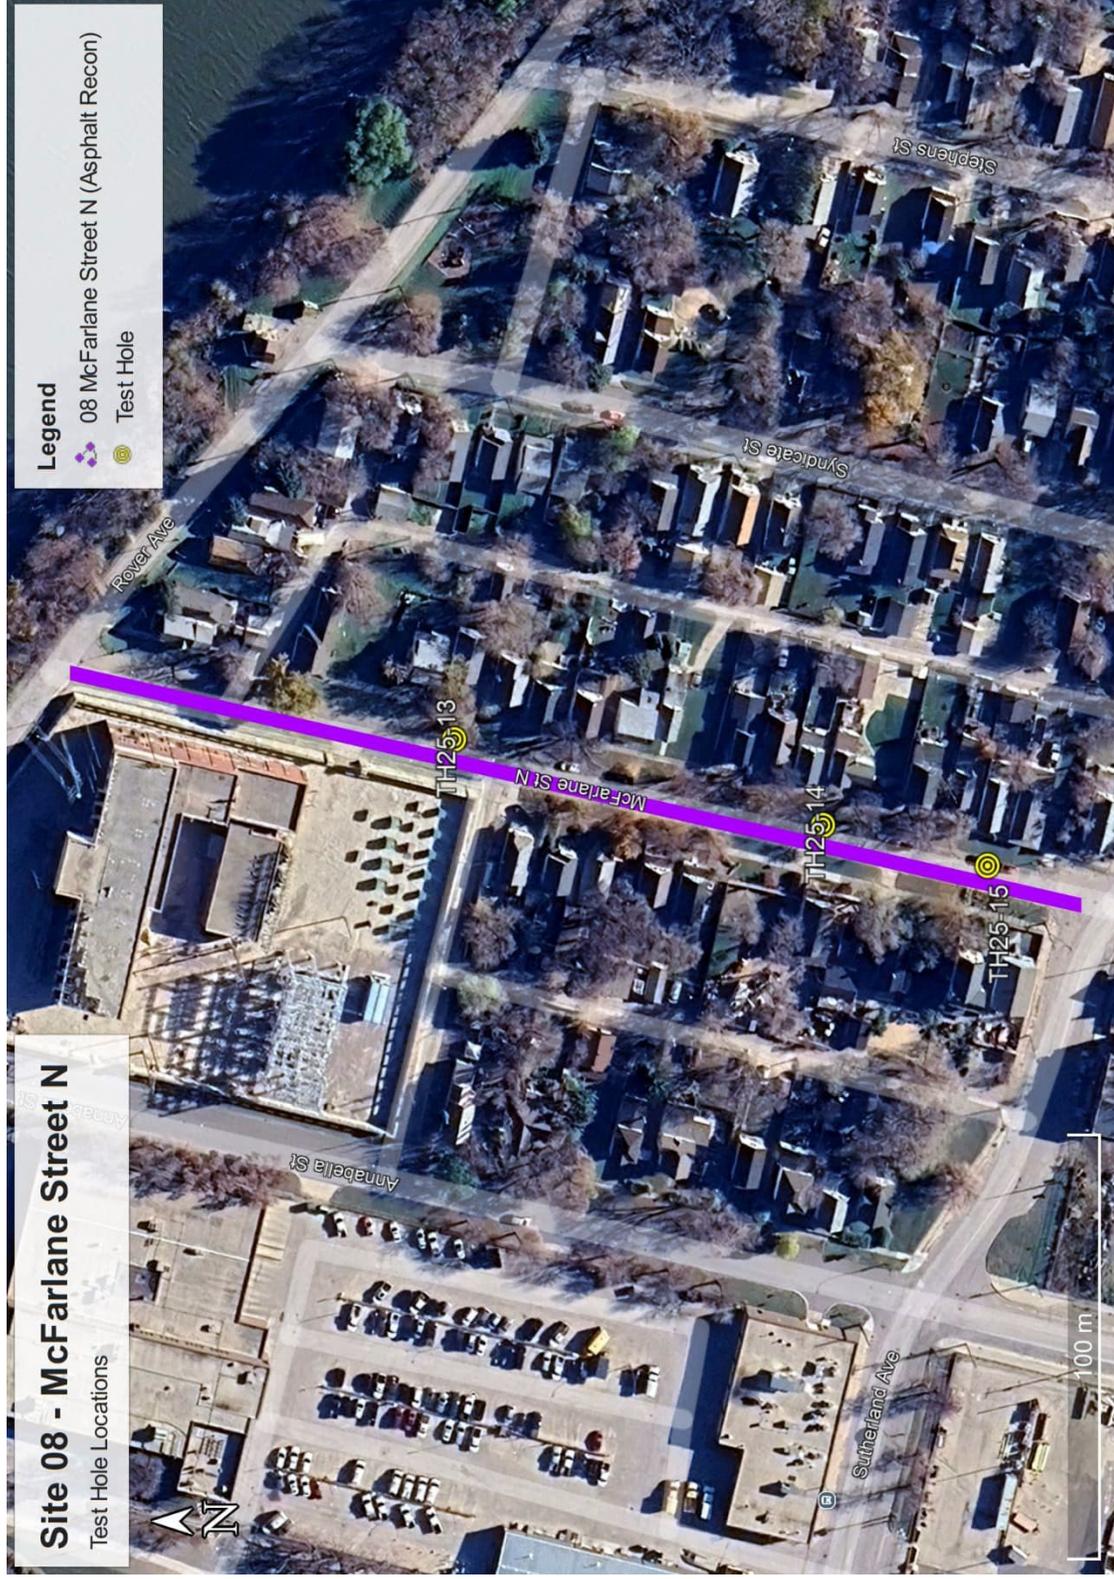
FIGURE 6: TEST HOLE LOCATIONS ON MCFARLANE STREET N (SITE 08)

A core investigation was conducted along McFarlane Street N, involving the extraction of three (3) cores from mid-slab locations. Additional soil investigations were conducted at each of the test hole locations and were advanced to a depth of 2.0 m (6.5 ft) below pavement surface. The general stratigraphy encountered within the test holes consisted of asphalt pavement overlying concrete, overlying gravel fill, overlying fat clay. A further description of each layer is provided below, with test hole logs provided in Appendix B and test hole locations shown in Figure 6.

Asphalt – The pavement surface consisted of asphalt with varying thicknesses of 25 to 50 mm.

Fat Clay (CH) – Fat clay was encountered below the concrete and gravel fill in all the test holes and extended to the depth of exploration. The clay was generally grey to brown, frozen, trace fine sand, trace to with silt, and moist below frozen material.

Undrained shear strengths of the clay were estimated during drilling using a handheld Torvane. The readings ranged from 30 kPa to 88 kPa, classifying the clay as firm to stiff in consistency. Two (2) Atterberg limits tests were completed on the clay with results indicating liquid limits of 70 to 75, plastic limits of 27 to 29, and plasticity indices between 43 to 46, classifying the material as of high plasticity. Two (2) particle size analysis tests were completed and indicated 0% gravel, 0 to 1% sand, 45 to 52% silt, and 47 to 55% clay. Moisture contents within the clay ranged from 25 to 33%.

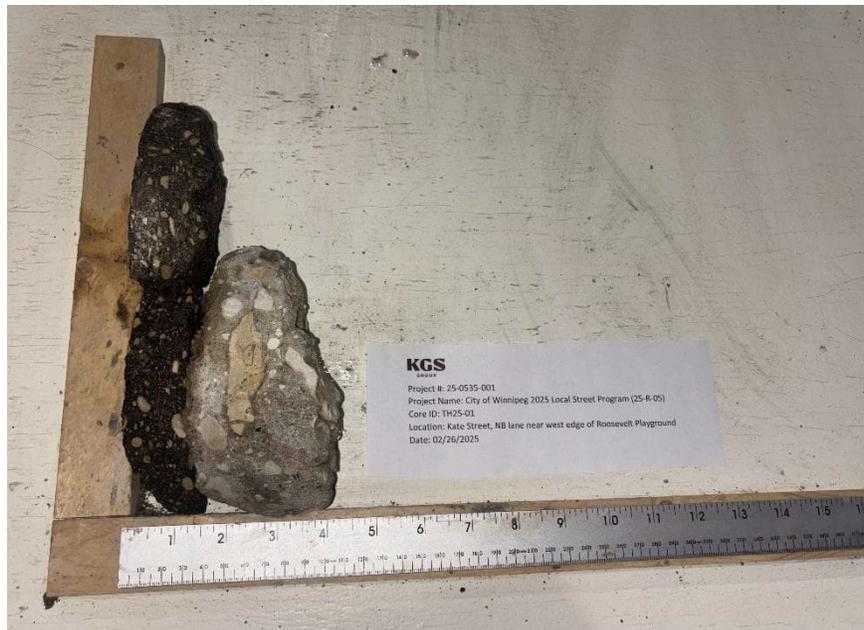
Photo 13: Kate Street, TH25-01

Concrete – Concrete was encountered directly below the asphalt in only one test hole, TH25-01 with thicknesses of 70 mm.

Clay Fill – Clay fill was encountered directly below the gravel fill in TH25-01 with thickness of 125 mm. The fill was black, frozen, and trace fine to medium sand.
