**THE CITY OF WINNIPEG**  
Winnipeg WATER AND WASTE DEPARTMENT

SHOAL LAKE AQUEDUCT  
DRAINAGE SIPHON REPAIRS  
MILES 50.31, 53.75 & 55.23  
DRAINAGE SIPHON 53.75  
(SITE 2)  
PLANS & SECTIONS

SHEET 4 OF 7  
CITY DRAWING NUMBER  
**D-11545**  
REV

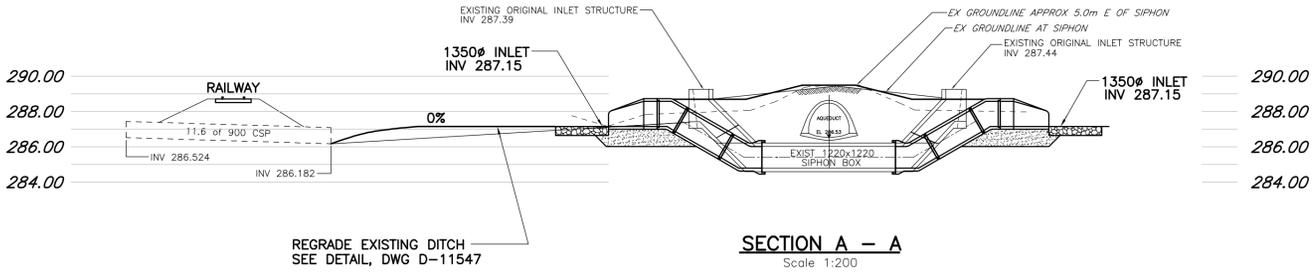
SECTION A - A  
Scale 1:200

HEADWALL	DESCRIPTION
SOUTH SIDE	- ORIGINAL HEADWALL, CONCRETE GOOD CONDITION - MINOR SPALLING AT TOP OF WALLS - MULTIPLE CRACKING ON LOWER EAST SIDE AND WING WALLS. CRACKS OPEN <1mm; NO INFILTRATION. - NO WARNING SIGN - NO INLET PROTECTION
NORTH SIDE	- ORIGINAL HEADWALL TILTED SLIGHTLY TO EAST - CONCRETE GOOD CONDITION - NO VISIBLE CRACKS - NO WARNING SIGN - NO INLET PROTECTION

DEFECT	DESCRIPTION	REMEDIAL ACTION
1	COMPLETE TRANSVERSE CRACK IN THROAT 1.5m FROM HEADWALL AND 1.3m FROM INLET INVERT. CRACK OPEN 1mm.	
2	WEST WALL BROKEN TO 300mm WIDE BETWEEN DEFECTS 1 & 3.	
3	COMPLETE TRANSVERSE CRACK IN THROAT 2.1m FROM HEADWALL AND 1.3m FROM INLET INVERT. CRACK OPEN >25mm (NO OFFSET). CONCRETE DELAMINATED & SPALLED AT CEILING; REINFORCING EXPOSED.	
4	HORIZ CONSTRUCTION JOINT OPEN 10mm FROM SIPHON BOX TO 0.9m FROM BOX, WHERE 5mm CRACK IN WALLS STARTS AND RUNS TO INLET INVERT (<5mm). CONSTRUCTION JOINT SOUTH OF CRACK IS TIGHT.	
5	50' CORE HOLE IN EAST AND WEST WALLS, 1.2m FROM CEILING OF BOX. LOCATION OF CORE HOLES FROM CEILING NOT RECORDED.	POLYURETHANE INJECTION
6	TRANSVERSE CRACK 3.6m FROM S END OF BOX. OPEN 1mm. NO INFILTRATION.	POLYURETHANE INJECTION
7	TRANSVERSE CRACK 7.2m FROM S END OF BOX. OPEN <1mm. NO INFILTRATION.	POLYURETHANE INJECTION
8	COMPLETE TRANSVERSE CRACK IN THROAT 1.0m FROM CEILING OF BOX, RUNNING TO HORIZ CONSTRUCTION JOINT AT THROAT FLOOR. CRACK OPEN >25mm. CONC SPALLED FROM WEST WALL AT FLOOR. REINFORCING EXPOSED.

9	TRANSVERSE CRACK IN EAST WALL AND CEILING OF THROAT, ABOVE DEFECT 7. CRACK OPEN <1mm.
