## Architectural Evaluation Report

VA Project No.: 11-14

Project Name: City of Winnipeg Machray Park Redevelopment

Re: Machray Park Redevelopment  
Architectural Evaluation of existing Wading Pool change room, washroom and mechanical building.

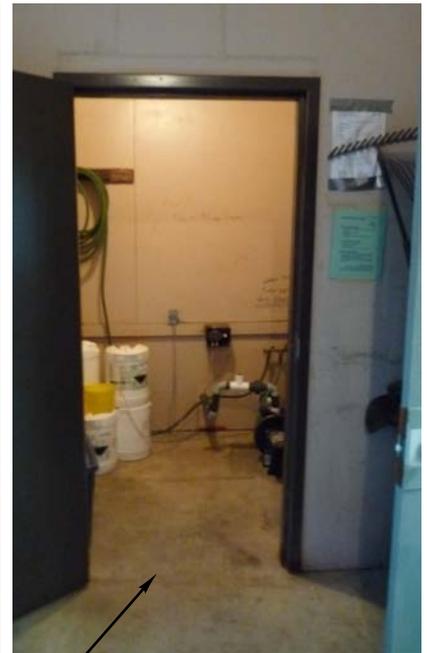
EXISTING 36" DOOR

The existing building features three 36" entry doors, two of them on the wading pool side of the building serve the large open change area and the third serves the mechanical room. The existing door hardware found on the doors are of the twist knob style and is not barrier free accessible. The 2010 City of Winnipeg Accessibility Design Standards recommends 39" (1000 mm) doors to allow for a 36" (915 mm) clear opening for newly constructed buildings while 36" (915 mm) doors are permitted only in retrofit situations where it is not technically feasible. Given the amount of wall space available and the age of the door and hardware, new doors should be 39" wide and feature hardware that conforms to barrier free accessibility design standards including power door operators.

Around the outside of existing entry doors, some settling has occurred and there is a considerable grade differential which pose challenges to those who use mobility devices and can be a tripping hazard to all users of the building. As per Sentence 4 of Article 3.8.3.3 of the Manitoba Building Code, a threshold for a doorway in a barrier free path of travel shall be not more than 13 mm higher than the finished floor surface and shall be beveled to facilitate the use of mobility devices. Site work needs to be performed to re-grade the paving stones surrounding the entrances.
