The City of Winnipeg

**Preliminary Engineering Study for Lyndale Drive
Retaining Wall – Monck Avenue to Gauvin Street
Geotechnical Assessment Report**

0015 014 00

February 23, 2016

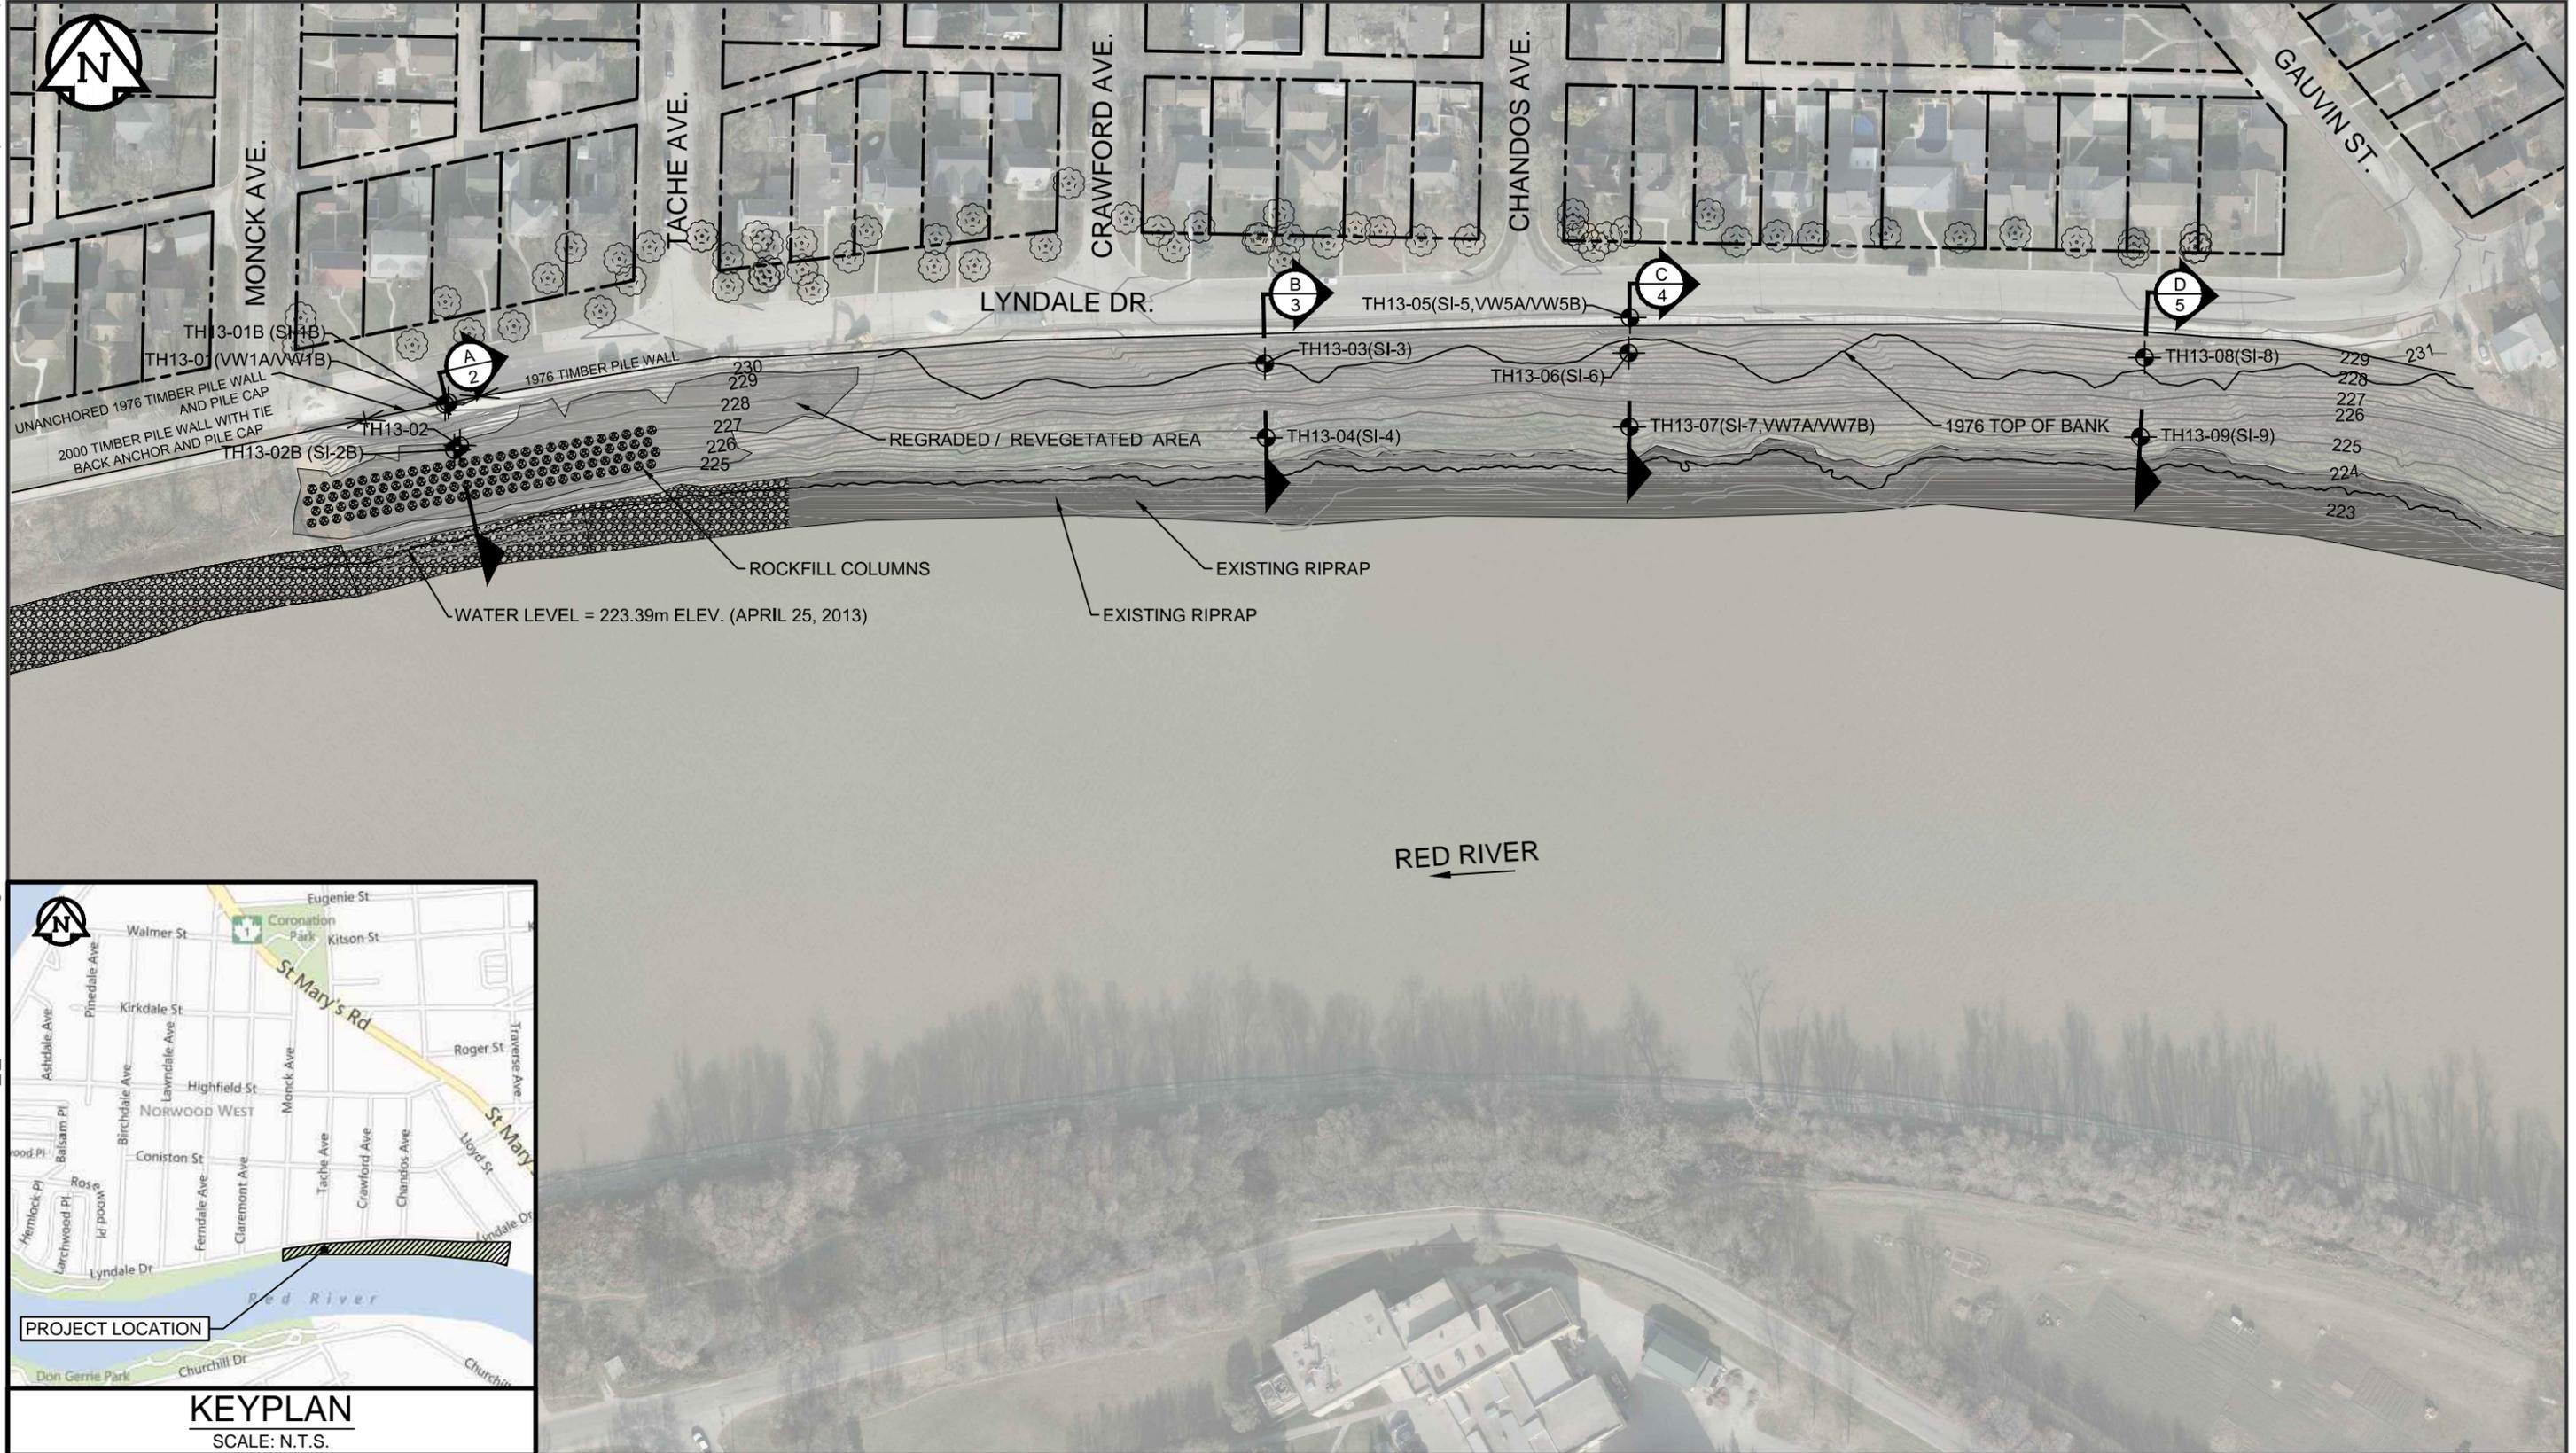
Lyndale Drive is located along high ground on the outside bend of the Red River which forms a portion of the City's Primary Diking System, Winnipeg's Primary Line of Defence during a flood (Figure 01). The existing timber pile wall along Lyndale Drive was constructed in 1976 to address ongoing riverbank instabilities which threatened the road and dike; the approximate bank crest (head scarps) observed prior to the 1976 wall construction is shown in Figure 01. The wall is approximately 575 m long, extending from just upstream of Gauvin Street to just upstream of Monck Avenue. It consists of 12 m long timber piles driven with their butts to ground (street) level. The riverbank was then excavated on the river side of the piles to a depth of about 2 m and timber lagging was installed. The bank was then regraded to the river at about 5 horizontal to 1 vertical (5H:1V) and riprap was placed along the edge of the river. A network of trench drains was also installed in the regraded portion of the slope to provide for a more rapid run-off of surface water.

Movements of the retaining wall towards the river were observed in April of 2013; about 300 mm of horizontal movement of the top of the wall and 100 mm settlement of the asphalt pavement in the east bound lane of Lyndale Drive were observed. Crack patterns in the pavement indicated the movement had extended north to about the middle of the road and as a result, the east bound lane was closed to traffic. The movements occurred along the downstream end of the 1976 retaining wall, including the 18 m wall section fitted with the concrete pile cap. Emergency riverbank stabilization works consisting of 48 rockfill columns were implemented in the fall of 2013 to address the ongoing movements. Wall deflections and pavement settlement continued as the stabilization works were constructed, however slowed significantly upon completion of the works. The pavement distress and deflected wall are shown in Photo 01. Vibrating-wire piezometers and slope inclinometers were installed in TH13-01 and 13-02 at the locations shown in Figure 01.

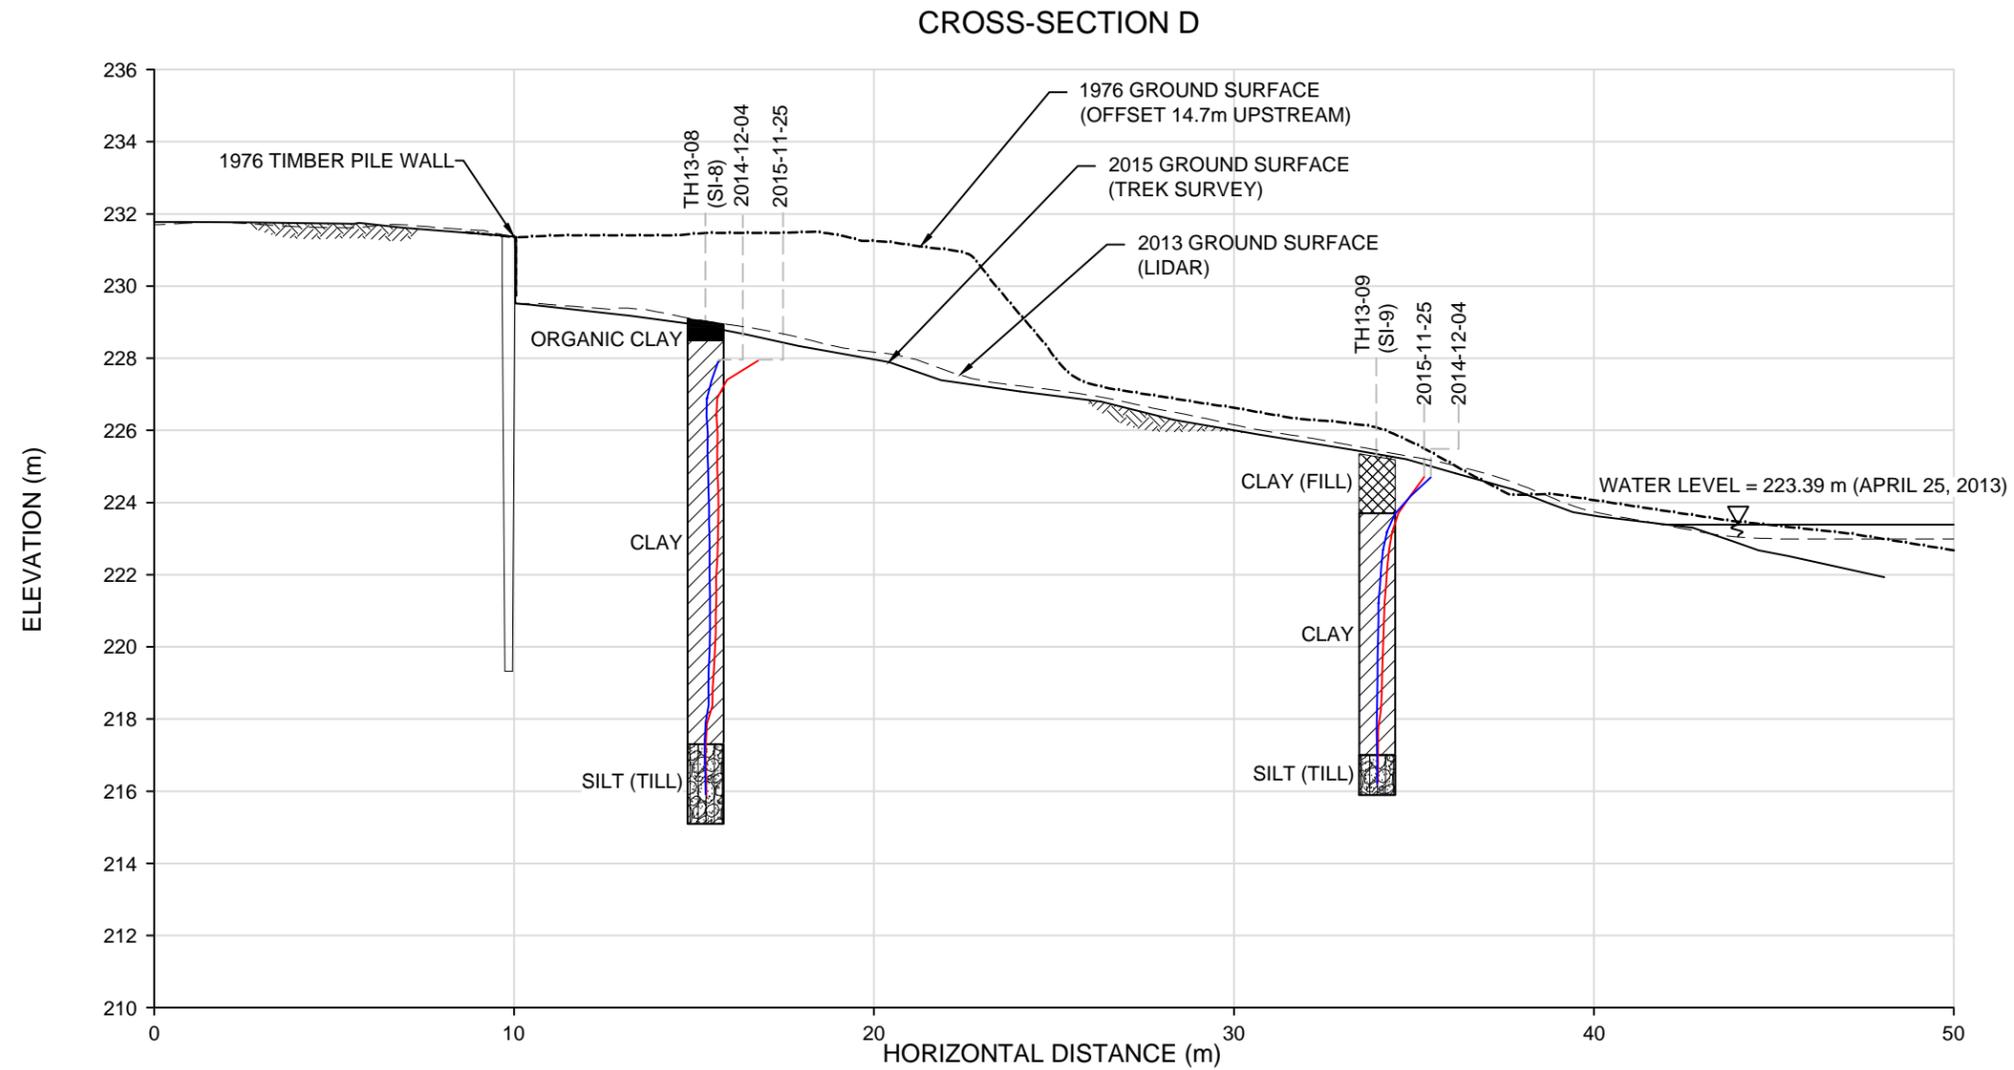
Figure 05
Cross Section D

differential shear displacement has not been observed at cross-section D, it is unlikely that this section will remain stable for the design life of the replacement structure (75 years) as a result of accumulated plastic (creep) shear strains.

The back-analysis of cross-section D was conducted on the 1976 slope geometry, and resulted in a calculated factor of safety of 0.98 along the critical slip surface (SS #1a); coincidentally, the slip surface geometry closely matches the zone of creep movements observed in the slope inclinometers (Figure B-5). The existing geometry was subsequently analysed with the current geometry, reflective of significant offloading but also some toe erosion. The factor of safety on the back-analysed slip surface increased to 1.18, while the critical slip surface is located further in the lower bank area with a factor of safety of 0.96 (Figure B-6). Although no differential shear movements have been observed in the lower-bank inclinometer, it is possible that unidentified factors are providing a stabilizing influence that is not captured in the model. Along this section, creep movements of similar magnitude to other cross-sections was observed below about a factor of safety of 1.18 (SS #1a); smaller creep movements observed just above the till layer in the mid-bank inclinometer coincide with factors of safety of about 1.25 or less (Figure B-7).

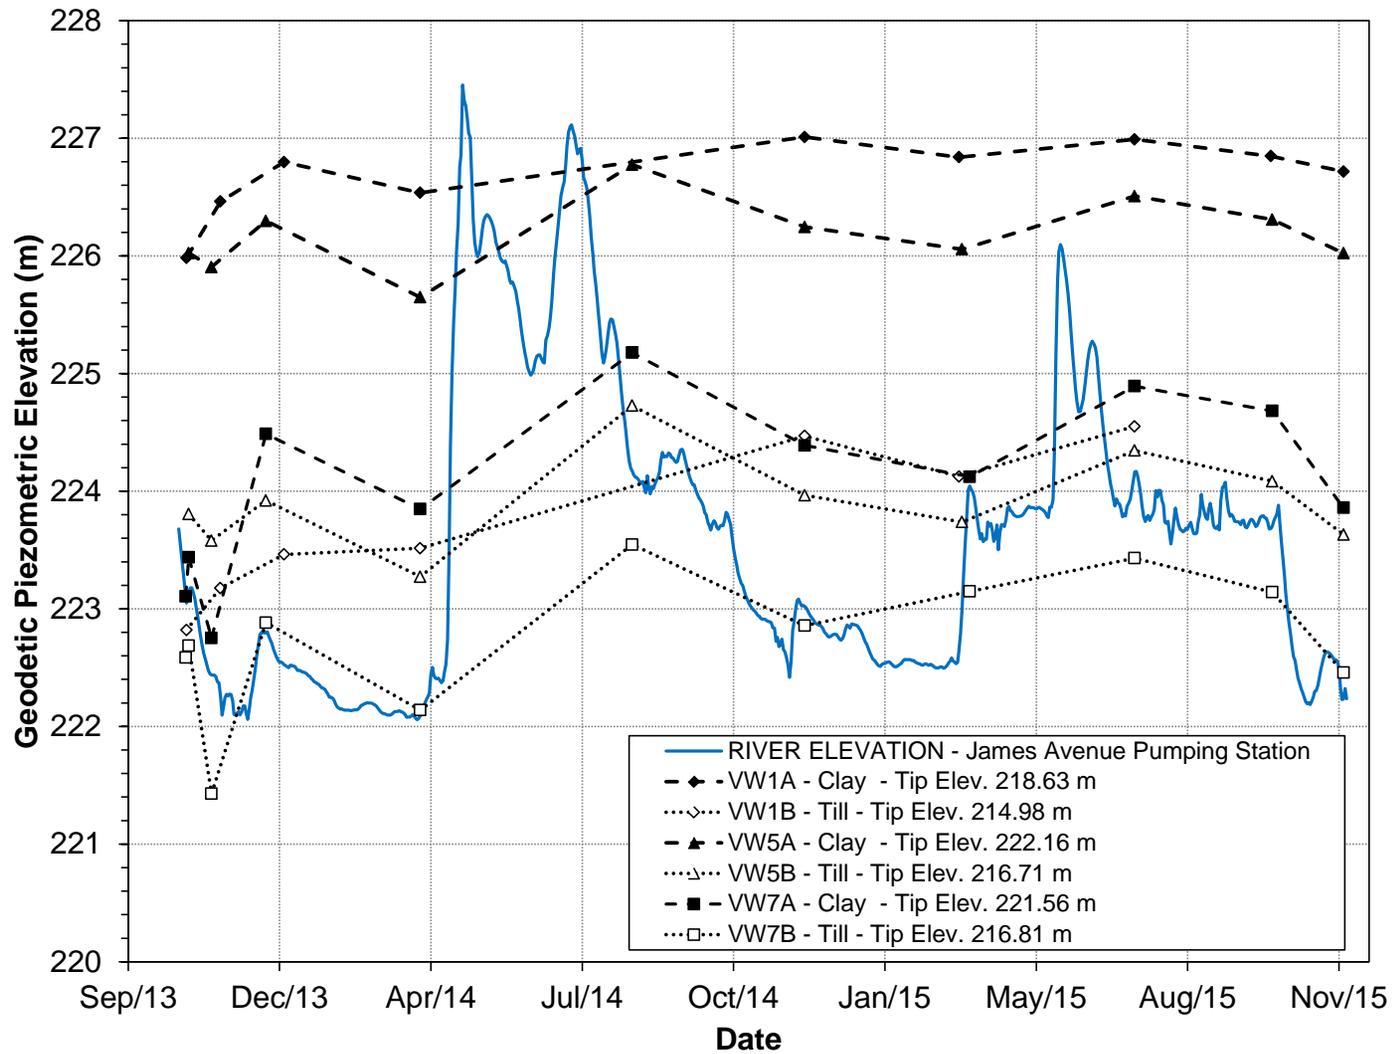
Figure 06 – Piezometer Monitoring Results

Figure 05 shows the monitoring results for all piezometers in both the stabilized and unstabilized portions of the riverbank. The critical period for stability is following the fall drawdown where piezometric levels in the clay and till remain high as the river level falls. Following the fall drawdown events, the piezometric elevation in the till closely follows the river level in the lower bank (VW-7B), but remains about 1 to 1.5 m higher than the river level in the upper bank (VWs 1B & 5B). Similarly, the piezometric elevation in the clay is approximately 1.5 m above the winter river level (VW-7A), whereas the upper bank piezometric elevation in the clay is about 3 to 4 m above river level. Based on these monitoring results, the groundwater flow regime after fall drawdown consists of a downward flow gradient (from the clay to the till) in the upper bank of about 0.4 to 0.7 m of head per metre of depth, with a smaller downward flow gradient in the lower bank of about 0.3 m of head per metre of depth. In comparison of the results for VW-1A/1B with VW-5A/5B, the piezometric levels at Cross-section A appear to be about 0.5 m higher than the level at Cross-section C, but show similar seasonal variations.

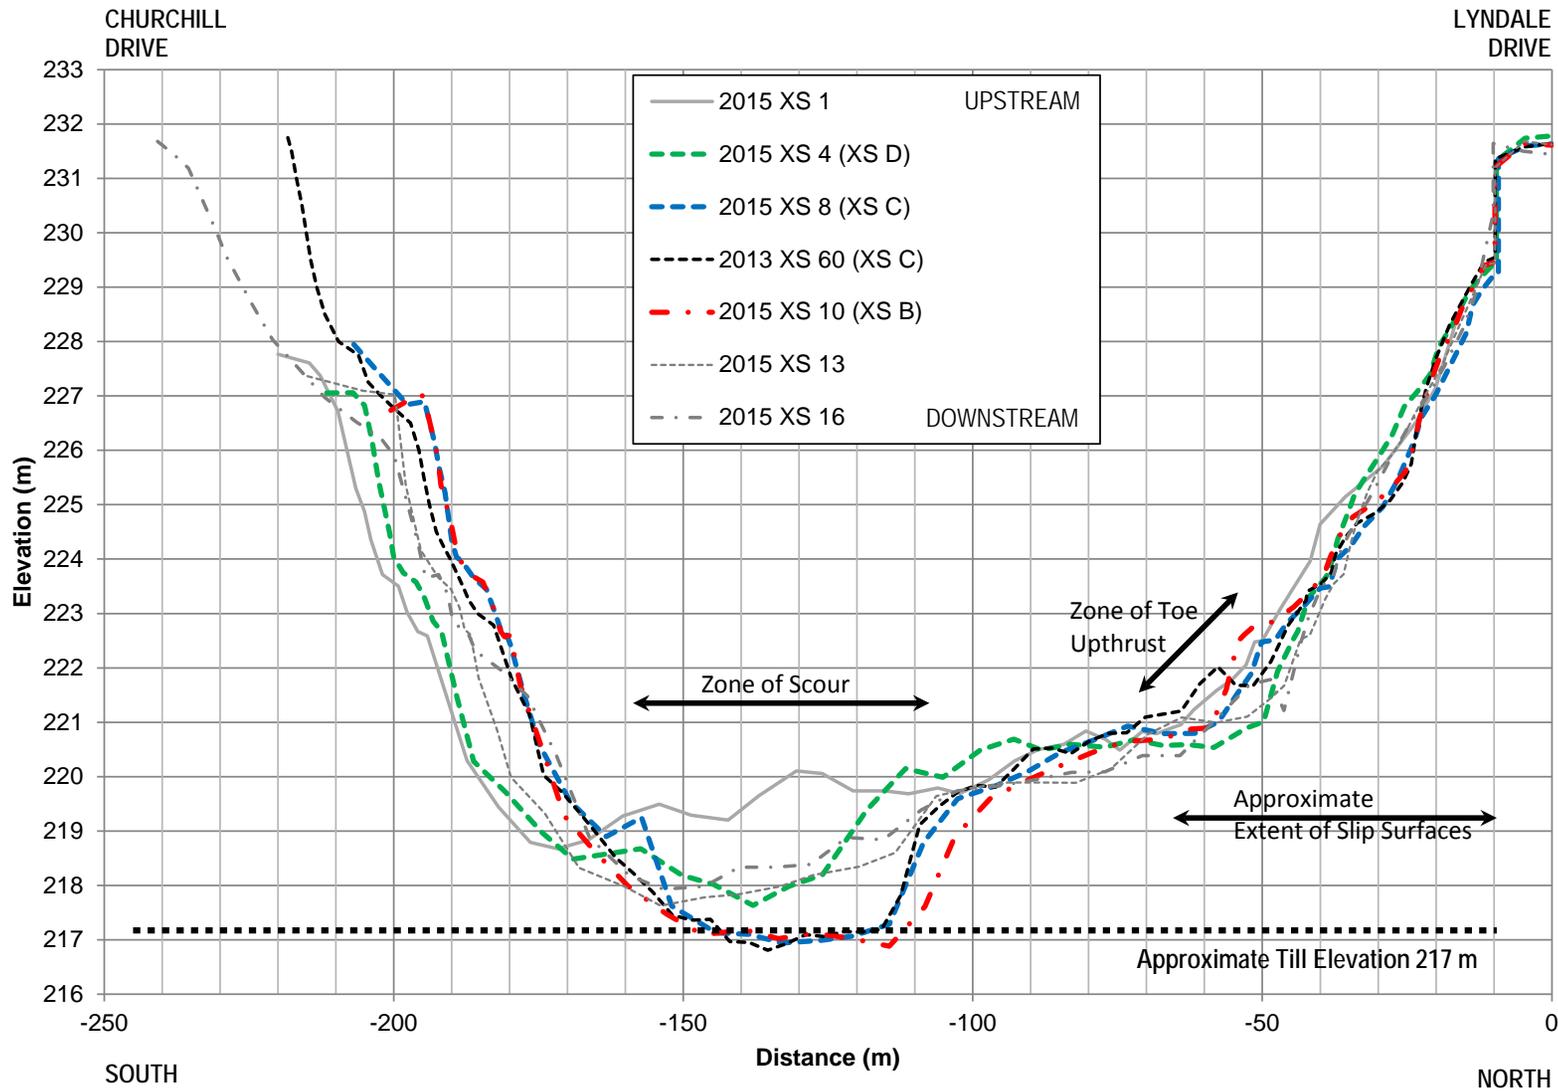
Figure 07 – Comparison of River Cross-Sections

In general, the outside bends of river meanders experience prolonged erosion and bank loss, whereas inside bends see aggradation (deposition) with the exception being during extreme flood events due to high river velocity profiles. At the current site, a constriction in the upper bank area (Churchill Drive) on the south bank (inside bend) has caused a constriction to flow at high flood stage, which has resulted in down-cutting (scour of the river bottom) within this reach of the river. Six cross-sections of the river were surveyed for ground topography as well as bathymetry, as shown on Figure 06; numbered cross-sections are as referenced in the hydraulics assessment report, whereas the lettered cross-sections correspond to those shown on Figure 01 for the geotechnical assessment. Upstream of the constriction (XS-1), the river bottom is relatively flat at Elev. 219 to 221 m. Proceeding in a downstream direction from XS-4 to XS-10, the river bottom lowers as a result of the flood-stage velocities, down to about Elev. 217 m; this elevation coincides with the approximate till elevation from the test holes. Downstream of the constriction (towards XS-13 and XS-16) the river bottom rises again, almost as high as at the upstream limit. The zone of scour in the river bottom is approximately 100 to 150 m south of the Lyndale Drive retaining wall, or about 50 to 100 mm south of the winter river level shoreline. Given the relative large distance from the shoreline to the scour zone, it is unlikely that the scour in this area is affecting stability of the Lyndale Drive riverbank. Minor erosion of the lower toe of the riverbank slope was noted during the site reconnaissance and in the hydraulics report, at or below about Elev. 223 m; due to the presence of riprap at surface and at shallow depths below ground along the shoreline, it is unclear if the visible erosion had undermined the riprap or if the eroded materials were recent sediments deposited by the river.

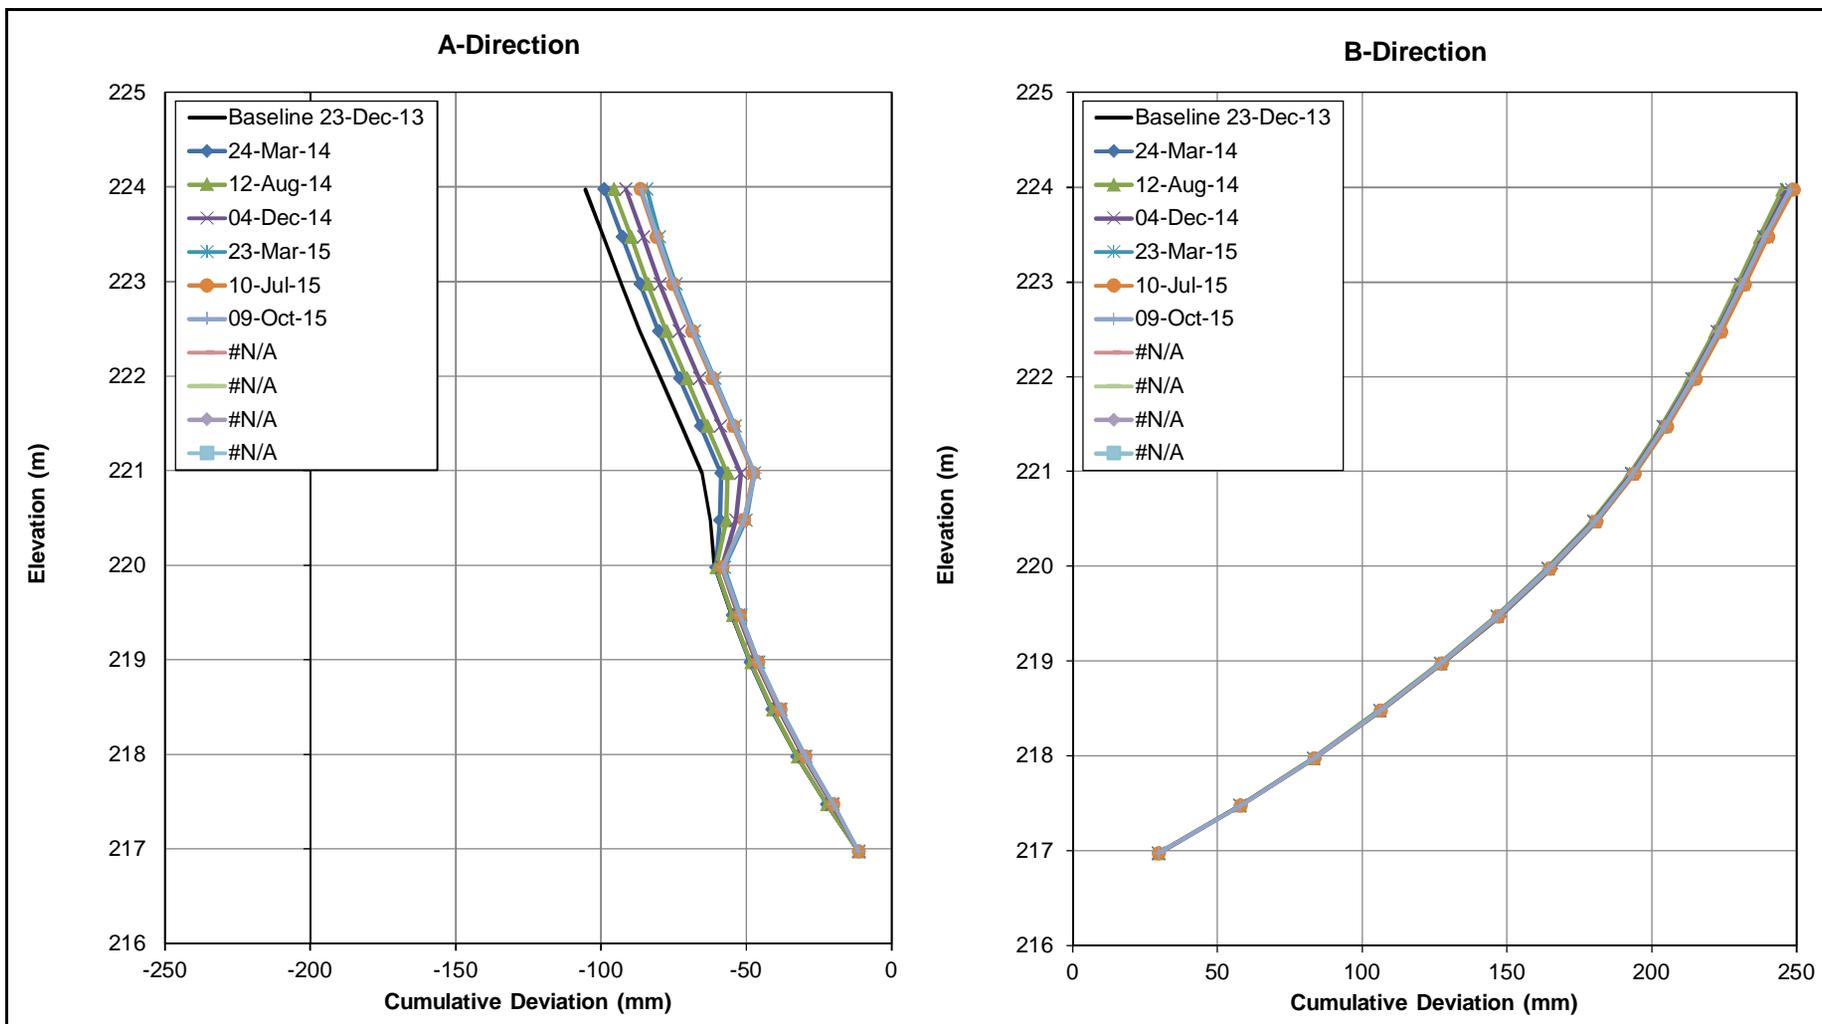
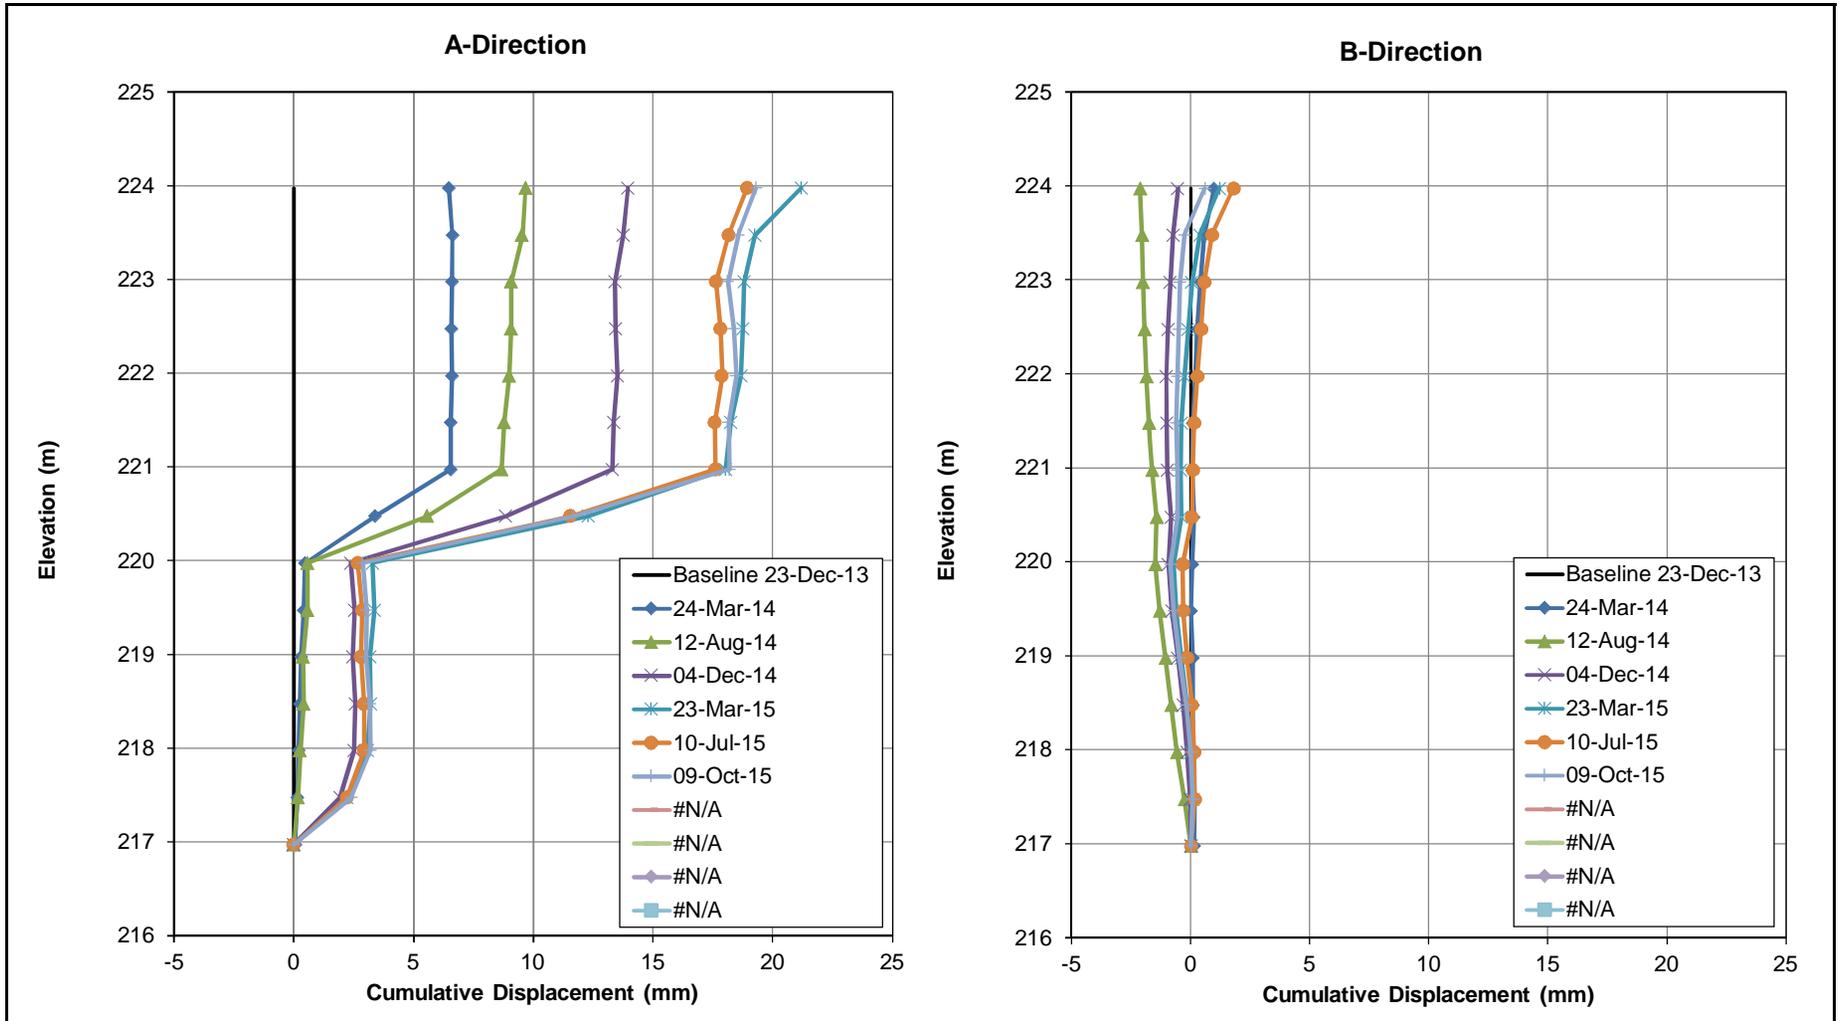
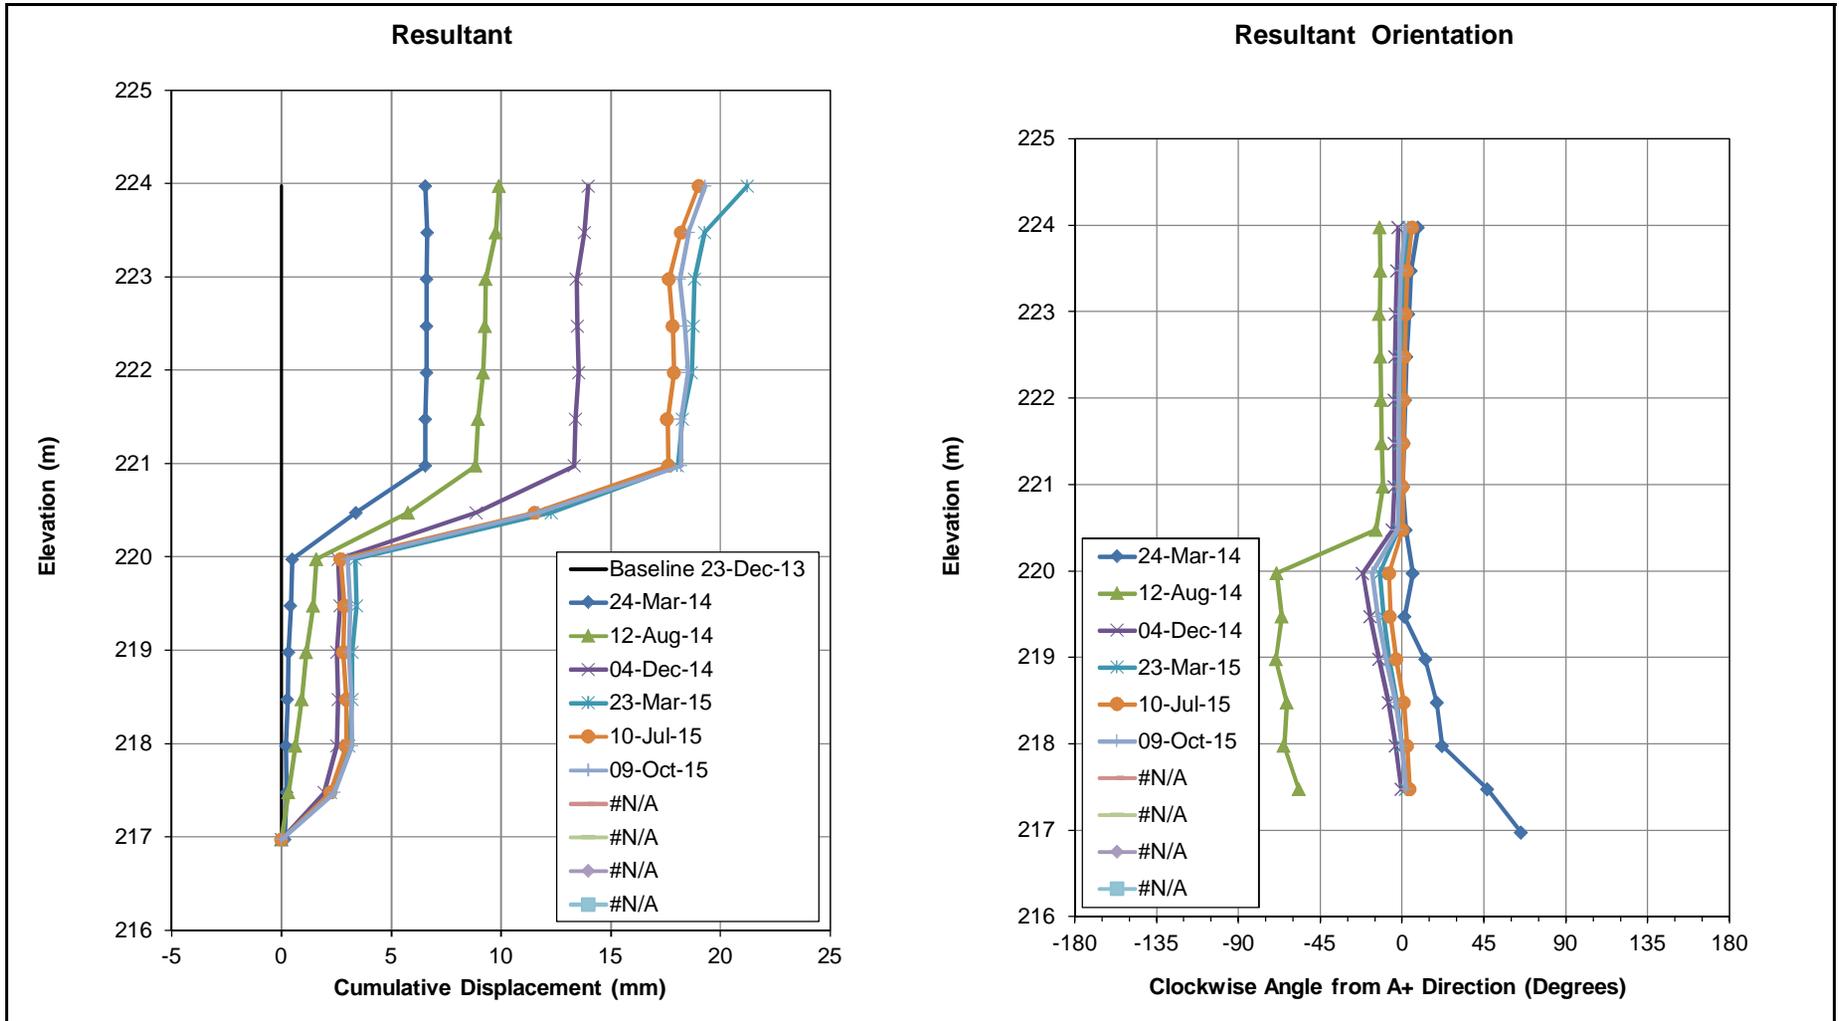
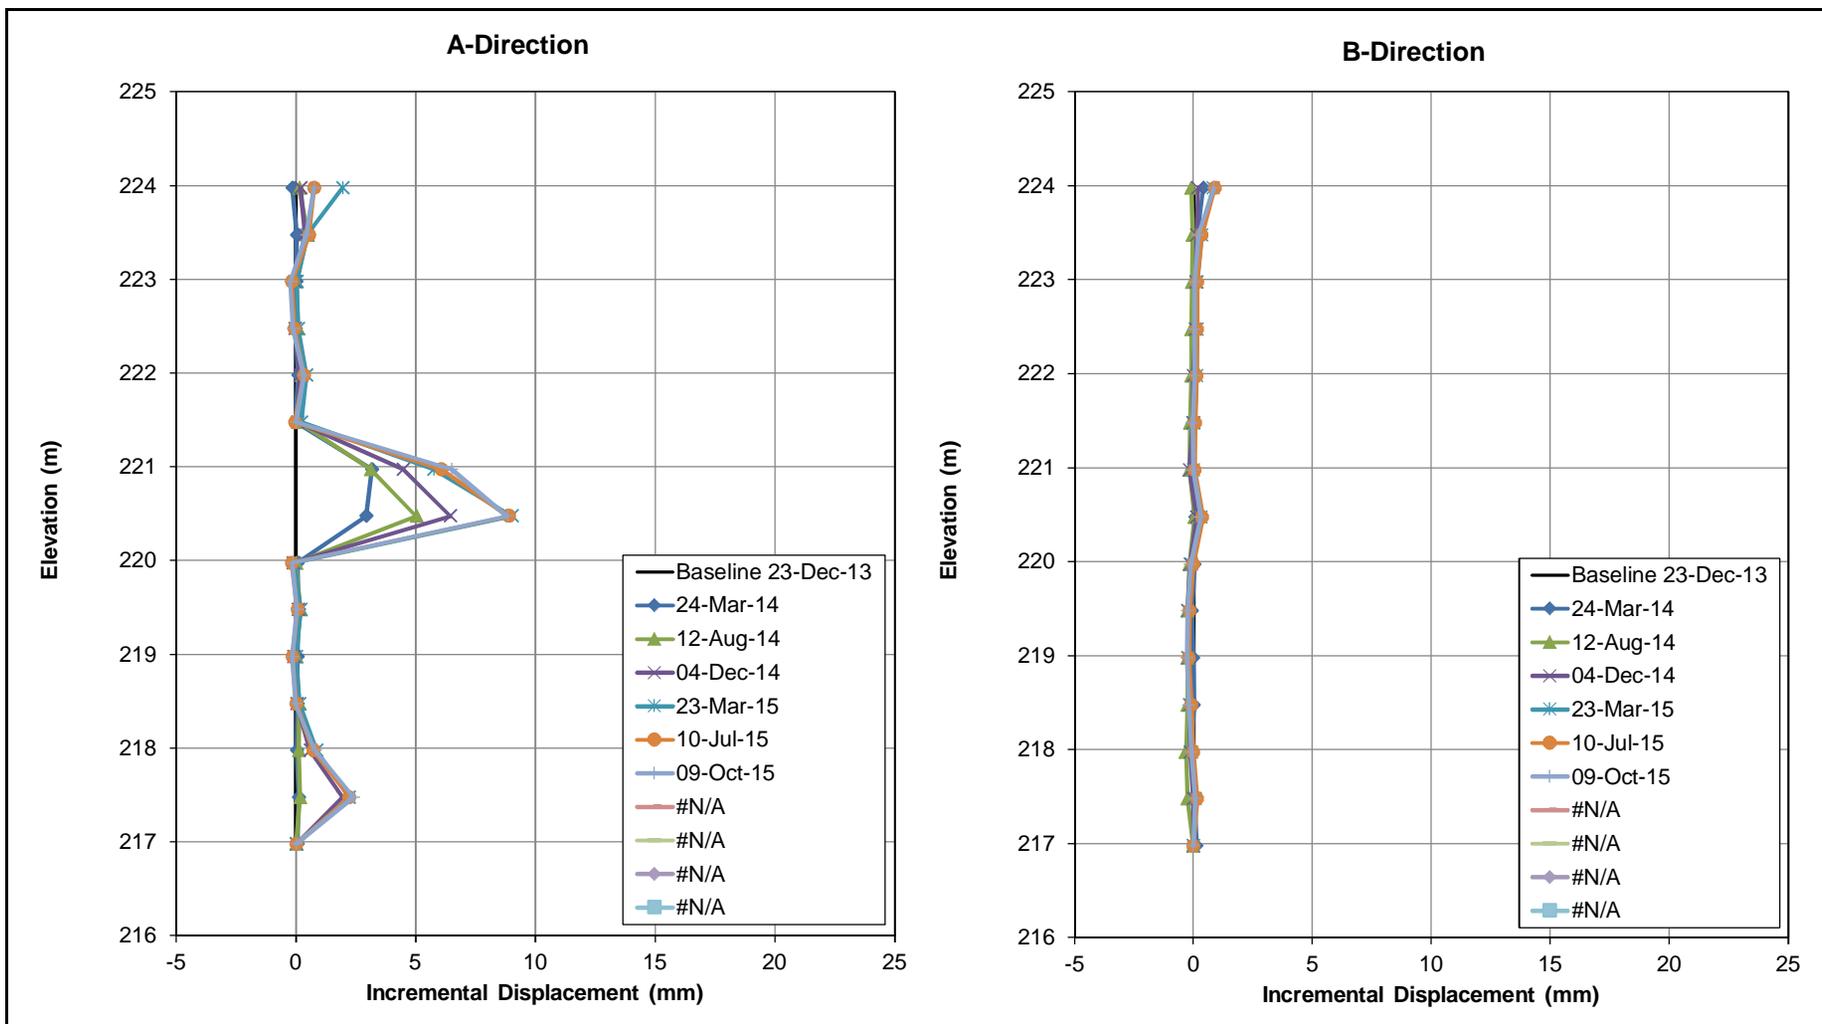
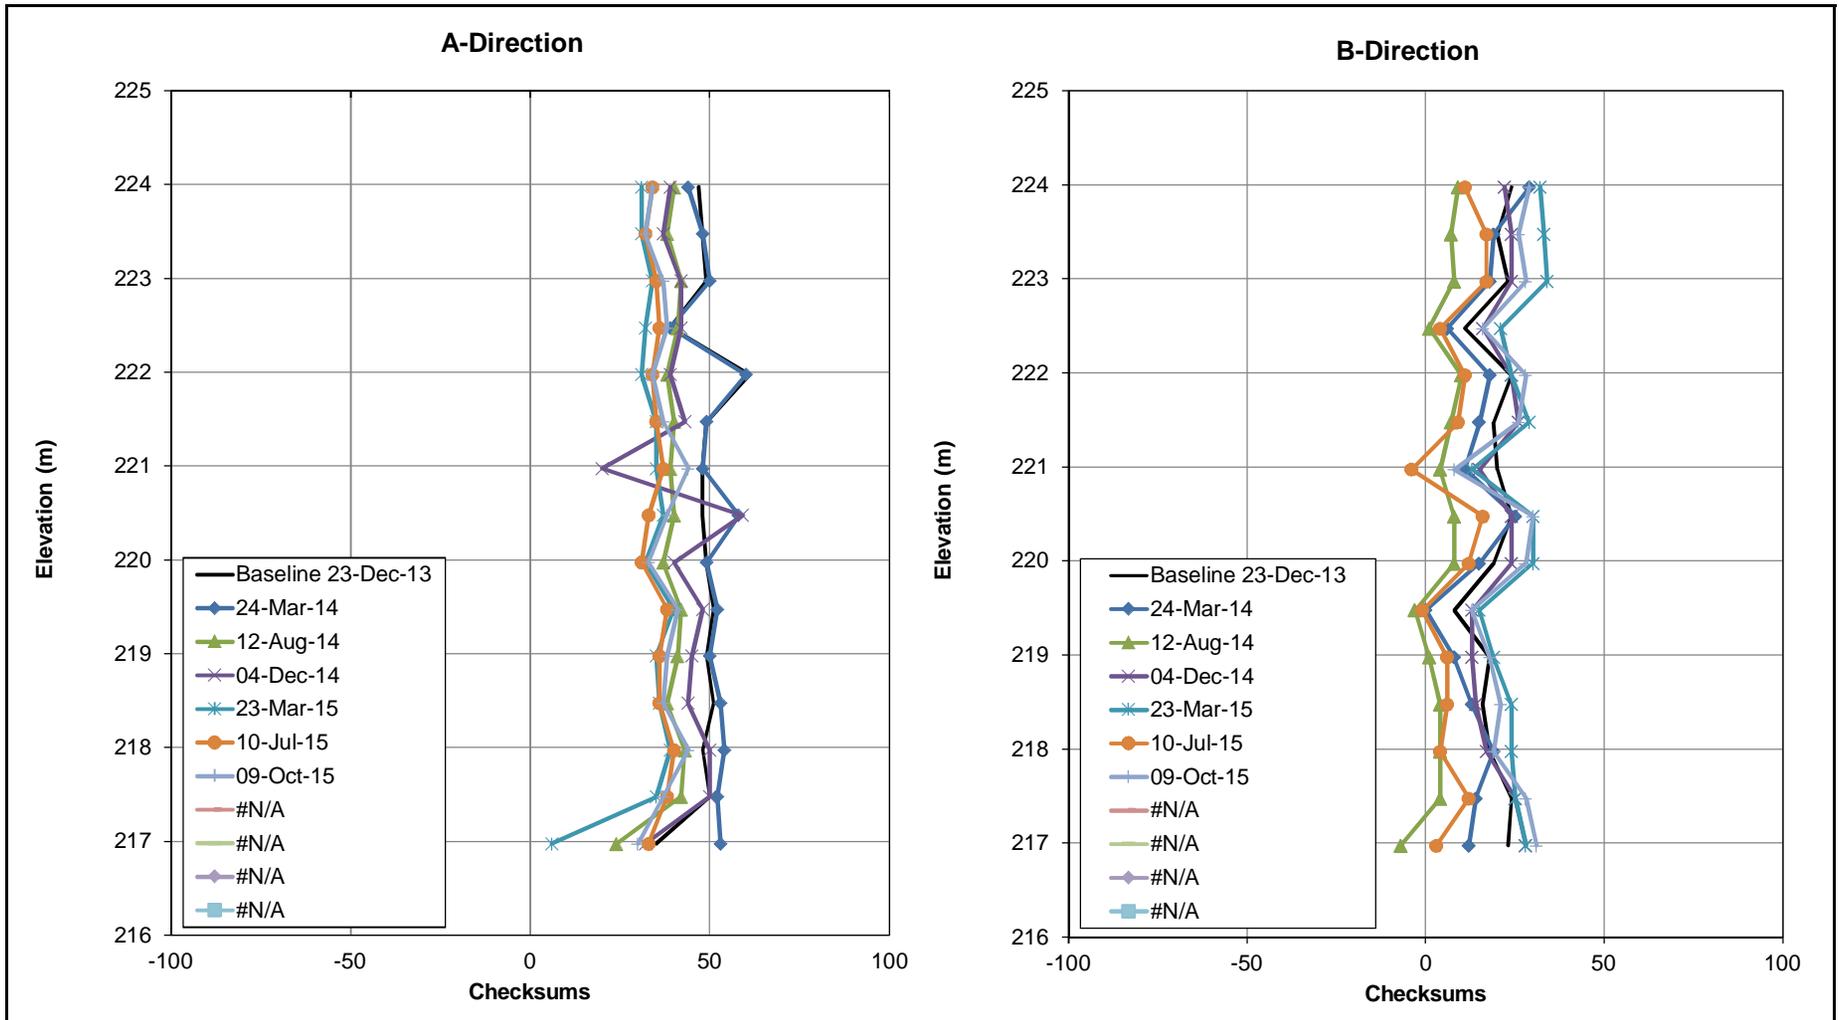
Project No. 0015 008 00
Project Title Lyndale Drive Retaining Wall Assessment
Client City of Winnipeg
Slope Incliner No. SI-7

Note: SI-7 casing is no longer readable after October 9, 2015
