NESS & ALCOTT FLAP GATE REPLACEMENT

- C1 - DRAWING OF EXISTING GATE CHAMBER MANHOLE (LD-209)
- C2 - SHOP DRAWING OF EXISTING FLAP GATE
- C3 - FLAP GATE INSPECTION REPORT (8 PAGES)
- C4 - SKETCH SHOWING PROPOSED MANHOLE CONFIGURATION

January 28, 2015 Inspection of Flap Gate near Sturgeon Creek at Ness
Inspection by Kyle Sanders, Service Technician, Power & Mine Supply Service Group

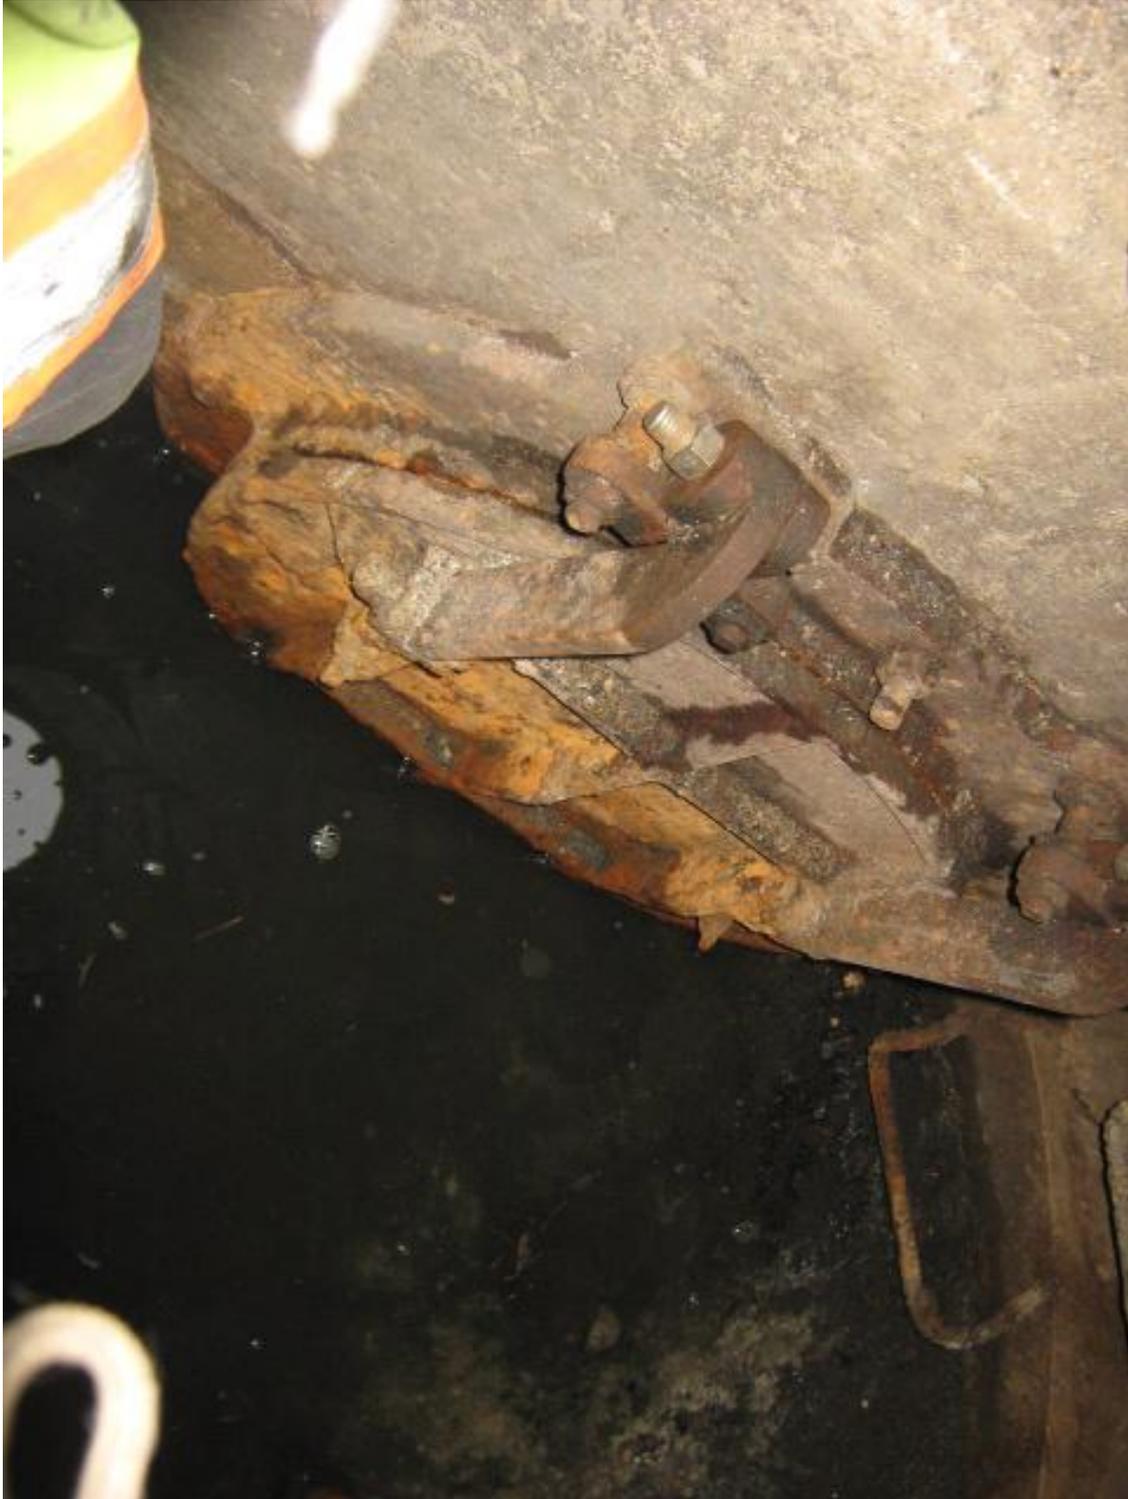
Figure 1 – Close up of the seating face on the back side of the gate disc

This Flap Gate appears to have excessive corrosion on the seating faces. Both the gate frame's seat face and the gate disc's seat face appear to be cast iron. In our experience, the City of Winnipeg prefers that all seating faces of cast iron flap gates are to be constructed of a bronze or brass material that is corrosion resistant to river water. Figure 1 and Figure 2 show the excessive corrosion evident on the seating faces. The corrosion is such that the faces are unable to seat together with a tolerance that is tight enough to provide an acceptable leakage rate. Figure 2 shows that some of the corrosion bumps are between 2 and 5 mm which cause large spaces between the seating faces and will easily allow water to pass. With this corrosion, the flap gate will definitely leak excessively. In addition, small debris and sticks collect on the seating face corrosion as shown in Figures 3 and 4 further increasing leak paths.
