Hazardous Building Materials Assessment of the Baltimore Flood Pumping Station

APRIL 17, 2018
ISSUED FOR REVIEW
FILE: 734-1800120700-REP-V0001-A

The City of Winnipeg
Corporate Finance Department
Materials Management Division
185 King Street, Main Floor
Winnipeg, MB R3B 1J1

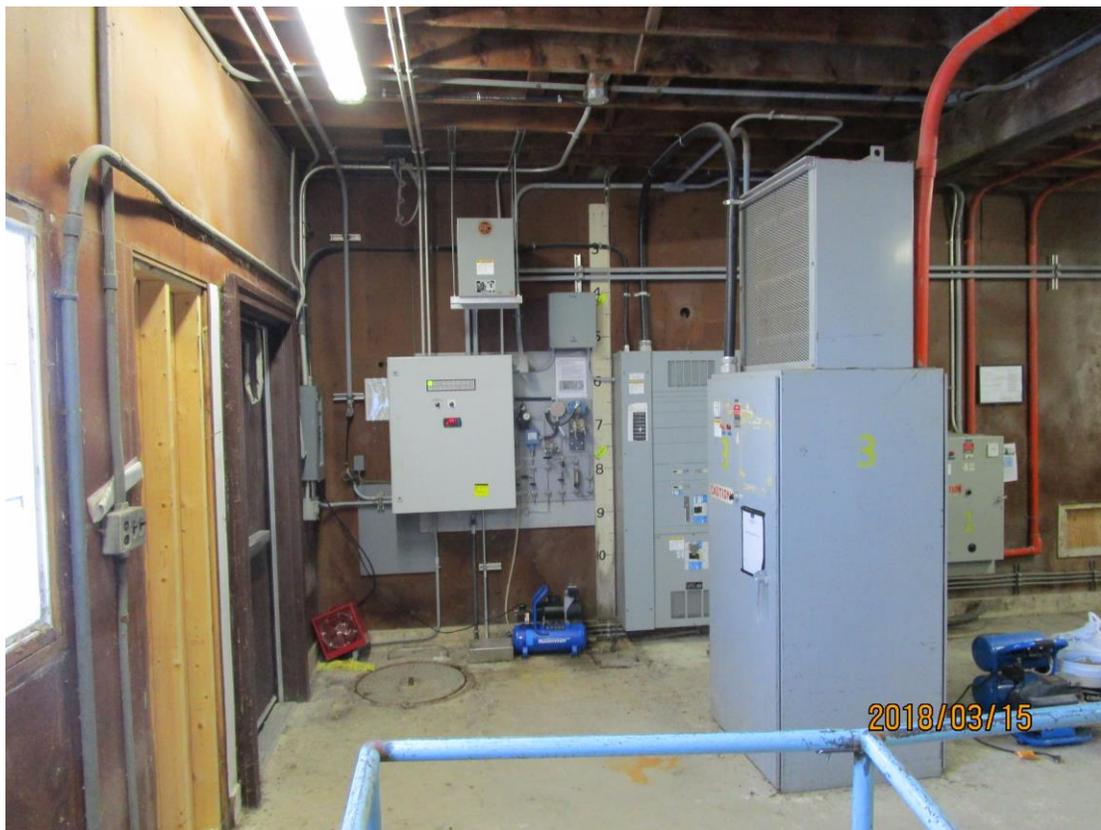
Photo 2: General view of electrical controls in northwest corner of building interior. View looking north at north wall. (March 15, 2018)

| Sample ID | Date Sampled | Material Description | General Classification | General Condition | Asbestos Content (%) |
|--|---|--|---|---|---|
| ACM-04 | 15-Mar-18 | Brown press board on the north wall of the main floor. | Non-Friable | Fair - some minor physical damage and water staining. (Photos 2 & 38) | <1 |

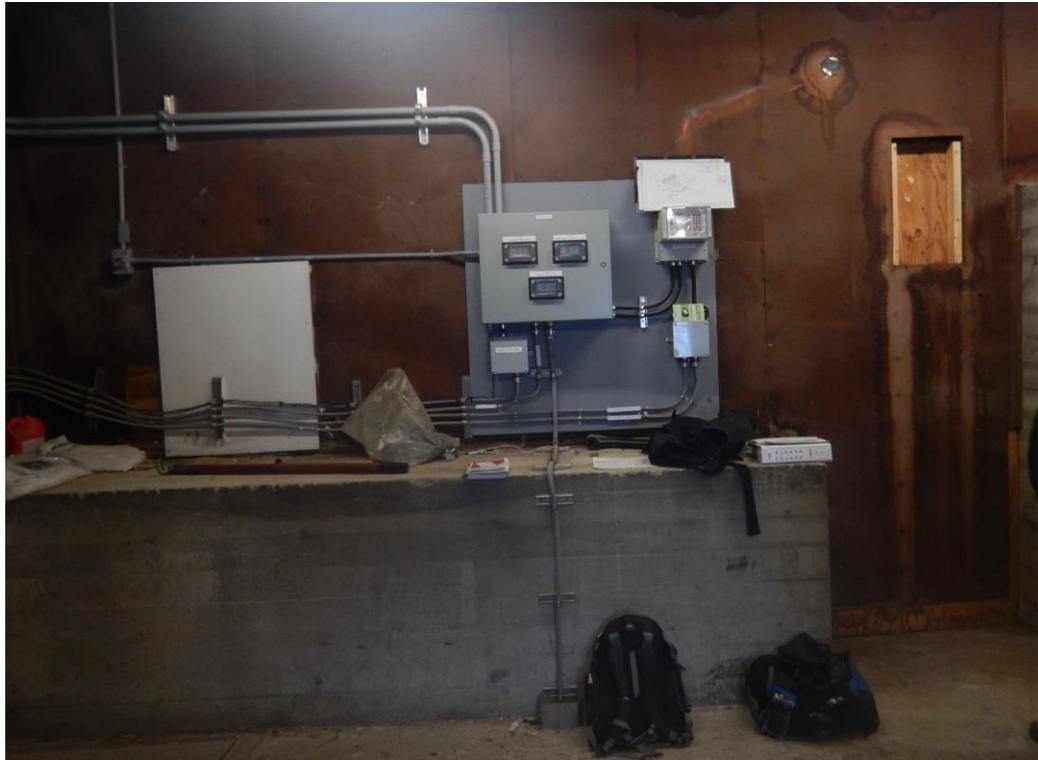
Photo 3: General view of controls along north half of east wall. View looking east at east wall (March 15, 2018)

| Sample ID | Date Sampled | Material Description | General Classification | General Condition | Asbestos Content (%) |
|--|---|--|---|---|---|
| ACM-03 | 15-Mar-18 | Brown press board on the east wall of the main floor. | Non-Friable | Fair - some minor physical damage and water staining. (Photos 3 & 37) | <1 |

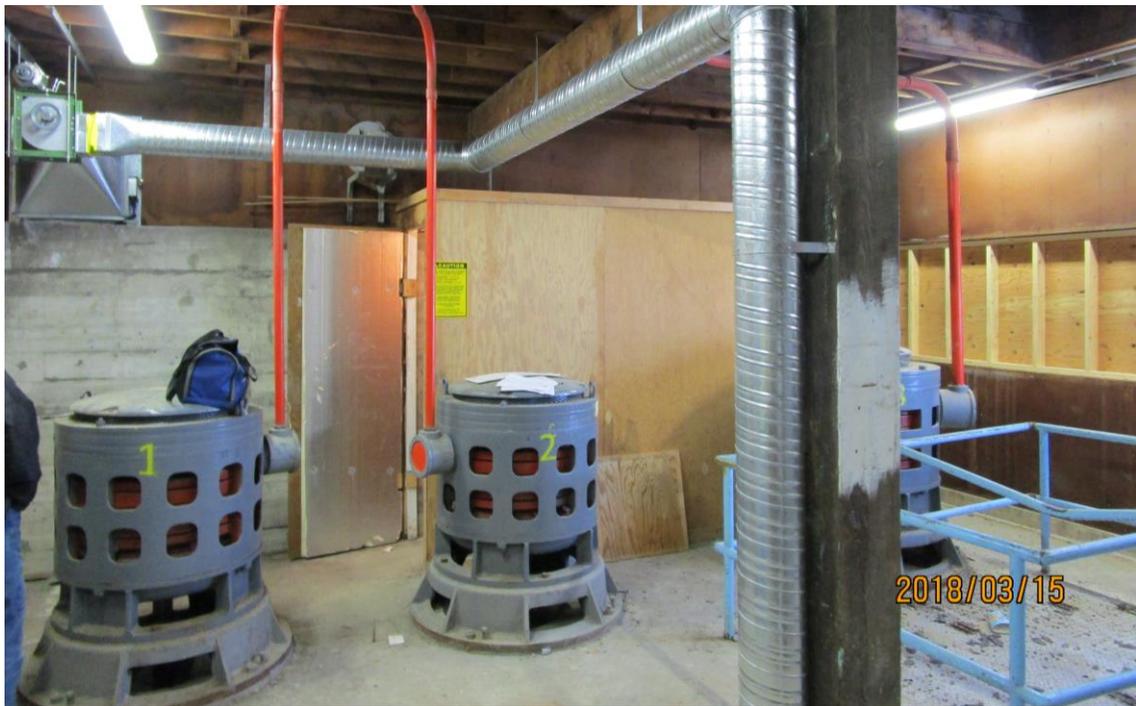
Photo 4: General view top drives units for centrifugal pumps positioned in the dry well. Vestibule for stairwell access to dry well is shown behind the centre drive unit. View looking south at south wall. (March 15, 2018)

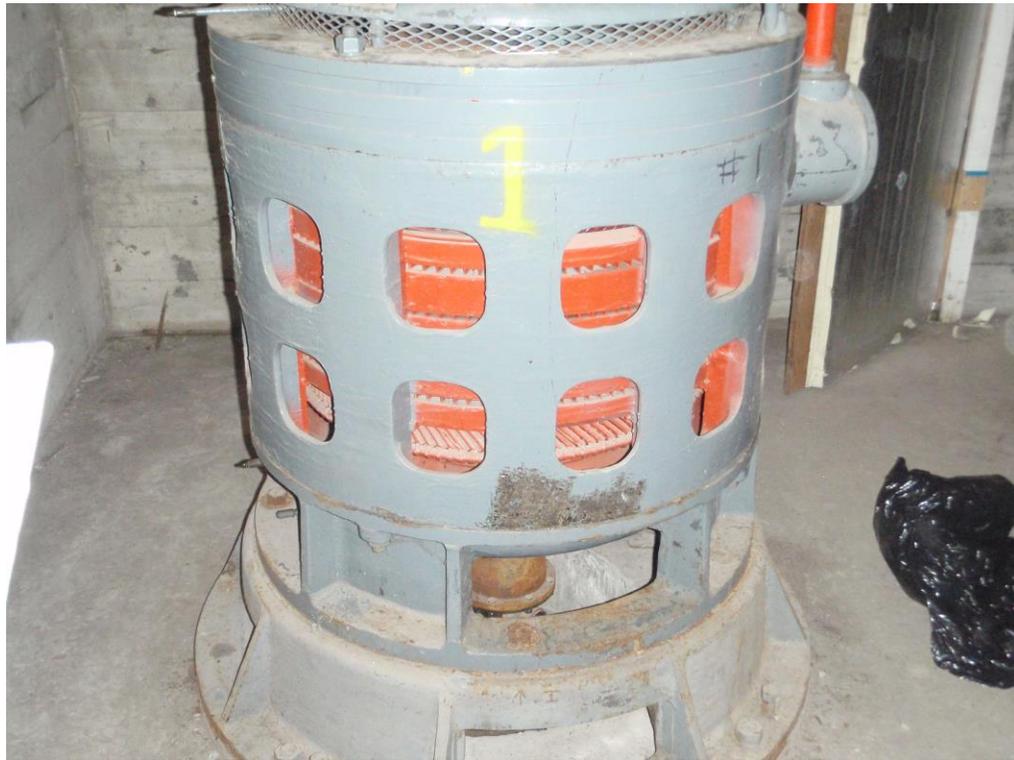
Photo 15: General view of top drive unit 1 on the main level. (March 15, 2018)

| Sample ID | Date Sampled | Material Description | General Condition | Paint Chip Samples | |
|--|---|--|---|---|---|
| LBP-07 | 15-Mar-18 | Gray paint - top drive unit for pump 1 on the main floor | Good (Photos 15 & 16) | 3810 | 0.152 |

| Table 2 Paint Chip Sample Toxicity Characteristic Leaching Procedure Laboratory Analytical Results Hazardous Building Materials Assessment City of Winnipeg Baltimore Flood Pumping Station, Winnipeg, Manitoba | | | | | |
|--|---|--|--|---|---|
| LBP-07 + LBP-08 + LBP-09 | 15-Mar-18 | Gray paint - top drive units 1, 2, and 3 on the main floor | Good (Photos 15, 16 & 17) | 32.3 | <0.01 |

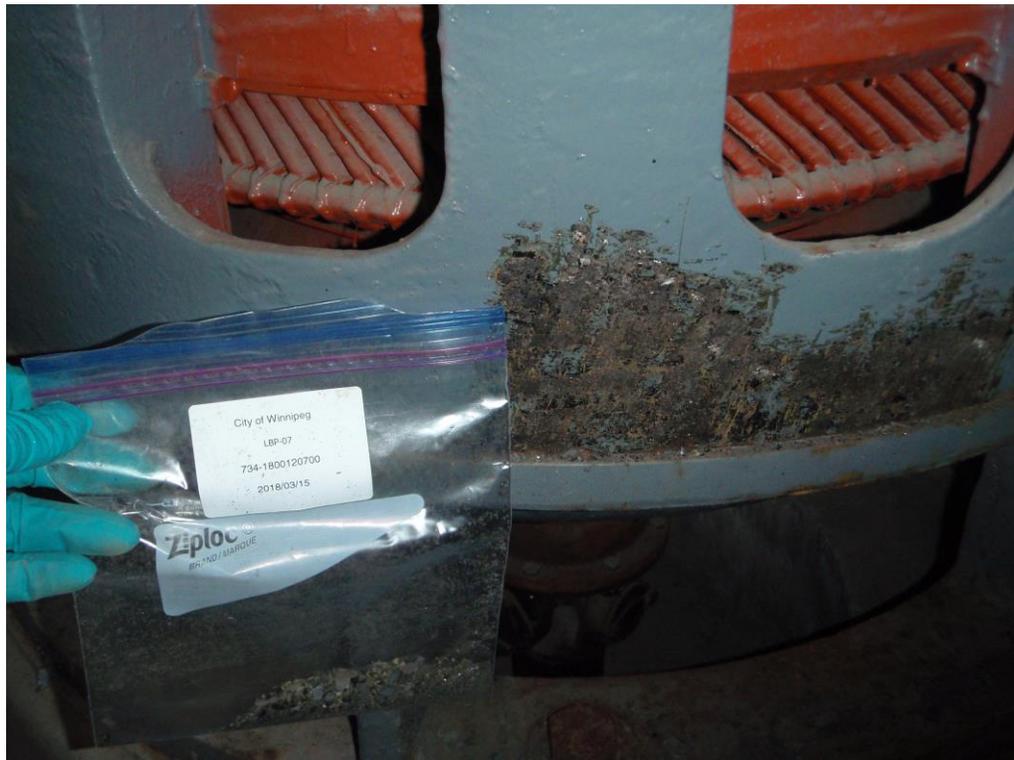
Photo 16: General view of the paint chip sample location LBP-07 on top drive unit 1 on the main level. (March 15, 2018)

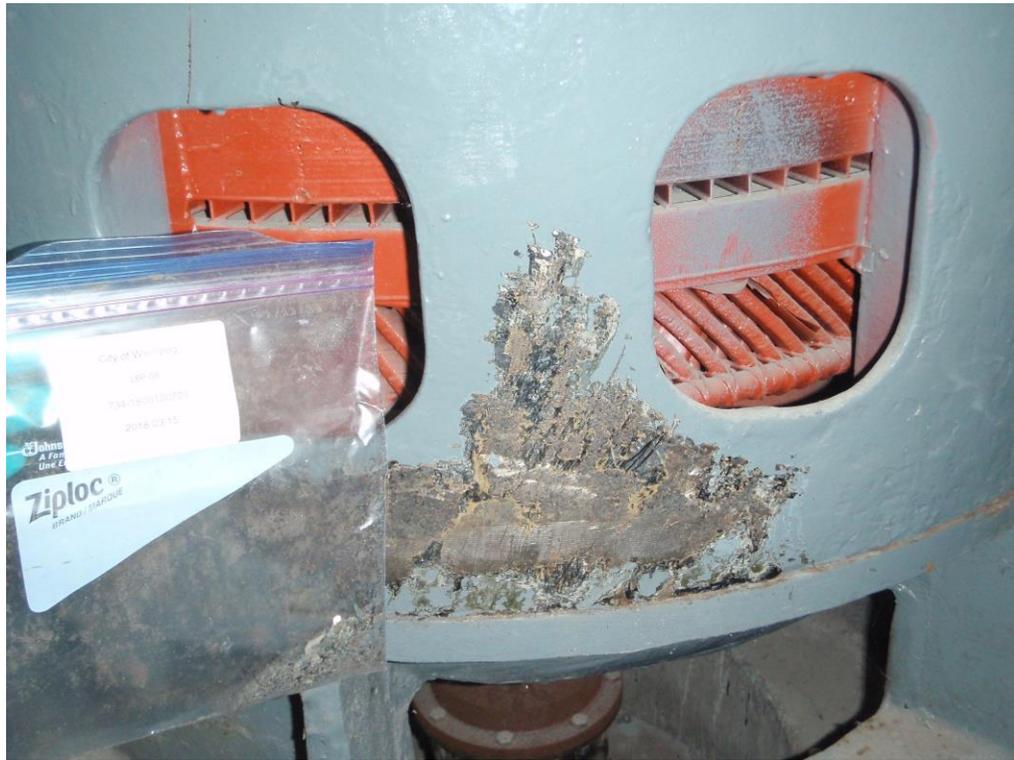
Photo 17: General view of paint chip sample LBP-08 location on top drive unit 2 on the main level. (March 15, 2018)

| Sample ID | Date Sampled | Material Description | General Condition | Paint Chip Samples | |
|--|---|--|---|---|---|
| LBP-08 | 15-Mar-18 | Gray paint - top drive unit for pump 2 on the main floor | Good (Photo 17) | 3770 | 0.140 |

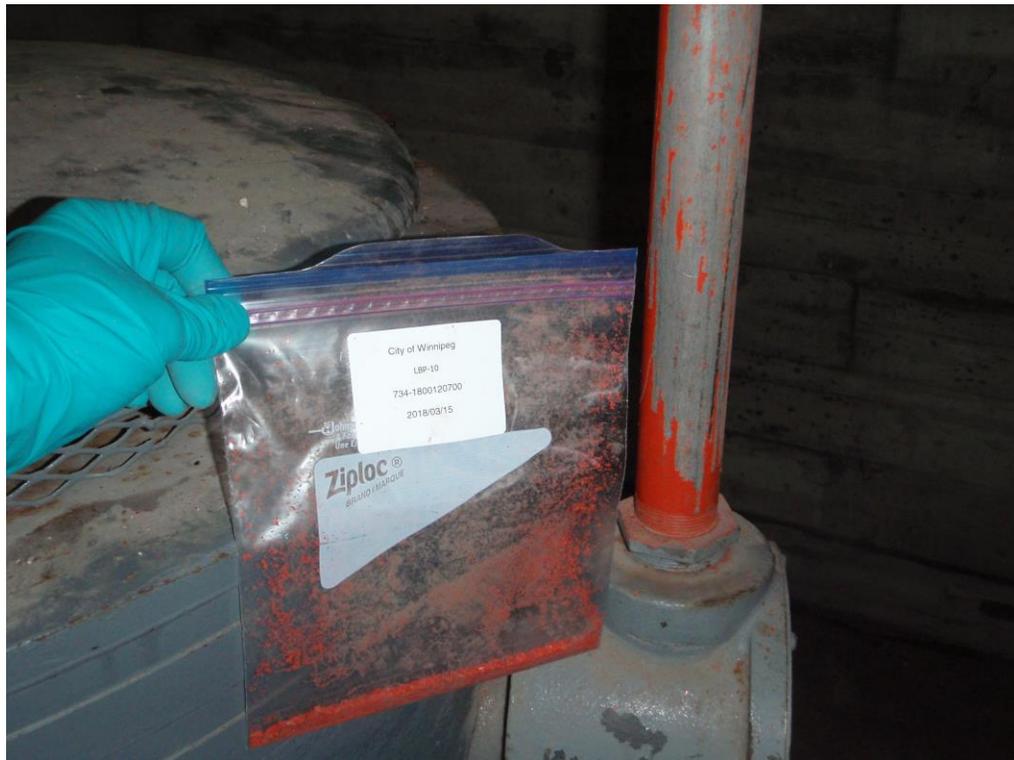
Photo 18: General view of paint chip sample LBP-10 location on the piping coming from top drive unit 1 on the main floor. (March 15, 2018)

| Sample ID | Date Sampled | Material Description | General Condition | Paint Chip Samples | |
|--|---|--|---|---|---|
| LBP-10 | 15-Mar-18 | Red paint - piping from top drive unit for pump 1 on main floor | Good (Photo 18) | 24 400 | 4.02 |

| Table 2 Paint Chip Sample Toxicity Characteristic Leaching Procedure Laboratory Analytical Results Hazardous Building Materials Assessment City of Winnipeg Baltimore Flood Pumping Station, Winnipeg, Manitoba | | | | | |
|--|---|--|--|---|---|
| LBP-10 + LBP-11 + LBP-12 | 15-Mar-18 | Red paint - piping from top drive units 1, 2, and 3 on main floor | Good (Photo 18, 19, & 20) | 4.4 | <0.01 |

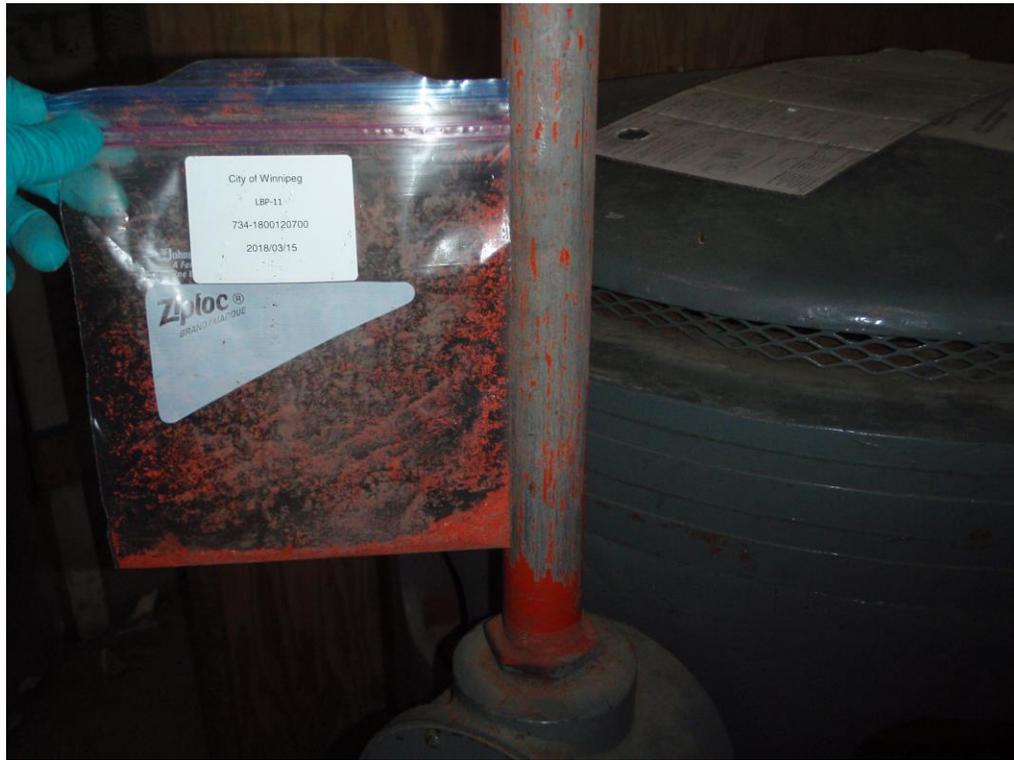
Photo 19: General view of paint chip sample LBP-11 location on the piping coming from the top drive unit 2 on the main level. (March 15, 2018)

| Sample ID | Date Sampled | Material Description | General Condition | Paint Chip Samples | |
|--|---|--|---|---|---|
| LBP-11 | 15-Mar-18 | Red paint - piping from top drive unit for pump 2 on main floor | Good (Photo 19) | 19 900 | 6.02 |

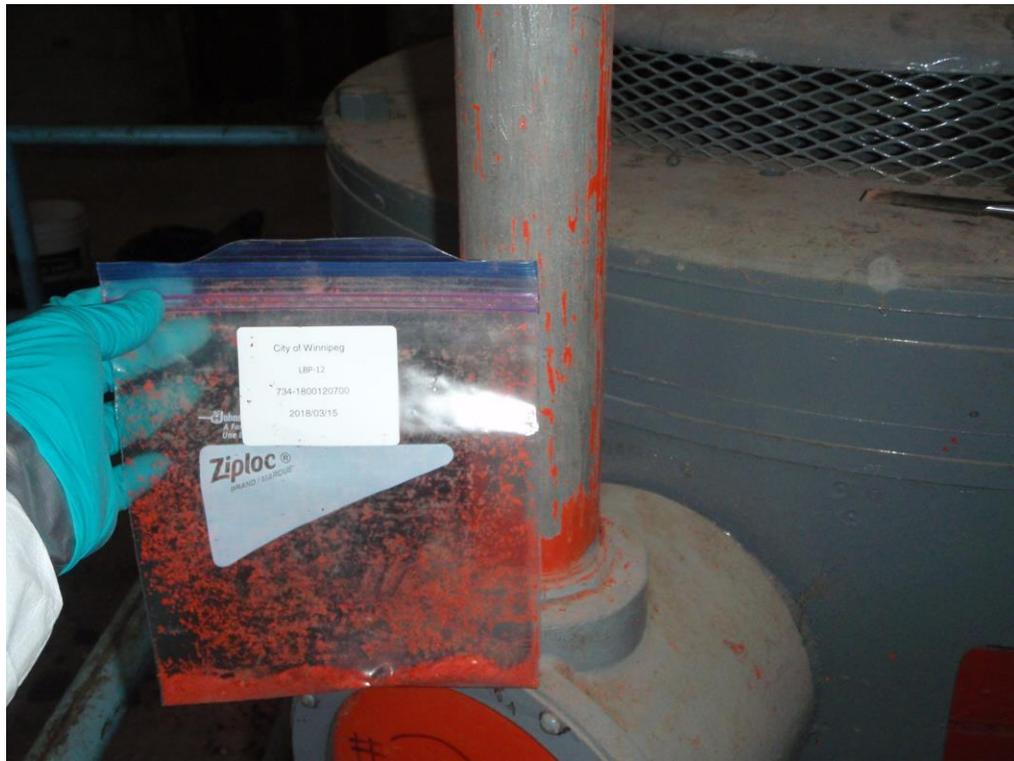
Photo 20: General view of paint chip sample LBP-12 location on the piping coming from the top drive unit 3 on the main level. (March 15, 2018)

| Sample ID | Date Sampled | Material Description | General Condition | Paint Chip Samples | |
|--|---|--|---|---|---|
| LBP-12 | 15-Mar-18 | Red paint - piping from top drive unit for pump 3 on main floor | Good (Photo 20) | 29 400 | 2.49 |

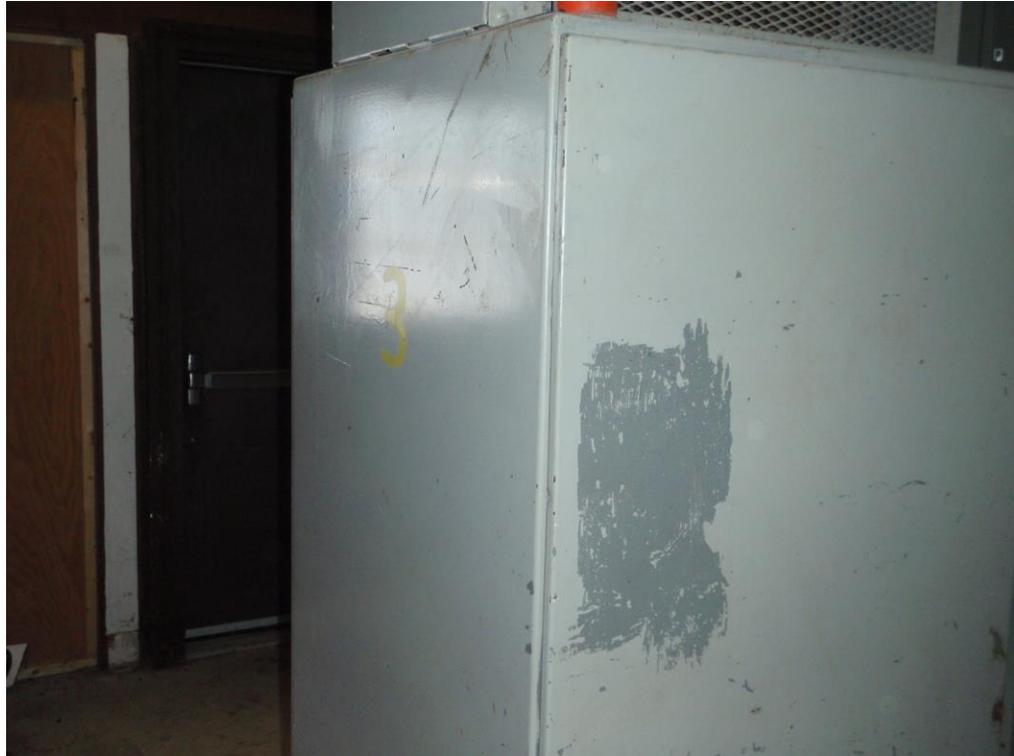
Photo 23: General view of the electrical panel unit near the centre of the main level. (March 15, 2018)

| Sample ID | Date Sampled | Material Description | General Condition | Paint Chip Samples | |
|--|---|--|---|---|---|
| LBP-15 | 15-Mar-18 | Gray paint - electrical panel near the center of the main floor room | Good (Photos 23 & 24) | 3290 | 0.938 |

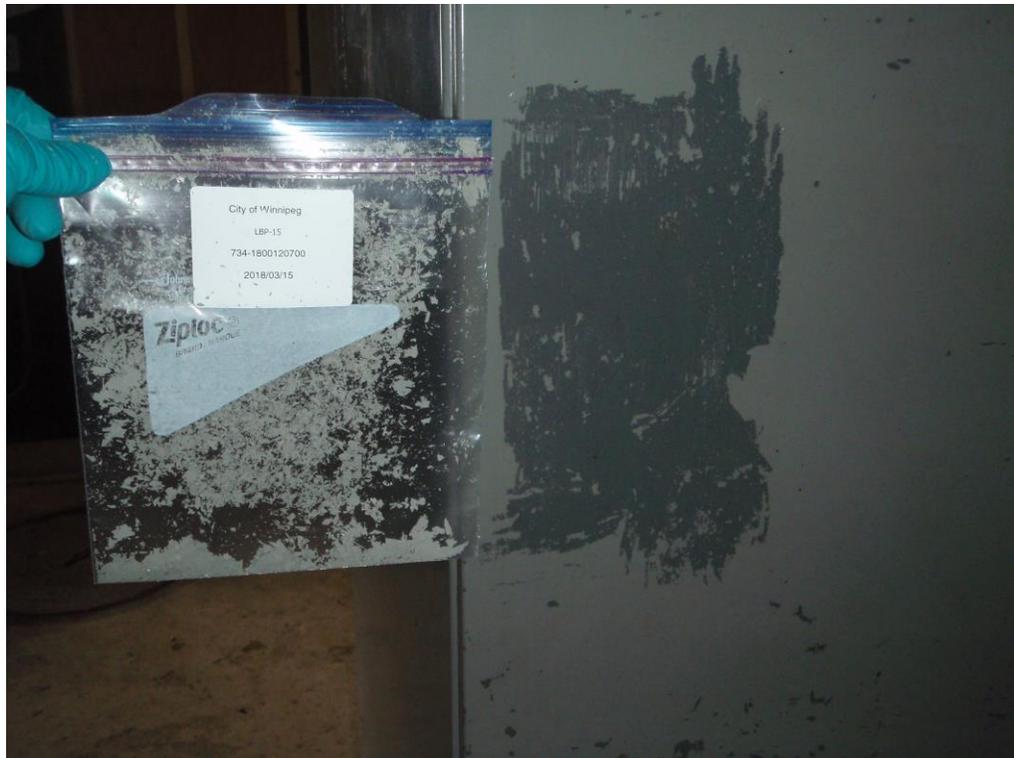
Photo 24: General view of paint chip sample LBP-15 location on the electrical panel near the centre of the main level. (March 15, 2018)

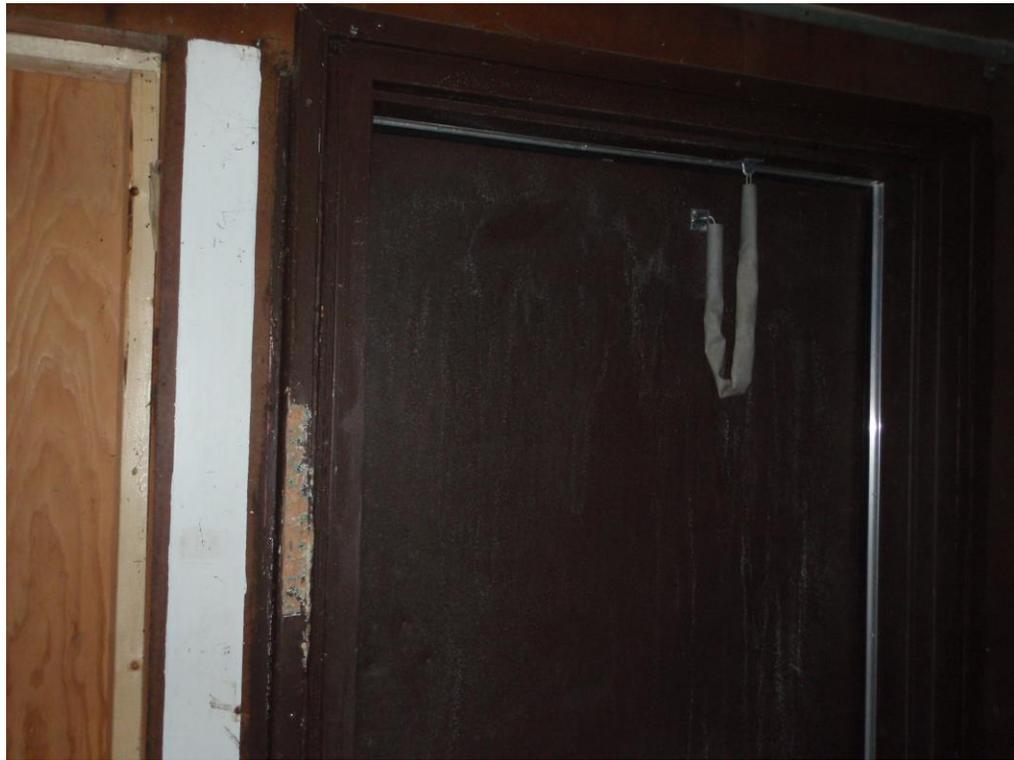
Photo 25: General view of the frame around the door at the main entrance near the northwest corner of the main level. (March 15, 2018)

| Sample ID | Date Sampled | Material Description | General Condition | Paint Chip Samples | |
|--|---|--|---|---|---|
| LBP-16 | 15-Mar-18 | Brown paint - door frame around entrance near northwest corner on the main floor | Good (Photos 25 & 26) | 11 800 | 15.1 |

| Table 2 Paint Chip Sample Toxicity Characteristic Leaching Procedure Laboratory Analytical Results Hazardous Building Materials Assessment City of Winnipeg Baltimore Flood Pumping Station, Winnipeg, Manitoba | | | | | |
|--|---|--|--|---|---|
| LBP-16 | 15-Mar-18 | Brown paint - door frame around entrance near northwest corner on the main floor | Good (Photos 25 & 26) | 7.4 | <0.01 |

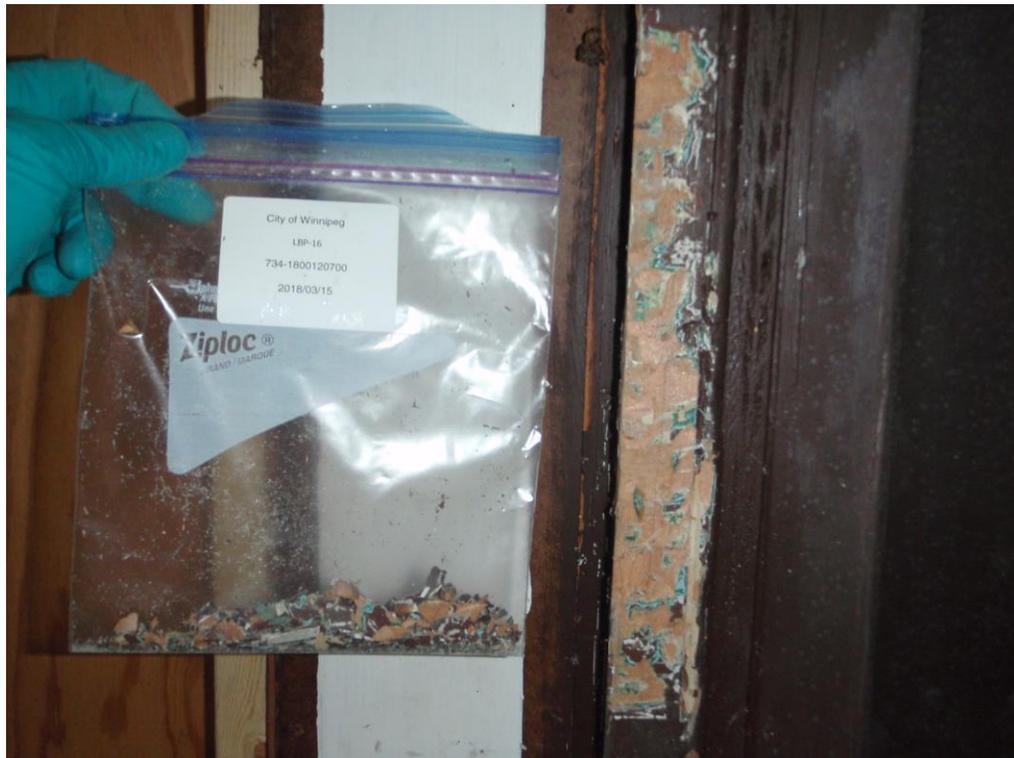
Photo 26: General view of paint chip sample LBP-16 location on the frame around the door at the main entrance near the northwest corner of the main level. (March 15, 2018)

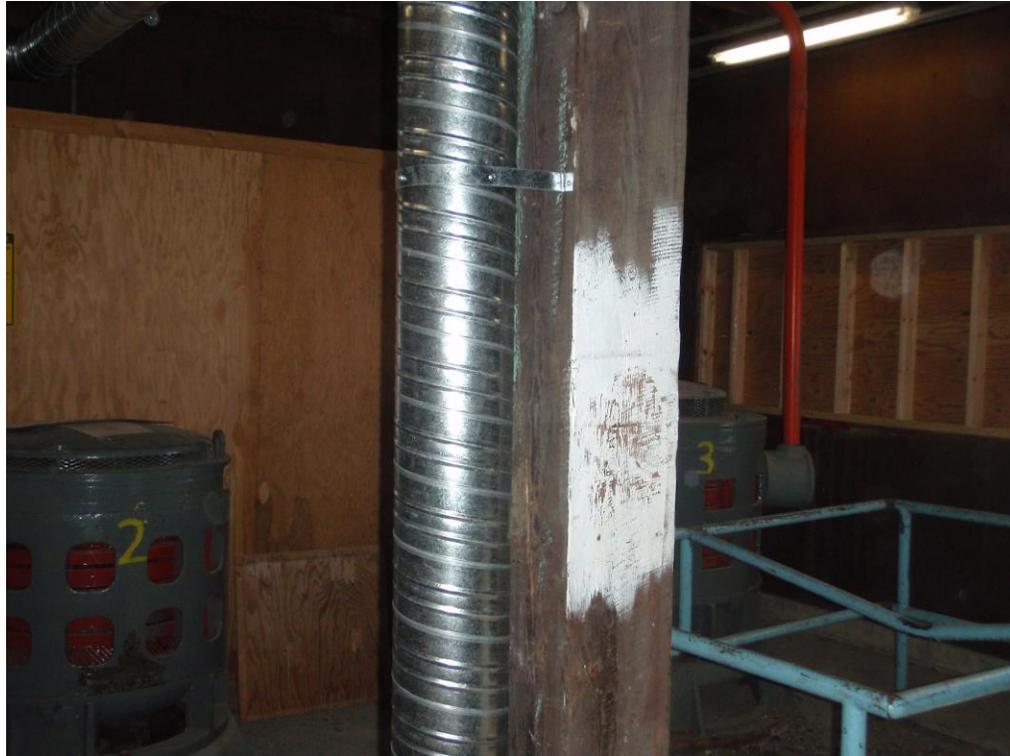
Paint chip sample LBP-19, white paint from the wood post near the center of the main floor (see photos 4, 31 and 32 in Appendix B), was the only sample that did not contain a lead or a mercury concentration above the assessment environmental quality guidelines. This paint on the post does not appear to be part of the original structure construction, but appears to have been applied simply as a means of cleaning a paint roller, possibly associated with the painting of a wooden support board for the electrical cables on the wall in the northwest corner of the building (see photo 3).

Photo 31: General view of paint on the wooden post near the centre of the main level. (March 15, 2018)

| Sample ID | Date Sampled | Material Description | General Condition | Paint Chip Samples | |
|--|---|--|---|---|---|
| LBP-19 | 15-Mar-18 | White paint - wooden support post in center of the room on the main floor | Good - only limited coverage on 3 sides of wooden post (Photos 31 & 32) | 72.0 | 0.893 |

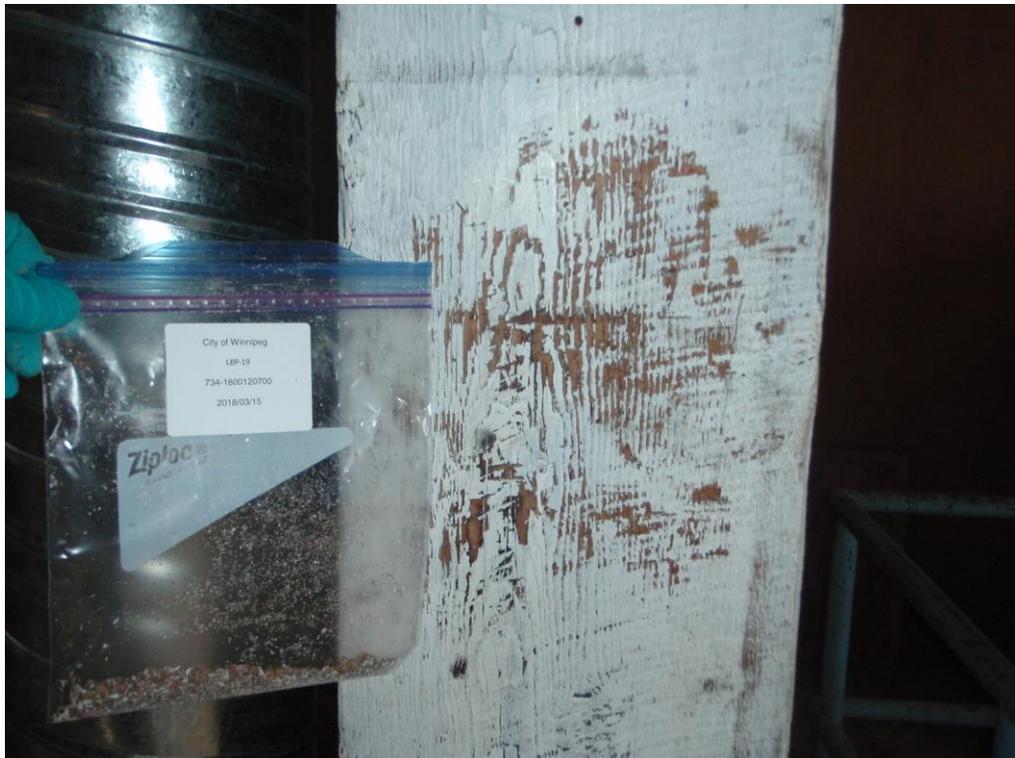
Photo 32: General view of paint chip sample LBP-19 location on the wooden post near the centre of the main level. (March 15, 2018)

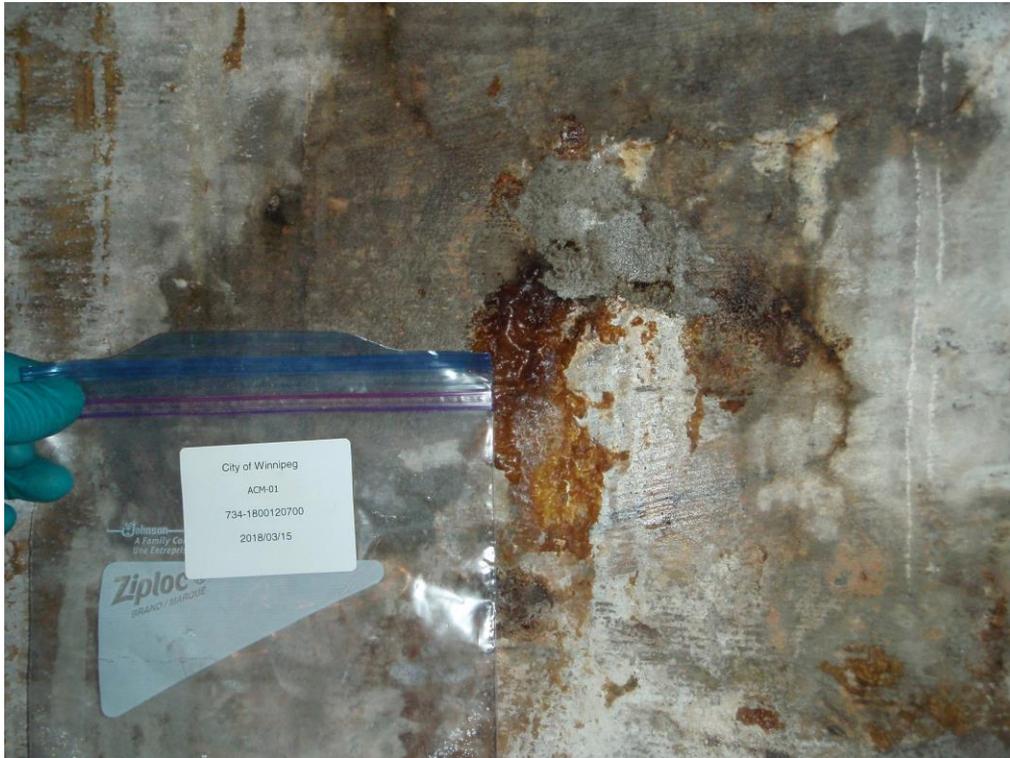
Photo 35: General view of bulk material sample ACM-01 location on the northwest wall in the dry well. (March 15, 2018)

| Sample ID | Date Sampled | Material Description | General Classification | General Condition | Asbestos Content (%) |
|--|---|--|---|---|---|
| ACM-01 | 15-Mar-18 | Cement filler on northeast wall in dry well. | Non-Friable | Fair - rough patch but seems to be cohesive. (Photo 35) | <1 |

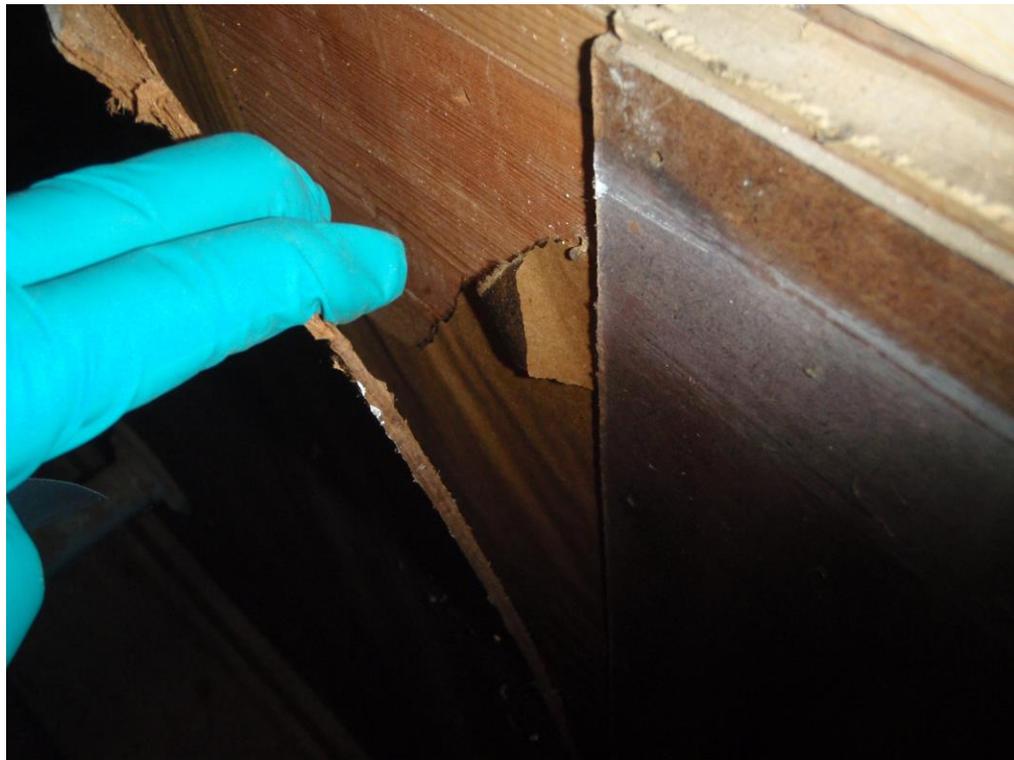
Photo 40: General view of bulk material sample ACM-06 location from the lining between the brown press board panelling and the wall studs on the west wall on the main level. (March 15, 2018)

| Sample ID | Date Sampled | Material Description | General Classification | General Condition | Asbestos Content (%) |
|--|---|--|---|---|---|
| ACM-06 | 15-Mar-18 | Lining between brown press board and wall studs on the west wall on the main floor. | Non-Friable | Good (Photo 40) | <1 |

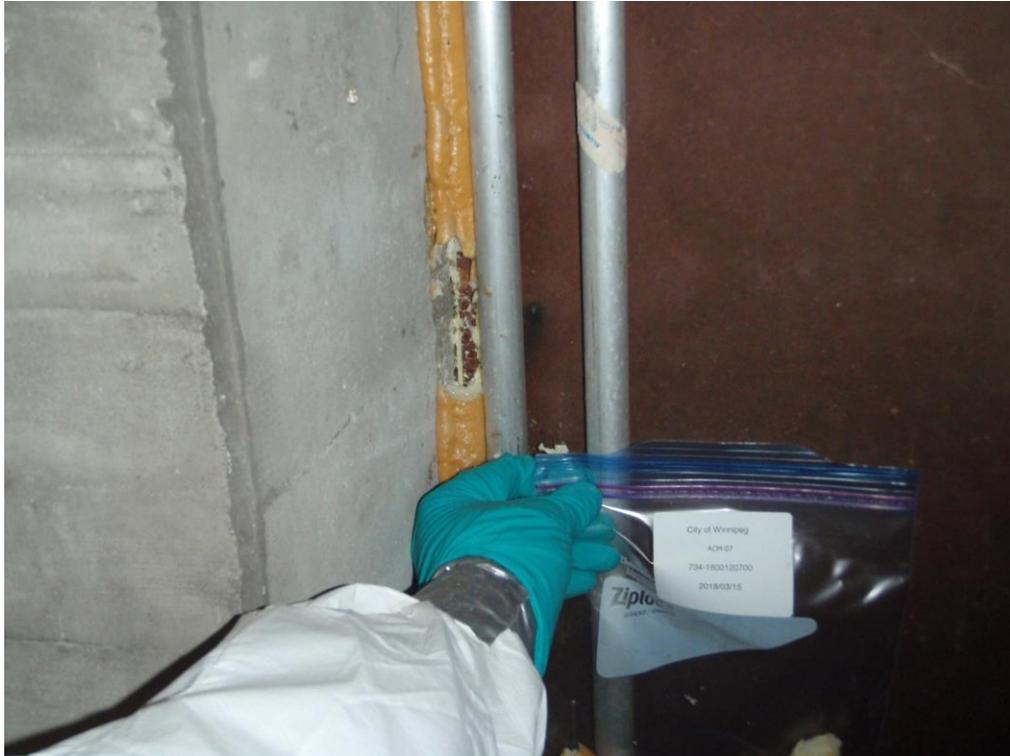
Photo 41: General view of bulk material sample ACM-07 location from the spray foam from the southwest corner of the main level. (March 15, 2018)

| Sample ID | Date Sampled | Material Description | General Classification | General Condition | Asbestos Content (%) |
|--|---|--|---|---|---|
| ACM-07 | 15-Mar-18 | Spray foam insulation between concrete and wooden wall in southwest corner of the main floor. | Friable | Good (Photo 41) | <1 |

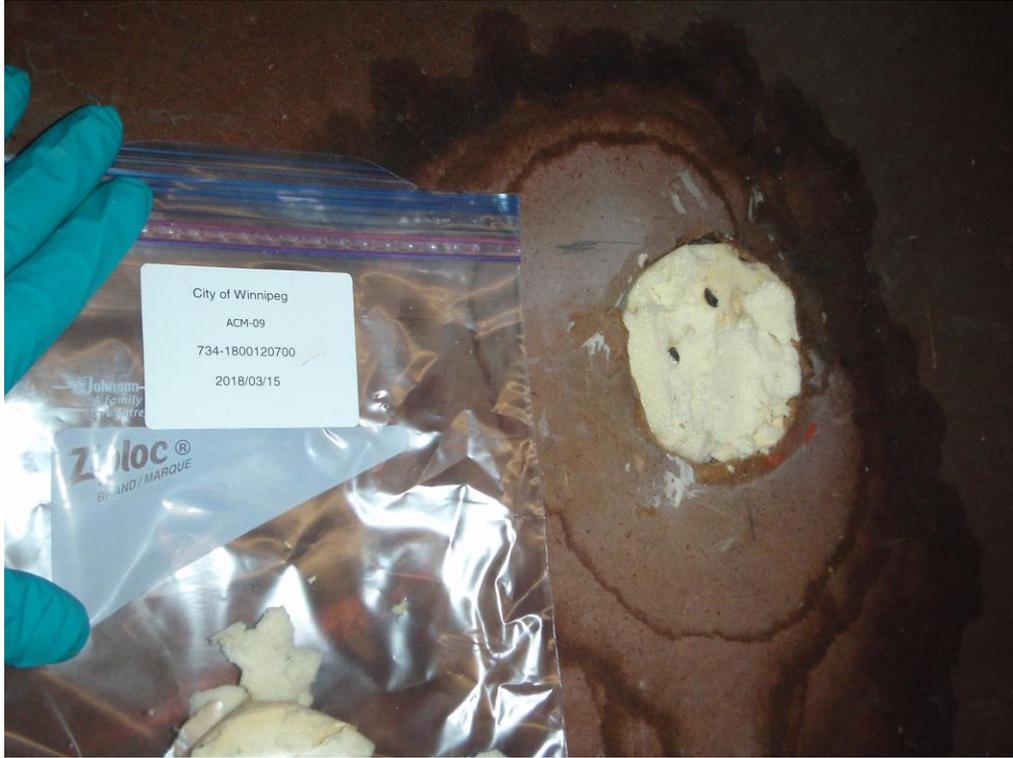
Photo 43: General view of bulk material sample ACM-09 location from spray foam from a removed pipe or duct opening on the east wall of the main level. (March 15, 2018)

| Sample ID | Date Sampled | Material Description | General Classification | General Condition | Asbestos Content (%) |
|--|---|--|---|---|---|
| ACM-09 | 15-Mar-18 | Spray foam insulation from removed pipe or duct opening on the east wall of the main floor. | Friable | Good (Photo 43) | <1 |

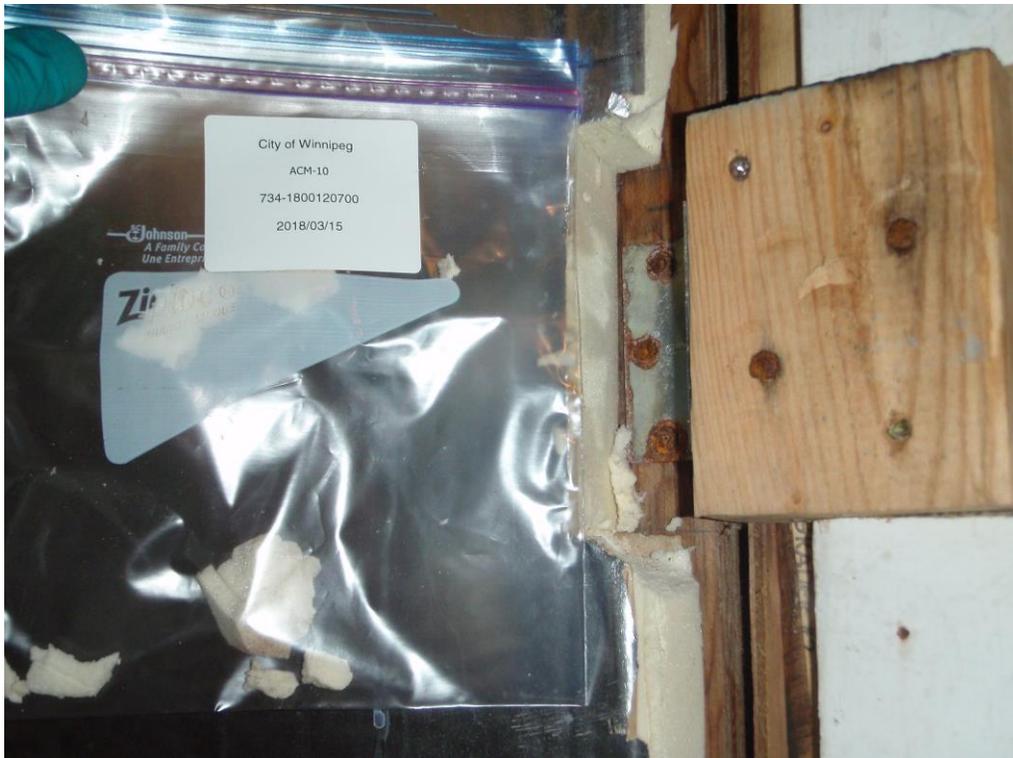
Photo 44: General view of bulk material sample ACM-10 location from foam insulation from the back of the vestibule door leading to the dry well. (March 15, 2018)

| Sample ID | Date Sampled | Material Description | General Classification | General Condition | Asbestos Content (%) |
|--|---|--|---|---|---|
| ACM-10 | 15-Mar-18 | Rigid foam insulation on the back of the door to the vestibule to the dry well stairwell along the south wall. | Friable | Good (Photo 44) | <1 |
