COMPOSITE SITE INSPECTION REPORT

City of Winnipeg Water and Waste Department

Inspection of: Sodium Hydroxide Tank Equipment No. TNK-S320A
 Serial No. N/A
 Built in 2008

Location: Deacon WTP
 Hwy 207, Access Road 57802
 Springfield, MB

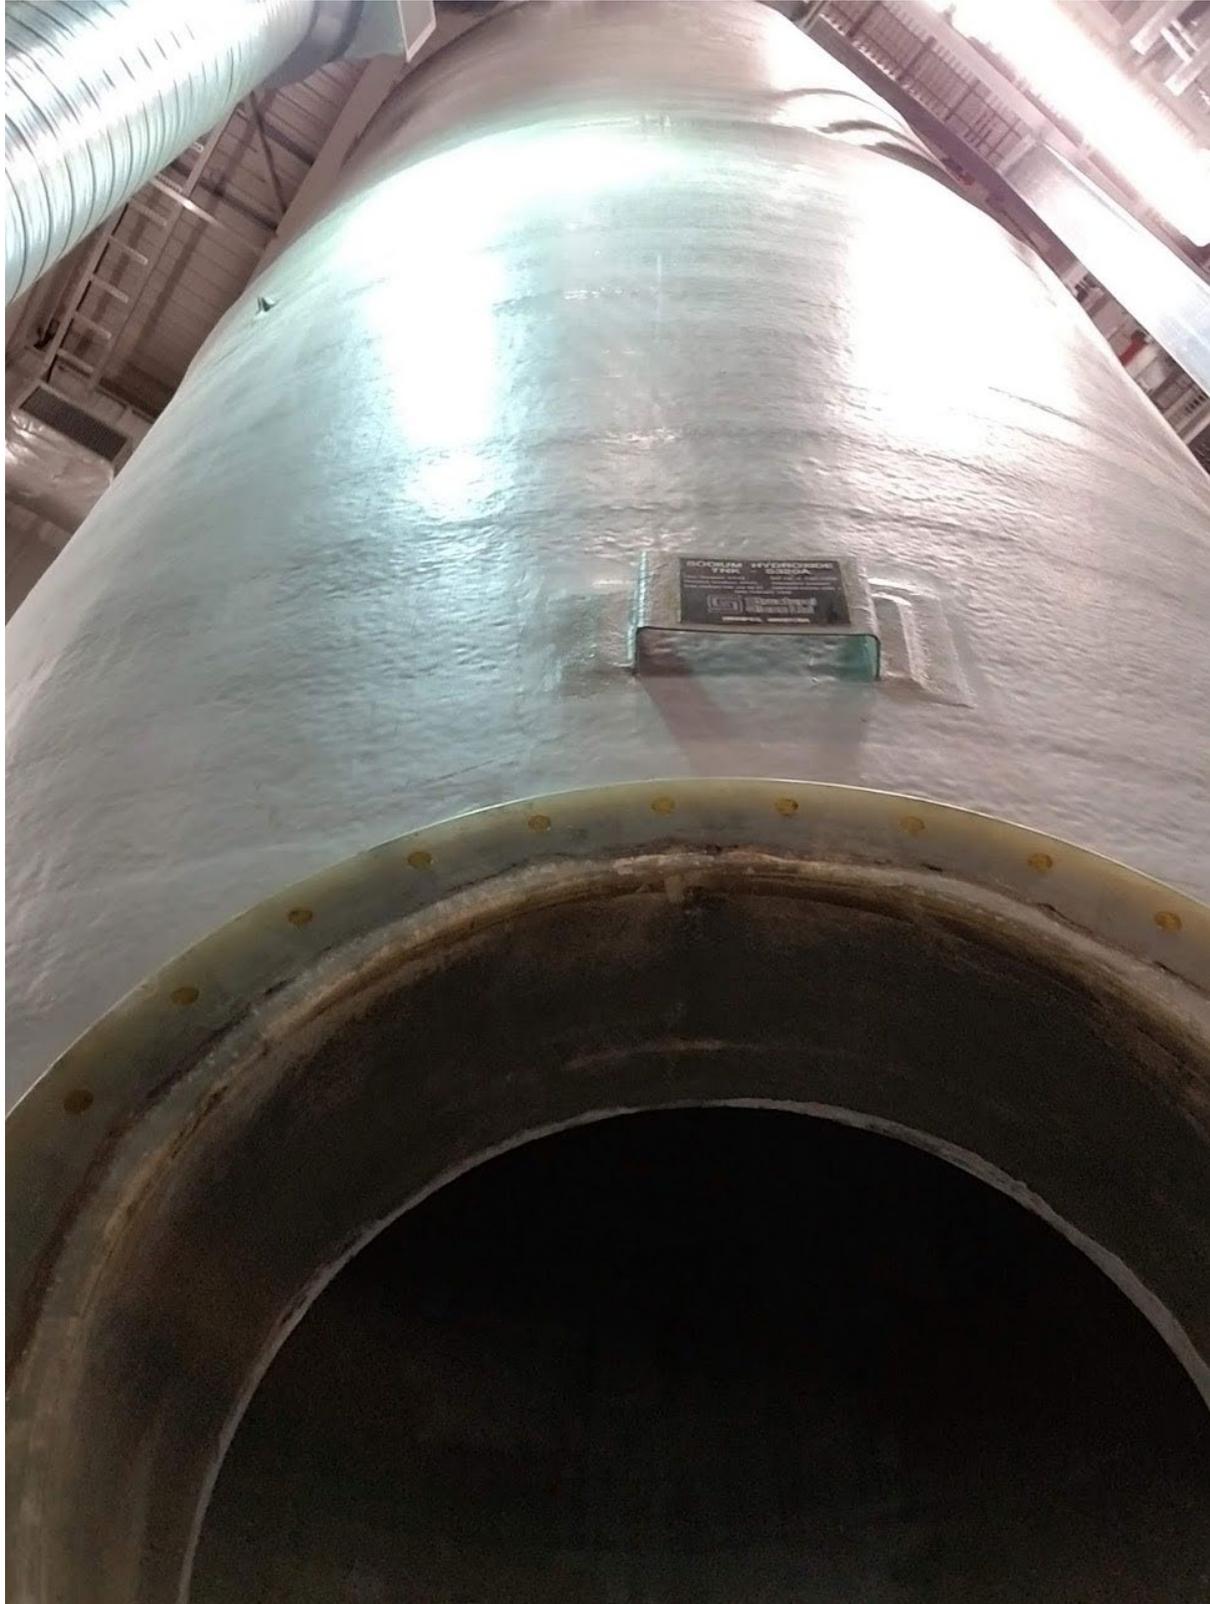
Nozzle 14 (TEMPERATURE TRANSMITTER) - This is bonded as a penetrating nozzle and was found to have **NOT** been bonded correctly to create an end seal which is to prevent chemical attack to the structure of the flange.
