Pan Am Indoor Pool 25 Poseidon Bay, Winnipeg MB Structural Condition and Building Envelope Assessment

Submitted to: City of Winnipeg
Planning, Property, and Development Department
Accommodation Services

Date: February 15th, 2022

Our File No. 2021-0268

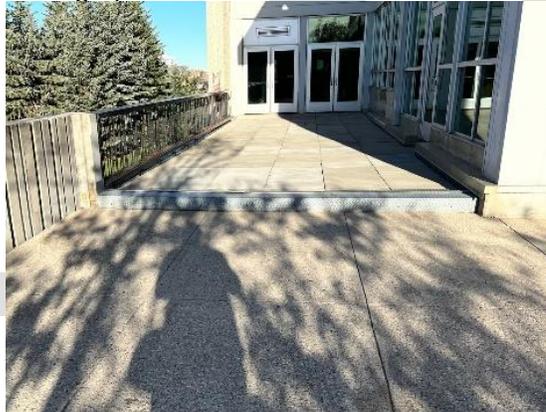
- .1 Above-grade structural podiums are located on northwest and southwest corners of the Main Building (Photographs 3.1.1.1-1, 2). Original structural and architectural drawings that show the construction in this area were not available. Based on the available information and visual observations it appears that the podium cross-section consists of precast concrete paving over insulation and waterproofing. The structure consists of a cast-in-place concrete waffle slab and is exposed on the north elevation (Photograph 3.1.1.2-1). The south elevation podium is finished with a metal soffit and not able to be viewed. The type, age, and condition of any existing waterproofing membrane could not be determined. Further investigation would be required to determine the condition and timing for replacement.

Photograph 3.1.1.1-1: Podium at northwest corner.

Recommendation 3.1.1.1-1: Investigate condition of the podium waterproofing. The proposed investigation would include removal of an area of the existing precast pavers and insulation on the north and south podiums to confirm cross-section and assess the condition of the existing waterproofing membrane. A flood test is also recommended to determine the source of leakage at the north podium.

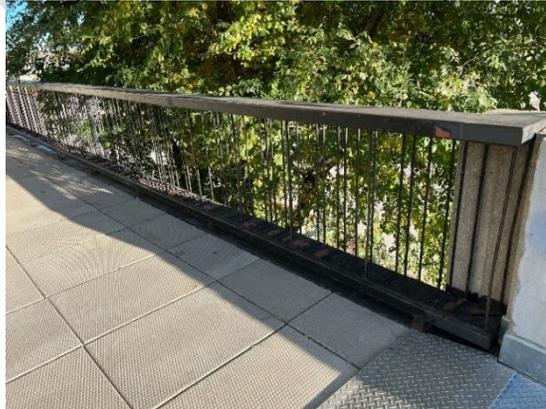
Photograph 3.1.1.1-2: Partial view of podium at southwest corner.

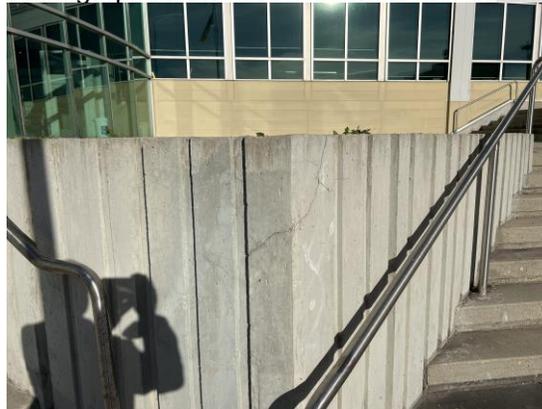
- .4 The concrete stairs, landings, and ramps at the west end entrance constructed as part of the Aquatic Hall of Fame addition are in fair to good condition. Minor cracking and delamination was visible on one planter wall.

Photograph 3.1.1.4-1: Partial view of delamination at concrete planter.

Recommendation 3.1.1.4-1: Localized concrete repairs are required in the short term and will consist of removing the loose concrete down to a sound substrate, preparation of the substrate and infilling with a proprietary repair material or ready-mix concrete.

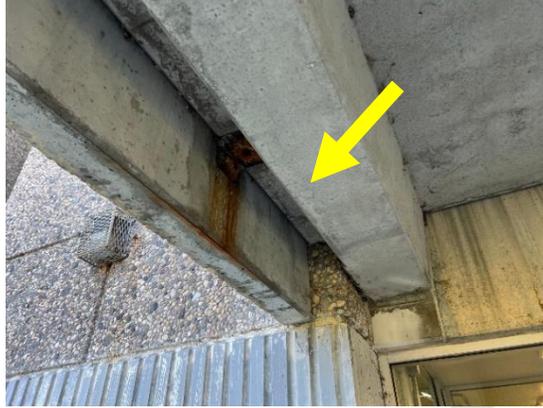
- .8 The precast stair and landing at the north end of the lap pool (Photograph 3.1.1.8-1). The joints are open and unsealed allowing water seepage through the joints and corrosion of the precast connections (Photograph 3.1.1.8-2). Sealing of the joints and cleaning and painting of the steel connections is recommended. The slab-on-grade landing at the bottom of the stairs has sunk creating a higher step and a potential tripping hazard. Replacement of the landing or jacking back into place is recommended.

Photograph 3.1.1.8-2: Corrosion of connections.

Recommendation 3.1.1.8-1: Seal precast joints with an elastomeric joint sealant. Clean and paint precast connections.

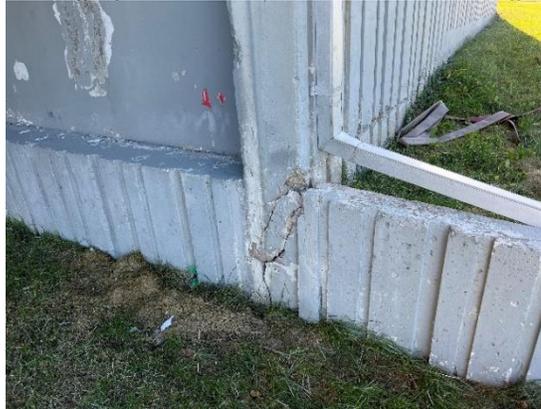
- .10 A concrete retaining wall on the north elevation is severely cracked and deteriorated. The cause of cracking appears to be related to movement of the retaining wall. Site personnel indicated that during landscaping work it was confirmed there are no piles below the retaining wall. As a result, the cracking is likely caused by expansion or shrinkage of the subgrade due to changes in moisture content. Conceptual repairs would include repair of the damage concrete and installation of a joint capable of accommodating differential movement.

Photograph 3.1.1.10-1: Cracked and damaged retaining wall.

Recommendation 3.1.1.10-1: Repair existing retain wall and install new expansion joint.

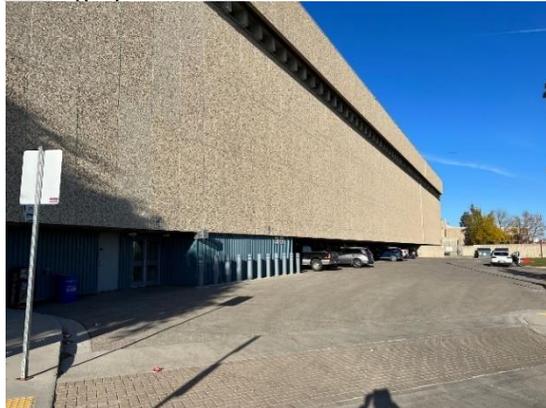
- .1 Pavement on the south parking lot in fair to good condition. No capital repairs are anticipated to be required within the timeframe considered in this report. Normal maintenance such as crack sealing and filling potholes will be required throughout the life of the structure. Budget pricing has not been provided for this work.

Photograph 3.1.2.1-1: Partial view of south elevation parking lot.

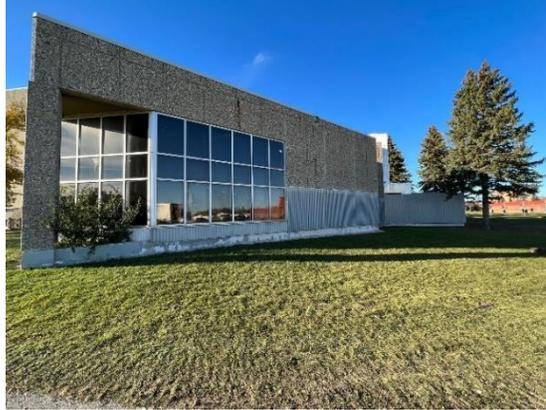
- .2 Landscaping around the east end of the building typically consists of sod and soil, or soft planting beds. A visual review suggests that surfaces are graded to direct water away from the foundation walls.

Photograph 3.1.2.2-1: Partial view of grading at east end of building.

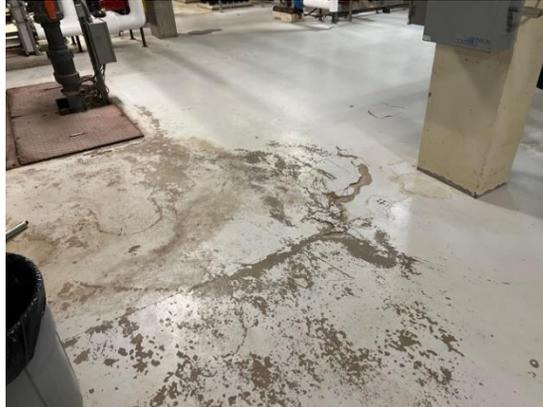
- .1 The basement below the Main Pool (1966 Building) is primary service space with a mechanical room located at the west end of the basement (Photograph 3.2.1.1-1). The existing floor slab has been painting and the paint is in good to fair conditions with areas of peeling. An area of delamination was observed that requires repair. Drawings indicate that the concrete floor is a 6" thick structurally reinforced, two-way spanning slab on 6" void form. A vapour barrier has been provided below the slab according to original drawings.

Photograph 3.2.1.1-1: Delamination of structural floor slab

Recommendation 3.2.1.1-1: Complete top surface concrete repairs including repainting to match existing.

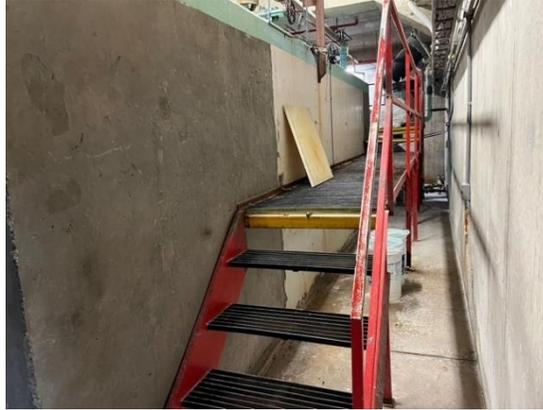
- .4 A steel access platform is provided around the chlorination tank. The access platform is in poor condition with severe corrosion full-depth section loss on some posts. Evidence of previous repairs were observed. Localized repairs are required in the short term. Replacement of the platform is recommended within the medium term.

Photograph 3.2.1.4-1: Partial view of chlorination tank access platform.

Recommendation 3.2.1.4-1: Complete localized repairs to address severe corrosion and safety concerns.

Recommendation 3.2.1.4-2: Replace existing access platform.

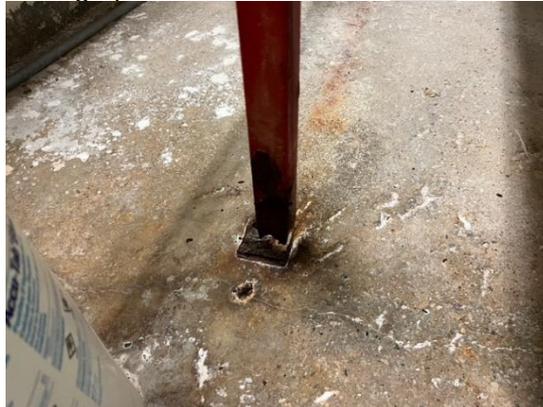
Photograph 3.2.1.4-2: Severe corrosion and full depth section loss of support.

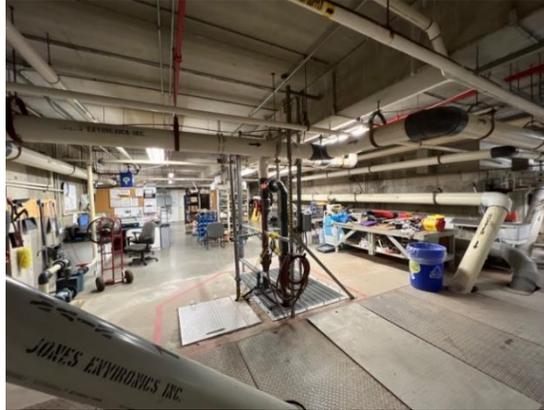
- .1 The basement below the Lap Pool building (1993 addition) includes a service space for mechanical and electrical equipment at the southwest corner of the building (Photograph 3.2.2.2-1). An unfinished crawlspace is located around the perimeter of the Lap and Wading Pools. Access to the crawlspace is provided by man doors off the mechanical/electrical room. Evidence of a polyethylene vapour barrier was observed but is discontinuous and in poor condition (Photographs 3.2.2.2-2,). The condition of the exposed grade appeared to be mostly dry. The main floor framing that is visible appears to be in good condition.

Photograph 3.2.2.1-1: Partial view of Lap Pool mechanical/electrical room.

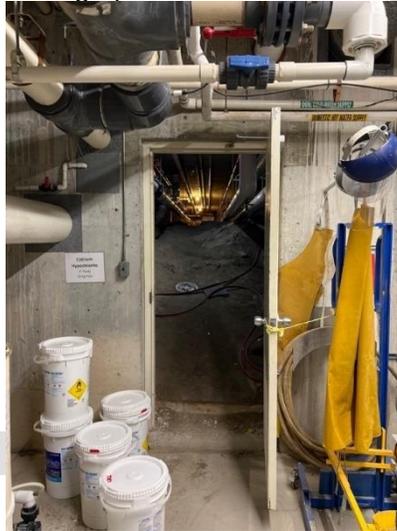
Photograph 3.2.2.1-2: Access to crawlspace between Lap Pool and Wading Pool.

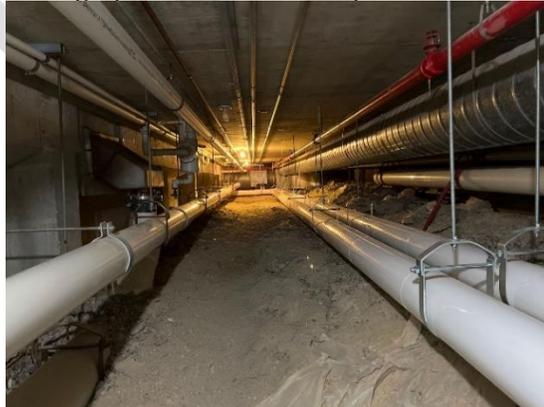
Photograph 3.2.2.1-3: Crawlspace between Lap Pool and Wading Pool

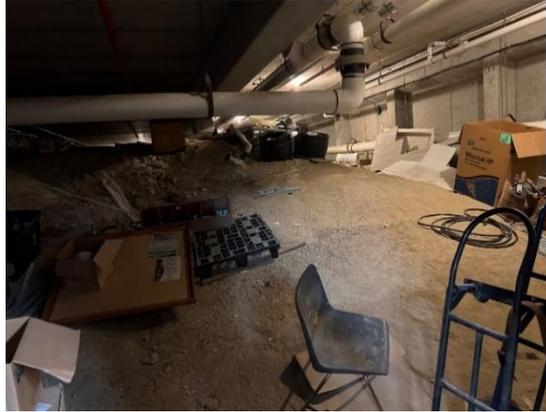
Photograph 3.2.2.1-4: Crawlspace on west side of the Lap Pool accessible.

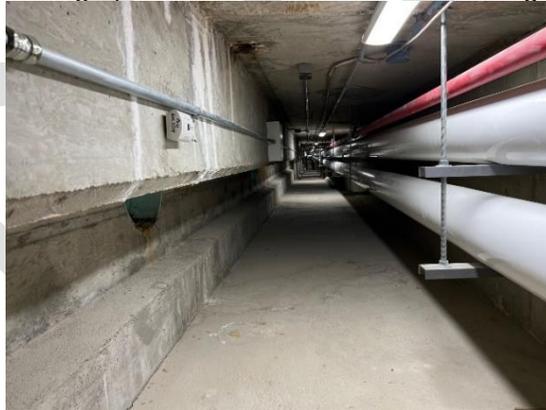
Photograph 3.2.3.1-2: North tank wall looking west from east end.

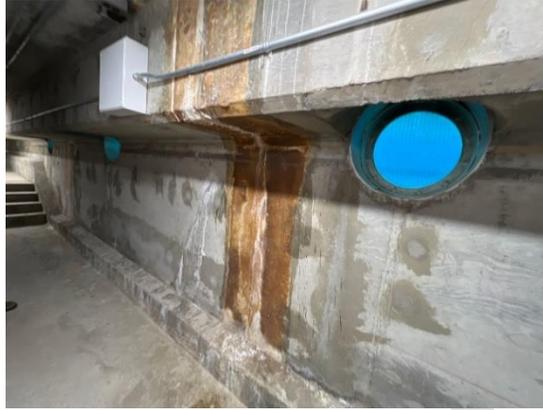
Photograph 3.2.3.1-3: North Tank Wall - Evidence of past leakage at construction joint.

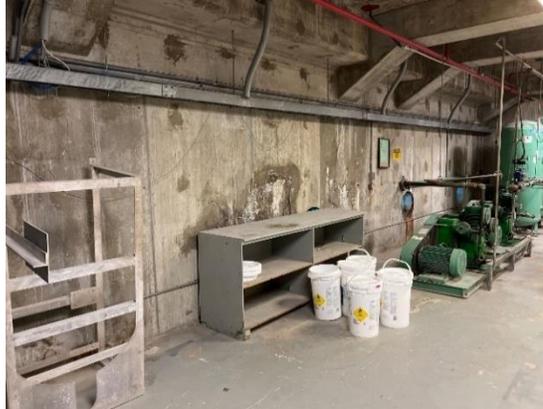
Photograph 3.2.3.1-4: West pool wall showing leakage and delamination.

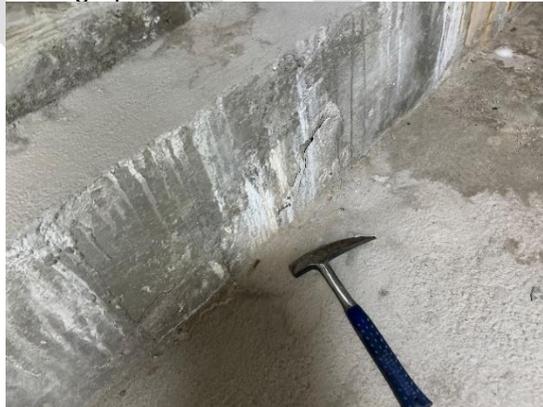
Localized areas of concrete delamination was observed on the bottom of the tank walls and is directly related to moisture seepage and exposure to chlorides from the chlorinated water.

Photograph 3.2.3.1-5: Localized delamination at base of wall.

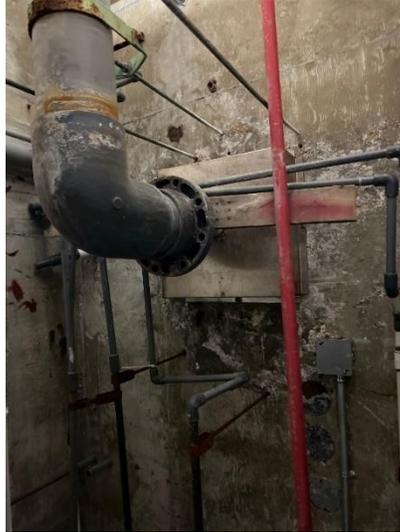
Photograph 3.2.3.1-6: Delamination visible on west tank wall around fill line.

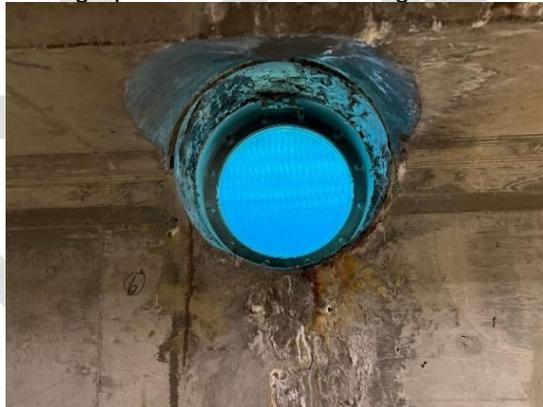
Evidence of leakage was observed around most of the porthole windows (Photograph 3.2.3.1-7). It is our understanding that the windows had included lights which have been removed and are no longer needed. Infilling the portholes windows would be feasible and could be completed as part of a tile replacement project. At some locations, delamination was also observed in areas of leakage and is a direct result of exposure to chlorinated water.

Photograph 3.2.3.1-7: Past leakage and urethane injection around porthole window.

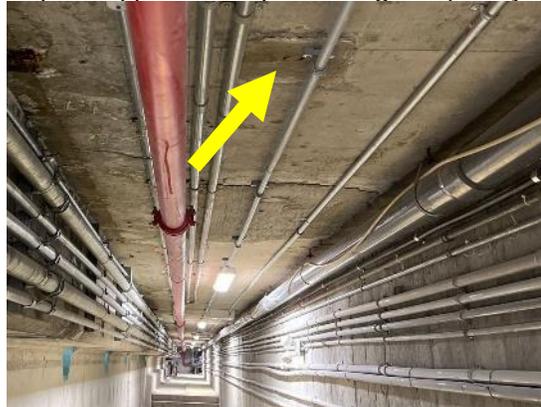
delamination of the slab soffit. Repairs appear to be performing as intended (3.2.3.1-8). No delamination was observed.

Photograph 3.2.3.1-8: Underside of south pool deck. Repairs completed previously. Repairs appear to be performing adequately.

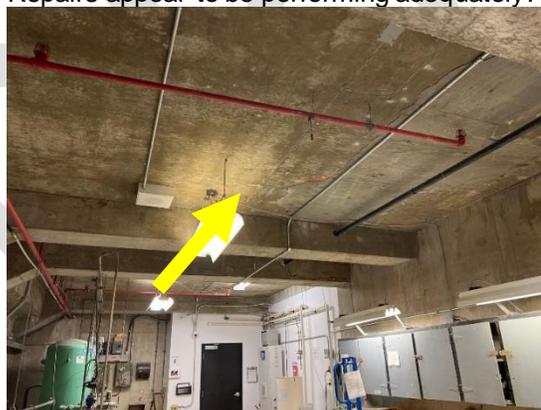
The pool deck on the west side (deep end) of the pool is located over the Chlorinator Room and service space and is constructed of 7" thick concrete slabs that span in the north-south direction and are supported on 18" x 22" concrete beams. Records indicate that structural concrete repairs were completed above the service tunnels in 2018 to address delamination of the slab soffit. Repairs were visible and appear to be performing as intended (Photograph 3.2.3.1-9). A localized area of soffit delamination was visible (Photograph 3.2.3.1-10).

Photograph 3.2.3.1-9: Underside of west pool deck. Repairs completed previously. Repairs appear to be performing adequately.

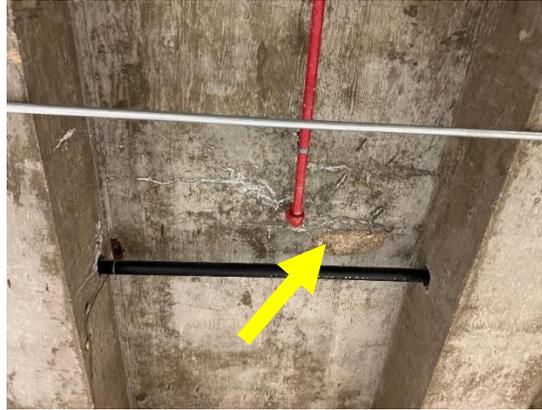
Photograph 3.2.3.1-10: Underside of west pool deck showing area of active delamination.

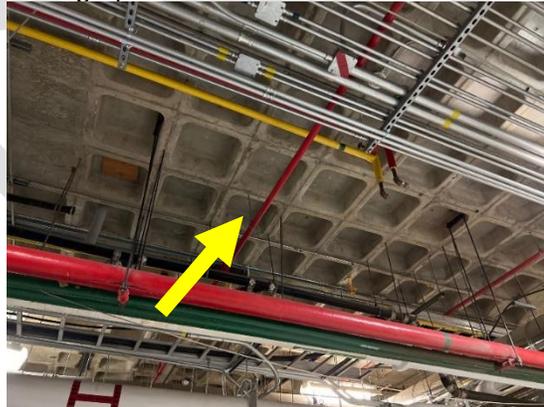
- .2 The main floor concourse floor structure above the west mechanical room is a two-way spanning 10" thick waffle slab supported directly on the cast-in-place concrete column (Photograph 3.2.3.2-1). The structure appears to be in good condition with no evidence of deterioration.

Photograph 3.2.3.2-1: Underside of west concourse from mechanical room.

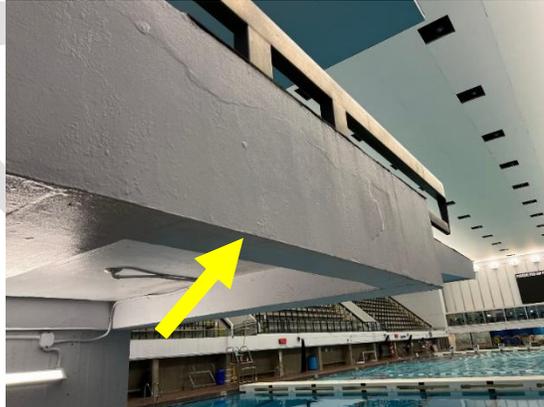
- .4 The main diving platform is constructed of cast-in-place concrete and has undergone repairs and been painted since original construction. Delamination was observed on the side of the 3 metre platform (Photograph 3.2.3.4-1), and the underside of the 5 (Photograph 3.2.3.4-2), 7-1/2 and 10 metre platforms, and walls of the internal staircase (Photograph 3.2.3.4-3). Evidence of previous repairs were also visible. Note that due to the harsh environment, periodic repairs will be required throughout the life of the structure and is considered normal maintenance.

Photograph 3.2.3.4-1: Delamination on 3 m Platform.

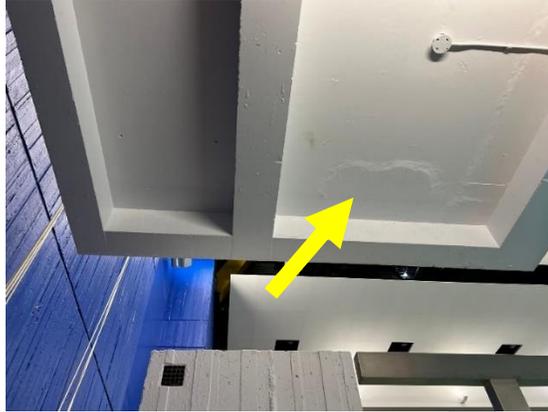
Photograph 3.2.3.4-2: Delamination on the underside of the 5 m Platform.

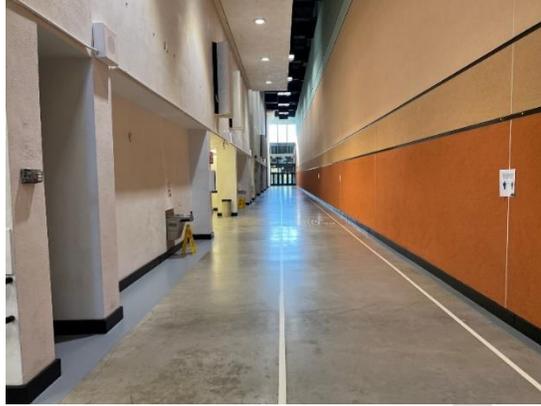
Photograph 3.2.5.3-1: Partial view of north concourse looking west.

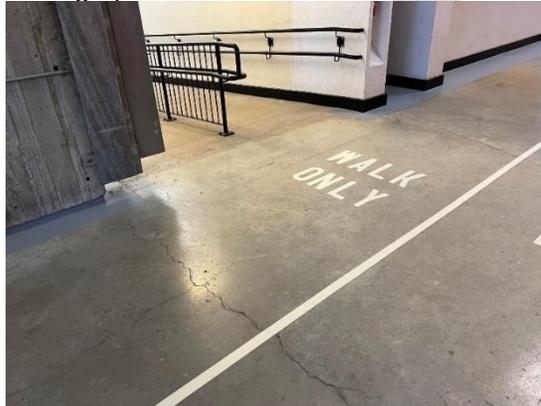
Photograph 3.2.5.3-2: Partial view of north concourse.

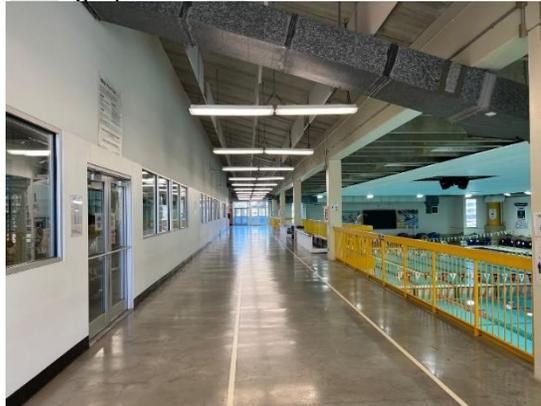
The east end of the running track is located within a mezzanine structure in the Lap Pool building. The structure in this area consists of 8" precast hollowcore floor panels supported on precast concrete beams. The exposed structural framing (hollowcore, beams, guards) below mezzanine are in good condition with no evidence of deterioration (Photographs 3.2.5.3-2, 3)

Photograph 3.2.5.3-2: Partial view east concourse within the Lap Pool mezzanine.

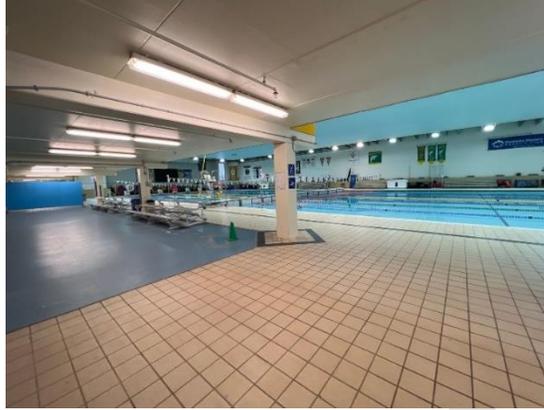
Photograph 3.2.5.3-3: Partial view of mezzanine framing.

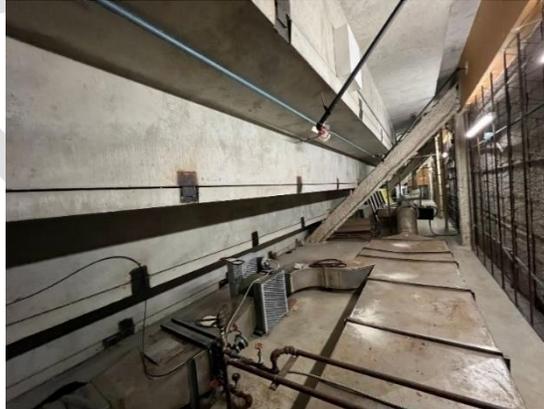
- .4 The exposed architectural concrete walls are in good condition with no evidence of deterioration.
- .5 The bleachers on the north and south side of the pool are constructed of precast concrete floor panels supported on steel framing. The steel framing has been protected with a spray-applied fire proofing material (Photographs 3.2.5.5-1). The fireproofing material was missing or damaged in a large portion of the areas. The precast concrete floor panels are in good condition with only some minor surface corrosion visible on the weld plates.

Photograph 3.2.5.5-1: Partial view of the bleacher framing.

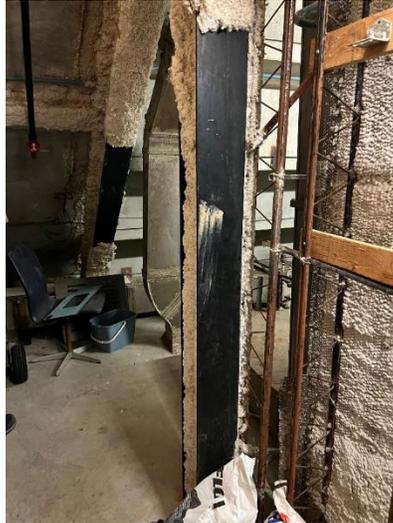
Photograph 3.2.5.5-2: Partial view of bleacher framing showing areas of missing fireproofing.

Recommendation 3.2.5.5-1: The damaged and missing fire proofing material has adversely affected the design fire-rating for the structure. Based on the condition of the material, removal and replacement of the fire-proofing material is required. Fire-rating is a life-safety issue and therefore a required repair.

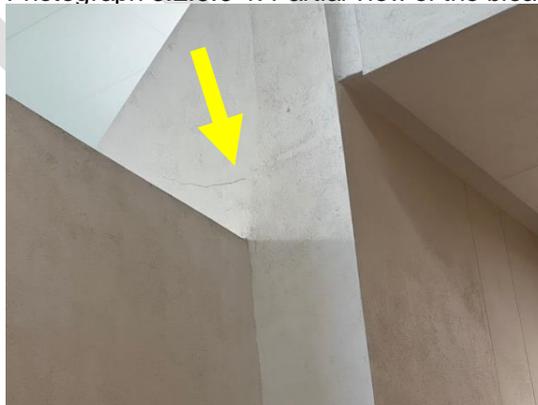
- .6 Cracking in the plaster finish was observed along the bleachers at one vomitory on the southwest corner. The cause of the cracking could not be determined but does not appear to be related to an underlying structural problem. Repair of the plaster finish can be completed.

Photograph 3.2.5.6-1: Partial view of the bleacher framing.

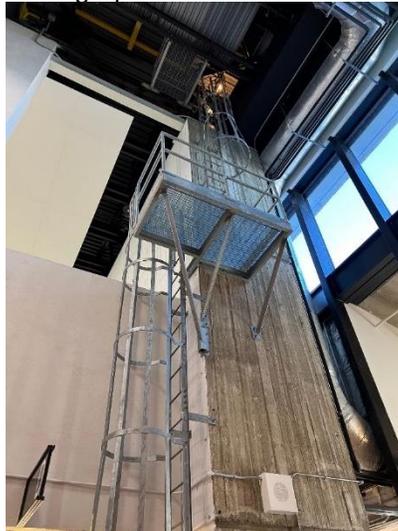
- .7 Galvanized steel fixed access ladders and platforms have been installed at the southeast and northeast corners of the main building to provide access to the catwalks within the roof framing. The framing is in good condition.

Photograph 3.2.5.7-1: Fixed access ladder at southeast corner.

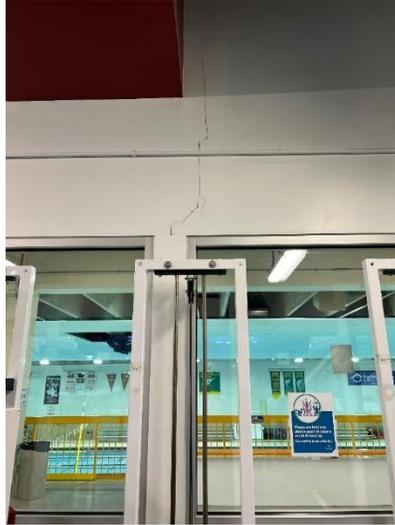
- .8 The existing guardrails and handrails within the vomitories and bleachers were upgraded to meet current building codes. The guardrails and handrails are in good condition.
- .9 Cracking in the drywall finish was observed within the weight room in the Lap Pool mezzanine (Photograph 3.2.5.9-1). The cracking appears to be related to the bulkhead and wall framing. No evidence of an underlying structural problem was observed. Repairing the drywall finishes can be completed.

Photograph 3.2.5.9-1: Cracking in drywall finish in weight room.

Recommendation 3.2.5.9-1: Repair cracked drywall. Install control joints in the drywall as necessary. Repairs are considered normal maintenance.

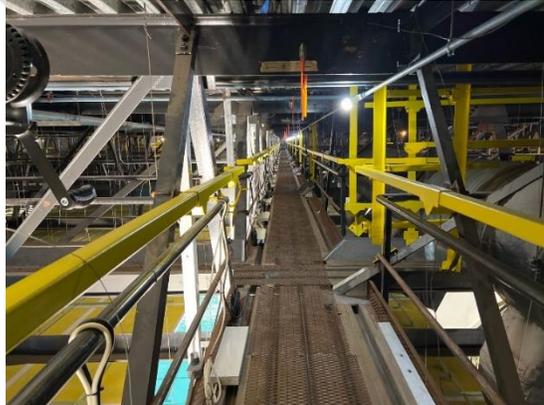
Photograph 3.2.6.1-1: Partial view east-west catwalk. Guardrail upgrades visible.

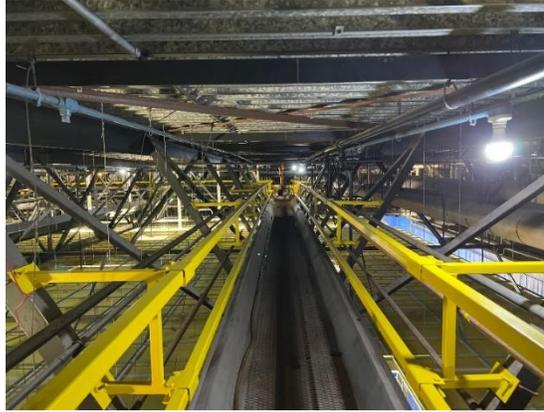
Photograph 3.2.6.1-2: Partial view north-south catwalk. Guardrail upgrades visible.

of the building. The structural framing for the catwalks is in good condition. The catwalks were undergoing safety upgrades at the time of the site visit. The upgrades included new handrails and enclosing the sides. Guardrails had been installed on the main east-west catwalks and select north-south catwalks.

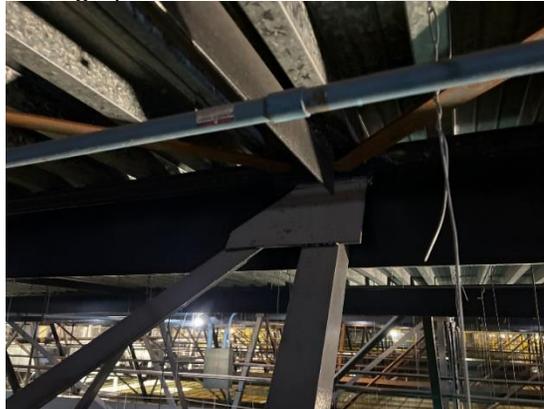
Photograph 3.2.6.1-3: Partial view of mezzanine framing.

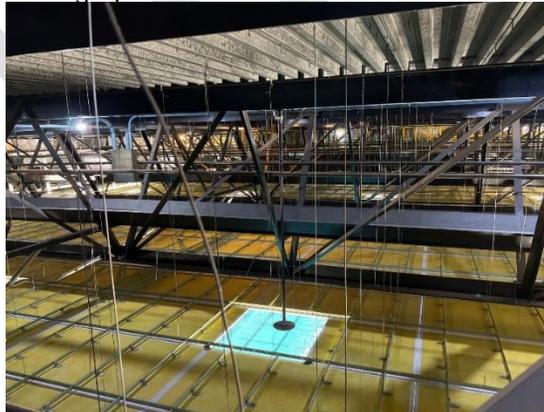
The suspended ceiling panels over the main pool are suspended from the steel roof deck. The support cables and roof framing appeared to be in good condition.

Photograph 3.2.6.1-4: Partial view of roof framing and suspended ceiling supports.

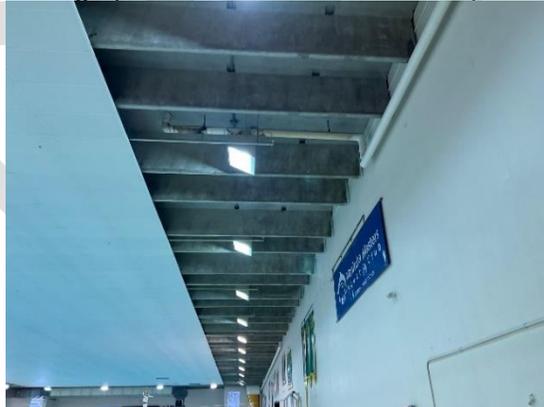
- .5 Access to roof catwalk system is provided by a steel stair at the northwest corner of the building. The steel access stair in good condition.
- .6 The roof framing over the Lap Pool consists of precast double-tees. The double-tees are only partially visible at each end and appear to be in good condition with no obvious evidence of cracking that could be indicative of corrosion of the embedded reinforcing steel or steel prestressing strands (Photographs 3.2.6.6-1).

Photograph 3.2.6.6-1: Partial view of Lap Pool roof.

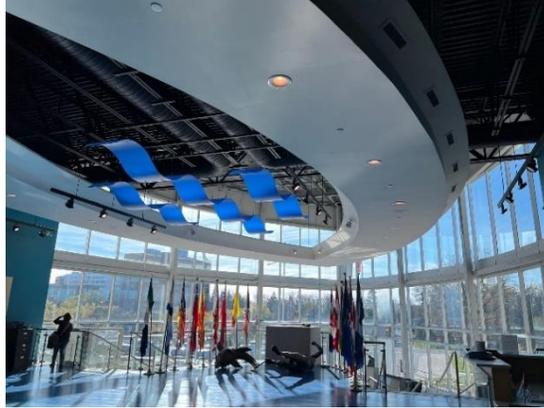
- .7 The exposed steel framing in the Aquatic Hall of Fame is in good condition with no obvious signs of deterioration or distress observed.

Photograph 3.2.6.7-1: Partial view of Aquatic Hall of Fame roof framing.

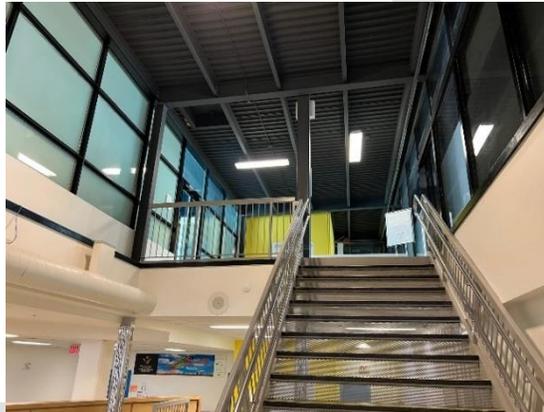
Photograph 3.2.6.7-2: Partial view of stair and mezzanine entrance to Aquatic Hall of Fame.

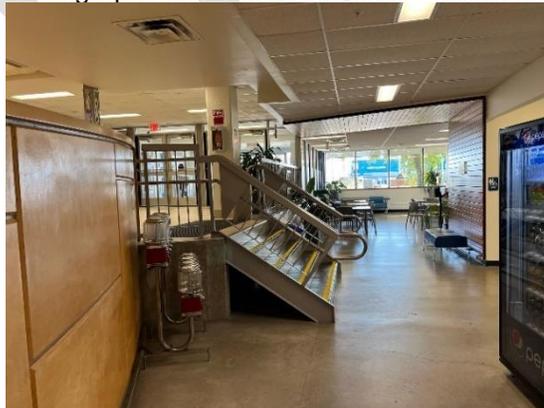
Photograph 3.2.6.8-1: Delamination of structural floor slab.

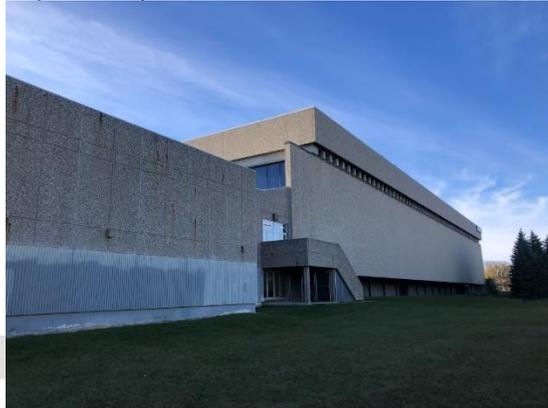
Photograph 3.3.1.1-2: Overview of north elevation, facing east, showing overall condition of pre-cast panels.

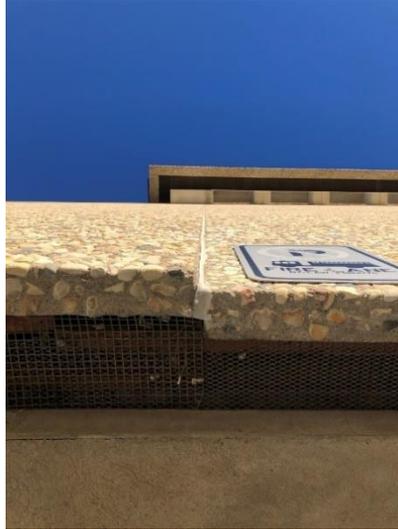
Photograph 3.3.1.1-3: Displacement of panels above the main pool entrance on the south elevation taken from below and showing displacement out of plane.

Recommendation 3.3.1.1-1: It is recommended that the cause of the pre-cast panel displacement be investigated further to assess the condition of the underlying anchorage. We recommend investigating the panels located above the main pool entrance on the south elevation as a starting point. The scale of the investigation, including access and selective demolition is outside the scope of this report.

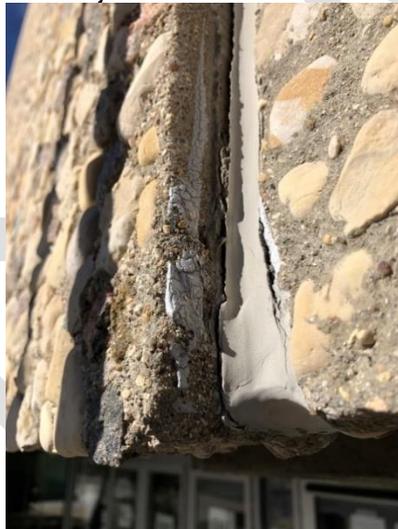
Photograph 3.3.1.1-4: Displacement of panels above the main pool entrance on the south elevation taken from the arial lift and showing vertical displacement as evidenced by torn sealant joint.

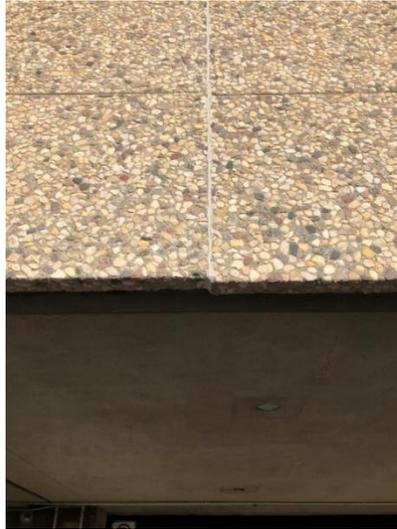
Photograph 3.3.1.1-5: Displacement of panels above maintenance yard on the south elevation taken from below and showing vertical displacement.

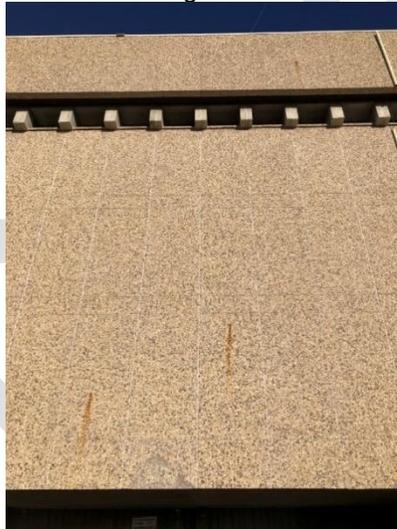
Some localized staining as a result of corrosion of iron ore inclusions in the exposed aggregate was observed throughout and though aesthetically not desirable is not considered a structural concern.

Photograph 3.3.1.1-6: Typical example of localized staining as a result of corrosion of iron ore inclusions in the exposed aggregate. Photo taken on south elevation but condition observed throughout.

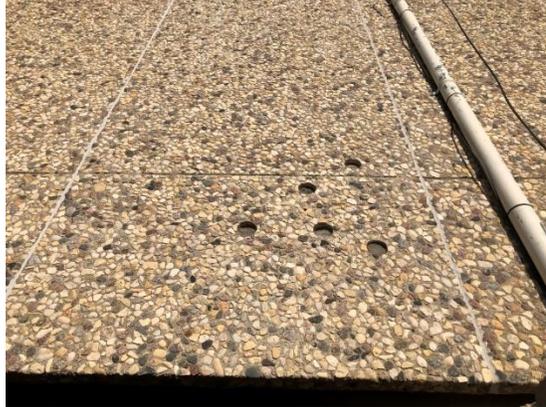
Five small cores were observed at lower panel on the east end of the south elevation adjacent the electrical conduit. The purpose of the cores is unknown.

Photograph 3.3.1.1-7: Five small cores were observed at lower panel on the east end of the south elevation adjacent the electrical conduit.

Recommendation 3.3.1.1-2: Repair five small cores at lower panel on the east end of the south elevation adjacent the electrical conduit.

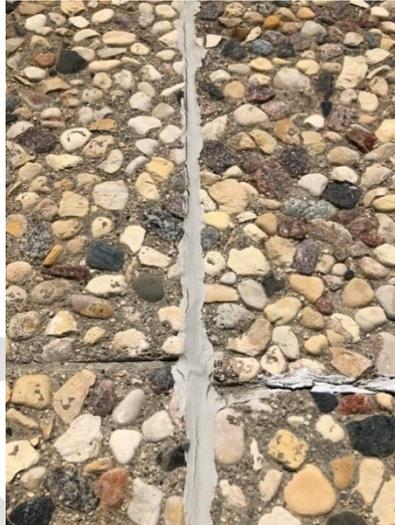
Vertical sealant panel joints were found to be degraded throughout exhibiting cracking, hardening, tearing, and discontinuities. Horizontal reveals in certain locations had been filled with sealant, and appear to be implemented as a remediation measure to seal underlying cracks in the panel. According to record drawings, the joint sealant was replaced under the Phase 1 and Phase 2 building envelope retrofits, undertaken circa 2009 and 2010, respectively. As such, the sealant is 12-13 years old and at the end of its expected service life.

Photograph 3.3.1.1-8: Typical example of degraded vertical sealant joint exhibiting cracking, hardening, and discontinuities. Note also horizontal reveal to the left of the joint and horizontal reveal filled with sealant to the right.

Recommendation 3.3.1.1-3: Remove and replace sealant at vertical panel joints complete with new foam backer rod to suit size of joint.

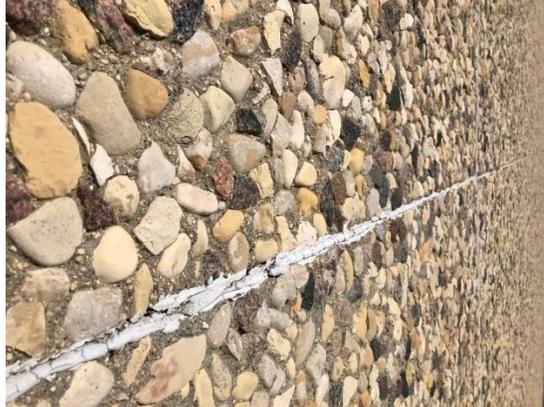
Photograph 3.3.1.1-9: Typical example of degraded horizontal sealant joint in horizontal reveal, exhibiting cracking, hardening, and discontinuities.

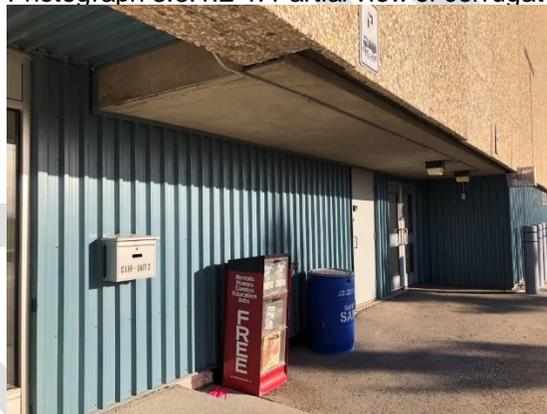
- .2 Original Pool Building - Corrugated metal cladding on the south elevation: With the exception of a localized depression/dent between the service door and glazed entrance, the corrugated metal cladding on the main level and partial soffit of the south elevation was found to be in good overall condition, including associated trims, flashings, and fasteners.

Photograph 3.3.1.2-1: Partial view of corrugated metal panel on the south elevation.

Recommendation 3.3.1.2-1: No remedial action required at this time.

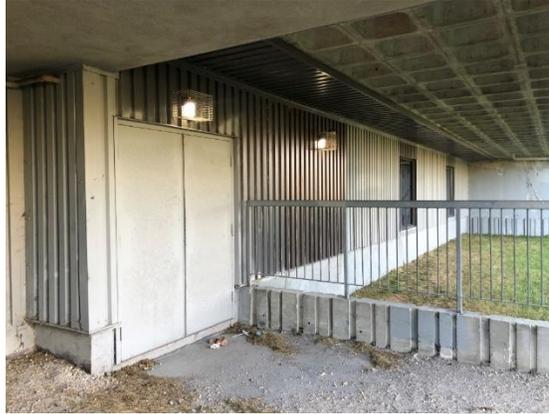
- .3 Original Pool Building - Corrugated metal cladding on the north elevation and below terrace of the Aquatic Hall of Fame: Corrugated metal cladding on the main level and partial soffit of the north elevation below the original building (brown cladding) and below the terrace of the Aquatic Hall of Fame (grey cladding) was found to be in good overall condition, including associated trims, flashings, and fasteners.

Photograph 3.3.1.3-1: Partial view of corrugated metal panel on the north elevation.

Recommendation 3.3.1.3-1: No remedial action required at this time.

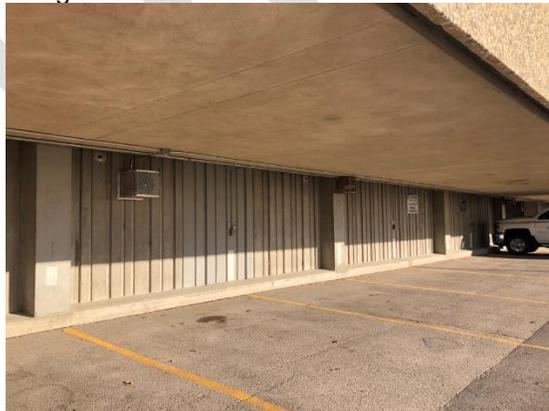
- .4 Original Pool Building - Cast-in-place 10" thick corrugated concrete wall: The corrugated concrete wall along the south elevation is largely uncoated and incorporates a cant bead of sealant at the base. The sealant was found to be largely intact, though crazed and hardened in localized areas. The wall along the north elevation was coated with an unknown material which was delaminating at the base of wall and throughout. The base of wall did not incorporate a sealant cant bead. Localized rust staining was typical on both elevations, emanating from behind the mesh vented and appeared to align with mechanical exhaust ducts, though this could not be confirmed on available drawings. Localised cracking and spalling was also observed.

Photograph 3.3.1.4-1: Partial view of cast-in-place 10" thick corrugated concrete wall along south elevation.

Recommendation 3.3.1.4-1: The condition of the 10” thick corrugated concrete walls along the north and south elevations are largely aesthetic in nature from a building envelope perspective. Since the type of the existing coating, presumably applied to conceal vandalism, is unknown, and since it is largely delaminating and in poor condition, thorough removal as required via pressure washing is recommended to better assess the condition of localized cracks in preparation for repairs as outlined in Recommendation 3.1.1.9-1. It is recommended that the existing cant bead sealant at the base of wall is removed and replaced along the south elevation and implemented along the north elevation to better protect this interface from bulk water infiltration.

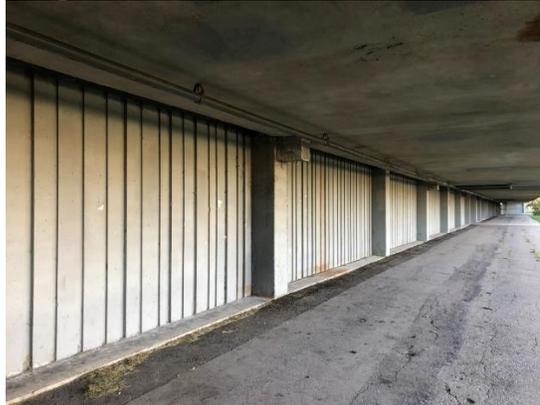
Photograph 3.3.1.4-2: Partial view of cast-in-place 10" thick corrugated concrete wall along north elevation.

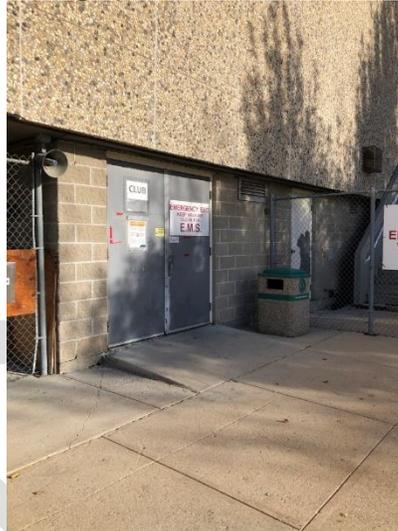
- .5 Original Pool Building - Concrete masonry walls (CMU): The CMU walls on the original pool building, at maintenance yard on south elevation and adjacent north stairwell exit, are both in good condition, including the mortar joints.

Photograph 3.3.1.5-1: View of CMU wall in maintenance yard on the south elevation.

Recommendation 3.3.1.5-1: No remedial action required at this time.

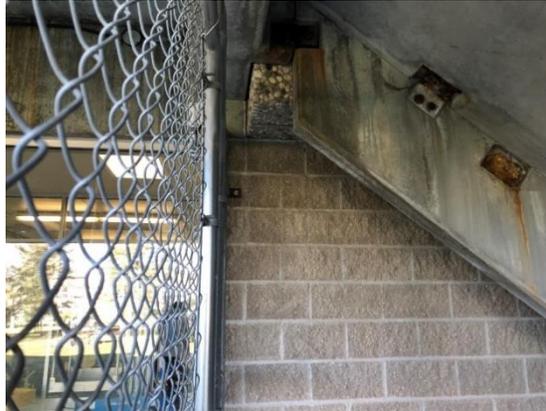
Photograph 3.3.1.5-2: Partial view of CMU wall below stair to second level entrance on the north elevation.

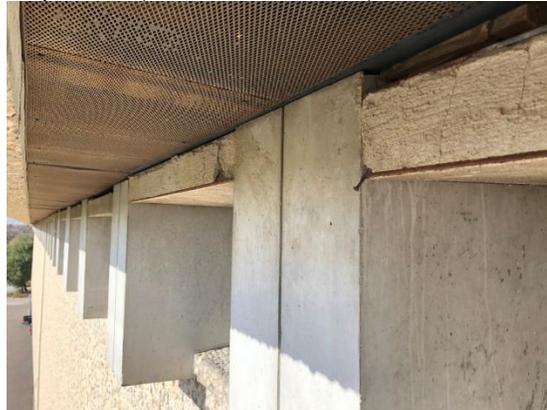
Photograph 3.3.1.6-1: Partial view, looking west, of multiple bays of clerestory windows, complete with pre-cast concrete features at the jambs, pre-cast exposed aggregate sloped sills, stucco clad soffits, and wire mesh closures.

Recommendation 3.3.1.6-1: The clerestory windows on both the south and north elevations are in need of significant remediation. At a minimum, all soffits and mesh require removal and replacement, all sealants must be re-instated, and repairs must be undertaken to the pre-cast concrete features at jambs. Due to the thermally inefficient nature of the window frames themselves, and the extent of repairs to adjacent surfaces, removal of existing windows and replacement with a more thermally efficient and air-tight opaque wall assembly is recommended. Should the COW wish to maintain a similar visual aesthetic as the original construction, the windows could be replaced with more thermally efficient units rather than an opaque wall assembly. All other remediation described herein would need to be undertaken simultaneously. Window replacement estimates are provided in Section 3.3.2.1 for glazing replacement only and the estimated costs outlined below would need to be adjusted accordingly to account for this design approach. The extent of this remediation, including tie-ins to underlying assemblies, material selection, and finishes is highly variable and the estimates below serve as a placeholder for planning purposes and are subject to final remediation scope and design.

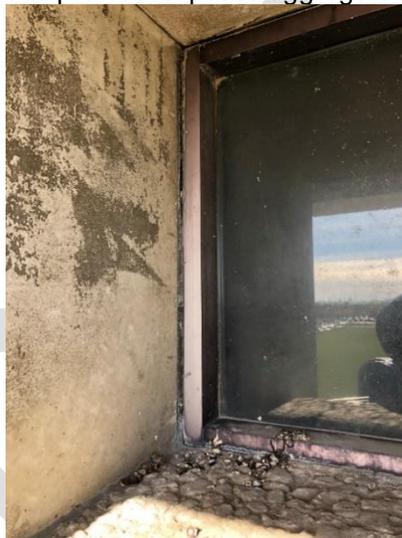
The windows themselves are in poor condition. Frost point testing was conducted on 19 windows, with failing results at 11 (58%), indicating failure of the insulated glazing unit and loss of thermal resistance. Refer to Section 3.3.2.1 for further discussion. Glazing sealant is severely degraded between the glass and metal frames resulting in significant discontinuities. Similarly, sealant beads at frame perimeter to adjacent soffit, pre-cast concrete features at jambs, and pre-cast exposed aggregate sloped sills is severely degraded or missing entirely, exhibiting cracking and stiffening, and large discontinuities observed along the length of the perimeter sealant bead.

Photograph 3.3.1.6-4: Typical example of degraded and/or missing glazing sealant and sealant beads at frame perimeter to adjacent soffit, pre-cast concrete features at jambs, and pre-cast exposed aggregate sloped sills.

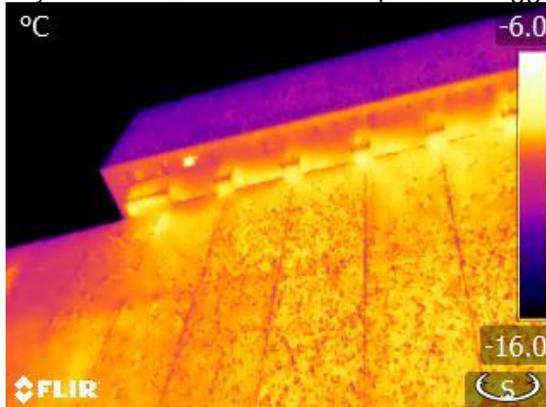
The stucco clad soffits are in very poor condition throughout with the majority having displaced from underlying wood framing, and evidence of corrosion of metal corner and lath. Underlying wood framing was dry at time of visit but exhibited evidence of prior wetting. Water staining on the window frame head below the soffit, emanating from the soffit above, is suggestive of condensation within the unconditioned and ventilated soffit. Air leakage is plausible given the interior condition at fascia/soffit level; the interior envelope retrofit angles up below roof structure to meet the original wall assembly which is penetrated by steel structure. This observation is further evidenced by the thermographic imagery of the upper soffit and clerestory windows, showing brighter and warmer temperatures at each bay and localized concentrated patterns suggestive of air leakage.

Photograph 3.3.1.6-7: Thermographic image of the upper soffit and clerestory windows at the west end of the south elevation, showing brighter and warmer temperatures at each bay and localized concentrated patterns suggestive of air leakage

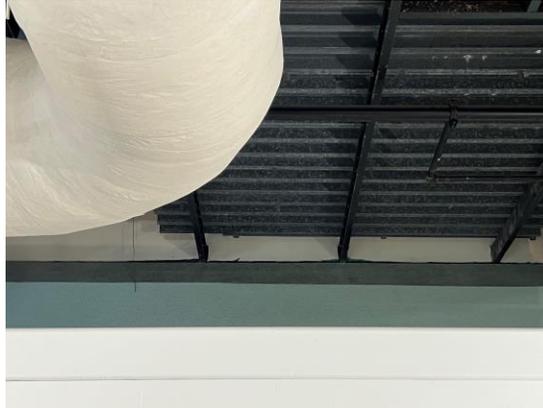
Photograph 3.3.1.6-8: Image taken from interior south elevation showing angled top of interior envelope retrofit (green) meeting original wall assembly which is penetrated by steel structure.

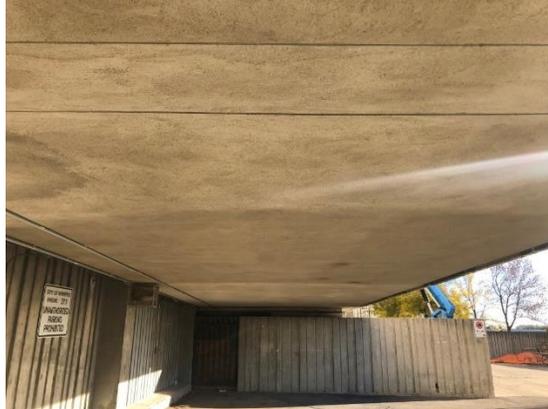
Photograph 3.3.1.7-1: Partial view showing typical condition of stuccoed soffit along south elevation (looking east) including joints either side of concrete beam above.

Recommendation 3.3.1.7-1: The soffit itself is in generally good condition, with minimal localized repairs required, most notably at the west end of the south soffit, at the underside outside corner where the stucco has cracked and the corner does not appear to be reinforced with mesh. Repair is recommended to prevent bulk water infiltration during driving rain and to mitigate continual degradation of the corner.

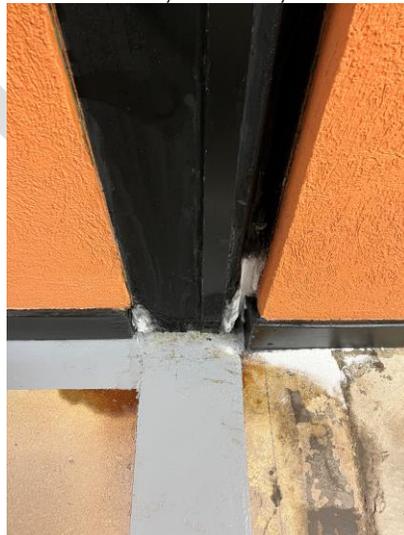
- .8 Original Pool Building – steel columns of original structure: At two points along the south side of the track, at the east and west ends, steel columns of the original structure have been left exposed through 2009/2010 interior envelope retrofit. Air leakage could be felt at the interface between the columns and adjacent wall assemblies with condensation observed on the column surface near this joint. The joint sealant at this interface was observed to be degraded, exhibiting hardening, crazing, and discontinuities. At both locations, ice and frost accumulation was observed at the column base and at the base of wall to floor interface. Staining of the slab and reports from COW personnel suggest that this has been a reoccurring issue since 2009/2010 interior envelope retrofit project completion.

Photograph 3.3.1.8-1: Partial view of west column base showing ice and frost accumulation, wet floor, and staining of slab.

Recommendation 3.3.1.8-1: Air leakage is evident at these column locations and along the base of wall, suggesting that the air barrier implemented as part of the interior building envelope retrofits in 2009/2010 is discontinuous. Further investigation, including removal of interior finishes and exterior grilles along the soffit edge to provide visual access to the underlying assembly is required to determine the extent of the discontinuity and to prepare appropriate remediation details. Though no evidence of condensation was observed at time of visit, the investigation should be completed along the north elevation as well, to determine if that assembly is affected similarly. The extent of this remediation, including tie-ins to underlying assemblies, material selection, and finishes is highly variable and the estimates below serve as a placeholder for planning purposes and are subject to final

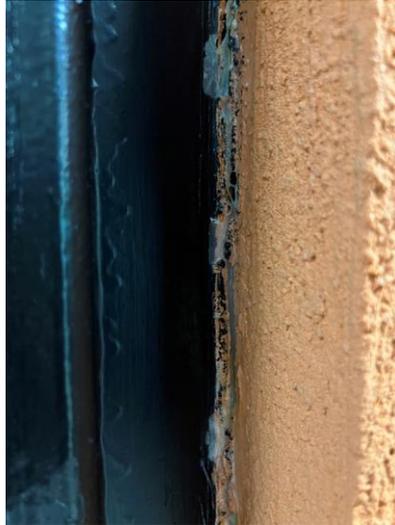
Photograph 3.3.1.8-2: Typical condition of degraded joint sealant at the interface between the columns and adjacent wall assembly, showing discontinuities and condensation.

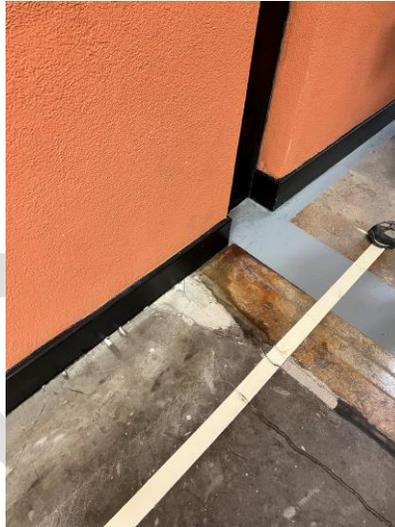
Photograph 3.3.1.8-3: Partial view of east column base showing ice and frost accumulation. Note also ice accumulation at base of wall.

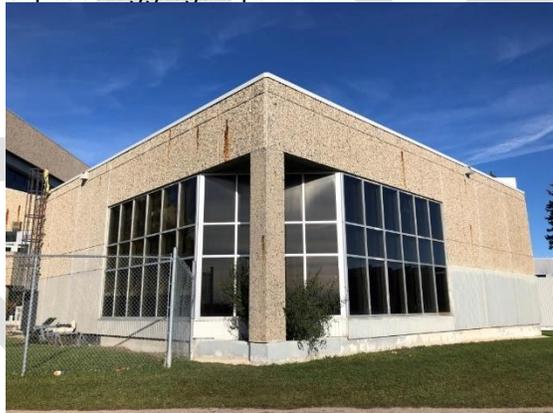
Some localized staining as a result of corrosion of iron ore inclusions in the exposed aggregate was observed throughout and though aesthetically not desirable is not considered a structural concern.

Photograph 3.3.1.9-1: Overall view of youth pool exterior showing condition of pre-cast exposed aggregate panels.

Recommendation 3.3.1.9-1: No remedial action required at this time.

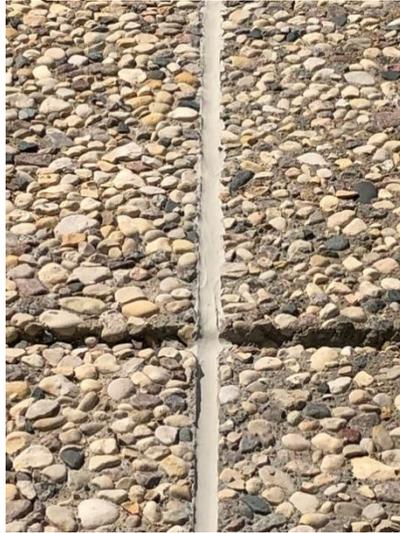
Photograph 3.3.1.9-2: Typical example of vertical sealant joint in pre-cast exposed aggregate concrete panel.
