Pan Am Indoor Pool 25 Poseidon Bay, Winnipeg MB Structural Condition and Building Envelope Assessment

Submitted to: City of Winnipeg
Planning, Property, and Development Department
Accommodation Services

Date: February 15th, 2022

Our File No. 2021-0268

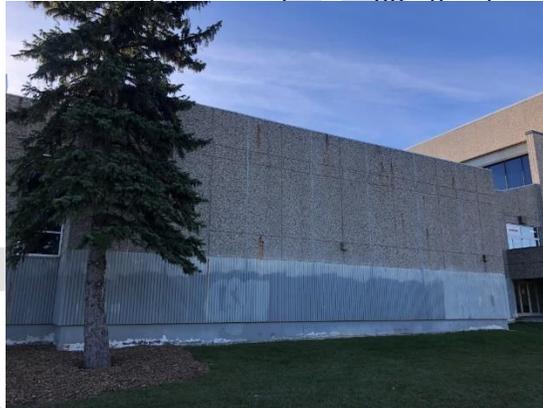
Photograph 3.3.1.9-3: Overall view of north elevation of lap pool exterior showing condition of pre-cast exposed aggregate panels and pre-cast fluted panels.

Recommendation 3.3.1.9-1: No remedial action required at this time.

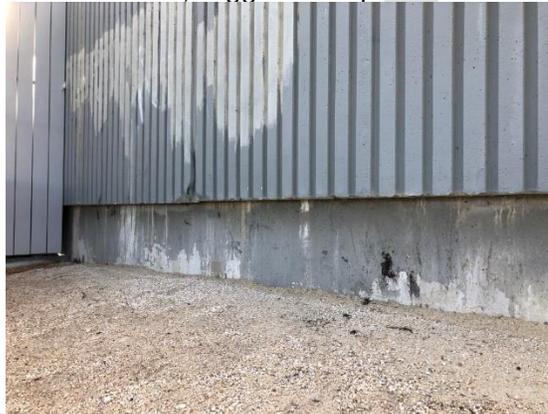
Water staining and efflorescence at the underside of the panel, emanating from behind the panel, on the foundation wall, is suggestive of prior condensation and possible air leakage. This is further evidenced by the thermographic imagery of the interface, which shows a concentrated line of relatively warmer surface below the panel. Though partially attributed to lack of insulation on the foundation wall, this concentrated heat signature could also be indicative of air leakage.

Photograph 3.3.1.10-1: Partial view of the pre-cast fluted concrete panel to foundation wall showing water staining and efflorescence at the underside of the panel, on the foundation wall, suggestive of prior condensation and possible air leakage

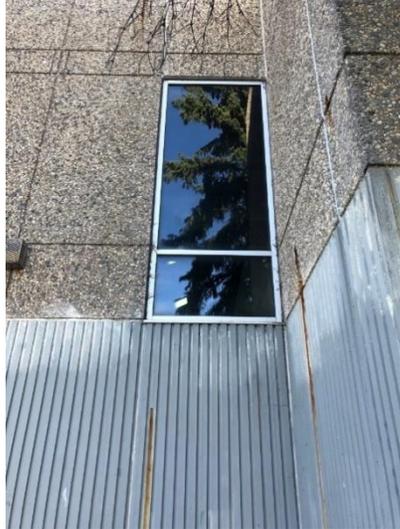
Photograph 3.3.1.10-2: Evidence of stain (graffiti) removal is present with portions of the coating appearing lighter with overspray debris accumulating on the pre-cast aggregate panels above.

Recommendation 3.3.1.10-1: Though primarily an aesthetic preference, consideration could be given to cleaning via pressure washing and refreshing the pre-cast fluted panels with a highly permeable coating to conceal repair work, staining, and graffiti/vandalism.

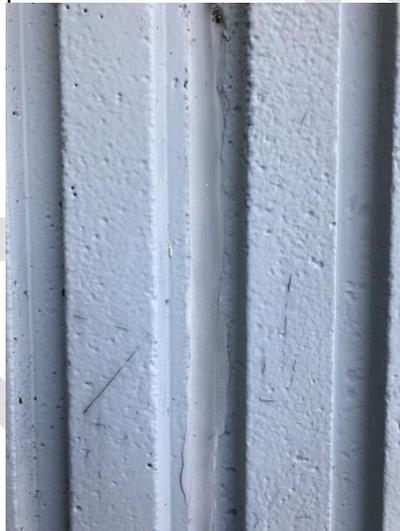
It is not clear how the transition between panels is sealed as no sealant joint was observed at this interface and it does not incorporate a drip flashing. Vertical sealant panel joints were found to be in good overall condition.

Photograph 3.3.1.10-3: Typical example of vertical sealant joint in pre-cast fluted concrete panel.

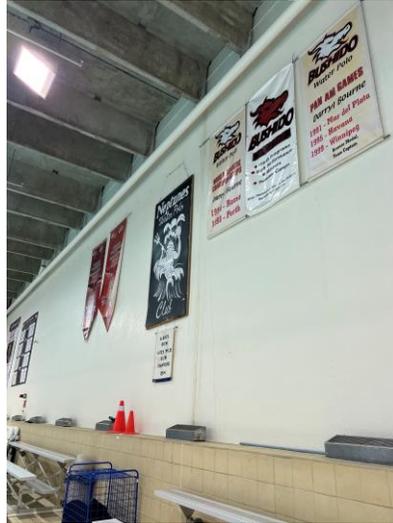
Photograph 3.3.1.12-1: Partial interior review of the east elevation of the lap pool showing location of water staining.

Recommendation 3.3.1.12-1: As the timing of the water infiltration is unknown and was not active at time of visit, it is recommended that the area be monitored as part of the ongoing roof maintenance program, specifically during wind driven rain events, to assess the conditions under which infiltration occurs and to correlate with the condition of the roof/parapet.

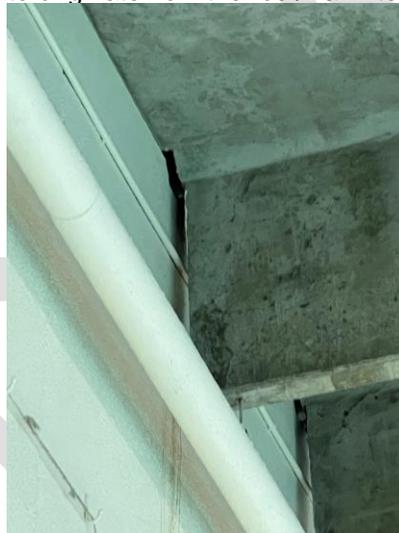
Photograph 3.3.1.12-2: Close up of roof/wall interface showing water staining appearing to originate from the roof/wall interface.

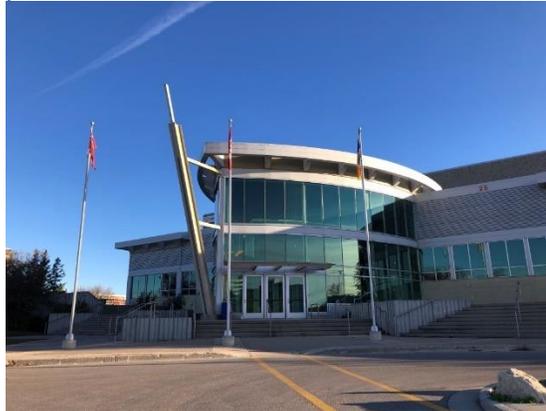
Photograph 3.3.1.13-1: View of the west elevation of the Aquatic Hall of Fame showing prow feature.

The condition of the cladding on the Aquatic Hall of Fame, coupled with the findings of the Curtainwall Leakage Review by Pinchin dated January 10th, 2020, which included selective demolition to review the condition of underlying envelope elements, warrants a comprehensive report on this part of the facility. The following is a summary of our non-destructive visual assessment. Note that no apparent repairs were completed since the issuance of the Pinchin report.

Recommendation 3.3.1.13-1: The observed condition of the cladding on the Aquatic Hall of Fame in conjunction with the findings of our thermographic scan and those of the Curtainwall Leakage Review by Pinchin dated January 10th, 2020, indicates that significant building envelope continuity issues are present, including water-shedding capabilities, air and vapour barrier continuity, and thermal resistance capacity.

The interconnectedness of the elements and complexity of the form lead us to recommend a full exterior envelope upgrade to the Aquatic Hall of Fame to fully address the persistent issues and mitigate further degradation of underlying structural components. The extent of the upgrade should include consideration of curtain wall remediation, which has been addressed separately under items 3.3.2.4-1 and 3.3.2.4-2 below. The extent of material options creates large variability in the costing of such an upgrade. At a minimum, the retrofit should incorporate rainscreen design practices consisting of an exterior air/vapour/water barrier supported by moisture resistant sheathing, outboard insulation to an effective thermal resistance appropriate to mitigate condensation potential within the assembly to protect steel sub-structures, and cladding materials appropriate for a pool assembly.

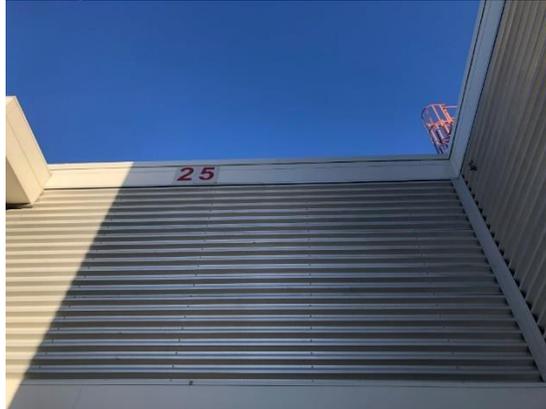
Horizontally corrugated metal cladding: The upper portions of the Aquatic Hall of Fame, above the punched curtain wall glazing, are clad in horizontally corrugated metal cladding. The cladding itself was observed to be in fair condition, with some visible denting of corrugations (cause unknown), no notably excessive signs of corrosion or missing fasteners. However, water staining and streaking was observed between pre-finished trim elements, specially at outrigger locations, and through wall flashings with drip edges were not incorporated at horizontal transitions above and below the corrugated cladding.

Photograph 3.3.1.13-2: Typical condition of corrugated metal cladding on upper portion of the Aquatic Hall of Fame.

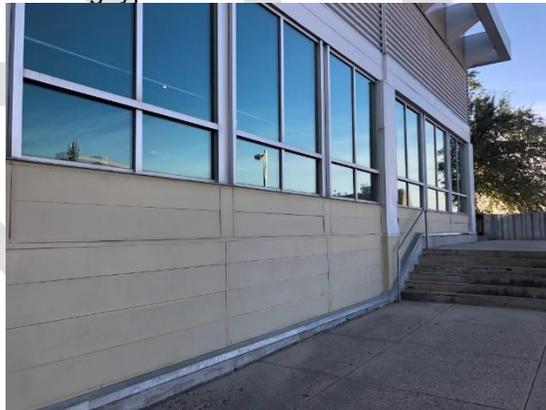
Horizontal metal cladding: The lower portions of the Aquatic Hall of Fame, below the punched curtain wall glazing, are clad in horizontal lap style pre-finished metal cladding. The cladding is in poor condition, exhibiting signs of corrosion and delaminating finish at multiple locations throughout. Review of drawing 2/A2.2 in the Phase 2 envelope retrofit package, dated 2010, indicates that an air barrier is not continuous with curb. Though our review consisted solely of non-invasive visual assessment, these findings are consistent with those of the 2020 Pinchin report which outlines significant deficiencies in the air barrier detailing of the Aquatic Hall of Fame. Similarly, our thermographic scan showed significant air leakage at the wall base.

Photograph 3.3.1.13-3: Partial view of west elevation of the of the Aquatic Hall of Fame showing typical condition of horizontal metal cladding.

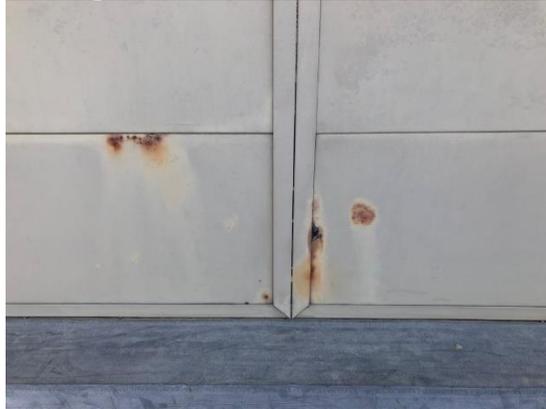
Photograph 3.3.1.13-4: Typical example of corrosion observed on horizontal metal cladding.

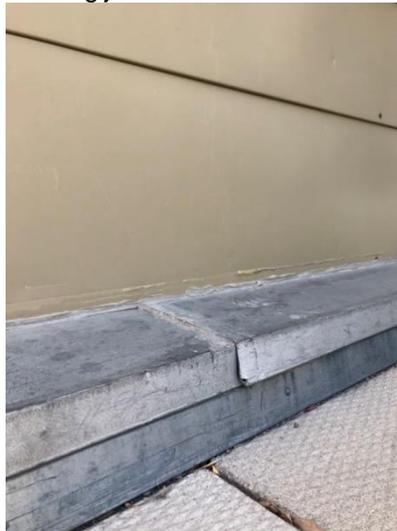
Metal cladding trims and flashings and sealants: Metal cladding trims and flashings were observed to be in fair to poor condition throughout, with notable discrete impact damages, discontinuities in joints, and installation not keeping with industry best practice, such as corner, termination, and lap joint detailing, in addition to maintenance of positive slope away from vertical cladding elements. Closure sealants were in poor condition, with evidence of prior repair work, most notably at curb flashing terminations adjacent to entrance doors. Without completing selective demolition, it could not be confirmed that through wall flashings were tied back to the underlying sheathing and air barrier, though the Pinchin report suggests that they are not, which is exacerbating the stresses on the building envelope through bulk water infiltration through the assemblies.

Photograph 3.3.1.13-7: View of base of wall curb flashing showing typical discontinuity at flashing joints.

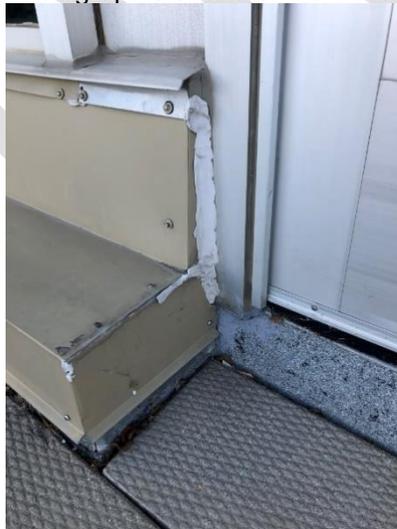
Photograph 3.3.1.13-8: View of sealant repair completed at curb next to entrance.

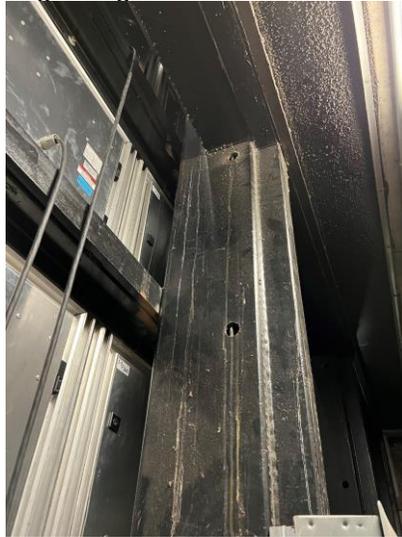
Though the acoustical panel wall assembly was not accessible, some water staining was observed on the structural steel elements behind the scoreboard, and on the back-side of the scoreboard itself, from overhead, though the point of origin was not visually accessible. Minor corrosion was observed on the inverted steel C-channel at platform floor level. As no active condensation or leakage was observed at time of visit, we cannot say for certain where or how the moisture is being deposited, though, it is our understanding that these structural elements were re-coated in 2019, and it therefore stands to reason that the observed water staining would have occurred in the interim.

Photograph 3.3.1.14-1: View of water staining observed on columns behind scoreboard, originating from overhead.

Recommendation 3.3.1.14-1: As no active condensation or leakage was observed at time of visit, and no visible signs of condensation were observed on the pool side of the acoustical panels, it is difficult to ascertain where or how the reported condensation events occurred, and therefore potential remediation measures cannot be recommended at this time.

It is therefore recommended that the east end of the pool be monitored for further condensation issues over the course of the winter and spring 2022. Should a situation arise, CKP will attend site to review the active issue. If further investigation is deemed necessary, including the removal of acoustical panels and the scaffold access as described above, it is recommended that these activities coincide with scheduled pool maintenance, to limit disturbance to patrons. Remediation recommendations would then be based on the findings of the subsequent investigations. The scope and costs associated with subsequent investigations will be provided under separate cover at COW request.

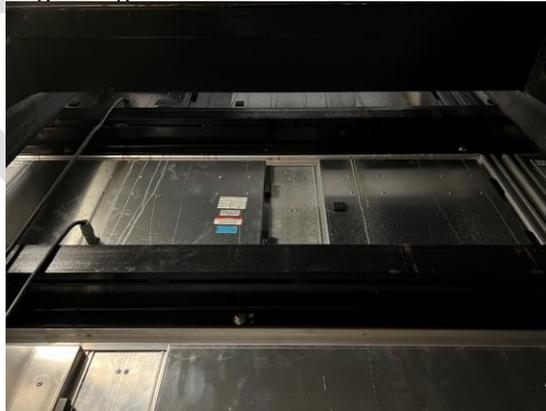
Photograph 3.3.1.14-2: View of water staining observed on back side of scoreboard, originating from overhead.

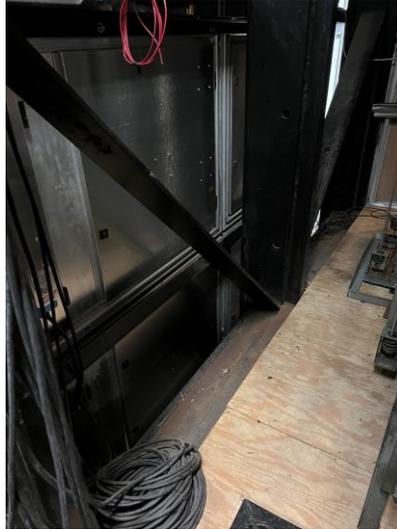
Photograph 3.3.1.14-3: Structural steel behind scoreboard showing inverted c-channel with minor corrosion.

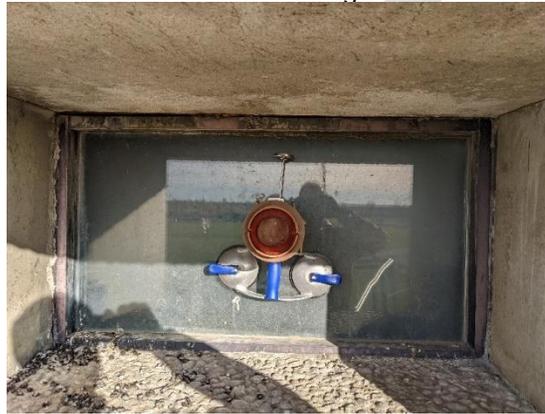
IGU's and framing on the south elevation were observed to be poor condition. Aluminum framing was noted to be corroded, especially at sill framing where bird droppings have built up. Sealant at frame perimeter (rough opening) as well as between the frame and the IGU was noted to be heavily deteriorated, missing, contaminated by biological growth or a combination. Multiple IGU's were noted to be cracked or perforated (cause unknown) and categorized as a visual failure.

Frost point testing was conducted at 19 IGU's which makes up approximately 15% of clerestory windows (north and south). 11 of 19 (58%) showed some level of frost or condensation.

Photograph 3.3.2.1-1: Typical example of clerestory windows during frost point testing. Note the deteriorated/missing sealant and corroded frame.

Recommendation 3.3.2.1-1: The reviewed clerestory areas are showing significant deterioration of the frames, IGU's and sealants. Given the height of these units, their condition is likely contributing to a significant amount of air leakage. It is highly recommended that these units be replaced with high performance glazing units suitable for high humidity applications to increase thermal performance and occupant comfort.

Recommendation 3.3.2.1-2: Should recommendations 3.3.2.1-1 not be desirable, and a non-glazed system be preferred (based on the original units being painted over), an insulated infill panel can be installed in place of the original windows. The thermal performance of an insulated panel infill can be significantly higher than a glazing unit. Refer to Section 3.3.1.6-1 for discussion of this option.

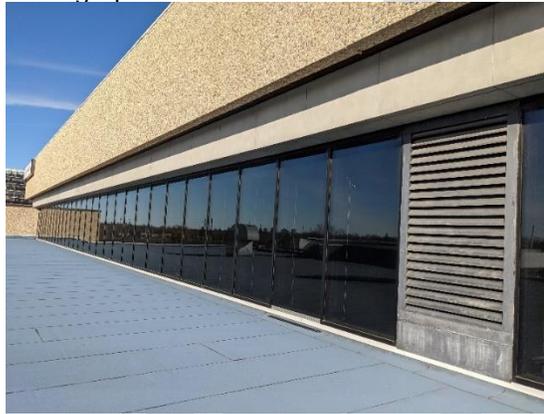
While the curtain wall framing and IGU's appeared to be in good condition and are still within their estimated life expectancy (12 years or 48%), the sealant used during installation is past its estimated life expectancy (12 years or 120%). Minor discontinuities in the curtain wall framing gaskets were also noted.

Photograph 3.3.2.2-1: Overview of West low roof curtain walls.

Recommendation 3.3.2.2-1: While the curtain wall system on the west and south low roof areas are in good overall condition, deteriorated and/or discontinuous sealant and seals can contribute to air leakage (loss in thermal performance) and water infiltration. Replacement of sealant and selective replacement of curtain wall gaskets is recommended to improve thermal performance and prevent premature deterioration of the curtain wall system and the adjacent structure.

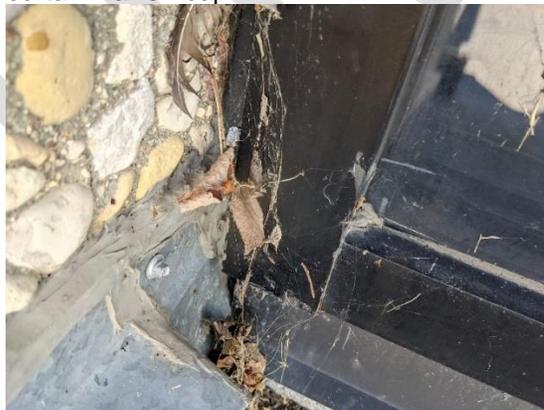
Photograph 3.3.2.2-2: Example of older sealant at curtain wall jamb and displaced seal at curtain wall sill cap.

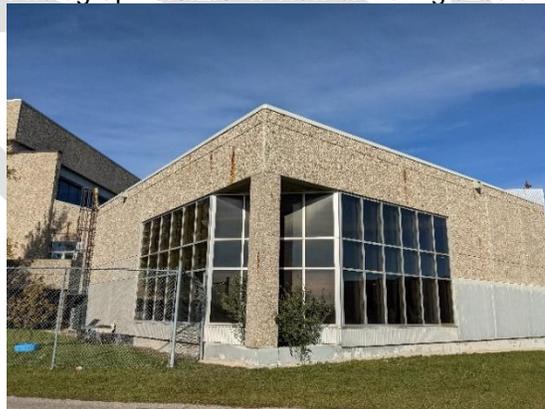
While the curtain wall framing and IGU's appeared to be in generally good condition and are still within their estimated life expectancy (14 years or 56%), the age of the sealant at these curtain walls is unknown. The age of the most recent remediation would mean the age of the sealant is conservatively estimated at 14 years or 140% of its life expectancy. Deterioration, discontinuities and missing curtain wall gaskets were noted as well as a damaged component of the curtain wall framing on the east jamb of the south assembly.

Photograph 3.3.2.3-1: View of main glazed area at the east addition.

Recommendation 3.3.2.3-1: While the curtain wall system on the south elevation is in good overall condition, deteriorated and/or discontinuous sealant and seals can contribute to air leakage (loss in thermal performance) and water infiltration. Replacement of sealant, curtain wall gaskets, damaged curtain wall frame components and the visually failed IGU is recommended to improve thermal performance and prevent premature deterioration of the curtain wall system and the adjacent structure. Further review of the two punch style curtain walls on the north elevation would be required, though similar recommendations are likely to be made.

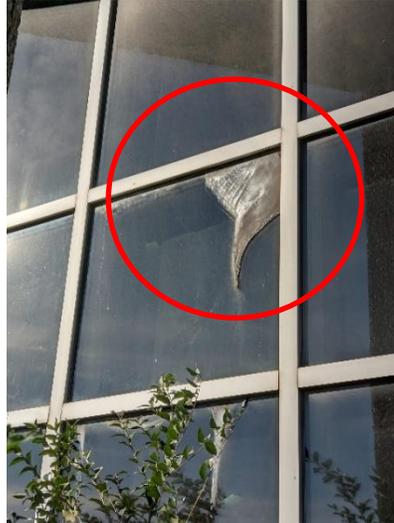
Photograph 3.3.2.3-2: Example of curtain wall seal peeling away from frame.

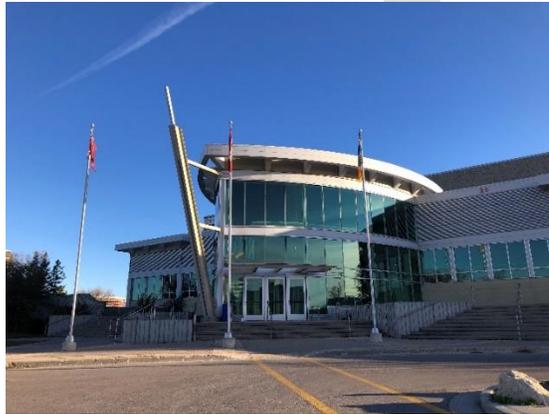
Curtain wall framing appeared to be in generally good condition at the prow section of the west addition. IGU's at this section were noted to be failing rapidly with multiple visual failures and a 50% failure rate in frost point testing (see below). Sealant and curtain wall gaskets were also noted to be deteriorated, missing and generally at the end of their service life. Gaps were noted in curtain wall framing and the presence of towels inside the occupied area suggest that significant water infiltration is occurring, likely due to failing sealant and general detailing issues around curtain wall joints/rough opening.

Photograph 3.3.2.4-1: Overall view of the prow and west elevation second level curtain wall.

Recommendation 3.3.2.4-1: The curtain wall system on the “prow” section of the west elevation of the west addition was noted to be where the majority of the significant issues were noted. Due to the significant amount of failed IGU’s, deteriorated sealant and gaskets as well as the noted water infiltration and general detailing issues, a full curtain wall refurbishment is recommended, though replacement or modification may be required should proper air/vapour barrier membrane tie in of the existing system prove impractical. Refurbishment of the system is recommended to improve overall thermal performance, eliminate water infiltration and problematic existing detailing as well as prevent premature deterioration of the adjacent structure(s).

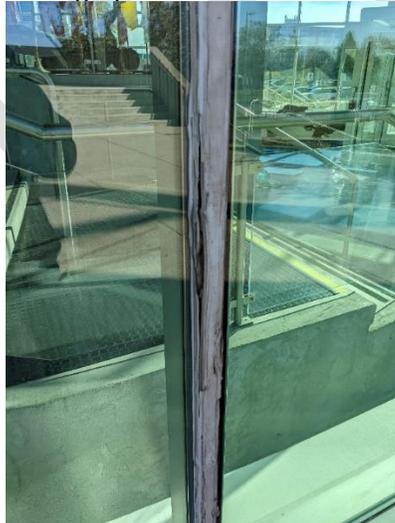
Photograph 3.3.2.4-2: Deteriorated SSG sealant at vertical joints (prow).

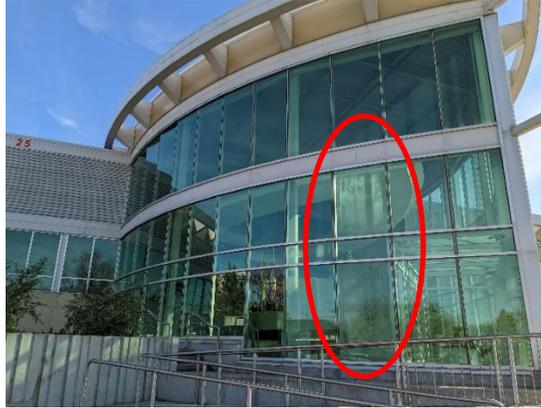
Frost point testing was conducted at 31 IGU's which makes up approximately 16% of curtain wall IGU's on the west addition (144 on west elevation, 23 on north elevation and 31 on south elevation). 8 of 31 (26%) showed some level of frost or condensation. In addition, six visual failures were noted. Note: 7 of the 8 recorded failures and all recorded visual failures were at the prow.

Photograph 3.3.2.4-3: Visual failures at prow IGUs.

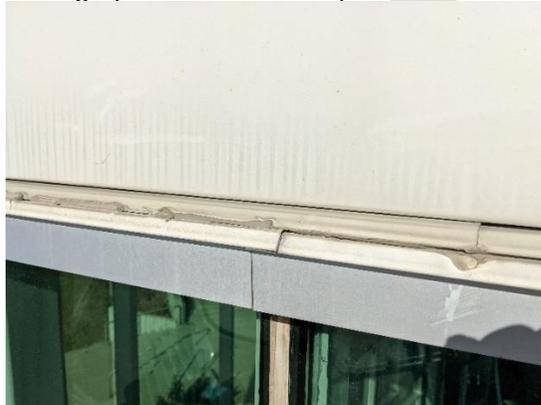
Photograph 3.3.2.4-4: Example of deteriorated sealant at curtain wall head flashing.

Recommendation 3.3.2.4-2: While the curtain wall system on “prow” section of the west addition was noted to be in poor condition, the remaining curtain wall systems and punch style curtain walls were noted to be in relatively good overall condition. Due to the age of the IGU’s, it is still recommended that the curtain wall system be refurbished and IGU’s be replaced, though it is not required as immediately as recommendation 3.3.2.4.1. The noted punch windows on the north elevation as well as the ground level south curtain wall

are included in this recommendation. Refurbishment of the system is recommended to improve overall thermal performance, as well as prevent premature deterioration of the adjacent structure(s).

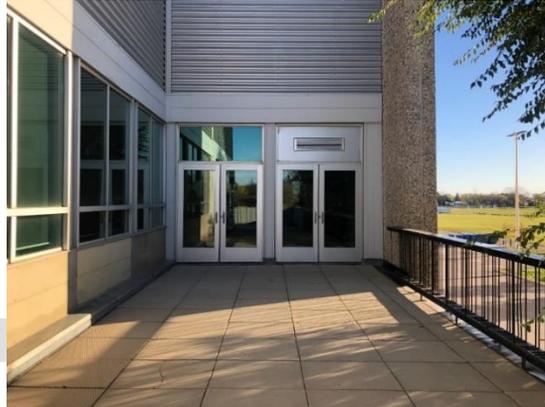
Generally, the frames for all curtain wall doors appear to be in good condition. Sealant and frame seals at these units were noted to be deteriorated (cracked, peeling) and past their useful service life. Although IGU's in these areas appeared to be in good condition, the majority are at or near the end of their expected service life (29-24 years old at most locations). Fixed IGU's at punch style doors (not prow area) are included in the door assessments.

Photograph 3.3.2.5-1: Example of curtain wall doors on the second level west addition.

Recommendation 3.3.2.5-1: The curtain wall style doors were noted to be in relatively good overall condition. Due to the age of the IGU's, it is recommended that the curtain wall doors be refurbished including IGU's be replaced, sweeps/seals being replaced, and perimeter sealant being removed and replaced. Refurbishment of the curtain wall doors is recommended to improve overall thermal performance, as well as prevent premature deterioration of the adjacent structure(s).

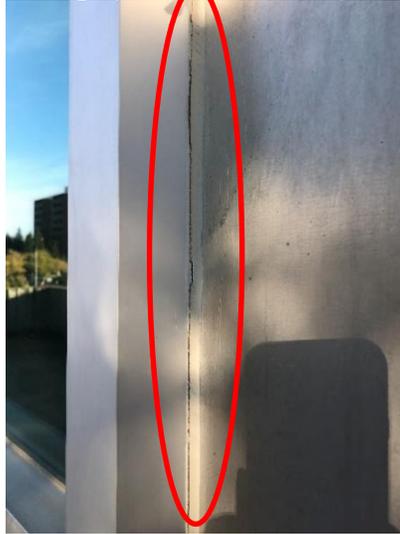
Photograph 3.3.2.5-2: Example of sealant condition at curtain wall door framing.

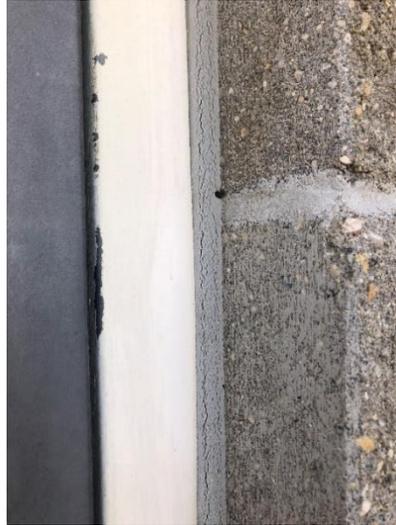
Generally, frames and door slabs appear to be fair condition though the majority of sealant was noted to be deteriorated or missing. Door seals were not reviewed, though they are expected to be deteriorated and generally past their useful service life.

Photograph 3.3.2.6-1: General condition of sealant at hollow metal service doors (where installed).

Recommendation 3.3.2.6-1: The majority of doors were noted to have deteriorated or missing perimeter sealant. Replacement or installation of perimeter sealant is recommended to eliminate potential water and air infiltration, preventing premature deterioration of the adjacent structure(s). Replacement or installation of door seals and sweeps is recommended as part of a regular maintenance program.

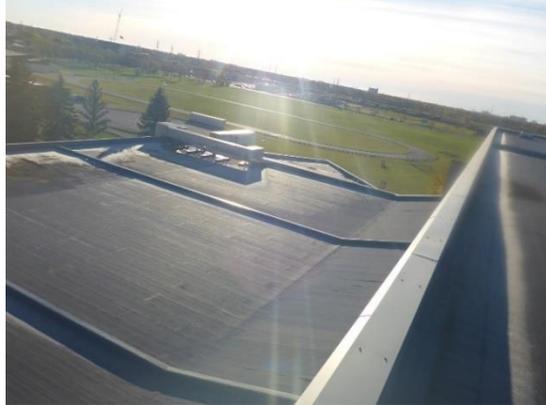
- .1 The east building roof facet is in overall fair condition, including southeast roof facet. The east roof is divided in 2 types of roof systems based on the geometry of the existing structure. The low slope roof Photograph 3.3.3.1-1 consists of 2-ply SBS vapor barrier on existing concrete deck, followed with 2 layers 38mm polyisocyanurate insulation panels, ¼" asphaltic board, all above layers are adhered with hot asphalt, heat welded SBS modified bitumen base and granulated cap membrane. The steep roof Photograph 3.3.3.1-2 consists of original 2-ply felt vapor barrier, 70mm polyisocyanurate insulation, 13mm fiberboard panel, all above are adhered with hot asphalt, SBS modified bitumen base membrane adhered with asphalt and heat welded SBS modified bitumen granulated cap membrane. The above mentioned system is existing and according to provided records the steep slope roof facet was recovered with a heat welded SBS modified bitumen granulated cap membrane. Overall, the condition is fair and future maintenance and small repairs are required. Blisters and wrinkles were observed throughout the roof cover, due to the asphalt sliding and asphaltic board movement underlying the SBS roof cover membrane. Refer to photograph 3.3.3.1-3 and 3.3.3.1-4

Photograph 3.3.3.1-1: Showing east low slope roof facet.

Recommendation 3.3.3.1-1: Repair as necessary to provide roof cover continuity.

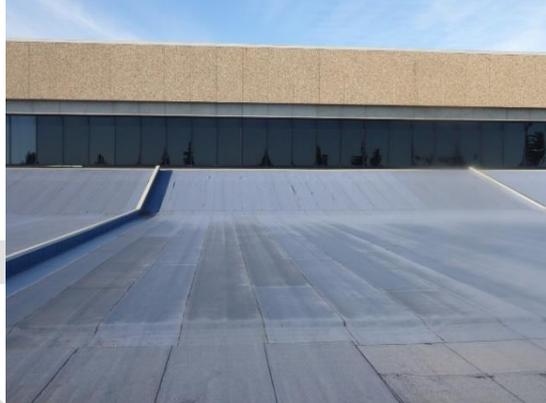
Photograph 3.3.3.1-2: Showing east steep slope roof facet.

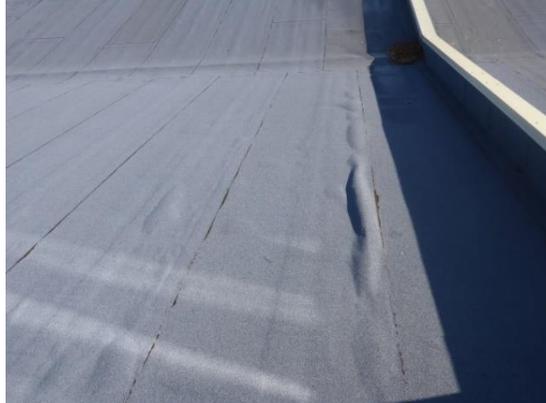
Photograph 3.3.3.1-3: Showing typical buckling in roof cover, east roof facet.

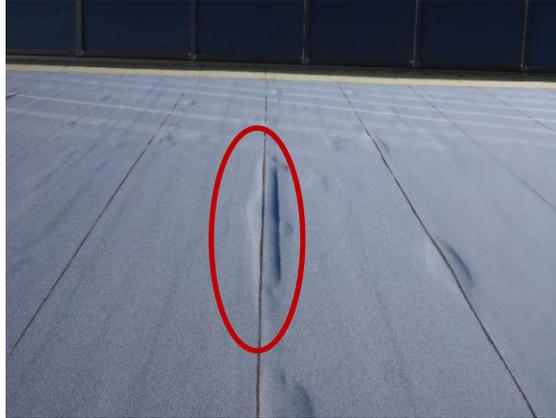
Photograph 3.3.3.1-4: Showing typical wrinkle at membrane seam, east roof facet.

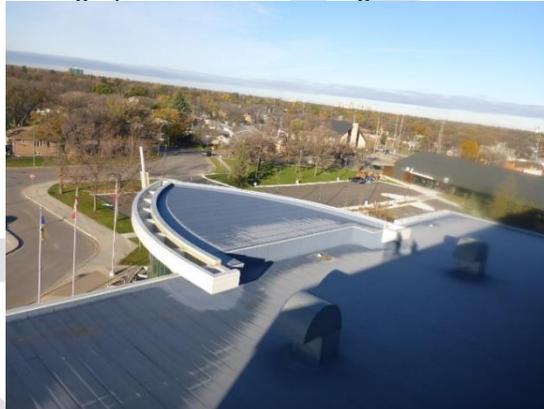
- .2 On the building west roof facet, the existing system is relatively new and in very good condition and performing as intended. No deficiencies or concerns were observed. Based on the age of the installed roofing system, the existing systems should still be under warranty with the membrane manufacturer as well as the roofing contractor. Drainage on the roof is satisfactory and sloped adequately throughout. Photograph 3.3.3.1-5.

Photograph 3.3.3.2-1: Showing West roof facet

Recommendation 3.3.3.2-1: Annual roof maintenance required.

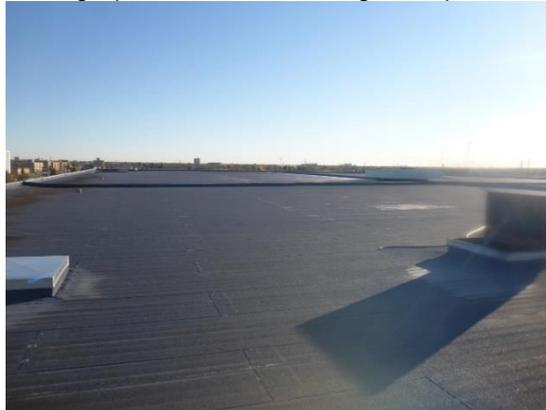
granulated cap membrane. Overall, the roof cover throughout the roof field is in good condition and general maintenance will be required. We observed minor deficiencies on the SBS cap flashing mainly at the roof control joints. According to site personnel leaks have occurred at the northwest units on the roof. We observed minor openings at the SBS flashing membrane and metal flashing/membrane joints. Photograph 3.3.3.3-1 and 3.3.3.3-3. We recommend that these deficiencies be addressed in the short term to prevent further water infiltration into the building. We recommend during annual maintenance the drain assemblies be reviewed, cleaned and repaired as necessary.

Photograph 3.3.3.3-1: Showing main pool roof facet.

Recommendation 3.3.3.3-1: Repair as necessary to provide waterproofing, re-seal flashing membranes.

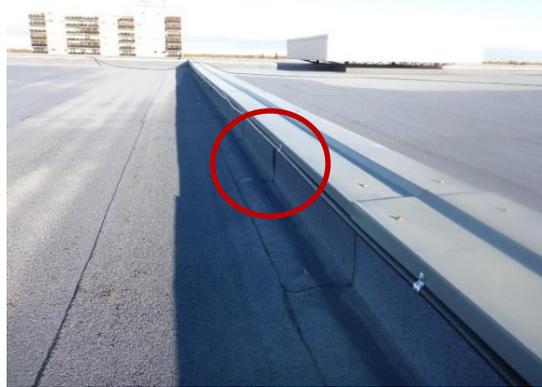
Photograph 3.3.3.3-3: Showing typical loose flashing membrane
