### DETAILED BRIDGE CONDITION SURVEY

## Pembina Highway Bridge Over Abinojii Mikanah (Bishop Grandin)

(Site No. B-215)

November 22, 2024

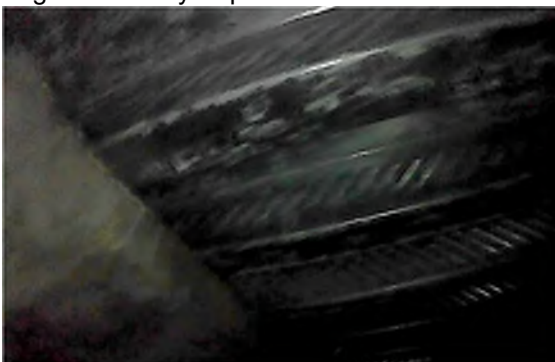
Figure 50: Stay-in-place Deck Forms at NAG6
