APPENDIX H: TETRA TECH GIRDER AND SUBSTRUCTURE CONDITION ASSESSMENT

Date: March 1, 2024

Project: Professional Consulting Services for Lagimodiere Blvd. Twin Overpasses Rehabilitation (Over Concordia Ave. and CPR Keewatin)

Subject: Bridge Condition Assessment Report

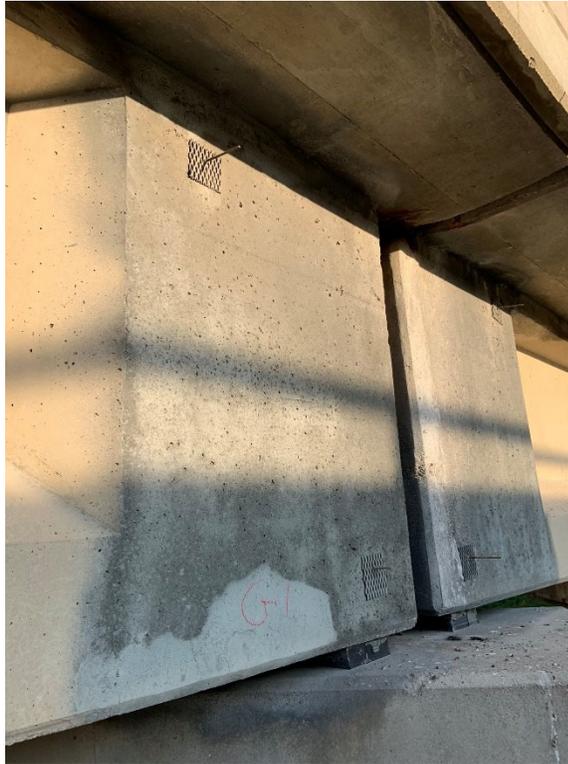
Figure 2 – Metalized Coating on Exterior Girder Ends

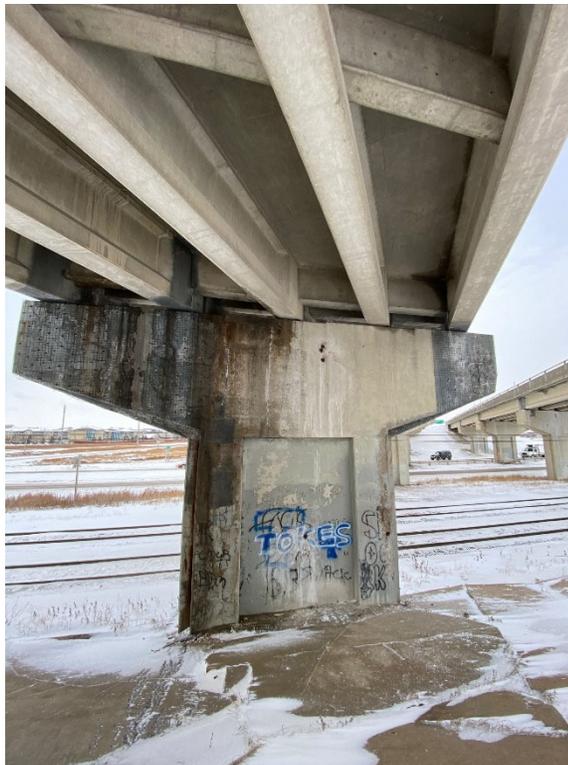
Figure 3 – Containment Meshing on Pier Hammerheads

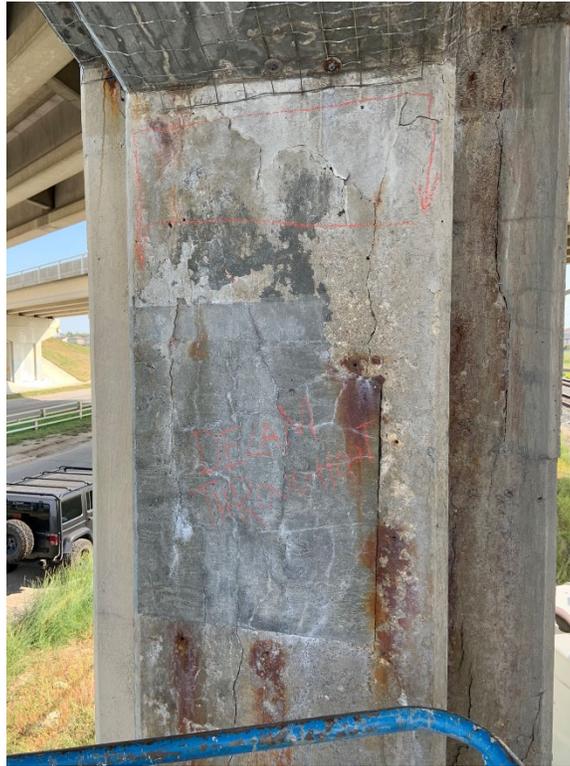
Figure 2 – Delamination in SB Pier 2 Ends

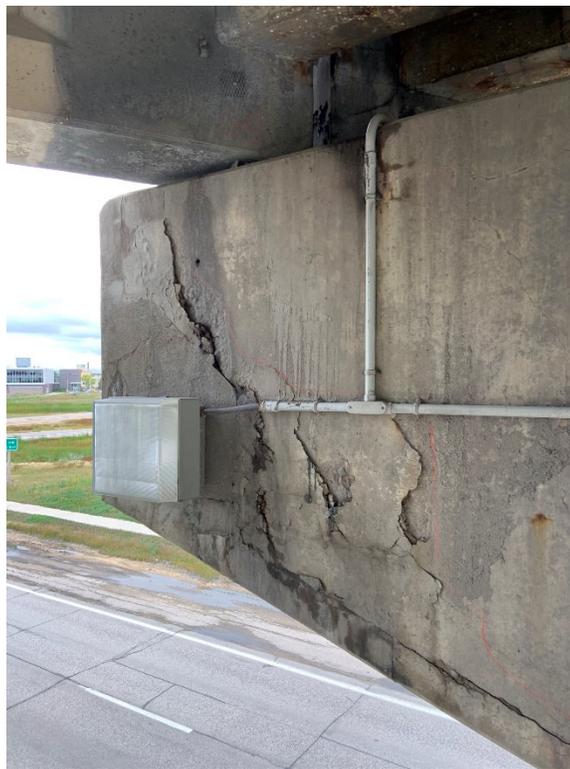
Figure 3 – Delamination in SB Pier 3 Hammerhead

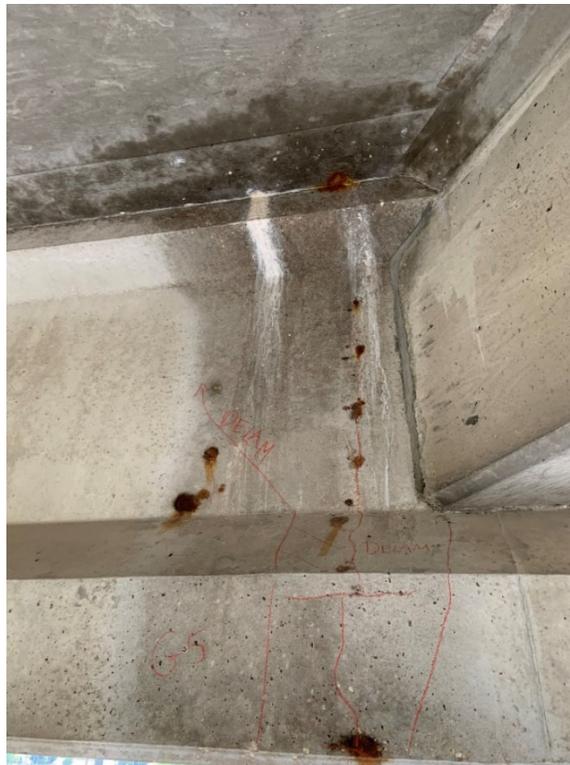
**Figure 12: G5 Full Height Delamination (600mm wide)
NB Structure, Span 4, between Pier 3 and South Diaphragm**

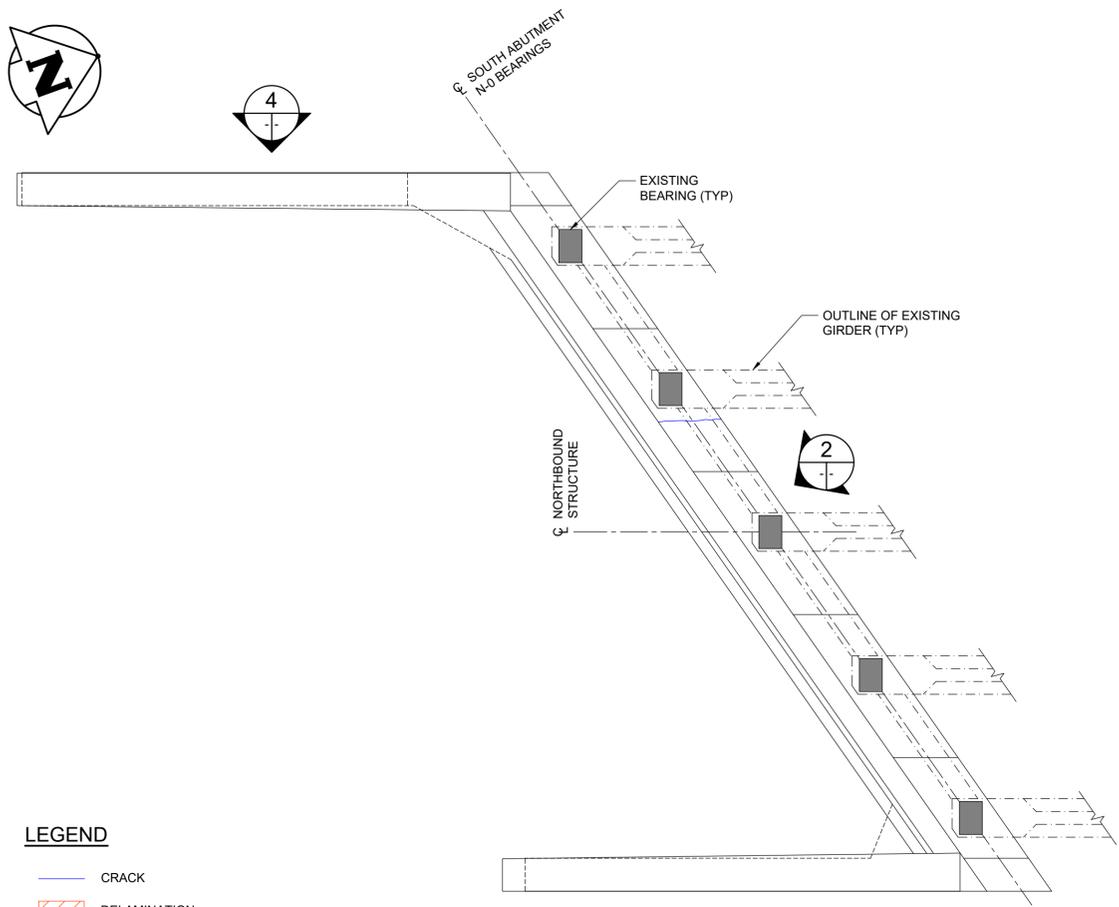
1 PLAN - ABUT N-0
1:50

NOTES:
1. CRACK LOCATIONS ARE APPROXIMATE. CRACK WIDTH VARIED.

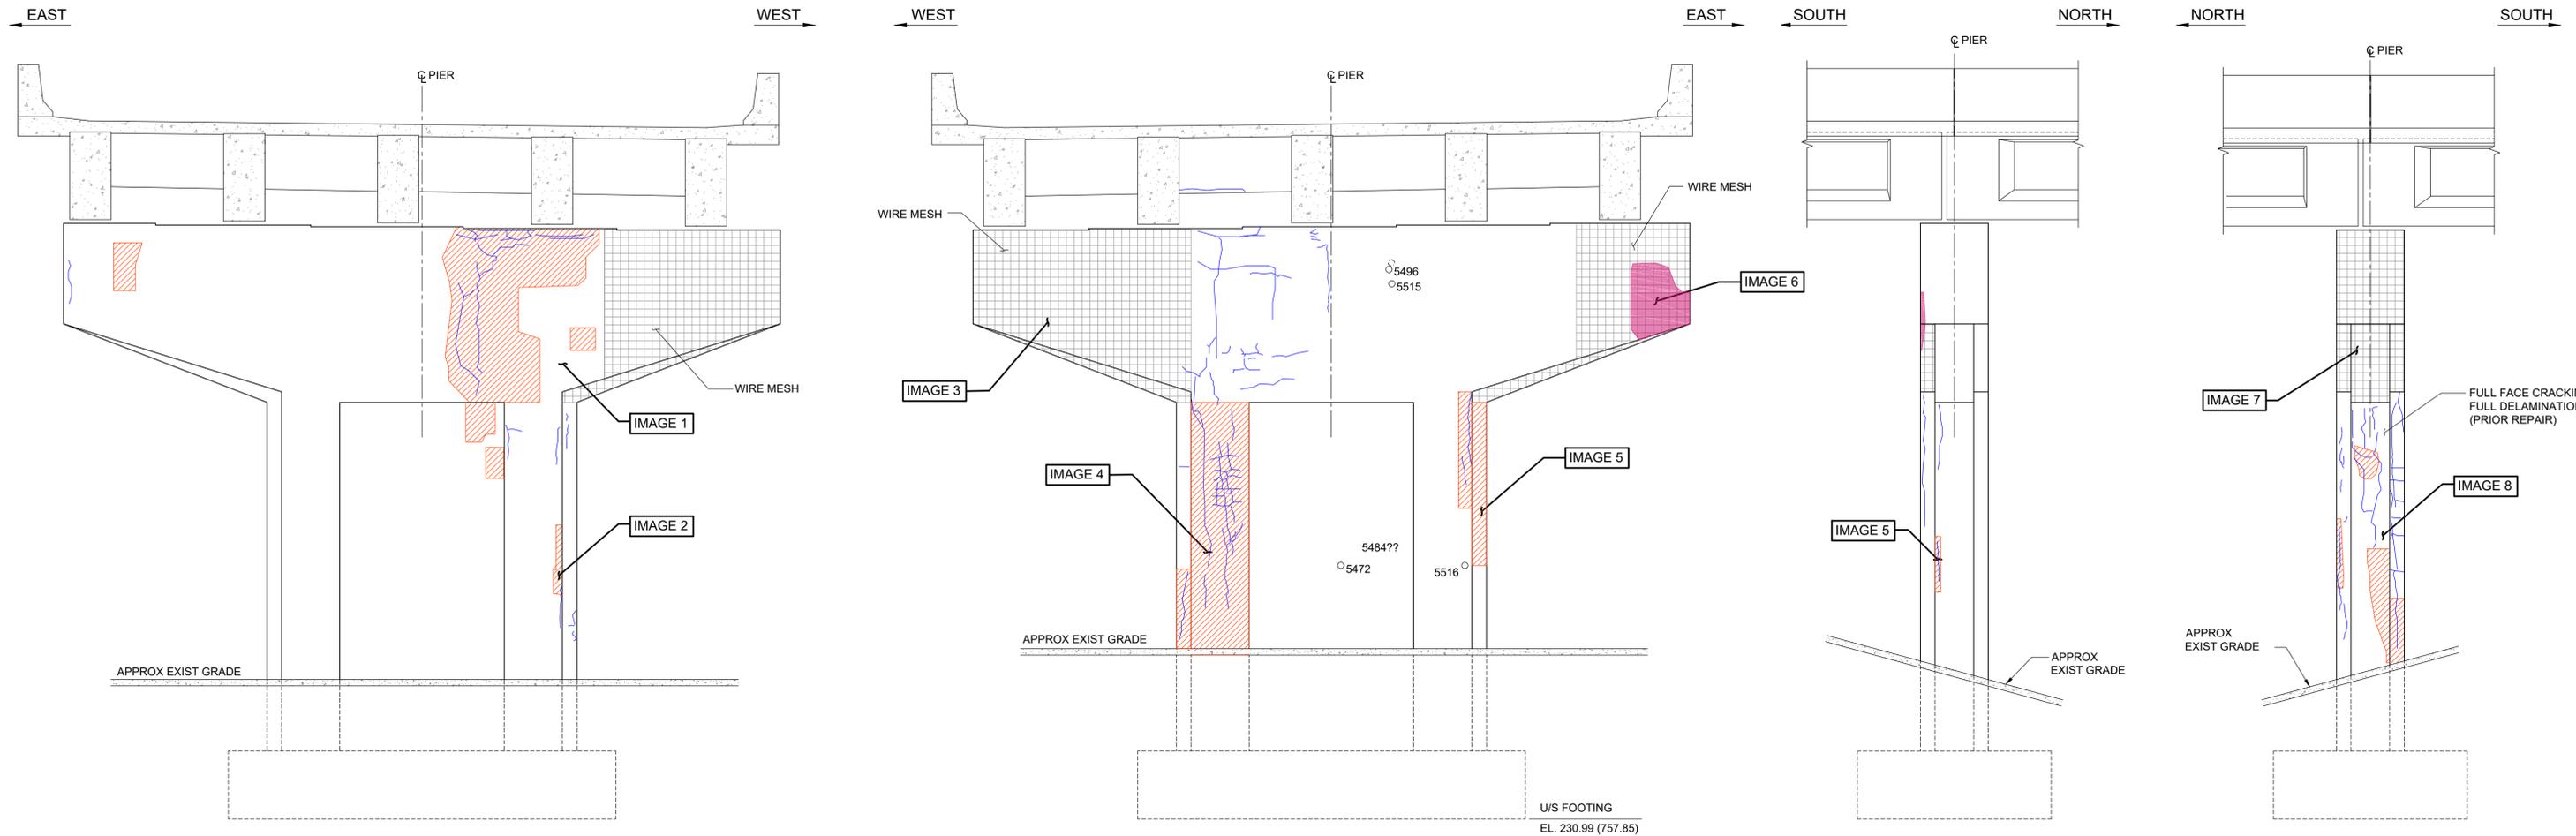
1 PIER S-1 - NORTH ELEVATION
1:50

2 PIER S-1 - SOUTH ELEVATION
1:50

3 EAST ELEVATION
1:50

4 WEST ELEVATION
1:50

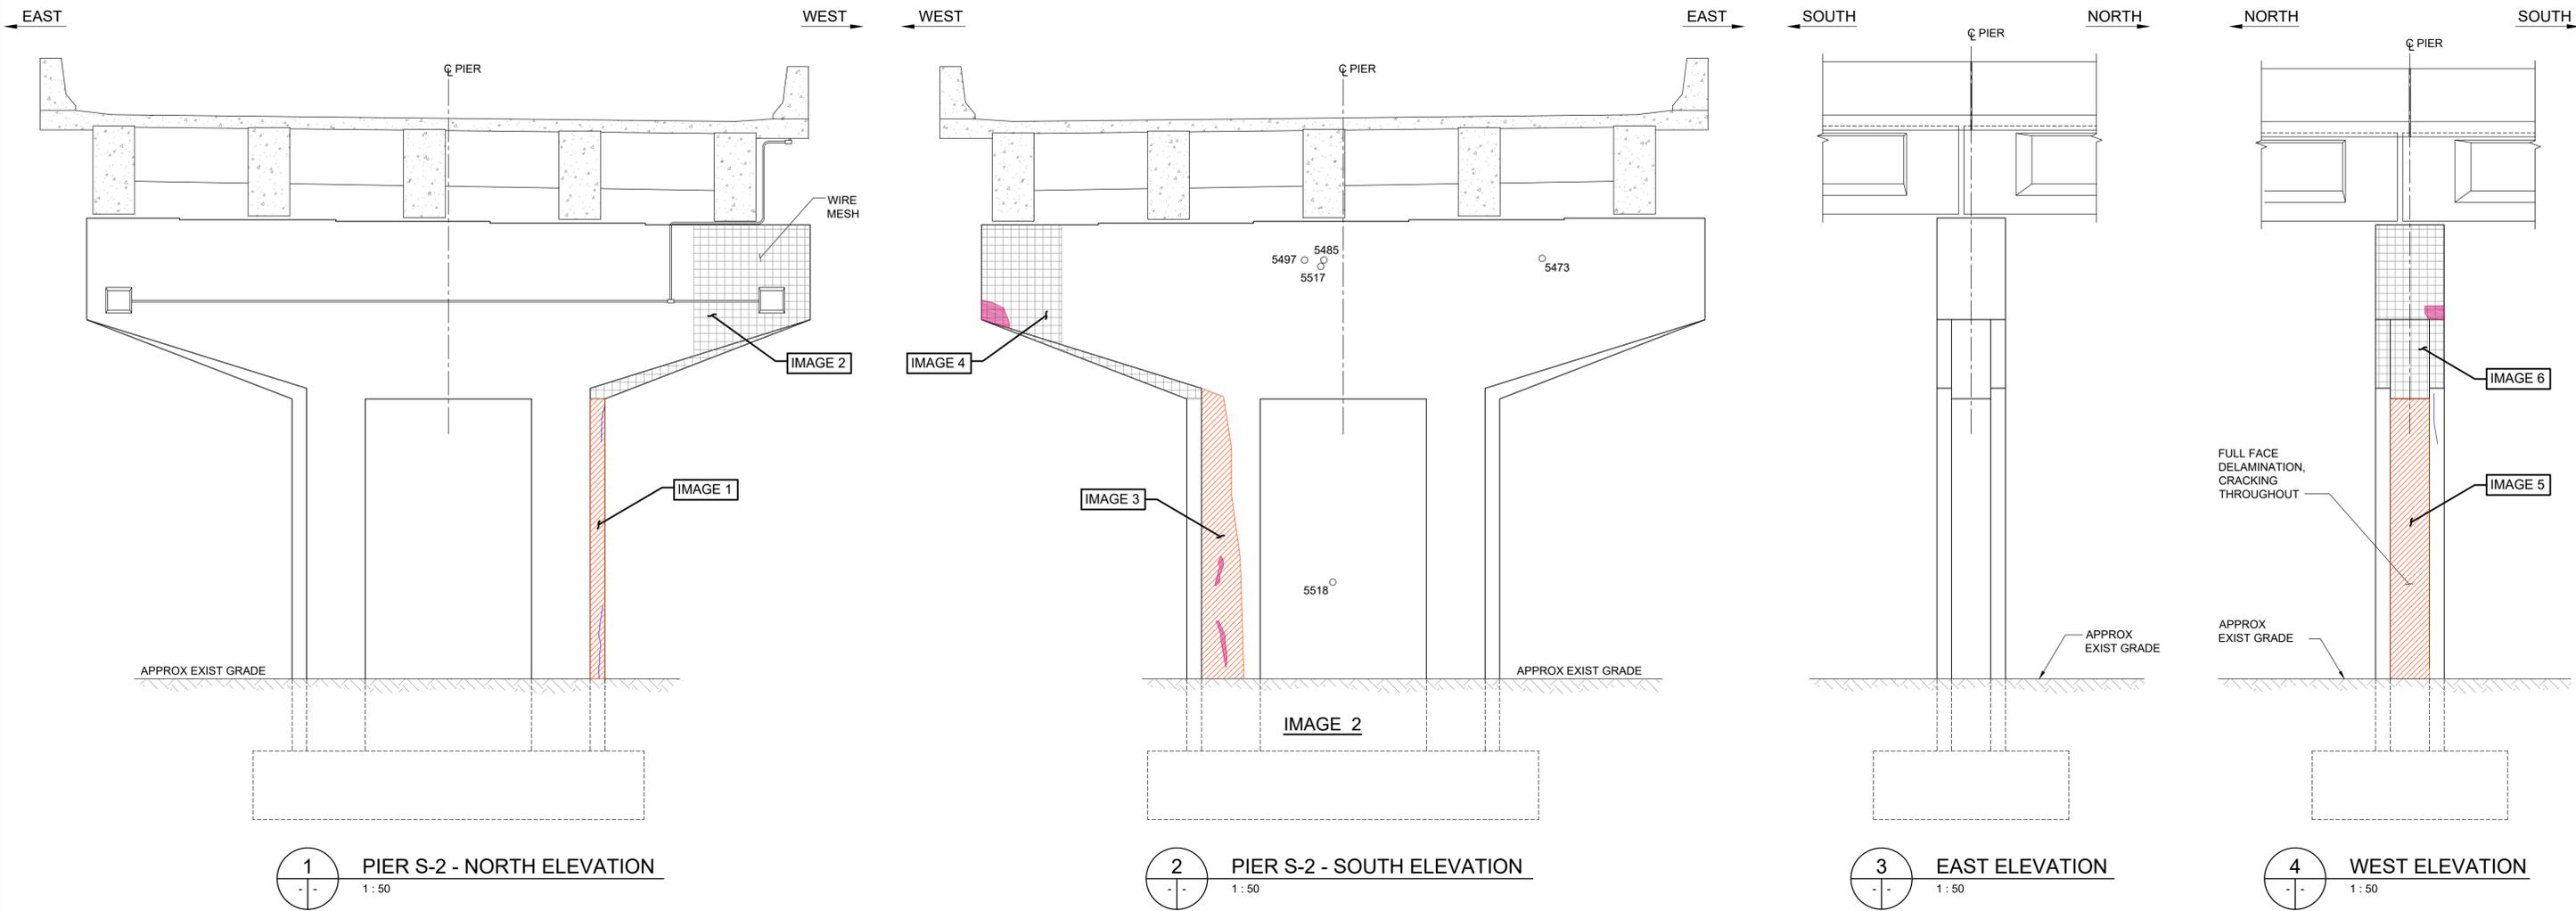
1 PIER S-2 - NORTH ELEVATION
1:50

2 PIER S-2 - SOUTH ELEVATION
1:50

3 EAST ELEVATION
1:50

4 WEST ELEVATION
1:50

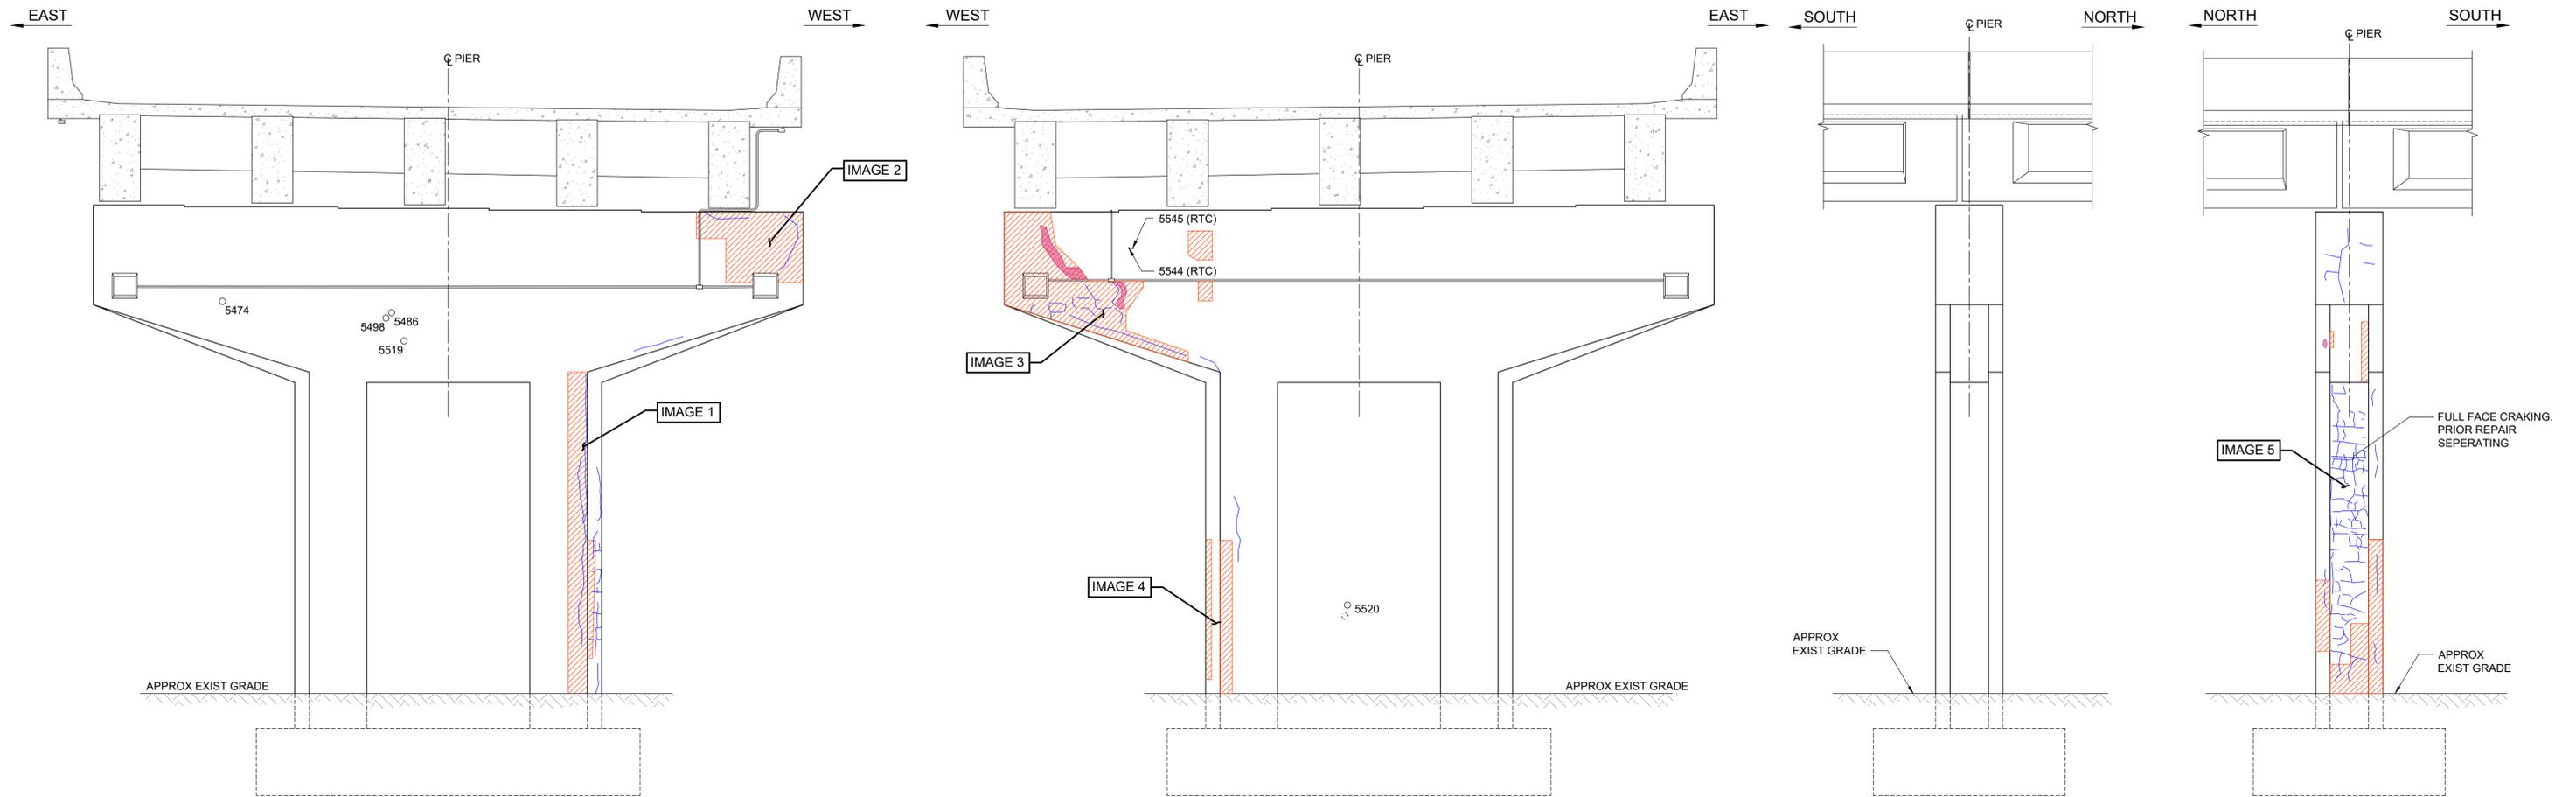
1 PIER S-3 - NORTH ELEVATION
1:50

2 PIER S-3 - SOUTH ELEVATION
1:50

2 EAST ELEVATION
1:50

3 WEST ELEVATION
1:50

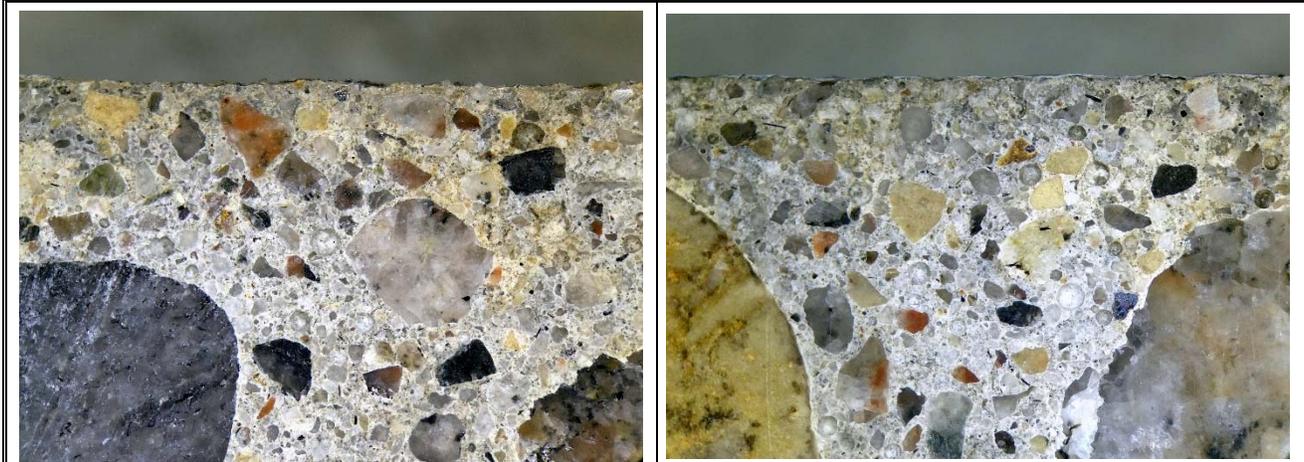
Views at upper/outer face of core, in profile. Slightly discoloured paste at surface. Magn. 10x, fov = 13 mm

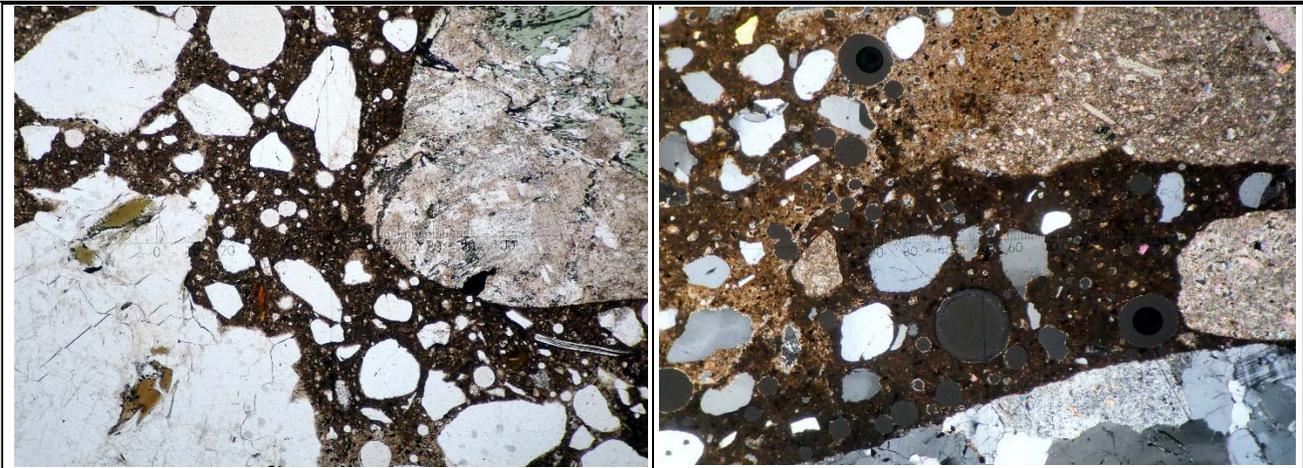
Thin-section views depict (left) cement paste that is generally dense and encapsulates aggregates, and (right) shows patchy carbonation in some areas (lighter brown in upper left area of image). Magnification 50x, field of view 3 mm.

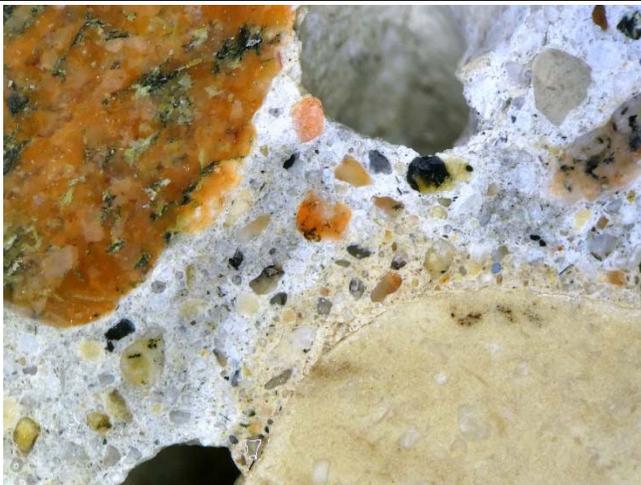
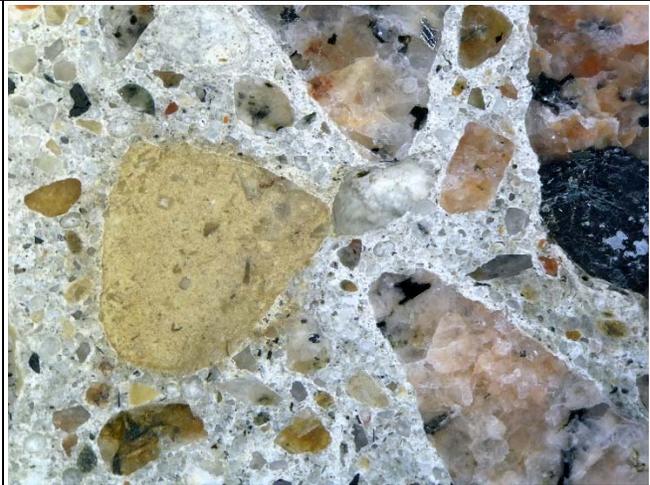
Views at 10x magnification illustrating (left) discoloured paste surrounding a limestone coarse aggregate, with a slight debond observed along its periphery, and an entrapped air void next to the granite aggregates at the upper left; and (right) general condition of paste that encloses granite, gneiss, and limestone aggregates. Fields of view about 13 mm.

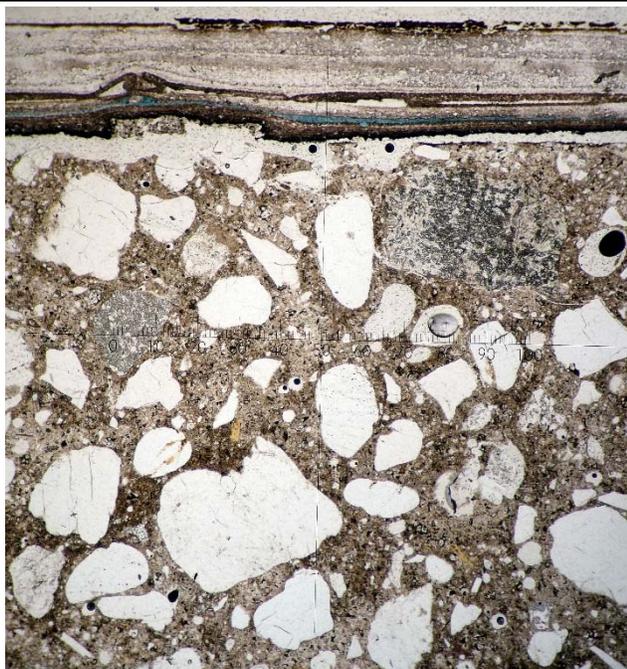
Outer surface of core showing applied layers of paint, etc., at top of image. 50x.

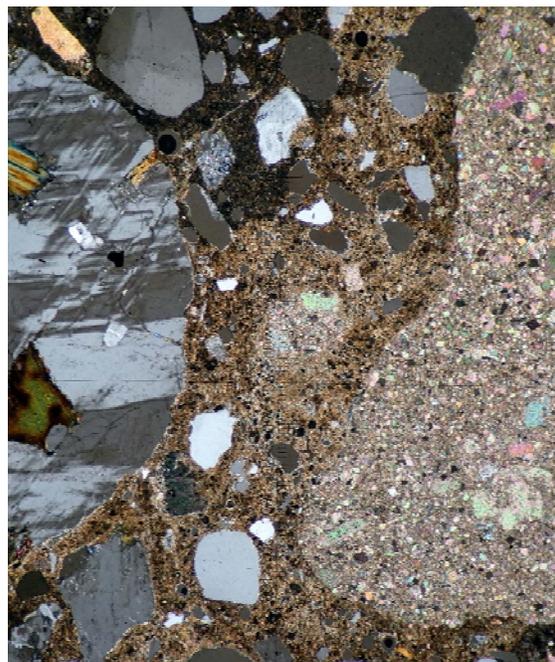
Slightly carbonated paste is seen in this image; 50x magnification.

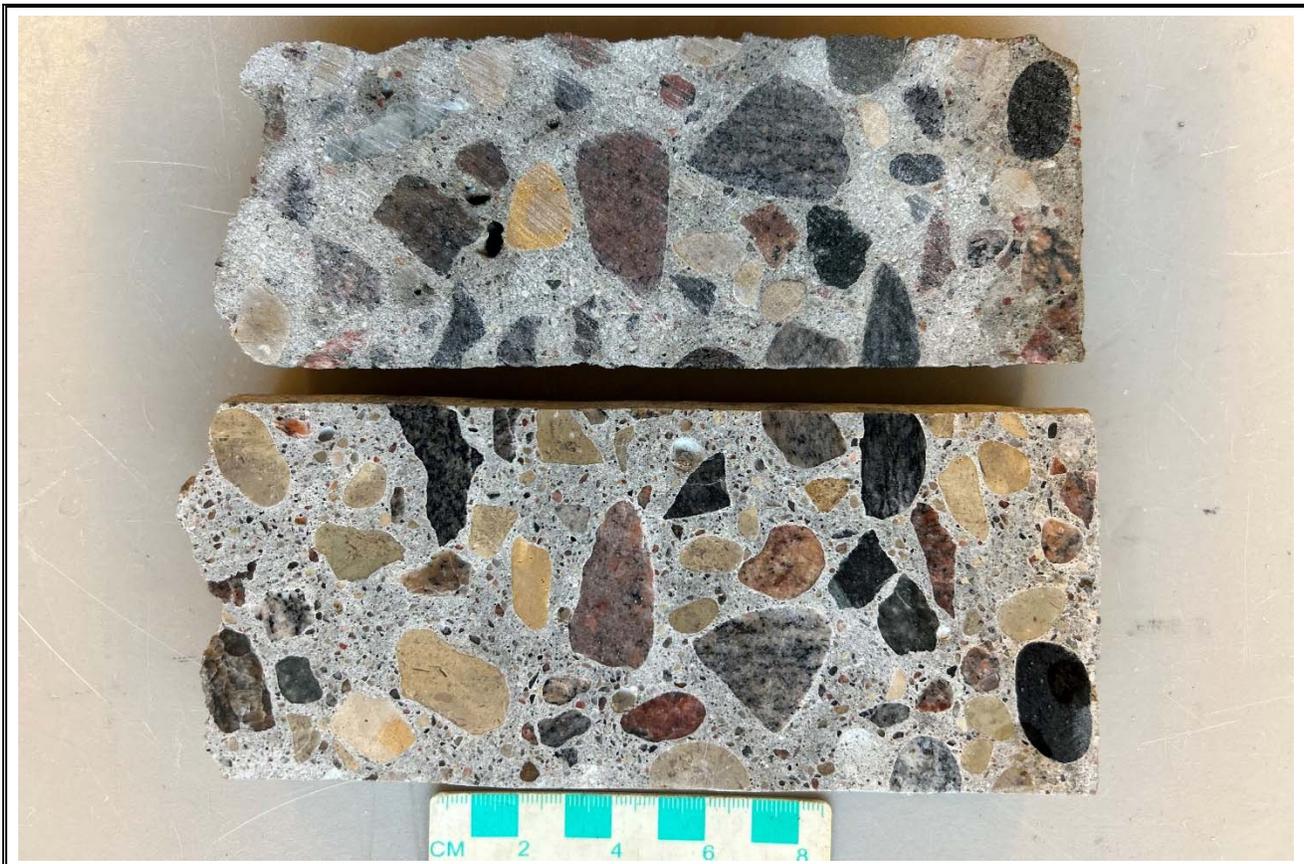
Core after cutting and polishing. Note slight discolouration of paste at outer end.

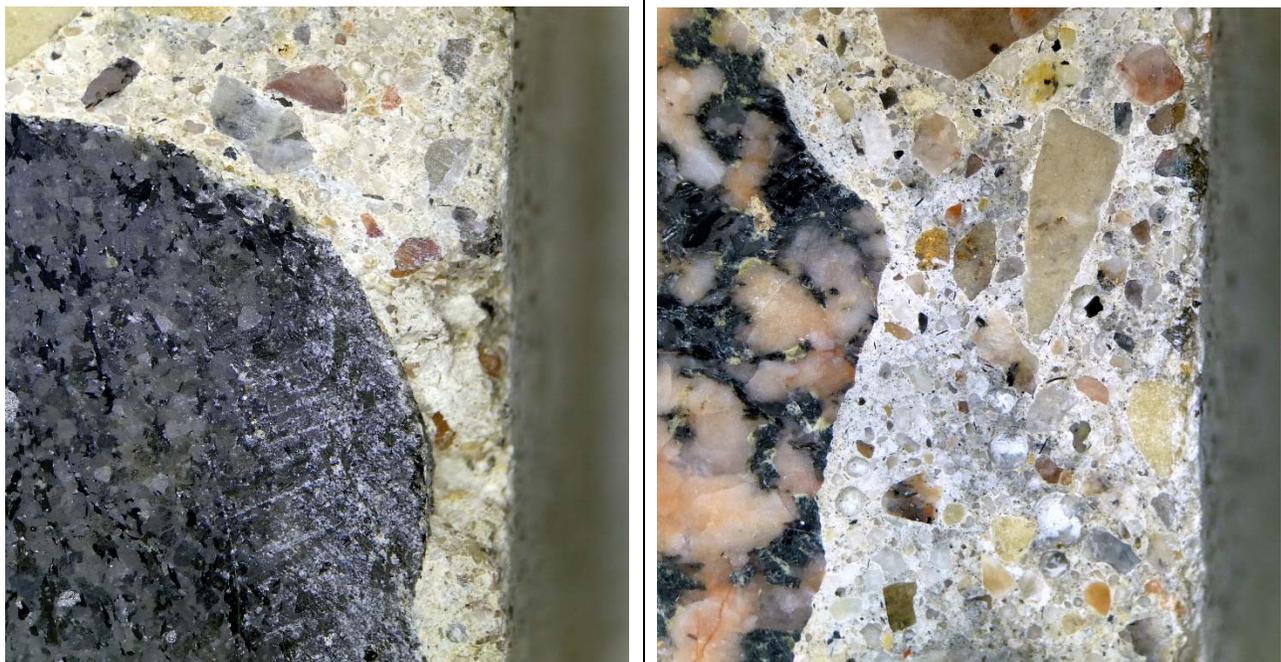
Views at upper/outer face of core, in profile, showing slight attrition of paste on surface and slight discolouration of paste at surface. Magn. 10x, fov = 13 mm

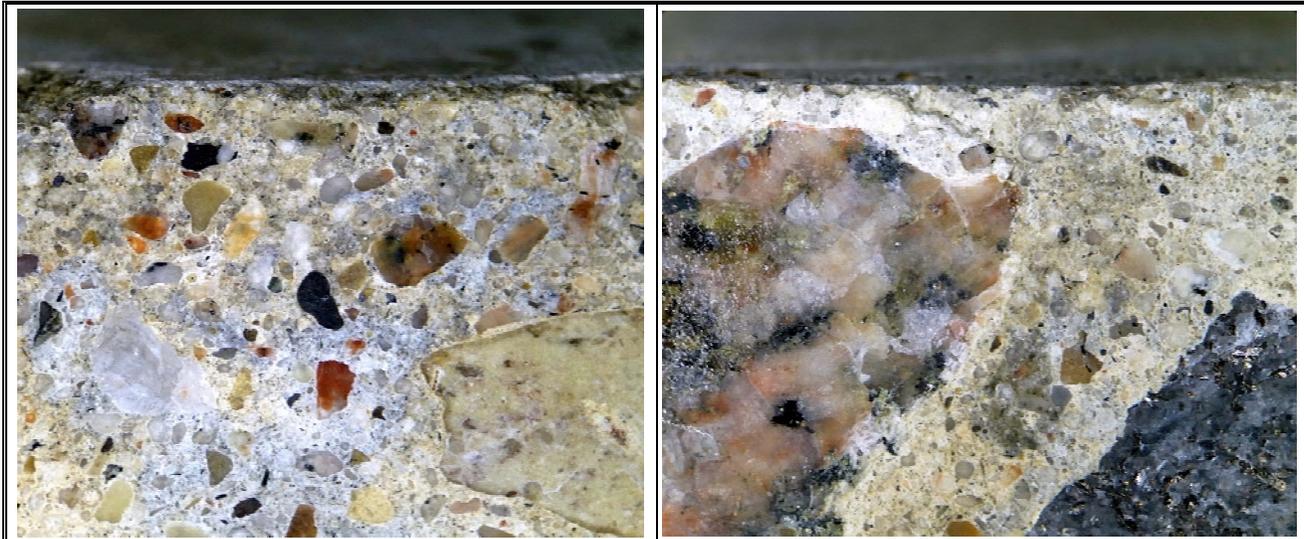
Views at upper/outer face of core, in profile, showing uneven discoloured paste at surface. Magn. 10x, fov = 13 mm

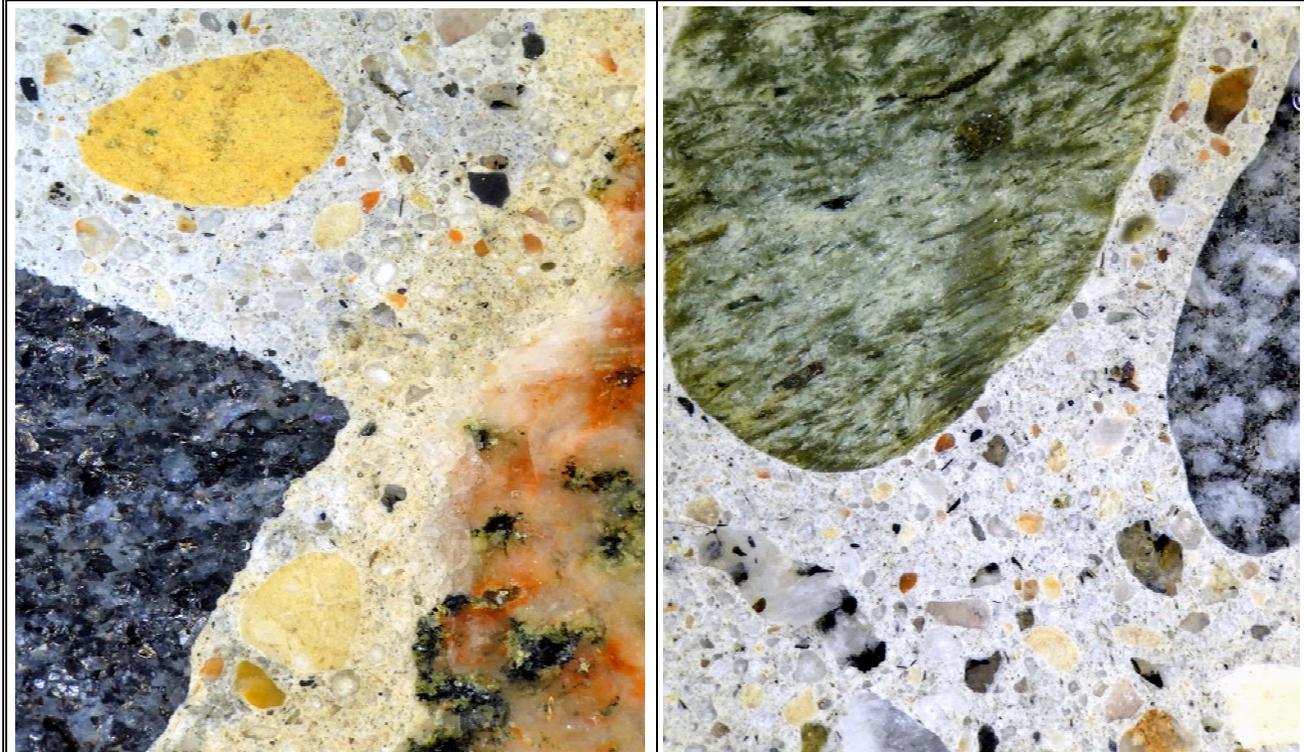
Discoloured, likely carbonated, cement paste at top of sample in left view contrasts with light grey paste seen in the right image, both at 10x magnification. Fields of view about 13 mm.

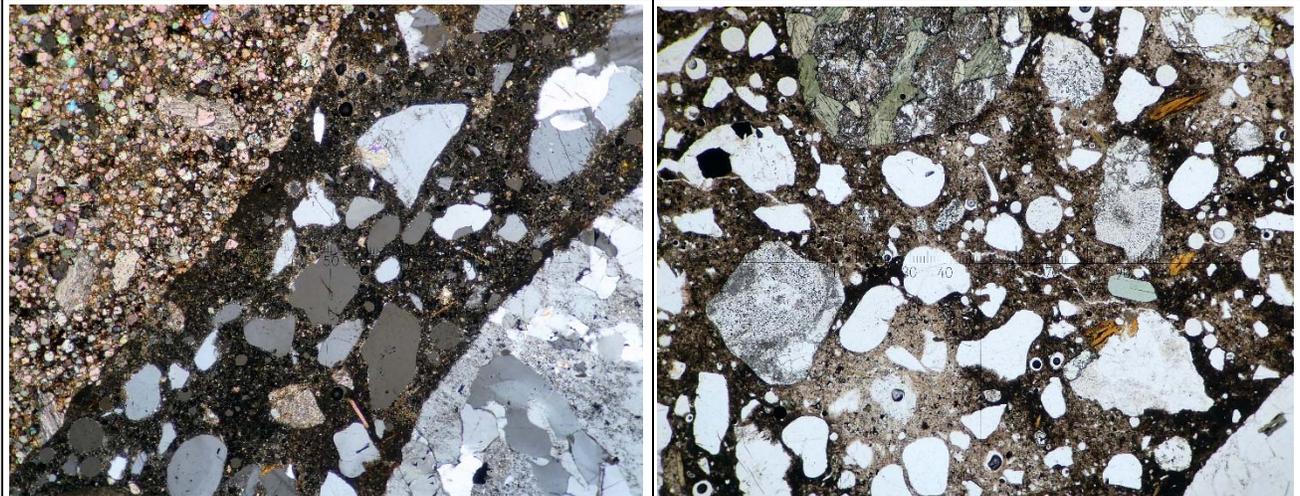
Sound paste is seen between dolomite particle on left and granite on right in this thin-section image; 50x magnification, field of view 3 mm across.

A microcrack is seen in this thin-section view extending through paste that exhibits variable carbonation. 50x.

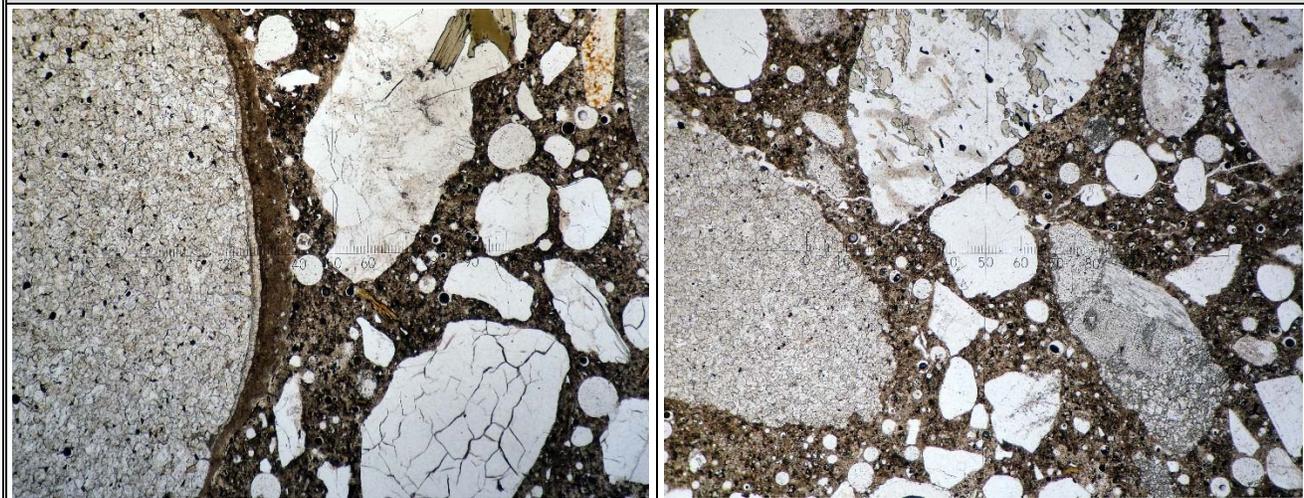
An encrustation of layered calcite is observed on the dolomite coarse aggregate seen at left in this thin-section view, set in dense paste. 50x magn. FOV – 3 mm.

A thin microcrack is observed passing through the paste in this view. 50x magnification.

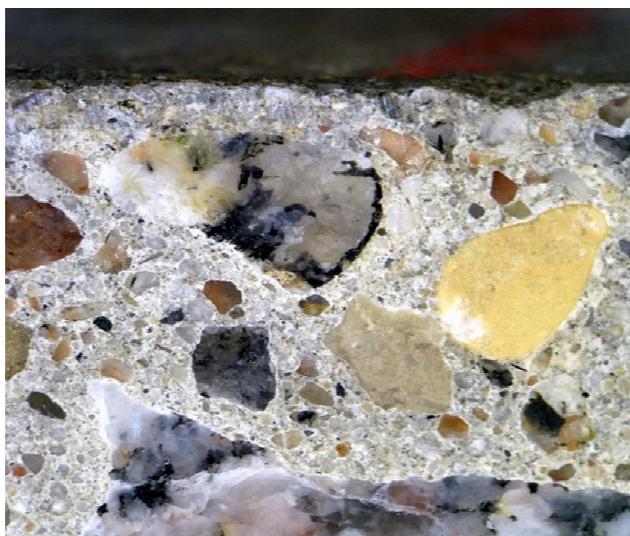
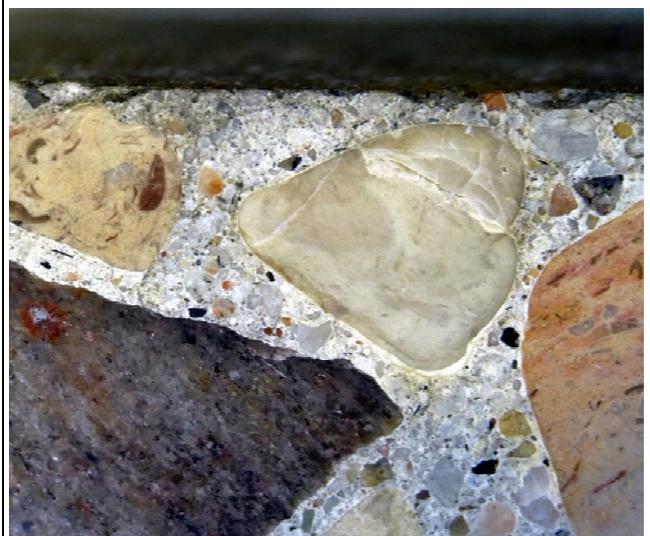
Views at upper/outer face of core, in profile, showing slight attrition paste. Magn. 10x, fov = 13 mm

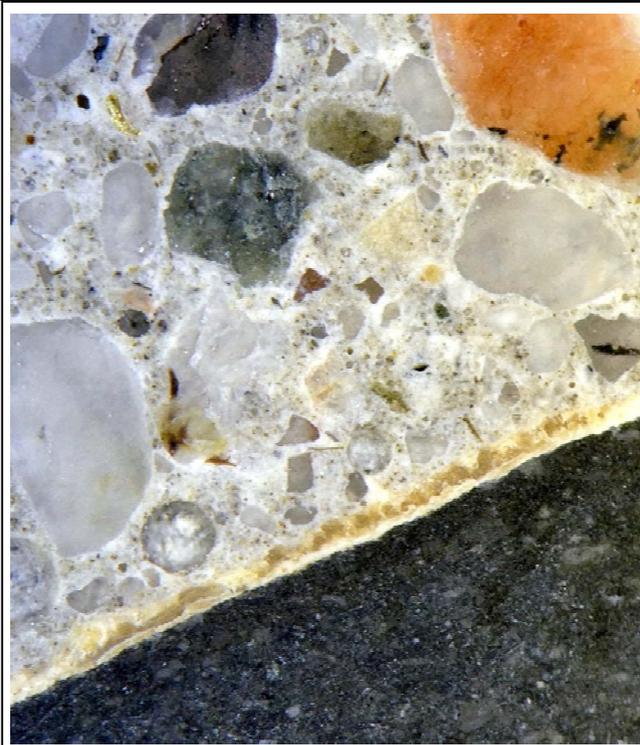
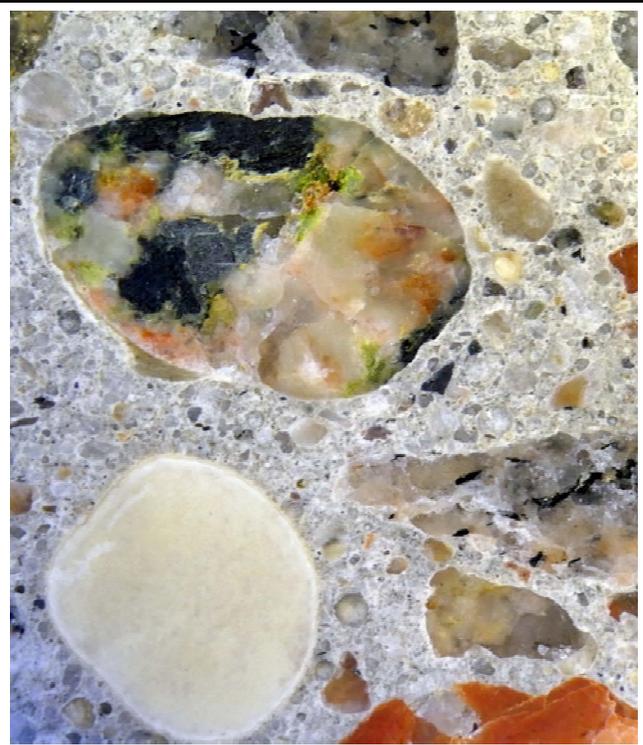
Views at 10x magnification illustrating (left) slight patches of discoloured paste, and (right) general condition of paste that encloses granite, gneiss, and limestone aggregates. Fields of view about 13 mm.

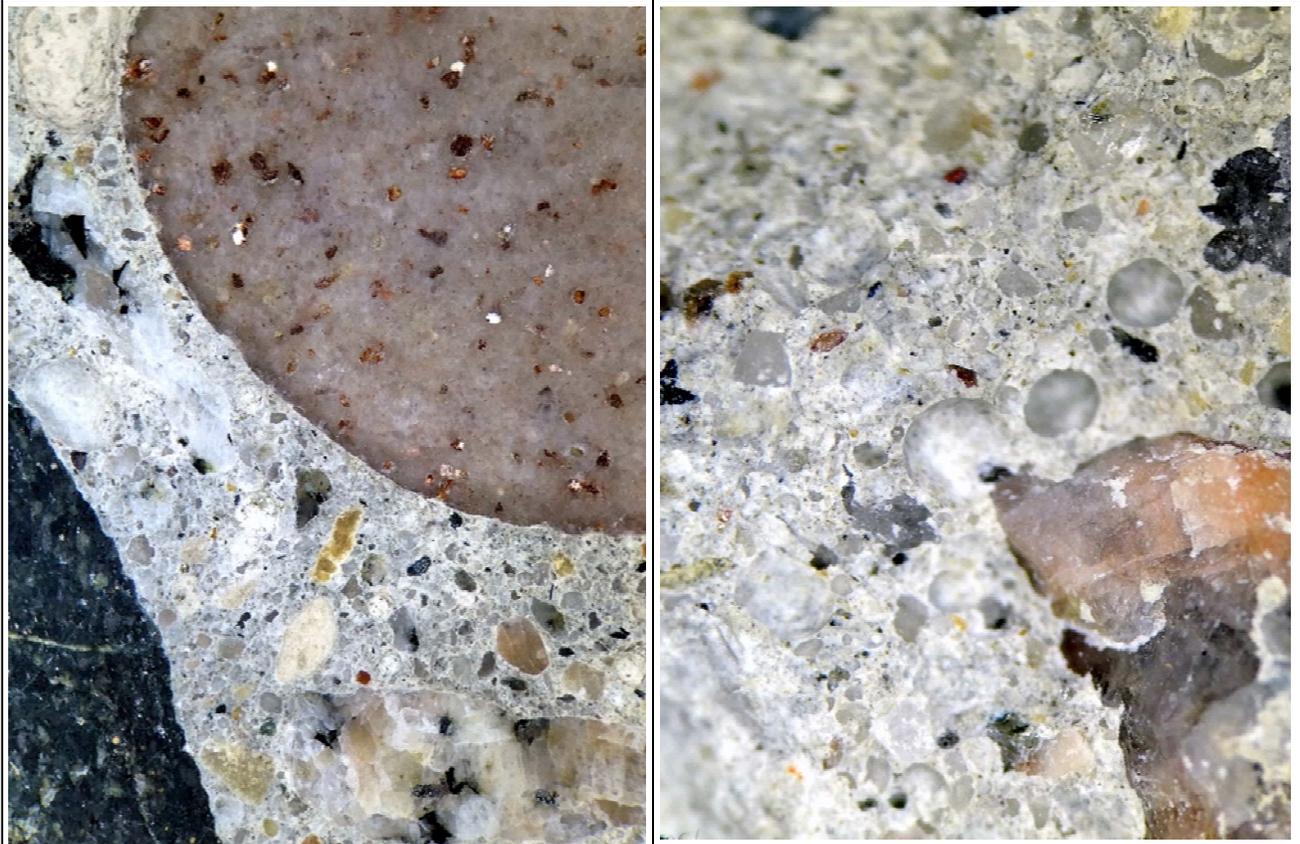
Sandstone coarse aggregate with a vague rim (left image) and view of a rough fractured surface (right image). 10x mag.

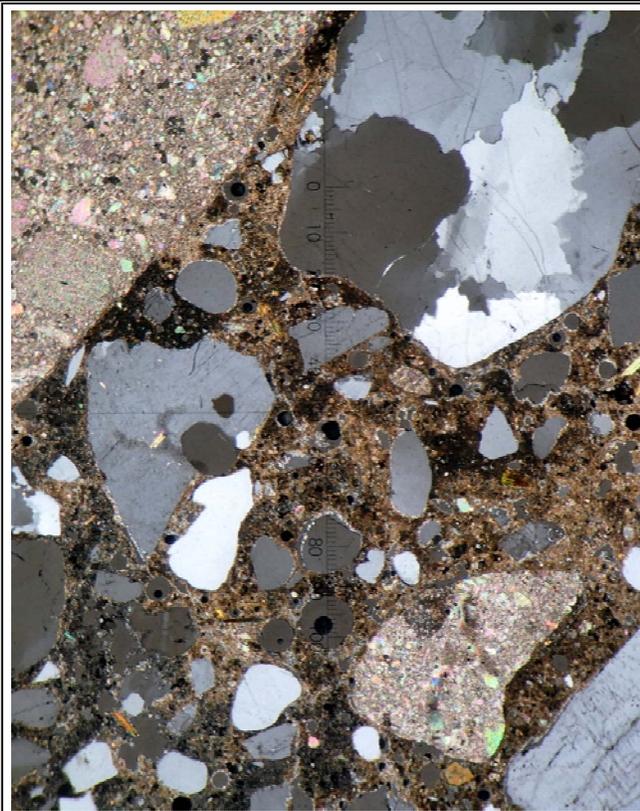
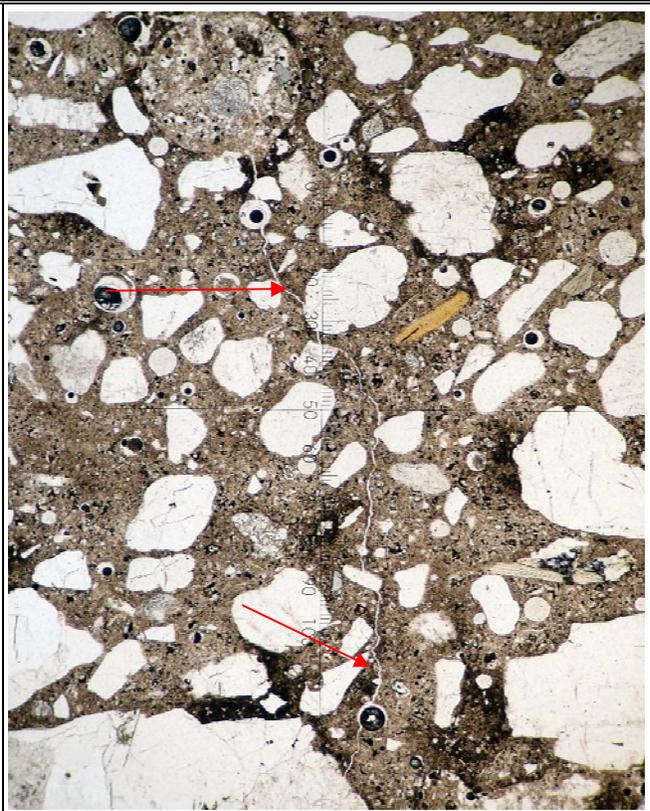
Thin-section, viewed in cross-polarized light illustrating generally dense paste containing a variety of lithologies as fine and coarse aggregates. 50x magnification, field of view 3 mm length.

Thin-section view in plane polarized light showing a very fine microcrack (red arrows) passing through the paste; 50x magnification, FOV 3 mm length.

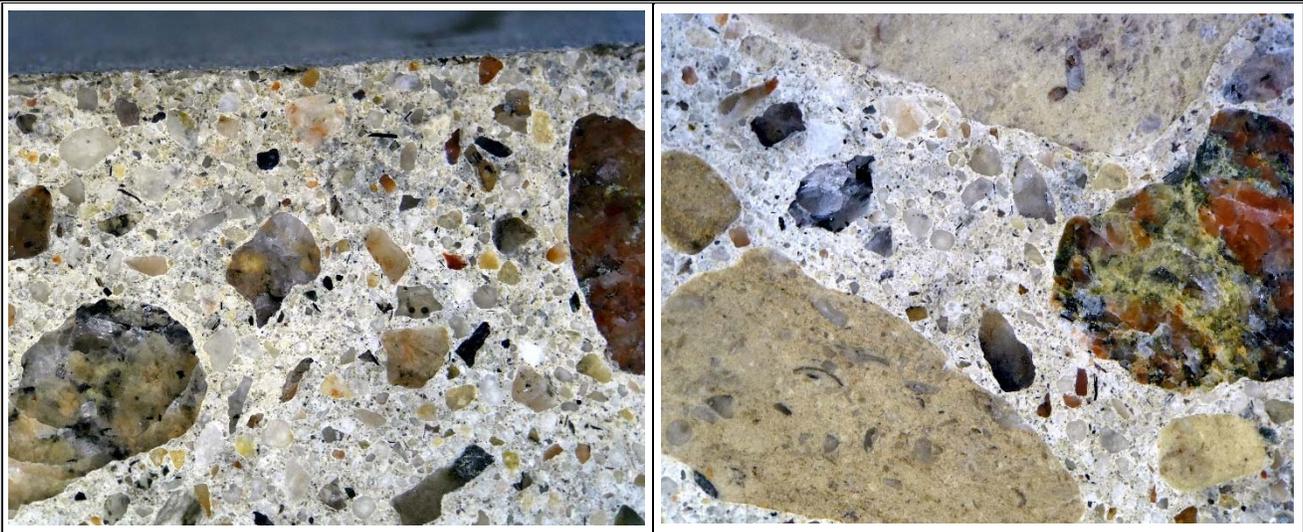
Views at 10x magnification showing profile at outer surface of core (left) and general view of paste and aggregates.. Fields of view about 13 mm.
