APPENDIX H: TETRA TECH GIRDER AND SUBSTRUCTURE CONDITION ASSESSMENT

Date: March 1, 2024

Project: Professional Consulting Services for Lagimodiere Blvd. Twin Overpasses Rehabilitation (Over Concordia Ave. and CPR Keewatin)

Subject: Bridge Condition Assessment Report

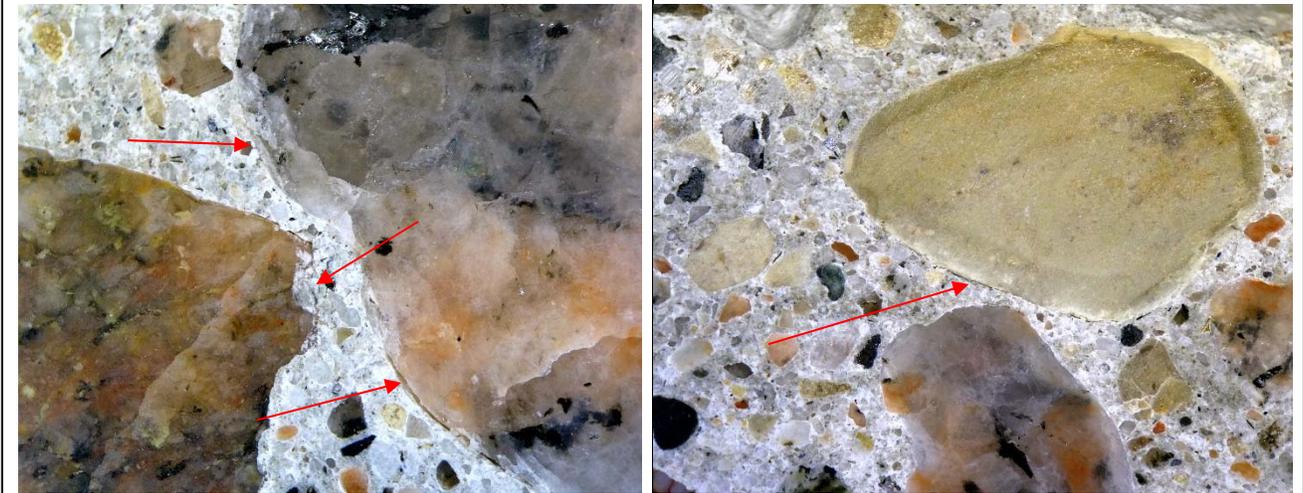
| Defects | A few water bleed cavities were observed adjacent aggregate particles. Instances of partial debonding of coarse aggregate from paste were also noted. Rare fine microcracks in paste; patches of carbonated paste. |

Coarse aggregate particles are partly debonded (arrows) from the paste. 10x mag.

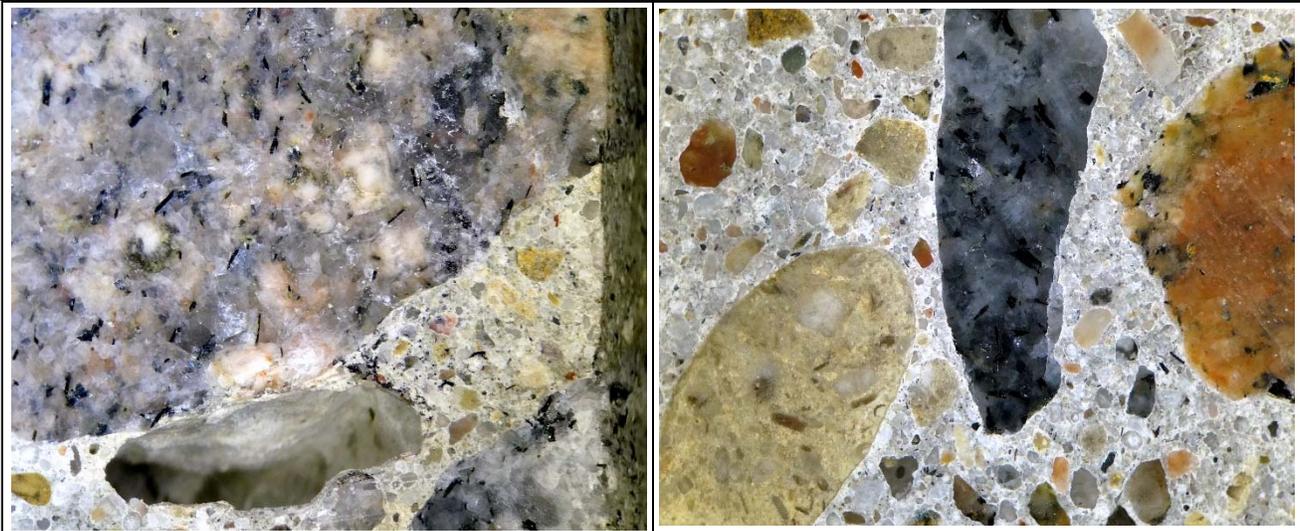
| Defects | A few entrapped air voids were observed adjacent aggregate particles. |

Views at 10x magnification showing entrapped air void adjacent gneiss coarse aggregate (left image) and general view of paste and aggregates. Fields of view about 13 mm.

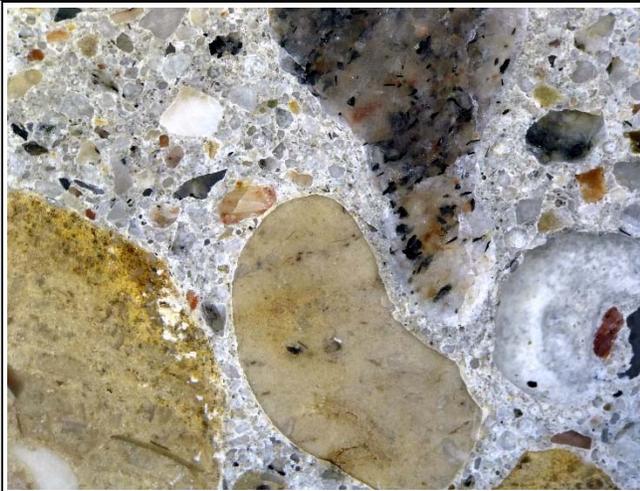
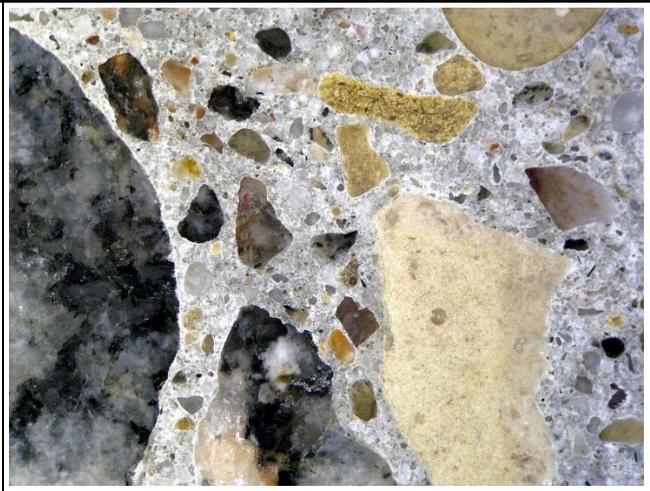
| Defects | A few entrapped air voids were observed adjacent aggregate particles. Minor microcracks in paste. |

Views at 10x magnification showing entrapped air void at right end of left image, and a general view of paste and aggregates in the right image. Fields of view about 13 mm.

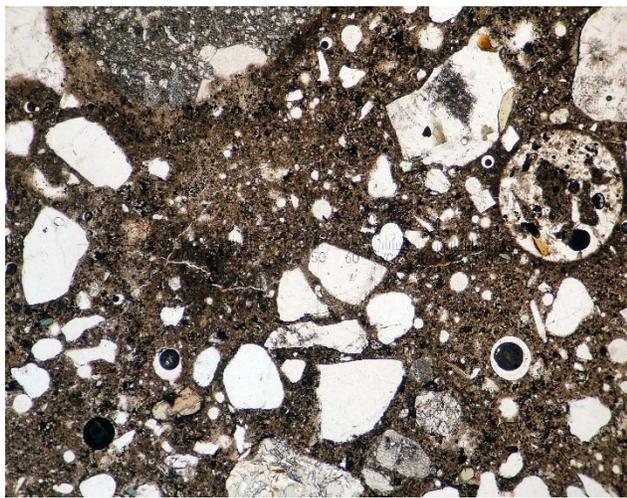
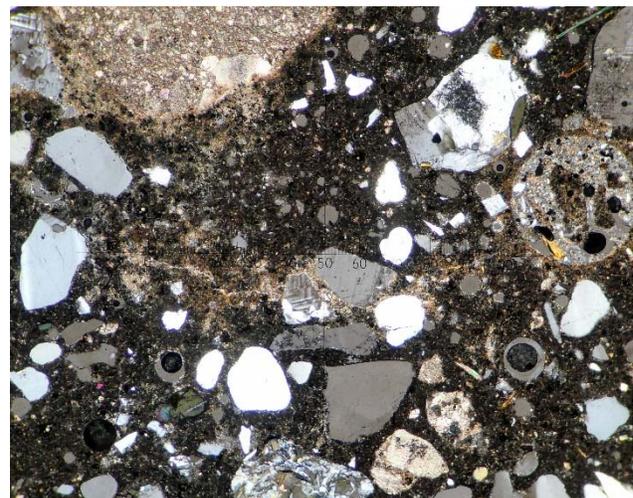
'Matched-pair' images in thin section, viewed in plane- (left) and cross-polarized light (right) illustrating microcracks in the paste; 50x magnification FOV of 3 mm.

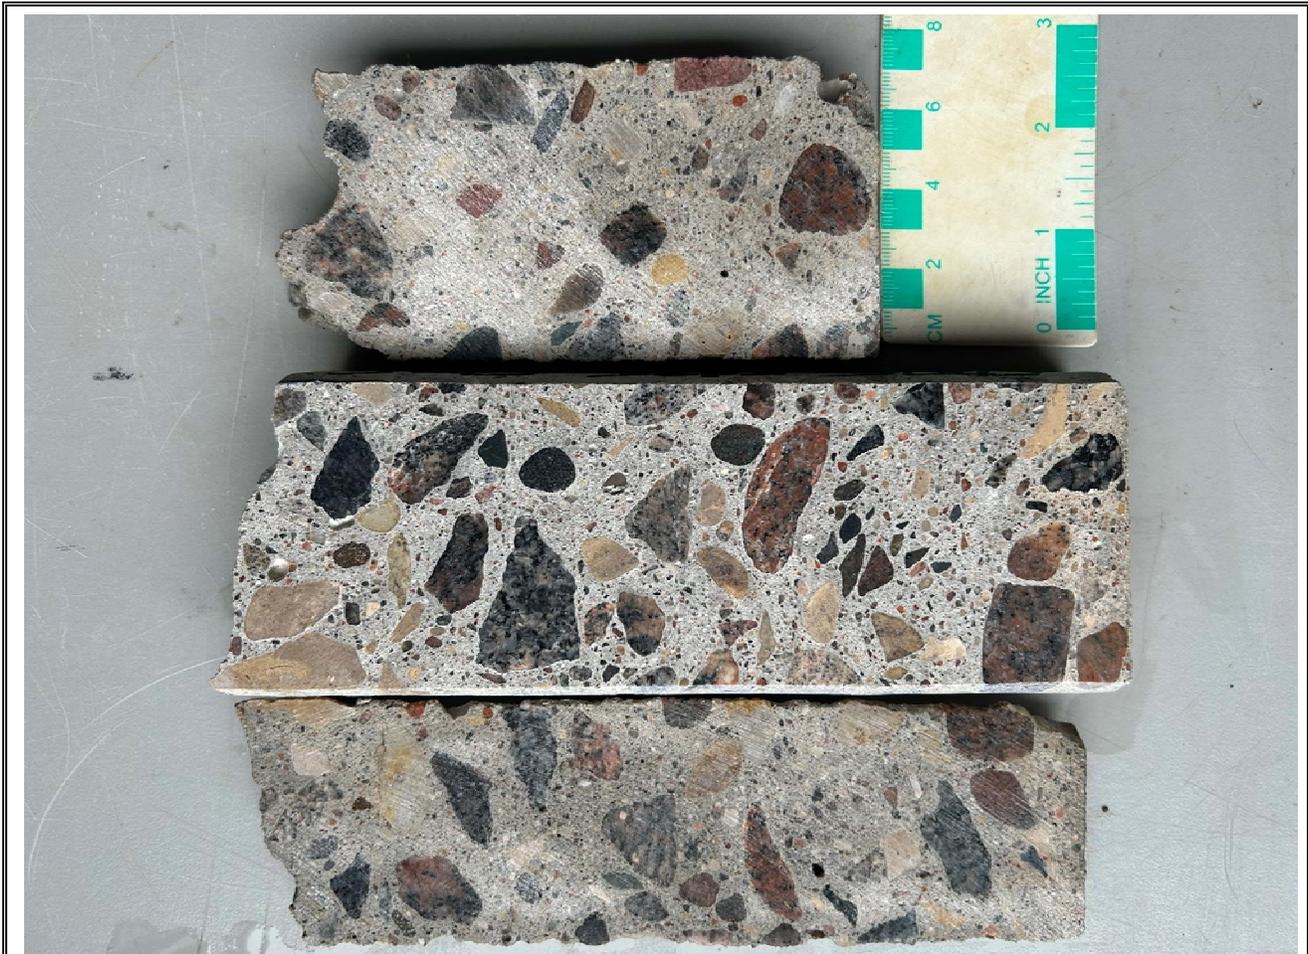
| Defects | Minor discoloured paste (carbonated) at outer 10 mm of core. Minor microcracking and carbonation in localized zones. |

Core after cutting and polishing. Note slightly discoloured paste zone at far right in polished (centre) slab.

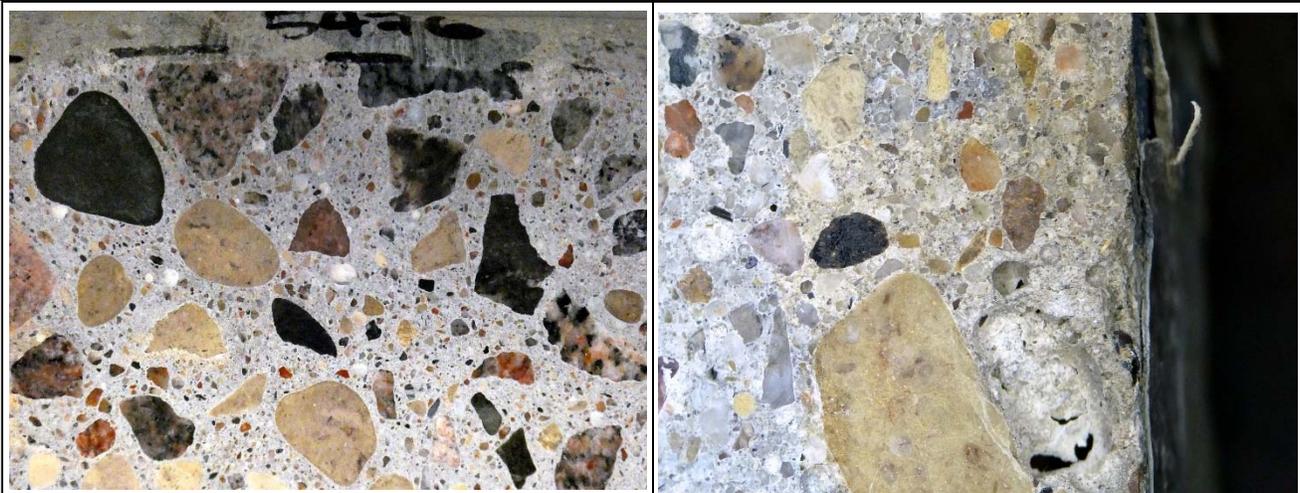
| Defects | A few entrapped air voids were observed adjacent aggregate particles. Slight discolouration of paste at core's outer edge. Rare microcracks in paste. |

Left: Detail view of the polished core surface, showing granitic, gneissic, quartzite and carbonate coarse aggregates in paste. Field of view about 90 mm.
Right: Profile view at top of core showing paint debonded slightly and brownish discolouration of paste to about 8 mm in this view. Mag. 10x, field of view about 13 mm.

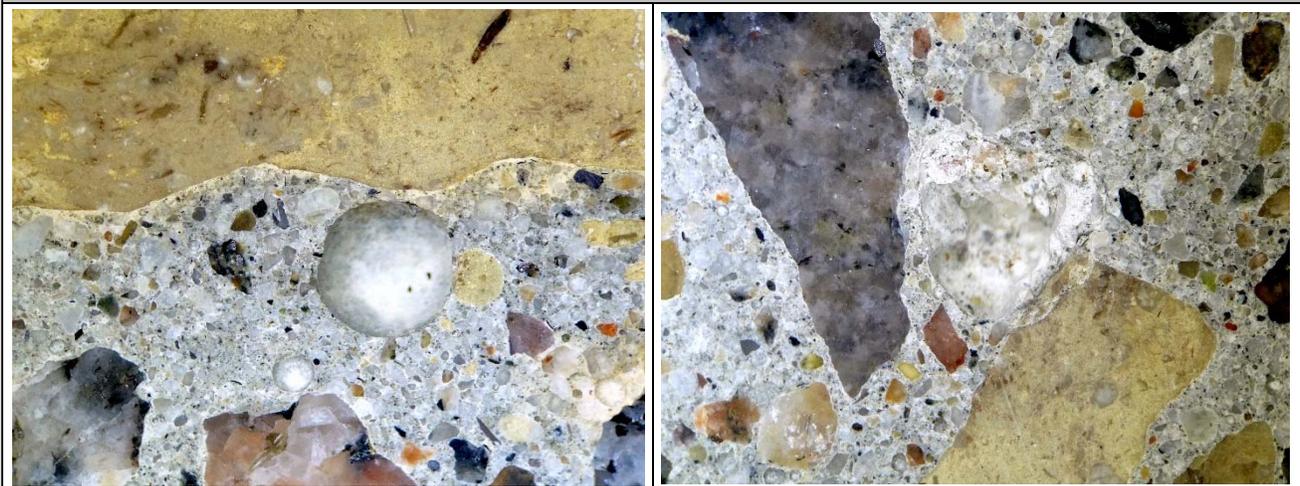
Views at 10x magnification showing entrapped air void; right image provides a general view of paste and aggregates. Fields of view about 13 mm.

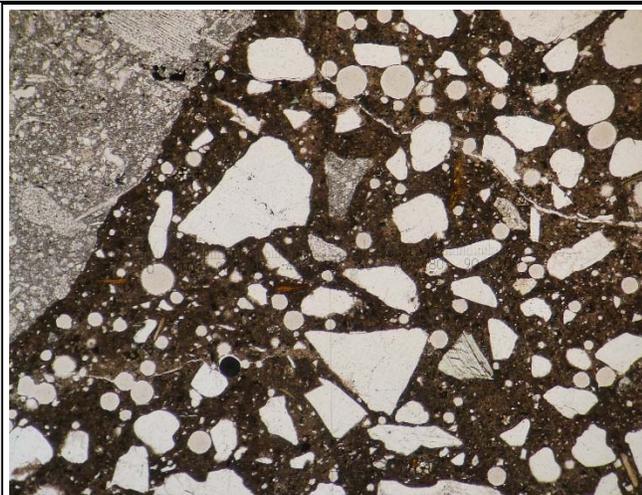
Microcrack in paste passes through the view, seen in thin-section. 50x magn.

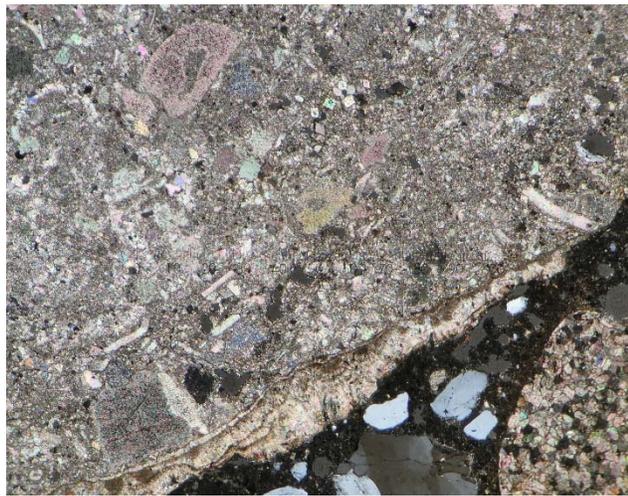
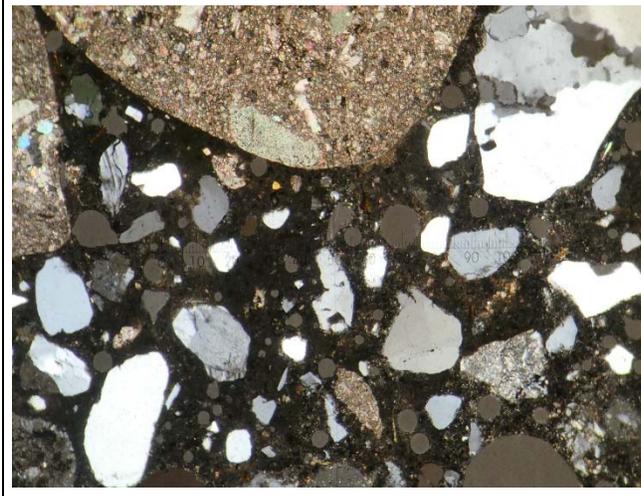
Two images in thin-section, viewed in cross-polarized light. Left image shows limestone coarse aggregate with encrusted layered calcite deposit, and right image illustrates dense paste. Both images at 50x magnification.
