## **PIPELINE ELECTROMAGNETIC INSPECTION REPORT**

## 600 mm Charleswood-Assiniboia Feeder Main

### Condition Assessment Report, Standard Analysis

**PICA Project: 8054**

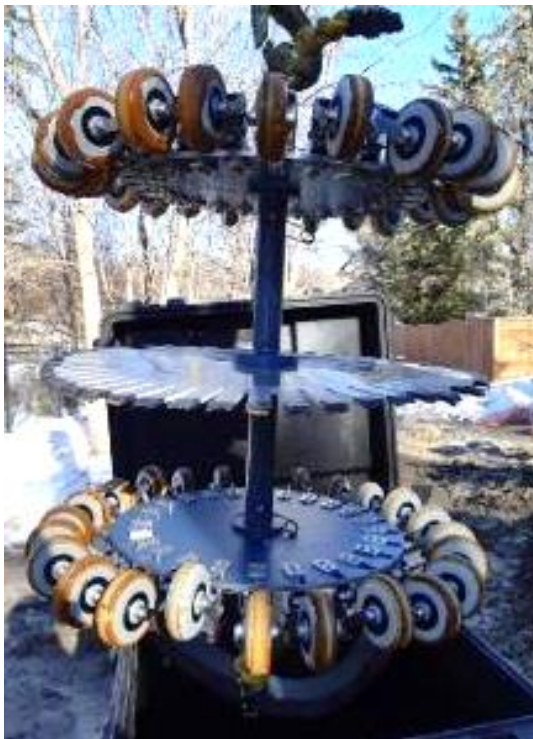
Before PICA's mobilization, the pipeline was gauged by J-Con using PICA's custom gauge assembly to confirm the minimum bore and ensure the 24-inch Chimera RFT ILI tool could safely navigate the Charleswood-Assiniboia Feeder Main. Figure 5 shows the gauge tool after being pulled through the Feeder Main. Minor deflections were observed on the gauge fins, but no major bore restrictions were indicated that would prevent tool passage. A tagline was left in the pipe after the gauging activities were completed, for use during the RFT inspection mobilization.

Figure 5. PICA's custom gauge tool assembly shown after being pulled through the Charleswood-Assiniboia Feeder Main
