GEOTECHNICAL REPORT

Geotechnical Report for Ness Avenue

Project No.: STA-701	Drawn By: SD	Testhole Location Plan 2007 Regional and Residential Streets Program Ness Avenue Belvidere Street to Moorgate Street
	Date: Jan. 30, 2007	Scale: NTS

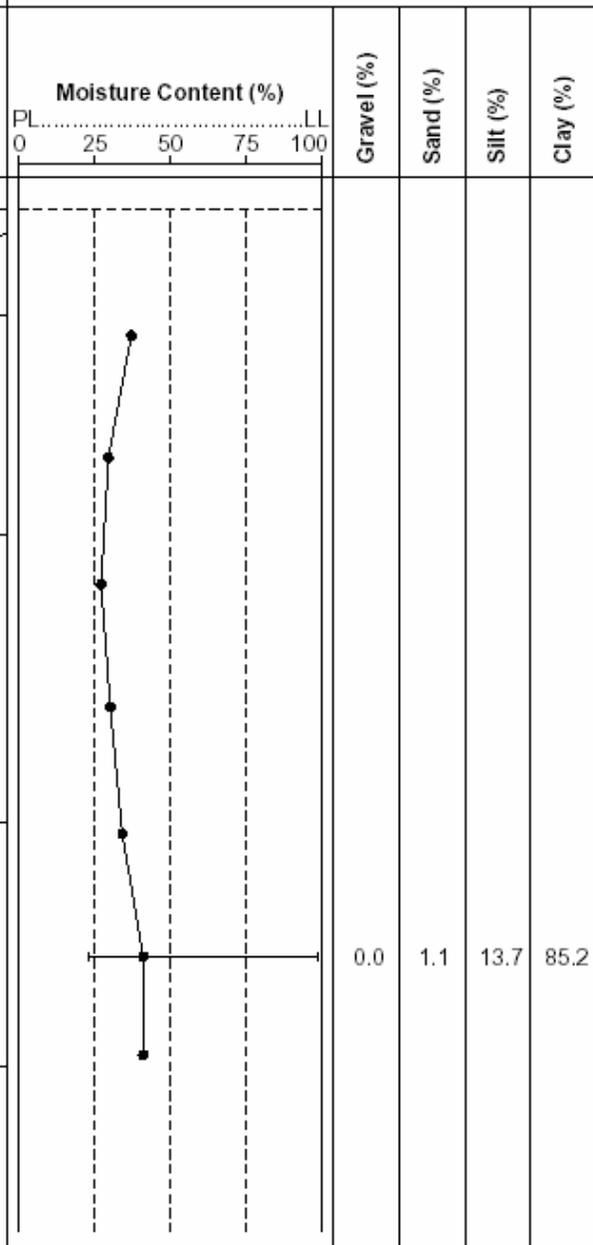
Test Hole Log for Test Hole 4

Subsurface Profile			Laboratory Testing					
Depth (m)	Symbol	Description	Moisture Content (%)		Gravel (%)	Sand (%)	Silt (%)	Clay (%)
			PL	LL				
0.0		Ground Surface						
		Asphalt						
		Concrete						
0.5		Clay - black/grey, moist, firm, high plasticity, some silt, trace fine grained gravel and fine to coarse grained sand at the surface - light grey below 0.6 m, intermediate plasticity, with silt						
1.0		Clayey Silt - tan, moist, soft to firm, low plasticity, with clay						
1.5		Clay - brown, moist, firm, high plasticity, some silt						
2.0					0.0	1.1	13.7	85.2
2.5		End of testhole at 2.1 m below grade. No water seepage or soil sloughing were observed during or after the completion of drilling.

TESTHOLE TH4

Project Name: 2007 Regional and Residential Streets Program
 Client: Stantec Consulting Ltd.
 Site: Ness Avenue, Belvidere Street to Moorgate Street
 Testhole Location: WB, 17.5 m E of the W property line of 393 Guildford St., 2.0 m S of the N curb

Date Drilled: January 17, 2007
 Depth of Testhole: 2.1 m
 Logged by: Kurtis Kulchyski

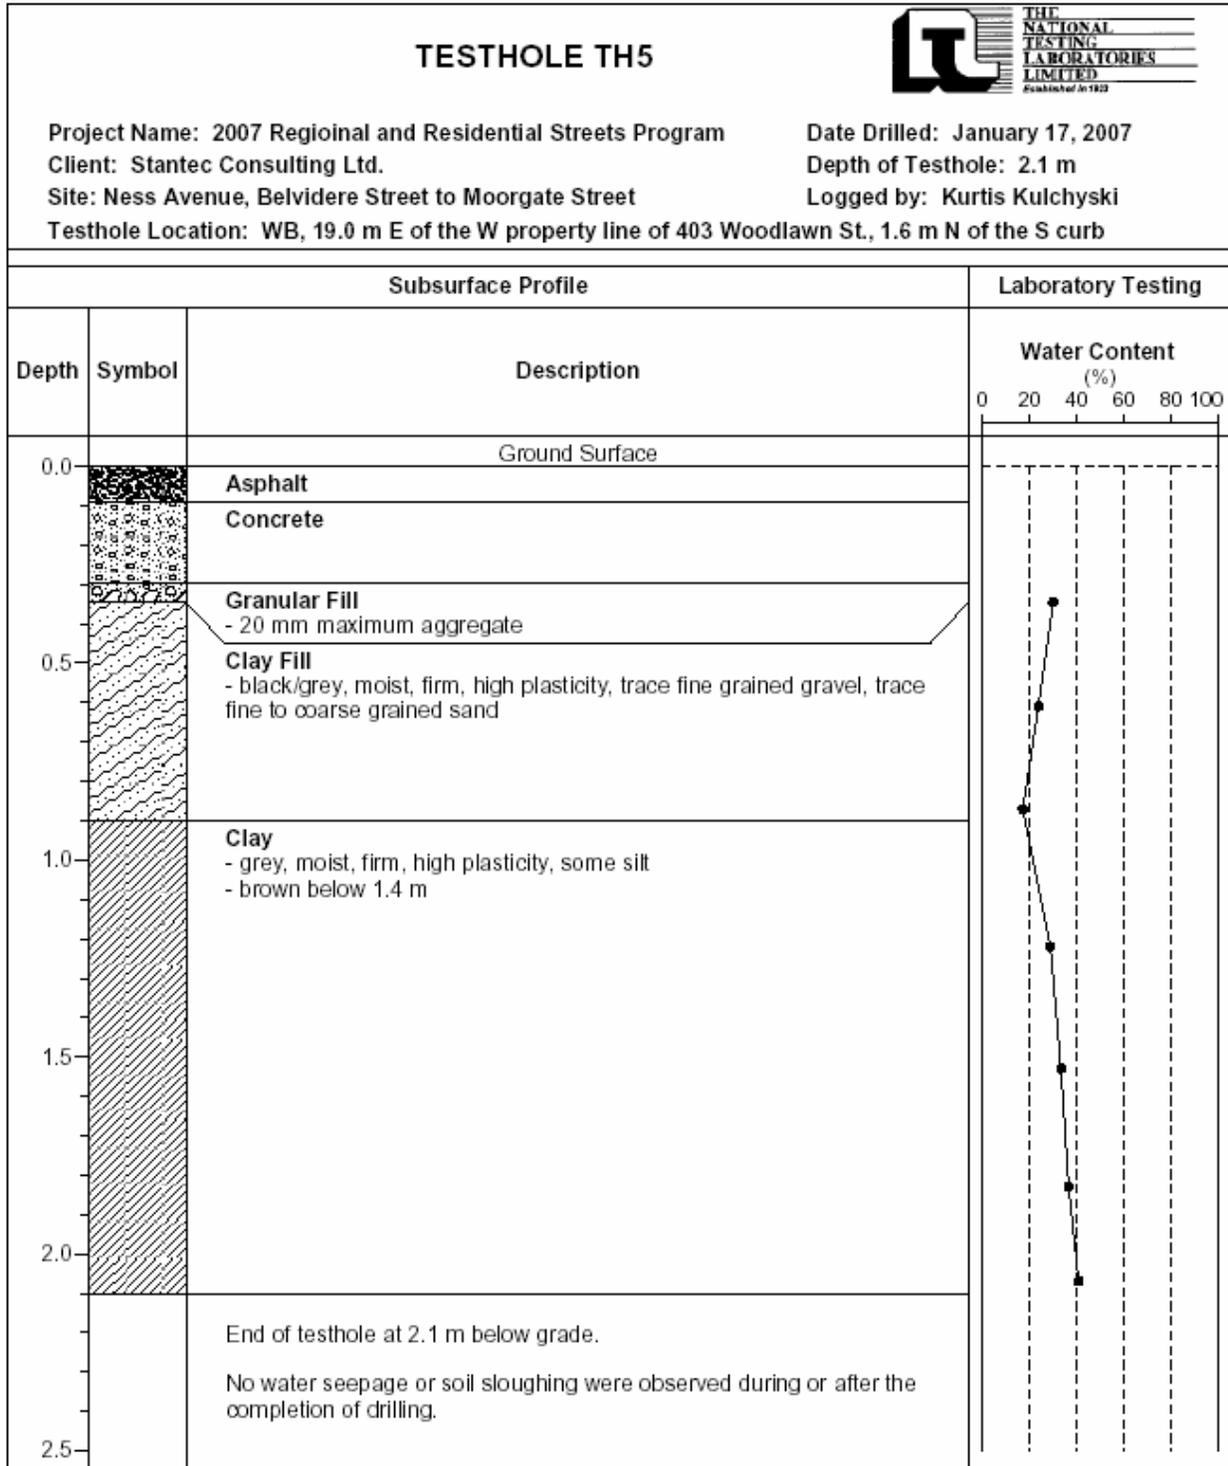
Test Hole Log for Test Hole 5

TESTHOLE TH5

Project Name: 2007 Regional and Residential Streets Program
Client: Stantec Consulting Ltd.
Site: Ness Avenue, Belvidere Street to Moorgate Street
Testhole Location: WB, 19.0 m E of the W property line of 403 Woodlawn St., 1.6 m N of the S curb

Date Drilled: January 17, 2007
Depth of Testhole: 2.1 m
Logged by: Kurtis Kulchyski
