**THE CITY OF WINNIPEG**  
WATER AND WASTE DEPARTMENT  
ENGINEERING DIVISION  
WILKES RESERVOIR NORTH CELL REHABILITATION  
CONCRETE REPAIRS  
SECTIONS AND DETAILS, SHEET 2 OF 2  
CONSTRUCTION PROCEDURE NOTES  
CONSULTANT DRAWING NUMBER: 14-1411-S-105  
SHEET 13 OF 47  
CITY DRAWING NUMBER: 1-0650R-S0005-002

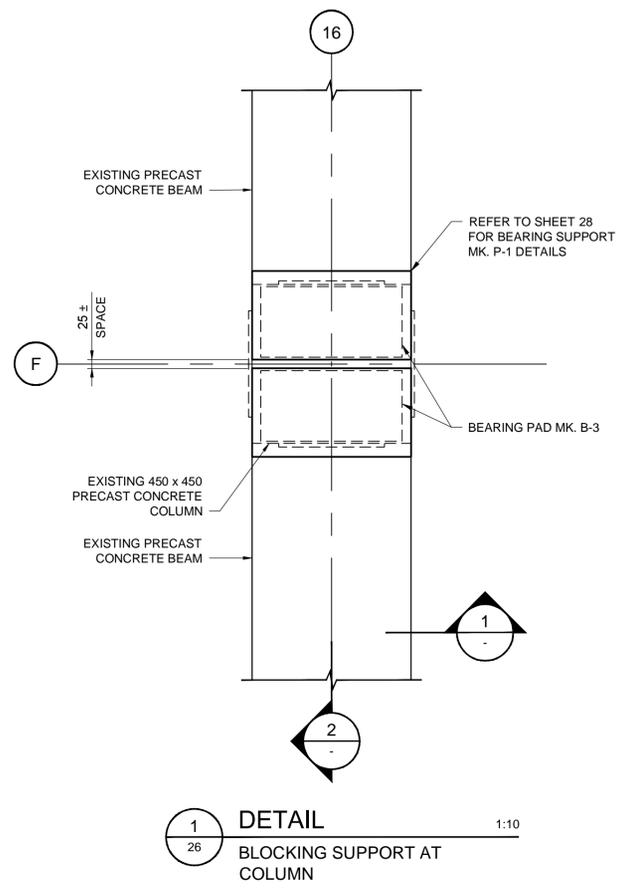
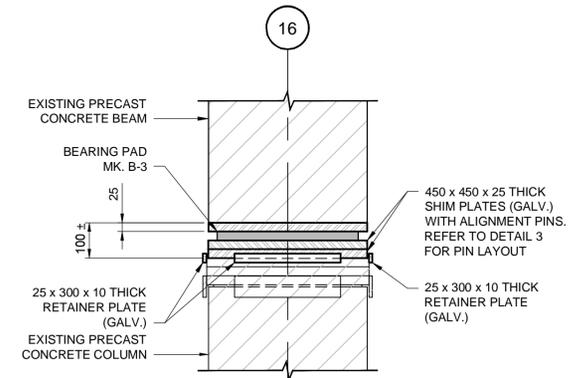
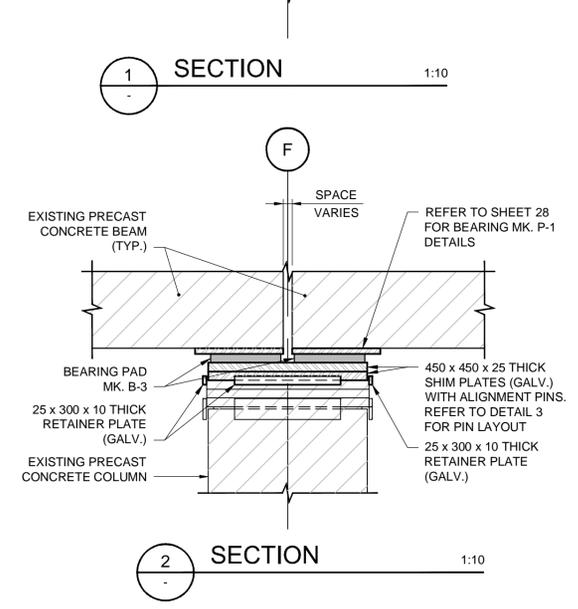
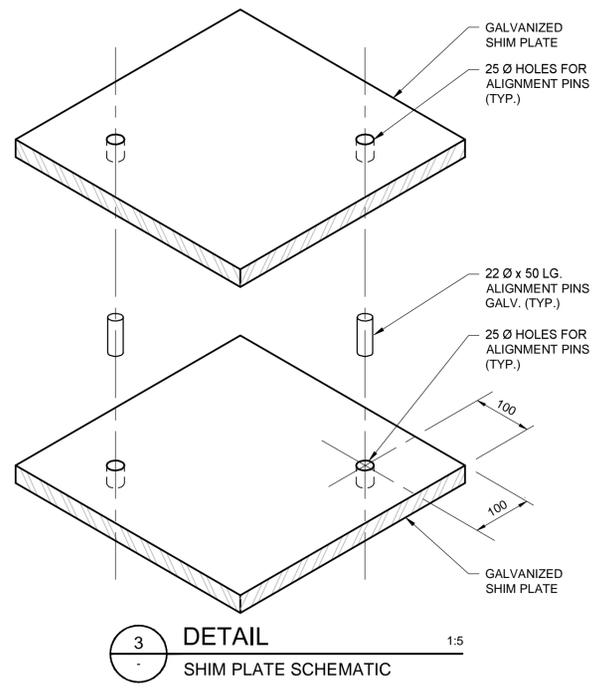
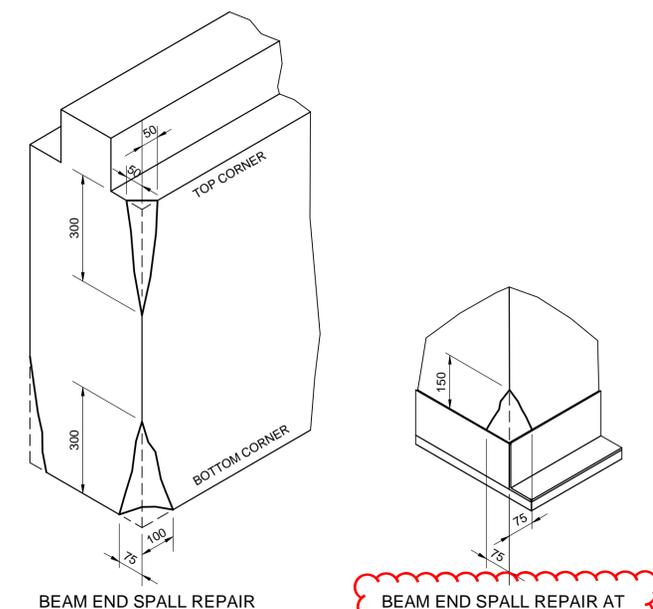
- BEAM END SPALL REPAIRS - CONSTRUCTION PROCEDURE NOTES:**
- CLEAN EXPOSED BEAM ENDS, SIDES, AND BOTTOMS BY SANDBLASTING TO REMOVE OLD COATINGS AND SURFACE CONTAMINANTS EXPOSING THE FINE AGGREGATE TO SCP 5-7.

- TYPICAL BEAM END SPALLS FOR TOP, BOTTOM CORNER AND ABOVE BEARING PLATE P-3 AND P-6 REPAIRED IN ACCORDANCE WITH THE SPECIFICATIONS.
  - BEAMS WITH EXISTING GROUT PATCHES OR CRACKS SHALL BE SOUNDED AND DETERIORATED MATERIAL REMOVED. PRIOR TO JACKING, IF NEW BEAM SPALLS OR FURTHER BEAM END DETERIORATION IS OBSERVED, INFORM THE CONTRACT ADMINISTRATOR IMMEDIATELY. ANY WORK DEEMED AN EXTRA BY THE CONTRACT ADMINISTRATOR SHALL BE DEEMED EXTRA WORK AND PAID FOR ON A UNIT BASIS IN ACCORDANCE WITH THE SPECIFICATIONS.

- BEAM END SPALL REPAIRS SHALL FOLLOW THE INSTALLATION OF THE NEW BEARING PLATES AND BEARING PADS. THE EXPOSED SPALLS SHALL BE PATCHED WITH SPECIFIED VERTICAL NON-SAG REPAIR MORTAR. THIS REPAIR MORTAR DOES NOT REQUIRE FORMING AND SHALL BE MIXED, APPLIED AND CURED IN ACCORDANCE WITH THE MANUFACTURER'S SPECIFICATIONS.

- BEARING BLOCKING CONSTRUCTION PROCEDURE NOTES:**
- REFER TO SHEET 12 FOR CONCRETE FOOTING SUPPORT REPAIR DETAILS AND CONSTRUCTION PROCEDURES.
  - ONCE CONCRETE HAS CURED FOR A MINIMUM OF SEVEN (7) DAYS, INSTALL BEARING PAD, NEW BEARING PLATE AND BLOCKING.
