Mould Remediation

Scope of Work Rev 2

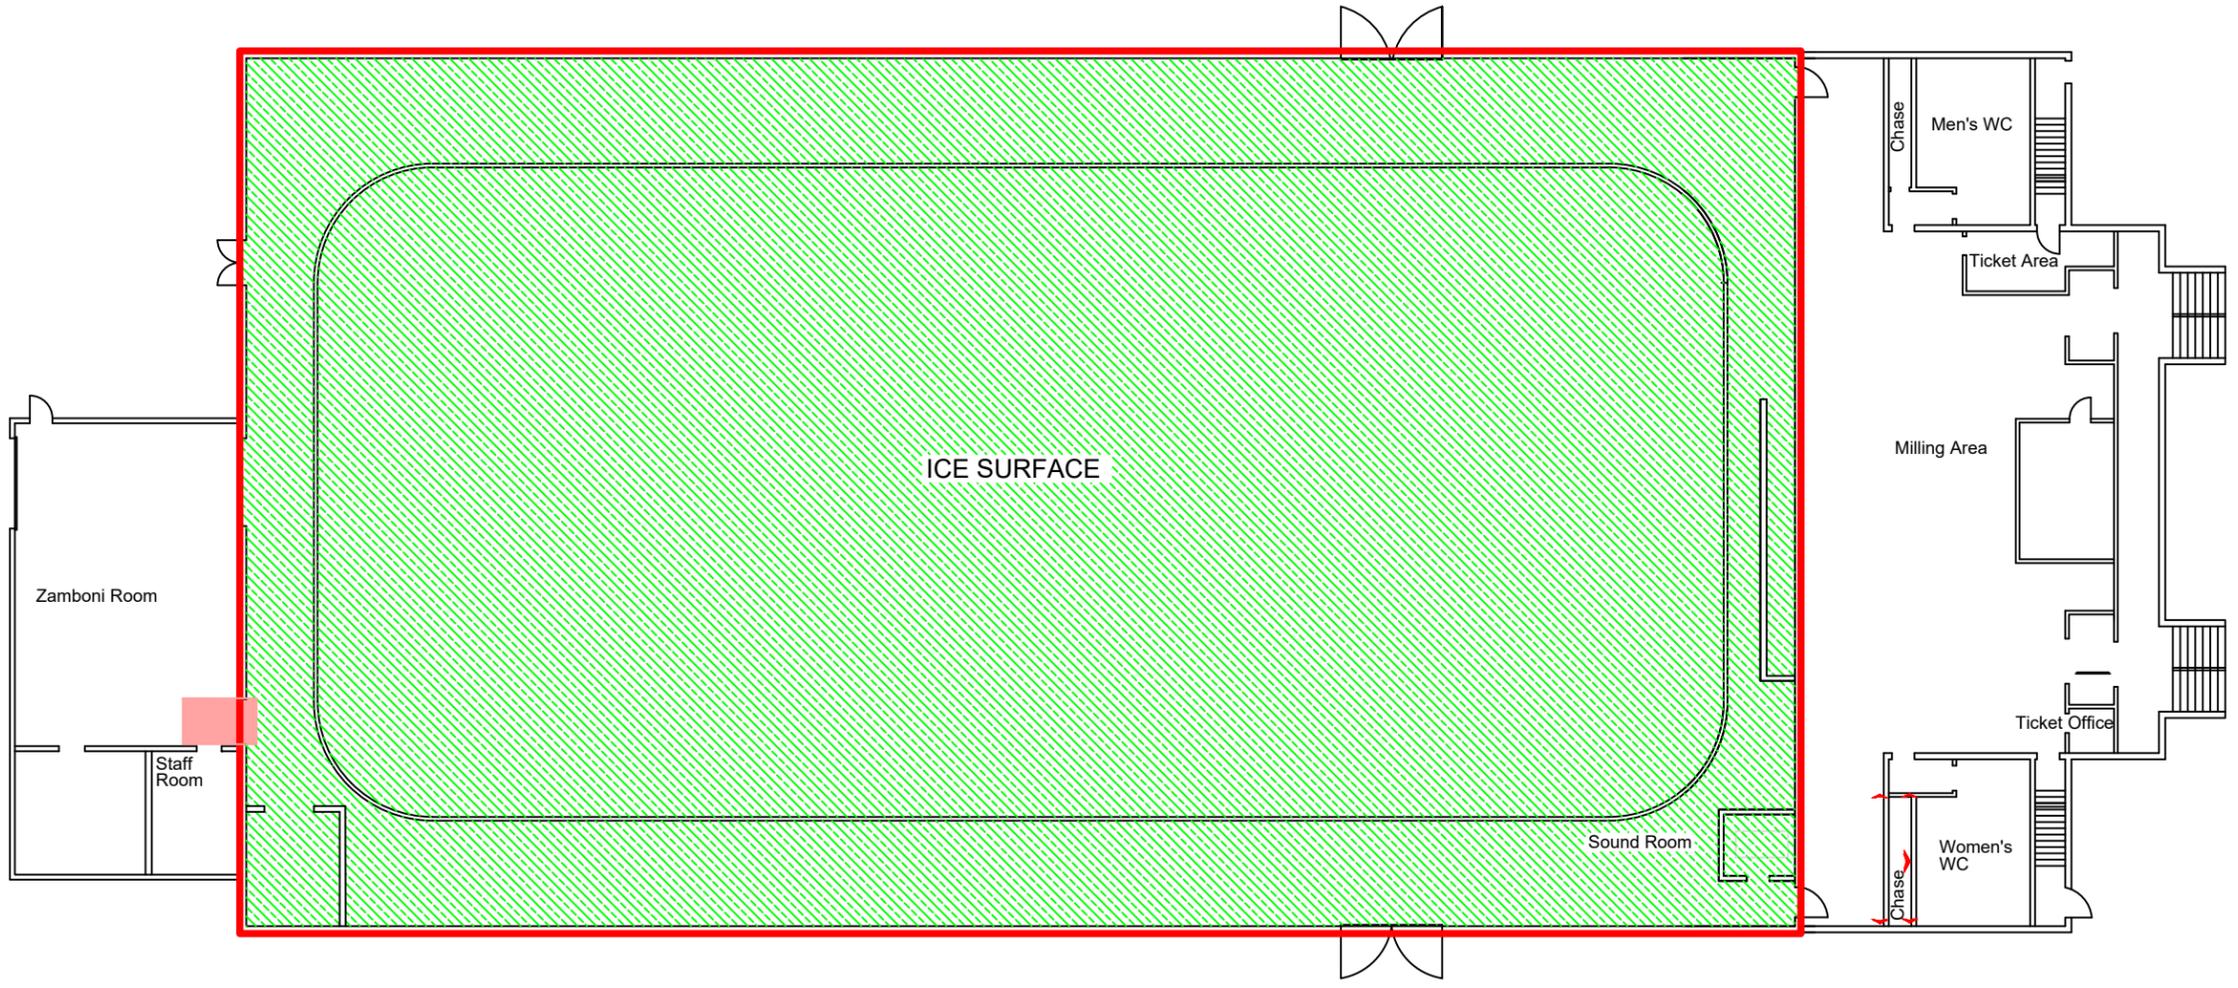
DATE: APR 2023	FIGURE NUMBER: 1 OF 1
-------------------	--------------------------

KEYNOTES:

1. WASHROOM IS LOCATED IN THE BASEMENT AREA. NO ACCESS IS ALLOWED TO THE SOUTH SIDE OF THE ARENA. SECONDARY AIRLOCK WILL NEED TO BE ESTABLISHED FOR ENTRY AND EXIT TO THE BASEMENT

- .1 Mould growth is present on the underside of the wood roof deck throughout the ice surface area of the arena at location identified on the attached Drawing.

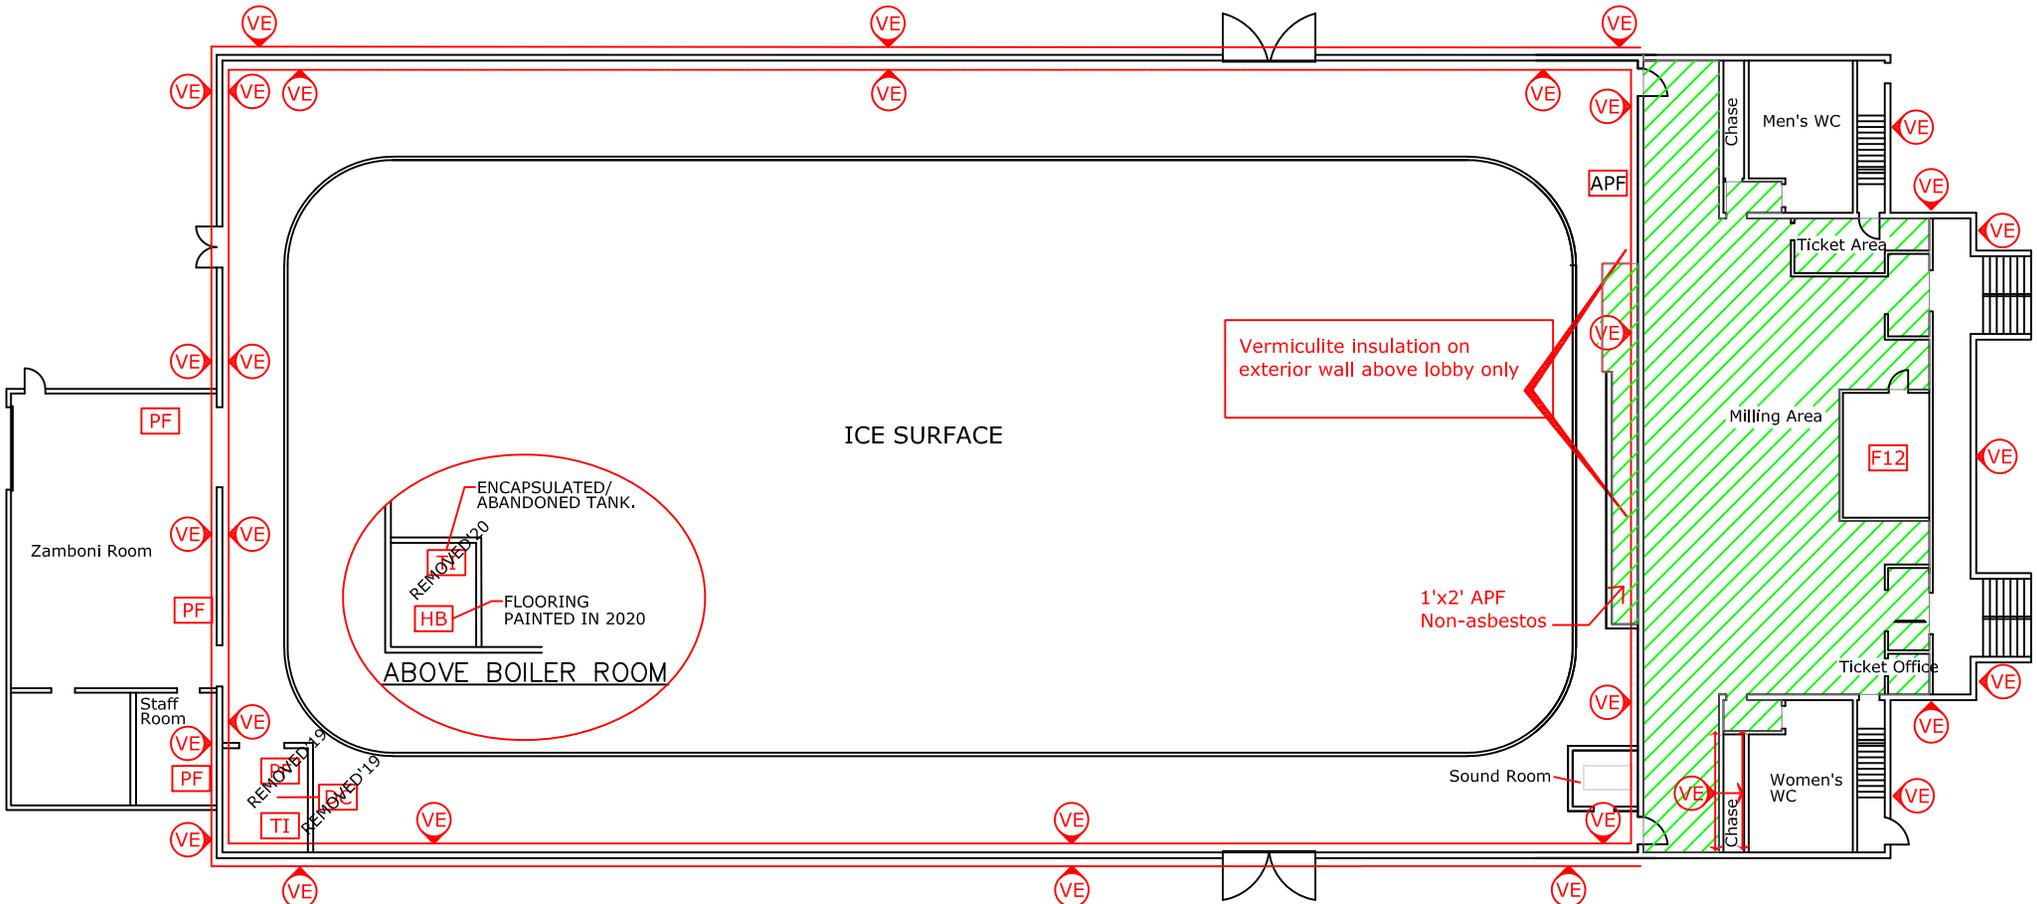
FLOOR PLAN

SCALE: NTS
