Mould Remediation

St. Vital Centennial Arena, 580 St. Annes Road, Winnipeg, Manitoba
City of Winnipeg Job No. 2022-103

**MOULD REMEDIATION
JON NO. 2022-103**

**ST. VITAL CENTENNIAL ARENA
580 ST. ANNES ROAD
WINNIPEG, MANITOBA**

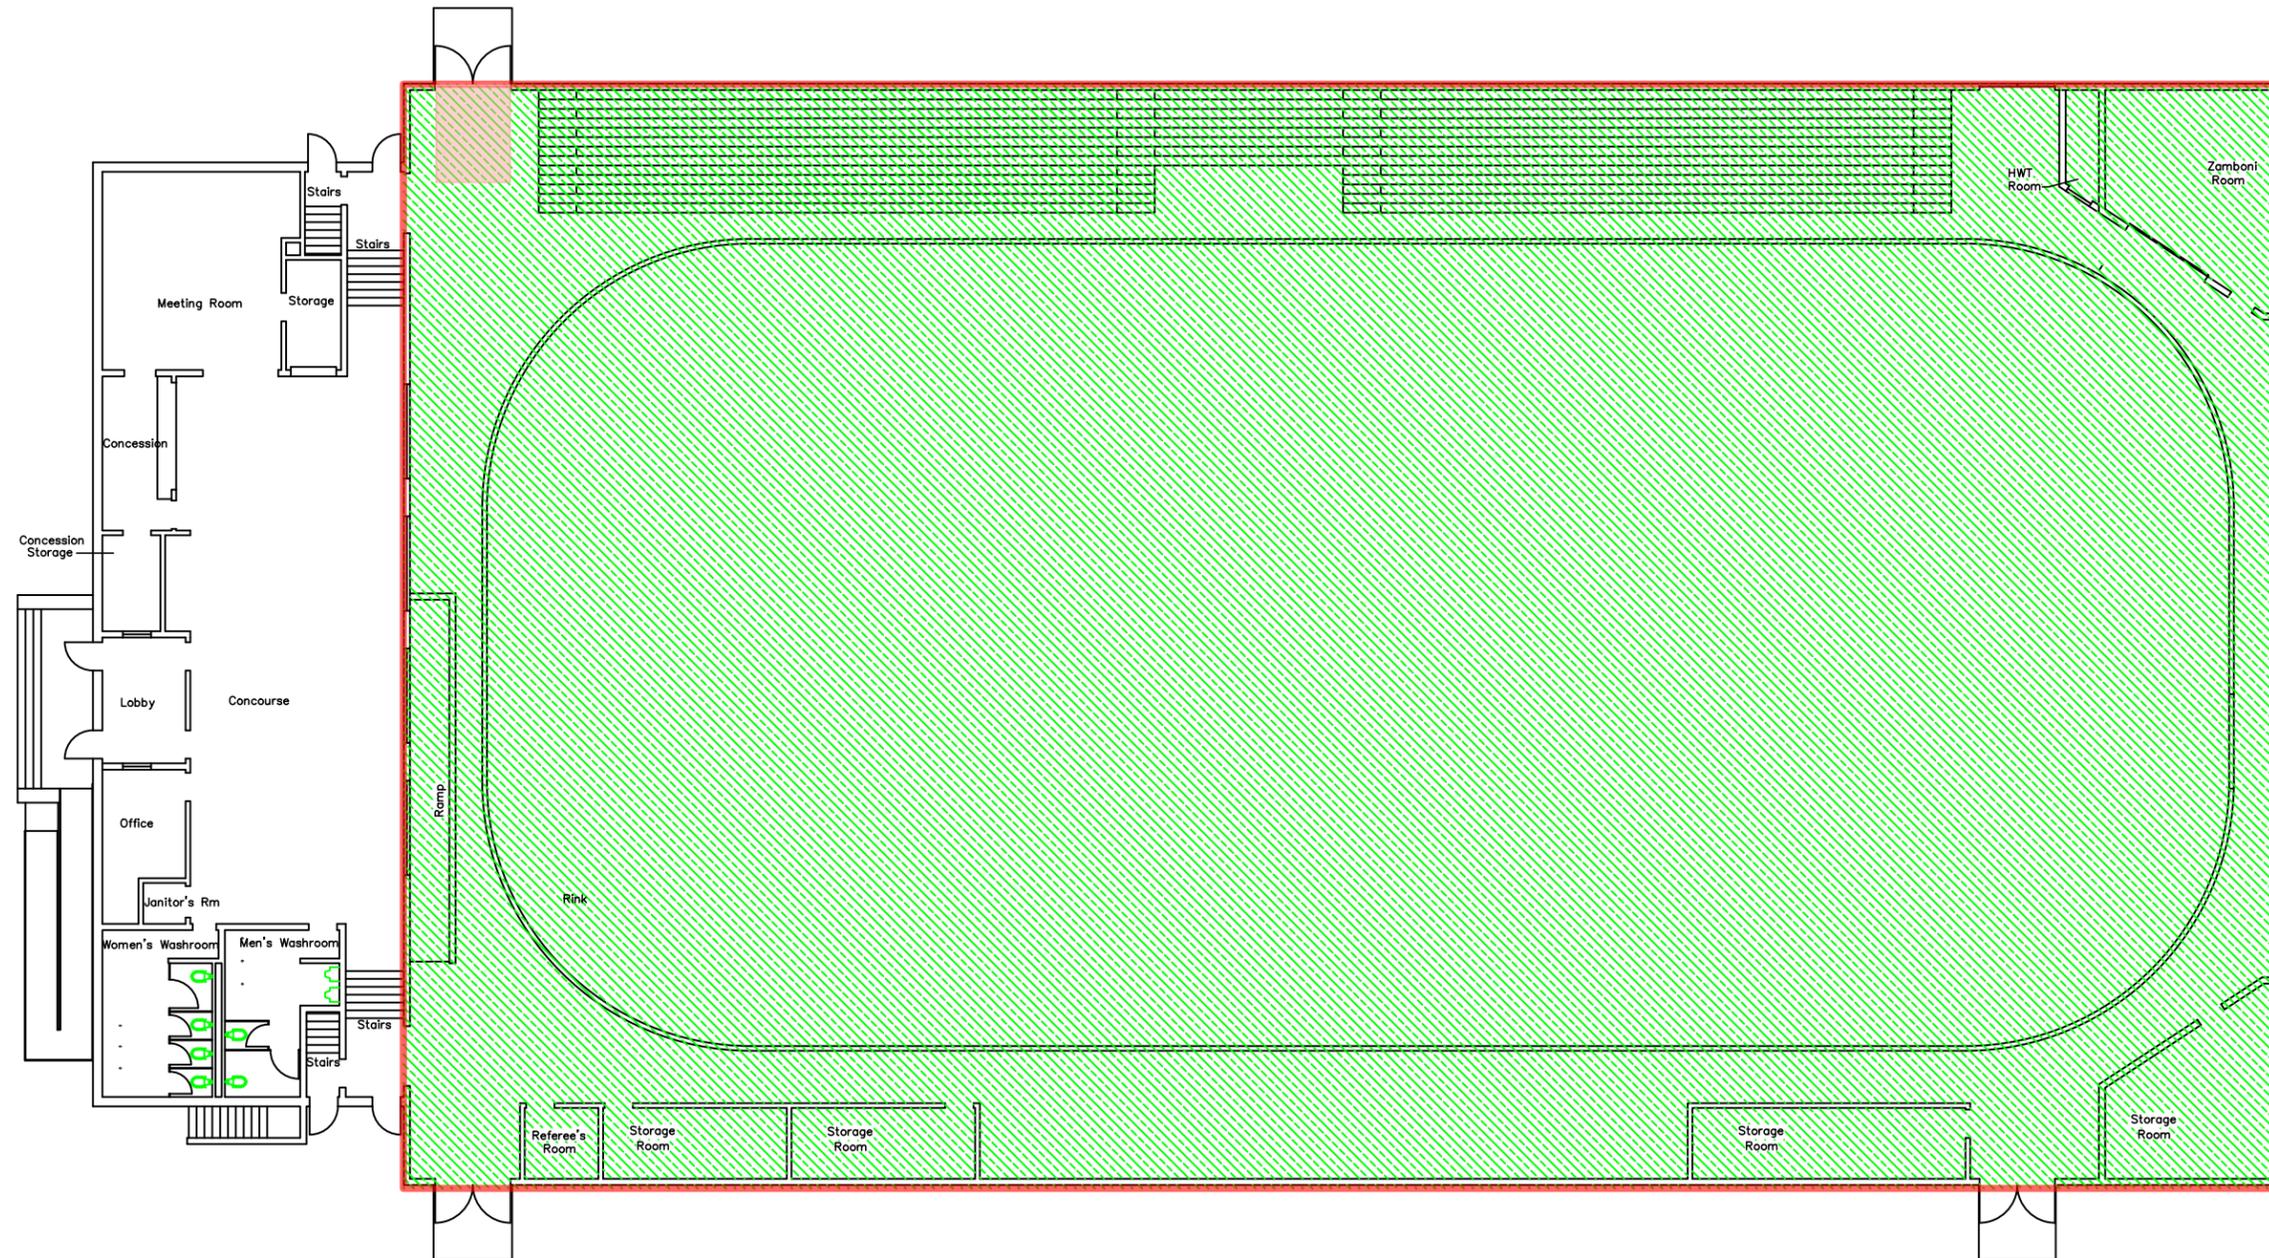
MR1

1. WASHROOM IS LOCATED IN THE BASEMENT AREA. NO ACCESS IS ALLOWED TO THE SOUTH SIDE OF THE ARENA. SECONDARY AIRLOCK WILL NEED TO BE ESTABLISHED FOR ENTRY AND EXIT TO THE BASEMENT

DEPICTS AREA AT UNDERSIDE OF ROOF DECK REQUIRING CLEANING VIA MEDIA BLASTING OR HIGH-PRESSURE WATER BLASTING TO REMOVAL VISIBLE TRACE OF MICROBIAL GROWTH; THEN ENCAPSULATE WITH FOSTERS SHEER DEFENSE40-51 MOULD RESISTANT CLEAR COAT.

APPROXIMATE LOCATION OF MAIN AIRLOCK TO BE CONSTRUCTED

- .1 Mould growth is present on the underside of the wood roof deck throughout the ice surface area of the arena at location identified on the attached Drawing.
- .2 Asbestos containing materials are not expected to be impacted by the planned remediation work, however, for reference, a copy of the City of Winnipeg Asbestos Inventory is attached.
- .3 The following work will be performed by the City of Winnipeg prior to the remediation:
 - .1 Lock-out / tag-out of the lighting above the rink surface area;
 - .2 Lock-out / tag-out of the dehumidifier above the rink surface area;
 - .3 Provision of the required electrical panelling;
 - .4 Removal of the hanging banners through-out the arena; and
 - .5 Removal of the netting around the Arena.
- .4 Ceiling / Underside of Roof Finishes: Tongue and groove (unconfirmed species) wood finish.

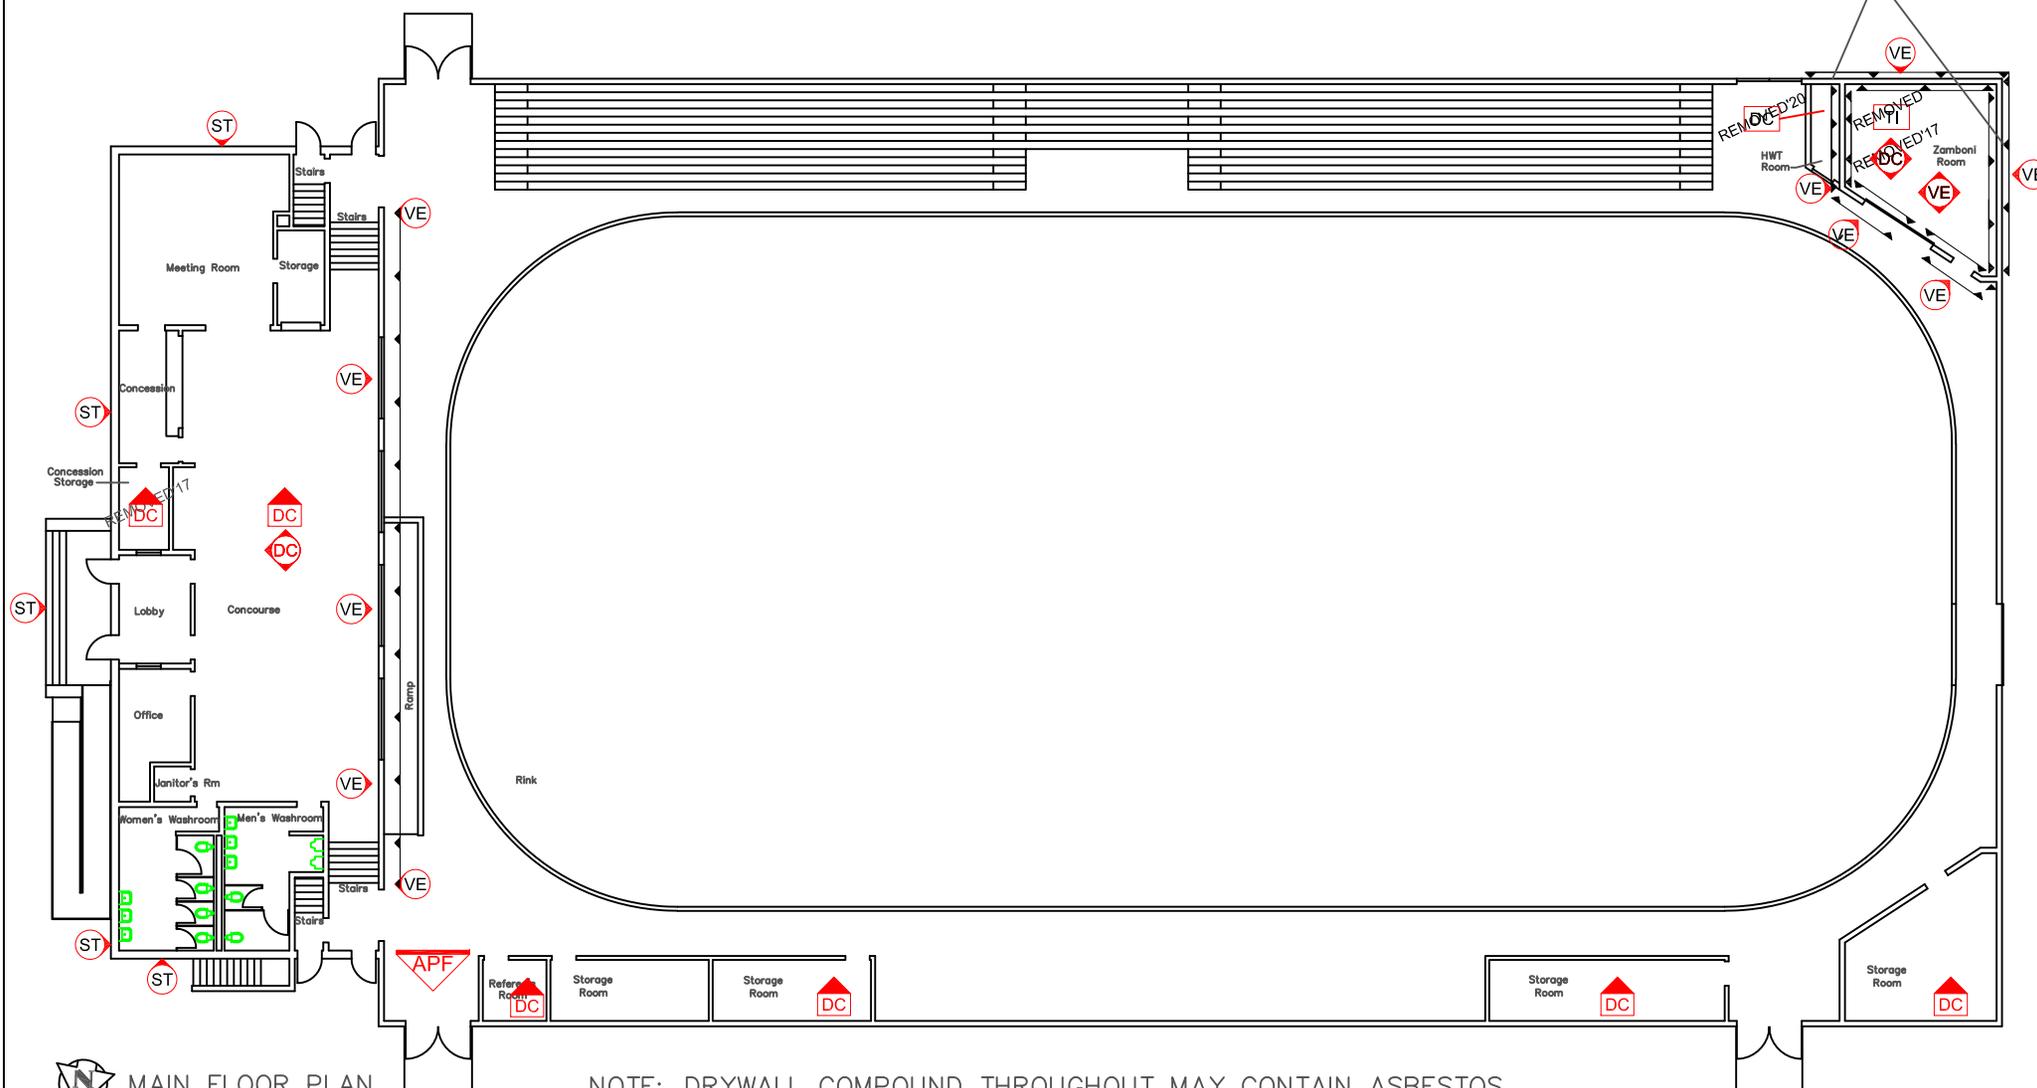
MAIN FLOOR PLAN
SCALE: _____ N.T.S.

ASBESTOS LOCATIONS			
BUILDING:		AR - 15 St. Vital Arena 580 St. Annes Road Winnipeg, Manitoba	
REVISED BY:	DATE:	SCALE:	SHEET #:
REM	MAY 31, 2021	N.T.S.	1/2
