# Replacement of the FGSV Siphon

Geotechnical Baseline Report  
FINAL

City of Winnipeg

May 2025

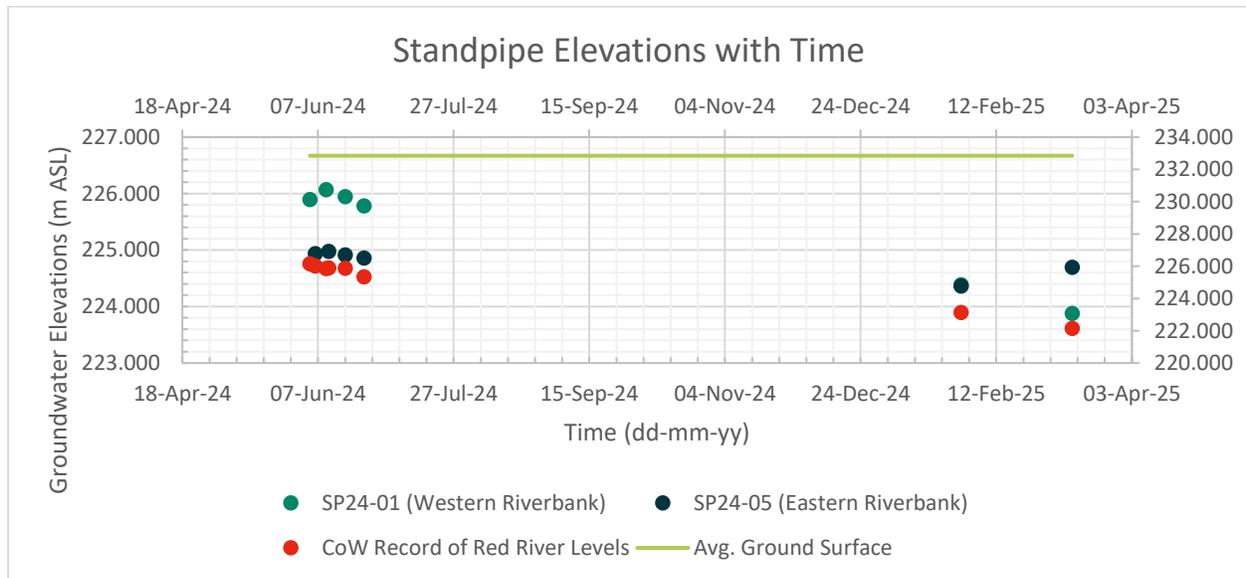
Groundwater instrumentation along the FGSV Siphon alignment consists of two (2) standpipe piezometers installed as part of the AECOM 2024 geotechnical investigations. Instrumentation was installed into the bedrock along the FGSV Siphon alignment, and the instruments were monitored between June 4, 2024, and March 12, 2025, by AECOM.

**Figure 6-1: Graph of Groundwater Elevations Versus Time**

A graphical summary of these results is provided in **Figure 6-1** and can also be found in the GDR.

It is anticipated that the launch and receiving pit will be constructed mostly within fat clay, at a depth of approximately 15 mBGS (216.40 mASL) and 10 mBGS (222.7 mASL). The typical range of hydraulic conductivity for fat clay is between  $1 \times 10^{-10}$  to  $1 \times 10^{-6}$  cm/s. Thus, there will be no significant groundwater seepage expected from within the fat clay. For the daily water level for Red River at James Avenue Pumping Station, see **Appendix III**.

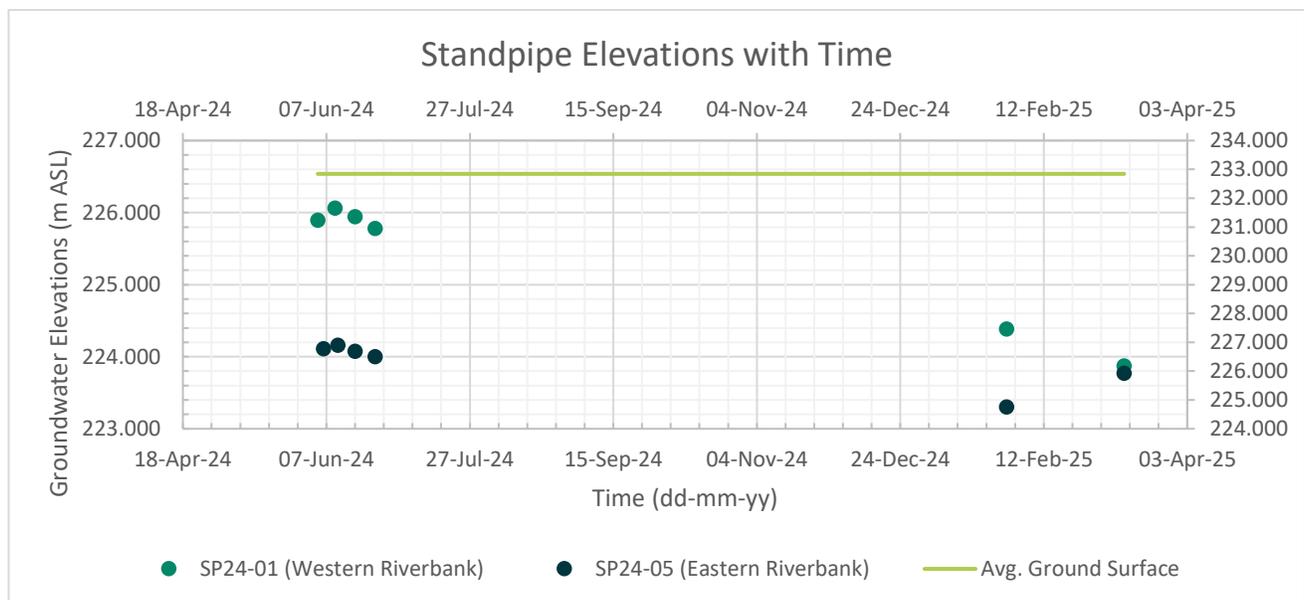
**Figure 6-1: Graph of Groundwater Elevations Versus Time**

A graphical summary of these results is provided in **Figure 6-1**.

Only short-term seepage and sloughing conditions were observed in the testholes. Groundwater levels will normally fluctuate during the year and will be dependent on precipitation, surface drainage, and regional groundwater regimes. Groundwater seepage and soil sloughing should be expected from the silt (ML) till layer and expected in entry and exit pit excavations during construction.

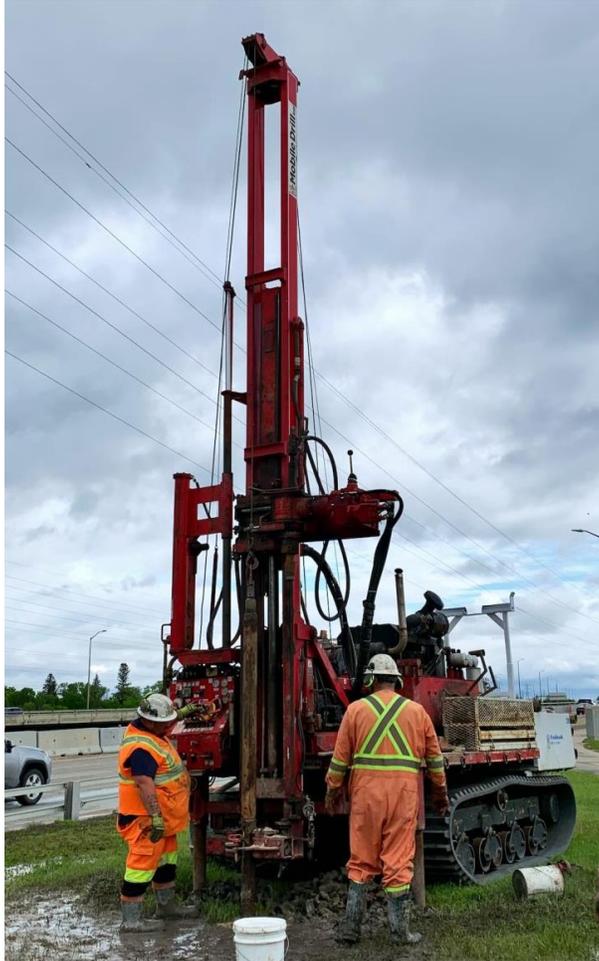
**TH24-01 Drilling**

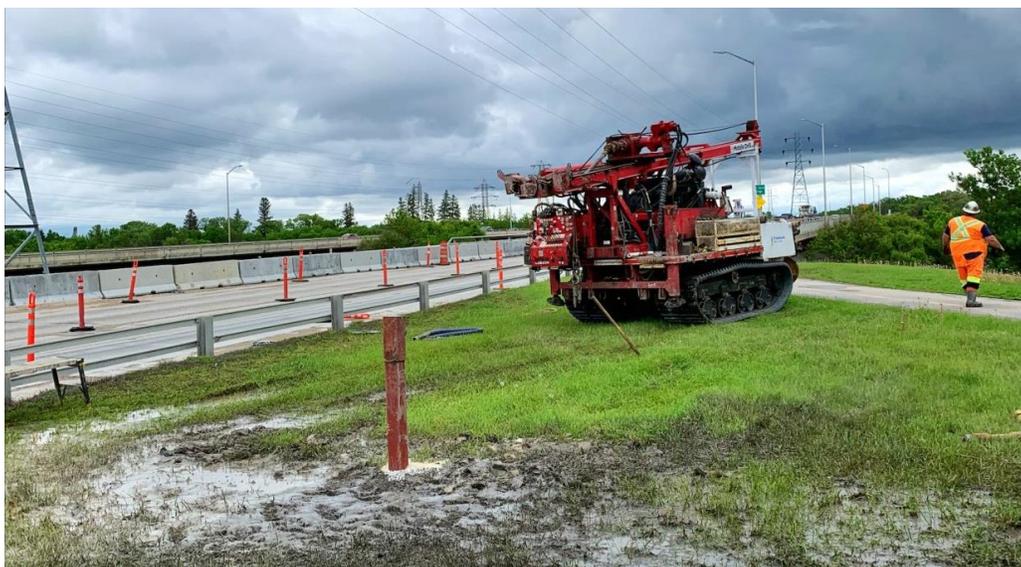
**TH24-01 Standpipe**

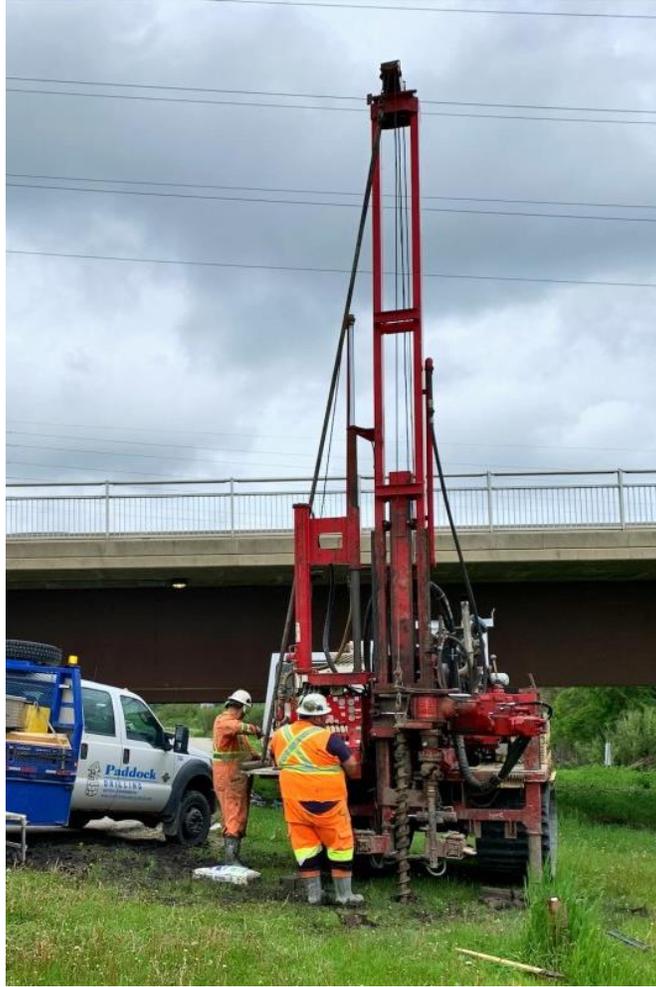
**TH24-02 Drilling**

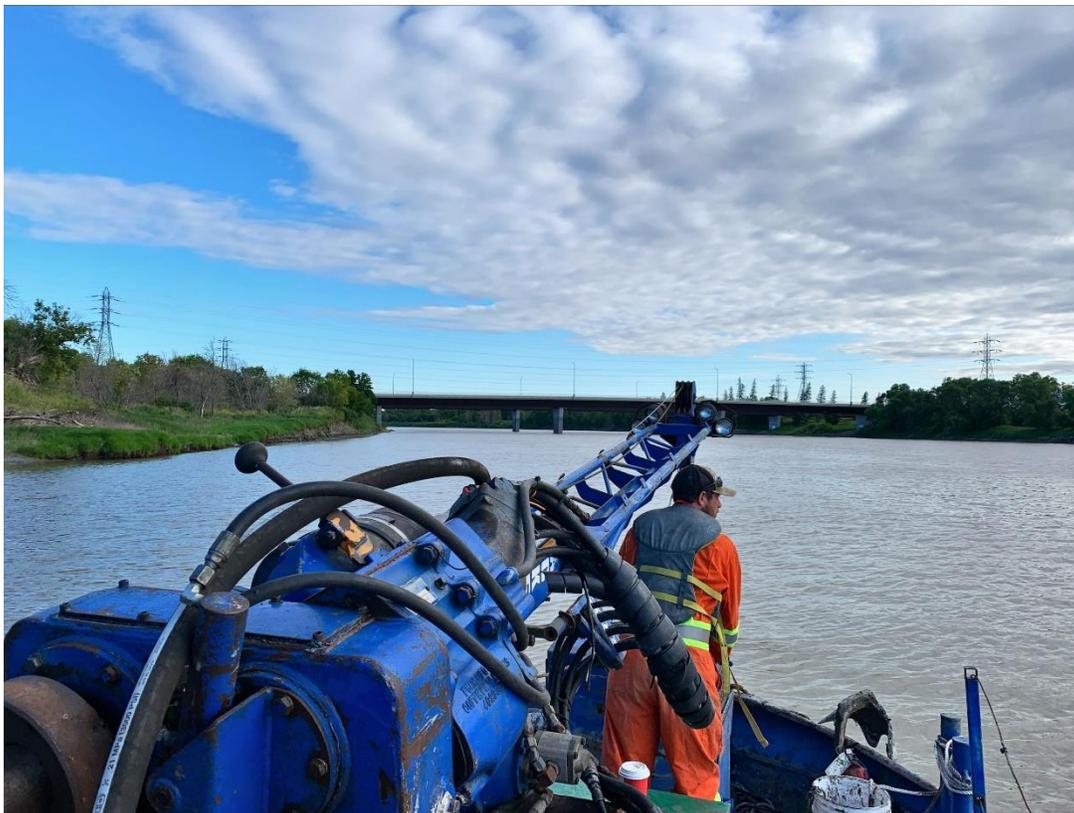
**TH24-03 Barge Launch**

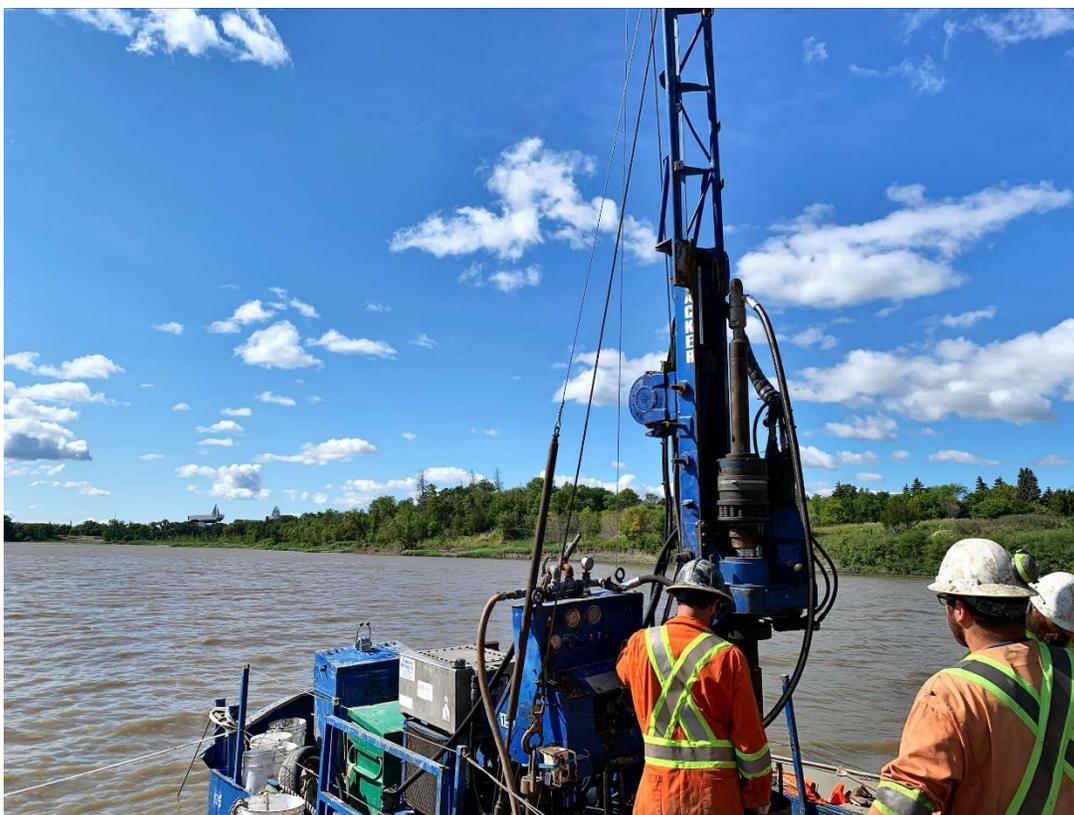
**TH24-03 Barge Drilling**

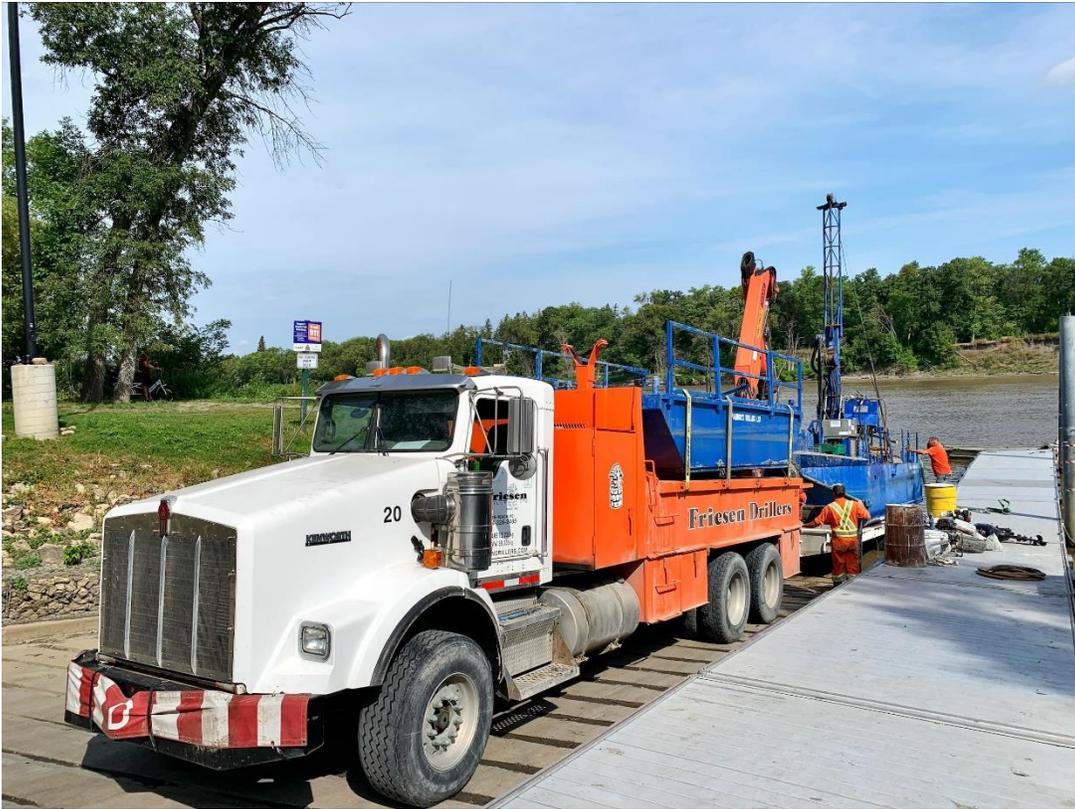
**TH24-03 Barge Demobilization**

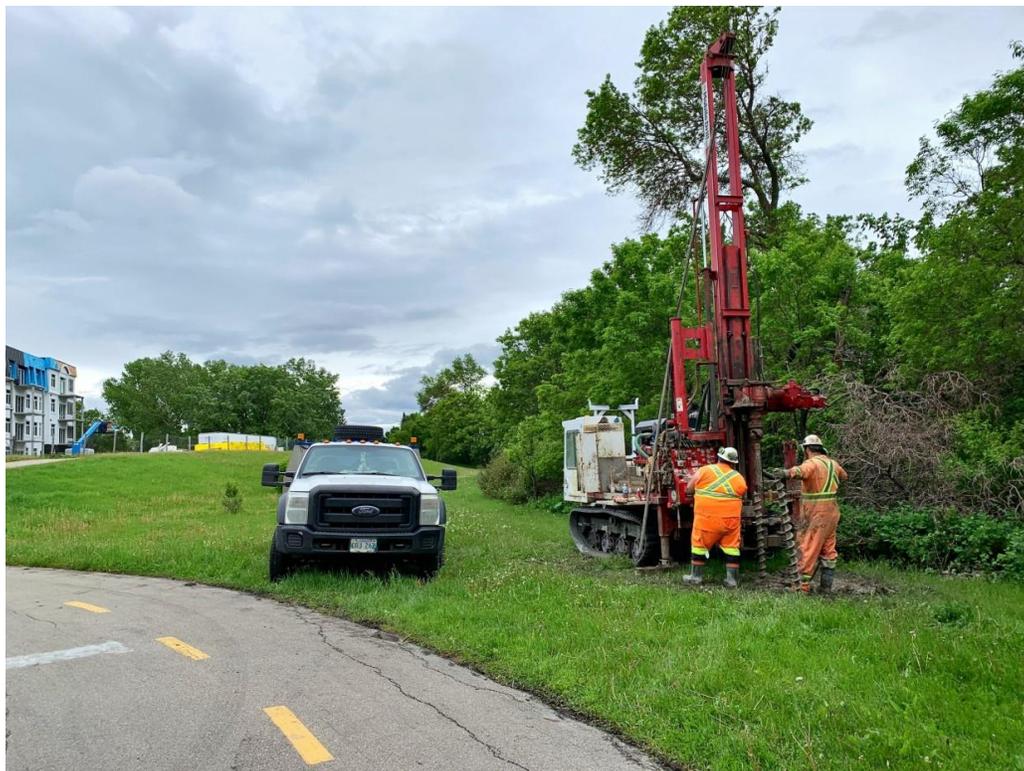
**TH24-04 Drilling**

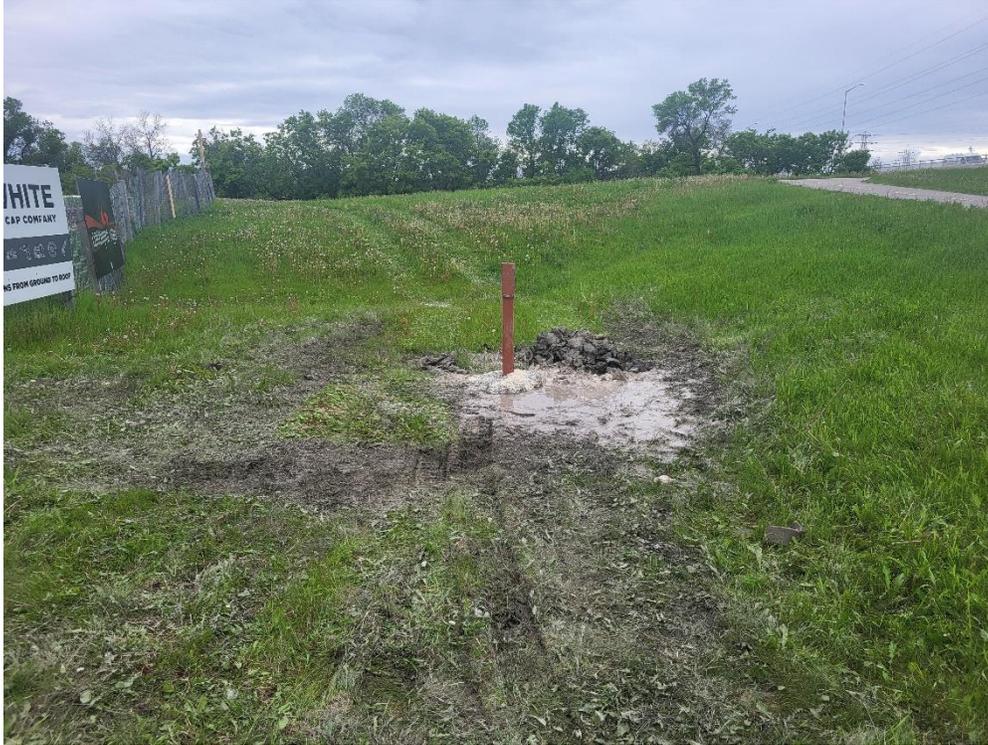
**TH24-05 Standpipe**

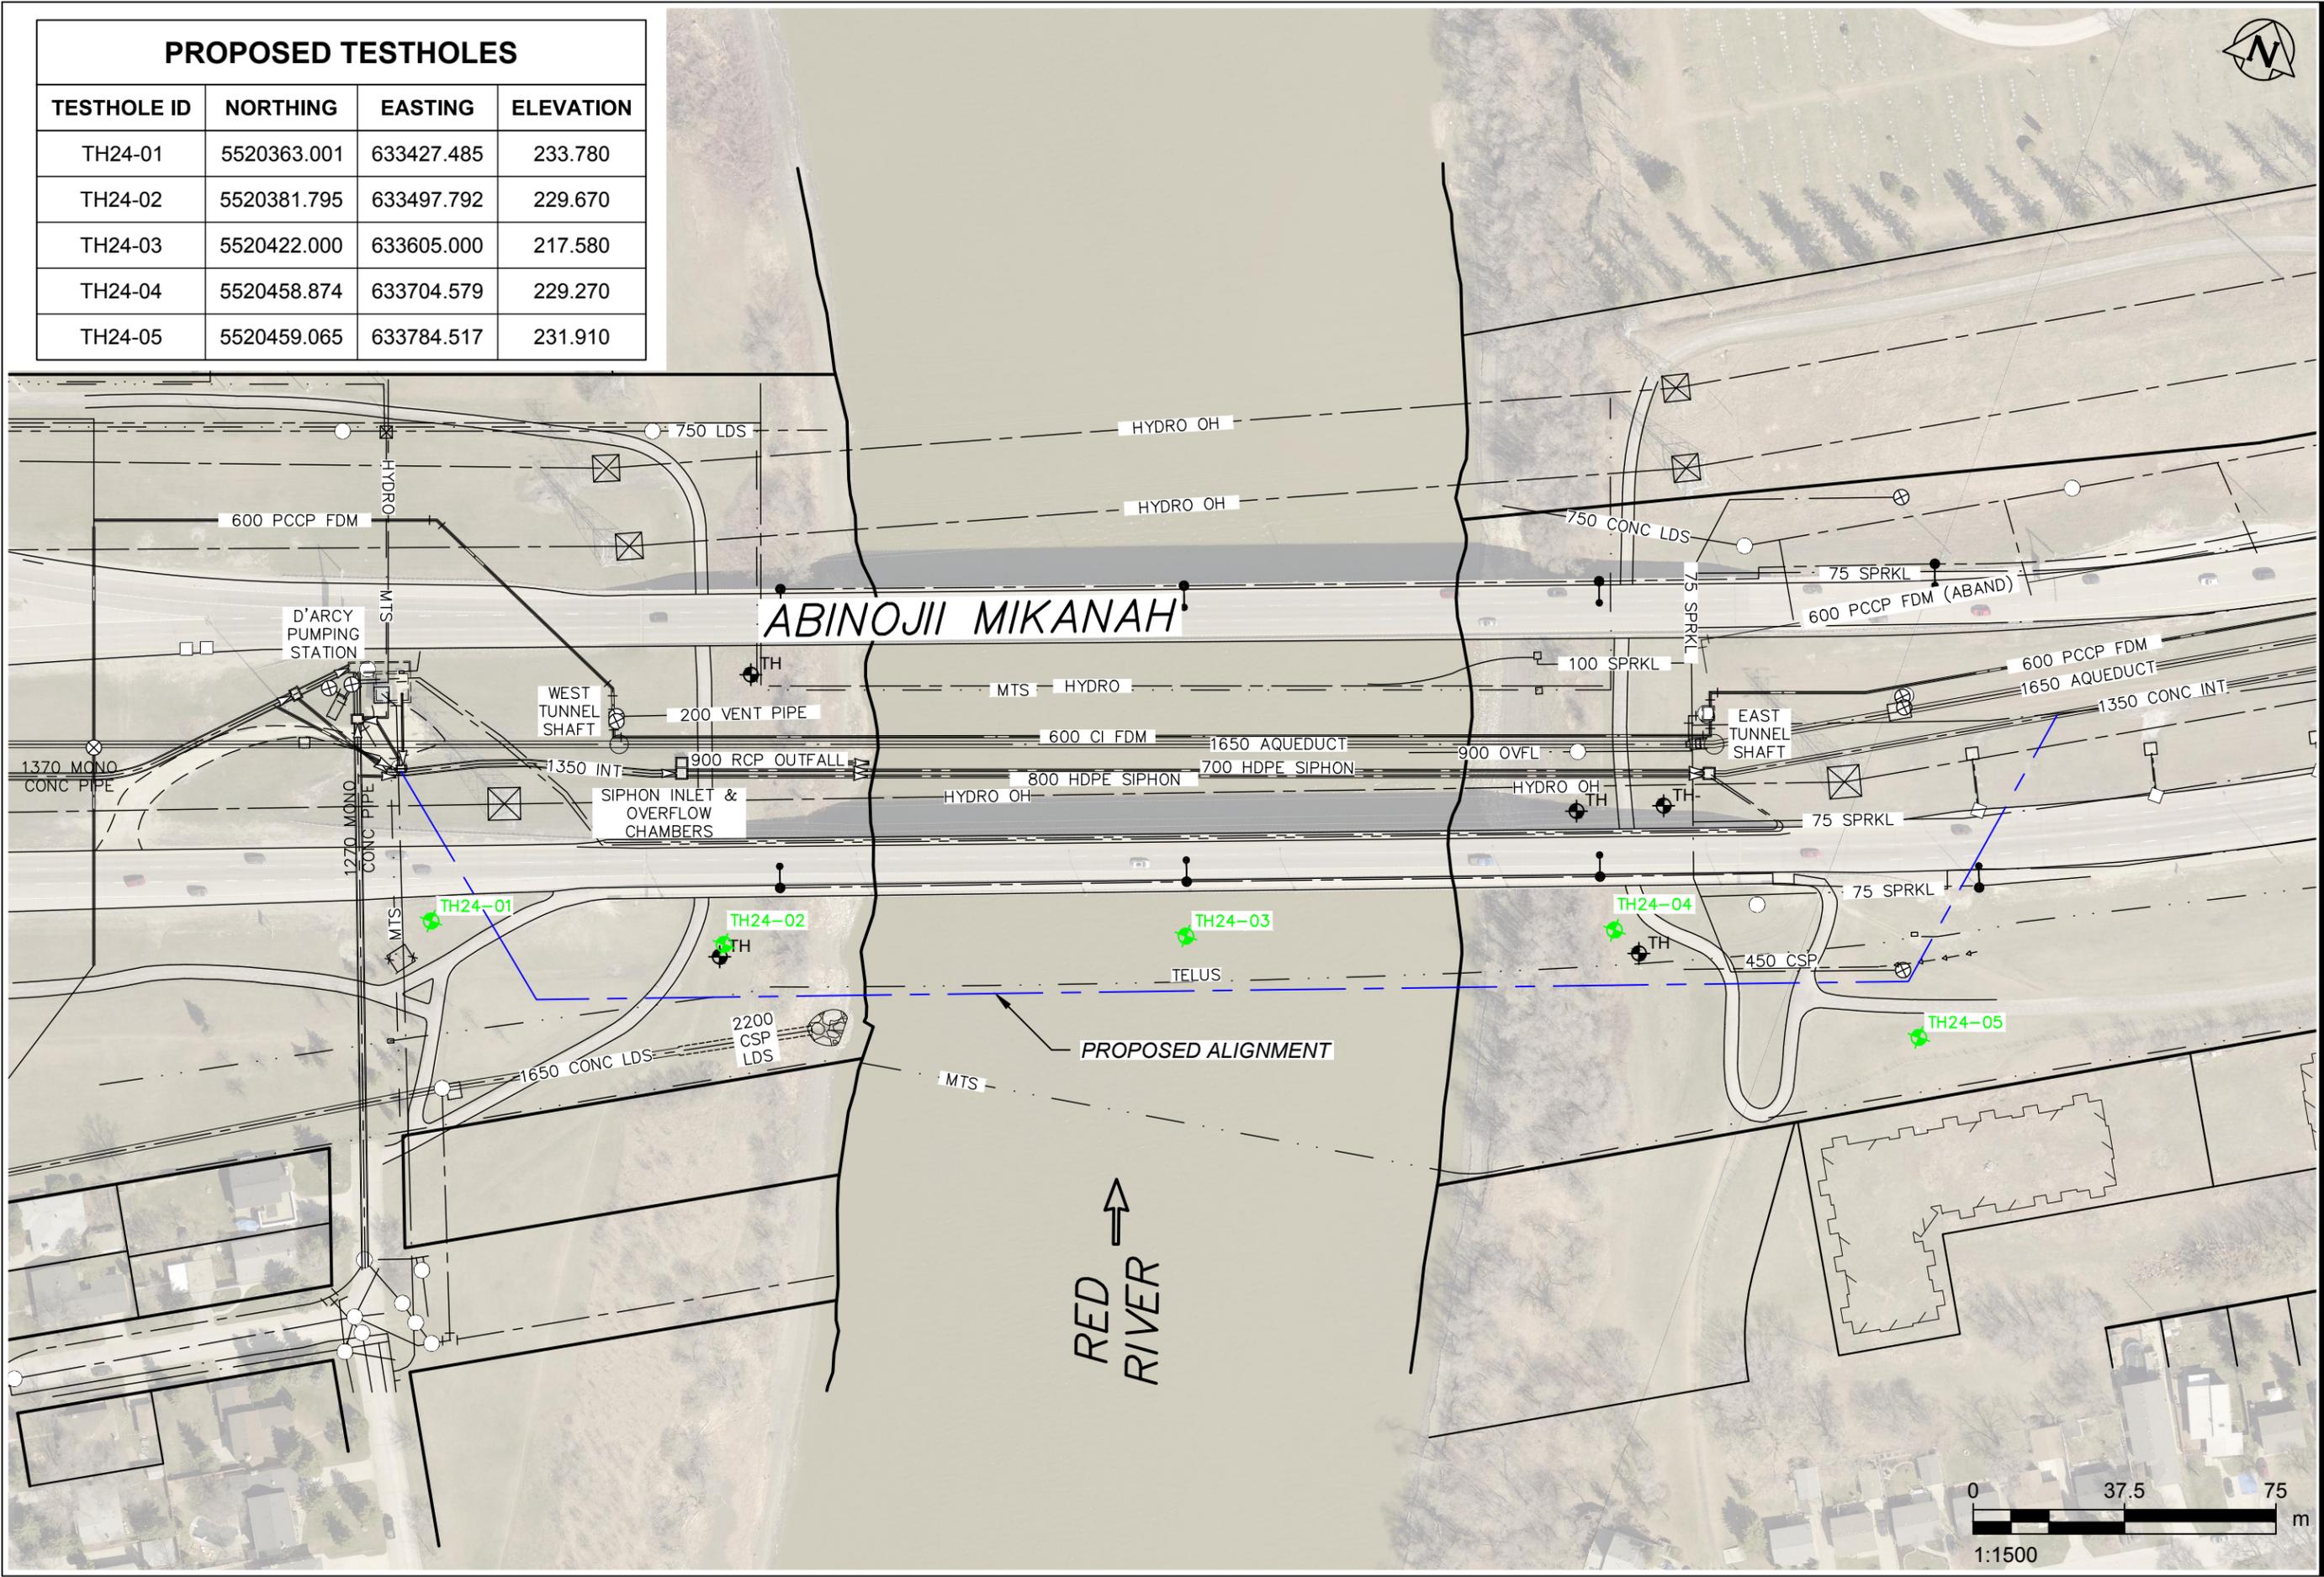
## Testhole Location Plan

PROPOSED TESTHOLES			
TESTHOLE ID	NORTHING	EASTING	ELEVATION
TH24-01	5520363.001	633427.485	233.780
TH24-02	5520381.795	633497.792	229.670
TH24-03	5520422.000	633605.000	217.580
TH24-04	5520458.874	633704.579	229.270
TH24-05	5520459.065	633784.517	231.910

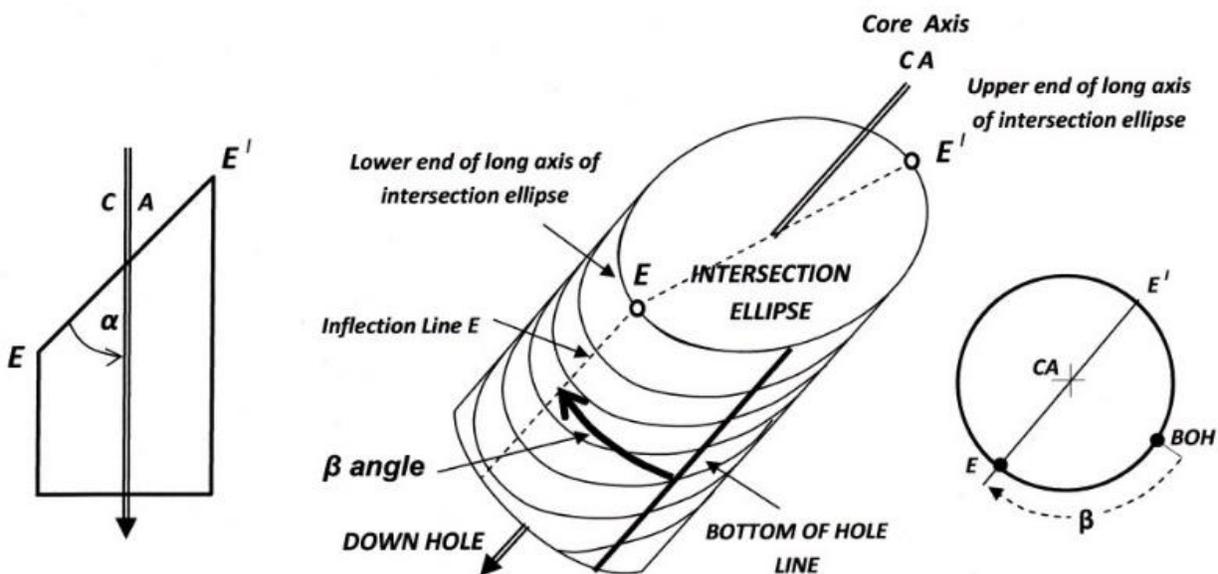
The orientation of a planar surface intersected by drill core can be defined by two angles called alpha ( $\alpha$ ) and beta ( $\beta$ ). The definition of these angles is shown in the diagram below:

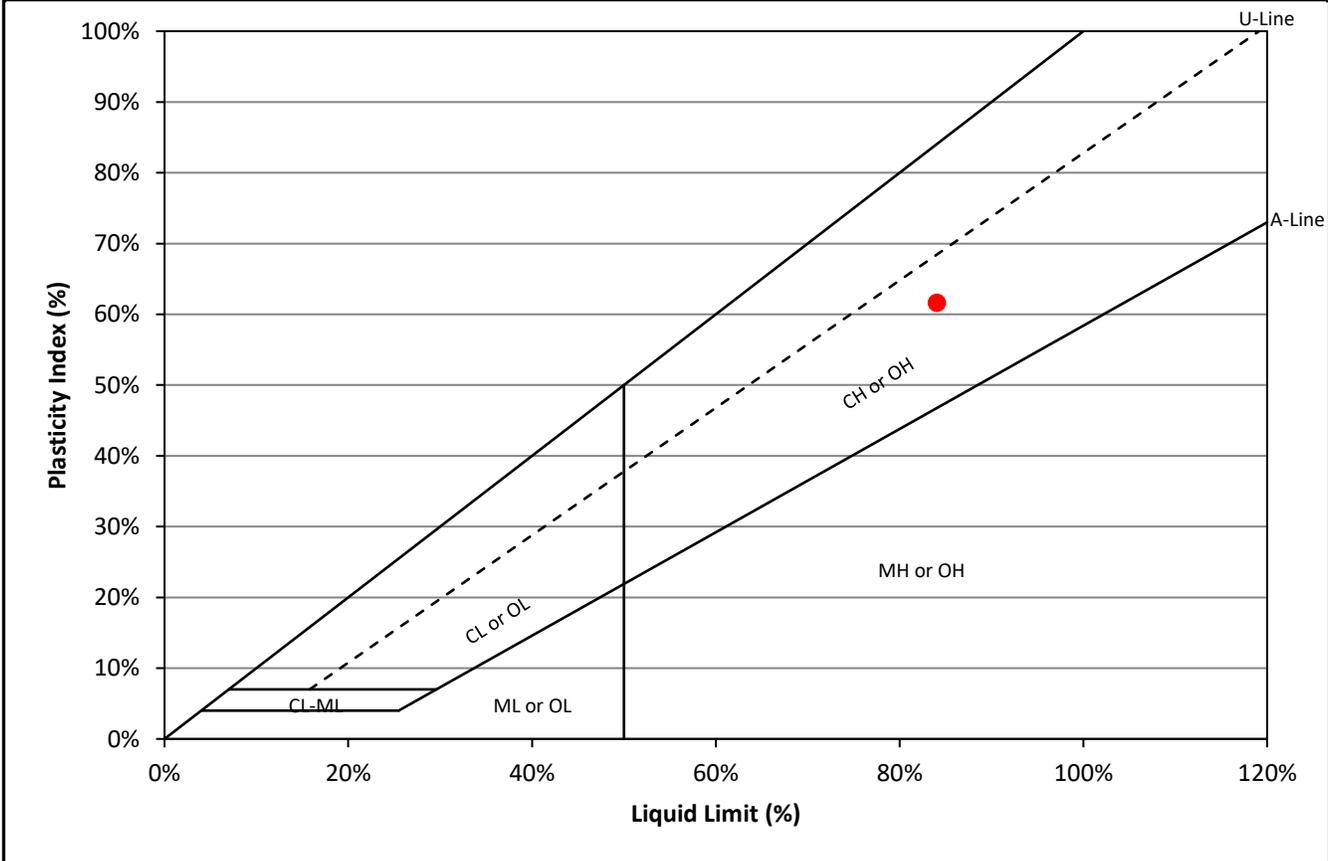
Liquid Limit:	<b>84</b>	Plastic Limit:	<b>22</b>	Plasticity Index:	<b>62</b>
---------------	-----------	----------------	-----------	-------------------	-----------

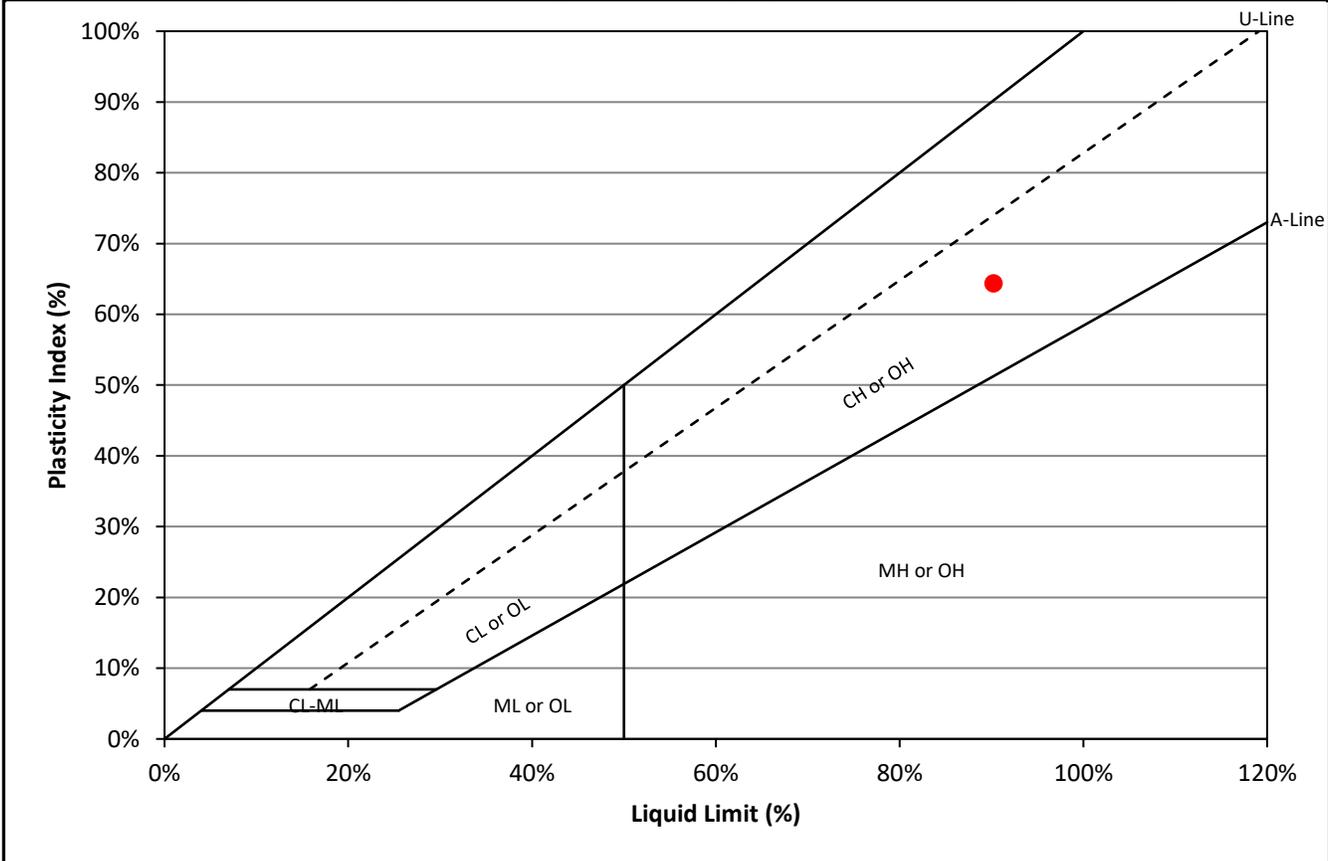
Liquid Limit:	<b>90</b>	Plastic Limit:	<b>26</b>	Plasticity Index:	<b>64</b>
---------------	-----------	----------------	-----------	-------------------	-----------

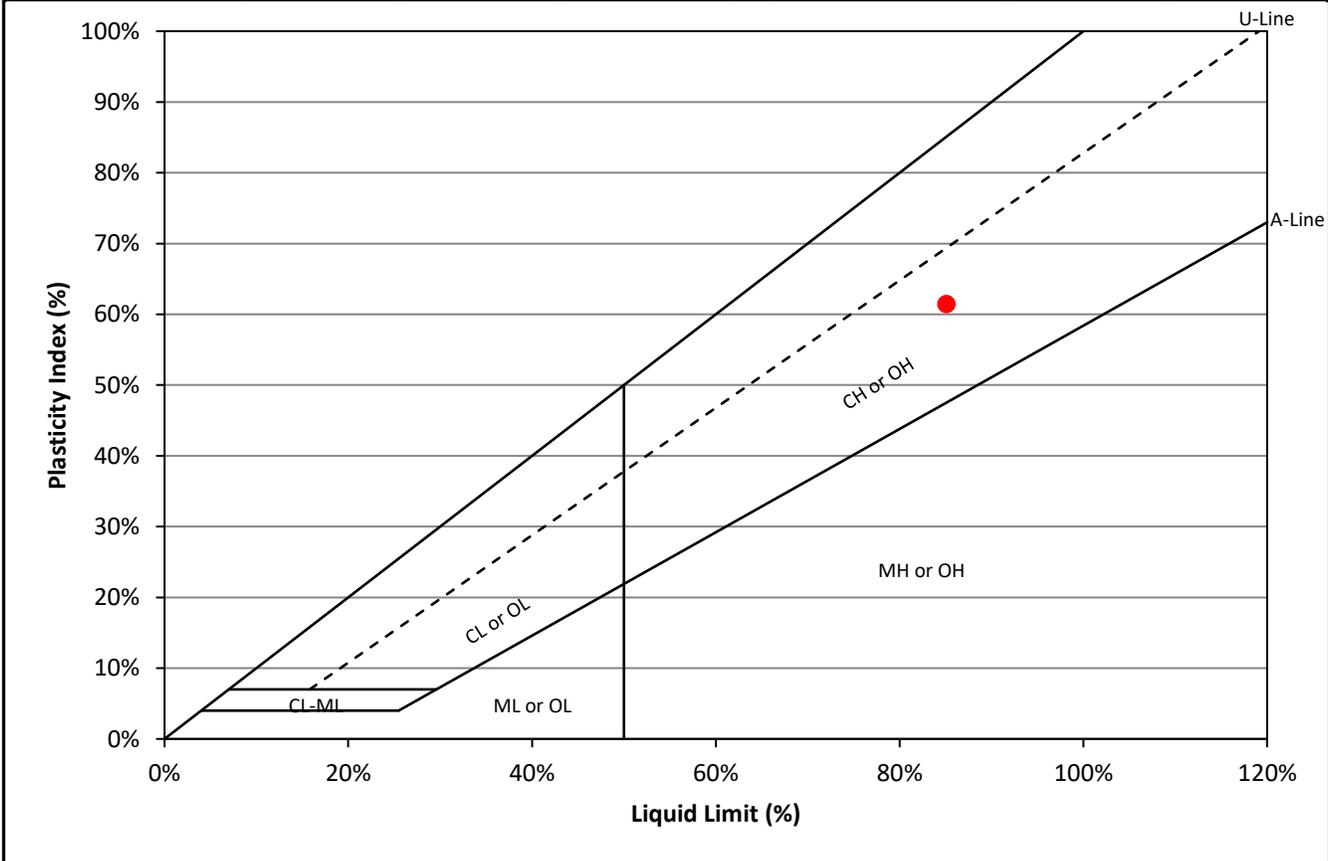
Liquid Limit:	<b>85</b>	Plastic Limit:	<b>24</b>	Plasticity Index:	<b>61</b>
---------------	-----------	----------------	-----------	-------------------	-----------

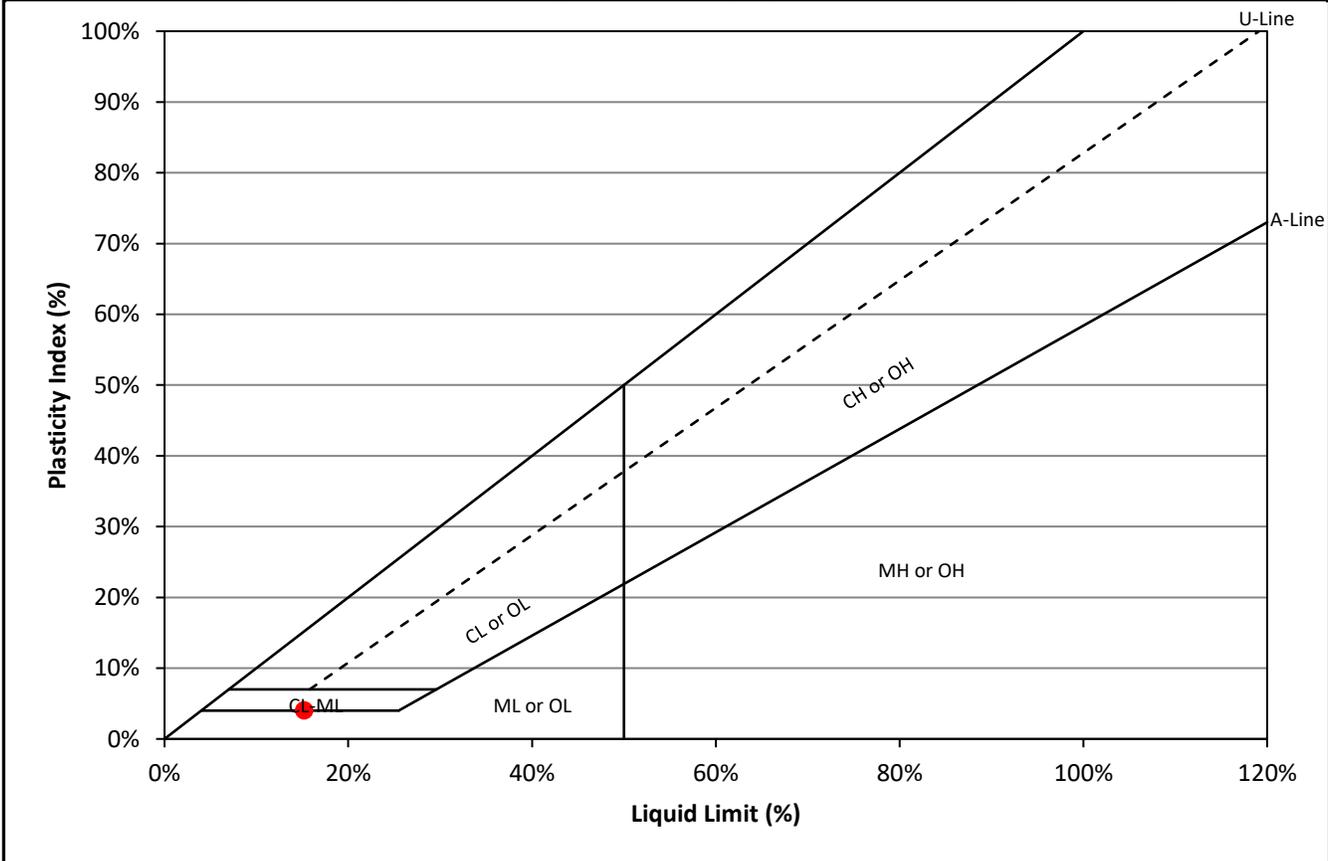
Liquid Limit:	<b>15</b>	Plastic Limit:	<b>11</b>	Plasticity Index:	<b>4</b>
---------------	-----------	----------------	-----------	-------------------	----------

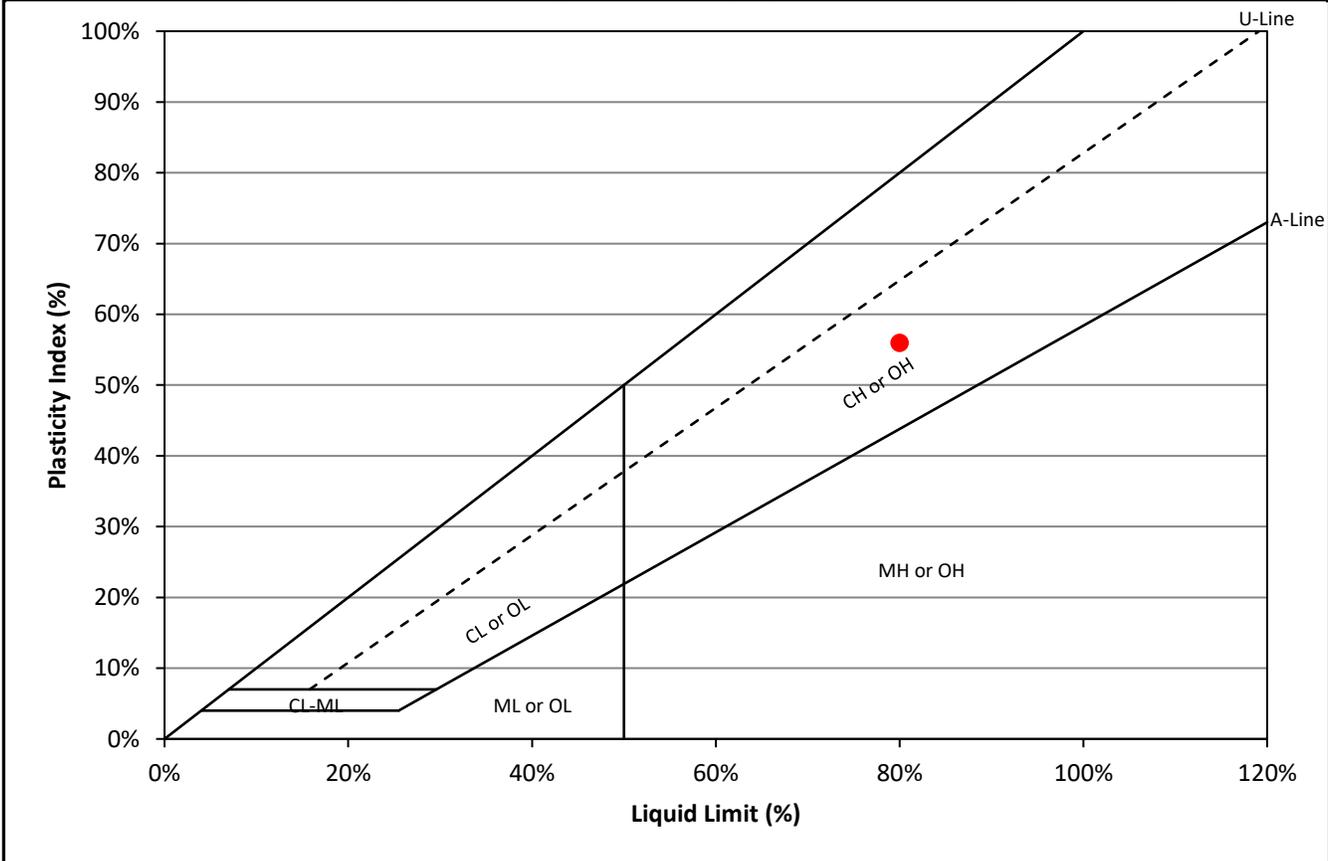
Liquid Limit:	<b>80</b>	Plastic Limit:	<b>24</b>	Plasticity Index:	<b>56</b>
---------------	-----------	----------------	-----------	-------------------	-----------

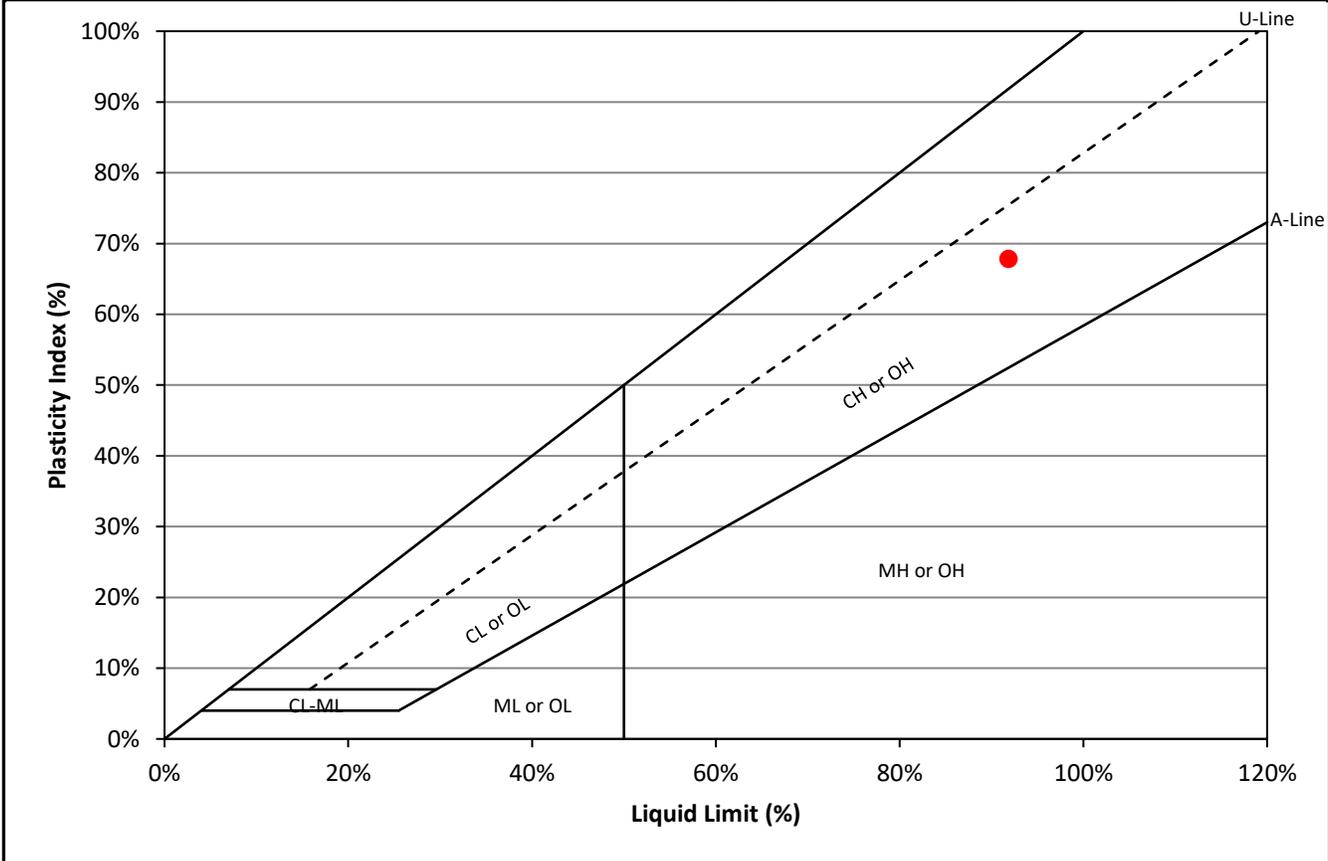
Liquid Limit:	<b>92</b>	Plastic Limit:	<b>24</b>	Plasticity Index:	<b>68</b>
---------------	-----------	----------------	-----------	-------------------	-----------

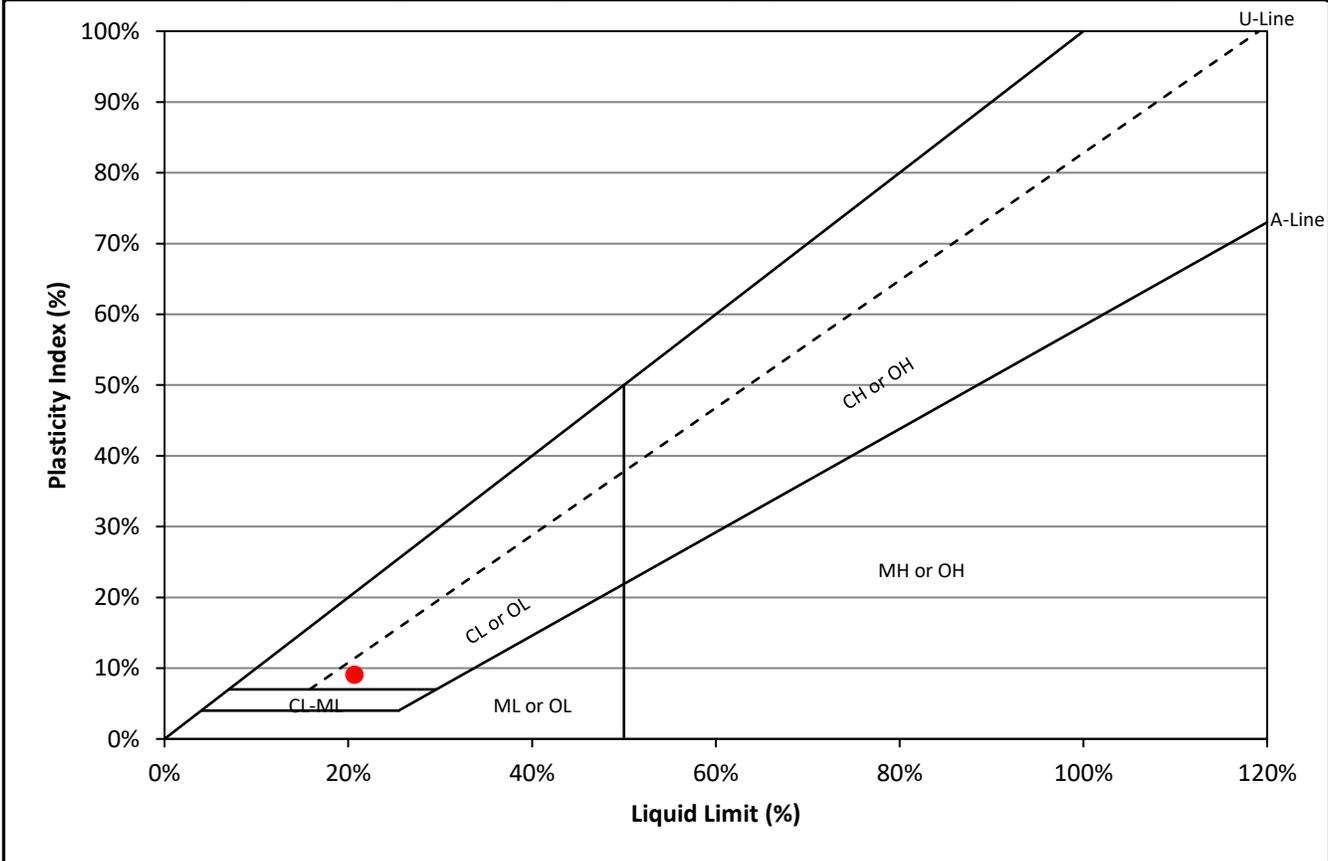
Liquid Limit:	<b>21</b>	Plastic Limit:	<b>12</b>	Plasticity Index:	<b>9</b>
---------------	-----------	----------------	-----------	-------------------	----------

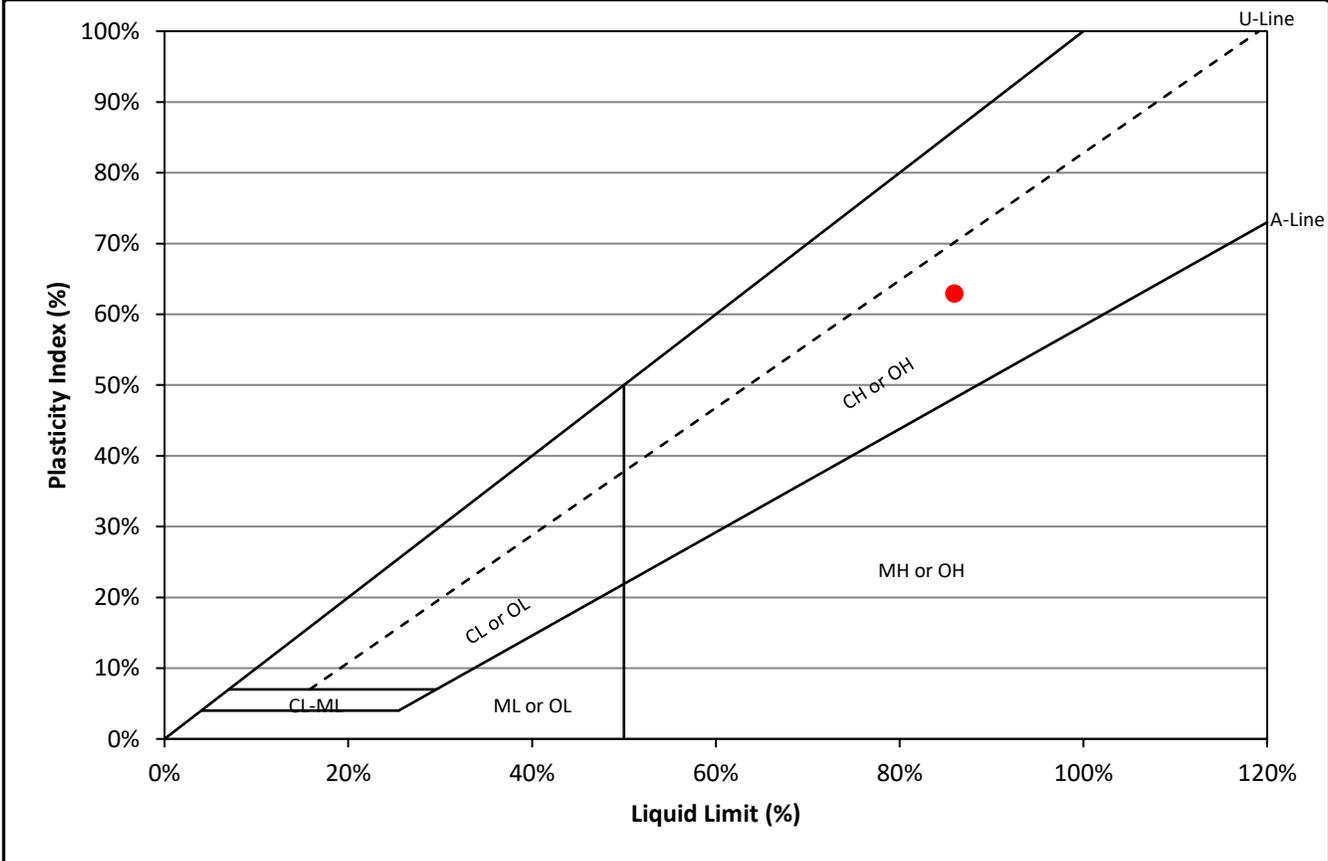
Liquid Limit:	<b>86</b>	Plastic Limit:	<b>23</b>	Plasticity Index:	<b>63</b>
---------------	-----------	----------------	-----------	-------------------	-----------

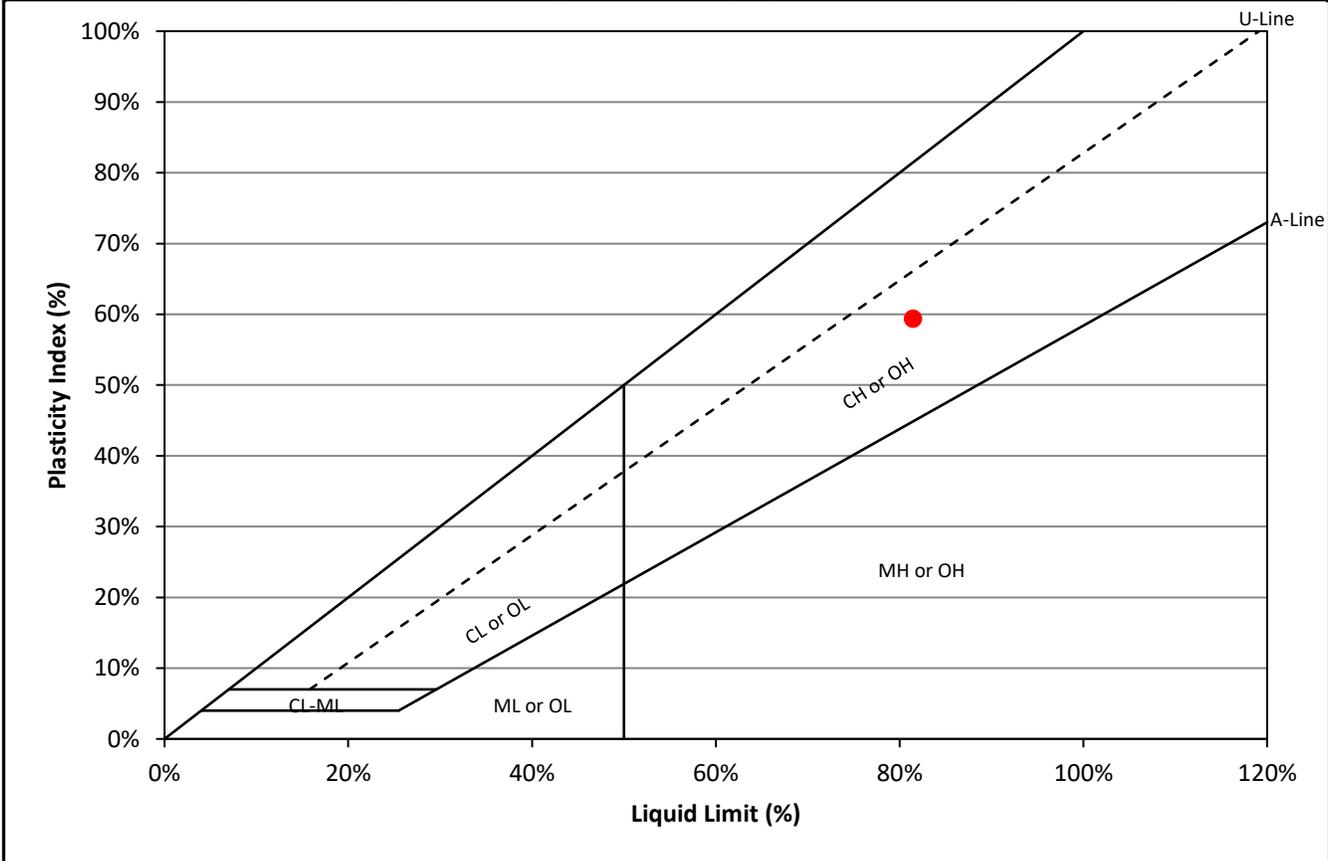
Liquid Limit:	<b>81</b>	Plastic Limit:	<b>22</b>	Plasticity Index:	<b>59</b>
---------------	-----------	----------------	-----------	-------------------	-----------
