# Replacement of the FGSV Siphon

Geotechnical Baseline Report  
FINAL

City of Winnipeg

May 2025

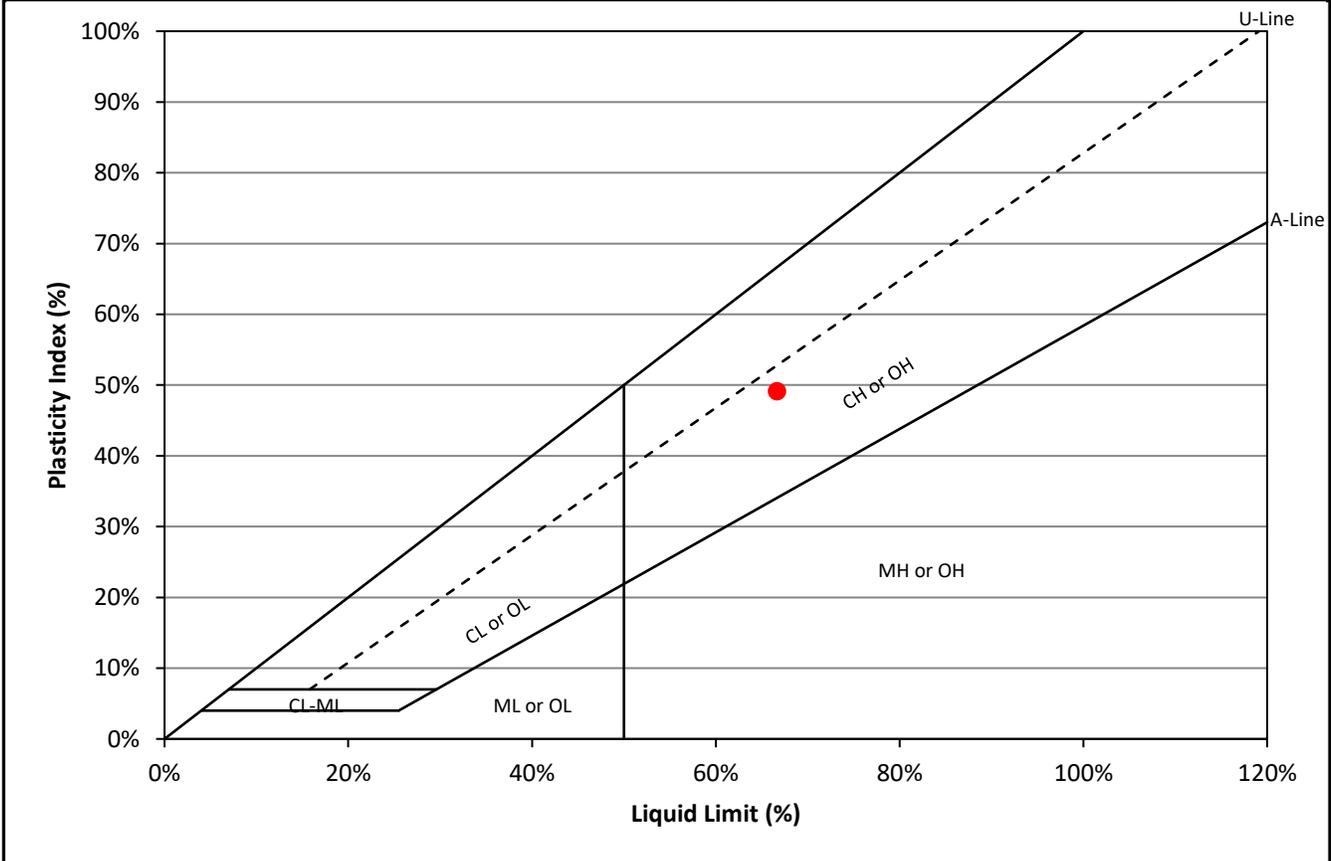
Liquid Limit:	<b>67</b>	Plastic Limit:	<b>18</b>	Plasticity Index:	<b>49</b>
---------------	-----------	----------------	-----------	-------------------	-----------

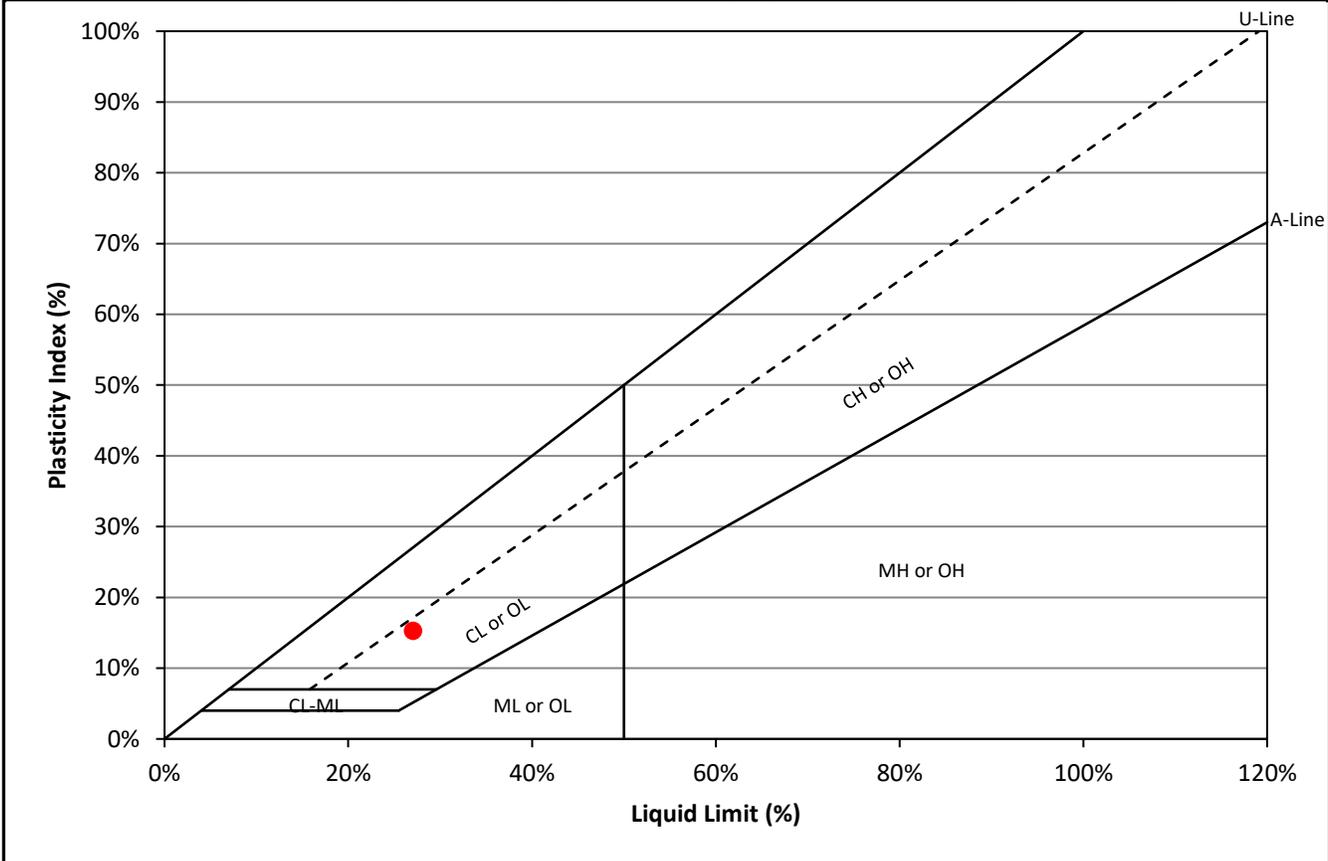
Liquid Limit:	<b>27</b>	Plastic Limit:	<b>12</b>	Plasticity Index:	<b>15</b>
---------------	-----------	----------------	-----------	-------------------	-----------

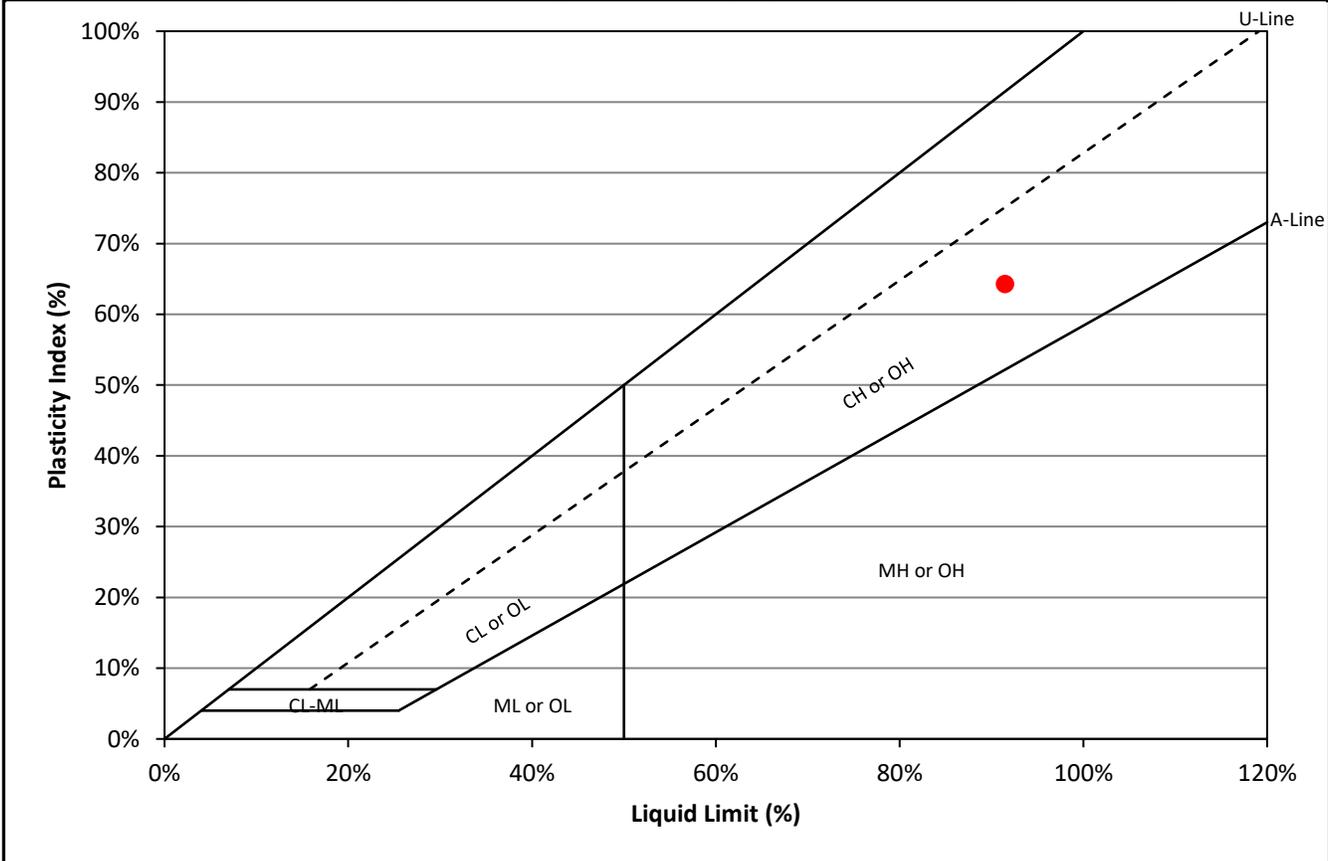
Liquid Limit:	<b>91</b>	Plastic Limit:	<b>27</b>	Plasticity Index:	<b>64</b>
---------------	-----------	----------------	-----------	-------------------	-----------

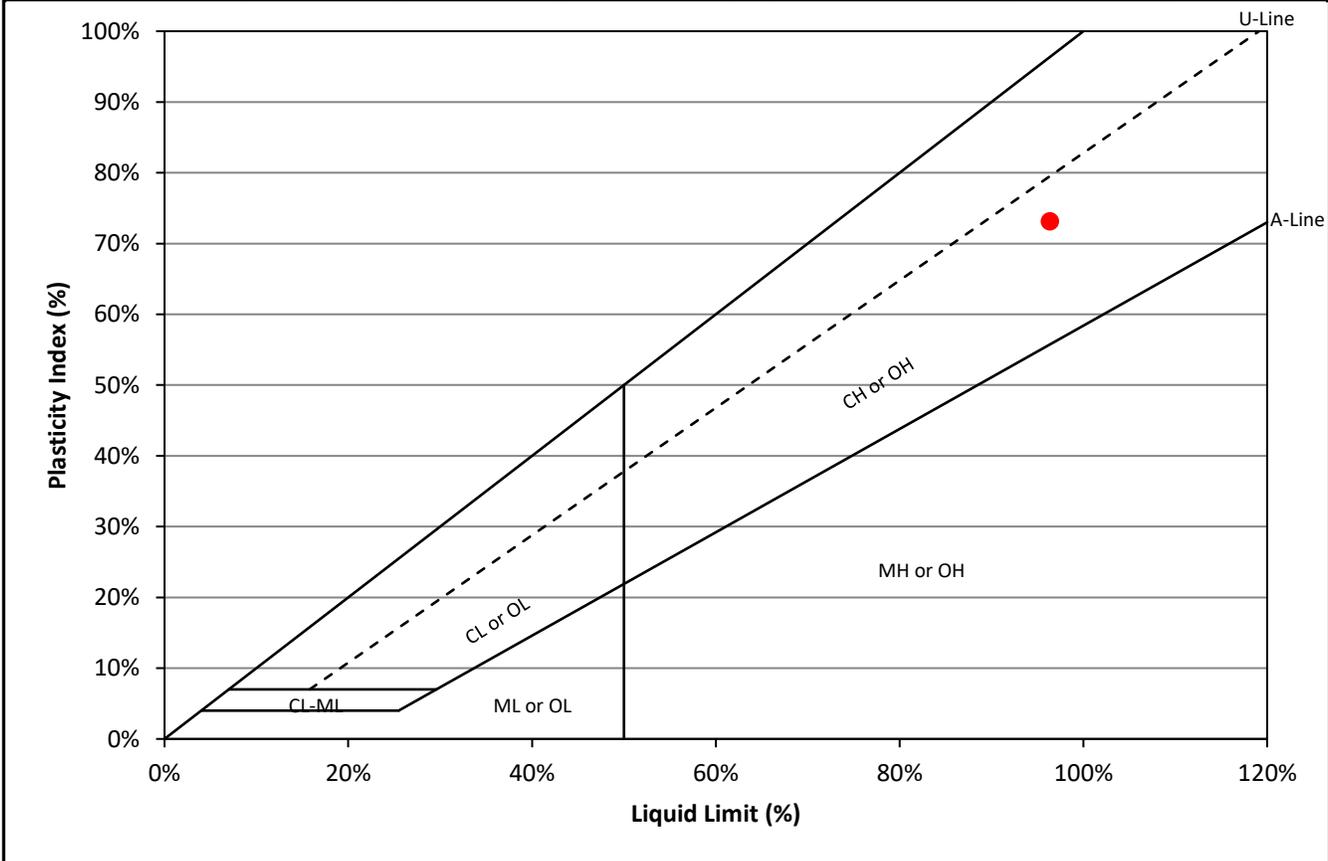
Liquid Limit:	<b>96</b>	Plastic Limit:	<b>23</b>	Plasticity Index:	<b>73</b>
---------------	-----------	----------------	-----------	-------------------	-----------

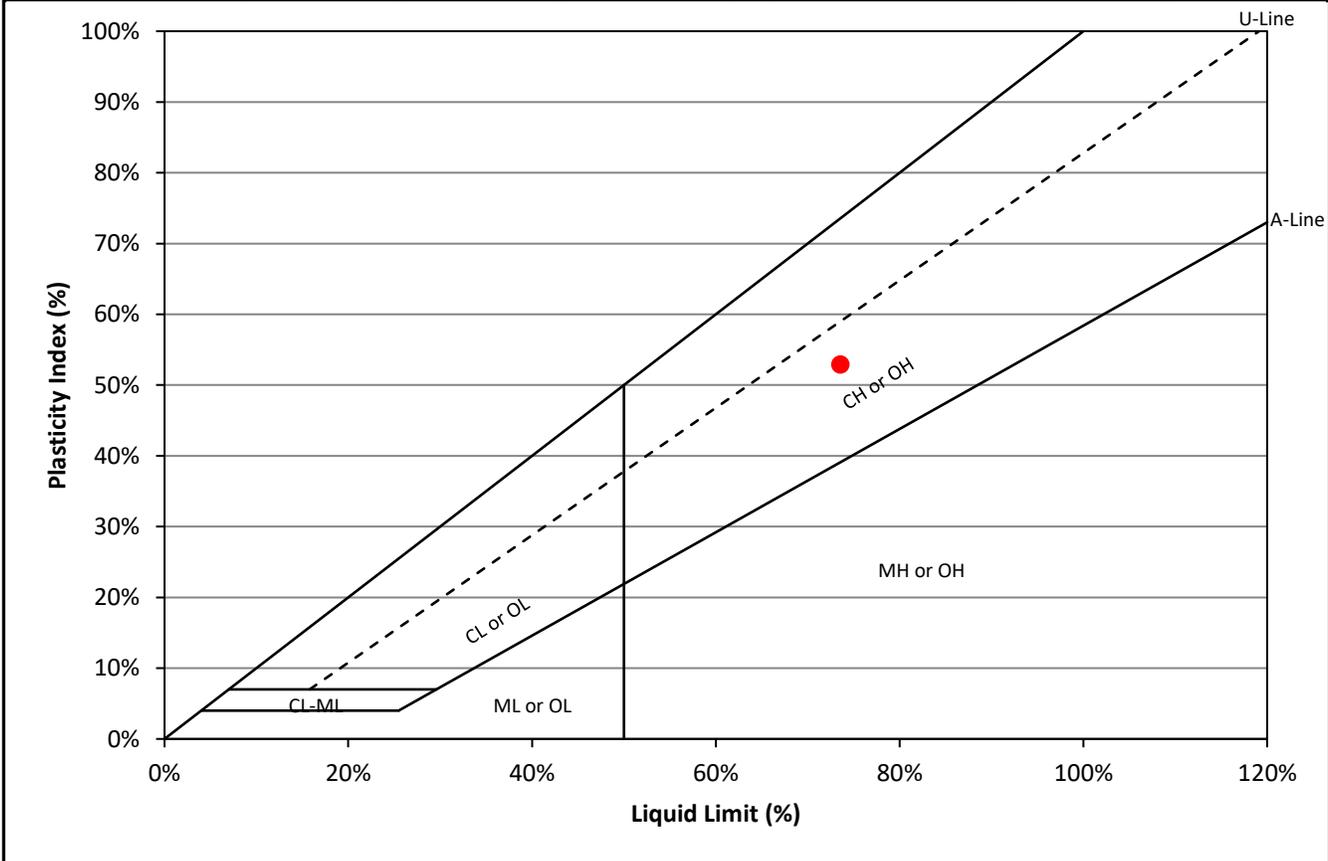
Liquid Limit			
Blows	25	20	15
Wet Sample (g)	13.8	12.3	14.5
Dry Sample (g)	8.0	6.9	8.1
Water Content (%)	73.1%	77.2%	79.3%

Plastic Limit		
Trial	1	2
Wet Sample (g)	6.6	7.0
Dry Sample (g)	5.5	5.8
Water Content (%)	21.0%	20.3%

Liquid Limit:	<b>74</b>	Plastic Limit:	<b>21</b>	Plasticity Index:	<b>53</b>
---------------	-----------	----------------	-----------	-------------------	-----------

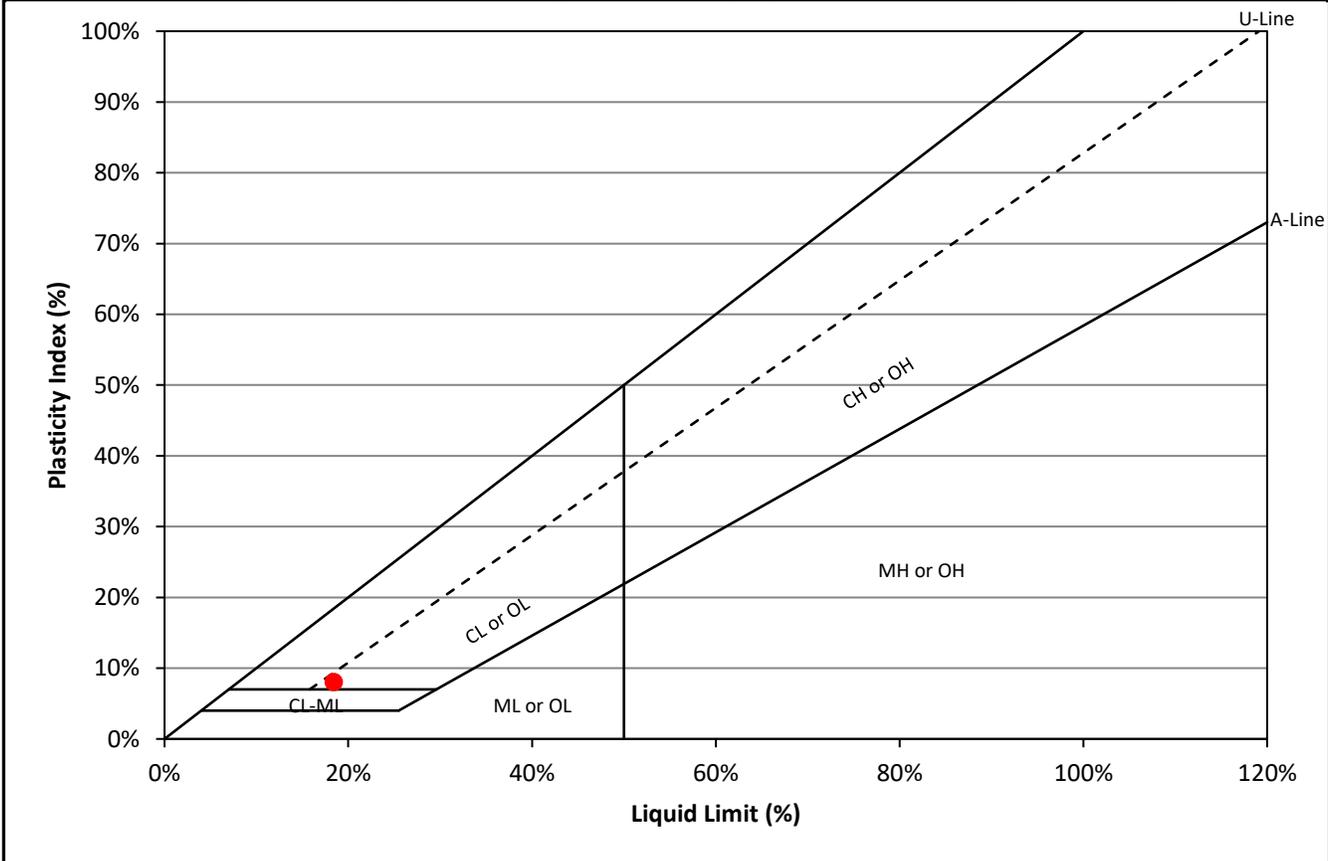
Liquid Limit			
Blows	18	24	26
Wet Sample (g)	13.1	14.3	13.8
Dry Sample (g)	11.0	12.0	11.7
Water Content (%)	19.2%	18.6%	18.2%

Plastic Limit		
Trial	1	2
Wet Sample (g)	8.3	8.3
Dry Sample (g)	7.5	7.5
Water Content (%)	10.5%	10.4%

Liquid Limit:	<b>18</b>	Plastic Limit:	<b>10</b>	Plasticity Index:	<b>8</b>
---------------	-----------	----------------	-----------	-------------------	----------

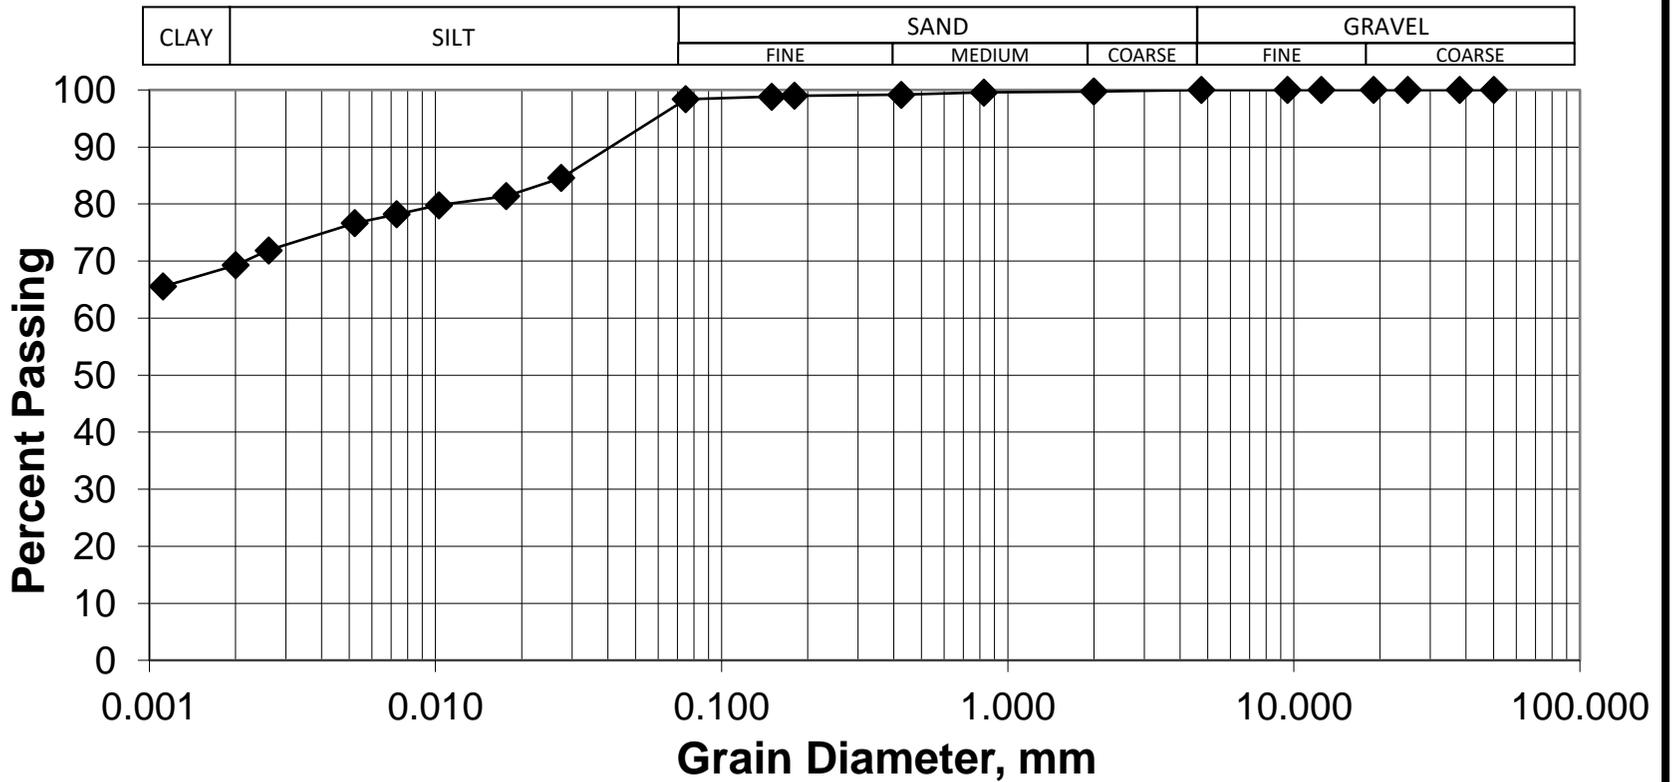
## GRAIN SIZE DISTRIBUTION CURVE

GRAVEL SIZES		SAND SIZES		FINES	
Grain Size (mm.)	Total Percent Passing	Grain Size (mm.)	Total Percent Passing	Grain Size (mm.)	Total Percent Passing
50.0	100.0	4.75	100.0	0.0750	98.4
38.0	100.0	2.00	99.7	0.0275	84.8
25.0	100.0	0.825	99.6	0.0177	81.6
19.0	100.0	0.425	99.1	0.0103	80.0
12.5	100.0	0.18	99.0	0.0073	78.4
9.5	100.0	0.15	98.8	0.0052	76.8
4.75	100.0	0.075	98.4	0.0026	72.1
				0.0020	69.5
				0.0011	65.7

<b>Gravel</b>	<b>0.0%</b>	<b>Silt</b>	<b>28.9%</b>
<b>Sand</b>	<b>1.6%</b>	<b>Clay</b>	<b>69.5%</b>

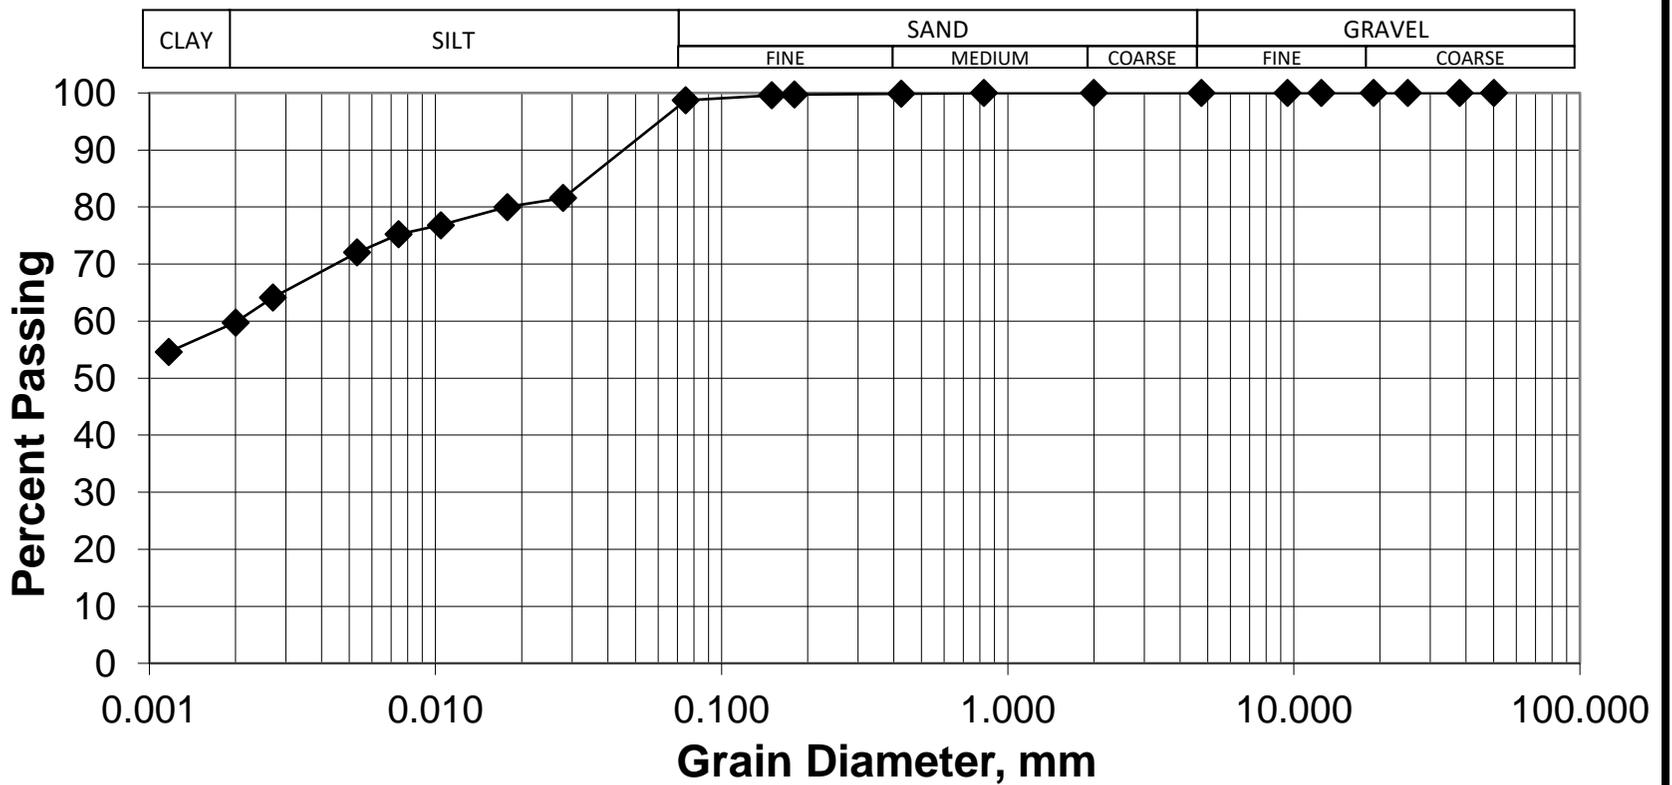
## GRAIN SIZE DISTRIBUTION CURVE

GRAVEL SIZES		SAND SIZES		FINES	
Grain Size (mm.)	Total Percent Passing	Grain Size (mm.)	Total Percent Passing	Grain Size (mm.)	Total Percent Passing
50.0	100.0	4.75	100.0	0.0750	98.7
38.0	100.0	2.00	100.0	0.0280	81.6
25.0	100.0	0.825	100.0	0.0178	80.0
19.0	100.0	0.425	99.9	0.0104	76.8
12.5	100.0	0.18	99.7	0.0074	75.2
9.5	100.0	0.15	99.6	0.0053	72.1
4.75	100.0	0.075	98.7	0.0027	64.1
				0.0020	59.8
				0.0012	54.6

Gravel	0.0%	Silt	38.9%
Sand	1.3%	Clay	59.8%

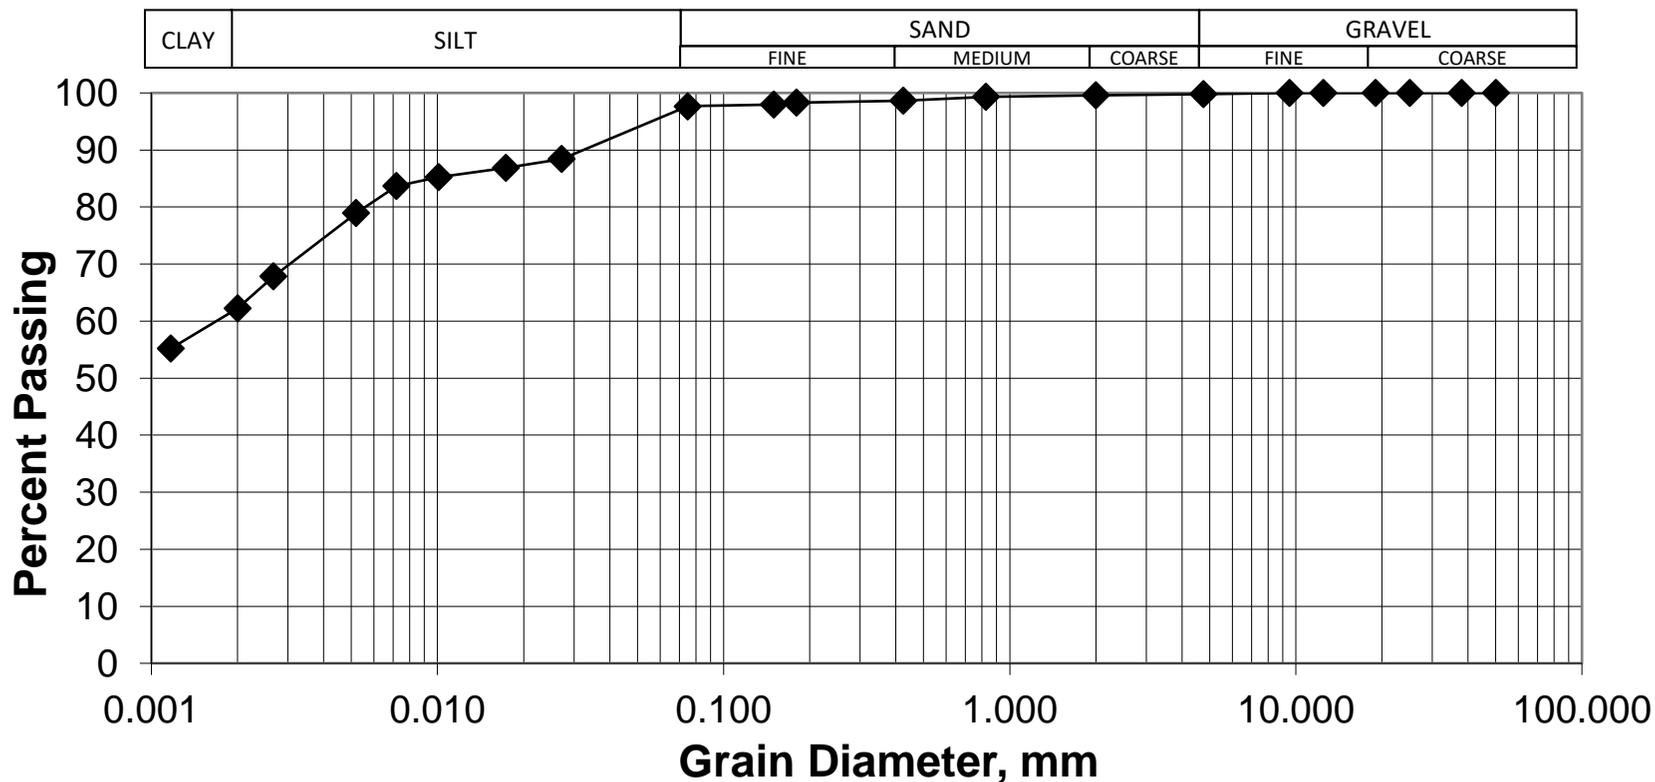
## GRAIN SIZE DISTRIBUTION CURVE

GRAVEL SIZES		SAND SIZES		FINES	
Grain Size (mm.)	Total Percent Passing	Grain Size (mm.)	Total Percent Passing	Grain Size (mm.)	Total Percent Passing
50.0	100.0	4.75	99.8	0.0750	97.7
38.0	100.0	2.00	99.6	0.0272	88.8
25.0	100.0	0.825	99.3	0.0173	87.2
19.0	100.0	0.425	98.7	0.0101	85.6
12.5	100.0	0.18	98.3	0.0072	84.0
9.5	100.0	0.15	98.0	0.0052	79.3
4.75	99.8	0.075	97.7	0.0027	68.2
				0.0020	62.5
				0.0012	55.5

<b>Gravel</b>	<b>0.2%</b>	<b>Silt</b>	<b>35.2%</b>
<b>Sand</b>	<b>2.2%</b>	<b>Clay</b>	<b>62.5%</b>

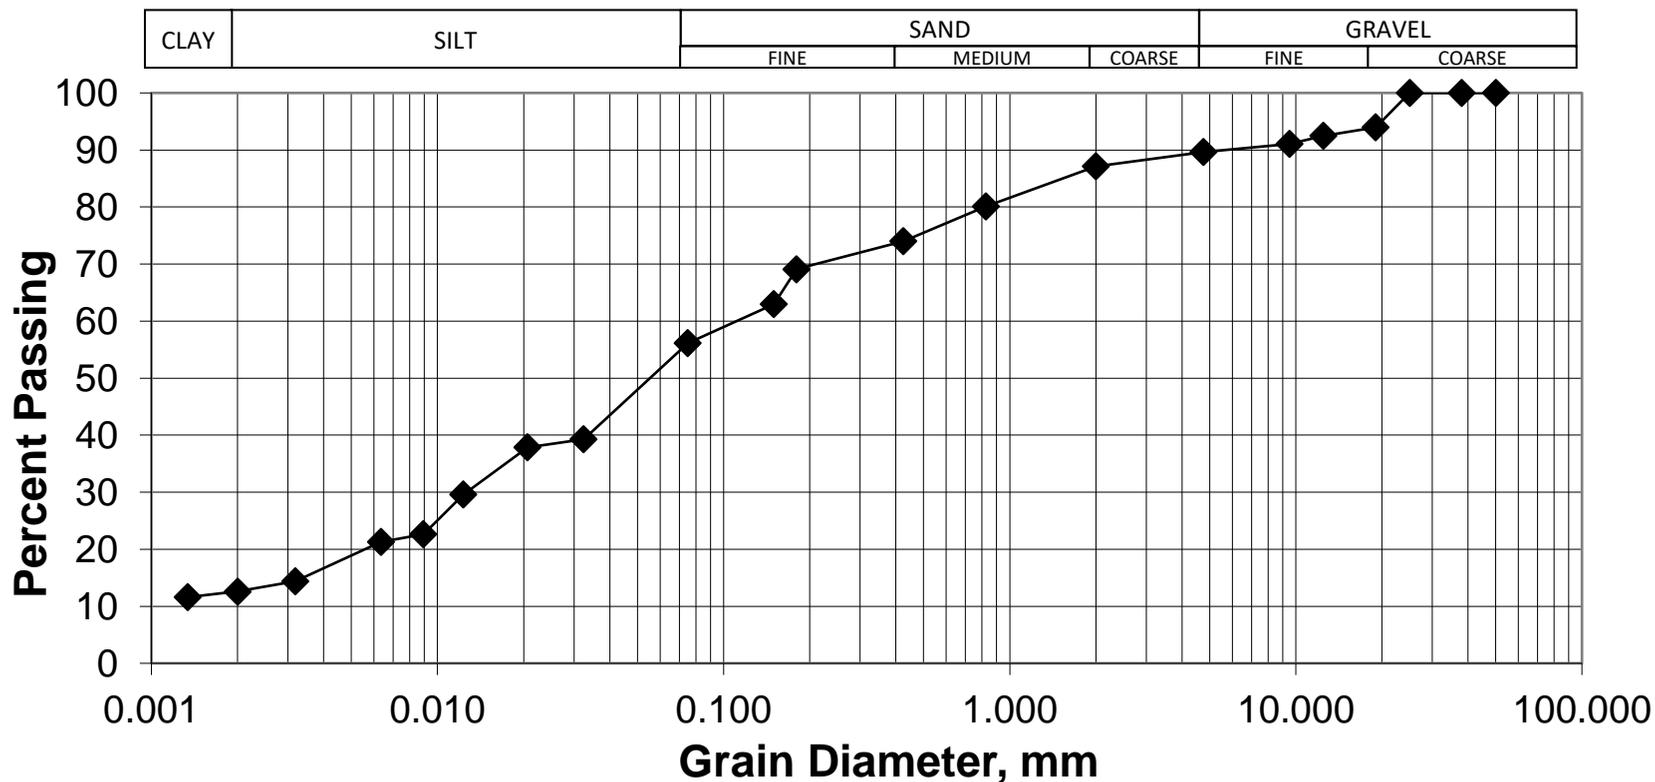
## GRAIN SIZE DISTRIBUTION CURVE

GRAVEL SIZES		SAND SIZES		FINES	
Grain Size (mm.)	Total Percent Passing	Grain Size (mm.)	Total Percent Passing	Grain Size (mm.)	Total Percent Passing
50.0	100.0	4.75	89.6	0.0750	56.2
38.0	100.0	2.00	87.1	0.0325	45.1
25.0	100.0	0.825	80.1	0.0206	43.5
19.0	93.9	0.425	74.0	0.0123	33.9
12.5	92.5	0.18	69.1	0.0089	26.0
9.5	91.1	0.15	63.0	0.0063	24.4
4.75	89.6	0.075	56.2	0.0032	16.5
				0.0020	14.4
				0.0013	13.3

<b>Gravel</b>	<b>10.4%</b>	<b>Silt</b>	<b>41.7%</b>
<b>Sand</b>	<b>33.5%</b>	<b>Clay</b>	<b>14.4%</b>

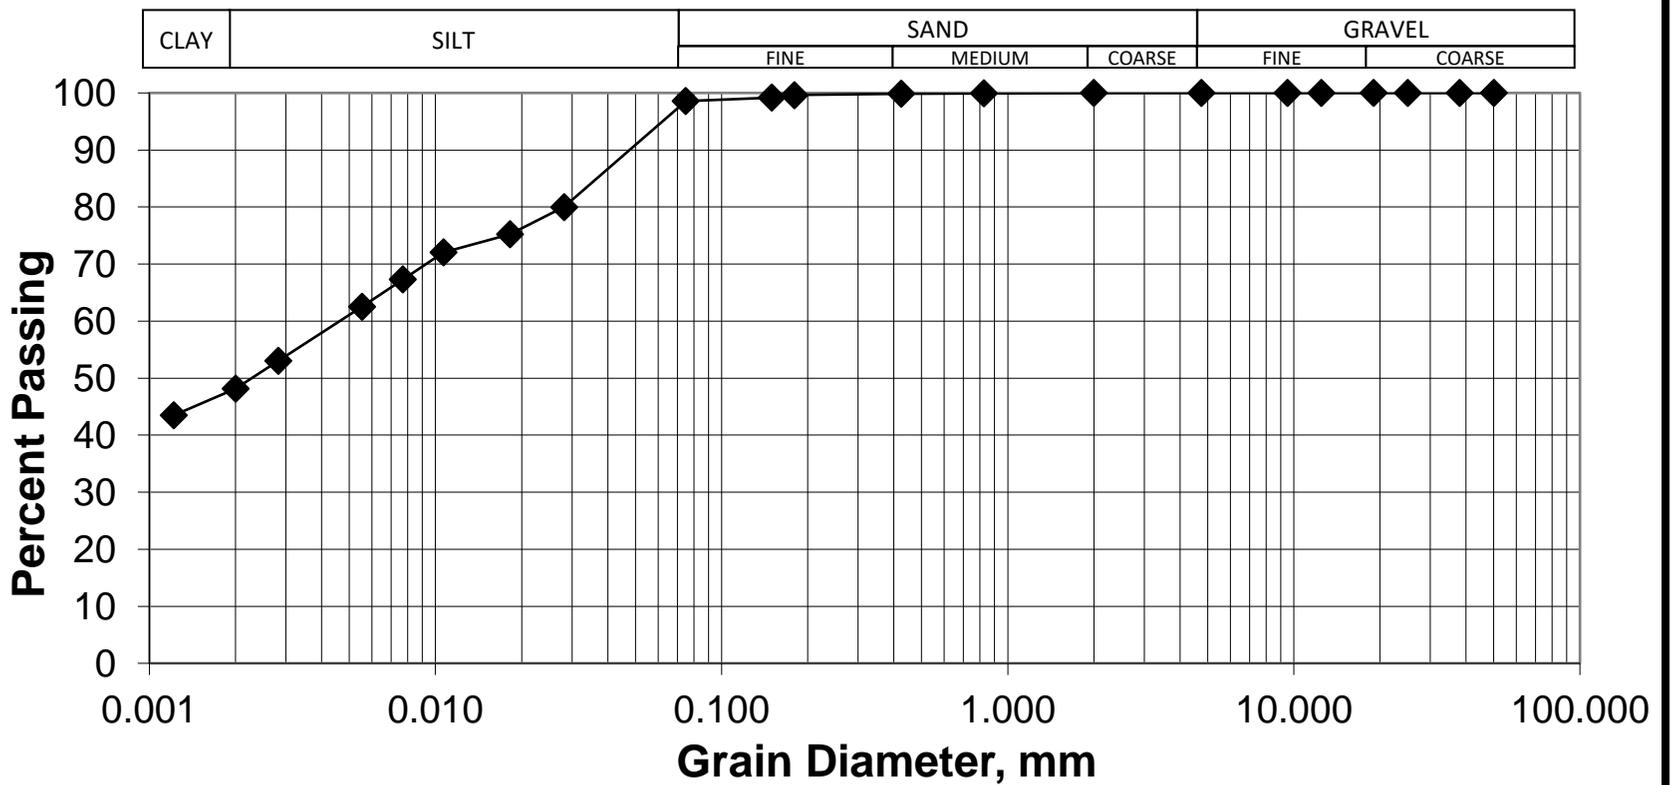
## GRAIN SIZE DISTRIBUTION CURVE

GRAVEL SIZES		SAND SIZES		FINES	
Grain Size (mm.)	Total Percent Passing	Grain Size (mm.)	Total Percent Passing	Grain Size (mm.)	Total Percent Passing
50.0	100.0	4.75	100.0	0.0750	98.6
38.0	100.0	2.00	100.0	0.0282	80.0
25.0	100.0	0.825	100.0	0.0182	75.2
19.0	100.0	0.425	99.9	0.0107	72.1
12.5	100.0	0.18	99.6	0.0077	67.3
9.5	100.0	0.15	99.2	0.0055	62.5
4.75	100.0	0.075	98.6	0.0028	53.0
				0.0020	48.1
				0.0012	43.5

<b>Gravel</b>	<b>0.0%</b>	<b>Silt</b>	<b>50.4%</b>
<b>Sand</b>	<b>1.4%</b>	<b>Clay</b>	<b>48.1%</b>

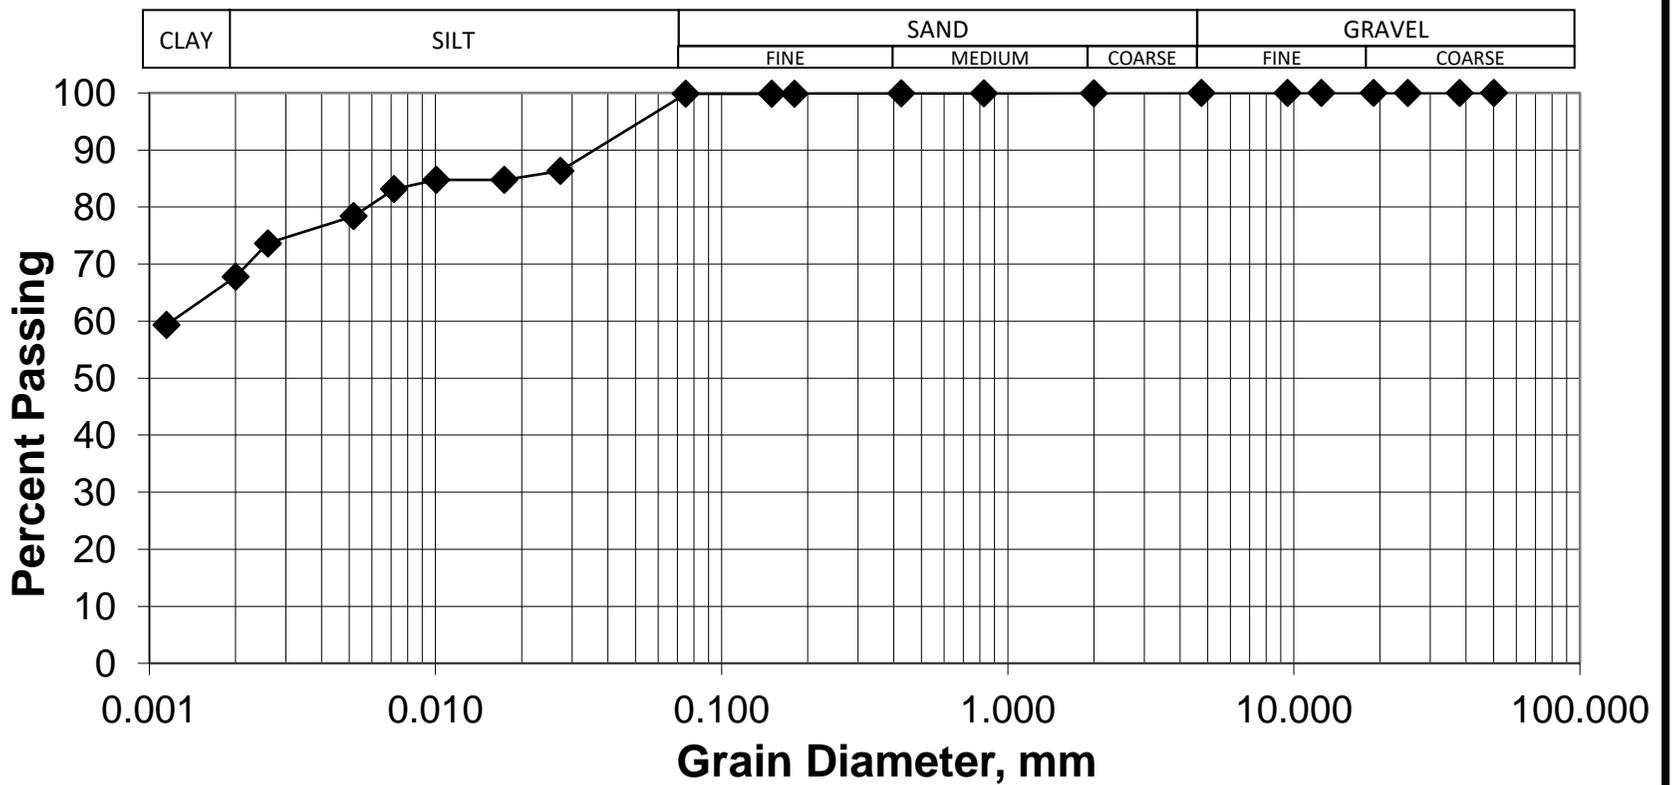
## GRAIN SIZE DISTRIBUTION CURVE

GRAVEL SIZES		SAND SIZES		FINES	
Grain Size (mm.)	Total Percent Passing	Grain Size (mm.)	Total Percent Passing	Grain Size (mm.)	Total Percent Passing
50.0	100.0	4.75	100.0	0.0750	99.8
38.0	100.0	2.00	100.0	0.0273	86.4
25.0	100.0	0.825	99.9	0.0174	84.8
19.0	100.0	0.425	99.9	0.0101	84.8
12.5	100.0	0.18	99.9	0.0072	83.2
9.5	100.0	0.15	99.9	0.0052	78.4
4.75	100.0	0.075	99.8	0.0026	73.7
				0.0020	67.8
				0.0011	59.4

Gravel	0.0%	Silt	32.1%
Sand	0.2%	Clay	67.8%

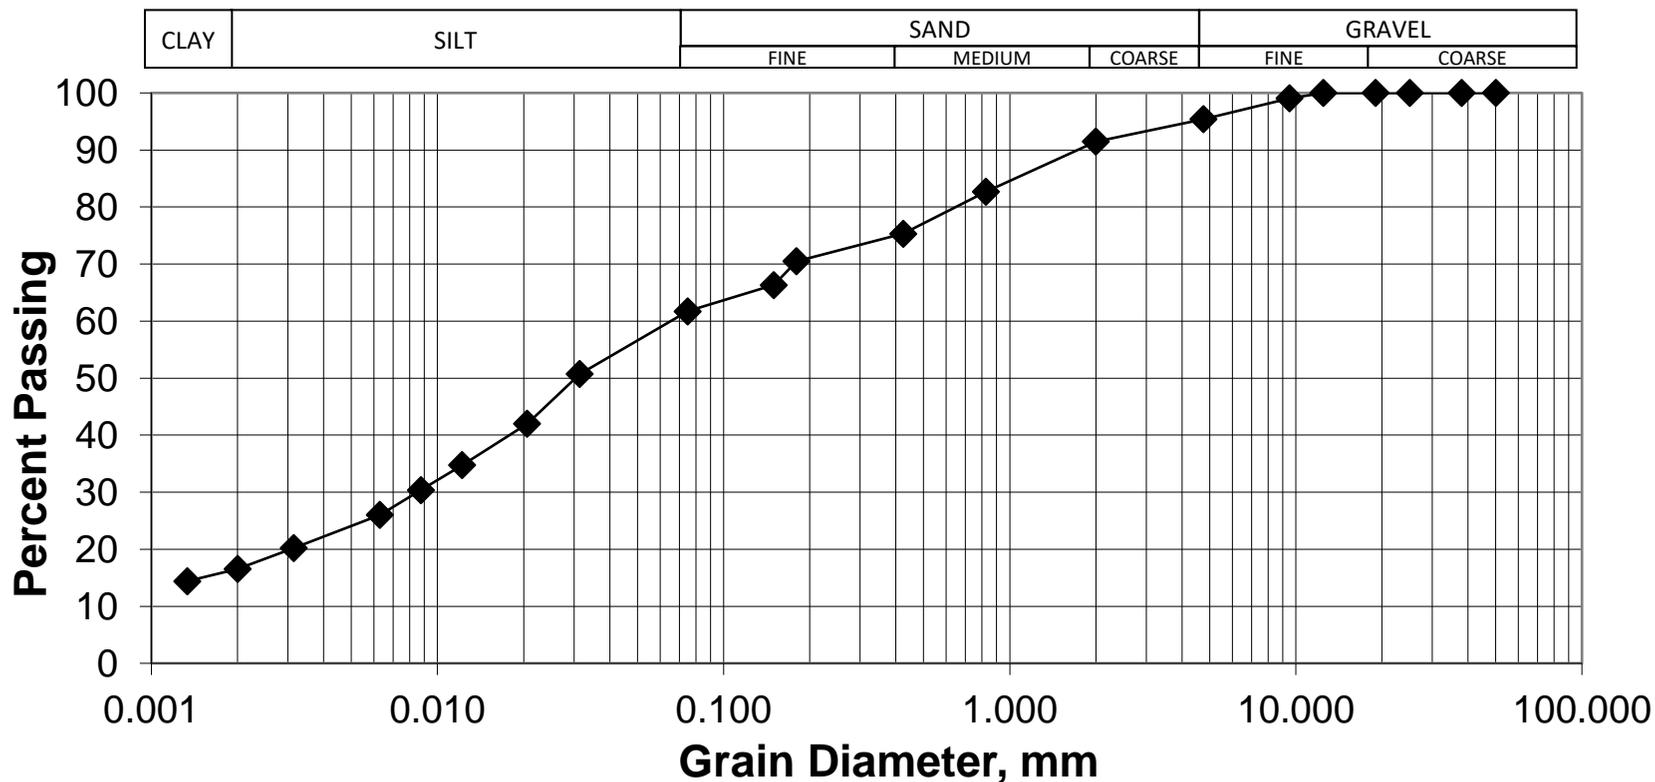
## GRAIN SIZE DISTRIBUTION CURVE

GRAVEL SIZES		SAND SIZES		FINES	
Grain Size (mm.)	Total Percent Passing	Grain Size (mm.)	Total Percent Passing	Grain Size (mm.)	Total Percent Passing
50.0	100.0	4.75	95.4	0.0750	61.7
38.0	100.0	2.00	91.4	0.0314	55.5
25.0	100.0	0.825	82.7	0.0206	45.9
19.0	100.0	0.425	75.3	0.0122	38.0
12.5	100.0	0.18	70.5	0.0088	33.2
9.5	99.0	0.15	66.3	0.0063	28.5
4.75	95.4	0.075	61.7	0.0031	22.1
				0.0020	18.1
				0.0013	15.8

<b>Gravel</b>	<b>4.6%</b>	<b>Silt</b>	<b>43.6%</b>
<b>Sand</b>	<b>33.6%</b>	<b>Clay</b>	<b>18.1%</b>

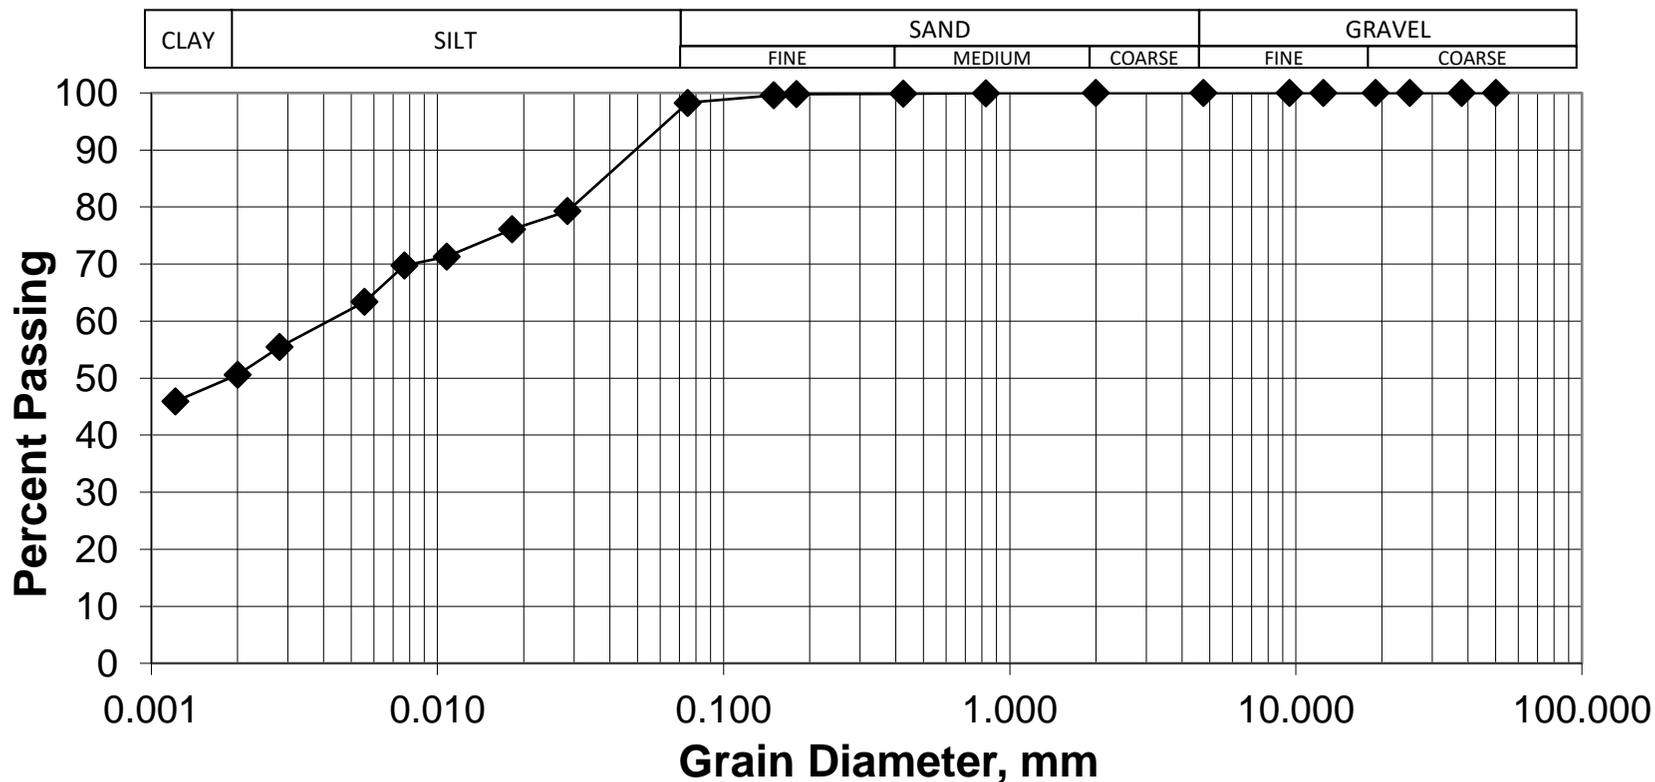
## GRAIN SIZE DISTRIBUTION CURVE

GRAVEL SIZES		SAND SIZES		FINES	
Grain Size (mm.)	Total Percent Passing	Grain Size (mm.)	Total Percent Passing	Grain Size (mm.)	Total Percent Passing
50.0	100.0	4.75	100.0	0.0750	98.3
38.0	100.0	2.00	100.0	0.0285	79.3
25.0	100.0	0.825	100.0	0.0183	76.1
19.0	100.0	0.425	99.9	0.0108	71.3
12.5	100.0	0.18	99.8	0.0077	69.7
9.5	100.0	0.15	99.6	0.0056	63.4
4.75	100.0	0.075	98.3	0.0028	55.5
				0.0020	50.6
				0.0012	45.9

Gravel	0.0%	Silt	47.6%
Sand	1.7%	Clay	50.6%

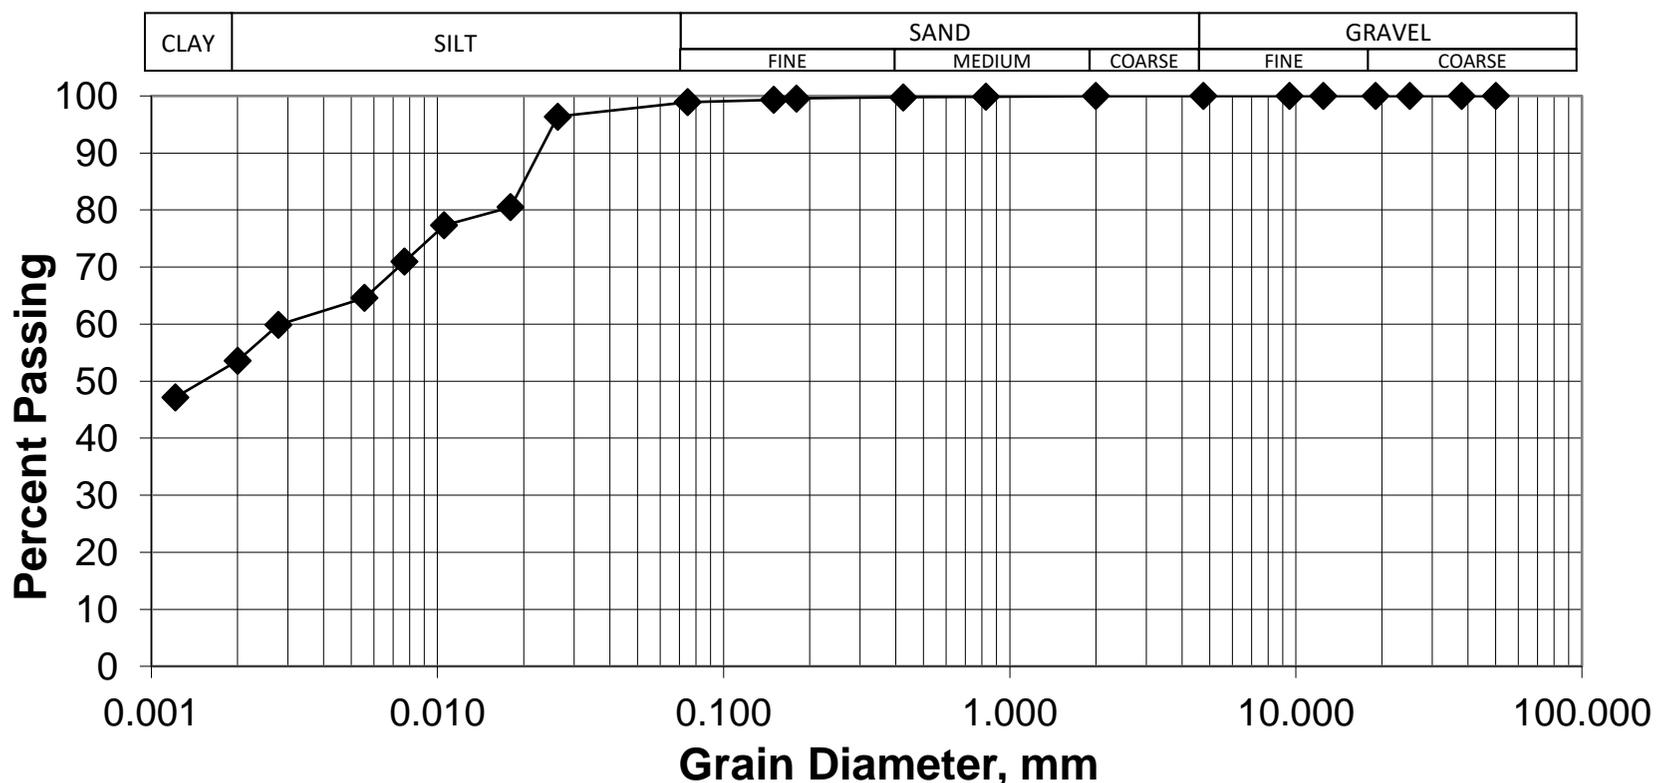
## GRAIN SIZE DISTRIBUTION CURVE

GRAVEL SIZES		SAND SIZES		FINES	
Grain Size (mm.)	Total Percent Passing	Grain Size (mm.)	Total Percent Passing	Grain Size (mm.)	Total Percent Passing
50.0	100.0	4.75	100.0	0.0750	98.9
38.0	100.0	2.00	100.0	0.0263	96.4
25.0	100.0	0.825	99.9	0.0180	80.5
19.0	100.0	0.425	99.8	0.0105	77.3
12.5	100.0	0.18	99.6	0.0077	71.0
9.5	100.0	0.15	99.3	0.0056	64.6
4.75	100.0	0.075	98.9	0.0028	59.9
				0.0020	53.5
				0.0012	47.1

<b>Gravel</b>	<b>0.0%</b>	<b>Silt</b>	<b>45.3%</b>
<b>Sand</b>	<b>1.1%</b>	<b>Clay</b>	<b>53.5%</b>

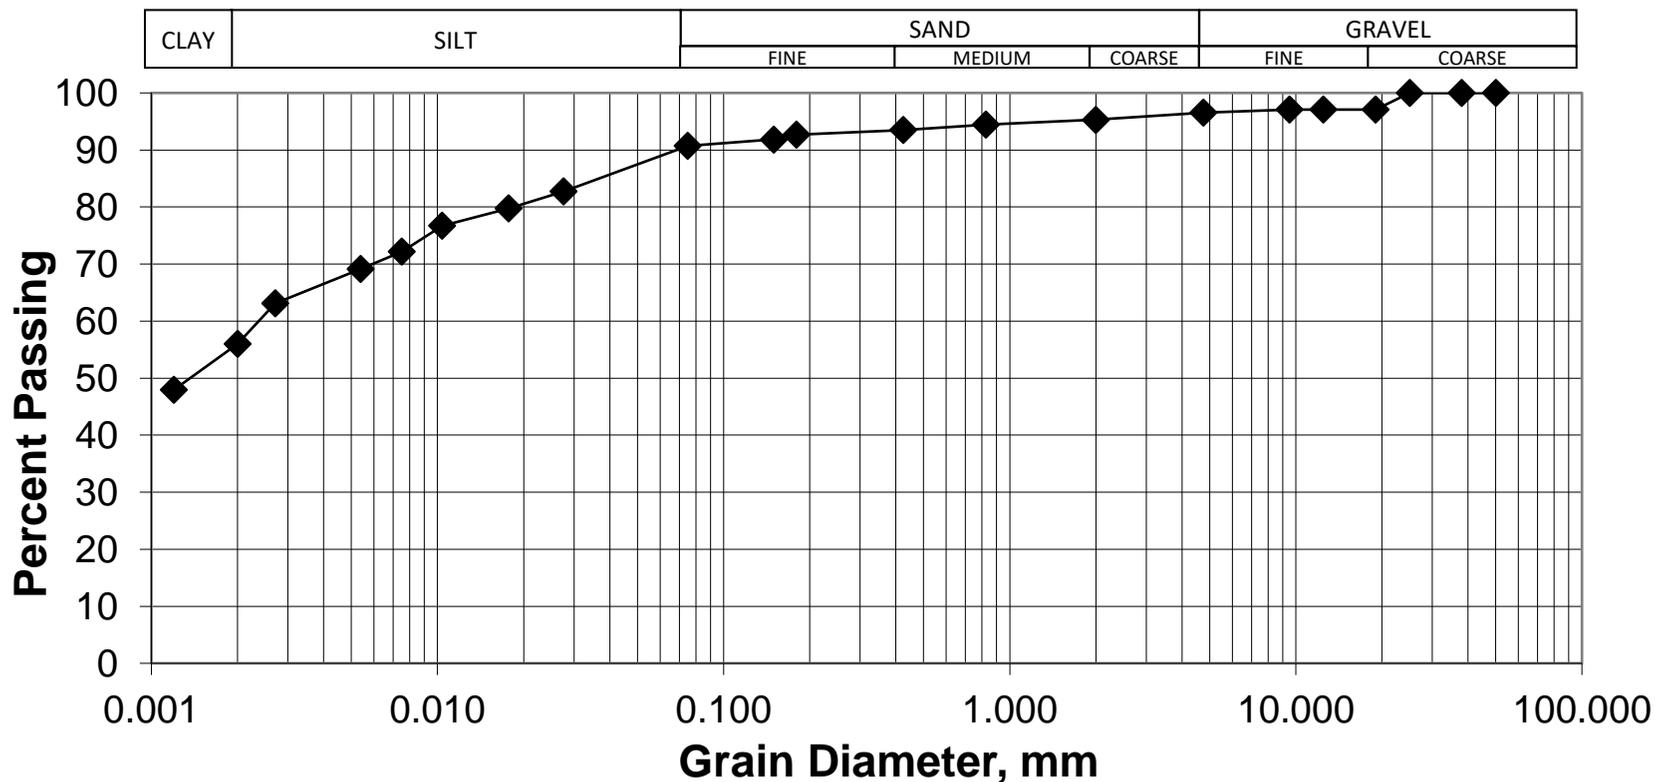
## GRAIN SIZE DISTRIBUTION CURVE

GRAVEL SIZES		SAND SIZES		FINES	
Grain Size (mm.)	Total Percent Passing	Grain Size (mm.)	Total Percent Passing	Grain Size (mm.)	Total Percent Passing
50.0	100.0	4.75	96.6	0.0750	90.7
38.0	100.0	2.00	95.3	0.0276	86.9
25.0	100.0	0.825	94.5	0.0177	83.7
19.0	97.1	0.425	93.5	0.0104	80.5
12.5	97.1	0.18	92.7	0.0075	75.7
9.5	97.1	0.15	91.8	0.0054	72.6
4.75	96.6	0.075	90.7	0.0027	66.2
				0.0020	58.7
				0.0012	50.3

<b>Gravel</b>	<b>3.4%</b>	<b>Silt</b>	<b>32.0%</b>
<b>Sand</b>	<b>5.9%</b>	<b>Clay</b>	<b>58.7%</b>

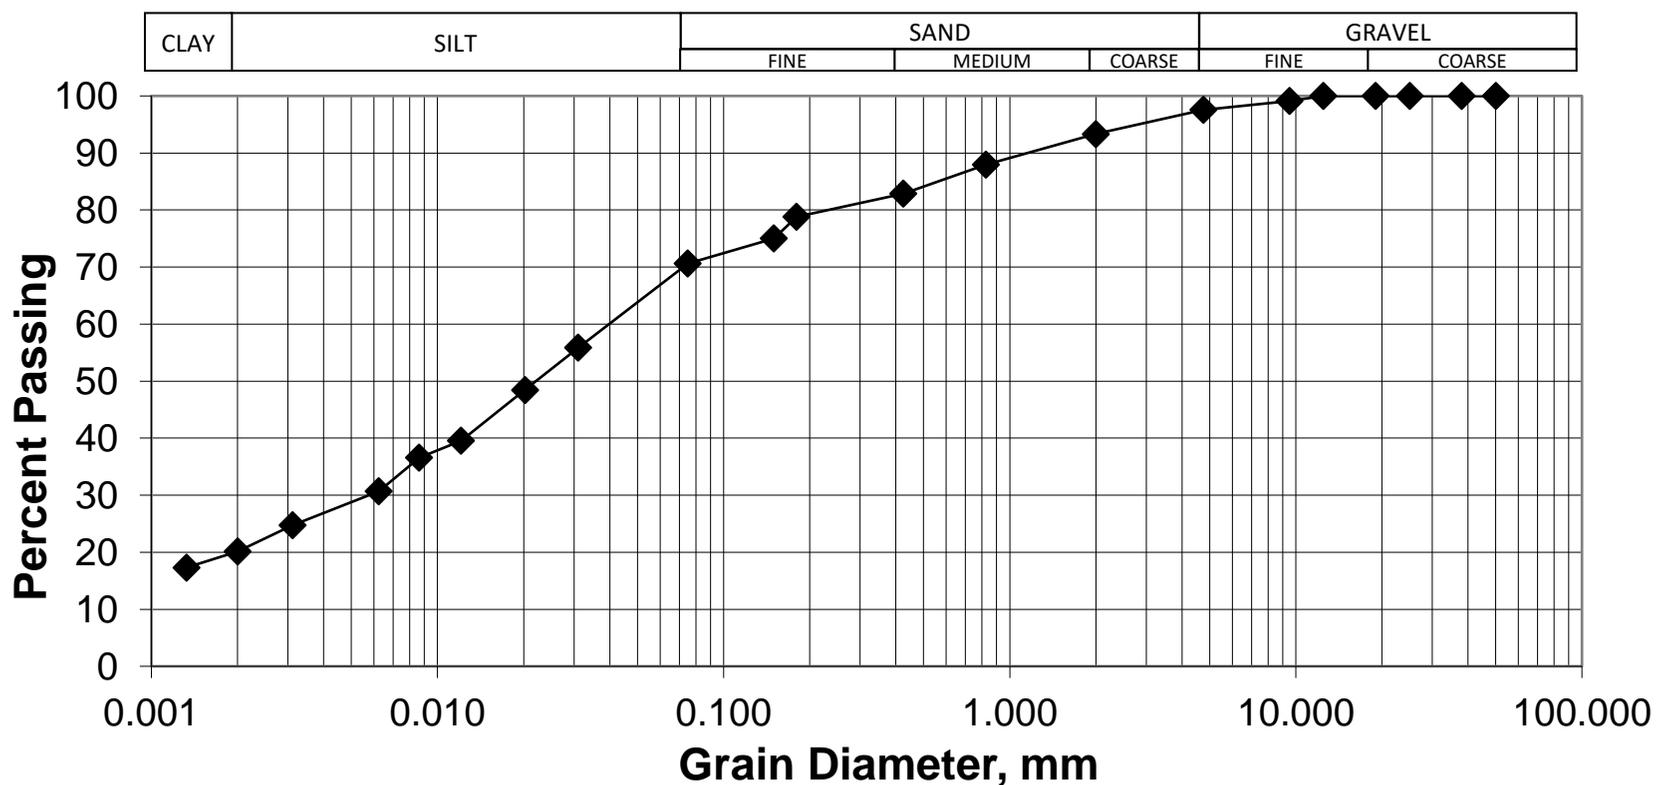
## GRAIN SIZE DISTRIBUTION CURVE

GRAVEL SIZES		SAND SIZES		FINES	
Grain Size (mm.)	Total Percent Passing	Grain Size (mm.)	Total Percent Passing	Grain Size (mm.)	Total Percent Passing
50.0	100.0	4.75	97.6	0.0750	70.6
38.0	100.0	2.00	93.3	0.0311	59.9
25.0	100.0	0.825	88.0	0.0202	51.9
19.0	100.0	0.425	82.9	0.0121	42.4
12.5	100.0	0.18	78.8	0.0086	39.2
9.5	99.1	0.15	75.0	0.0062	32.9
4.75	97.6	0.075	70.6	0.0031	26.5
				0.0020	21.5
				0.0013	18.6

<b>Gravel</b>	<b>2.4%</b>	<b>Silt</b>	<b>49.1%</b>
<b>Sand</b>	<b>26.9%</b>	<b>Clay</b>	<b>21.5%</b>
