# Replacement of the FGSV Siphon

Geotechnical Baseline Report  
FINAL

City of Winnipeg

May 2025

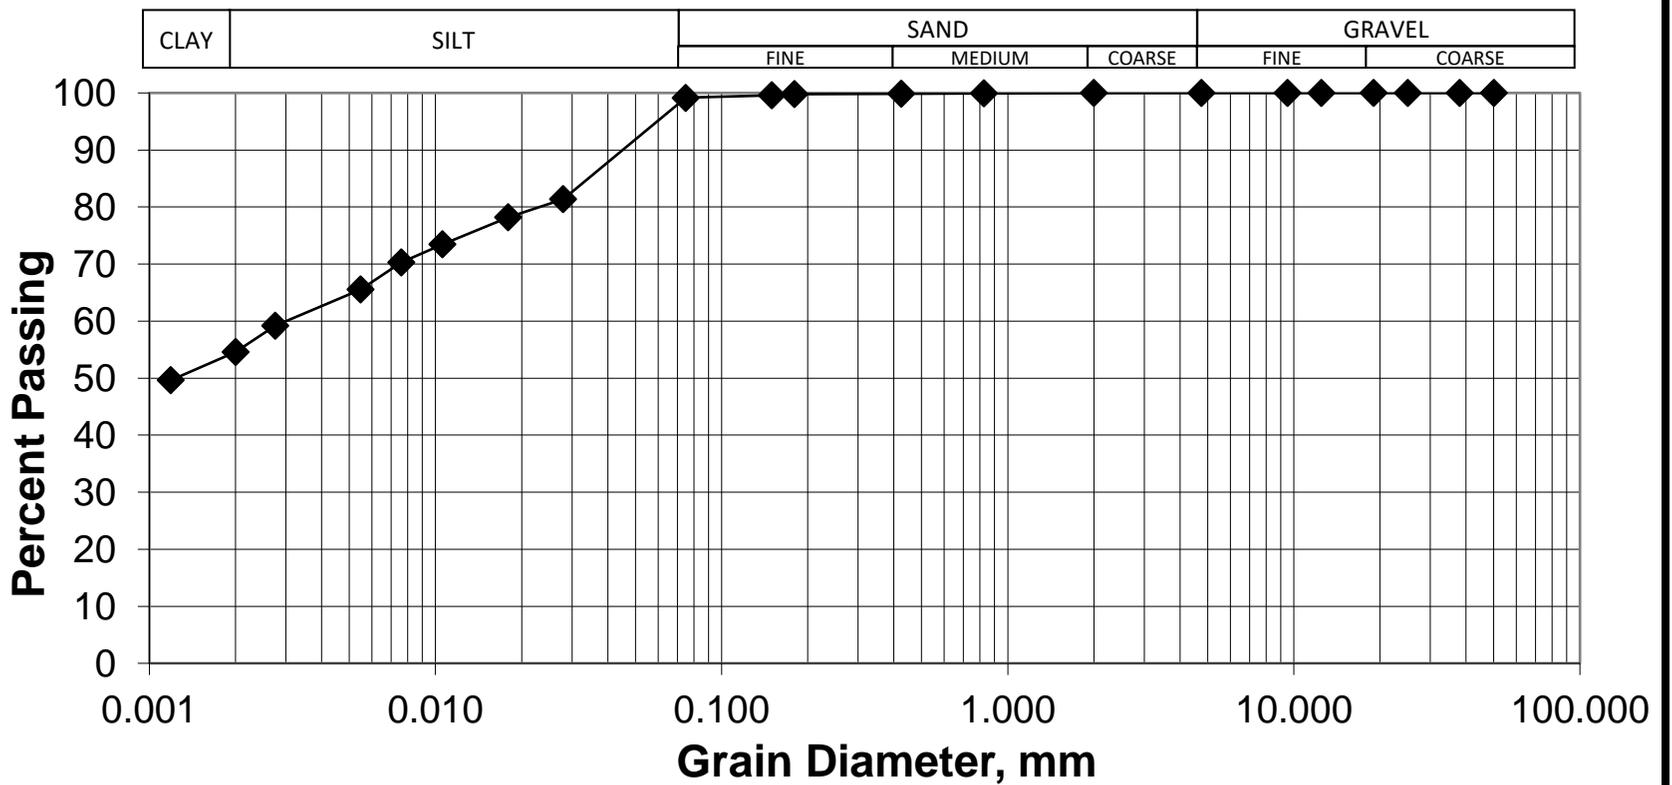
## GRAIN SIZE DISTRIBUTION CURVE

GRAVEL SIZES		SAND SIZES		FINES	
Grain Size (mm.)	Total Percent Passing	Grain Size (mm.)	Total Percent Passing	Grain Size (mm.)	Total Percent Passing
50.0	100.0	4.75	100.0	0.0750	99.1
38.0	100.0	2.00	100.0	0.0280	81.4
25.0	100.0	0.825	99.9	0.0179	78.2
19.0	100.0	0.425	99.9	0.0106	73.5
12.5	100.0	0.18	99.8	0.0076	70.3
9.5	100.0	0.15	99.6	0.0055	65.5
4.75	100.0	0.075	99.1	0.0028	59.2
				0.0020	54.6
				0.0012	49.6

<b>Gravel</b>	<b>0.0%</b>	<b>Silt</b>	<b>44.6%</b>
<b>Sand</b>	<b>0.9%</b>	<b>Clay</b>	<b>54.6%</b>

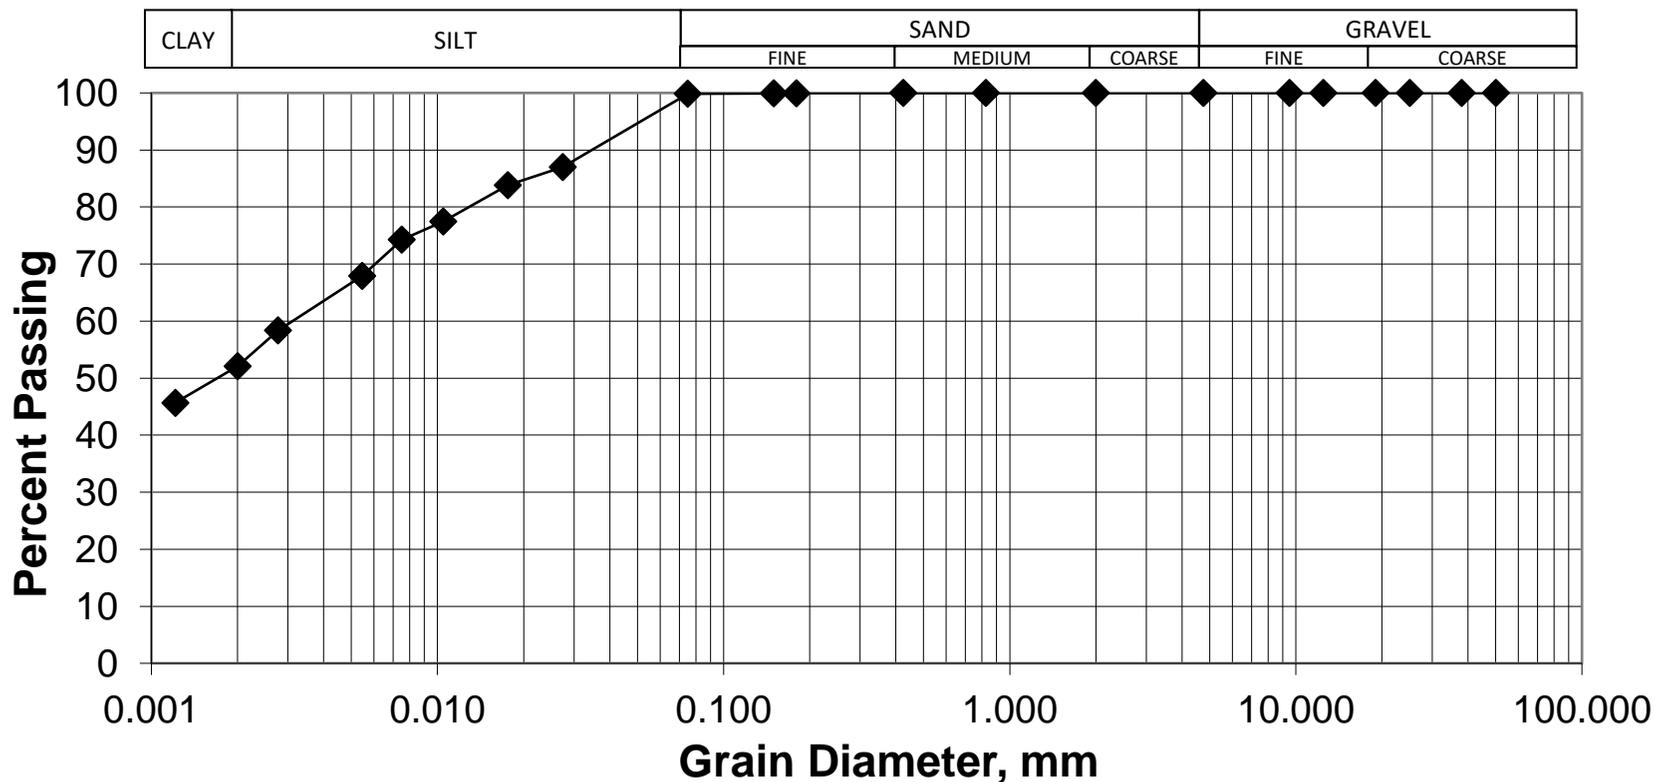
## GRAIN SIZE DISTRIBUTION CURVE

GRAVEL SIZES		SAND SIZES		FINES	
Grain Size (mm.)	Total Percent Passing	Grain Size (mm.)	Total Percent Passing	Grain Size (mm.)	Total Percent Passing
50.0	100.0	4.75	100.0	0.0750	99.9
38.0	100.0	2.00	100.0	0.0274	87.0
25.0	100.0	0.825	100.0	0.0176	83.8
19.0	100.0	0.425	100.0	0.0105	77.4
12.5	100.0	0.18	100.0	0.0075	74.3
9.5	100.0	0.15	99.9	0.0055	67.9
4.75	100.0	0.075	99.9	0.0028	58.4
				0.0020	52.1
				0.0012	45.7

<b>Gravel</b>	<b>0.0%</b>	<b>Silt</b>	<b>47.8%</b>
<b>Sand</b>	<b>0.1%</b>	<b>Clay</b>	<b>52.1%</b>

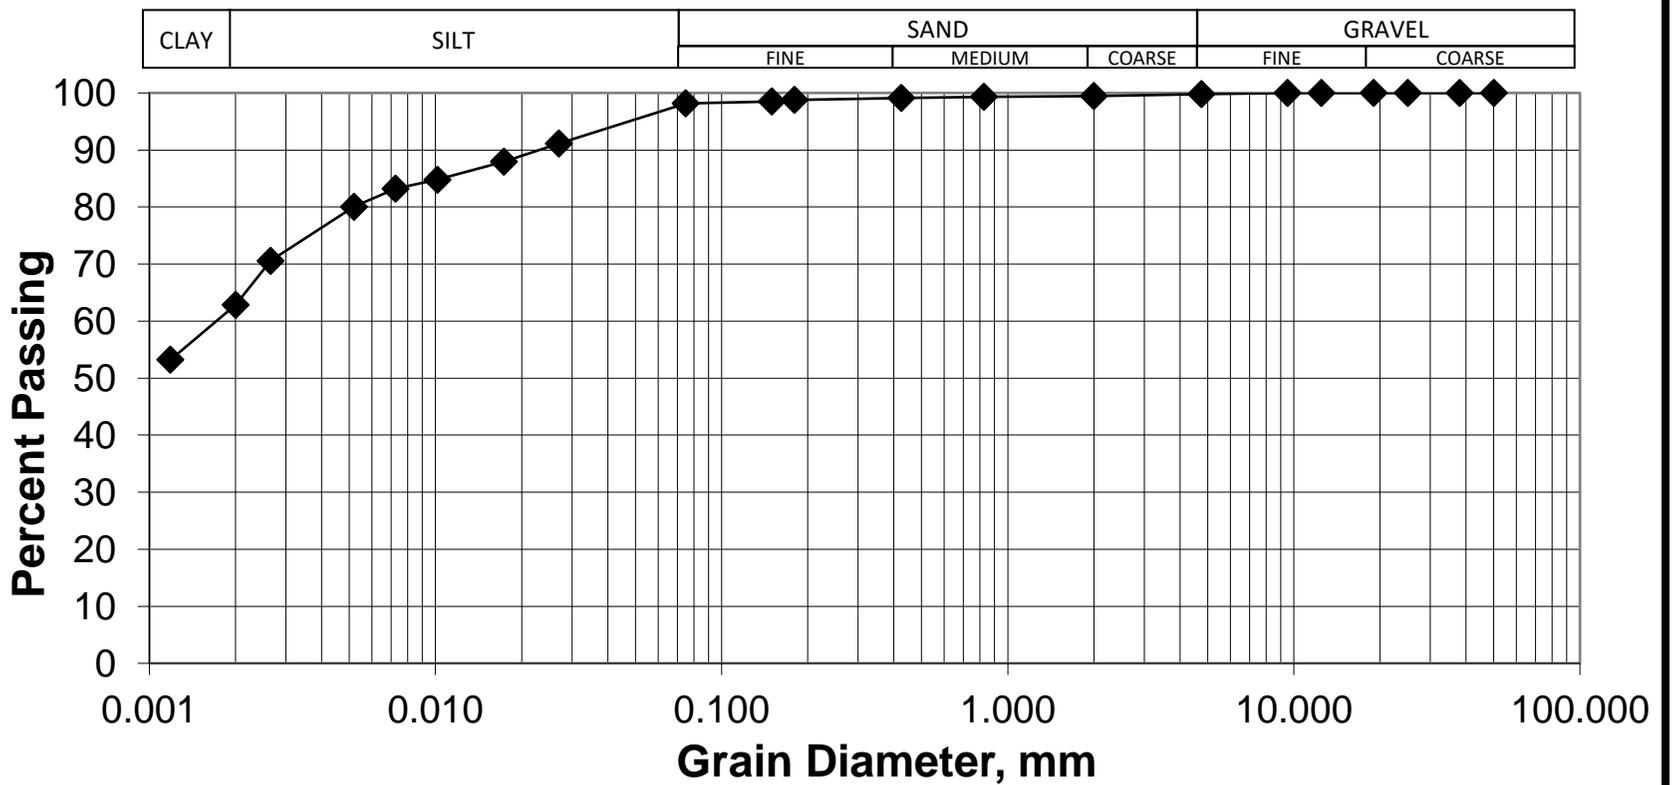
## GRAIN SIZE DISTRIBUTION CURVE

GRAVEL SIZES		SAND SIZES		FINES	
Grain Size (mm.)	Total Percent Passing	Grain Size (mm.)	Total Percent Passing	Grain Size (mm.)	Total Percent Passing
50.0	100.0	4.75	99.8	0.0750	98.2
38.0	100.0	2.00	99.5	0.0270	91.6
25.0	100.0	0.825	99.3	0.0173	88.4
19.0	100.0	0.425	99.1	0.0102	85.3
12.5	100.0	0.18	98.8	0.0072	83.7
9.5	100.0	0.15	98.5	0.0052	80.5
4.75	99.8	0.075	98.2	0.0027	71.0
				0.0020	63.2
				0.0012	53.5

Gravel	0.2%	Silt	35.0%
Sand	1.6%	Clay	63.2%

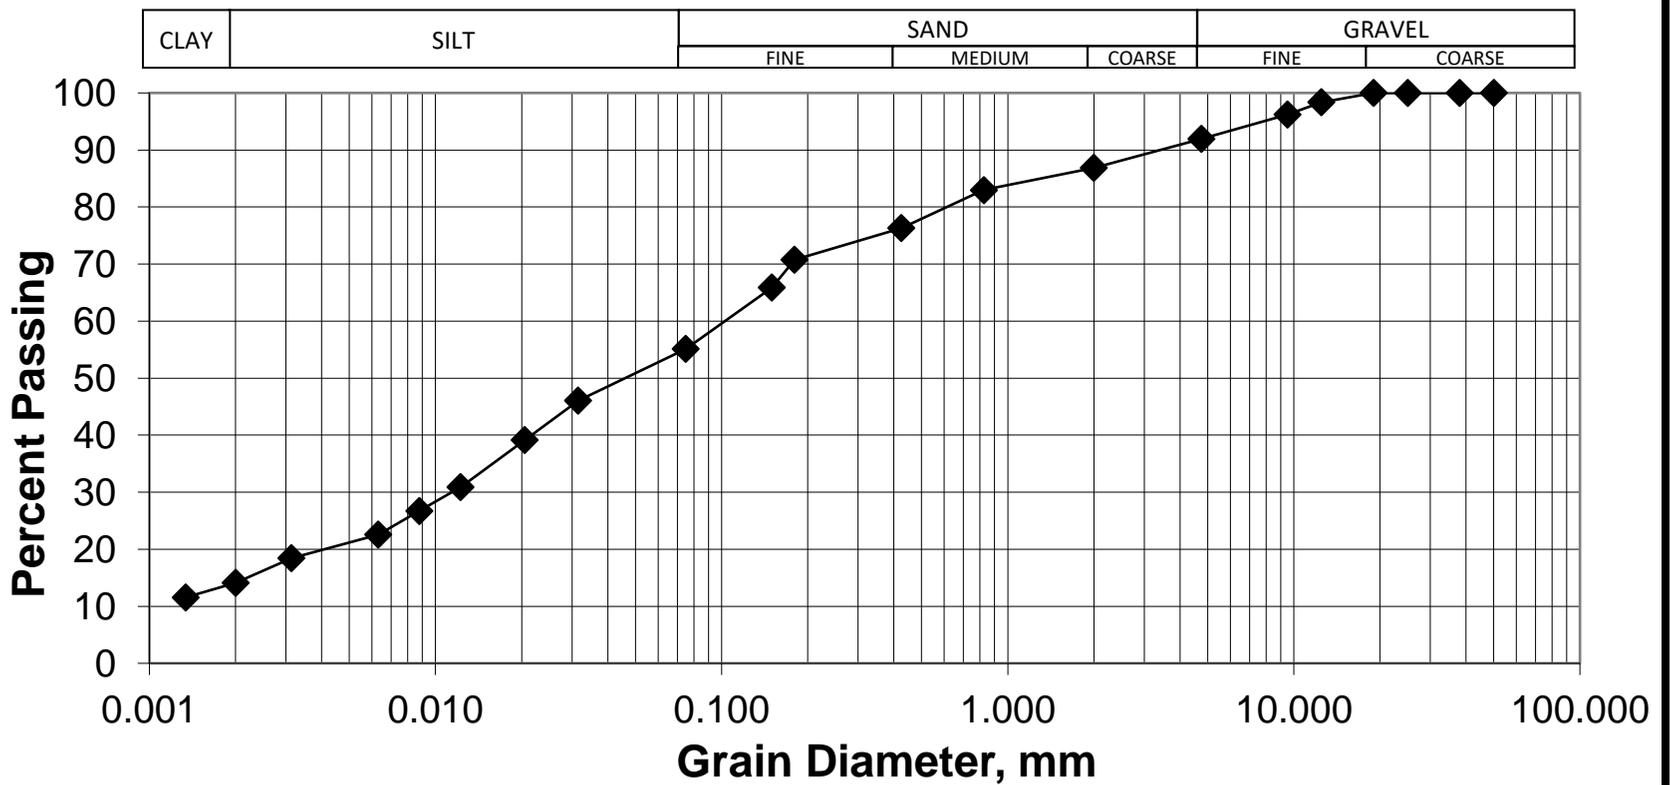
## GRAIN SIZE DISTRIBUTION CURVE

GRAVEL SIZES		SAND SIZES		FINES	
Grain Size (mm.)	Total Percent Passing	Grain Size (mm.)	Total Percent Passing	Grain Size (mm.)	Total Percent Passing
50.0	100.0	4.75	92.0	0.0750	55.1
38.0	100.0	2.00	86.9	0.0315	53.0
25.0	100.0	0.825	83.0	0.0205	45.1
19.0	100.0	0.425	76.3	0.0122	35.5
12.5	98.4	0.18	70.7	0.0088	30.8
9.5	96.2	0.15	65.9	0.0063	26.0
4.75	92.0	0.075	55.1	0.0031	21.2
				0.0020	16.2
				0.0013	13.3

<b>Gravel</b>	<b>8.0%</b>	<b>Silt</b>	<b>38.9%</b>
<b>Sand</b>	<b>36.8%</b>	<b>Clay</b>	<b>16.2%</b>

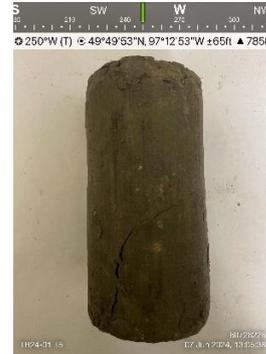
### FAILURE SKETCH

Soil Description:	CLAY - grey, stiff, moist, silty, high plasticity, homogeneous
-------------------	--

Average Diameter (cm):	7.17
Average Length (cm):	14.90
Length/Diameter Ratio:	2.08
Moisture content (%):	13.6
Bulk Density (g/cm <sup>3</sup> ):	1.940
Bulk Unit Weight (kN/m <sup>3</sup> ):	19.0
Bulk Unit Weight (pcf):	121.1
Dry Unit Weight (kN/m <sup>3</sup> ):	16.74

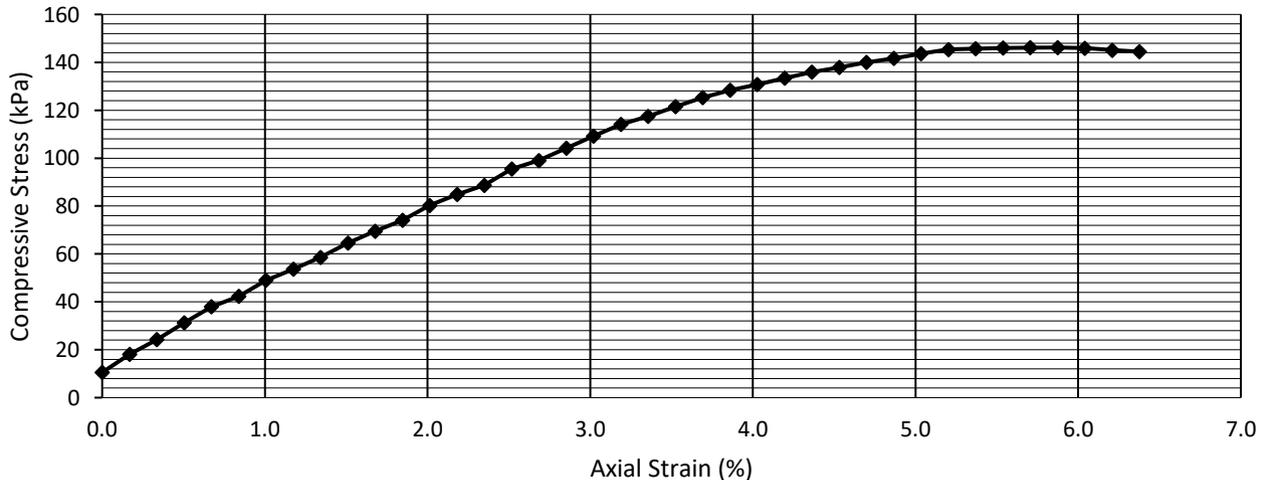
### Unconfined Compressive Strength

UCS	Unconfined compressive strength (kPa)	146.18	Undrained Shear Strength (kPa)	73.09
	Unconfined compressive strength (ksf)	3.053	Undrained Shear Strength (ksf)	1.526
	Avg. Rate of Strain to Failure (%/min):	1.01	Strain at Failure (%):	5.87

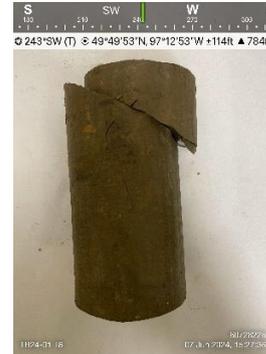
### FAILURE SKETCH

Soil Description:	CLAY - brown, stiff, moist, silty, high plasticity, slickensided
-------------------	--

Average Diameter (cm):	7.10
Average Length (cm):	14.73
Length/Diameter Ratio:	2.08
Moisture content (%):	15.0
Bulk Density (g/cm <sup>3</sup> ):	1.797
Bulk Unit Weight (kN/m <sup>3</sup> ):	17.6
Bulk Unit Weight (pcf):	112.2
Dry Unit Weight (kN/m <sup>3</sup> ):	15.32

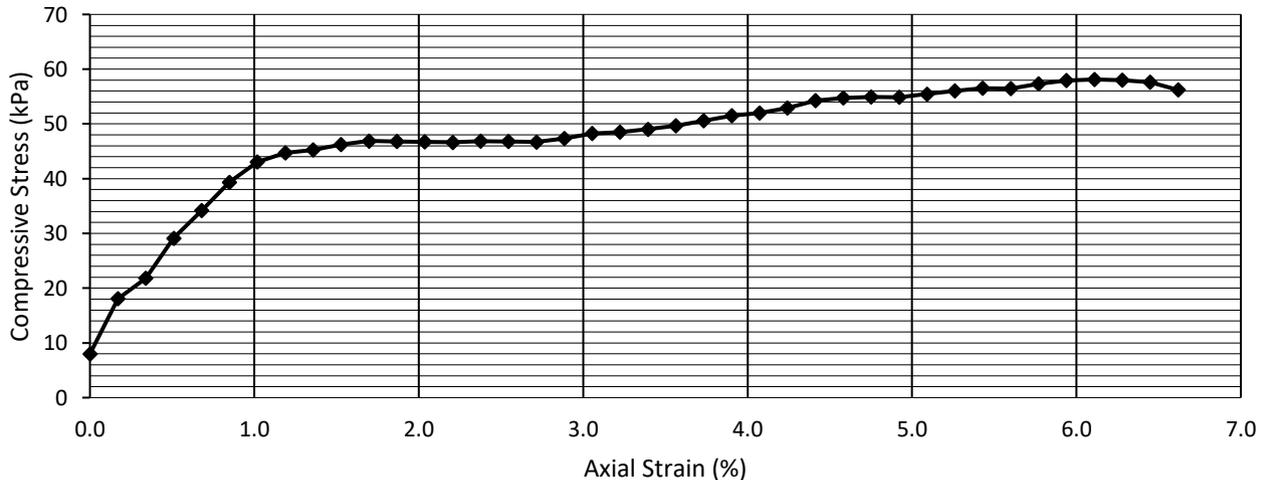
### Unconfined Compressive Strength

UCS	Unconfined compressive strength (kPa)	58.12	Undrained Shear Strength (kPa)	29.06
	Unconfined compressive strength (ksf)	1.214	Undrained Shear Strength (ksf)	0.607
	Avg. Rate of Strain to Failure (%/min):	1.02	Strain at Failure (%):	6.11

Lower undrained shear strength (kPa) for unconfined compressive test due to the structure being slickensided.

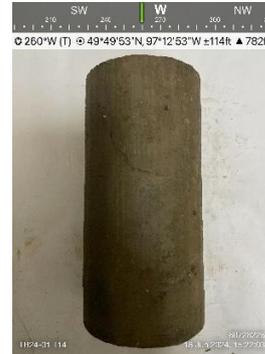
### FAILURE SKETCH

Soil Description:	CLAY - brown, stiff, moist, silty, high plasticity, homogeneous
-------------------	---

Average Diameter (cm):	7.20
Average Length (cm):	14.40
Length/Diameter Ratio:	2.00
Moisture content (%):	47.3
Bulk Density (g/cm <sup>3</sup> ):	1.725
Bulk Unit Weight (kN/m <sup>3</sup> ):	16.9
Bulk Unit Weight (pcf):	107.7
Dry Unit Weight (kN/m <sup>3</sup> ):	11.49

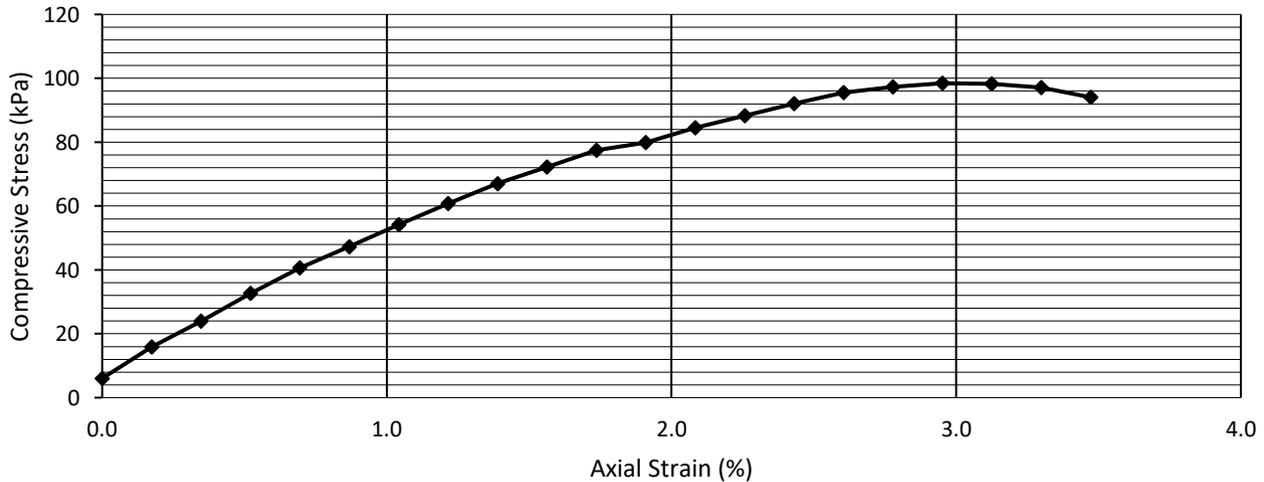
### Unconfined Compressive Strength

UCS	Unconfined compressive strength (kPa)	98.45	Undrained Shear Strength (kPa)	49.23
	Unconfined compressive strength (ksf)	2.056	Undrained Shear Strength (ksf)	1.028
	Avg. Rate of Strain to Failure (%/min):	1.04	Strain at Failure (%):	2.95

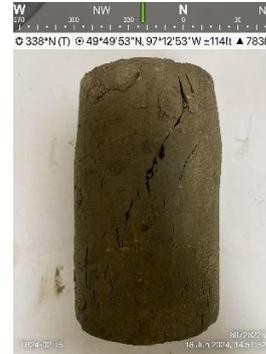
### FAILURE SKETCH

Soil Description:	CLAY - brown, stiff, moist, silty, high plasticity, homogeneous
-------------------	---

Average Diameter (cm):	7.20
Average Length (cm):	13.90
Length/Diameter Ratio:	1.93
Moisture content (%):	33.4
Bulk Density (g/cm <sup>3</sup> ):	1.884
Bulk Unit Weight (kN/m <sup>3</sup> ):	18.5
Bulk Unit Weight (pcf):	117.6
Dry Unit Weight (kN/m <sup>3</sup> ):	13.84

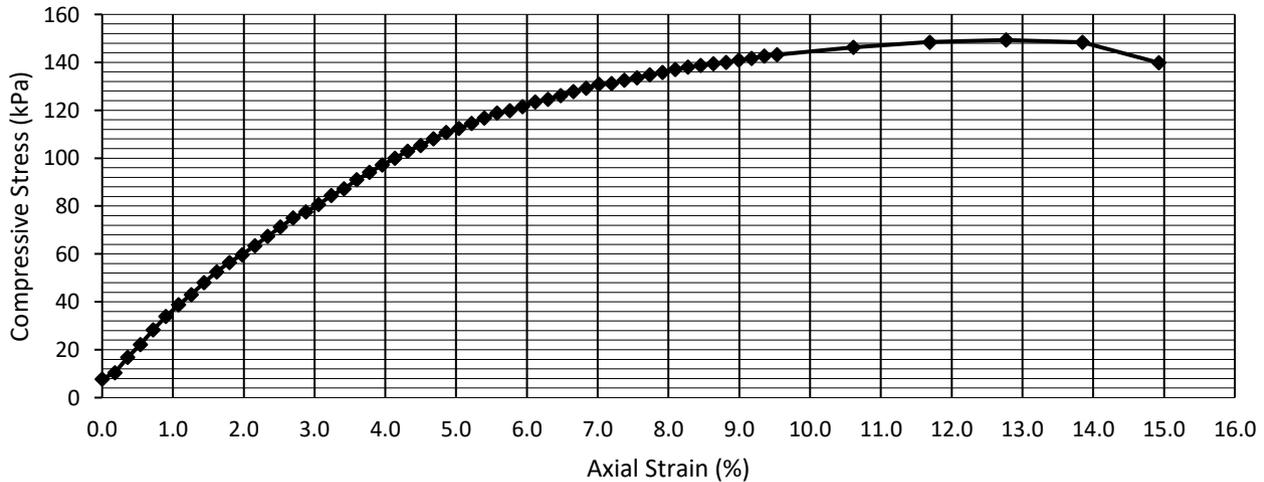
### Unconfined Compressive Strength

UCS	Unconfined compressive strength (kPa)	149.31	Undrained Shear Strength (kPa)	74.65
	Unconfined compressive strength (ksf)	3.118	Undrained Shear Strength (ksf)	1.559
	Avg. Rate of Strain to Failure (%/min):	1.08	Strain at Failure (%):	12.77

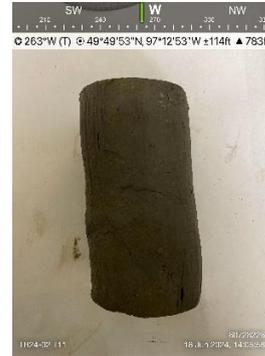
### FAILURE SKETCH

Soil Description:	CLAY - grey, stiff, moist, silty, high plasticity, homogeneous
-------------------	--

Average Diameter (cm):	7.07
Average Length (cm):	14.50
Length/Diameter Ratio:	2.05
Moisture content (%):	32.7
Bulk Density (g/cm <sup>3</sup> ):	2.107
Bulk Unit Weight (kN/m <sup>3</sup> ):	20.7
Bulk Unit Weight (pcf):	131.5
Dry Unit Weight (kN/m <sup>3</sup> ):	15.57

UCS	Unconfined compressive strength (kPa)	136.74	Undrained Shear Strength (kPa)	68.37
	Unconfined compressive strength (ksf)	2.856	Undrained Shear Strength (ksf)	1.428
	Avg. Rate of Strain to Failure (%/min):	1.03	Strain at Failure (%):	15.34

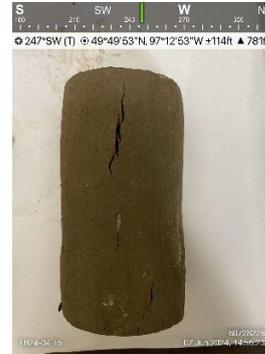
FAILURE SKETCH

Soil Description:	CLAY - brown, stiff, moist, silty, high plasticity, homogeneous
-------------------	---

Average Diameter (cm):	7.10
Average Length (cm):	14.70
Length/Diameter Ratio:	2.07
Moisture content (%):	14.6
Bulk Density (g/cm <sup>3</sup> ):	1.936
Bulk Unit Weight (kN/m <sup>3</sup> ):	19.0
Bulk Unit Weight (pcf):	120.9
Dry Unit Weight (kN/m <sup>3</sup> ):	16.57

Torvane	Undrained Shear Strength (kPa)	66.7
Pocket Pen.	Undrained Shear Strength (kPa)	39.9

UCS	Unconfined compressive strength (kPa)	97.93	Undrained Shear Strength (kPa)	48.97
	Unconfined compressive strength (ksf)	2.045	Undrained Shear Strength (ksf)	1.023
	Avg. Rate of Strain to Failure (%/min):	1.02	Strain at Failure (%):	10.03

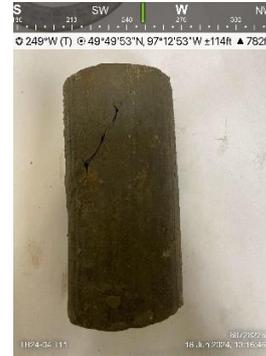
### FAILURE SKETCH

Soil Description:	CLAY - grey, firm, moist, silty, high plasticity, homogeneous
-------------------	---

Average Diameter (cm):	7.10
Average Length (cm):	15.60
Length/Diameter Ratio:	2.20
Moisture content (%):	33.1
Bulk Density (g/cm <sup>3</sup> ):	1.961
Bulk Unit Weight (kN/m <sup>3</sup> ):	19.2
Bulk Unit Weight (pcf):	122.4
Dry Unit Weight (kN/m <sup>3</sup> ):	14.45

Torvane	Undrained Shear Strength (kPa)	39.2
Pocket Pen.	Undrained Shear Strength (kPa)	39.9

UCS	Unconfined compressive strength (kPa)	100.19	Undrained Shear Strength (kPa)	50.09
	Unconfined compressive strength (ksf)	2.092	Undrained Shear Strength (ksf)	1.046
	Avg. Rate of Strain to Failure (%/min):	0.96	Strain at Failure (%):	7.69

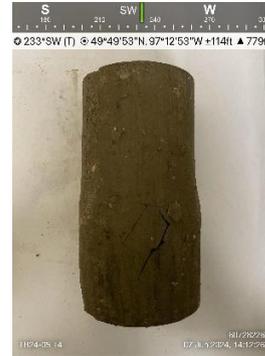
### FAILURE SKETCH

Soil Description:	CLAY - brown, stiff, moist, silty, high plasticity, homogeneous
-------------------	---

Average Diameter (cm):	7.20
Average Length (cm):	15.00
Length/Diameter Ratio:	2.08
Moisture content (%):	14.2
Bulk Density (g/cm <sup>3</sup> ):	1.912
Bulk Unit Weight (kN/m <sup>3</sup> ):	18.8
Bulk Unit Weight (pcf):	119.4
Dry Unit Weight (kN/m <sup>3</sup> ):	16.42

Torvane	Undrained Shear Strength (kPa)	83.4
Pocket Pen.	Undrained Shear Strength (kPa)	79.8

UCS	Unconfined compressive strength (kPa)	191.25	Undrained Shear Strength (kPa)	95.63
	Unconfined compressive strength (ksf)	3.994	Undrained Shear Strength (ksf)	1.997
	Avg. Rate of Strain to Failure (%/min):	1.00	Strain at Failure (%):	9.83

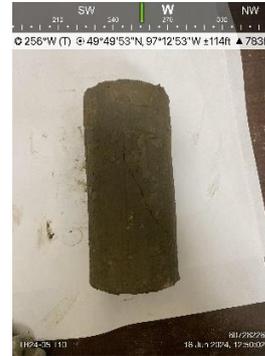
### FAILURE SKETCH

Soil Description:	CLAY - grey, stiff, moist, silty, high plasticity, homogeneous
-------------------	--

Average Diameter (cm):	7.07
Average Length (cm):	15.50
Length/Diameter Ratio:	2.19
Moisture content (%):	32.1
Bulk Density (g/cm <sup>3</sup> ):	2.020
Bulk Unit Weight (kN/m <sup>3</sup> ):	19.8
Bulk Unit Weight (pcf):	126.1
Dry Unit Weight (kN/m <sup>3</sup> ):	14.99

Torvane	Undrained Shear Strength (kPa)	66.7
Pocket Pen.	Undrained Shear Strength (kPa)	54.3

UCS	Unconfined compressive strength (kPa)	105.34	Undrained Shear Strength (kPa)	52.67
	Unconfined compressive strength (ksf)	2.200	Undrained Shear Strength (ksf)	1.100
	Avg. Rate of Strain to Failure (%/min):	0.97	Strain at Failure (%):	5.32

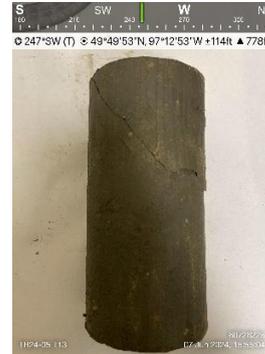
### FAILURE SKETCH

Soil Description:	CLAY - grey, firm, moist, silty, high plasticity, homogeneous
-------------------	---

Average Diameter (cm):	7.10
Average Length (cm):	14.80
Length/Diameter Ratio:	2.08
Moisture content (%):	16.1
Bulk Density (g/cm <sup>3</sup> ):	1.811
Bulk Unit Weight (kN/m <sup>3</sup> ):	17.8
Bulk Unit Weight (pcf):	113.1
Dry Unit Weight (kN/m <sup>3</sup> ):	15.31

Torvane	Undrained Shear Strength (kPa)	44.1
Pocket Pen.	Undrained Shear Strength (kPa)	23.9

UCS	Unconfined compressive strength (kPa)	61.74	Undrained Shear Strength (kPa)	30.87
	Unconfined compressive strength (ksf)	1.289	Undrained Shear Strength (ksf)	0.645
	Avg. Rate of Strain to Failure (%/min):	1.01	Strain at Failure (%):	3.55

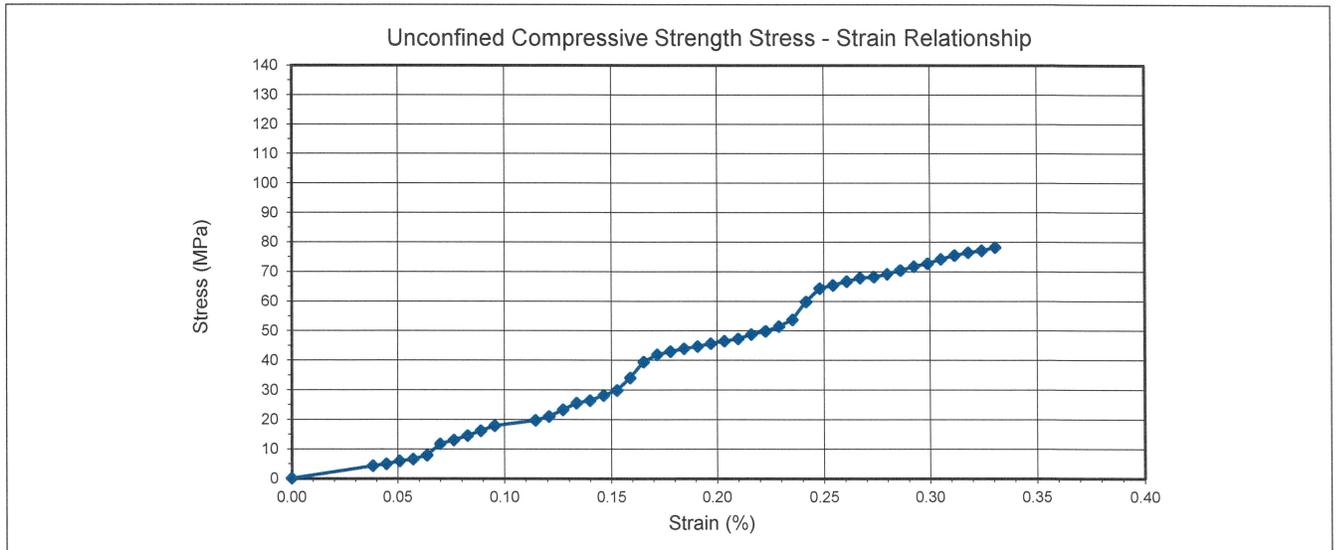
Client I.D.	C18	Submitted By:	Client
Test Hole/Depth	TH24-01, 18.3 - 18.5 meters	Date Tested:	Aug 7/24
Date Cored:	-	Tested By:	ENG-TECH (Kevin Dowbeta)
Date Received:	Aug 1/24	Method:	ASTM D2938-95
Compression Machine Model:	Soil Test CT-710

Test Data			
Specimen Moisture Condition:	As received moisture	Specimen Temperature:	24°C
Average Length of Specimen:	157.25 mm	Average Diameter of Specimen:	63.00 mm
Load Rate:	0.7 kN/s	Compressive Strength:	78 MPa
Maximum Load:	243.3 kN

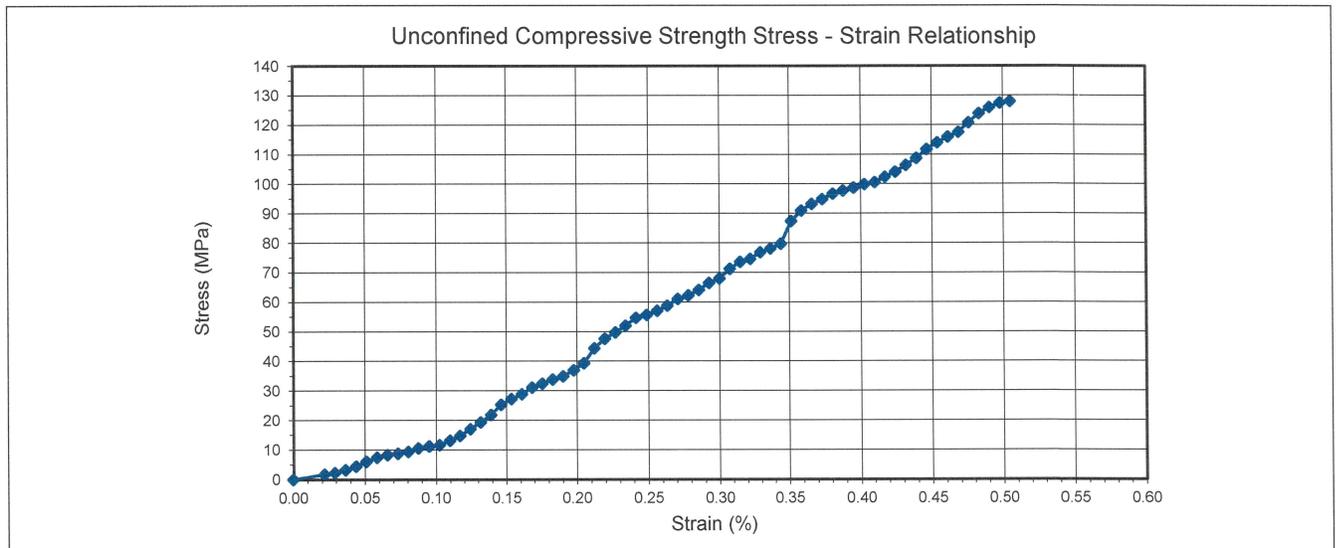
Client I.D.	C23	TH24-05, 23.75 - 24.2
Test Hole/Depth	TH24-05, 23.75 - 24.2 meters	Submitted By: Client
Date Cored:	-	Date Tested: Aug 7/24
Date Received:	Aug 1/24	Tested By: ENG-TECH (Kevin Dowbeta)
Compression Machine Model:	Soil Test CT-710	Method: ASTM D2938-95

Test Data			
Specimen Moisture Condition:	As received moisture	Specimen Temperature:	24°C
Average Length of Specimen:	136.50 mm	Average Diameter of Specimen:	63.00 mm
Load Rate:	0.7 kN/s	Maximum Load:	398.5 kN
		Compressive Strength:	128 MPa

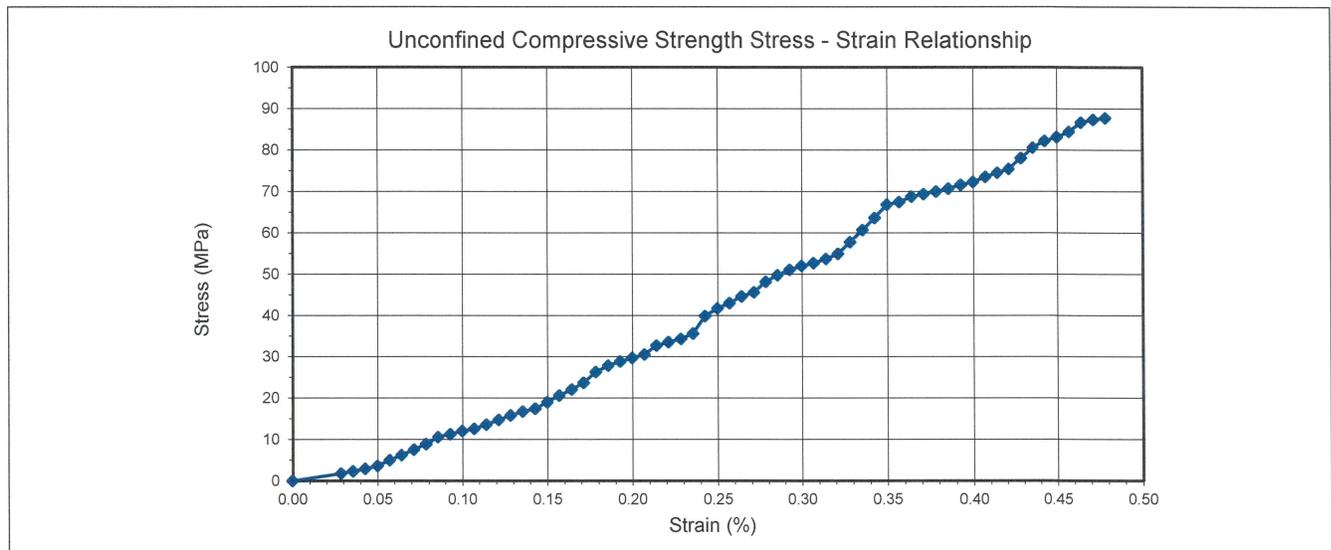
Client I.D.	C20	Submitted By:	Client
Test Hole/Depth	TH24-03, 29.97 - 30.19 meters	Date Tested:	Aug 22/24
Date Cored:	-	Tested By:	ENG-TECH (Kyle Zebiere)
Date Received:	Aug 16/24	Method:	ASTM D2938-95
Compression Machine Model:	Soil Test CT-710

Test Data			
Specimen Moisture Condition:	As received moisture	Specimen Temperature:	24.0°C
Average Length of Specimen:	140.00 mm	Average Diameter of Specimen:	63.00 mm
Load Rate:	0.7 kN/s	Compressive Strength:	87.7 MPa
	Maximum Load:		273.4 kN

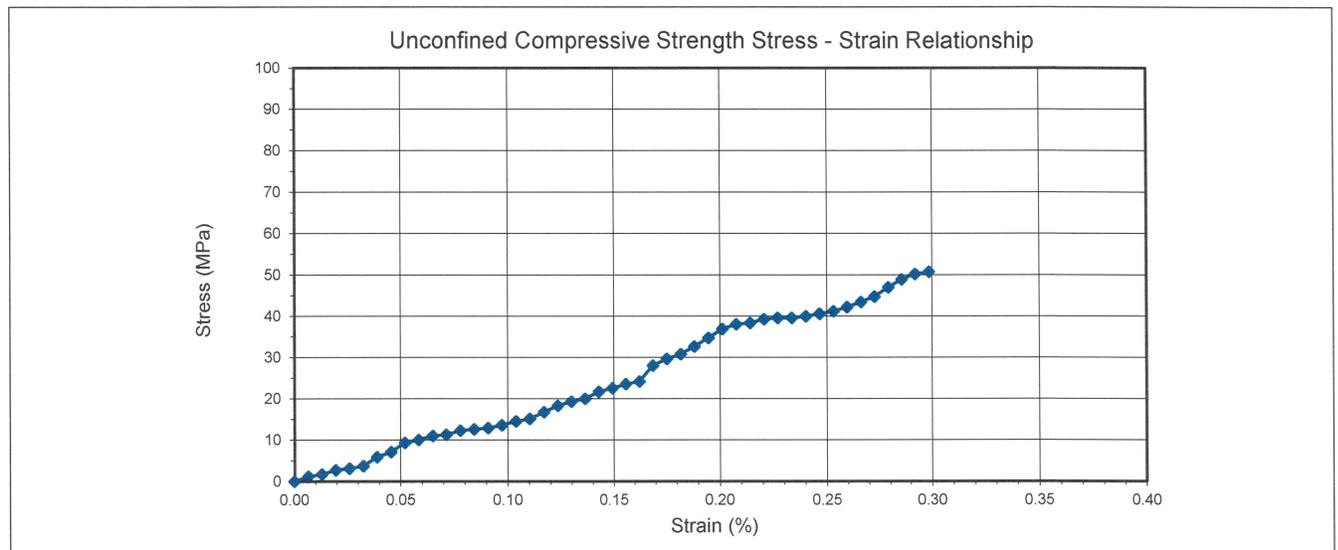
Client I.D. C21  
 Test Hole/Depth TH24-03, 31.43 - 31.65 meters  
 Date Cored: -  
 Date Received: Aug 16/24  
 Compression Machine Model: Soil Test CT-710

Test Data			
Specimen Moisture Condition:	As received moisture	Specimen Temperature:	24°C
Average Length of Specimen:	154.00 mm	Average Diameter of Specimen:	63.00 mm
Load Rate:	0.7 kN/s	Maximum Load:	157.7 Kn
		Compressive Strength:	50.6 MPa

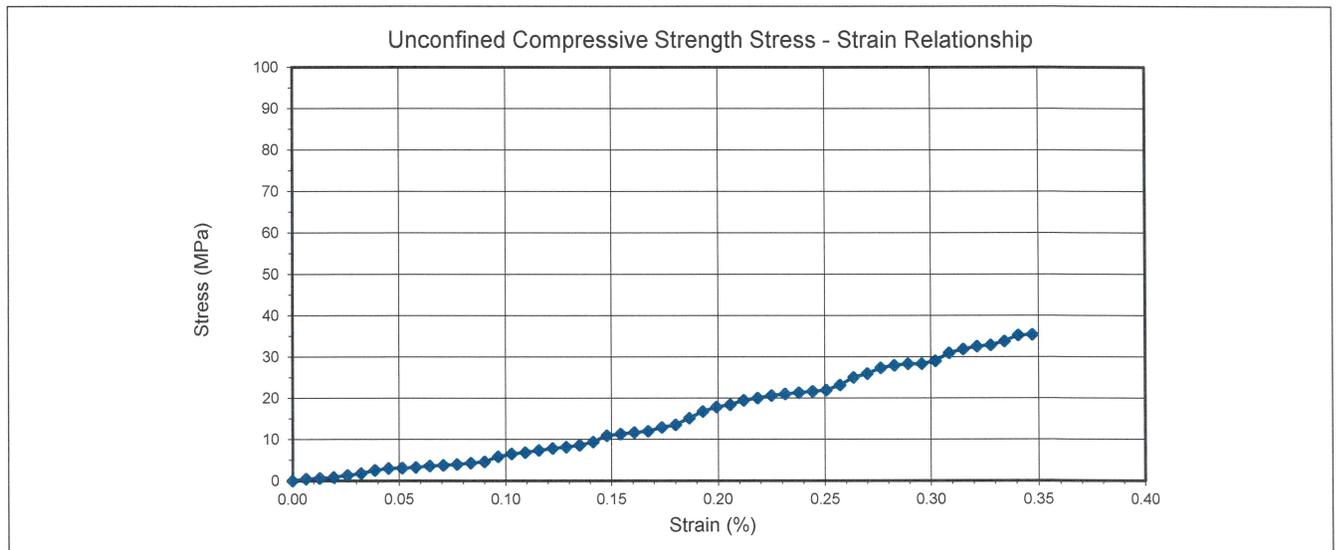
Client I.D. C22  
 Test Hole/Depth TH24-03, 32.28 - 32.76 meters  
 Date Cored: -  
 Date Received: Aug 16/24  
 Compression Machine Model: Soil Test CT-710

Test Data			
Specimen Moisture Condition:	As received moisture	Specimen Temperature:	24°C
Average Length of Specimen:	155.50 mm	Average Diameter of Specimen:	63.00 mm
Load Rate:	0.7 kN/s	Maximum Load:	110.0 kN
		Compressive Strength:	35.3 MPa

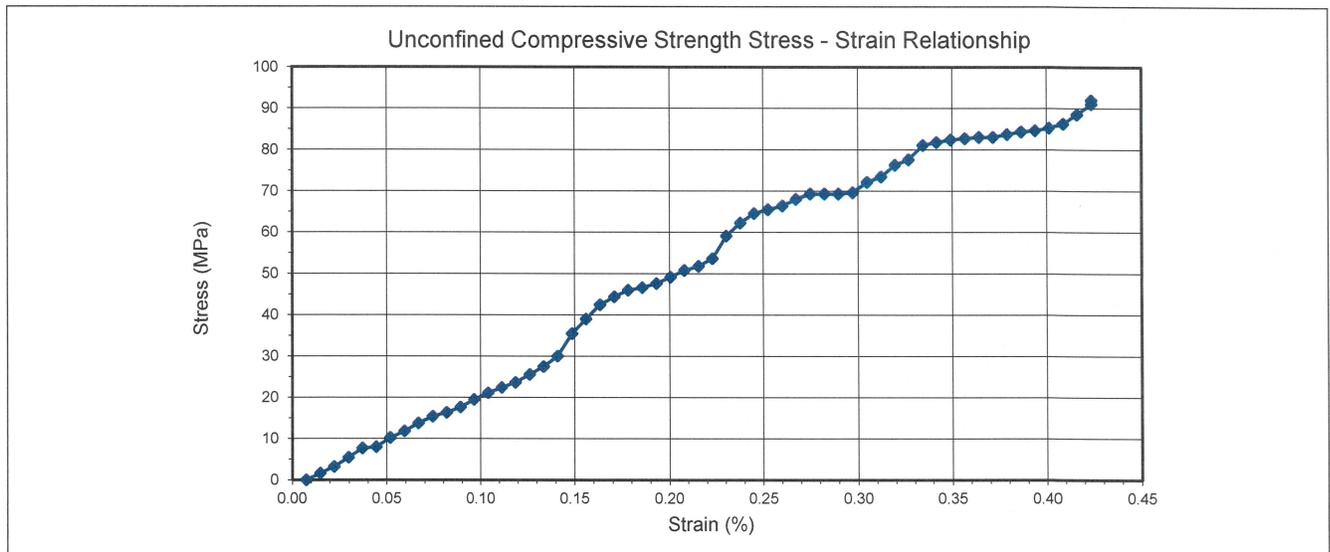
Client I.D. C09  
 Test Hole/Depth TH24-03, 53' 5.5" to 54' 1.5"  
 Date Cored: Aug 13/24  
 Date Received: Feb 7/25  
 Compression Machine Model: Soil Test CT-710

Test Data			
Specimen Moisture Condition:	As received moisture	Specimen Temperature:	23.0 °C
Average Length of Specimen:	134.50 mm	Average Diameter of Specimen:	63.25 mm
Load Rate:	0.12 kN/s	Maximum Load:	291.8 kN
		Compressive Strength:	93 MPa

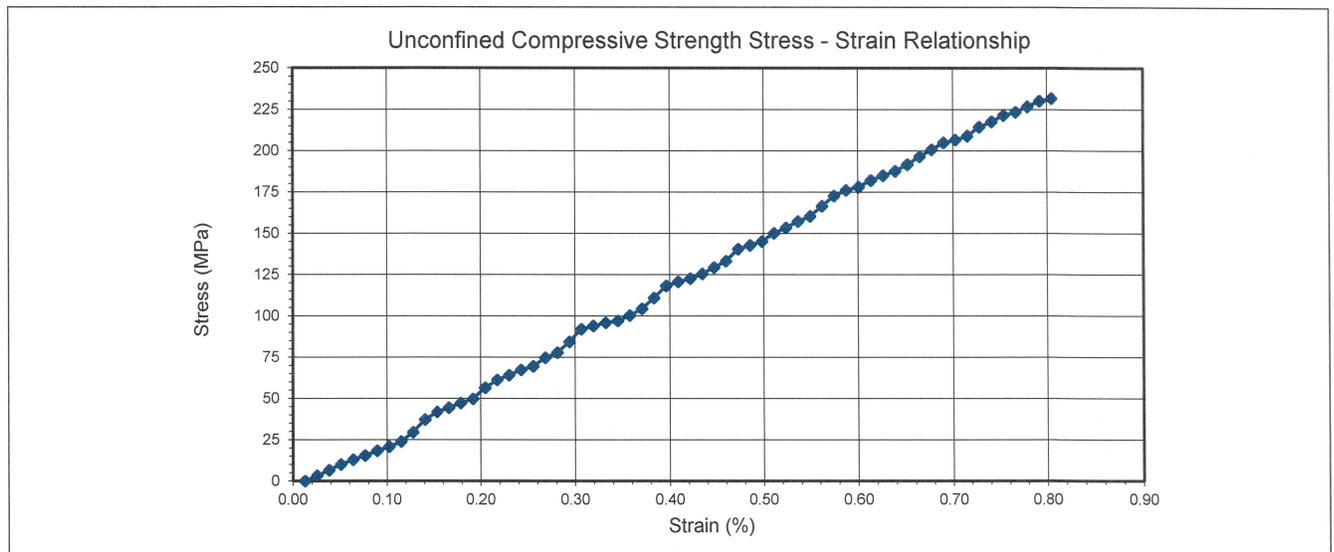
Client I.D. C10  
 Test Hole/Depth TH24-03, 57' 3.5" to 58' 1.5"  
 Date Cored: Aug 13/24  
 Date Received: Feb 7/25  
 Compression Machine Model: Soil Test CT-710

Test Data			
Specimen Moisture Condition:	As received moisture	Specimen Temperature:	23.0 °C
Average Length of Specimen:	156.50 mm	Average Diameter of Specimen:	63.10 mm
Load Rate:	0.12 kN/s	Maximum Load:	734.5 kN
		Compressive Strength:	235 MPa

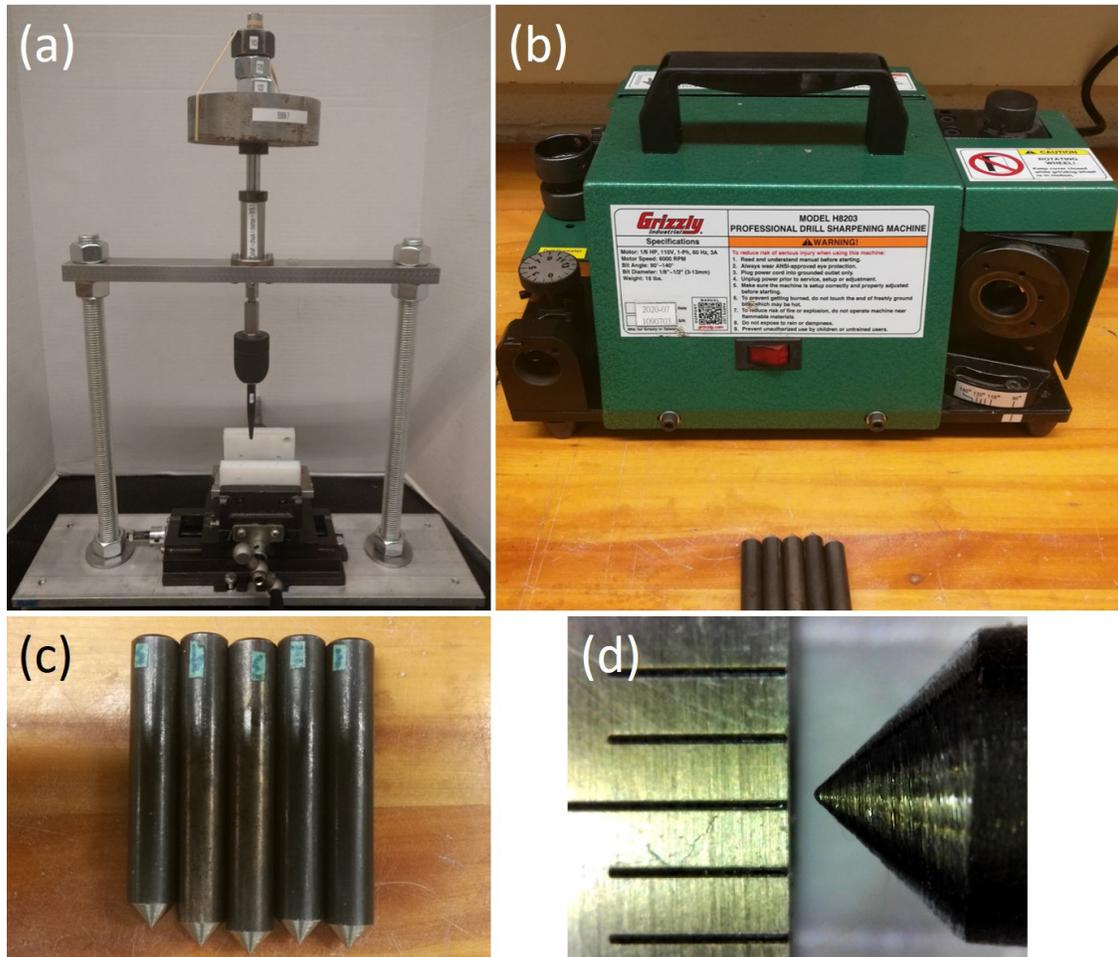
Figure 1: Photos showing (a) the CERCHAR apparatus, (b) tip sharpening setup, (c) the five styluses used to perform the test and (d) a microscope image of one of the stylus tips.

This section summarizes the results of CERCHAR abrasivity testing. Testing was performed using a Type-2 CERCHAR apparatus as shown in Figure 1a. The tips of the styluses were sharpened to a conical angle of  $90^\circ$  using the setup shown in Figure 1b. The styluses used to perform the tests are shown in Figure 1c-d (Rockwell hardness  $55\pm 1$ ). A static force of 70 N was applied on top of the stylus by using a combination of weights. Details of the testing procedure are as follows:

1. The tips of the five styluses are sharpened using the grinding apparatus (Figure 1b).
2. The styluses are placed under a microscope (60x magnification) and three scaled photos ( $120^\circ$  apart) are captured before the test is conducted to ensure the  $90^\circ$  point has been properly formed.

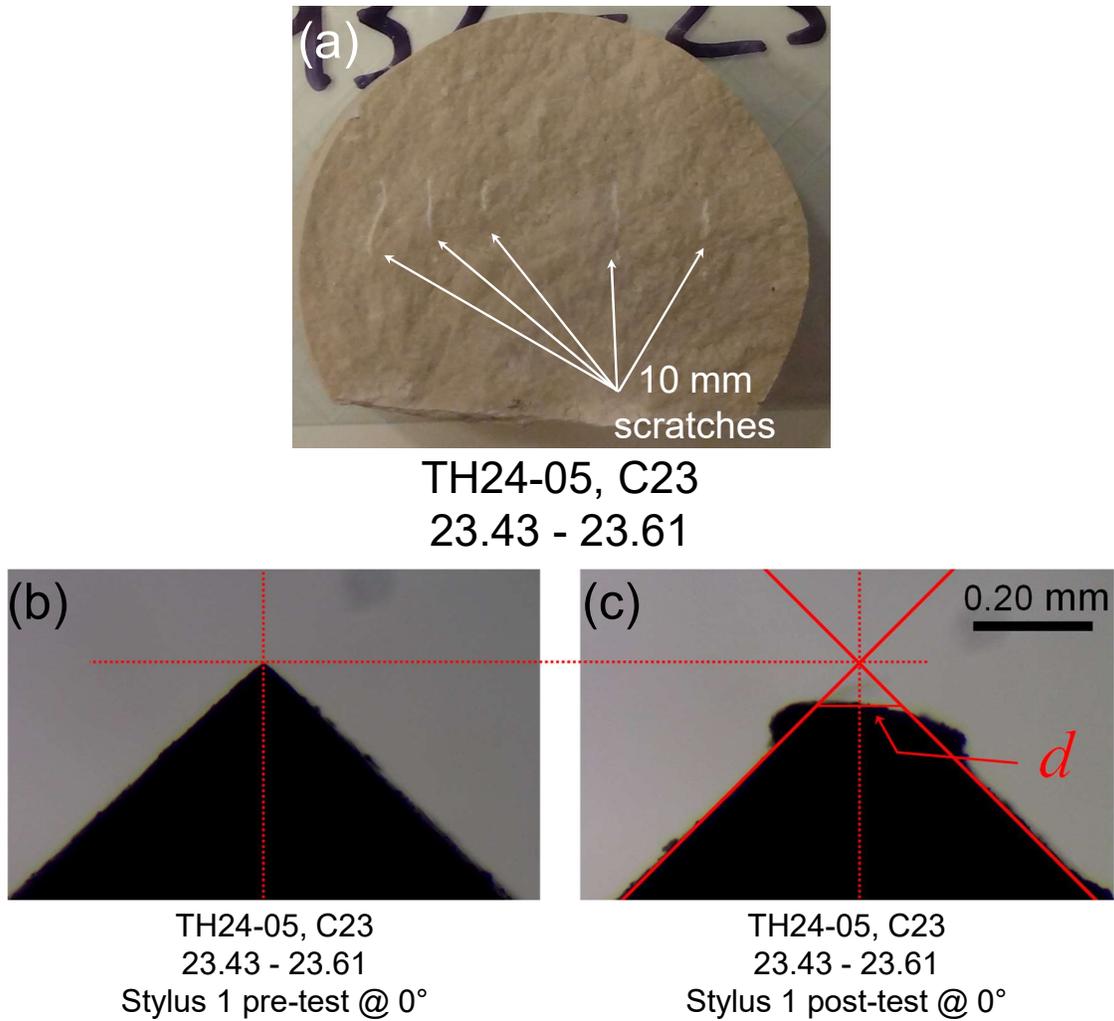
Figure 2: (a) Photograph showing an example of the five 10 mm scratches on a test specimen; (b) microscope image of select stylus prior to testing at the noted position; and (c) microscope image of the same stylus at the same position following testing with the wear flat,  $d$ , denoted.

5. A scratch measuring 10 mm in length is performed over a duration of 10 seconds. This process is repeated with all five styluses on undisturbed parts of the fracture surface (e.g., Figure 2a).

6. Lastly, the worn tips are re-examined under the microscope. From three scaled photos ( $120^\circ$  apart), the wear flat,  $d$ , is measured (e.g., Figure 2c).

The length or the diameter of the wear flat,  $d$ , was measured from scaled microscope images using the image processing software Fiji (e.g., Figure 2b-c). The mean wear of the tip is calculated by taking the average  $d$  of all tests. The CERCHAR-Abrasivity-Index (CAI) of the sample is subsequently calculated by taking the mean wear and multiplying it by 10. The above testing procedure followed ASTM D7625.

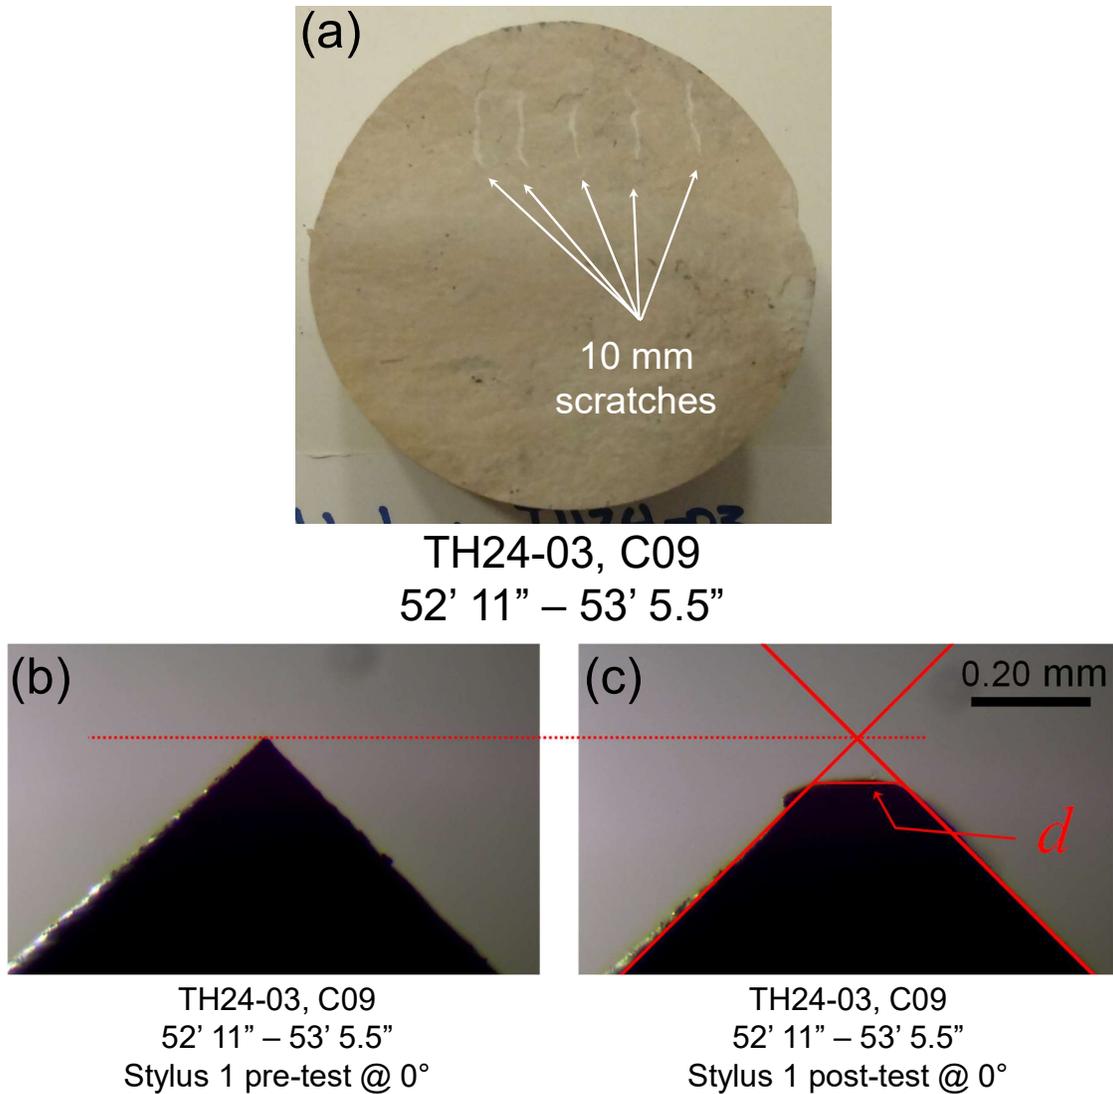
Figure 2: (a) Photograph showing an example of the five 10 mm scratches on a test specimen; (b) microscope image of select stylus prior to testing at the noted position; and (c) microscope image of the same stylus at the same position following testing with the wear flat, *d*, denoted.

5. A scratch measuring 10 mm in length is performed over a duration of 10 seconds. This process is repeated with all five styluses on undisturbed parts of the fracture surface (e.g., Figure 2a).

6. Lastly, the worn tips are re-examined under the microscope. From three scaled photos ( $120^\circ$  apart), the wear flat,  $d$ , is measured (e.g., Figure 2c).

The length or the diameter of the wear flat,  $d$ , was measured from scaled microscope images using the image processing software Fiji (e.g., Figure 2b-c). The mean wear of the tip is calculated by taking the average  $d$  of all tests. The CERCHAR-Abrasivity-Index (CAI) of the sample is subsequently calculated by taking the mean wear and multiplying it by 10. The above testing procedure followed ASTM D7625.

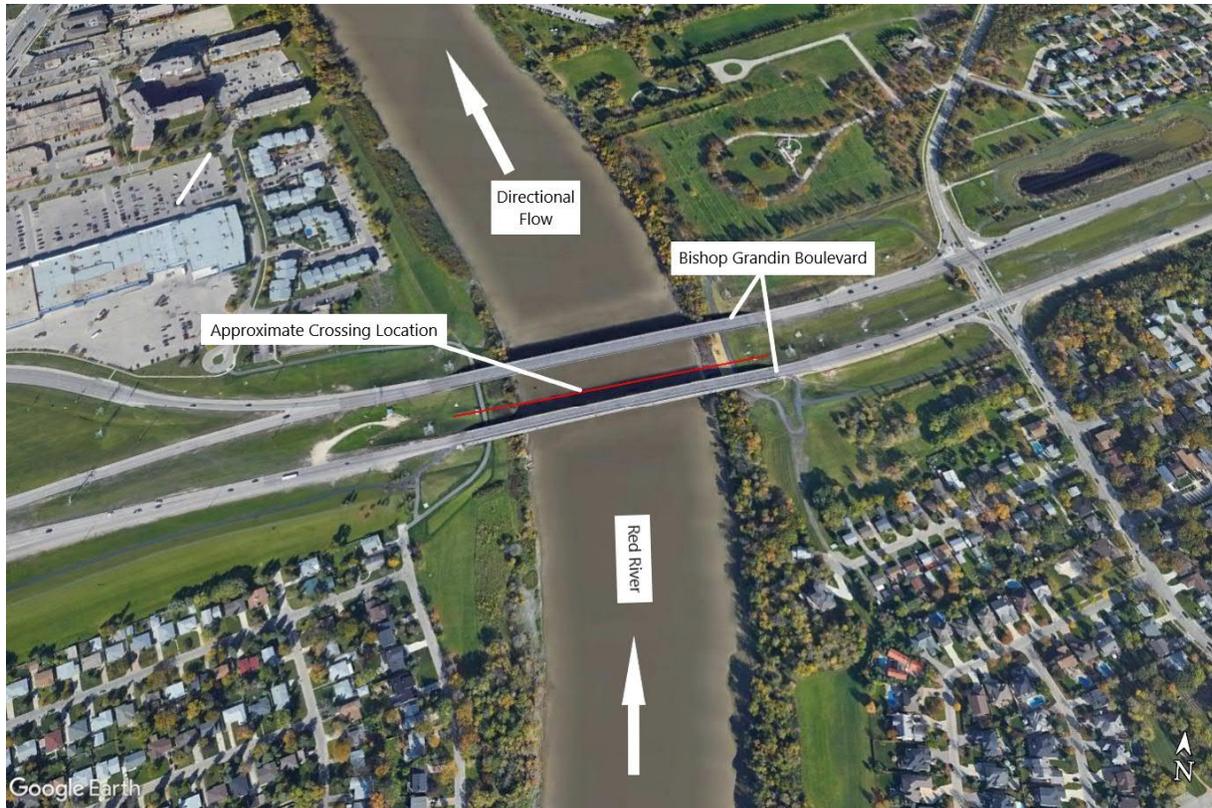
**Figure 2-1 – Site 4 Location**

Site 4 is located along the Red River at the Bishop Grandin Bridge crossing in south Winnipeg. The Red River crossing at Bishop Grandin Boulevard currently consists of two bridge structures with an under-bridge pedestrian crossing at both banks. An aerial location view of the site is shown in **Figure 2-1**.

The Red River flows north, with the crossing located near a gentle bend in the river. The west bank is on the inside of the bend (convex section) and the east bank is on the outside of the bend (concave section).
