# Replacement of the FGSV Siphon

Geotechnical Baseline Report  
FINAL

City of Winnipeg

May 2025

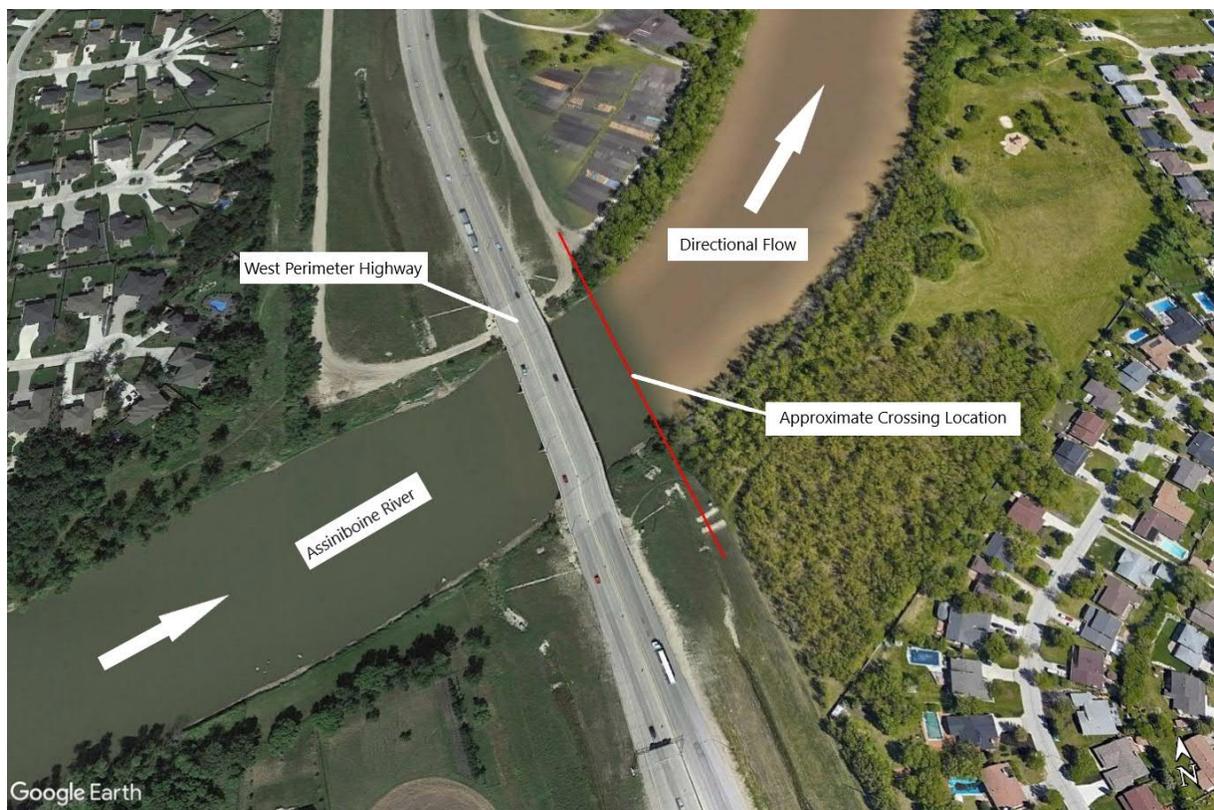
**Figure 2-2 - Site 5 Location**

Site 5 is located along the Assiniboine River at the West Perimeter Highway Bridge crossing located near the west end of Winnipeg. The Assiniboine River crossing at the West Perimeter Highway currently consists of a single bridge structure with an under-bridge roadway at the north bank (Oxbow Bend Road). An aerial view of the site is shown in **Figure 2-2**.

The Assiniboine River flows approximately east, with the crossing located along a relatively straight stretch of the river, transitioning into a curve downstream of the crossing (with the south bank turning into an outside/concave bend, and the north bank turning into an inside/convex bend).

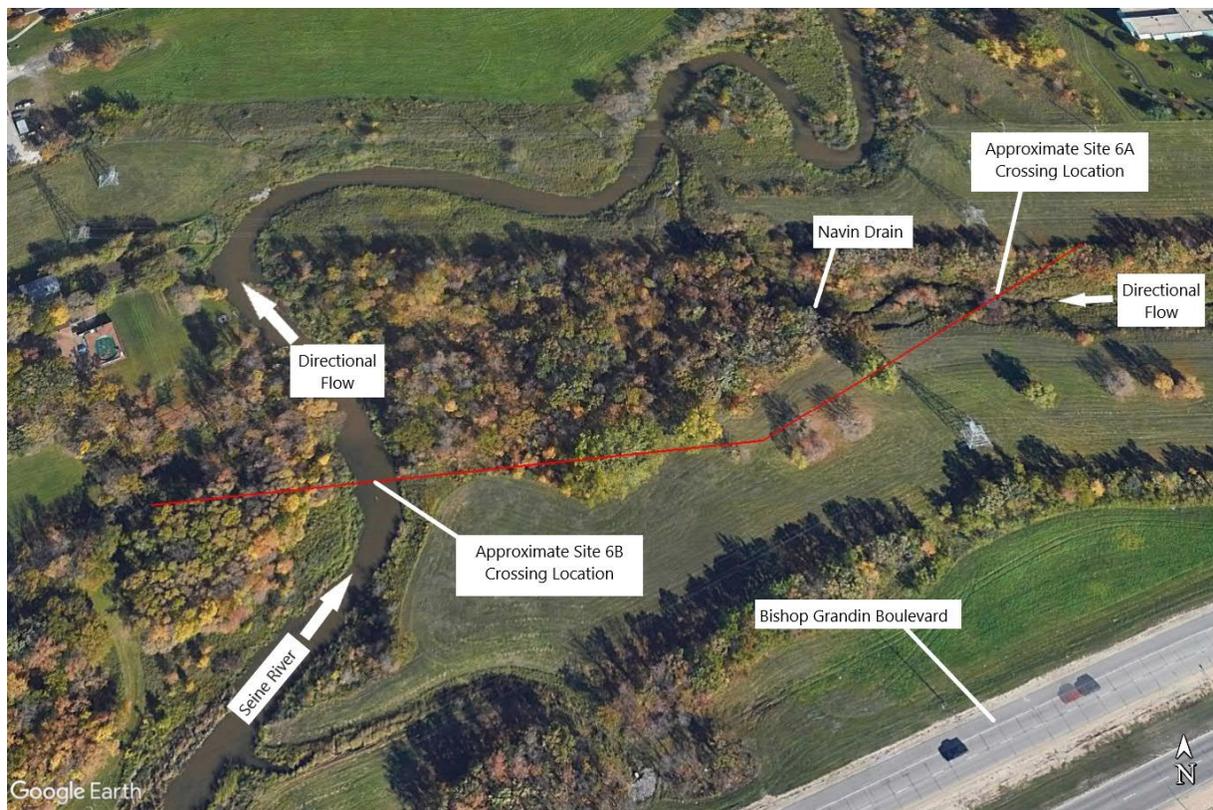
**Figure 2-3 – Site 6 Location**

Site 6 is located along the Seine River and Navin Drain, located north of Bishop Grandin Boulevard in south Winnipeg. The Navin Drain crossing location has been identified as “Site 6A”, while the Seine River crossing location has been identified as “Site 6B”. An aerial view of both crossings is shown in **Figure 2-3**.

The Navin Drain is a slightly meandering, man-made drainage channel that flows west and discharges into the Seine River. The Seine River flows generally north towards the Red River, with the Site 6B crossing located within a moderate bend in the river. The west bank is on the inside of the bend (convex section) and the east bank is on the outside of the bend (concave section).

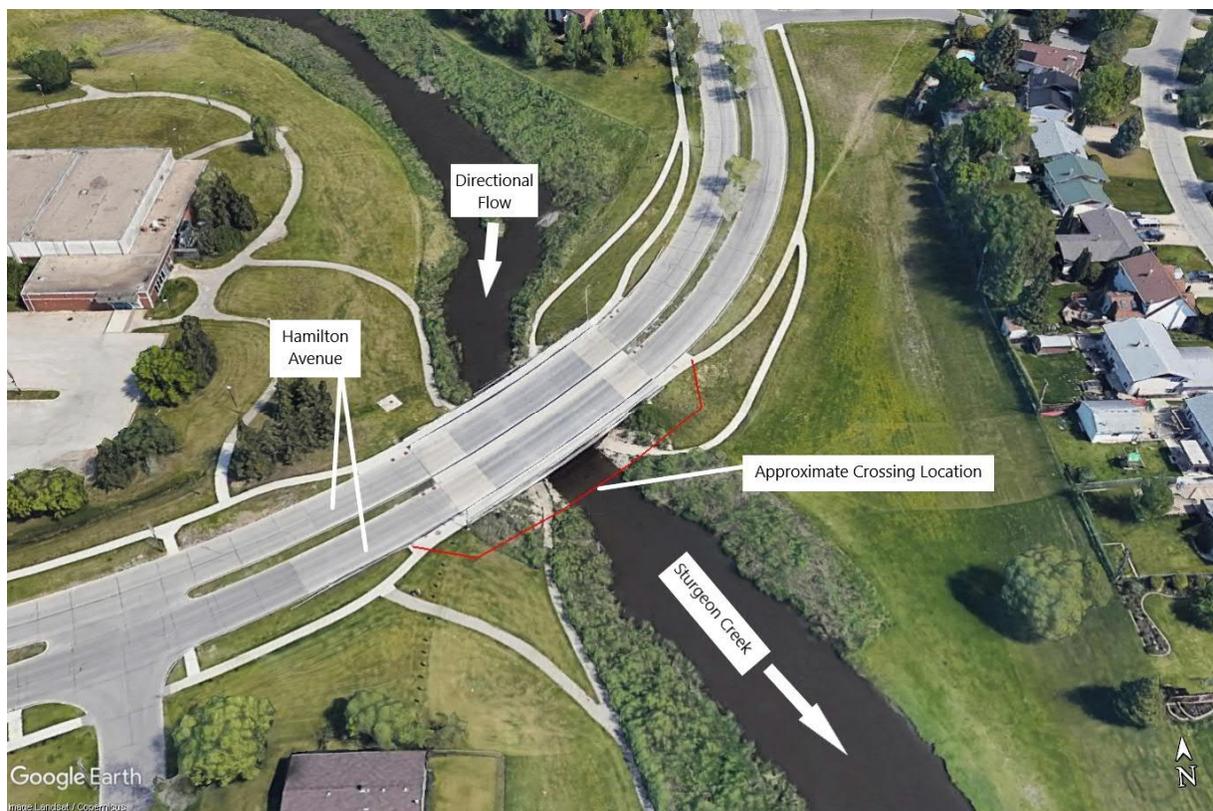
**Figure 2-4 – Site 7 Location**

Site 7 is located along Sturgeon Creek near the Hamilton Avenue Bridge in west Winnipeg. The Sturgeon Creek crossing at Hamilton Avenue currently consists of a single bridge structure with an under-bridge pedestrian crossing at both banks. An aerial view of the site is shown in **Figure 2-4**.

Sturgeon Creek flows south towards the Assiniboine River, with the Site 7 crossing located within a straight portion of the creek immediately downstream of a creek bend.

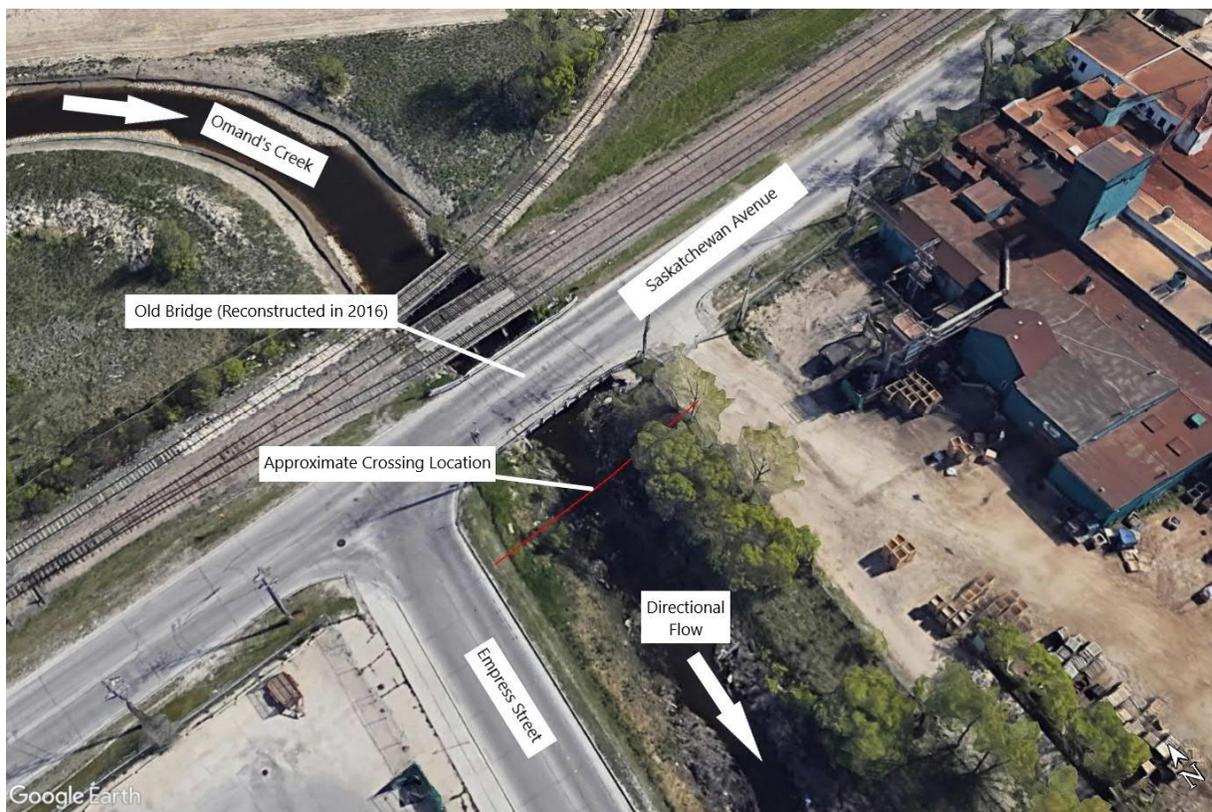
**Figure 2-5 – Site 8 Location**

Site 8 is located along Omand’s Creek at the Saskatchewan Avenue Bridge crossing. The Omand’s Creek crossing currently consists of a relatively new roadway bridge structure (constructed in 2016) and two Canadian Pacific (CP) rail bridges upstream of it. An aerial view of the site is shown in **Figure 2-5**.

Omand’s Creek flows generally south towards the Assiniboine River, with the crossing located within a straight portion of the creek immediately downstream of a riprap-armoured creek bend.

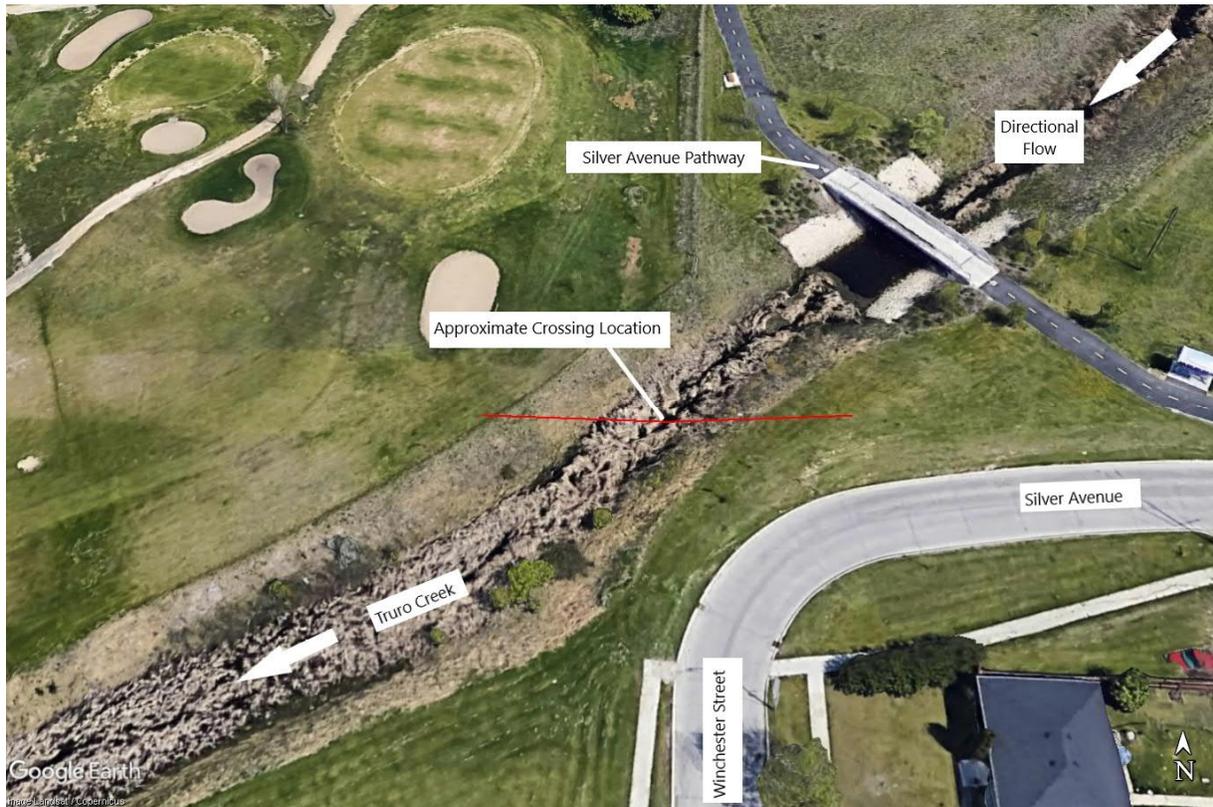
**Figure 2-6 – Site 9 Location**

Site 9 is located along Truro Creek southwest of the Silver Avenue Pathway pedestrian bridge, and east of the Assiniboine Golf course. An aerial view of the site is shown in **Figure 2-6**.

Truro Creek flows south towards the Assiniboine River, with the pipeline crossing the creek on a skew within a straight portion of the creek immediately upstream of a gentle bend in the creek.

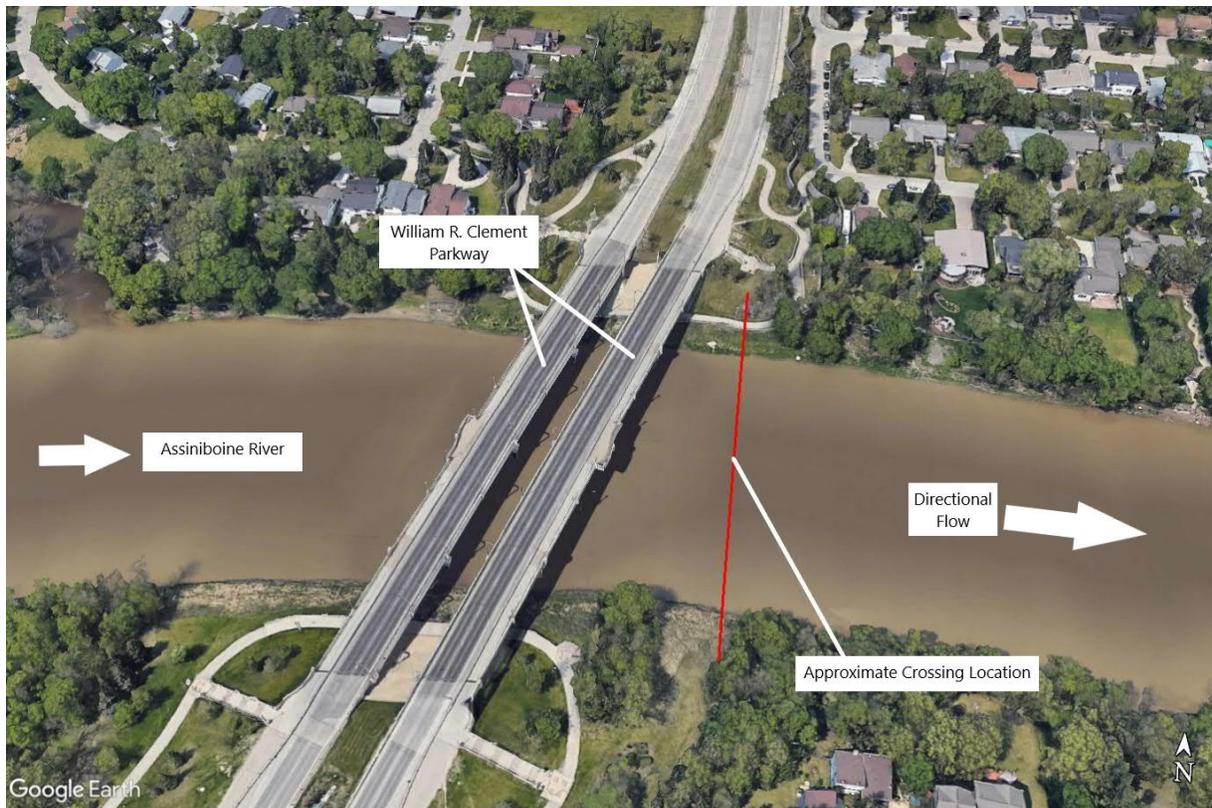
**Figure 2-7 – Site 10 Location**

Site 10 is located along the Assiniboine River at the William R. Clement Parkway Bridge crossing. The crossing currently consists of two bridge structures with an under-bridge pedestrian crossing at both banks. An aerial view of the site is shown in **Figure 2-7**.

The Assiniboine River flows east, with the crossing located within a gentle bend in the river. The north bank is on the outside of the bend (concave section) and the south bank is on the inside of the bend (convex section).

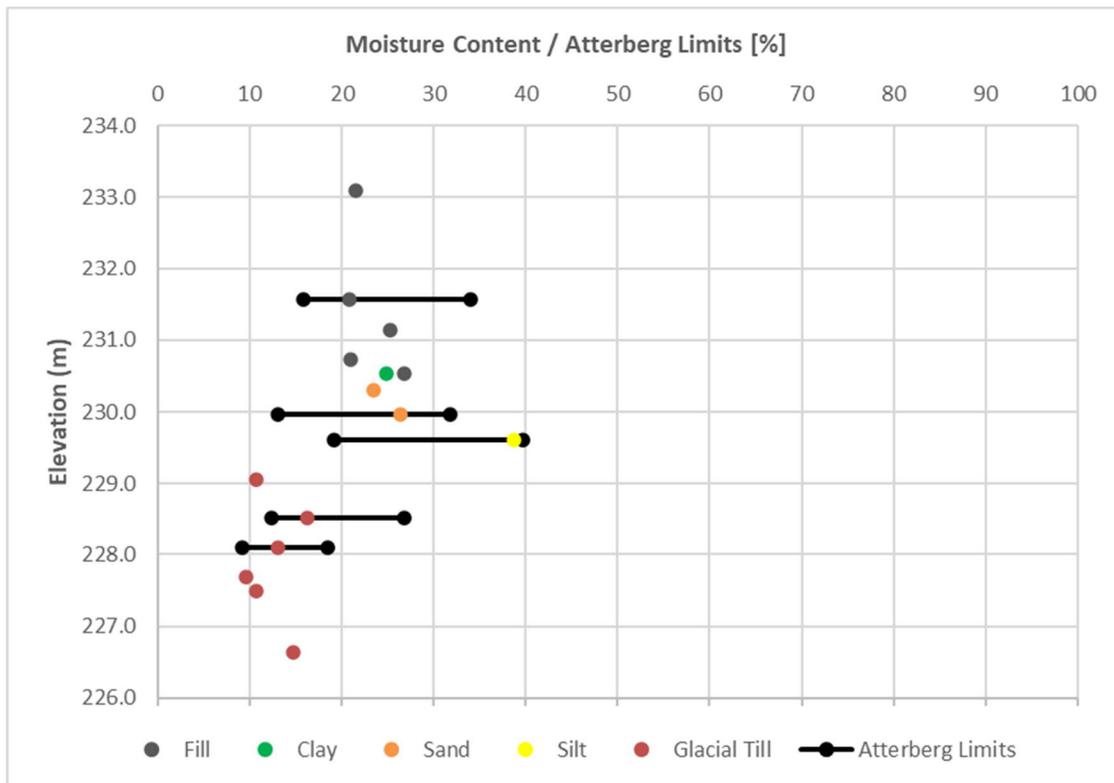
**Figure 4-1 - Summary of Moisture Content and Atterberg Limits vs. Depth (Site 5)**

**Table 4-2** summarizes the number of each test completed, and **Figure 4-1** illustrates the variation in moisture content and Atterberg Limits with depth.

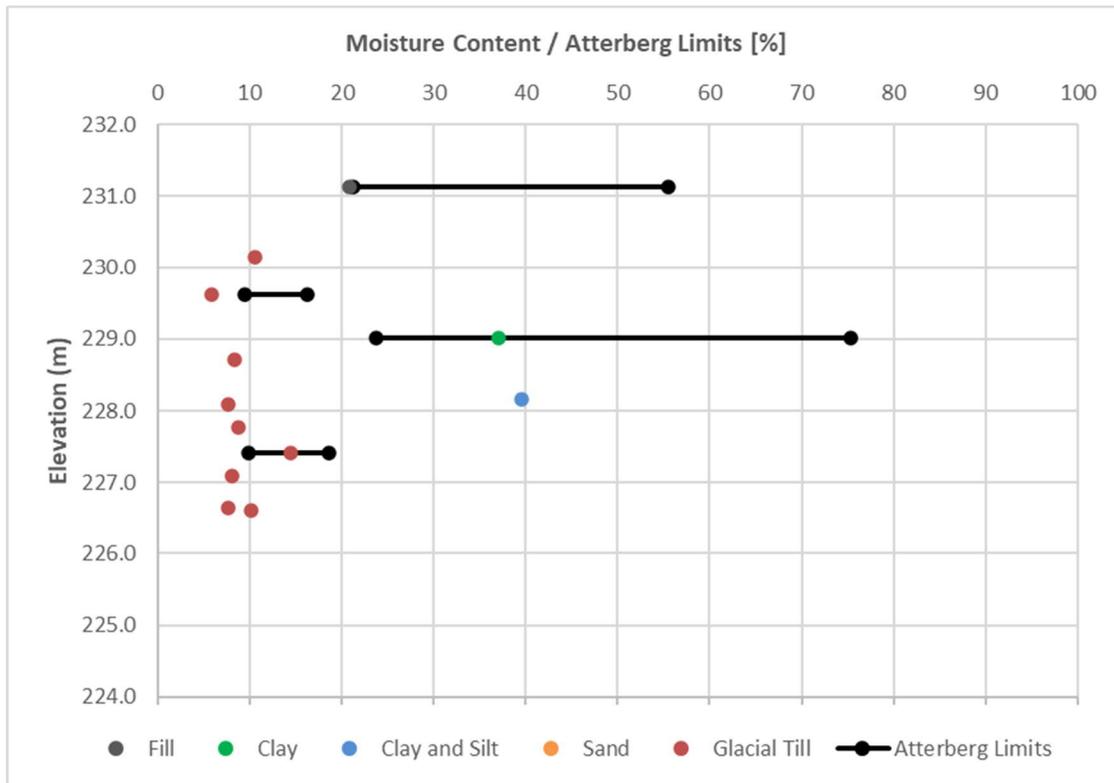
**Figure 4-2 - Summary of Moisture Content and Atterberg Limits vs. Depth (Site 10)**

**Table 4-12** summarizes the number of each test completed, and **Figure 4-2** illustrates the variation in moisture content and Atterberg Limits with depth.

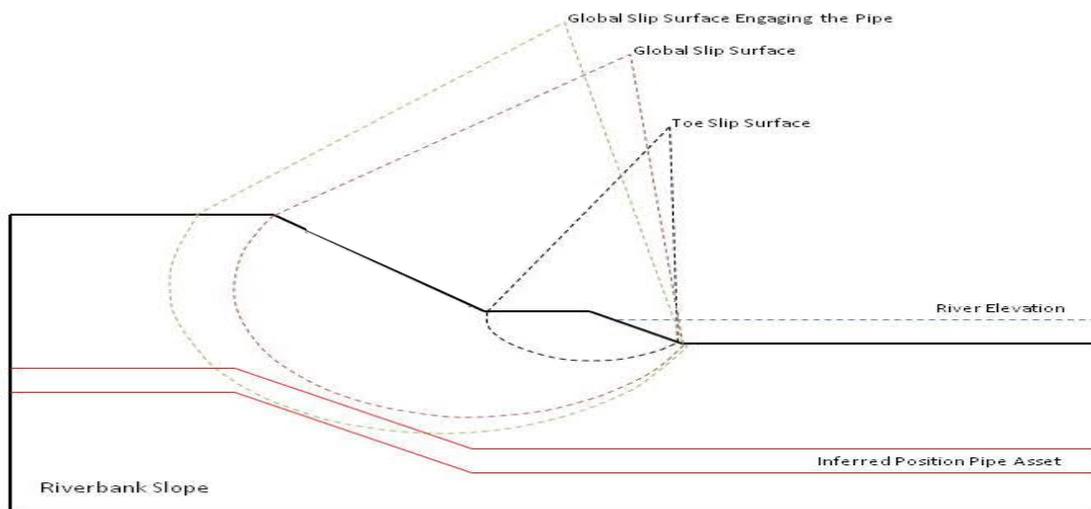
**Figure 5-1 - Assessed Slip Surfaces**

As part of the analysis, the following slip surfaces were considered of interest and are conceptually illustrated in **Figure 5-1**. A Factor of Safety (FS) was determined for each of the following:

- **Global Slip Surface Engaging Pipe (GS+P)**: is defined as a slip surface that meets the criteria of a global slip surface and encompasses part of the buried pipe.
- **Global Slip Surface (GS)**: is defined as a slip surface that largely encompasses the slope soil mass and has an entry and exit point at or just beyond the slope crest and/or toe.
- **Toe Slip Surface (TS)**: is defined as a slip surface that is localized to the toe of the slope and which has a minimum depth of 0.5m. At some locations the FS of this slip surface may be lower than the critical or global FS. Instability at the toe of the slope may reduce the FS for the global or critical slip surfaces. Retrogressive failures starting at the toe will generally work towards the riverbank.

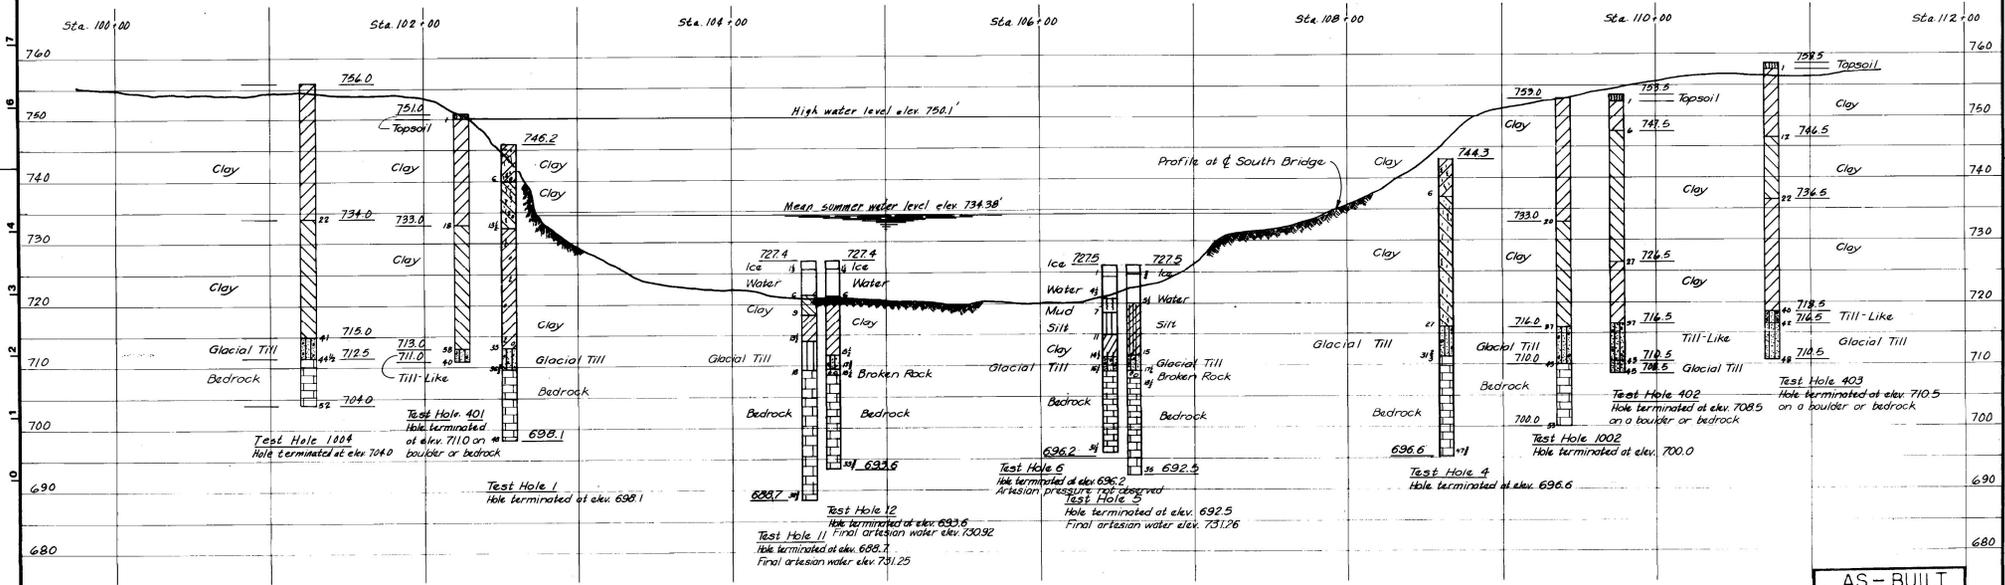
**TEST HOLE DATA**  
Scale: Horiz. 1"=40'-0"  
Vert. 1"=10'-0"

- Legend:
- Bridge test holes
  - Aqueduct test holes for information only, taken from existing data (1960) see aqueduct soils data.
- Notes:
1. Subsurface information shown on this drawing was obtained solely for use in establishing design controls for the project. This information is not guaranteed to be accurate or all-inclusive and it is not to be construed as part of the plans governing construction of the project. The Contractor is to satisfy himself as to actual conditions prevailing at the site.
  2. Water levels measured at James Avenue Pumping Station.
  3. The above drawing should be read in conjunction with Klahn Leonoff Consultants Ltd's Report W-1064.

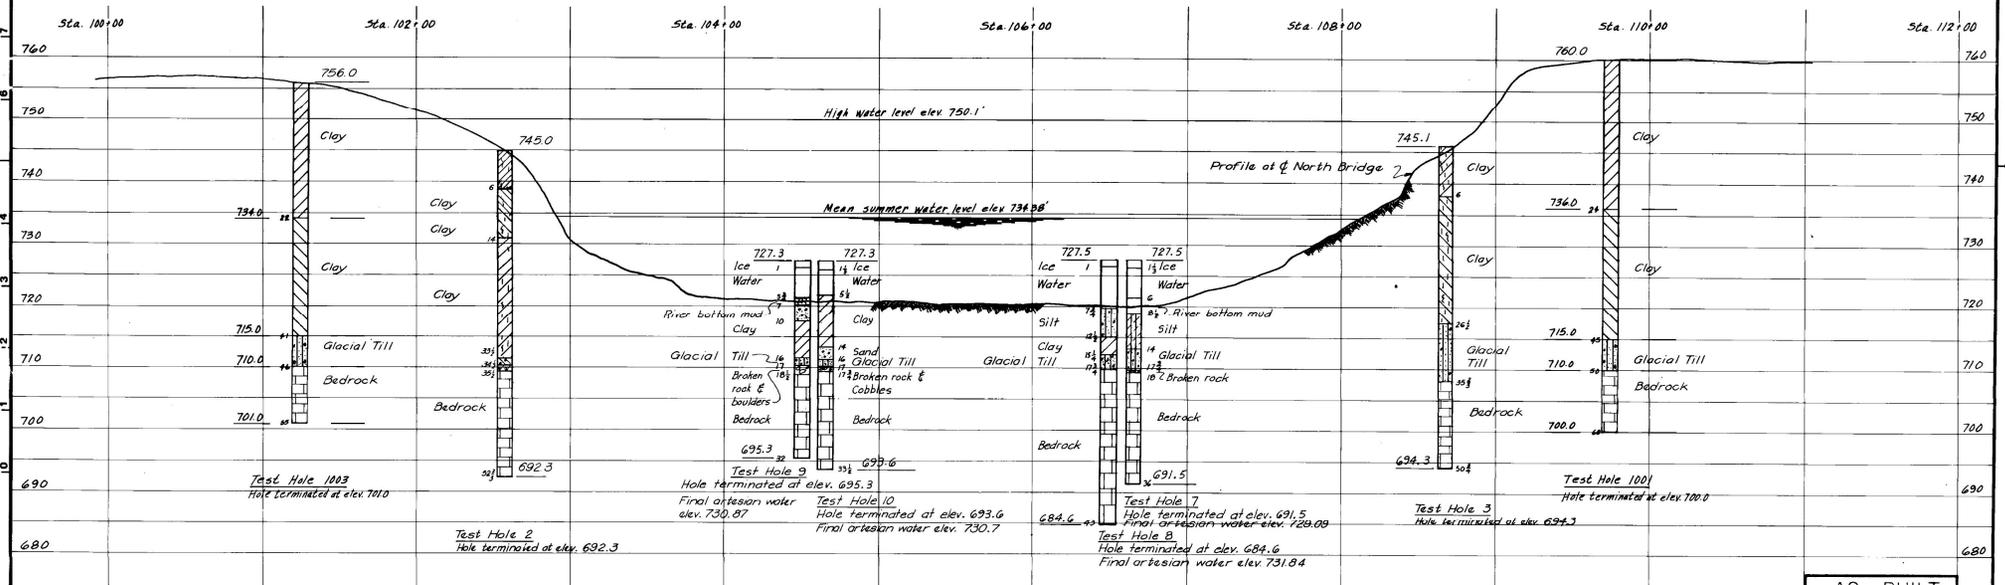
**TEST HOLE DATA**  
Scale: Horiz. 1" = 40'-0"  
Vert. 1" = 10'-0"

**Legend:**  
 ● Bridge test holes  
 ○ Aqueduct test holes for information only, taken from existing data (1960) see aqueduct soils data.

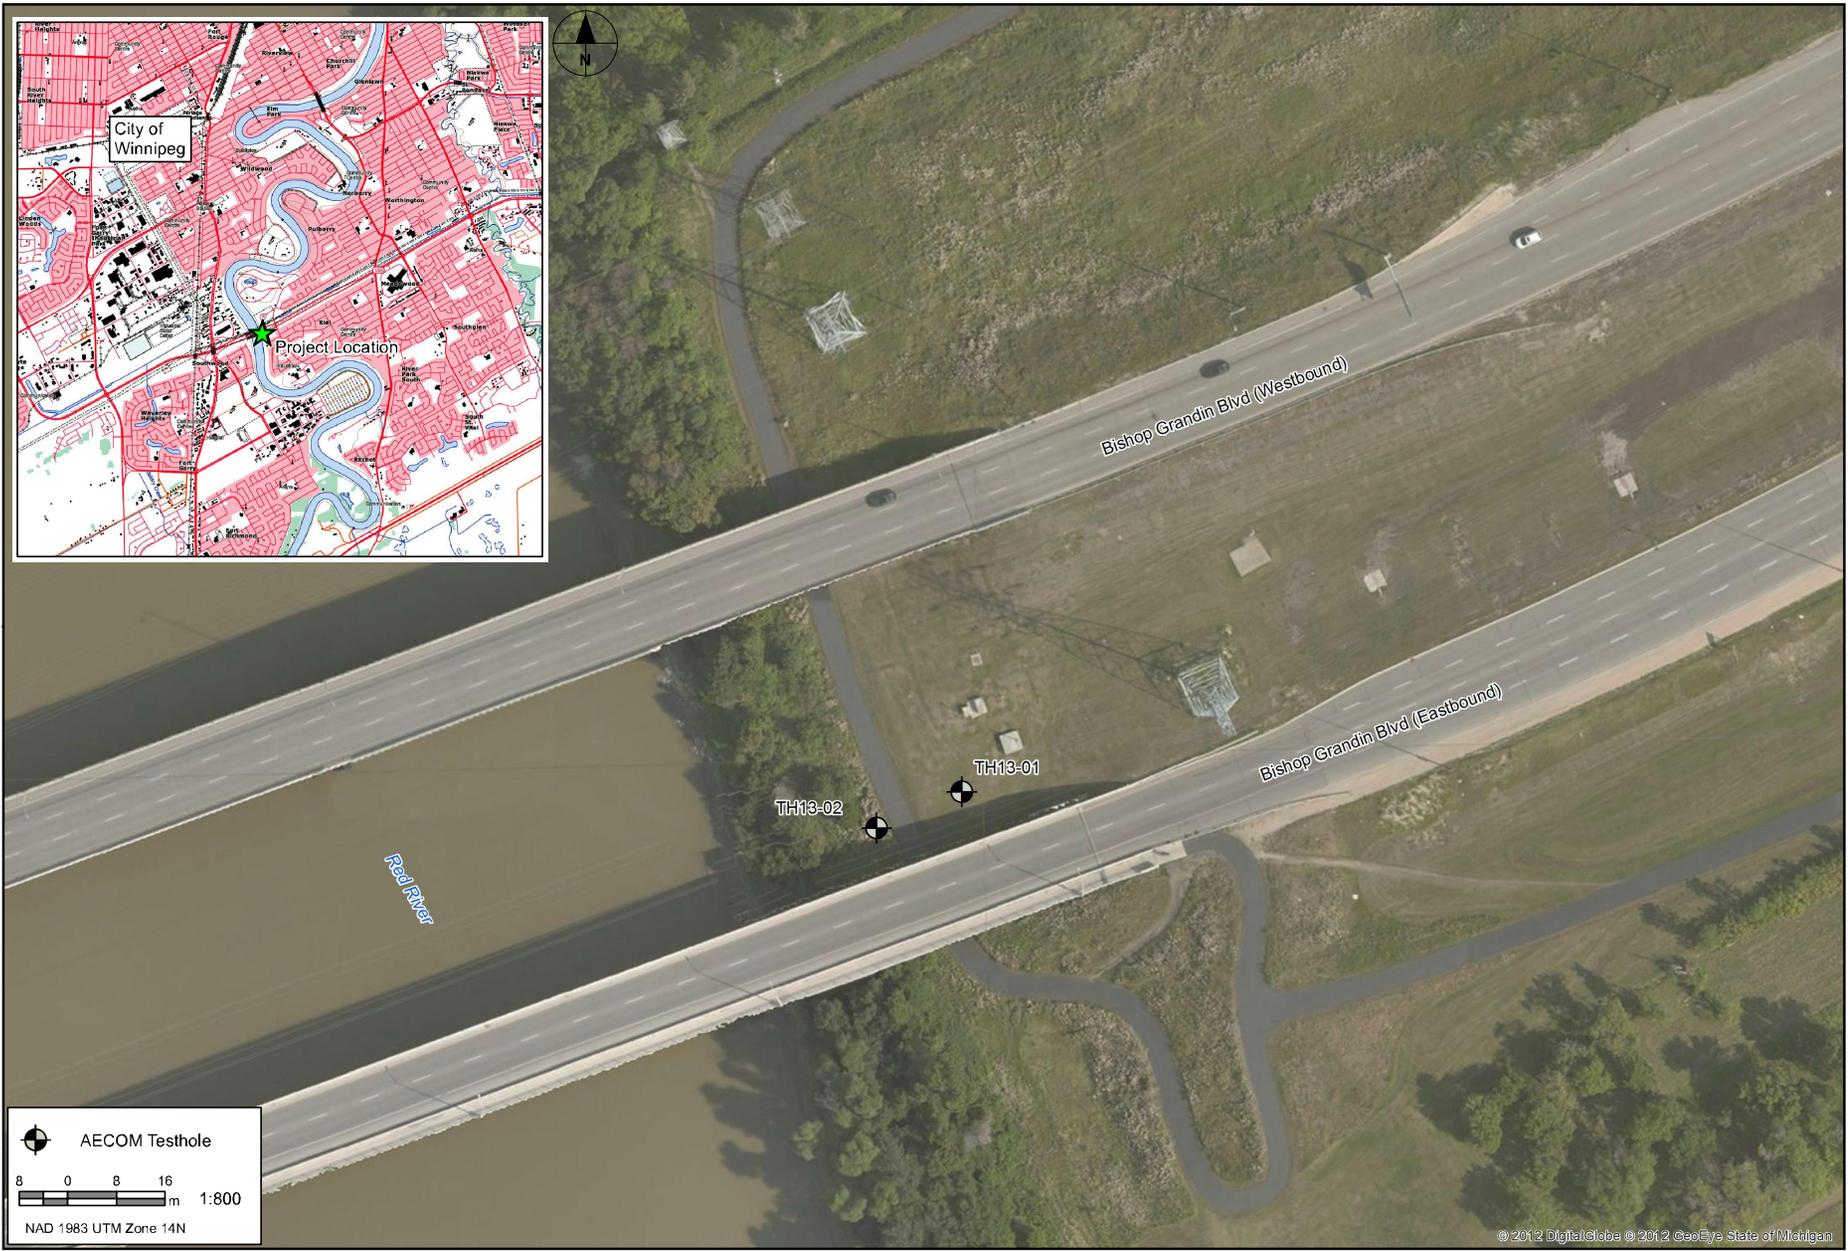
PROJECT: FGSV Interceptor Siphon		CLIENT: City of Winnipeg		TESTHOLE NO: TH13-01		
LOCATION: Upper Bank of Red River, UTM: 14 U, N 5520496, E 0633705				PROJECT NO.: 60274906		
CONTRACTOR: Paddock Drilling		METHOD: Truck Mounted Acker MP-8		ELEVATION (m):		
SAMPLE TYPE	GRAB	SHELBY TUBE	SPLIT SPOON	BULK	NO RECOVERY	CORE
BACKFILL TYPE	BENTONITE	GRAVEL	SLOUGH	GROUT	CUTTINGS	SAND

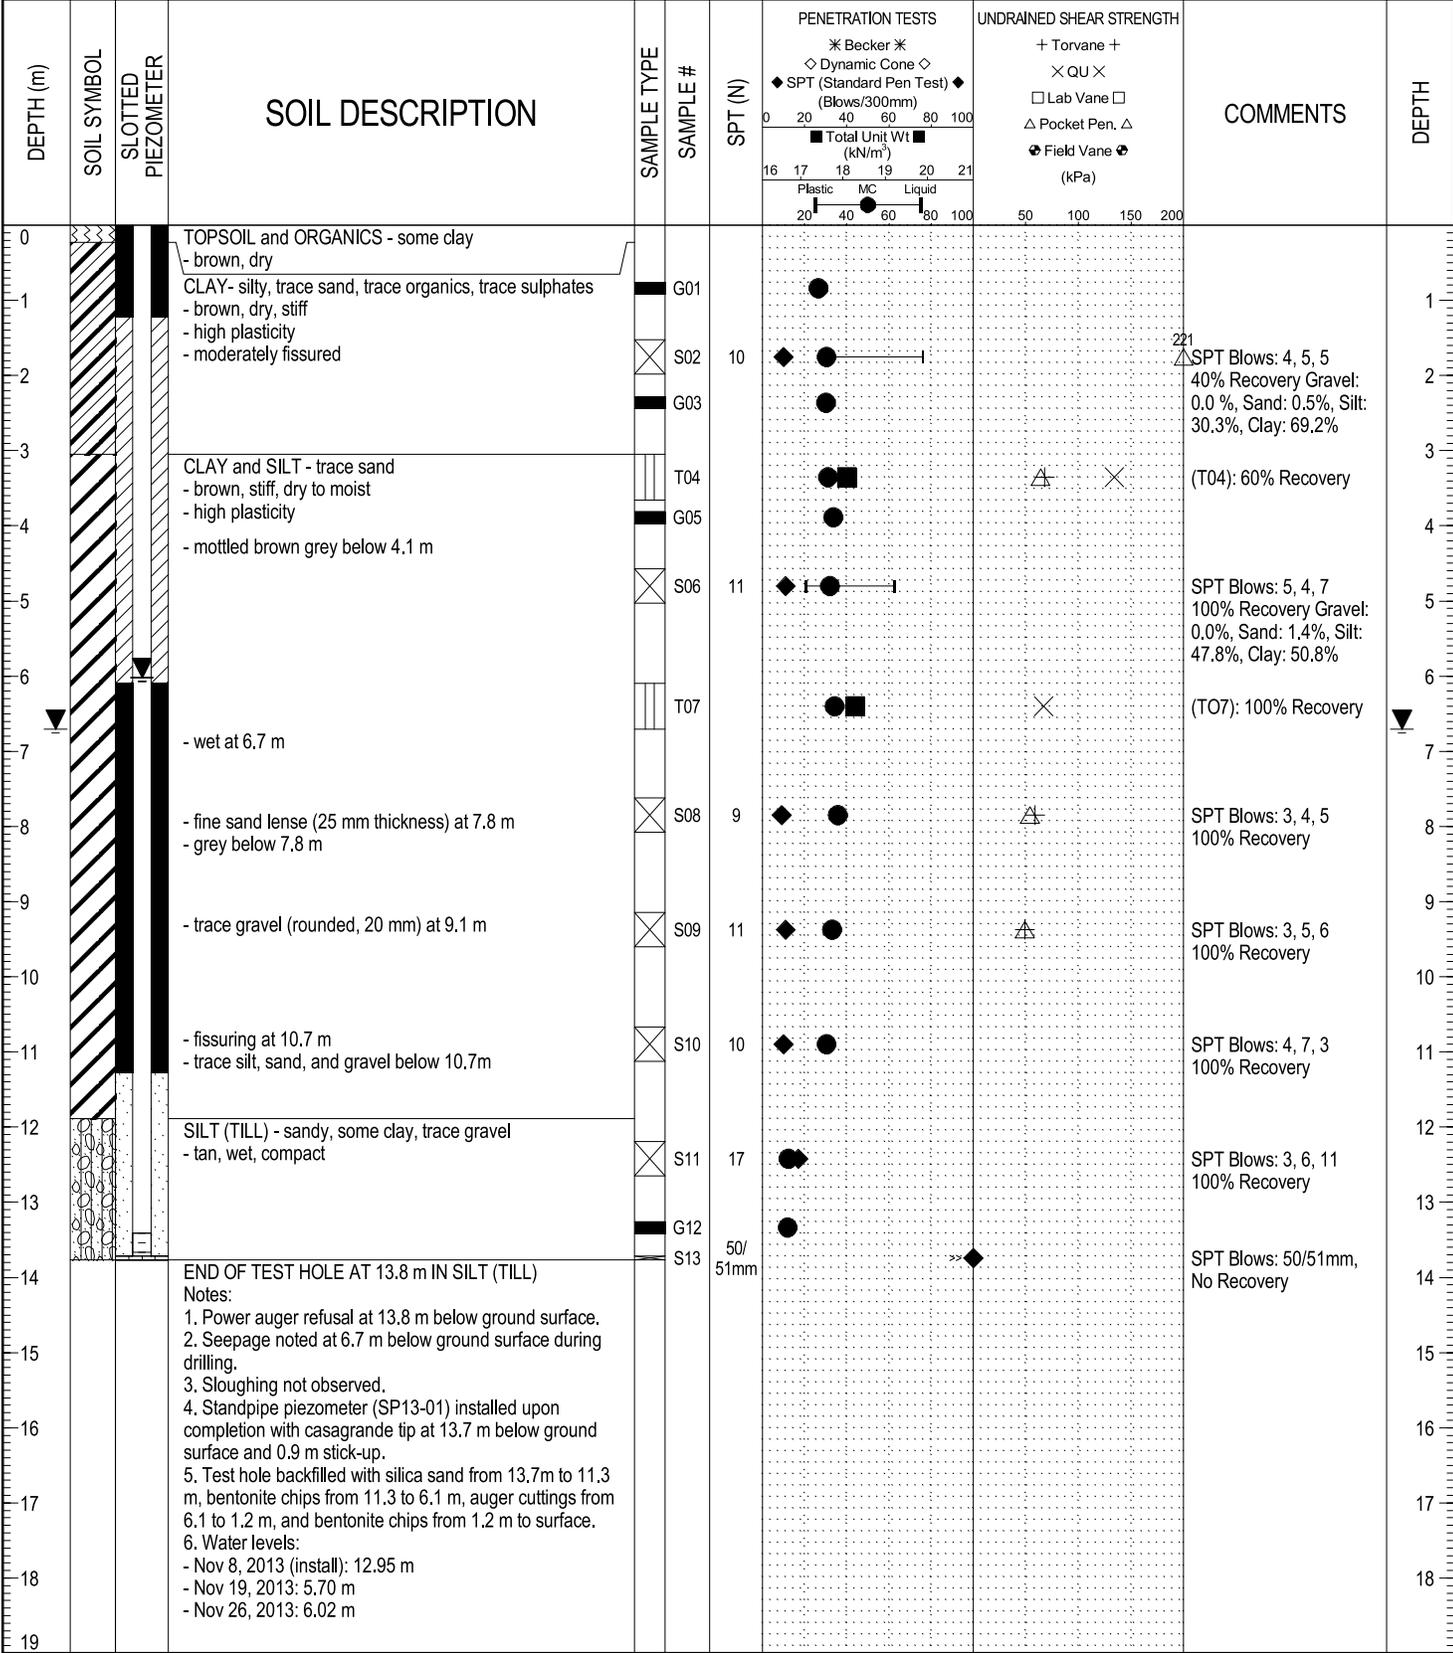
LOG OF TEST HOLE TEST HOLE LOGS.GPJ UMA WINN.GDT 12/9/13

LOGGED BY: Aaron Kaluzniak	COMPLETION DEPTH: 13.76 m
REVIEWED BY: Alex Hill	COMPLETION DATE: 11/8/13
PROJECT ENGINEER: Marvin McDonald	Page 1 of 1

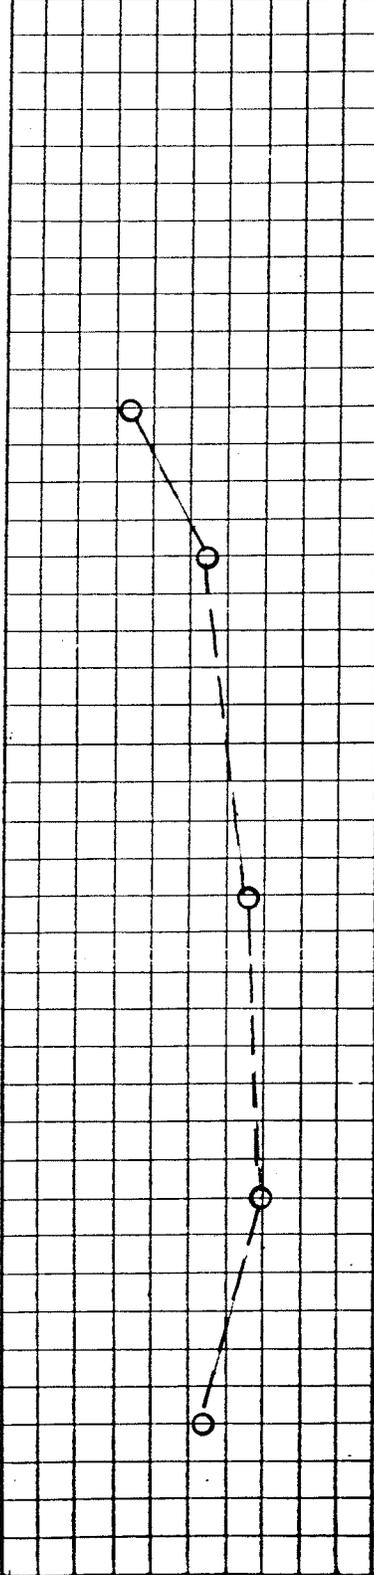
FILL  
- clay  
- topsoil  
- silt  
- stiff to firm

CLAY  
- brown  
- 75 mm silt layer at 2.7 m  
- stiff to firm with depth

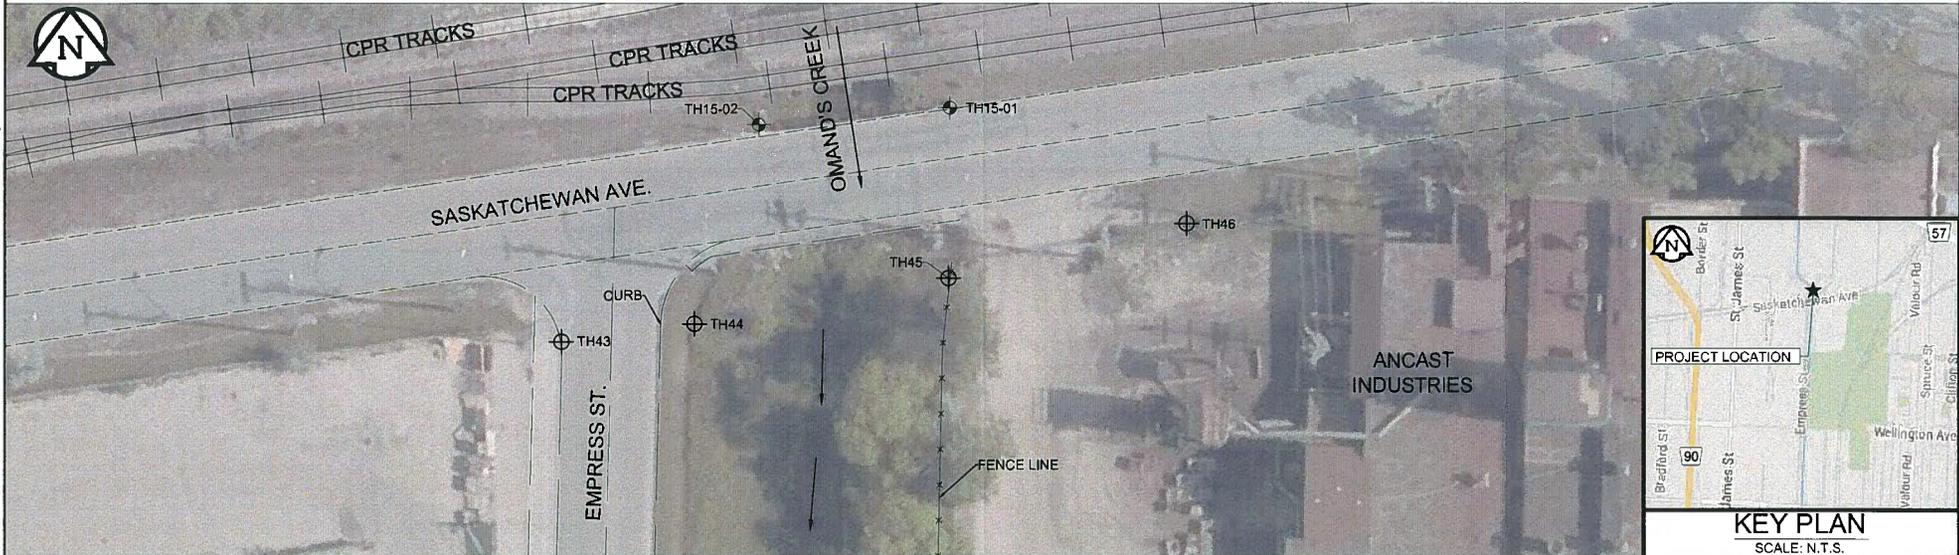
FILE NAME: FIG-001 2015-06-17 Site Plan 0\_F\_HA 0035 020 00.dwg

- ◆ TEST HOLE (TREK, APRIL 7, 2015)
- ⊕ TEST HOLE (M.H.A. 2008)

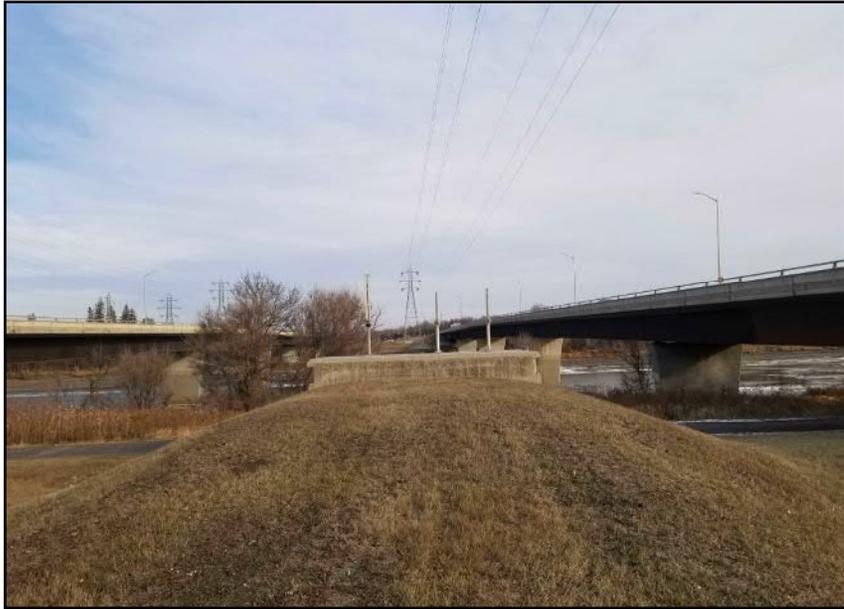
**Site 4 - Western Riverbank** | Steepened slopes around siphons inlet chamber structure (facing E)

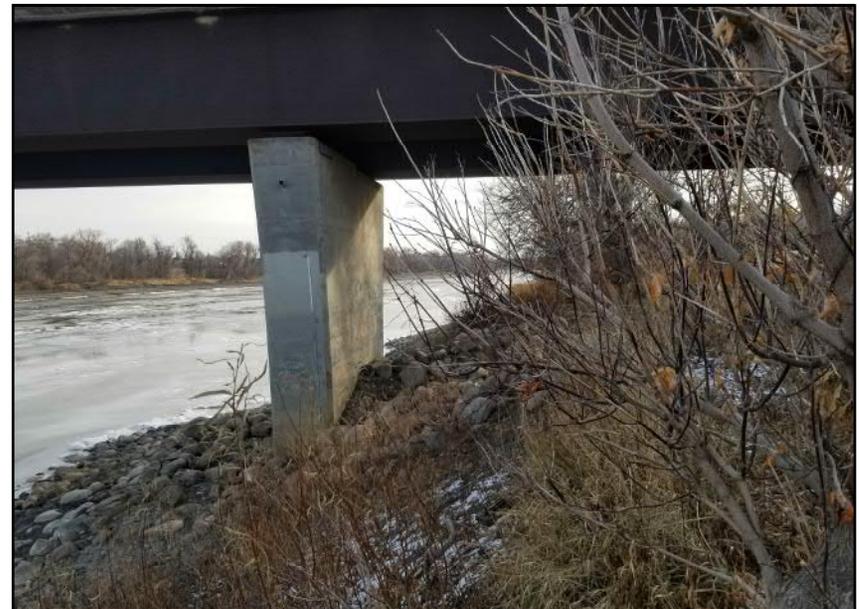
**Site 4 - Western Riverbank** | South bridge pier near river edge surrounded in rip-rap armouring (facing S)

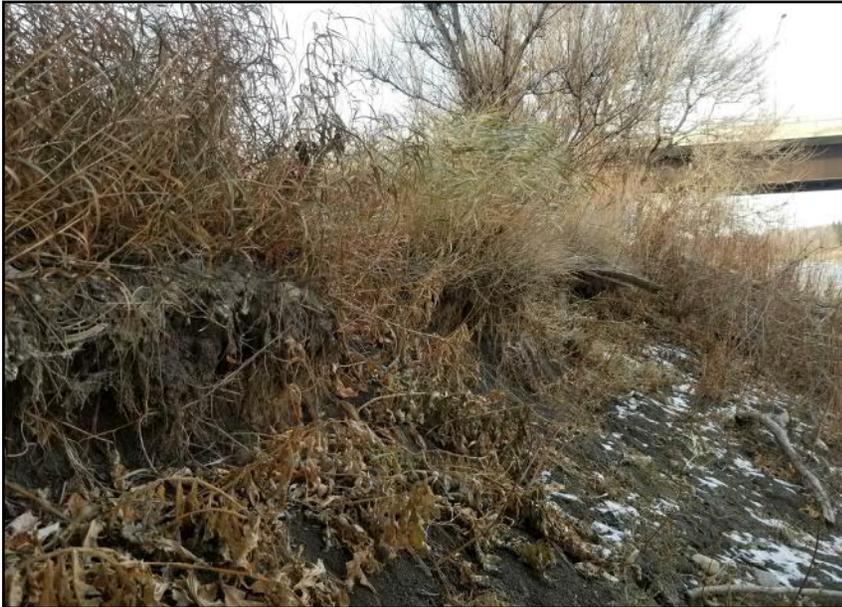
**Site 4 - Western Riverbank** | Observed scarp near oversteepened riverbank crest in adjacent to crossing alignment (facing N)

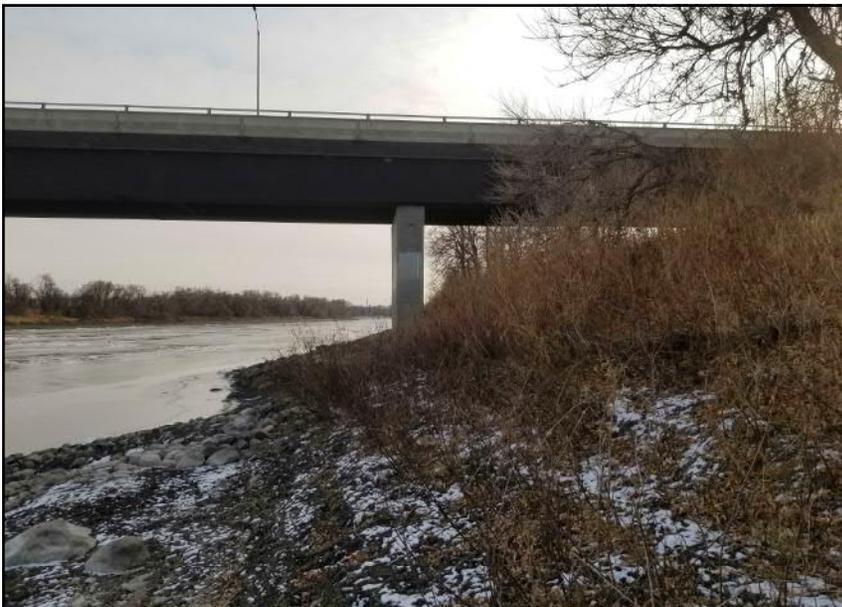
**Site 4 - Western Riverbank** | Short erosion scarps, localized rip-rap, gradual toe slope adjacent to crossing alignment (facing S)

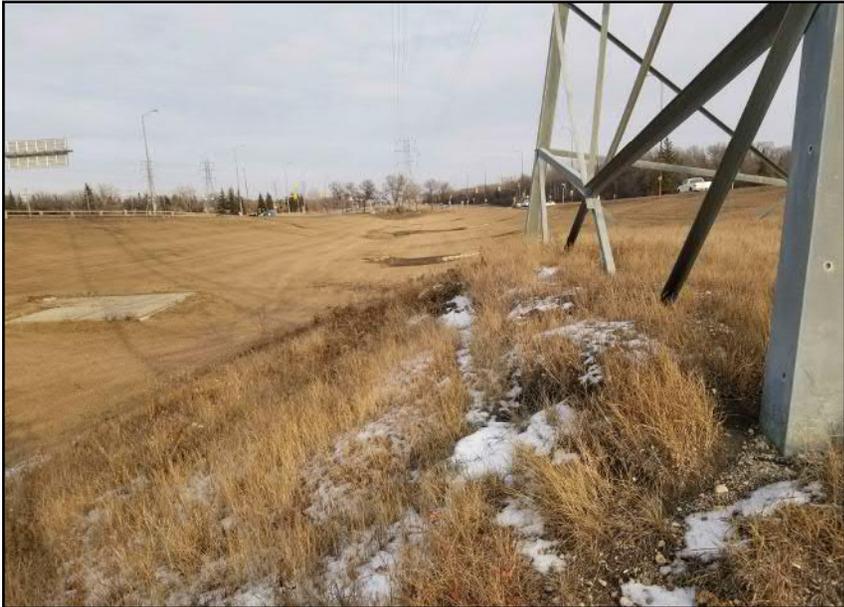
<b>Site 4 - Eastern Riverbank</b>	Steeper slopes around hydro tower showed signs of slope instability and animal burrows (facing E)
-----------------------------------	---

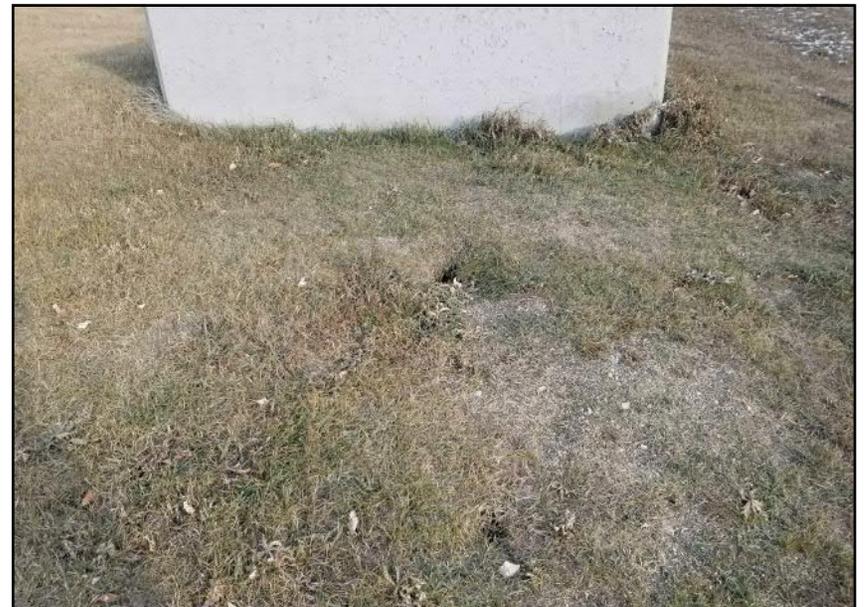
<b>Site 4 - Eastern Riverbank</b>	Animal burrows observed in front of siphons inlet chamber structure (facing W)
-----------------------------------	--

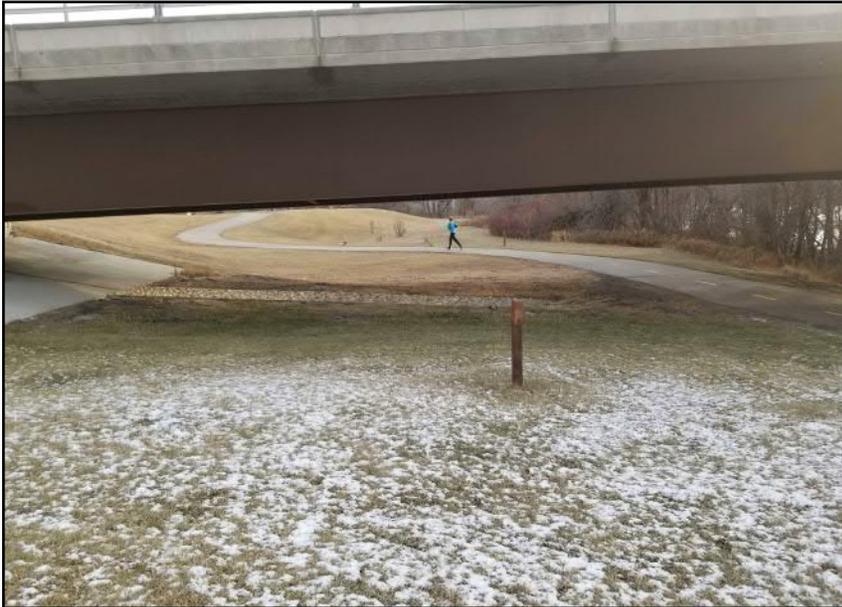
**Site 4 - Eastern Riverbank** Gradually sloping riverbank crest east of pedestrian pathway, groundwater well (facing S)

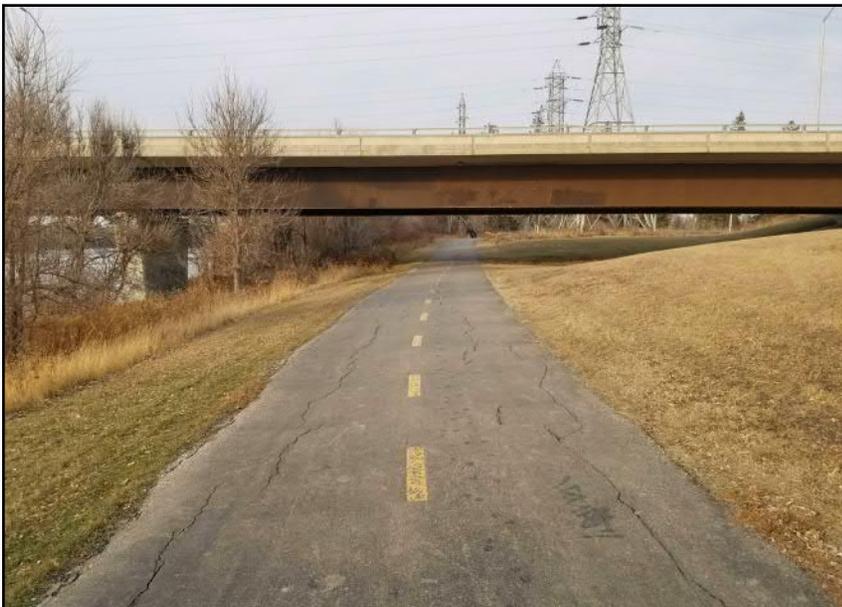
**Site 4 - Eastern Riverbank** Asphalt paved pedestrian pathway. Minor cracking observed parallel to bank crest (facing N)
