# Replacement of the FGSV Siphon

Geotechnical Baseline Report  
FINAL

City of Winnipeg

May 2025

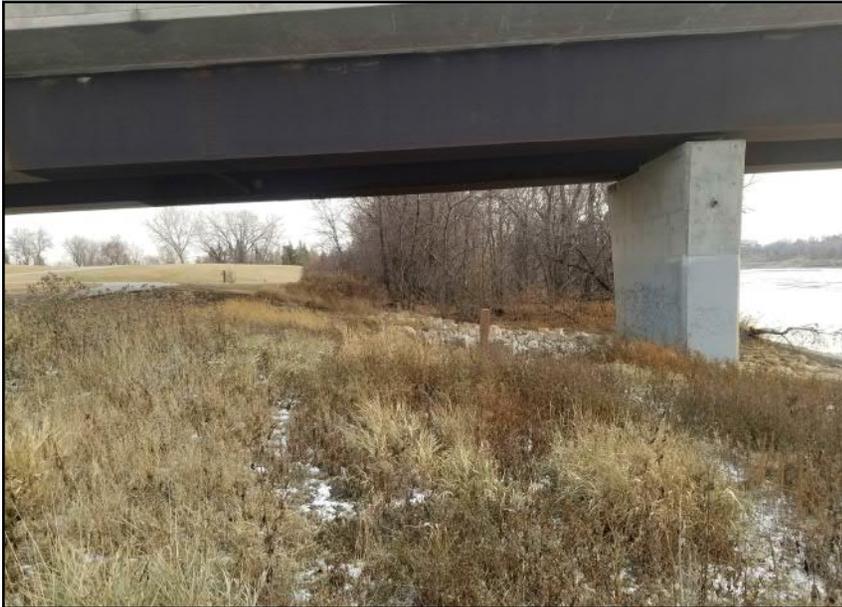
**Site 4 - Eastern Riverbank** Riverbank slightly steepening west of pedestrian pathway, groundwater well (facing S)

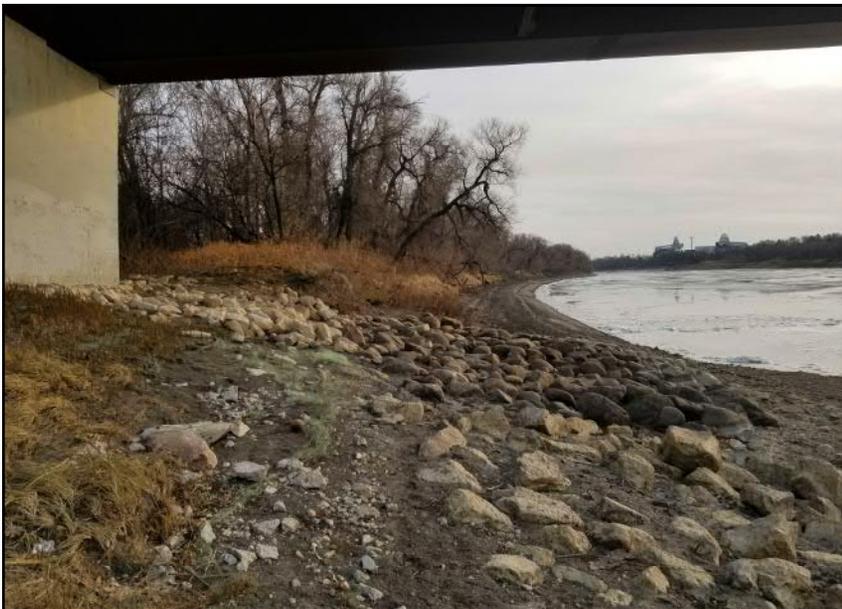
**Site 4 - Eastern Riverbank** Rip-rap armoring around south bridge pier and along gradually sloping bank toe (facing S)

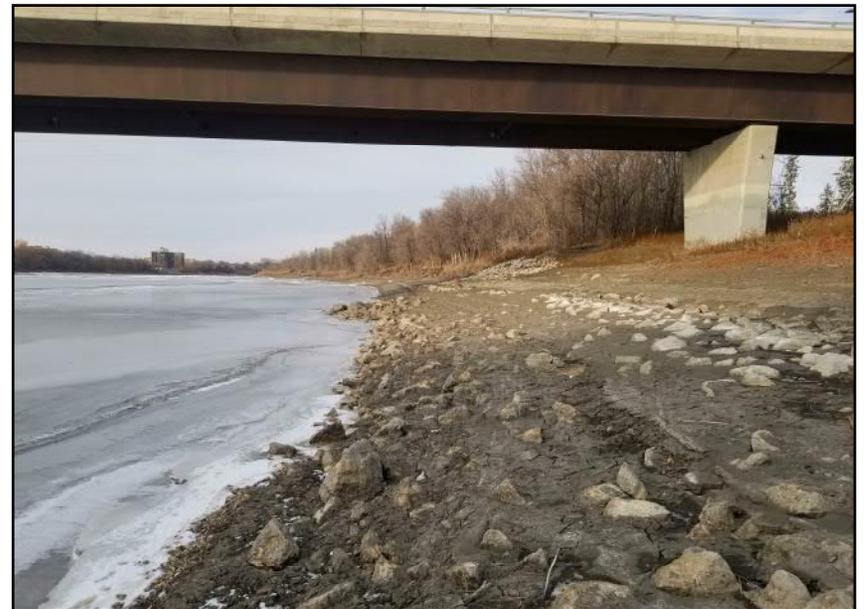
**Site 4 - Eastern Riverbank** Rip-rap armoring along entire lower portion of riverbank between bridges (facing N)

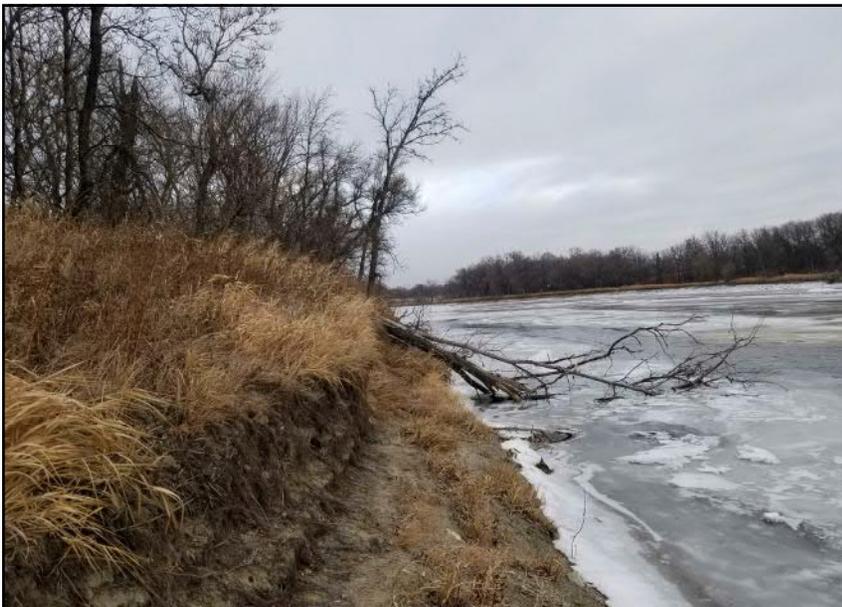
**Site 5 - Northern Riverbank** | Erosion scarp observed near bank toe within eastern portion of study area (facing E)

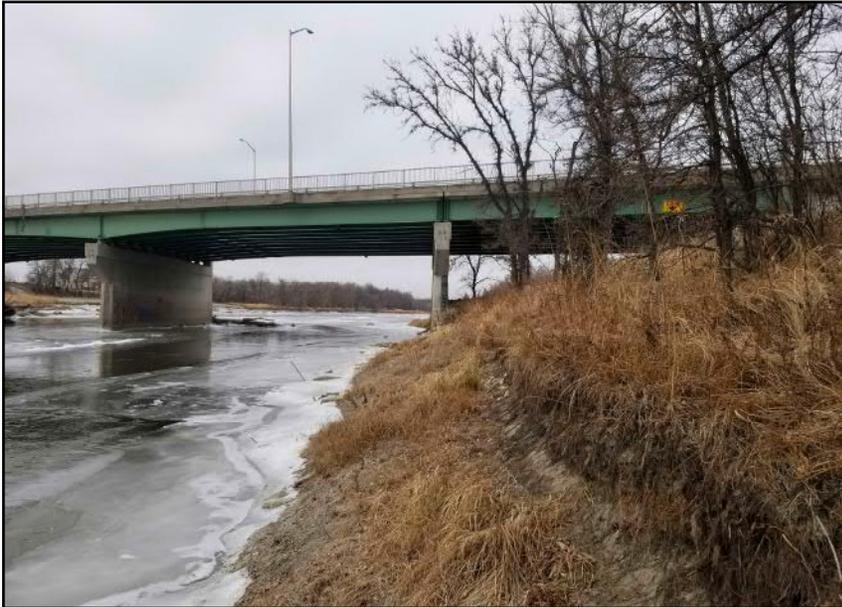
**Site 5 - Northern Riverbank** Erosion scarp observed near bank toe within western portion of study area (facing W)

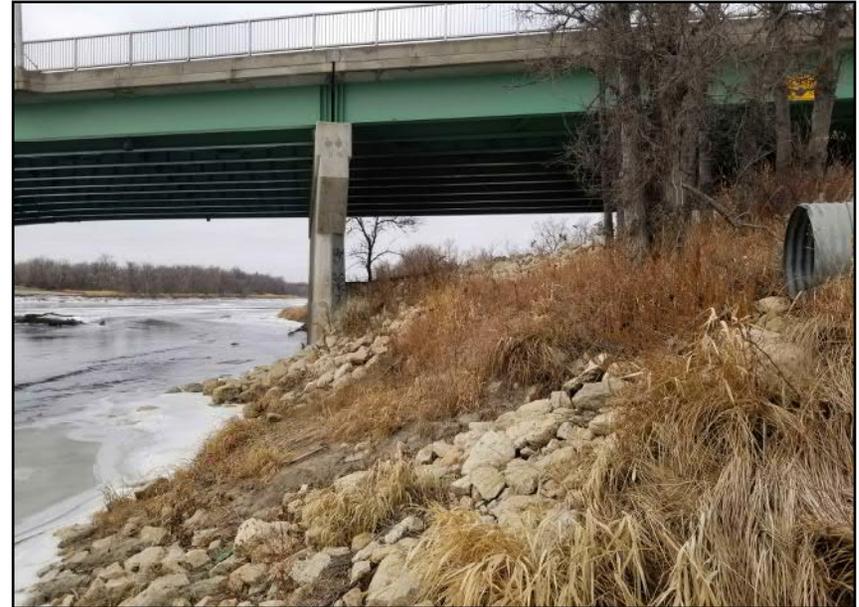
**Site 5 - Northern Riverbank** Rip-rap along slope within discharge path of CSP outfall in western portion of study area (facing W)

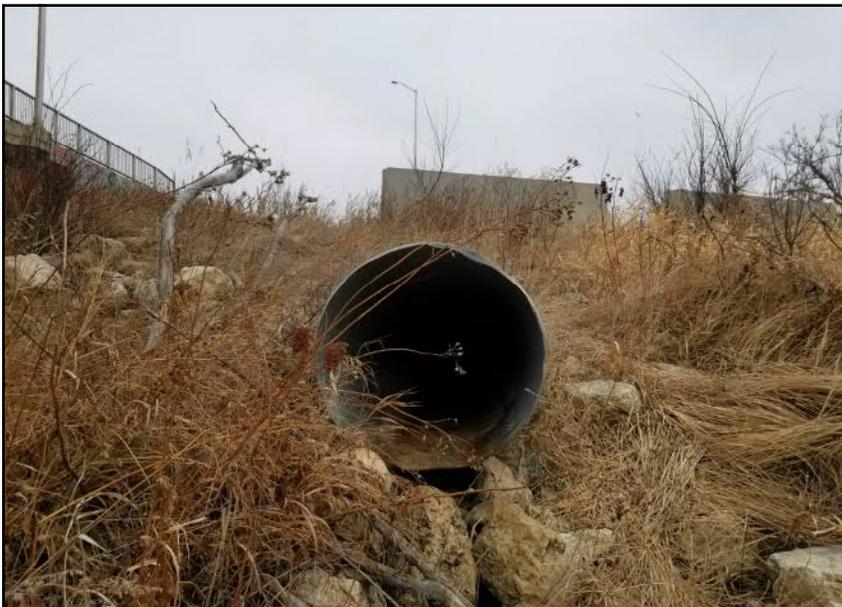
**Site 5 - Northern Riverbank** CSP outfall daylighting along bank slope, some erosion of bank material between rip-rap (facing N)

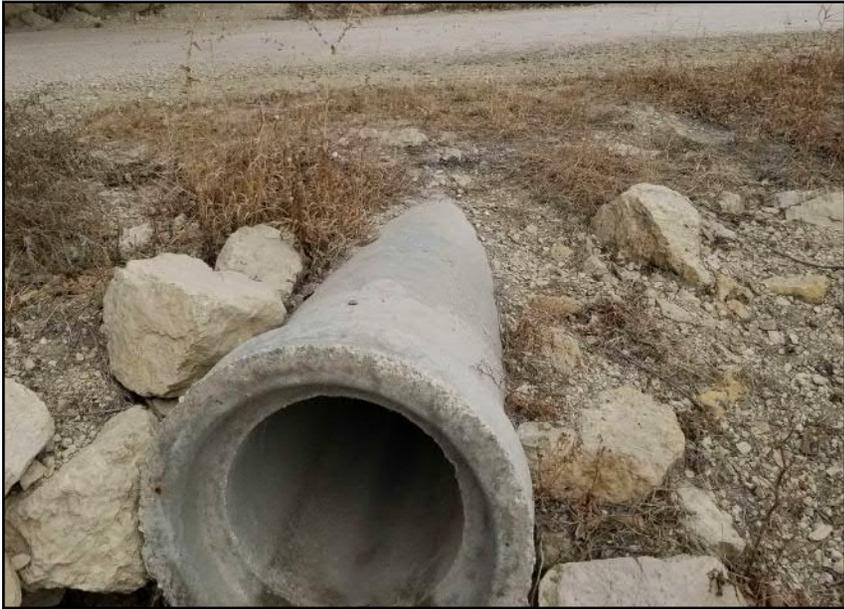
<b>Site 5 - Northern Riverbank</b>	Concrete drainage culvert beneath roadway near bank crest close to bridge structure (facing N)
--	---

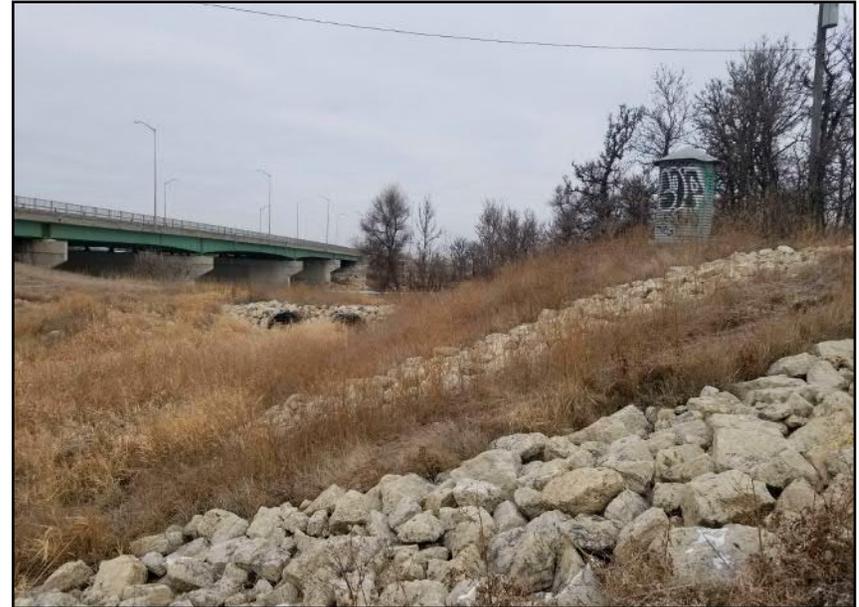
**Site 5 - Southern Riverbank** | Rock drains installed within steeper slopes of rip-rap lined drainage channel (facing N)

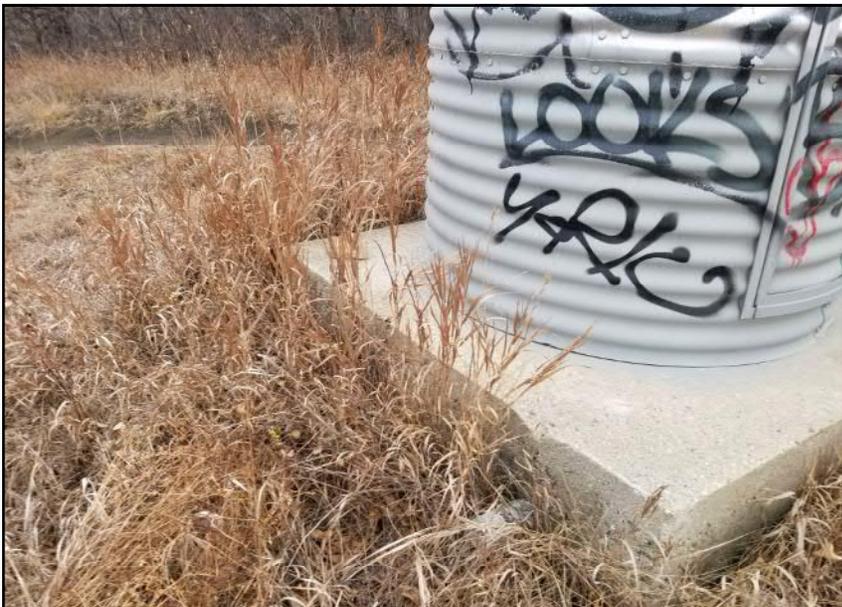
**Site 5 - Southern Riverbank** | No observed movement of lift station located at east crest of rip-rap drainage channel (facing E)

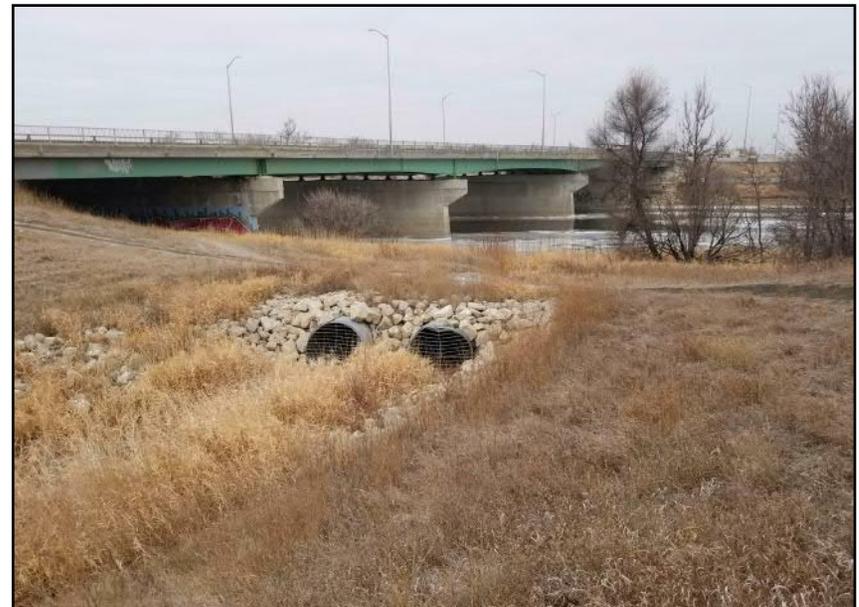
**Site 5 - Southern Riverbank** | Drainage channel sloped towards CSP culverts west of crossing alignment (facing NW)

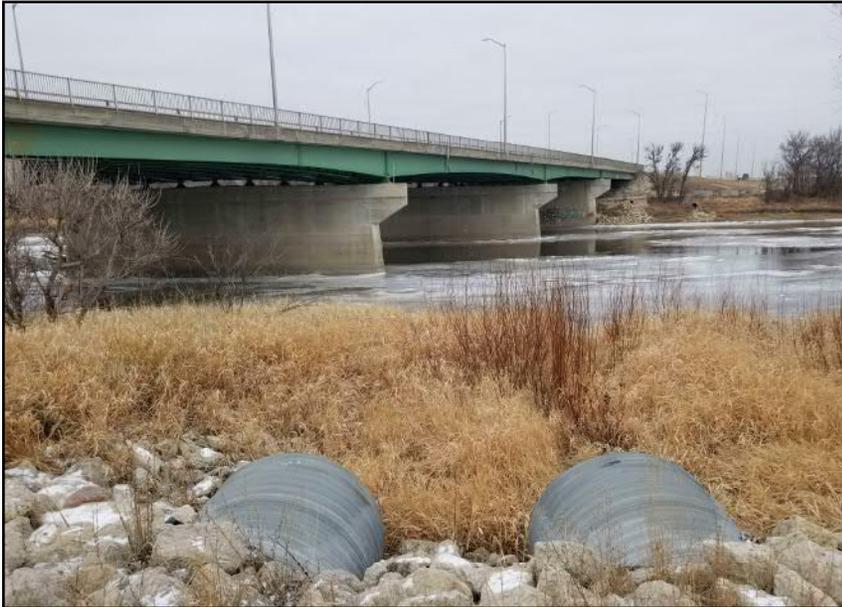
**Site 5 - Southern Riverbank** Discharge path of CSP culverts west of crossing alignment, gradual bank slopes (facing NW)

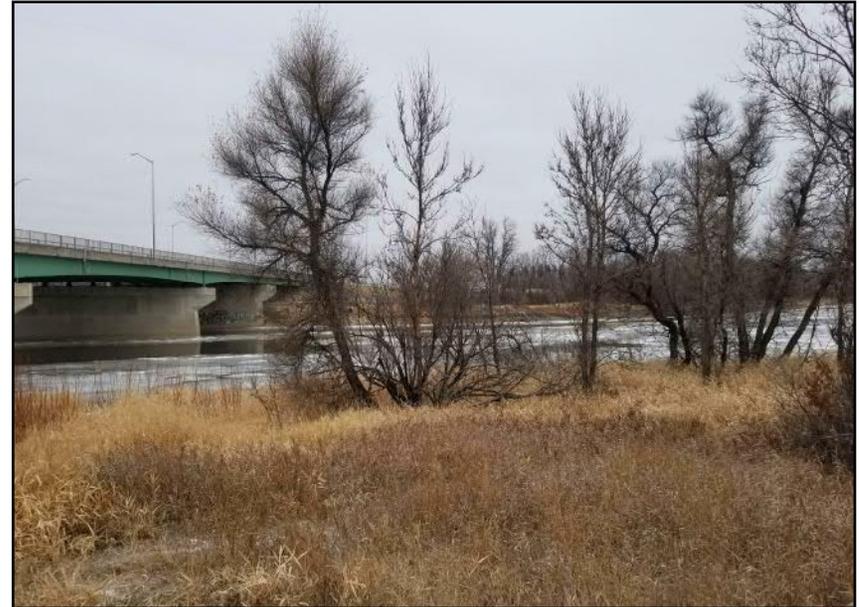
**Site 5 - Southern Riverbank** View from riverbank crest along approximate crossing alignment (facing N)

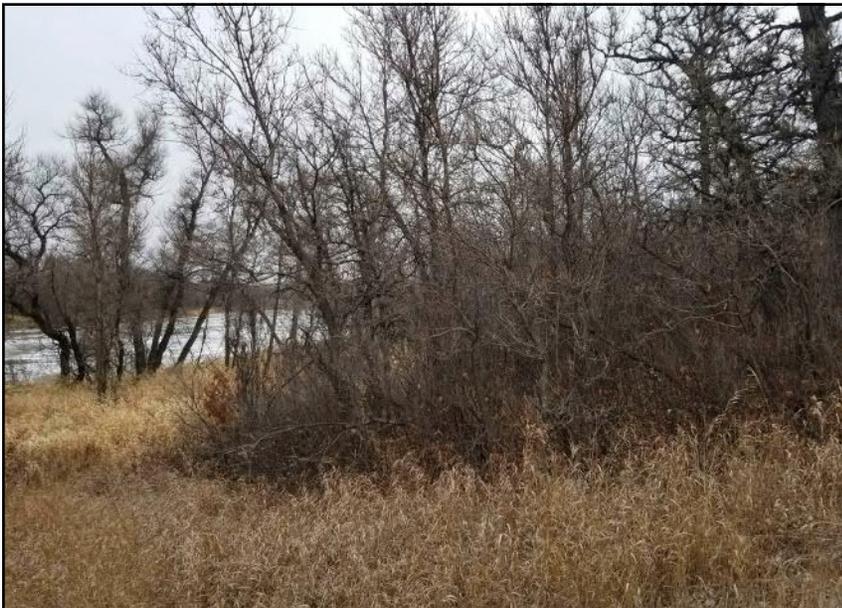
**Site 5 - Southern Riverbank** Gradual slopes, brush, shrubs, and trees observed along bank crest near crossing alignment (facing E)

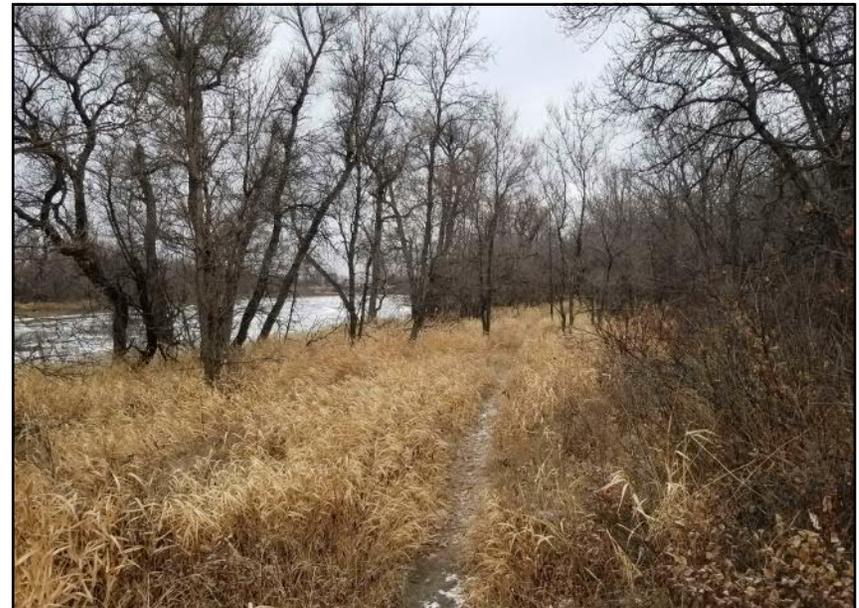
**Site 5 - Southern Riverbank** Flattened bank crest slope closer to river edge, signs of pedestrian passage (facing E)

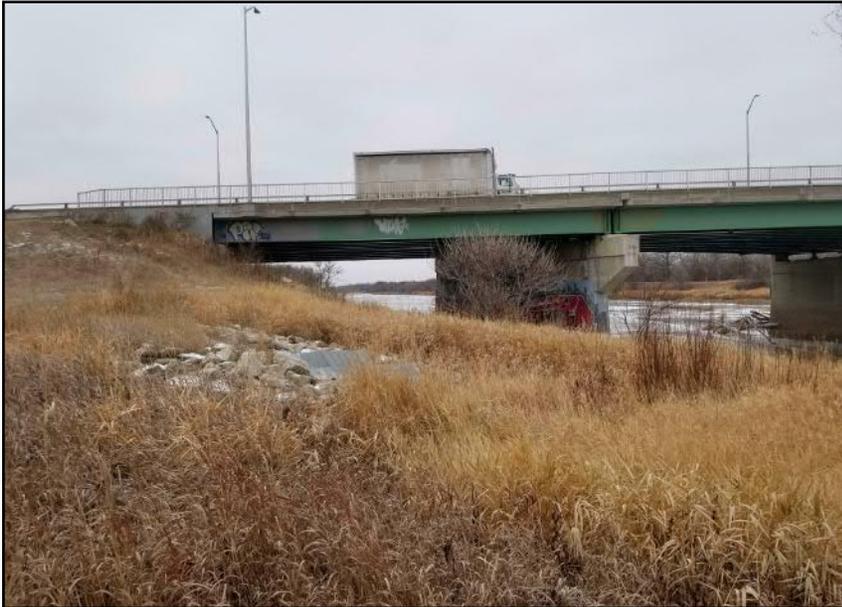
**Site 5 - Southern Riverbank** Gradual slopes, brush, trees observed along bank crest west of crossing alignment (facing W)

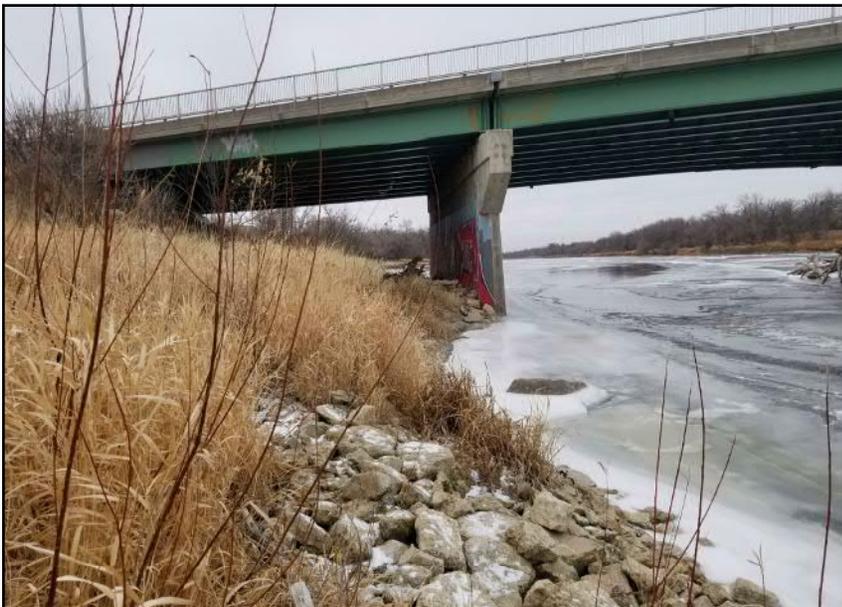
**Site 5 - Southern Riverbank** Rip-rap armoring along bank slope between CSP culverts and river edge (facing W)

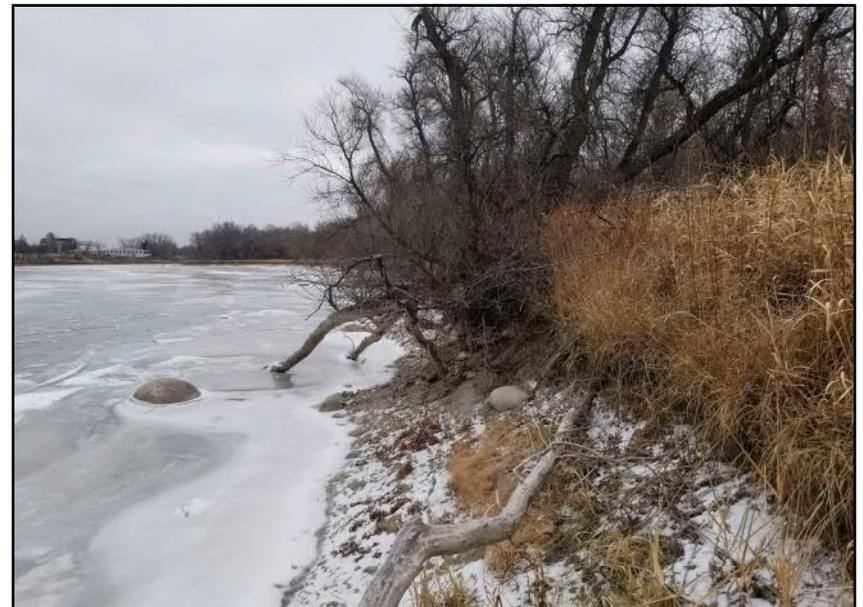
**Site 5 - Southern Riverbank** Sloped riverbank edge, erosion scarp, fallen tree in close proximity to crossing alignment (facing E)

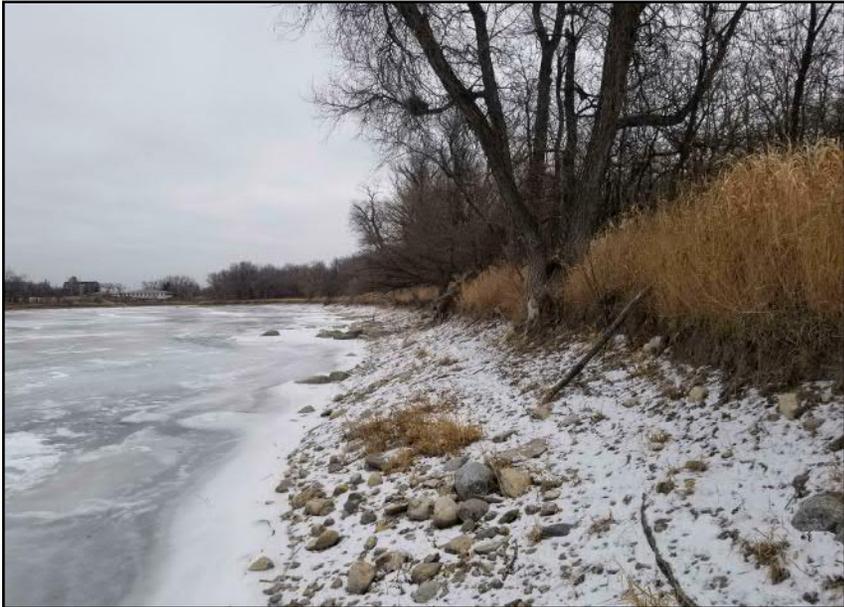
**Site 5 - Southern Riverbank**

Increasing width of exposed bank further east from the crossing alignment (facing E)

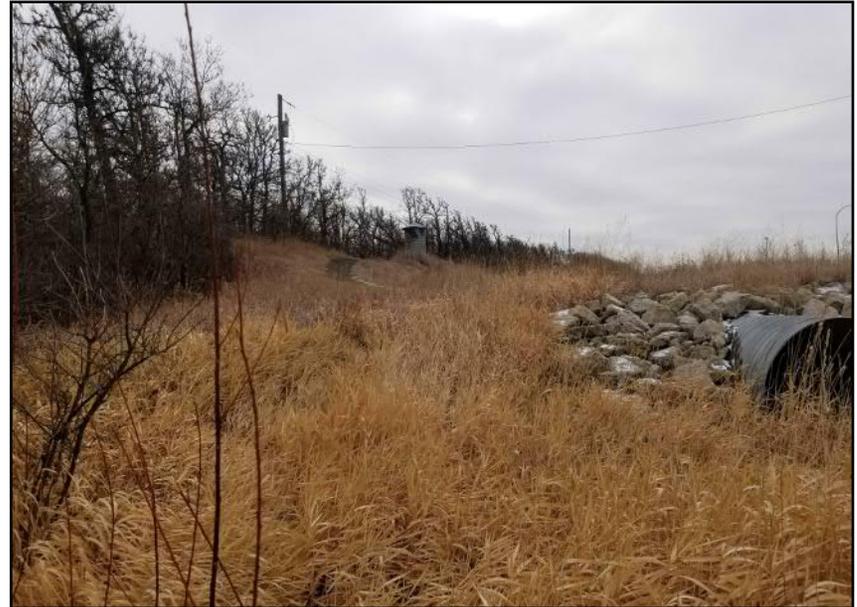
**Site 5 - Southern Riverbank**

View near river edge along approximate crossing alignment (facing S)

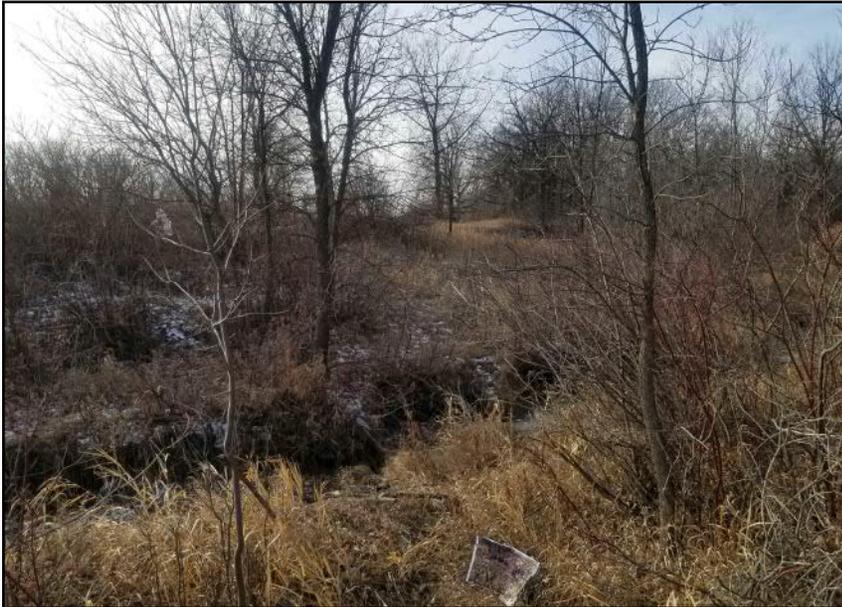
**Site 6A - Northern Bank** | View from bank crest along approximate crossing alignment (facing SW)

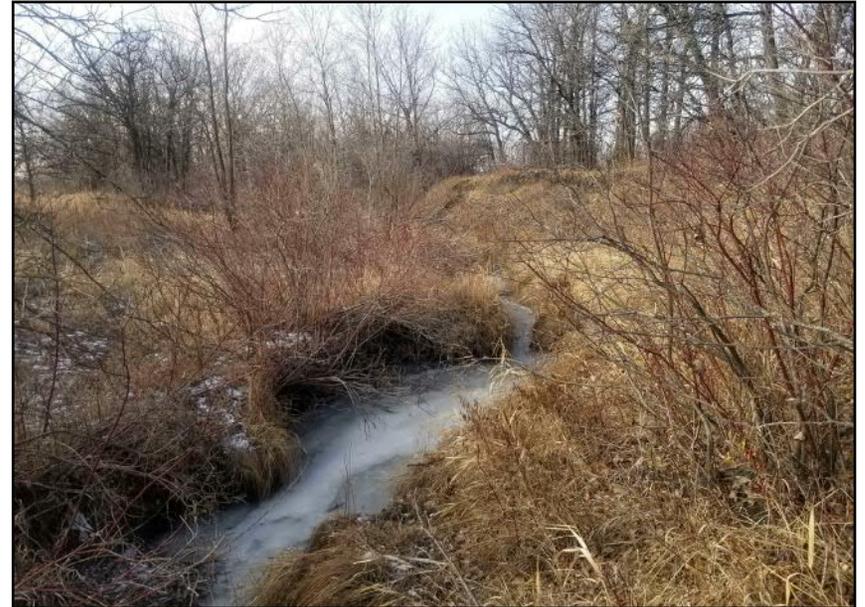
**Site 6A - Northern Bank** | Flatter slopes around drain, steepening sharply towards bank crest (facing W)

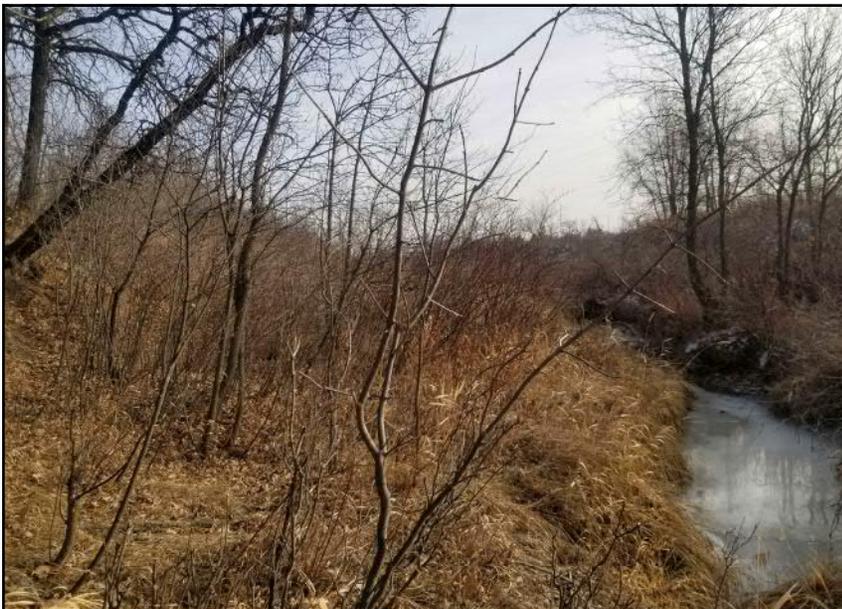
**Site 6A - Northern Bank** | Flatter slopes around drain, steepening sharply towards bank crest (facing SE)

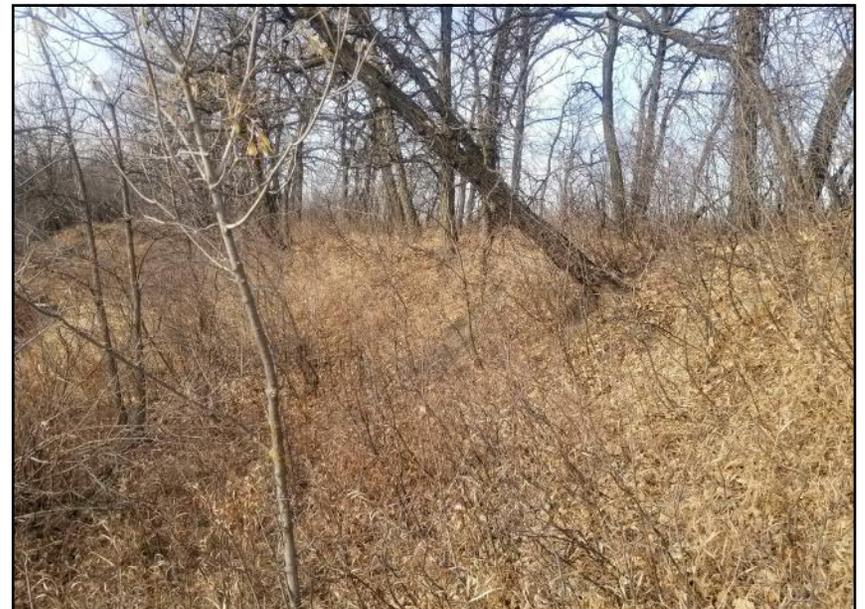
**Site 6A - Northern Bank** | Oversteepened bank slopes, leaning trees, brush, shrub vegetation near bank crest (facing NW)

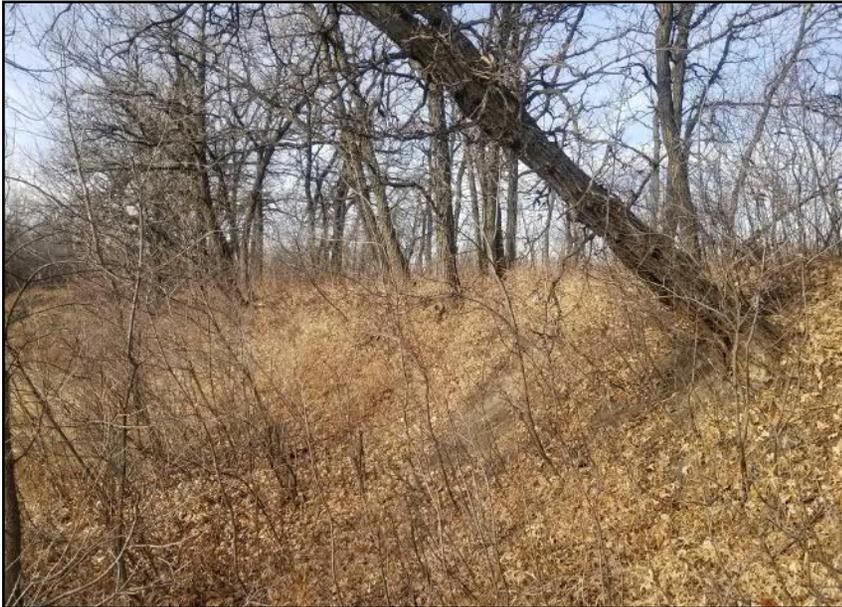
**Site 6A - Northern Bank** | Scarps from slope instabilities observed along oversteepened portion of banks (facing NW)

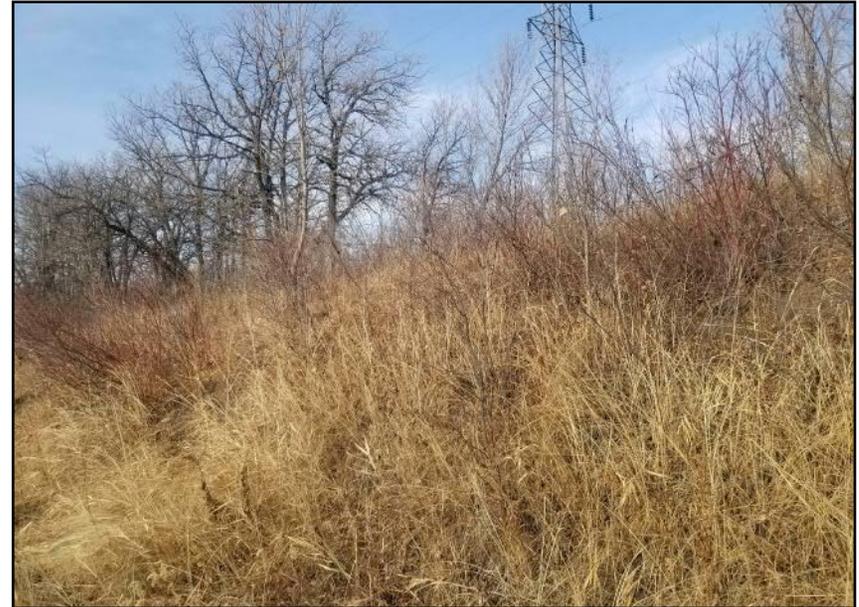
**Site 6A - Northern Bank** | Consistently sloping ground from crest to bank toe east of crossing alignment (facing NW)

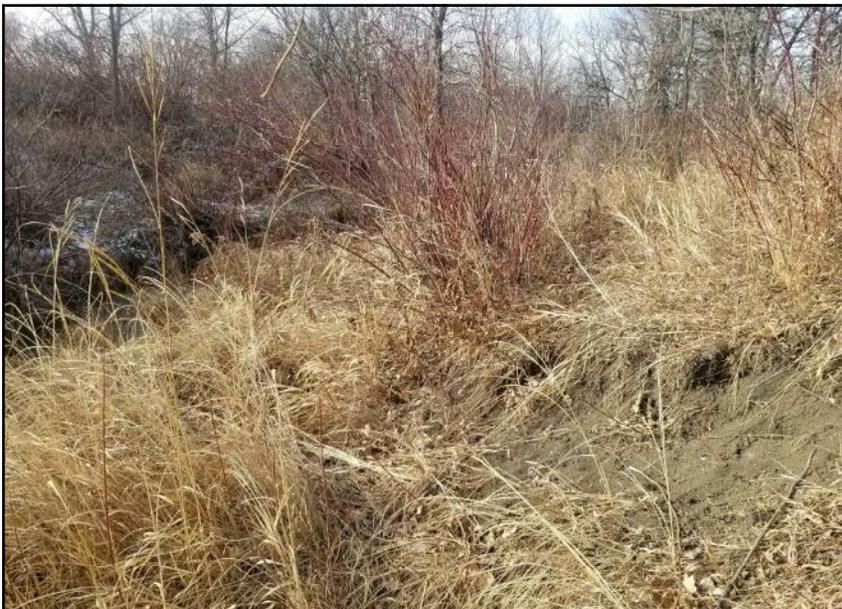
**Site 6A - Northern Bank** | Scarps observed near flatter portion near drain in vicinity of crossing alignment (facing W)

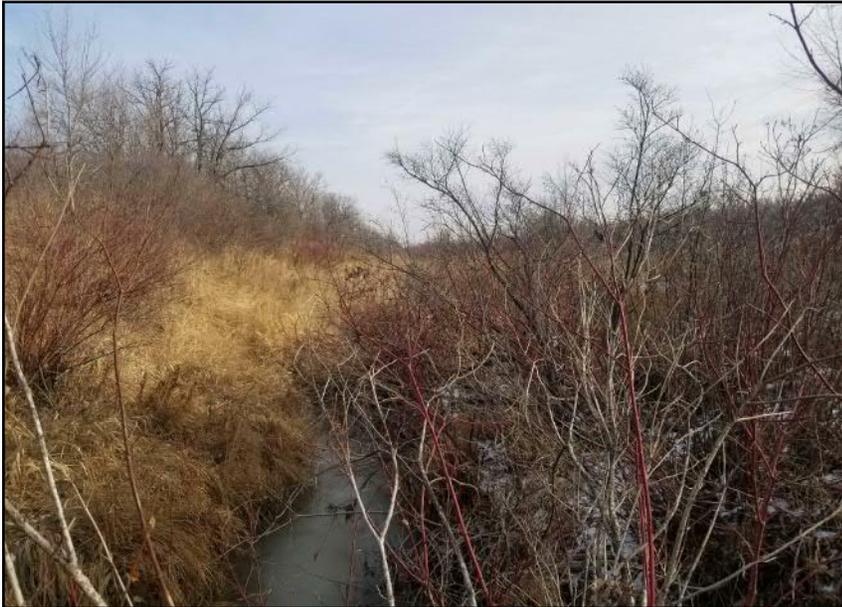
**Site 6A - Southern Bank** | Flatter slopes around drain, steepening sharply towards bank crest (facing E)

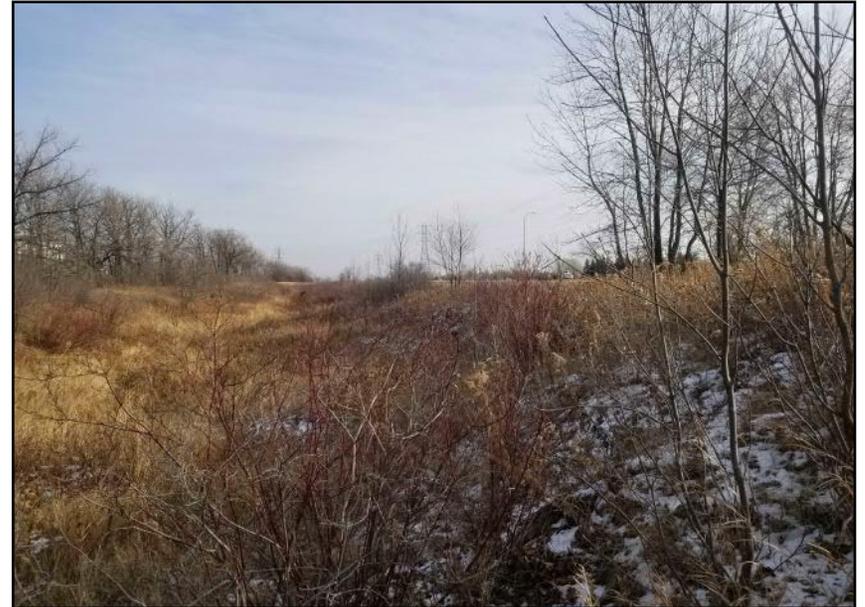
**Site 6A - Southern Bank** | Consistently sloping ground from crest to bank toe east of crossing alignment (facing E)

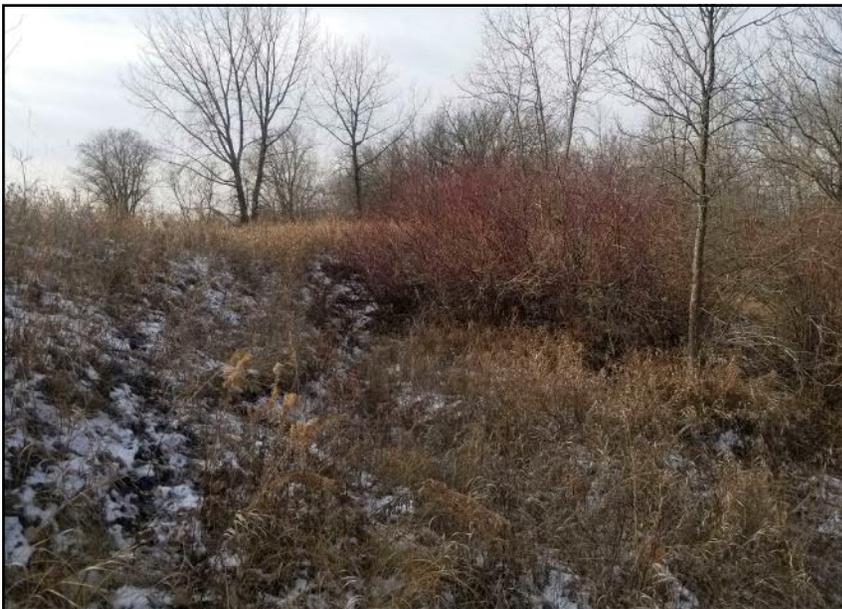
**Site 6A - Southern Bank** | Progressive slope instabilities observed in close proximity to crossing alignment (facing W)

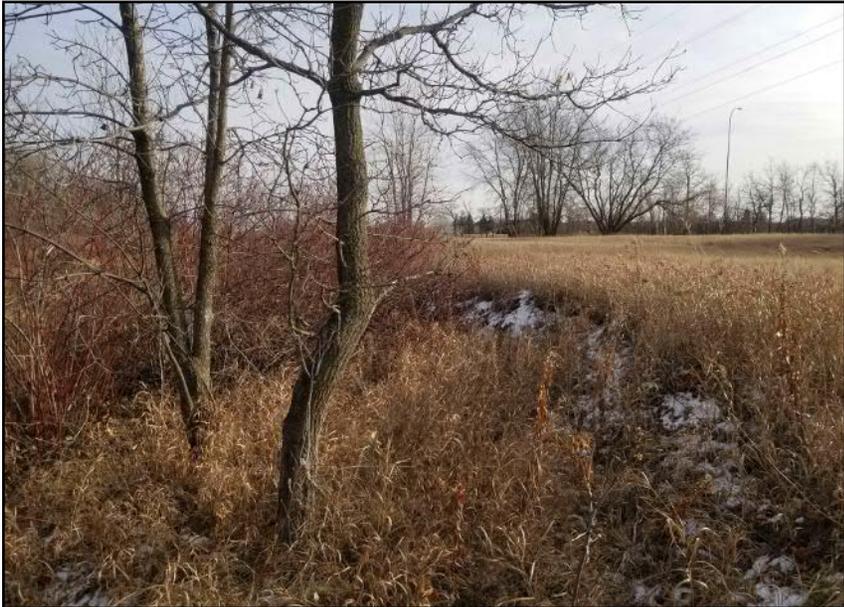
<b>Site 6A - Southern Bank</b>	Progressive slope instabilities have progressed towards the bank crest (facing E)
--------------------------------	---

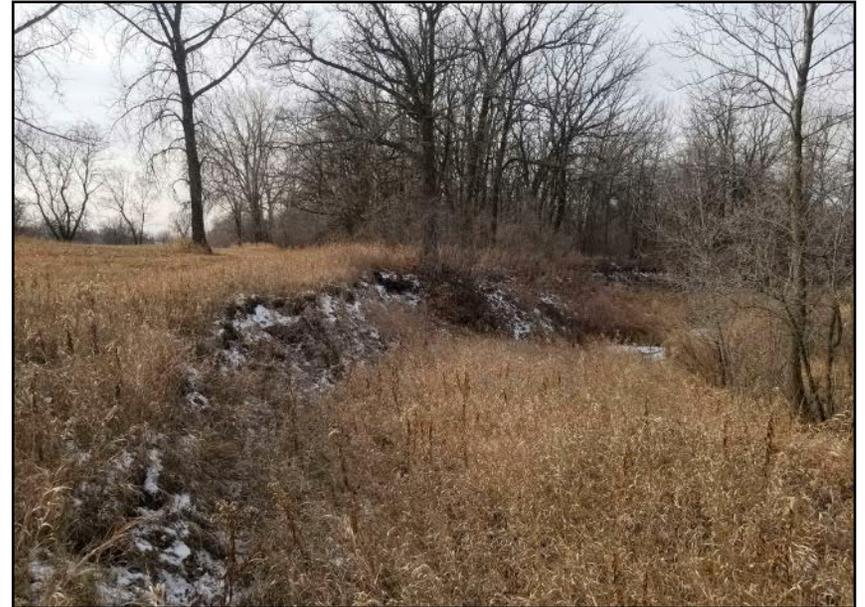
<b>Site 6A - Southern Bank</b>	Slope instability ridges observed near bank crest west of the crossing alignment (facing W)
--------------------------------	---

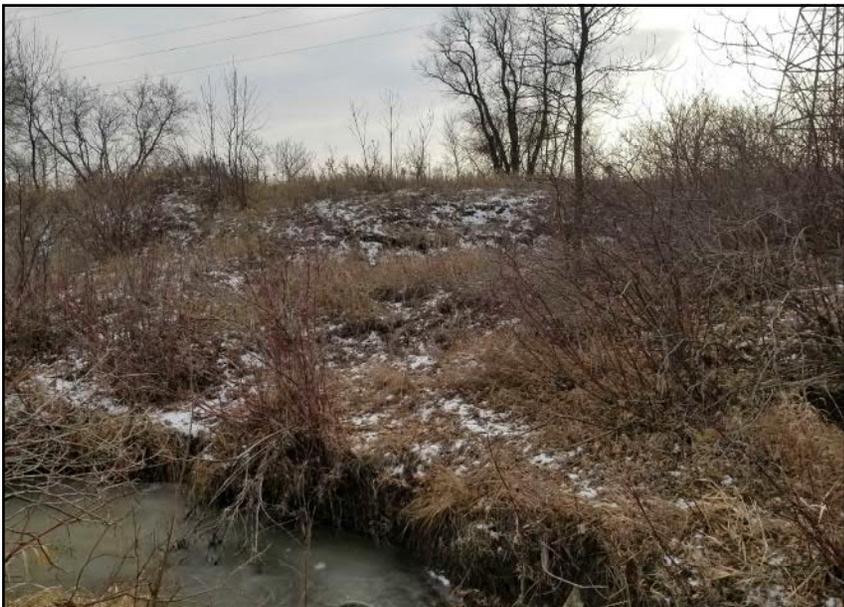
<b>Site 6A - Southern Bank</b>	Progressive slope instabilities along bank slope near crossing alignment (facing SE)
--------------------------------	--

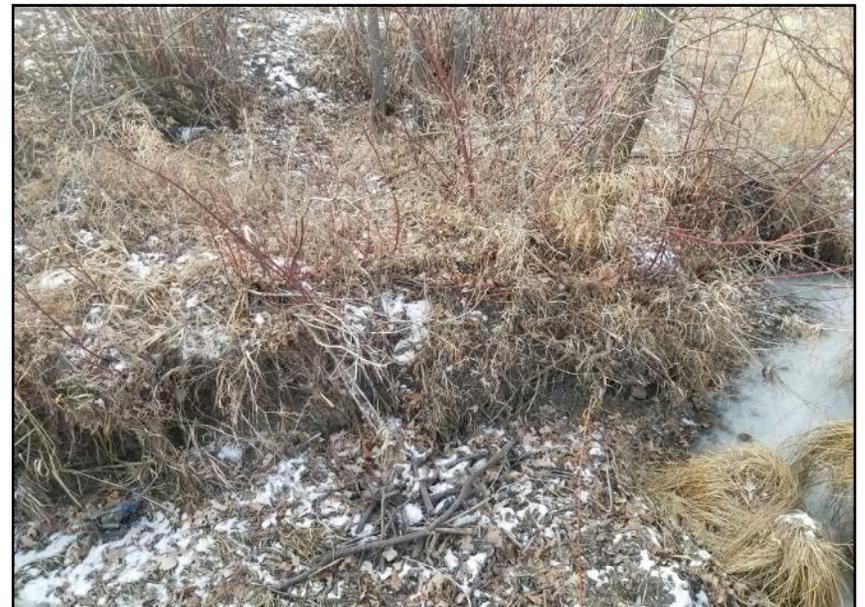
<b>Site 6A - Southern Bank</b>	Shallow slope instabilities observed at localized areas along bank toe (facing S)
--------------------------------	---

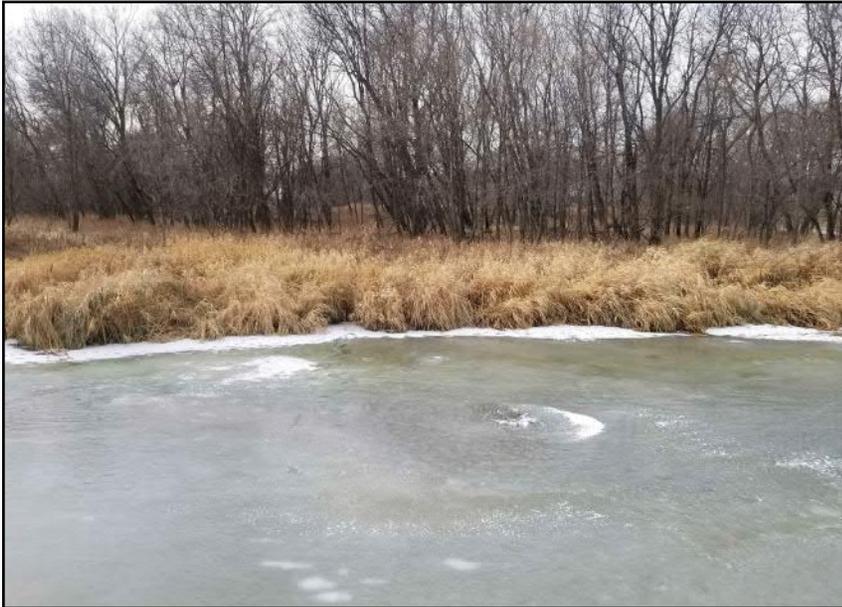
<b>Site 6B - Western Bank</b>	View of western riverbank from eastern riverbank near crossing alignment (facing W)
-----------------------------------	---

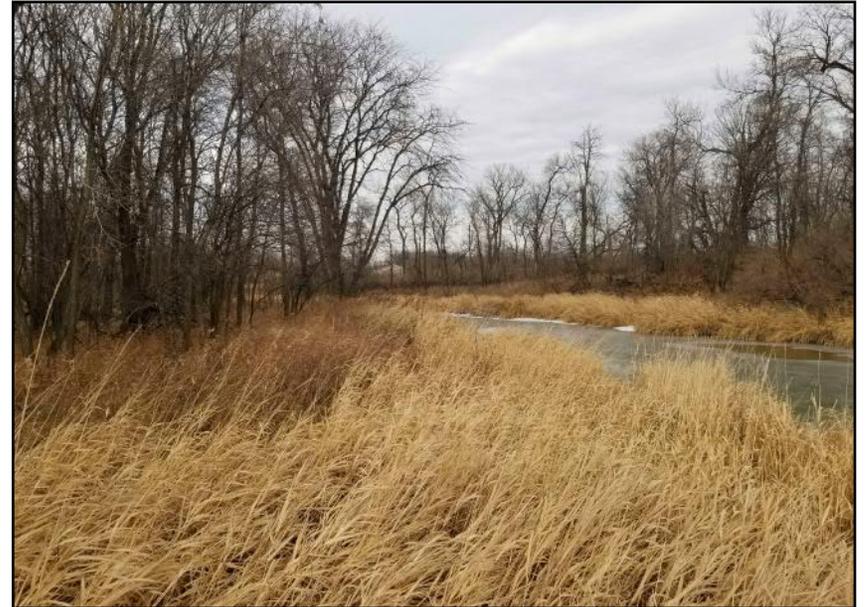
<b>Site 6B - Western Bank</b>	Flatter slopes, dense brush large trees along bank crest north of crossing (facing N)
-----------------------------------	---

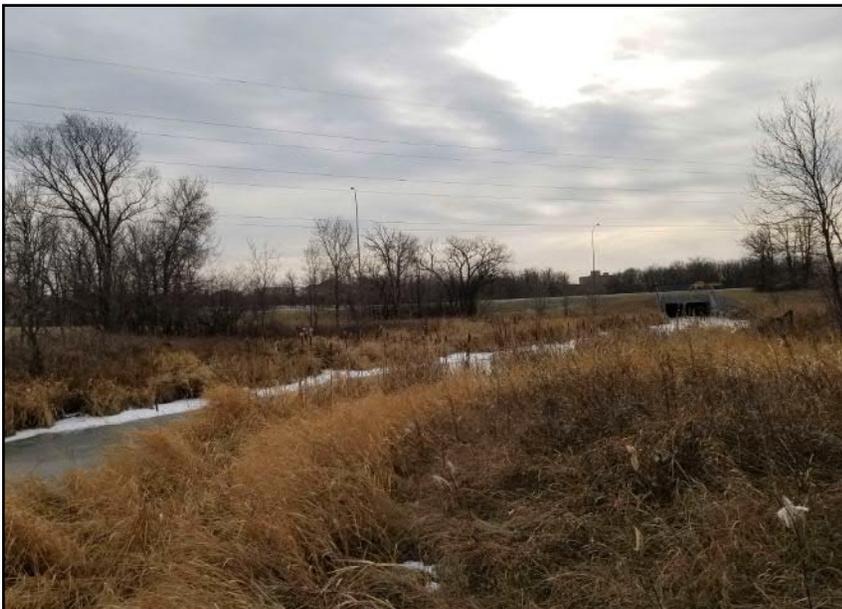
<b>Site 6B - Western Bank</b>	Flatter slopes steepening slightly near river, dense brush along bank crest south of crossing (facing S)
-----------------------------------	--

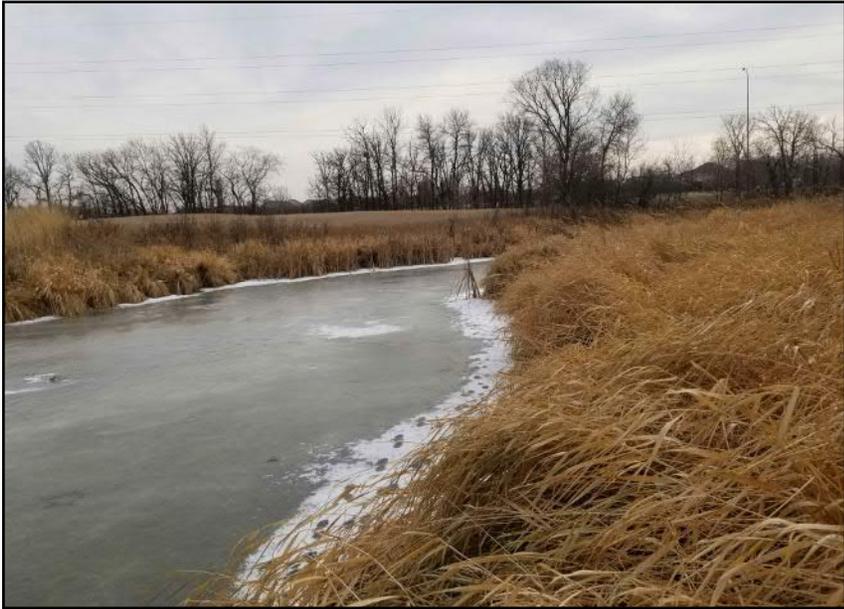
**Site 6B -  
Western Bank**

Minor erosion observed at localized areas along bank toe (facing S)

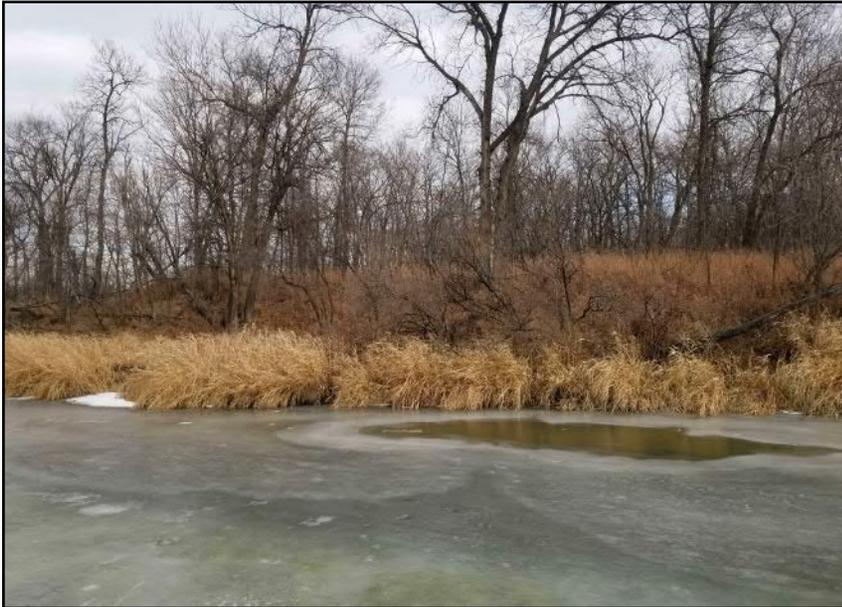
**Site 6B - Eastern Bank** | View of eastern riverbank from western riverbank near crossing alignment (facing E)

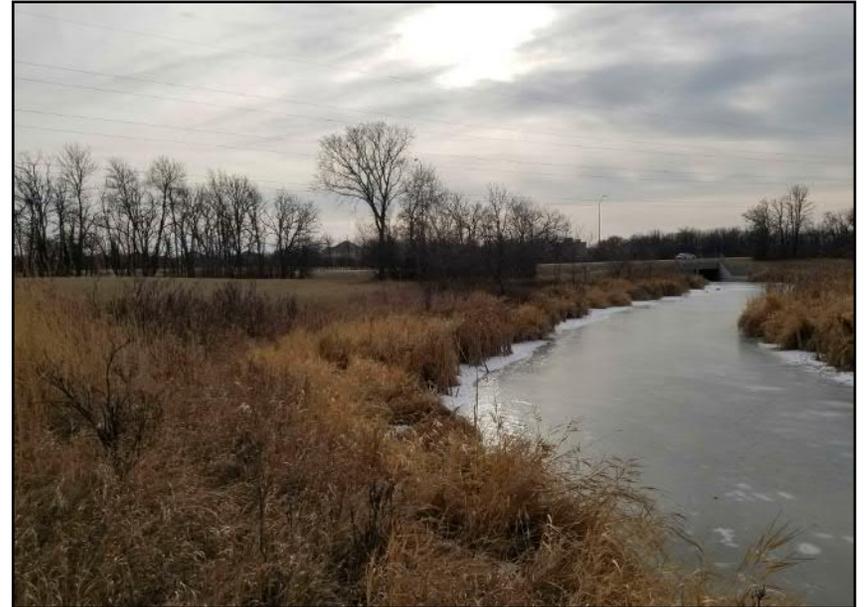
**Site 6B - Eastern Bank** | Slopes steepening slightly near river, dense brush within southern portion of study area (facing S)

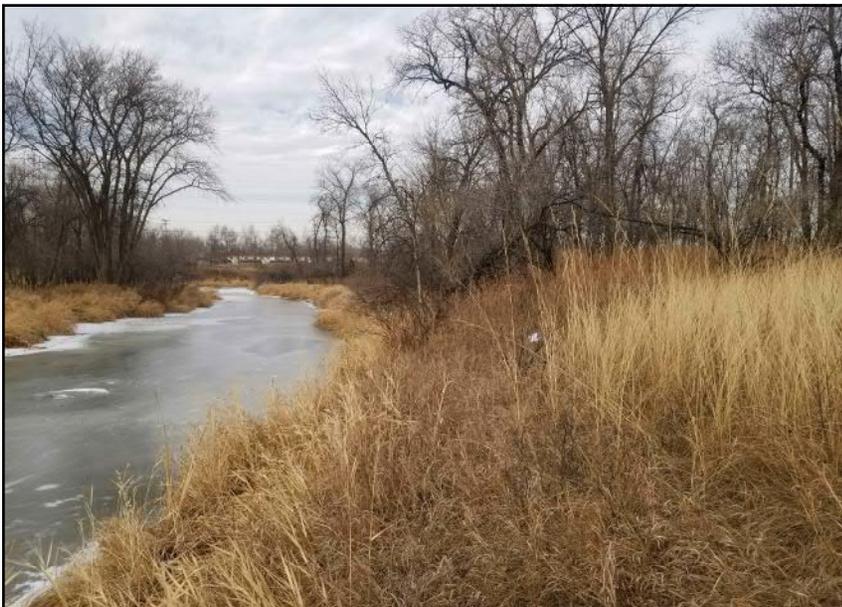
**Site 6B - Eastern Bank** | Slightly steepening bank slope down towards river within northern portion of study area (facing E)

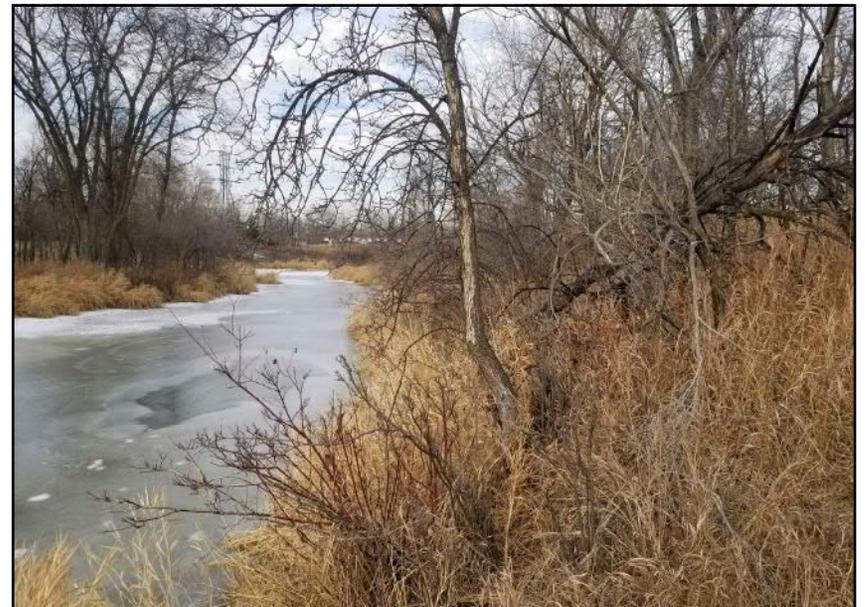
**Site 6B - Eastern Bank** | Steepened banks slope extends from bank crest down to bank toe (facing N)
