# Replacement of the FGSV Siphon

Geotechnical Baseline Report  
FINAL

City of Winnipeg

May 2025

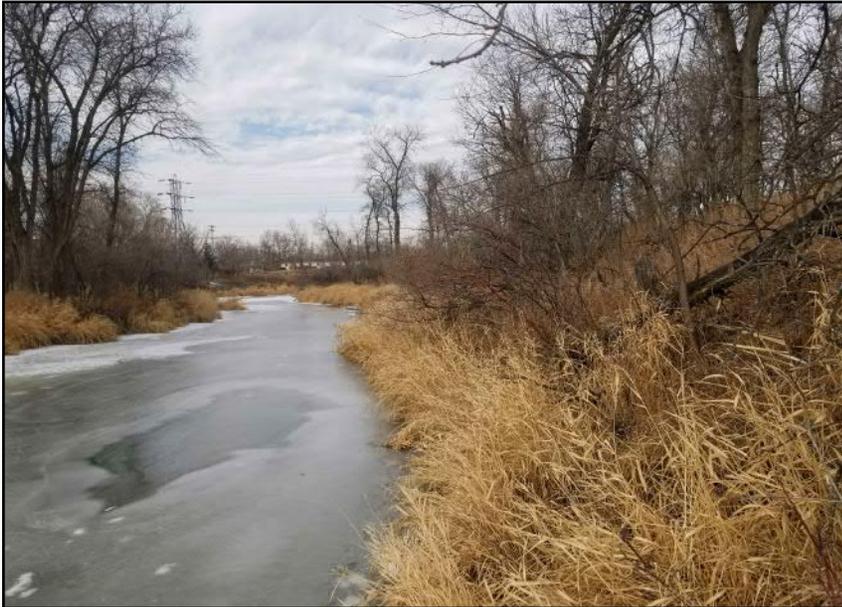
<b>Site 6B - Eastern Bank</b>	Minor erosion observed at localized areas along bank toe (facing N)
-------------------------------	---

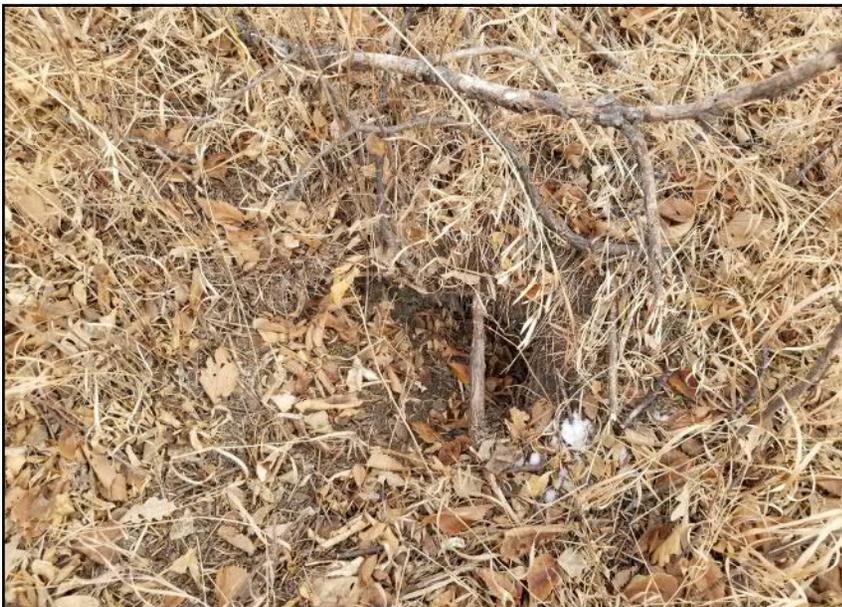
<b>Site 6B - Eastern Bank</b>	Animal burrows observed within the steeper bank slopes (facing E)
-------------------------------	---

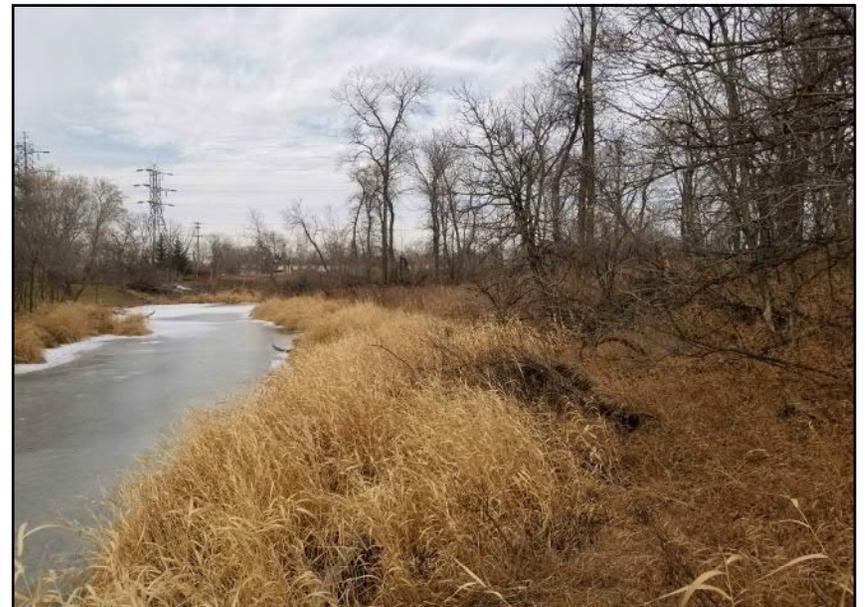
<b>Site 6B - Eastern Bank</b>	Bank slopes flatten out near the river edge north of the study area (facing N)
-------------------------------	--

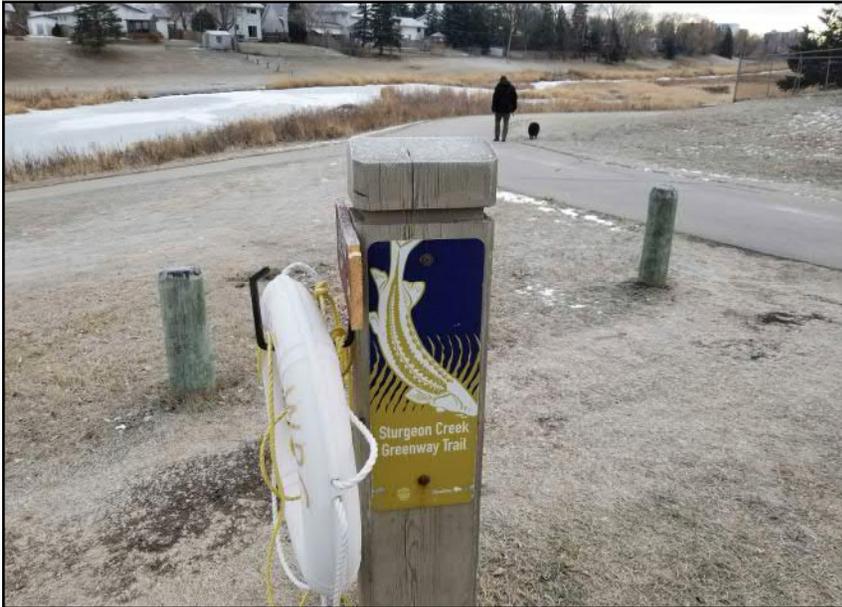
**Site 7 - Western Bank** | Sturgeon Creek Greenway Trail and gradual riverbank slopes east of crossing (facing SE)

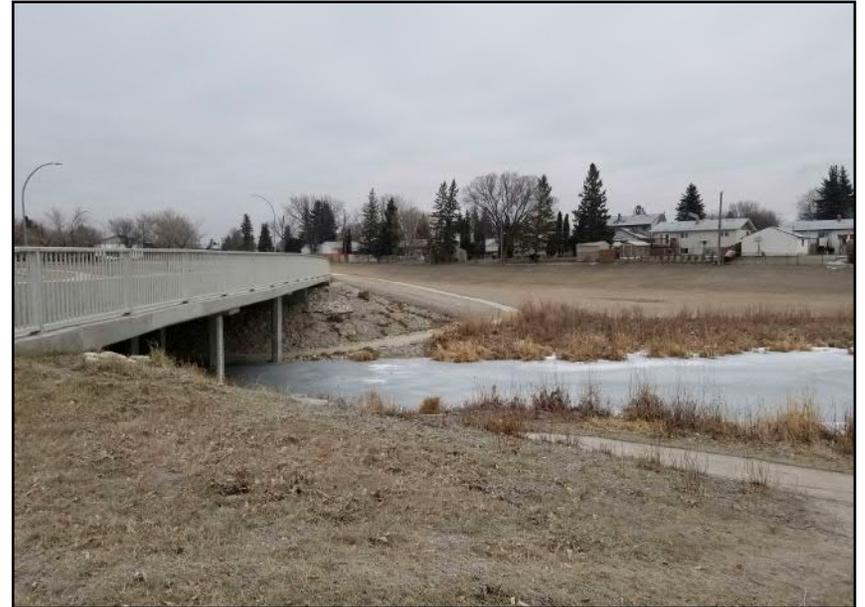
**Site 7 - Western Bank** | View from the west bank facing the east bank along the approximate crossing alignment (facing E)

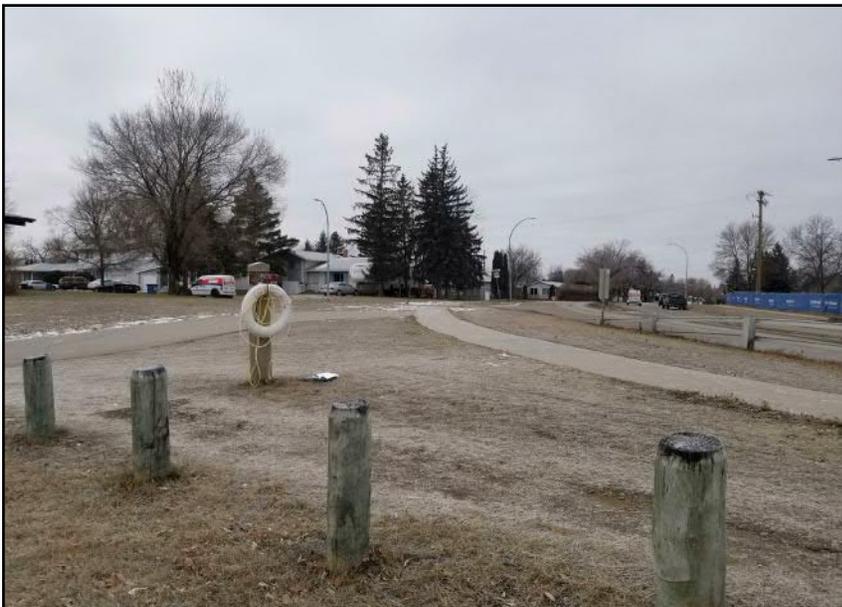
**Site 7 - Western Bank** | Gradual slope, manicured grass, wood posts along riverbank crest beside bridge abutment (facing W)

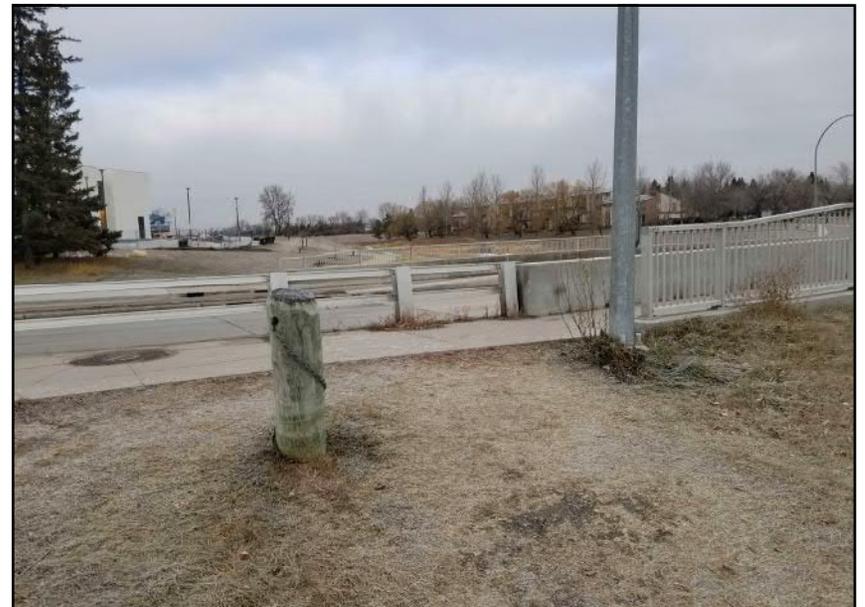
**Site 7 - Western Bank** | Western bridge abutment near bank crest (facing N)

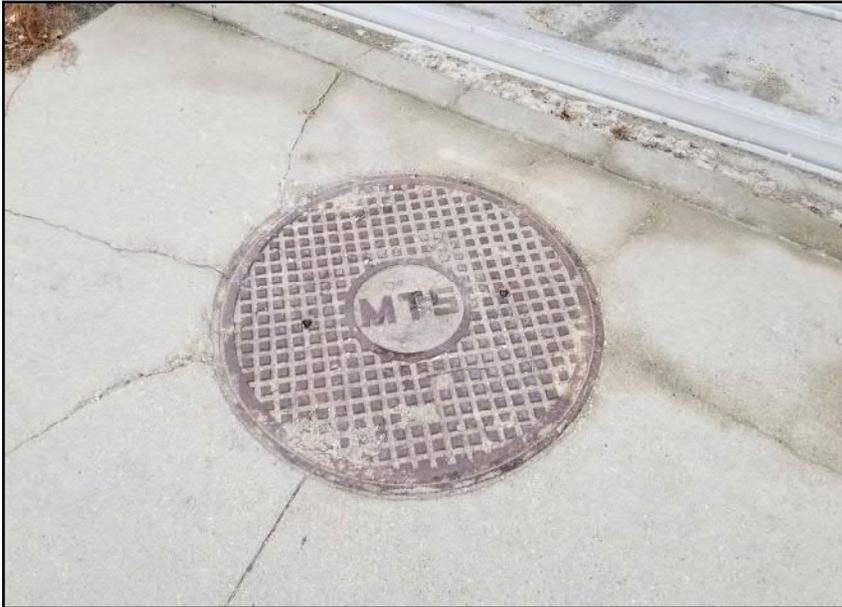
**Site 7 - Western Bank** Cracks around MTS manhole located in paved bridge sidewalk near abutment

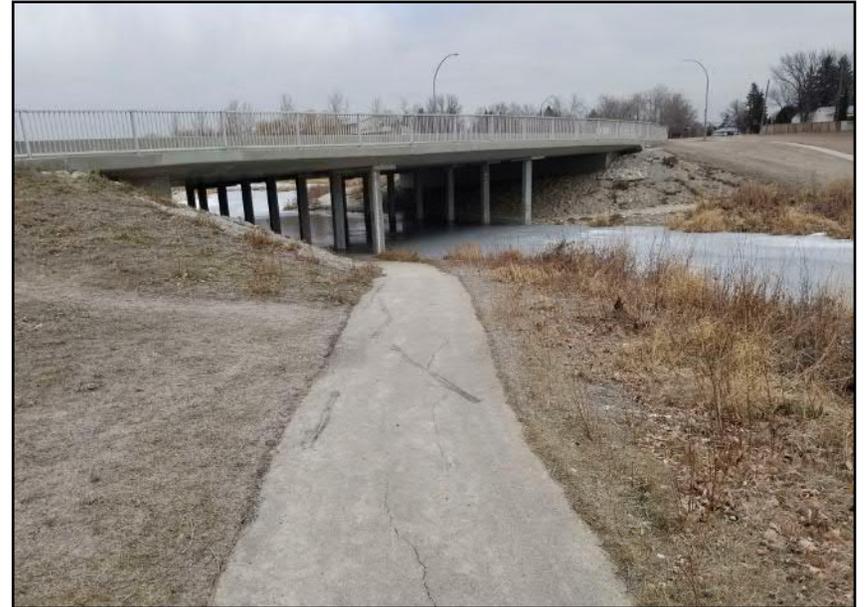
**Site 7 - Western Bank** Steeper slope around bridge abutment and minor cracking along pedestrian pathway (facing NE)

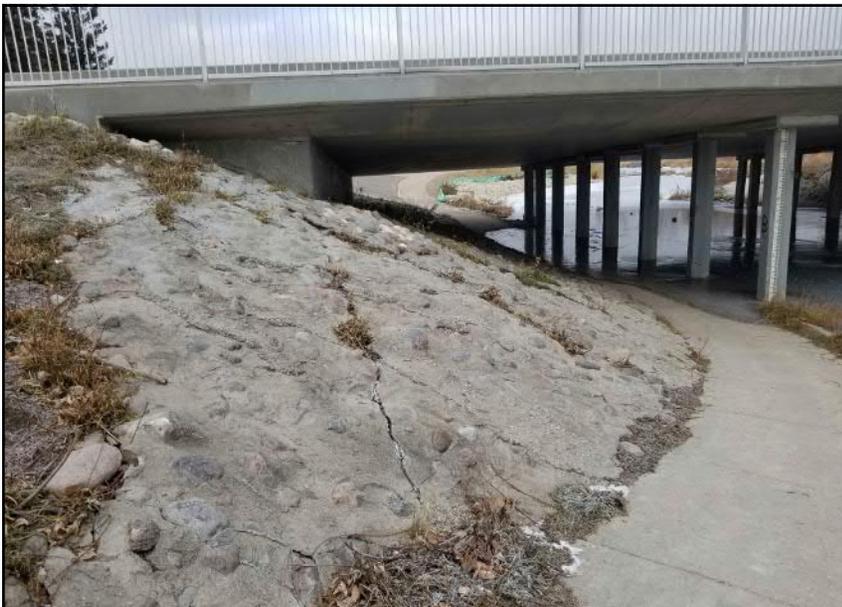
**Site 7 - Western Bank** Grouted rip-rap armorment along steeper banks in close proximity to bridge abutment (facing N)

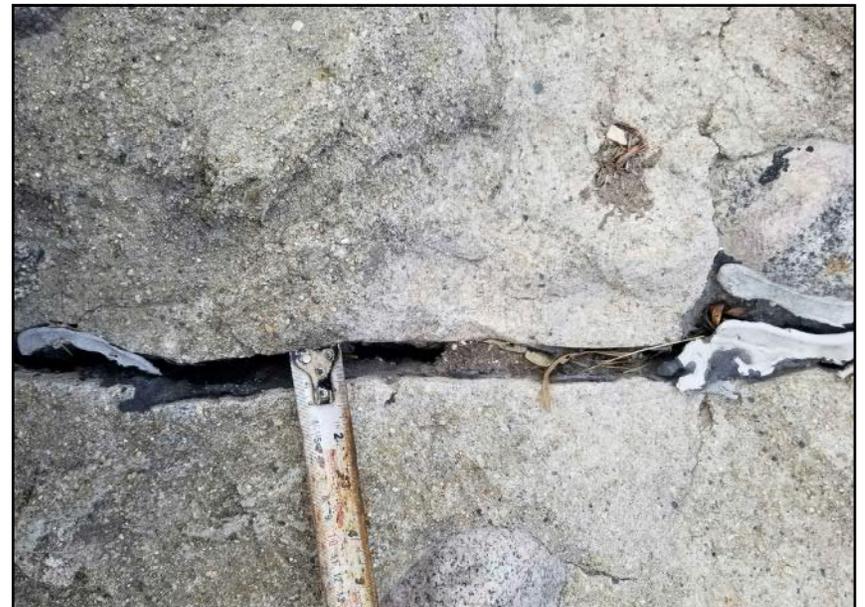
**Site 7 - Western Bank** Cracks observed within grouted rip-rap armorment at various orientations

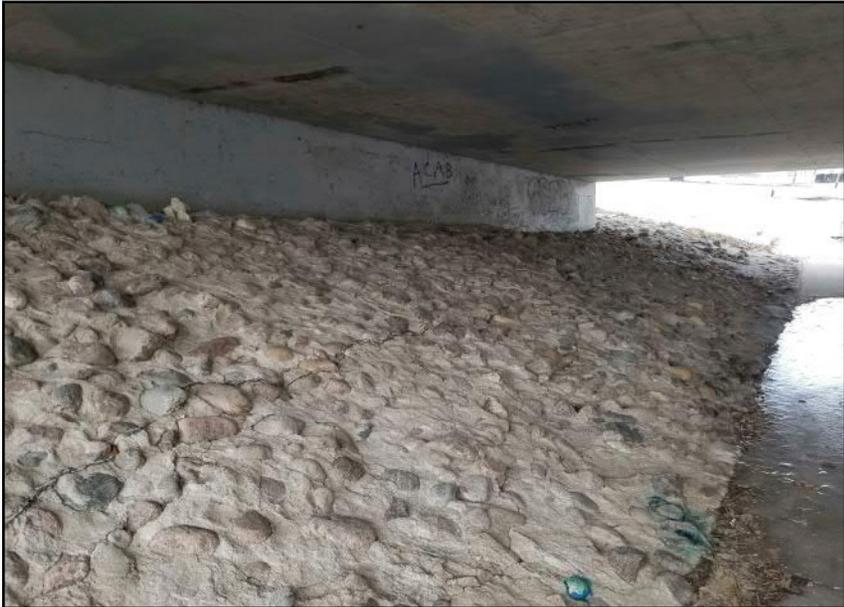
**Site 7 - Western Bank** Grouted rip-rap along abutment head slope below bridge structure (facing NW)

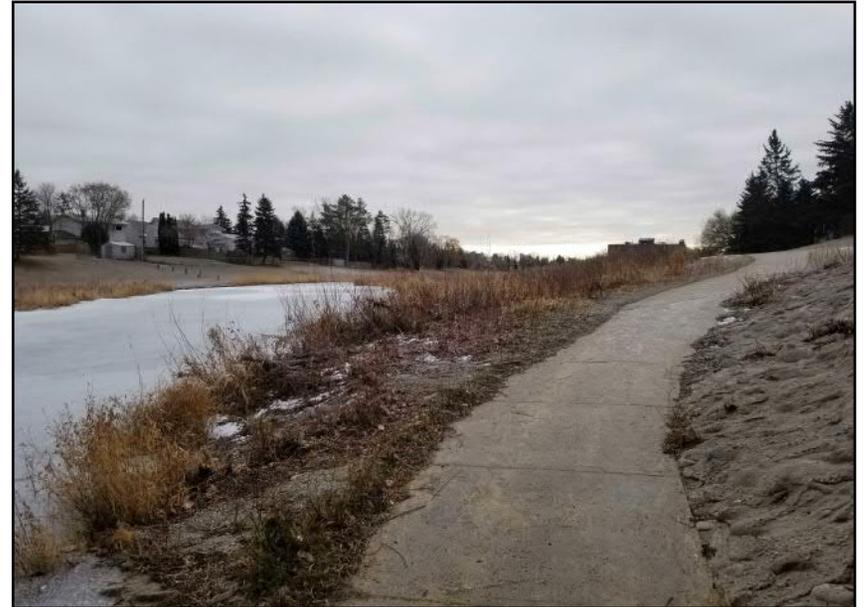
**Site 7 - Western Bank** Exposed grouted rip-rap and brush vegetation east of pathway near crossing alignment (facing S)

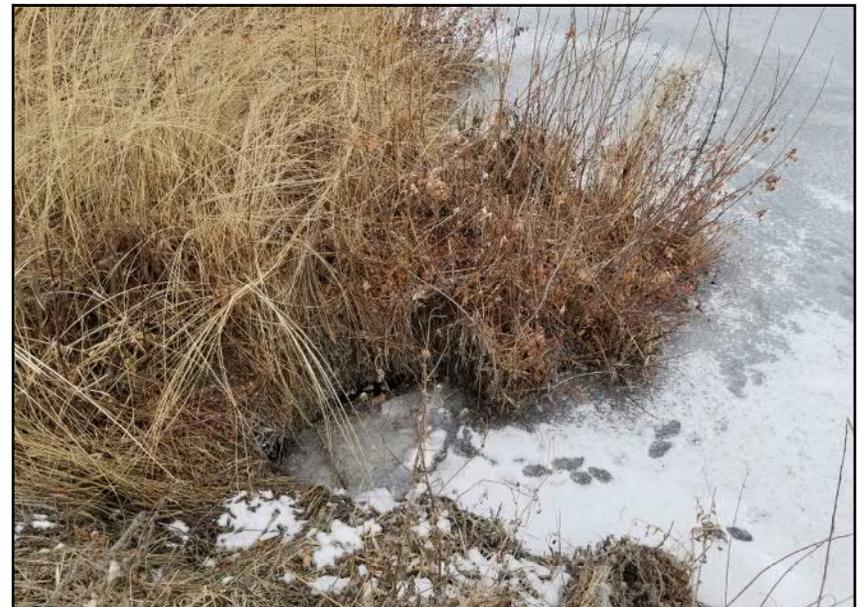
**Site 7 - Western Bank** Localized scarps and gully areas along exposed bank toe in southern portion of study area (facing N)

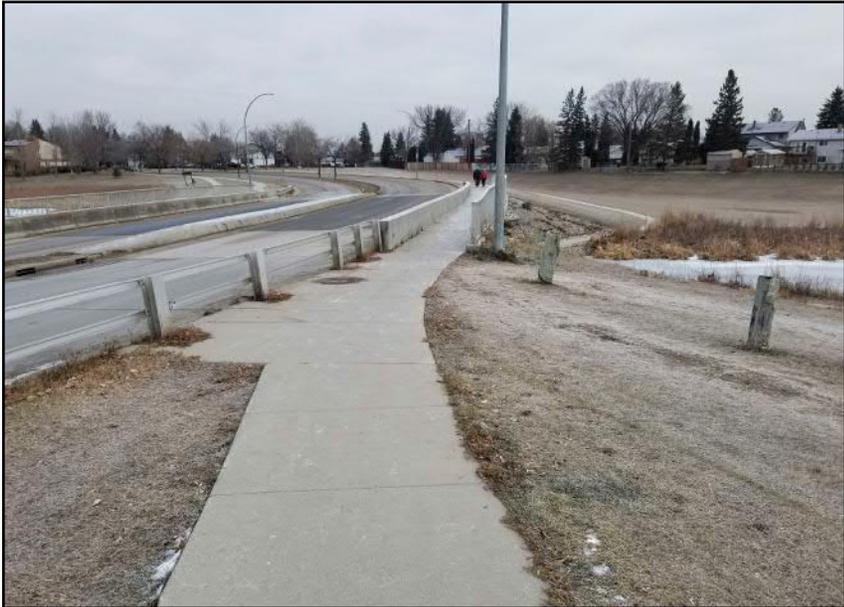
Ground sloping southeastward from the bridge structure, vertical light post (facing E)

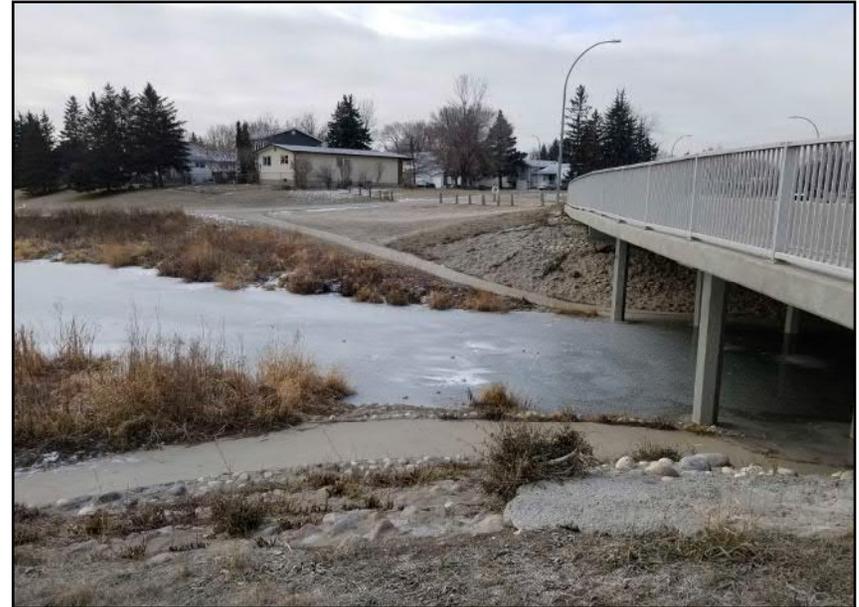
**Site 7 - Eastern Bank** | Steeper bank slopes close to bridge structure, under-bridge pedestrian pathway (facing W)

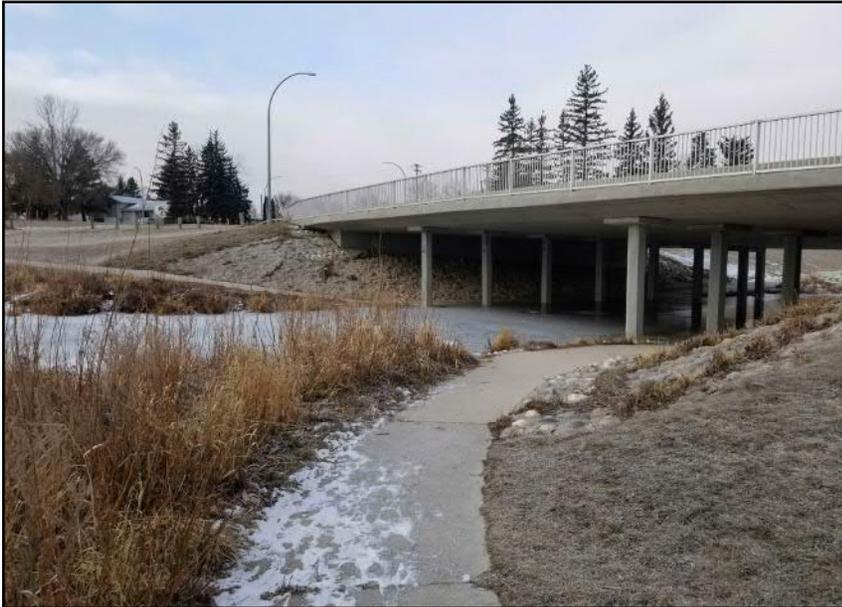
**Site 7 - Eastern Bank** Steeper slopes to the east of pedestrian pathway, gradual slope to the west of it (facing NW)

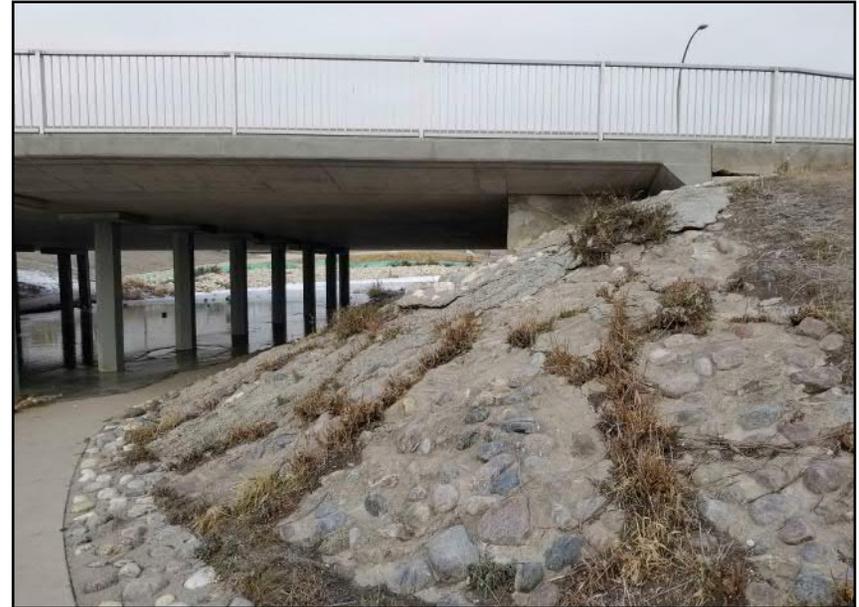
**Site 7 - Eastern Bank** Grouted rip-rap armouring along steeper banks in close proximity to bridge abutment (facing N)

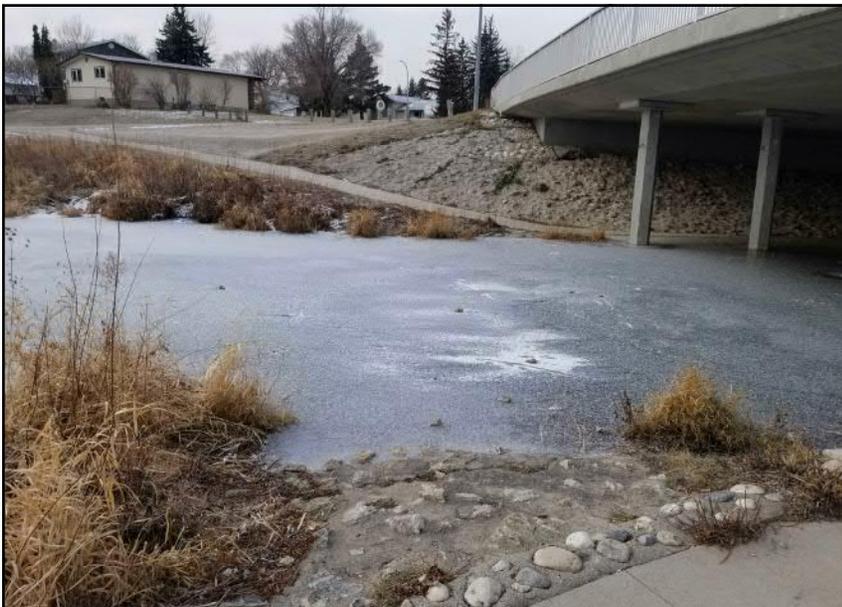
**Site 7 - Eastern Bank** Exposed grouted rip-rap and brush vegetation west of pathway near crossing alignment (facing W)

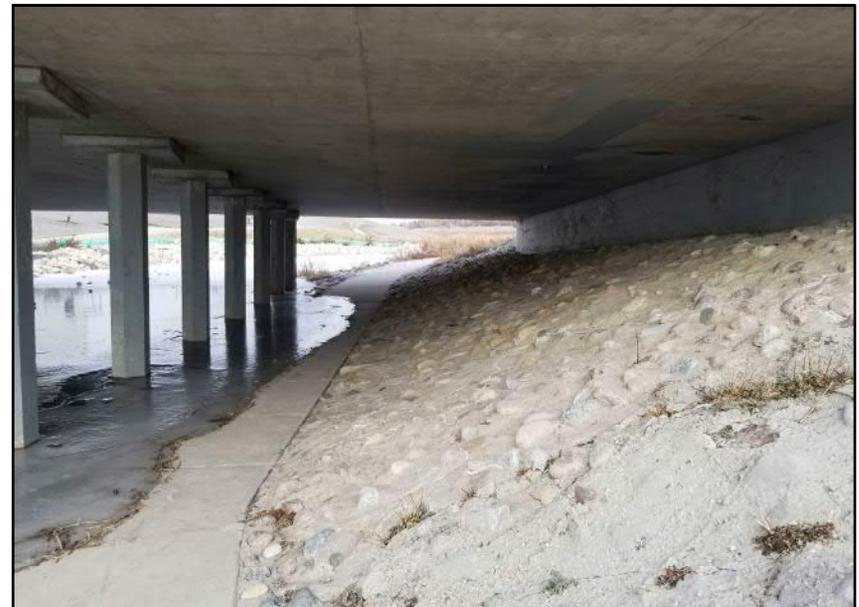
**Site 7 - Eastern Bank** Grouted rip-rap along abutment head slope below bridge structure (facing N)

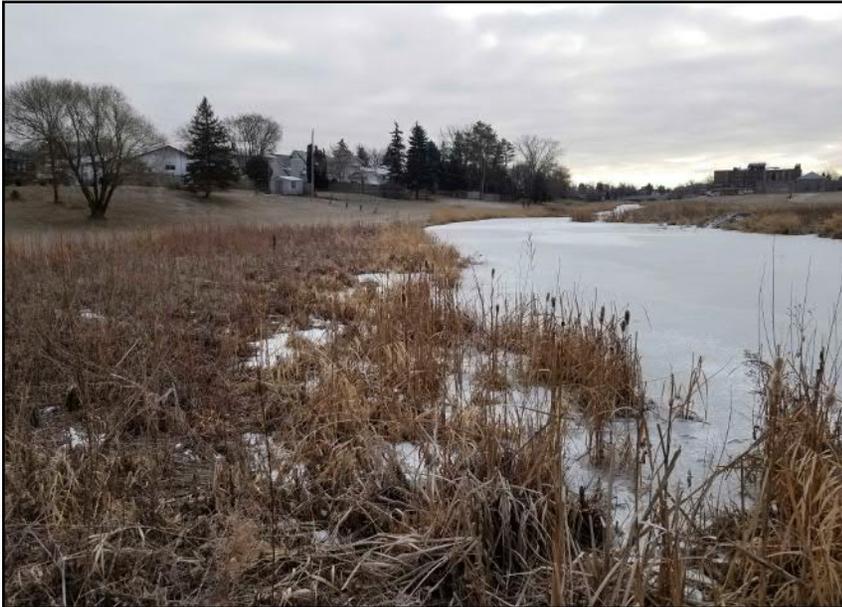
<b>Site 7 - Eastern Bank</b>	Bank toe within southern portion of study area, indicating higher than usual water level (facing S)
------------------------------	---

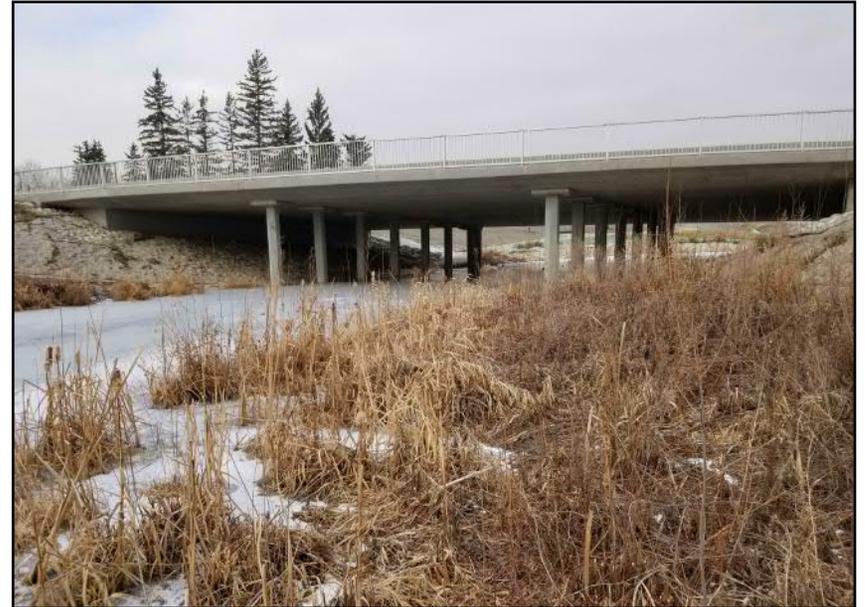
<b>Site 7 - Eastern Bank</b>	Bank toe within southern portion of study area, indicating higher than usual water level (facing NW)
------------------------------	--

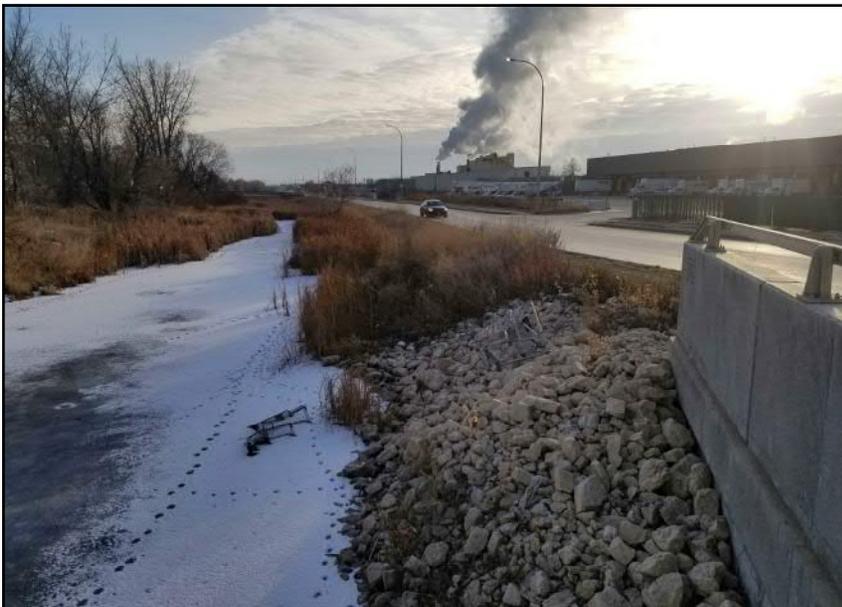
<b>Site 8 - Western Bank</b>	Regraded and rip-rap armored slope within crossing alignment (facing S)
------------------------------	---

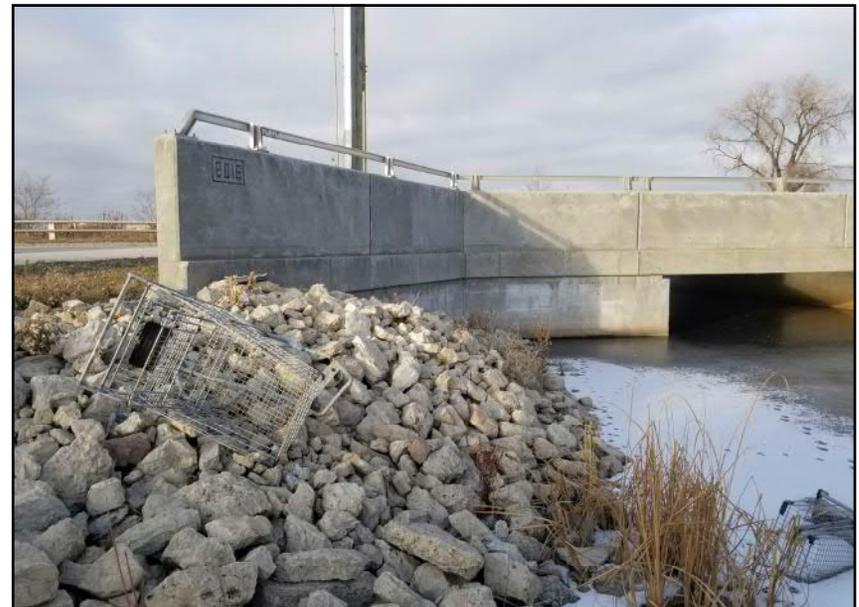
<b>Site 8 - Western Bank</b>	Regraded and rip-rap armored slope near bridge structure. Steeper slope near abutment (facing N)
------------------------------	--

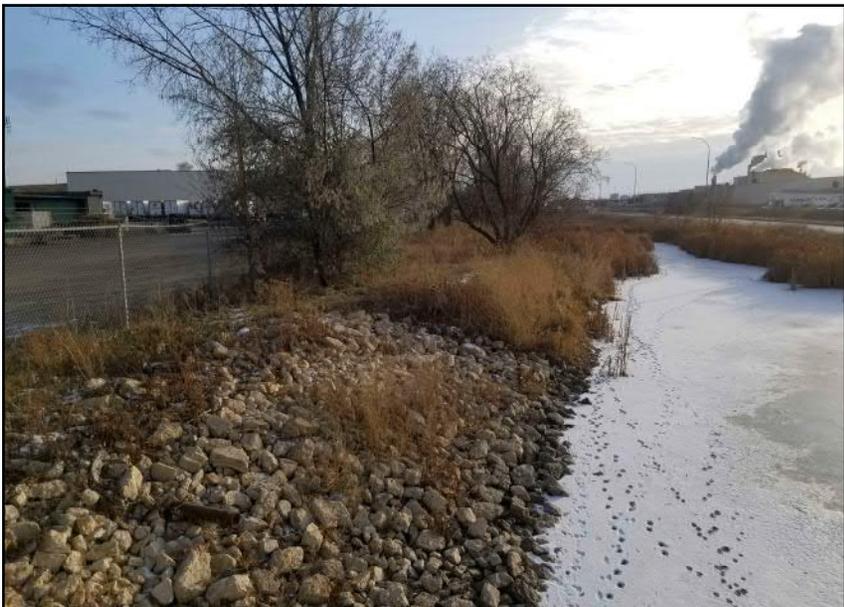
**Site 8 - Eastern Bank** | Regraded and rip-rap armored slope within crossing alignment (facing S)

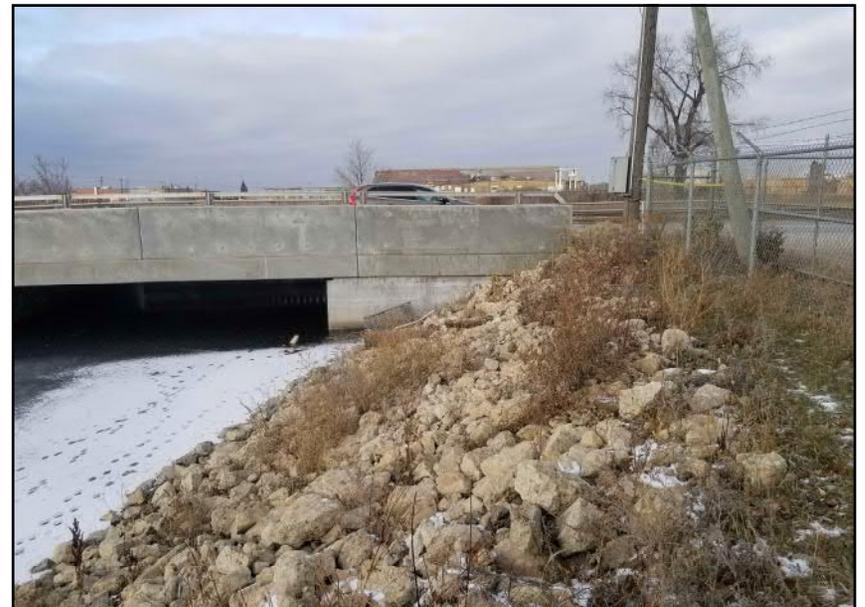
**Site 8 - Eastern Bank** | Regraded and rip-rap armored slope near bridge structure (facing N)

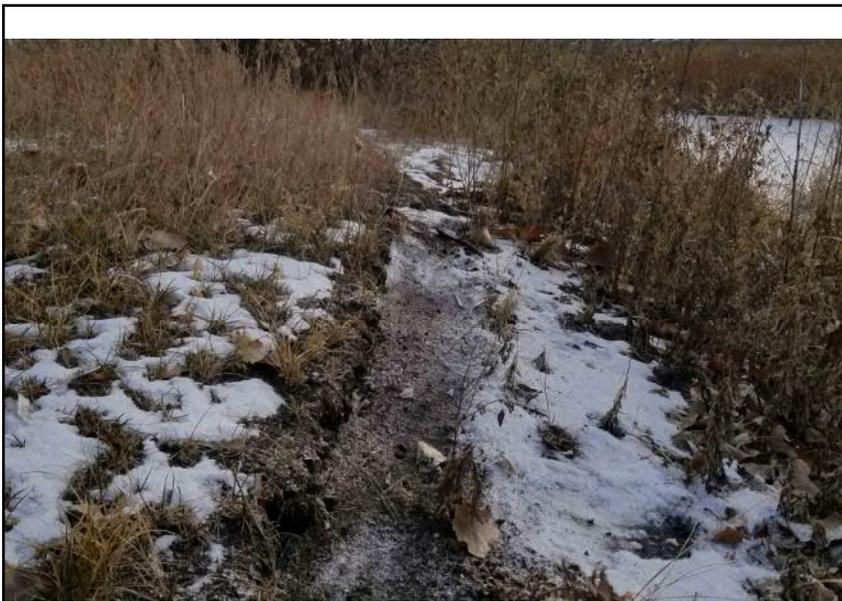
<b>Site 8 - Eastern Bank</b>	Scarp ridge observed near bank crest at oversteepened bank south of rip-rap area (facing S)
------------------------------	---

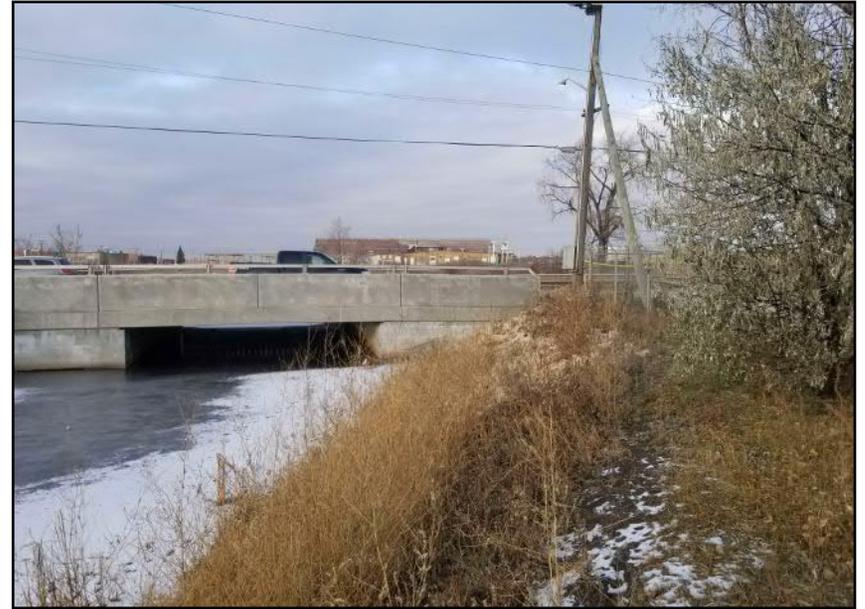
<b>Site 8 - Eastern Bank</b>	Observed bank slope change due to regrading near start of rip-rap area (facing N)
------------------------------	---

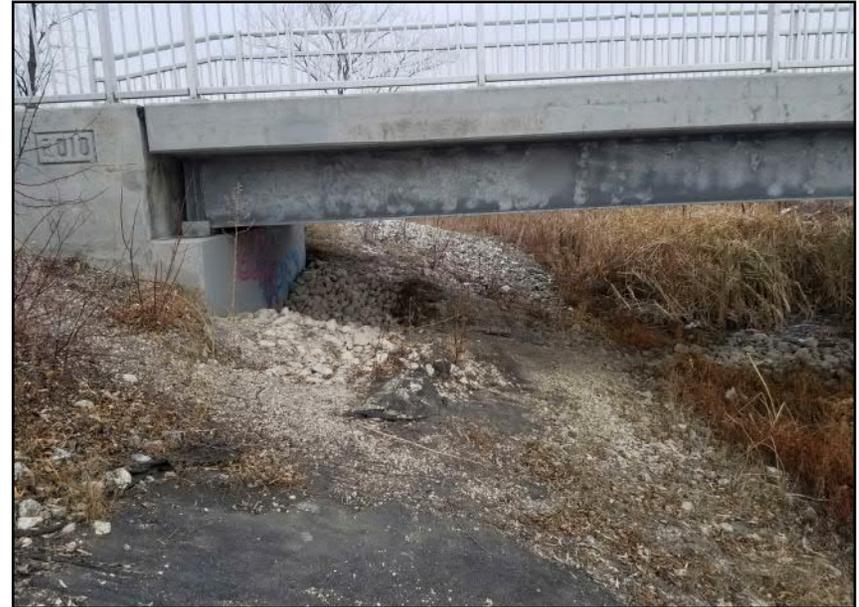
<b>Site 9 - Western Bank</b>	Displaced rip-rap and exposed geotextile at bridge abutment north of the crossing (facing NW)
------------------------------	---

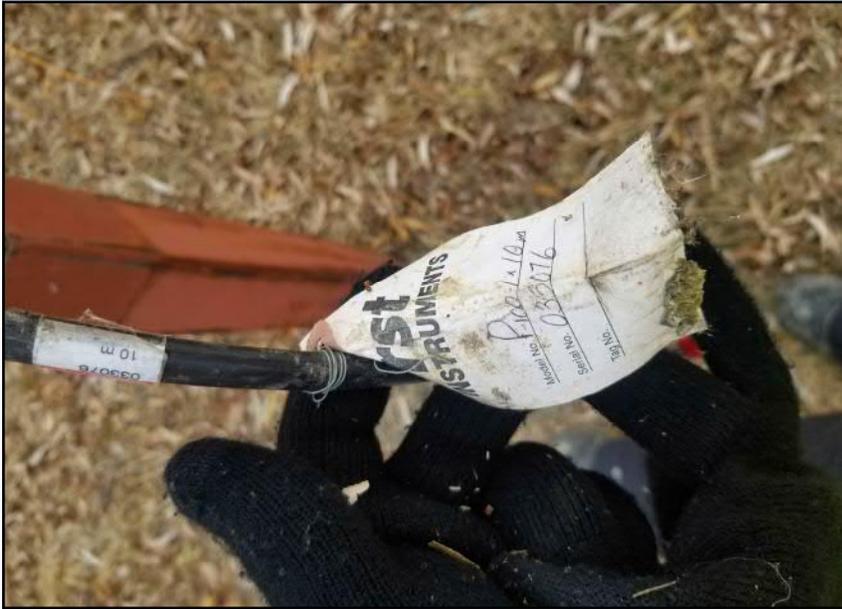
<b>Site 9 - Western Bank</b>	Groundwater well near west bridge abutment containing pneumatic piezometer
------------------------------	--

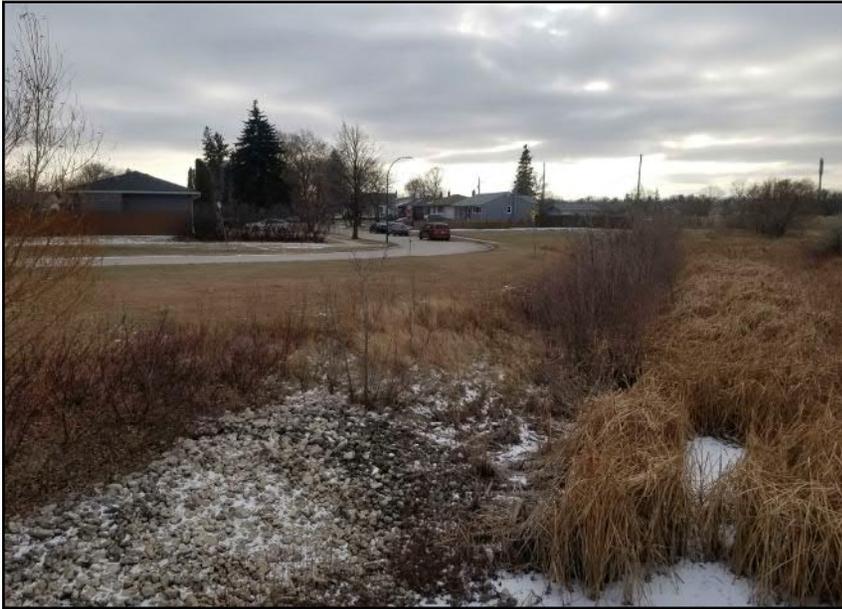
**Site 9 - Eastern Bank** | View of eastern riverbank from pedestrian bridge north of study area (facing S)

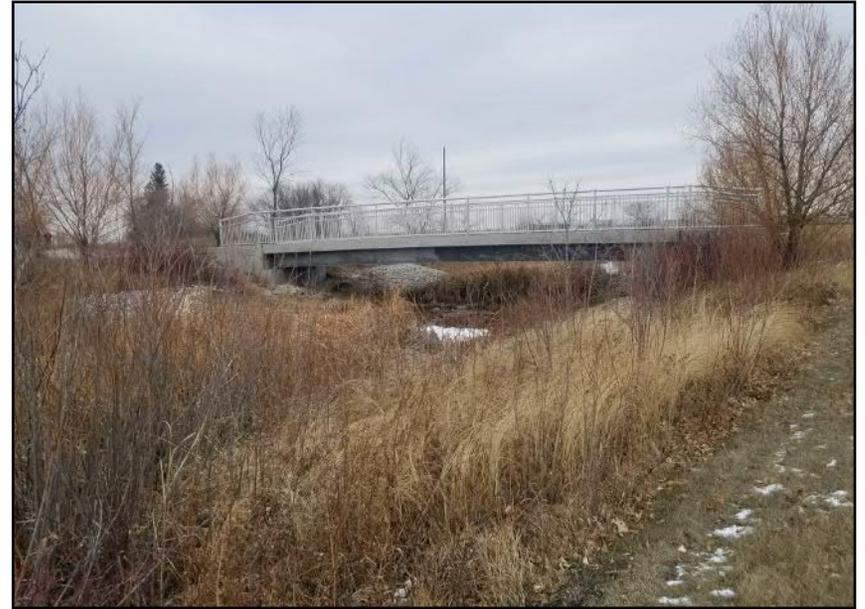
**Site 9 - Eastern Bank** | Gradual bank slopes densely vegetated with brush, shrubs, and trees (facing N)

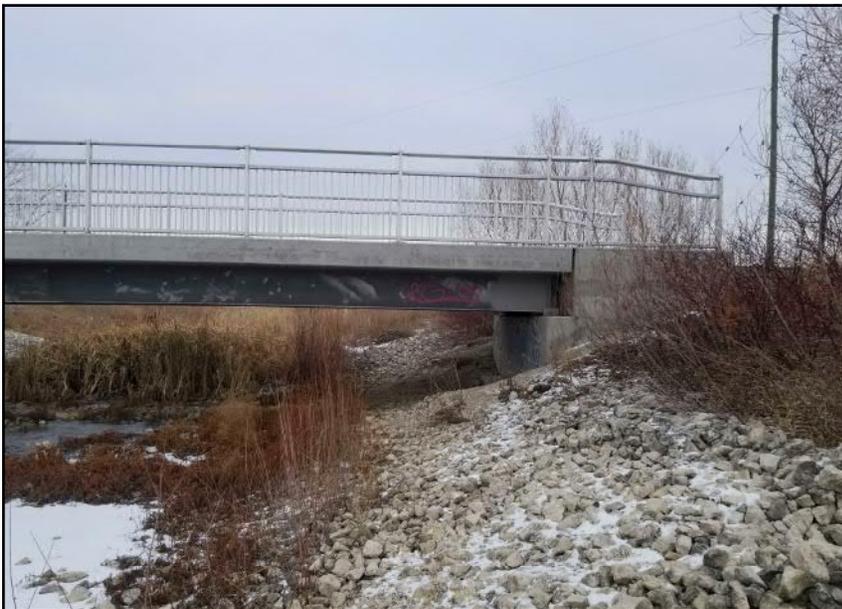
**Site 9 - Eastern Bank** | Rip-rap at bridge abutment north of the crossing (facing NE)

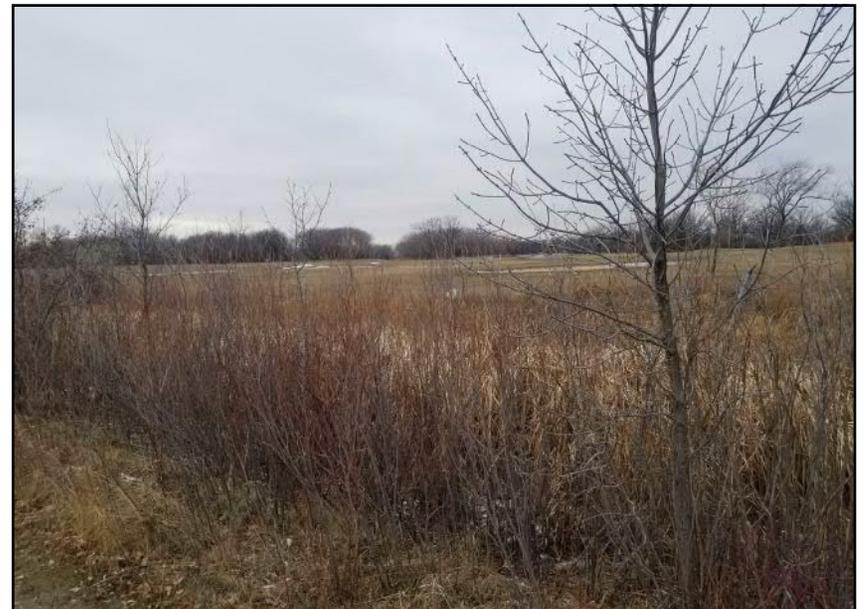
**Site 9 - Eastern Bank** | Dense vegetation along bank slopes near creek (facing W)

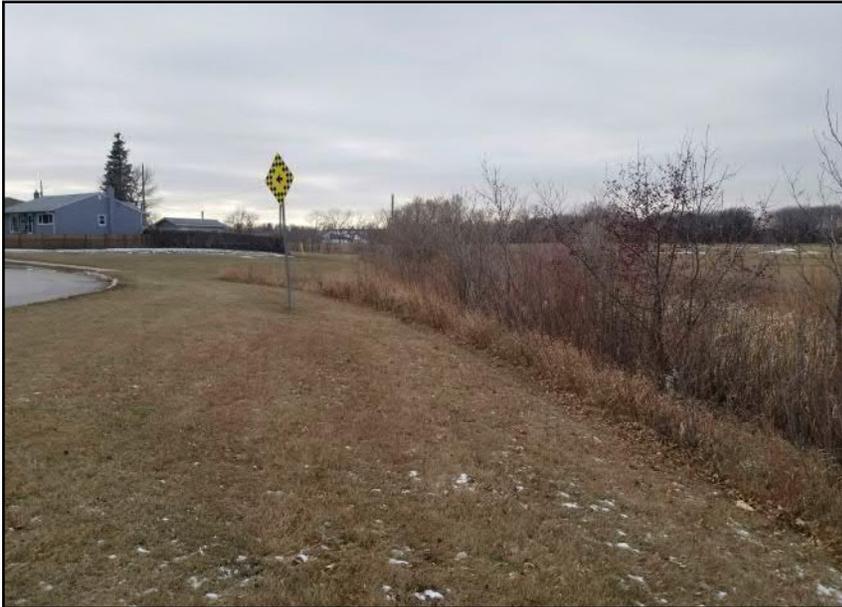
<b>Site 9 - Eastern Bank</b>	Flatter slopes and manicured grass along bank crest, traffic signage (facing SW)
------------------------------	--

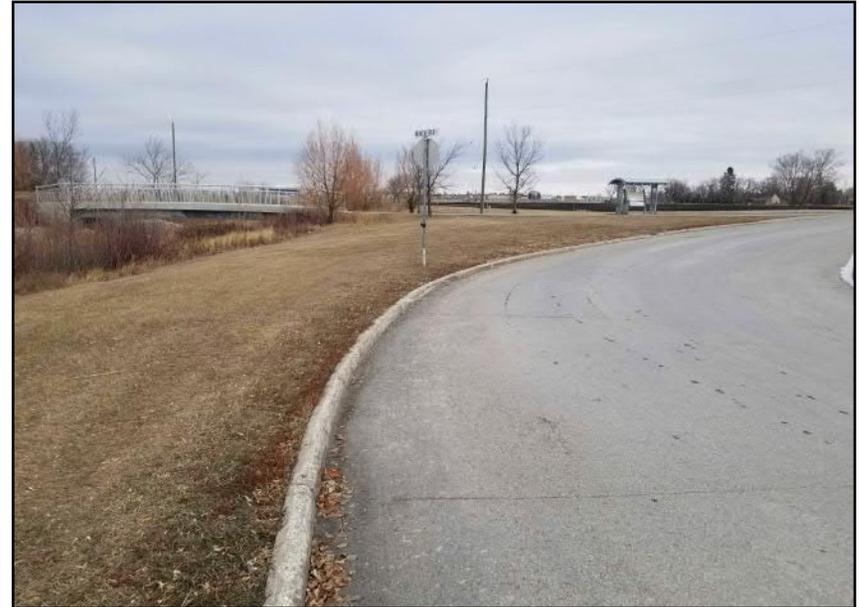
<b>Site 9 - Eastern Bank</b>	N-S portion of Silver Avenue, no significant cracks observed, generally flat bank crest (facing N)
------------------------------	--

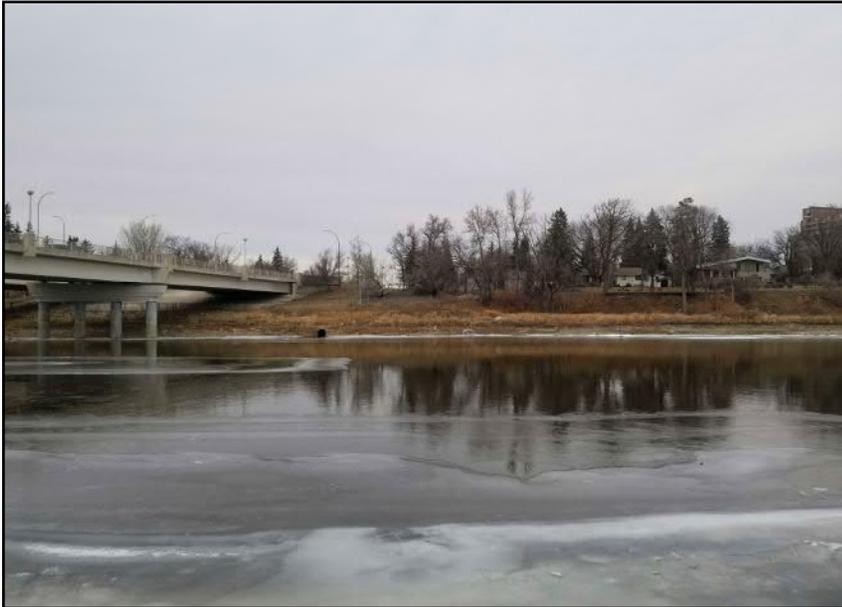
**Site 10 - Northern Riverbank** | View of northern bank from southern bank along approximate crossing alignment (facing N)

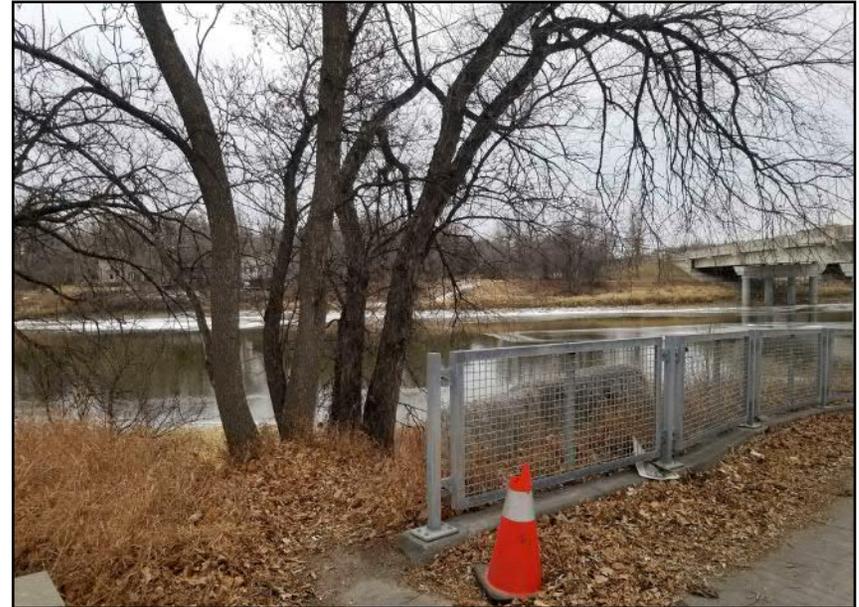
**Site 10 - Northern Riverbank** | Bank slope located near edge of pedestrian pathway within study area (facing S)

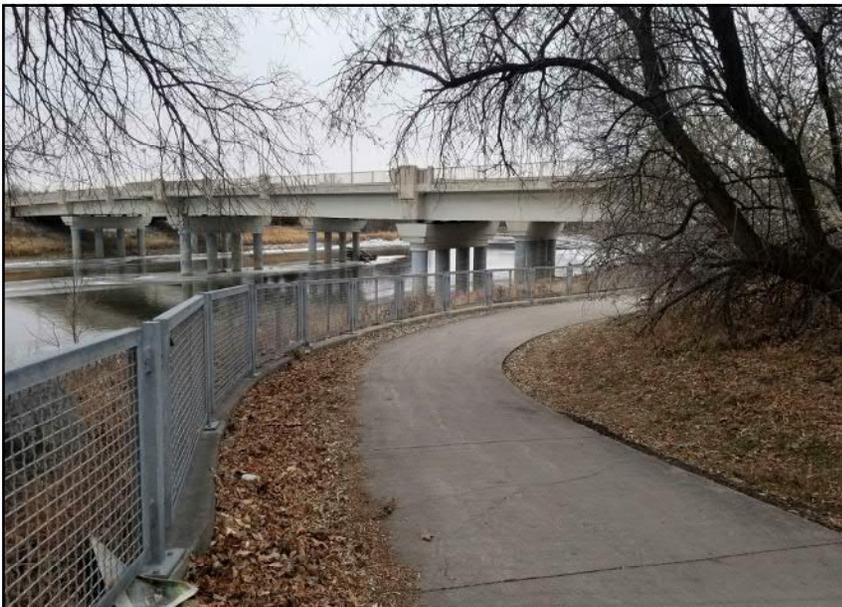
**Site 10 - Northern Riverbank** | Pedestrian pathway with minor cracking and railing along bank slope (facing SW)

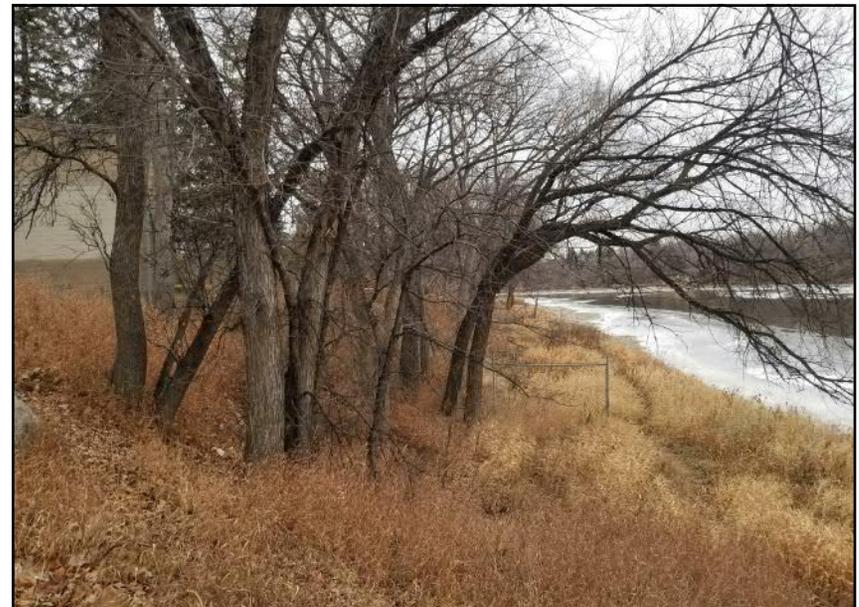
**Site 10 - Northern Riverbank** | Slope that flattens out closer to the river edge within southern portion of study area (facing E)

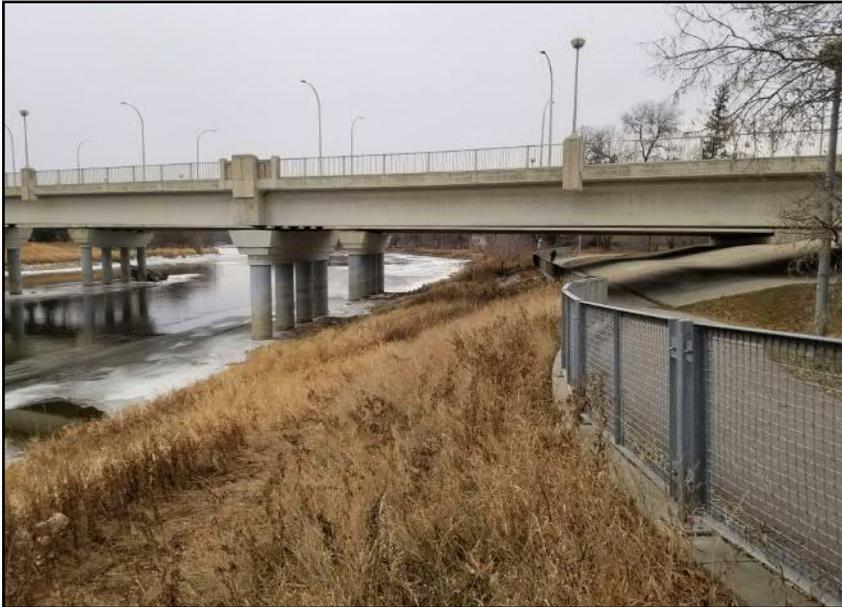
**Site 10 - Northern Riverbank** Slope from pathway down towards river edge within northern portion of study area (facing W)

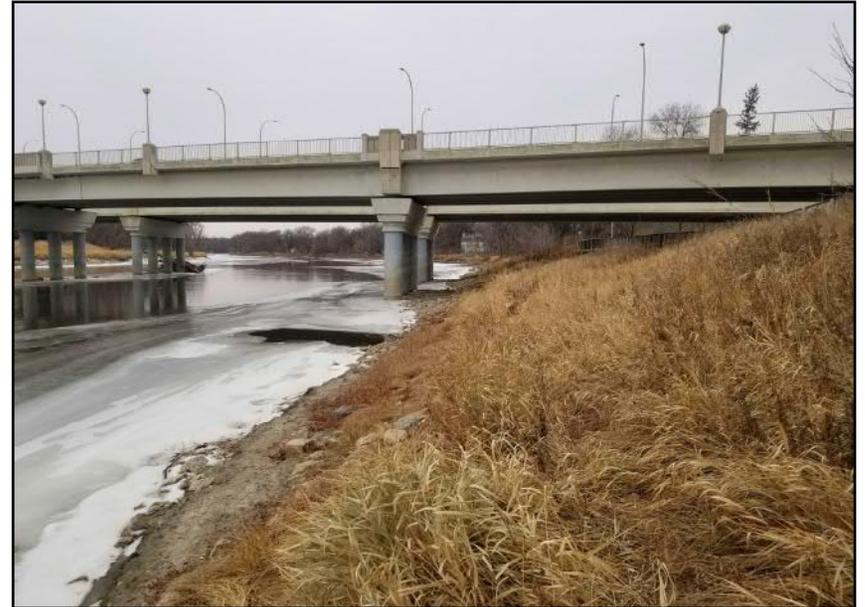
**Site 10 - Northern Riverbank** Lower bank slope within northern portion of study area (facing W)
