# Replacement of the FGSV Siphon

Geotechnical Baseline Report  
FINAL

City of Winnipeg

May 2025

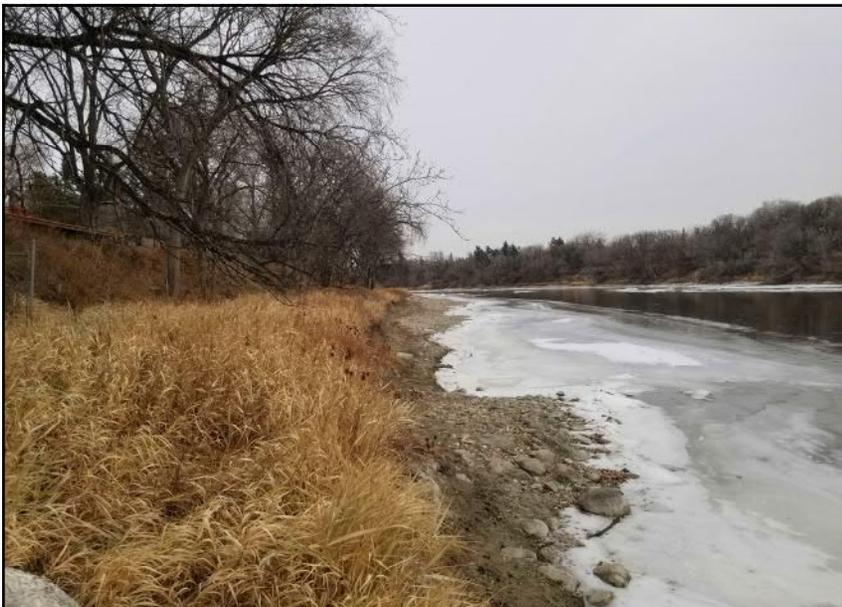
**Site 10 - Northern Riverbank** Lower bank slope within southern portion of study area (facing E)

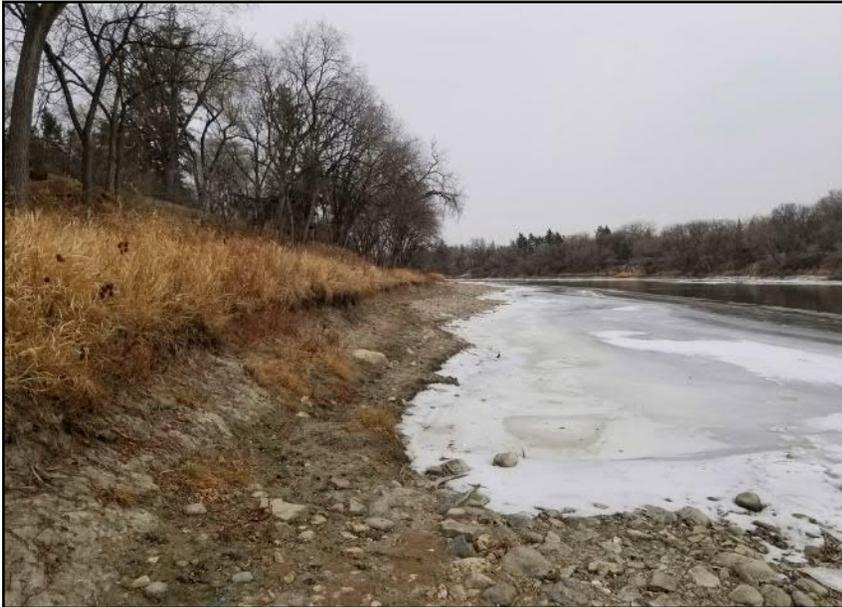
<b>Site 10 - Northern Riverbank</b>	Scarp near river edge observed along full length of bank toe within study area (facing E)
-------------------------------------	---

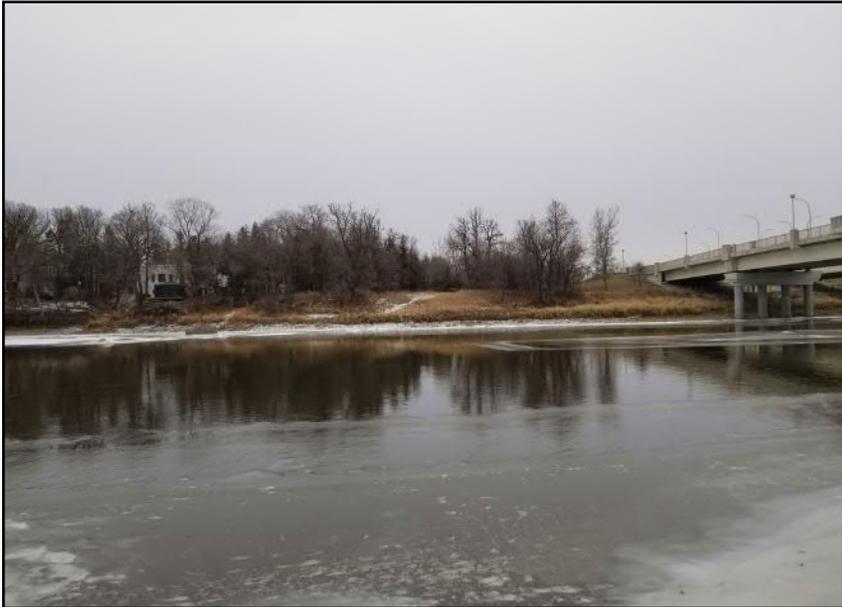
**Site 10 - Southern Riverbank** | View of southern bank from eastern bank along approximate crossing alignment (facing S)

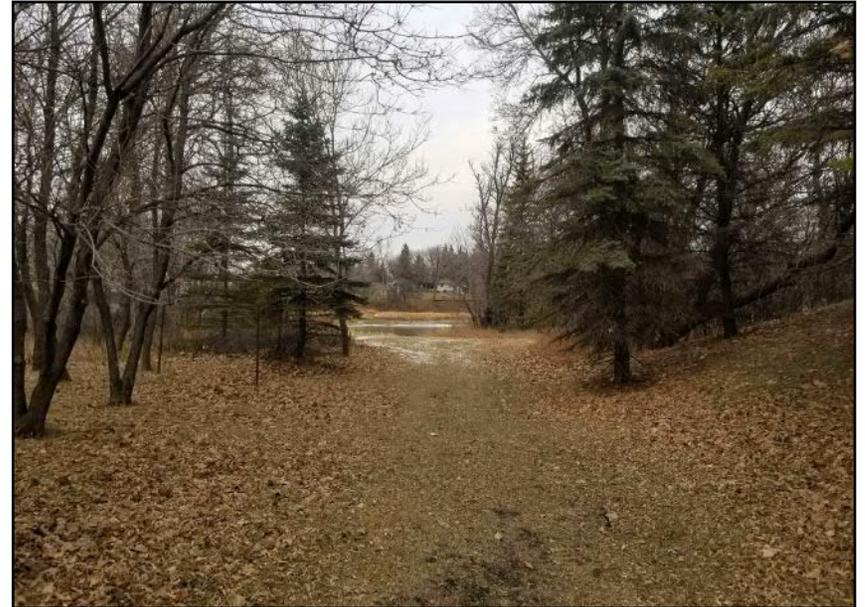
**Site 10 - Southern Riverbank** | Gradually sloped bank crest and clearing down towards river along pipe alignment (facing N)

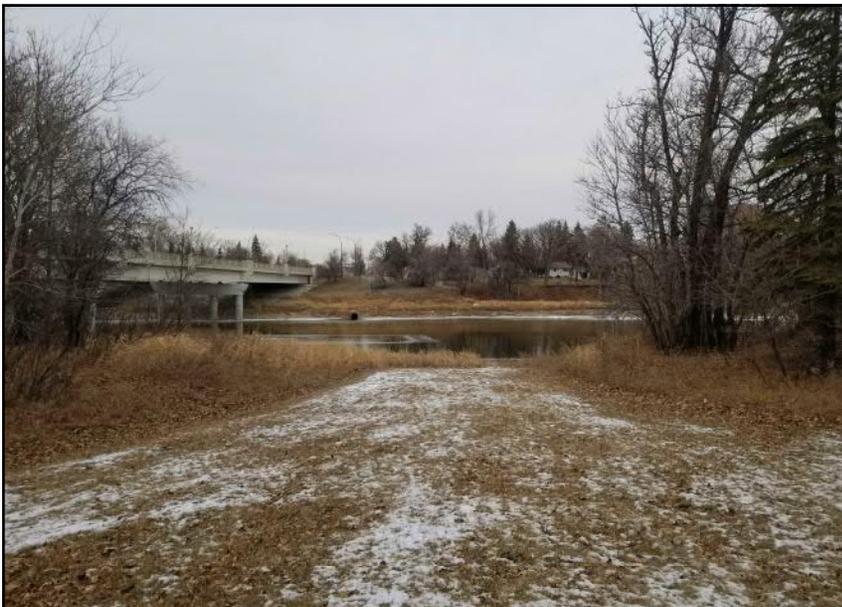
**Site 10 - Southern Riverbank** | Riverbank crest begins to slope more steeply closer to the river (facing N)

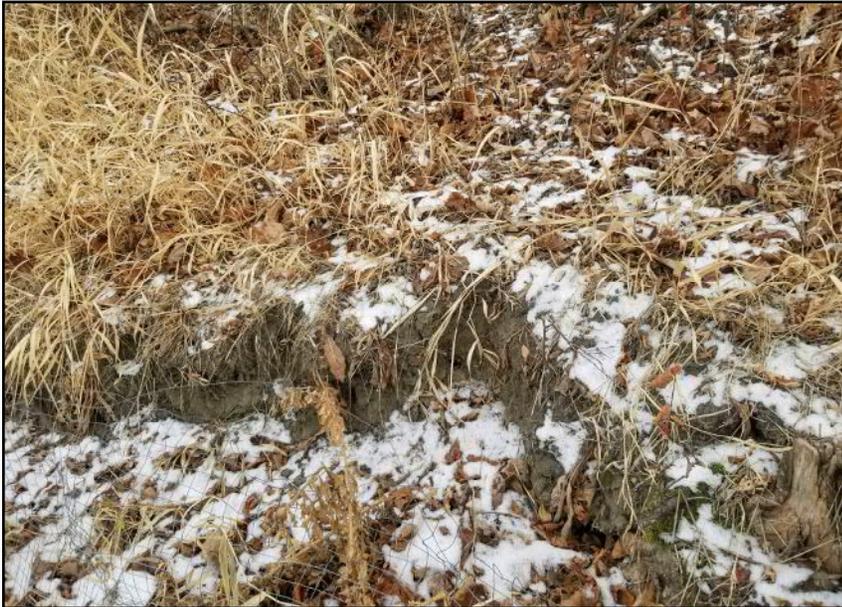
**Site 10 - Southern Riverbank** Scarp face observed along oversteepened slope within eastern portion of study area

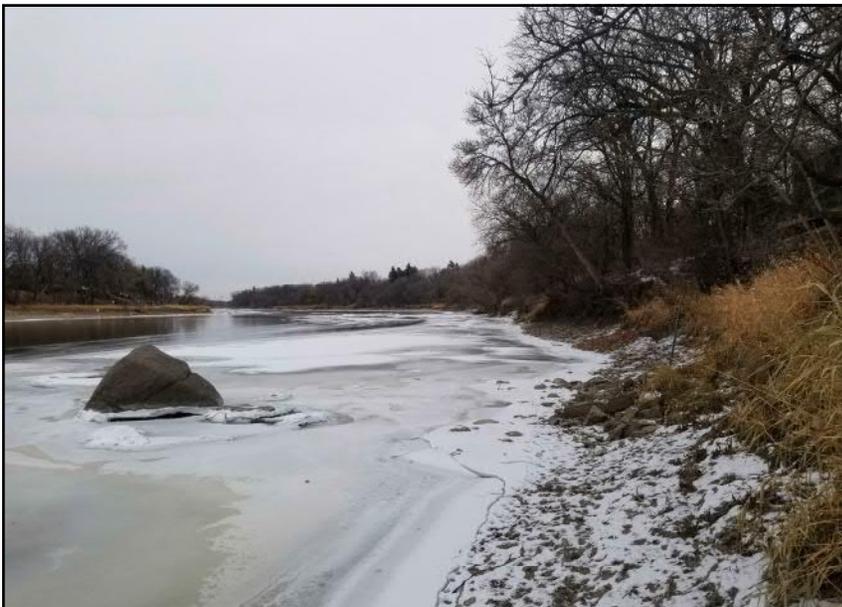
**Site 10 - Southern Riverbank** Scarp near river edge observed within southern portion of study area (facing E)

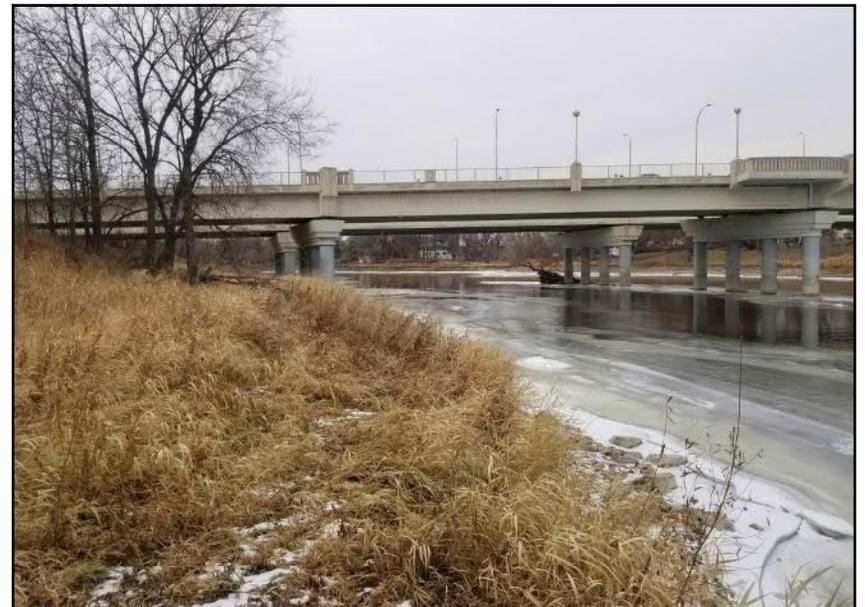
**Site 10 - Southern Riverbank** Gradually sloping bank crest within western portion of study area (facing W)

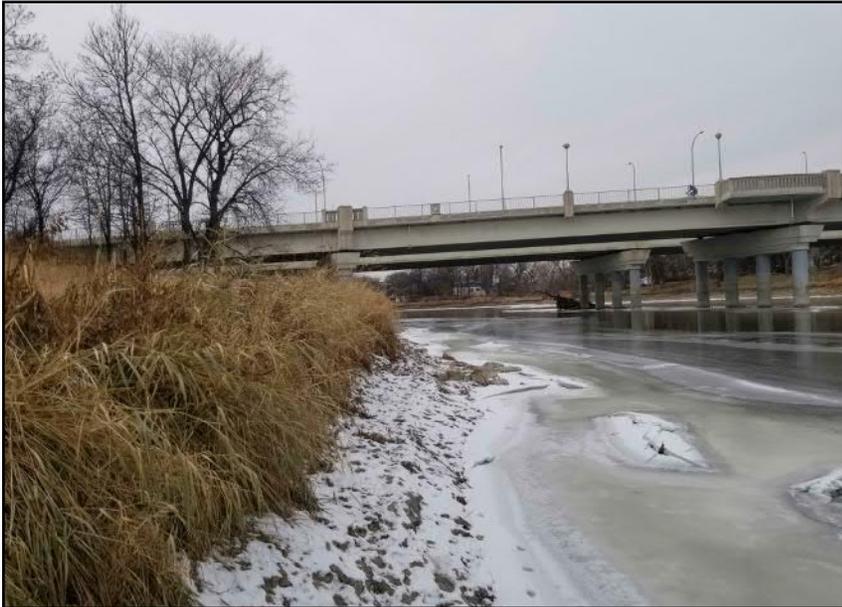
**Site 10 - Southern Riverbank** Scarp near river edge observed within eastern portion of study area (facing W)

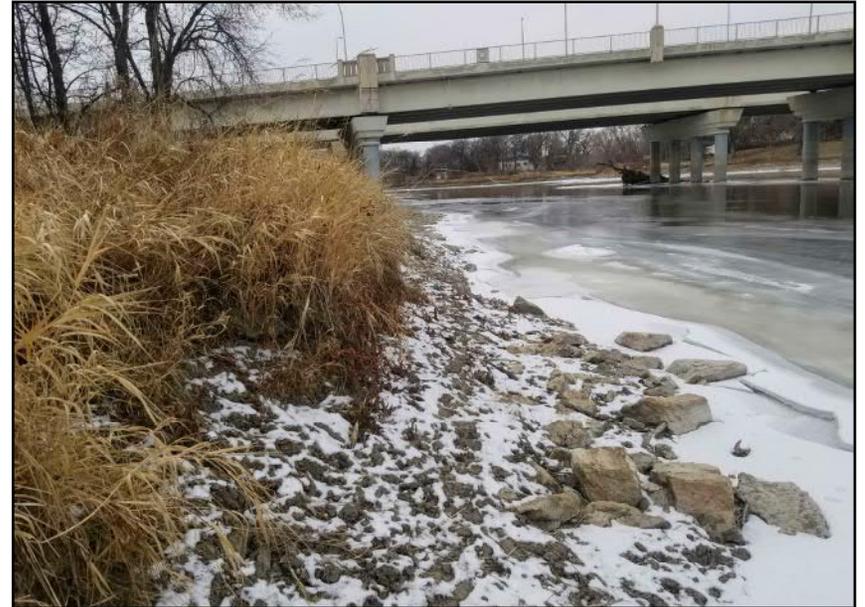
**Site 10 - Southern Riverbank** Local rip-rap observed along the bank toe near the crossing alignment (facing W)

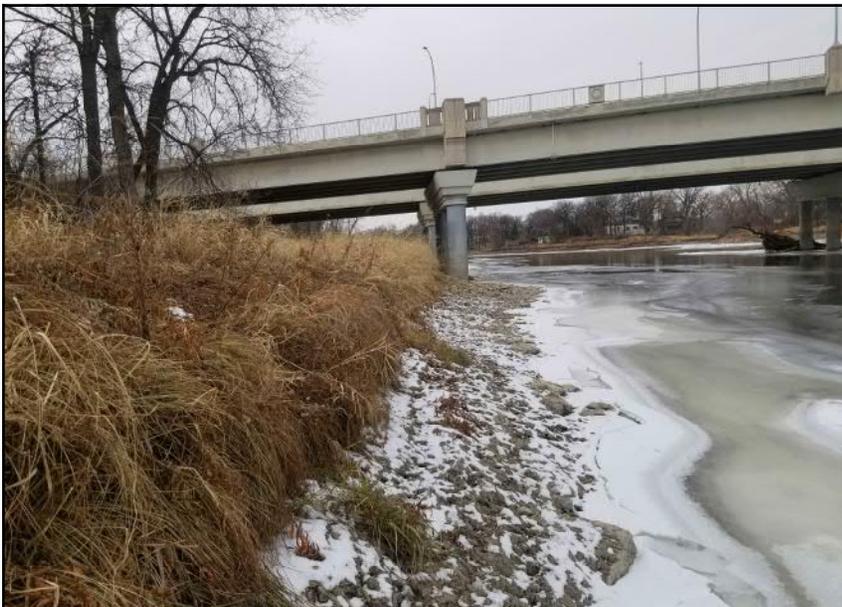
**Site 10 - Southern Riverbank** Scarp near river edge observed within western portion of study area (facing W)

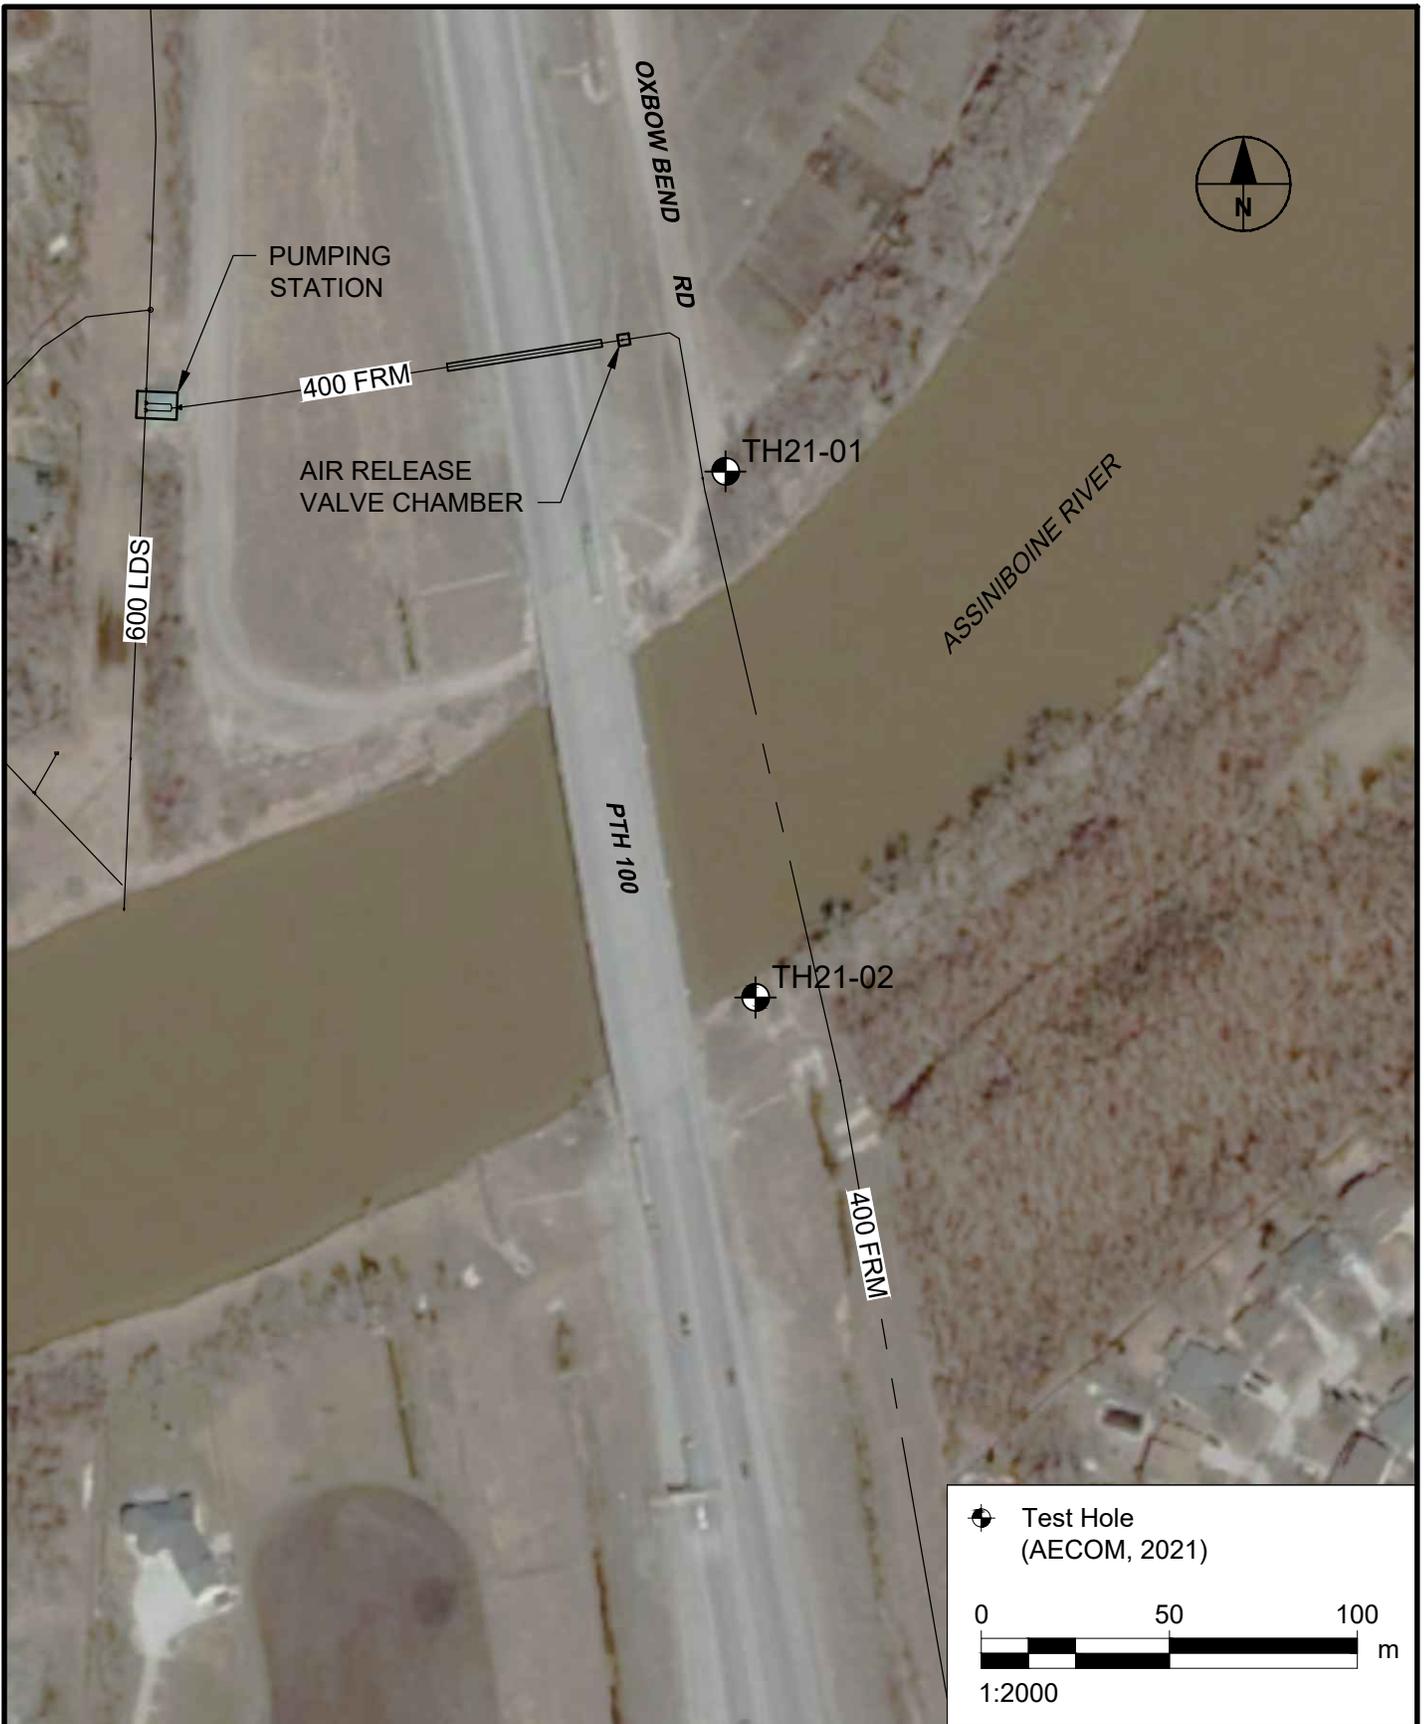
## **AECOM 2021 Geotechnical Investigation: Test Hole Location Plans**

Test Hole  
 (AECOM, 2021)

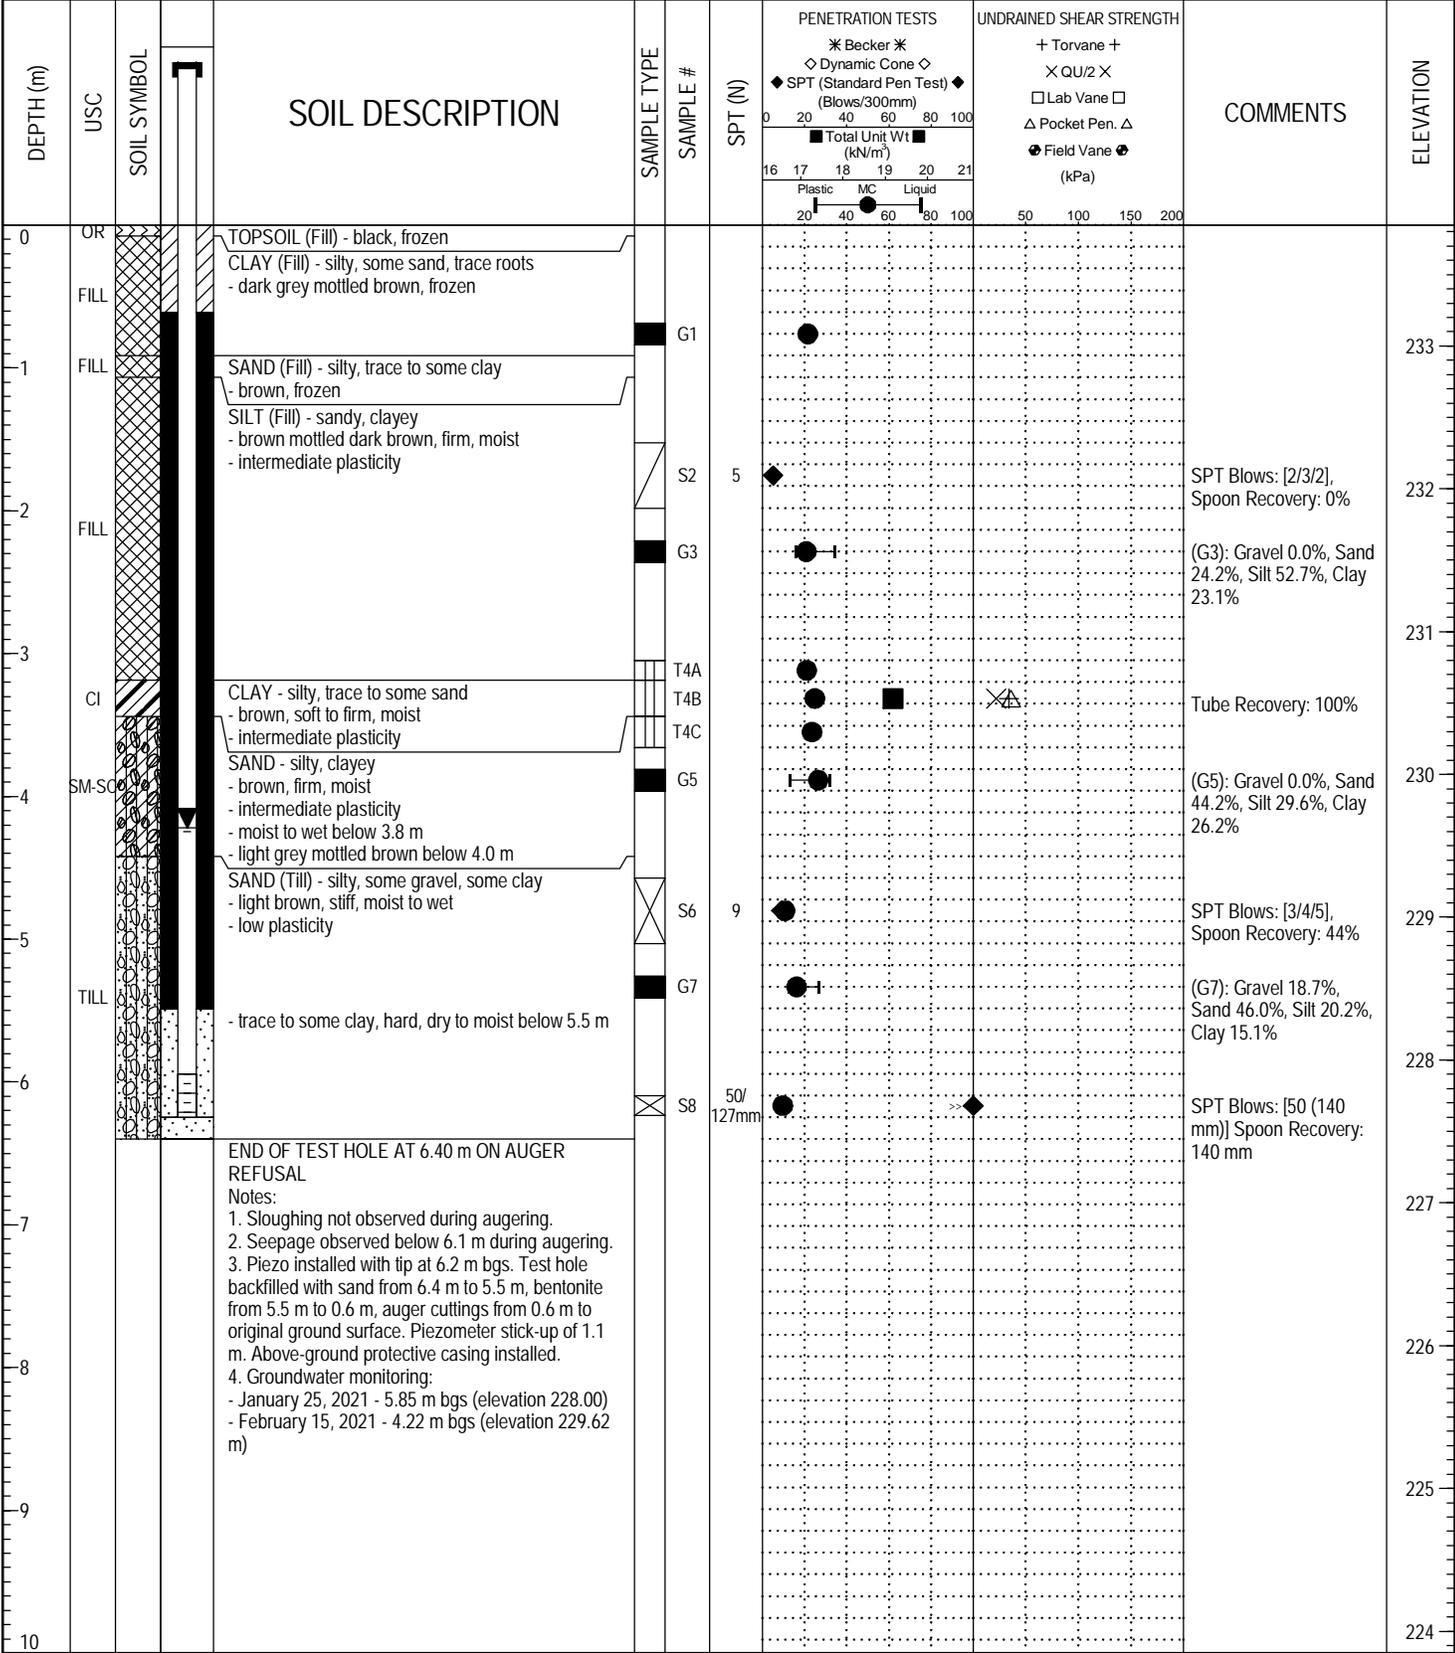
PROJECT: High Risk River Crossing Phase 3		CLIENT: City of Winnipeg		TESTHOLE NO: TH21-01		
LOCATION: Site 5 - North Bank (5525506 m N, 620343 m E)				PROJECT NO.: 60645745		
CONTRACTOR: Maple Leaf Drilling			METHOD: Track-Mounted - 125 mm SSA		ELEVATION (m): 233.85	
SAMPLE TYPE	GRAB	SHELBY TUBE	SPLIT SPOON	BULK	NO RECOVERY	CORE
BACKFILL TYPE	BENTONITE	GRAVEL	SLOUGH	GROUT	CUTTINGS	SAND

LOGGED BY: Ryan Harras	COMPLETION DEPTH: 6.40 m
REVIEWED BY: Elliott Drumright	COMPLETION DATE: 1/25/21
PROJECT ENGINEER: Marv McDonald	Page 1 of 1

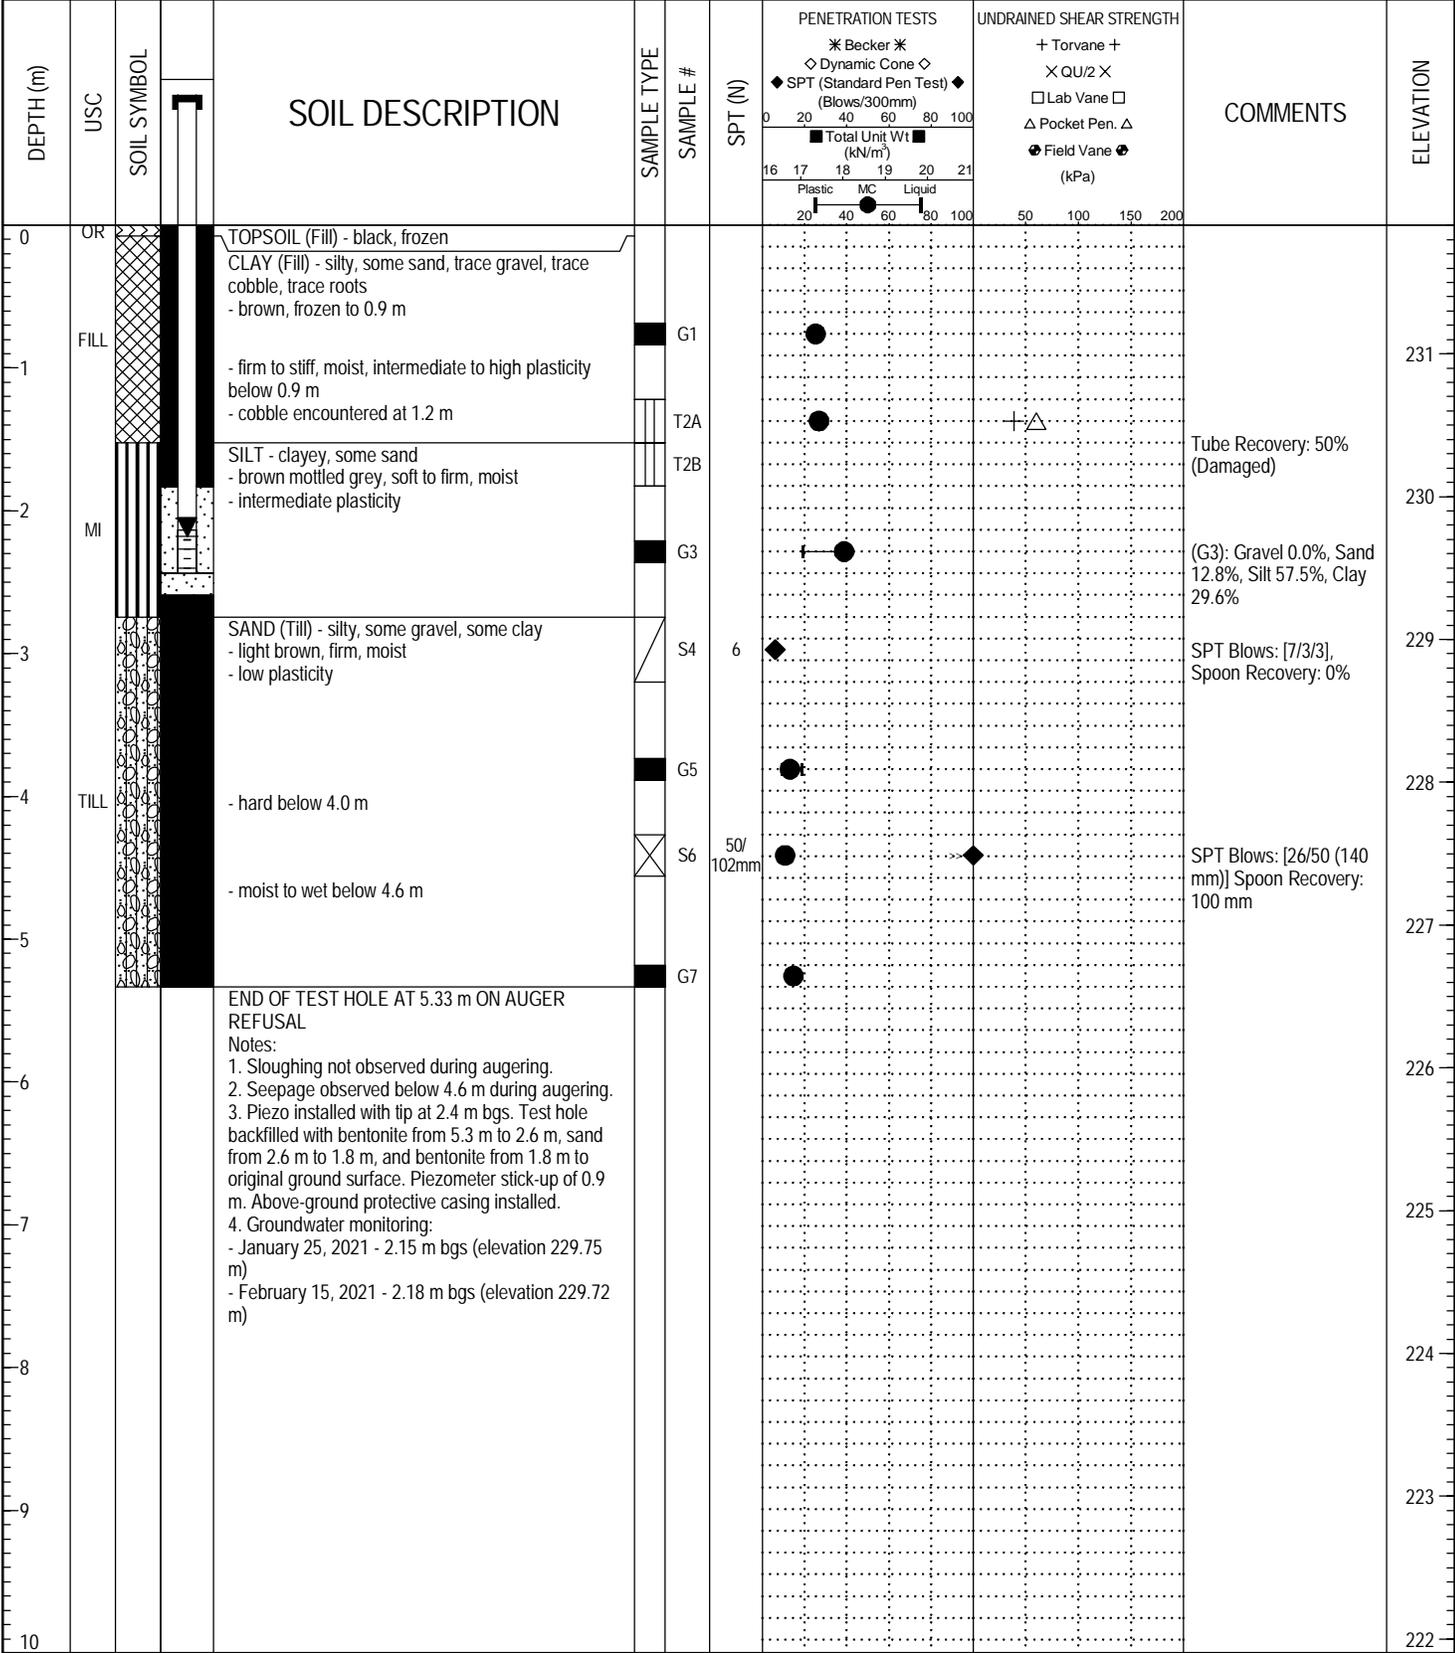
PROJECT: High Risk River Crossing Phase 3		CLIENT: City of Winnipeg		TESTHOLE NO: TH21-02		
LOCATION: Site 5 - South Bank (5525366 m N, 620351 m E)				PROJECT NO.: 60645745		
CONTRACTOR: Maple Leaf Drilling			METHOD: Track-Mounted - 125 mm SSA		ELEVATION (m): 231.90	
SAMPLE TYPE	GRAB	SHELBY TUBE	SPLIT SPOON	BULK	NO RECOVERY	CORE
BACKFILL TYPE	BENTONITE	GRAVEL	SLOUGH	GROUT	CUTTINGS	SAND

LOGGED BY: Ryan Harras	COMPLETION DEPTH: 5.33 m
REVIEWED BY: Elliott Drumright	COMPLETION DATE: 1/25/21
PROJECT ENGINEER: Marv McDonald	Page 1 of 1

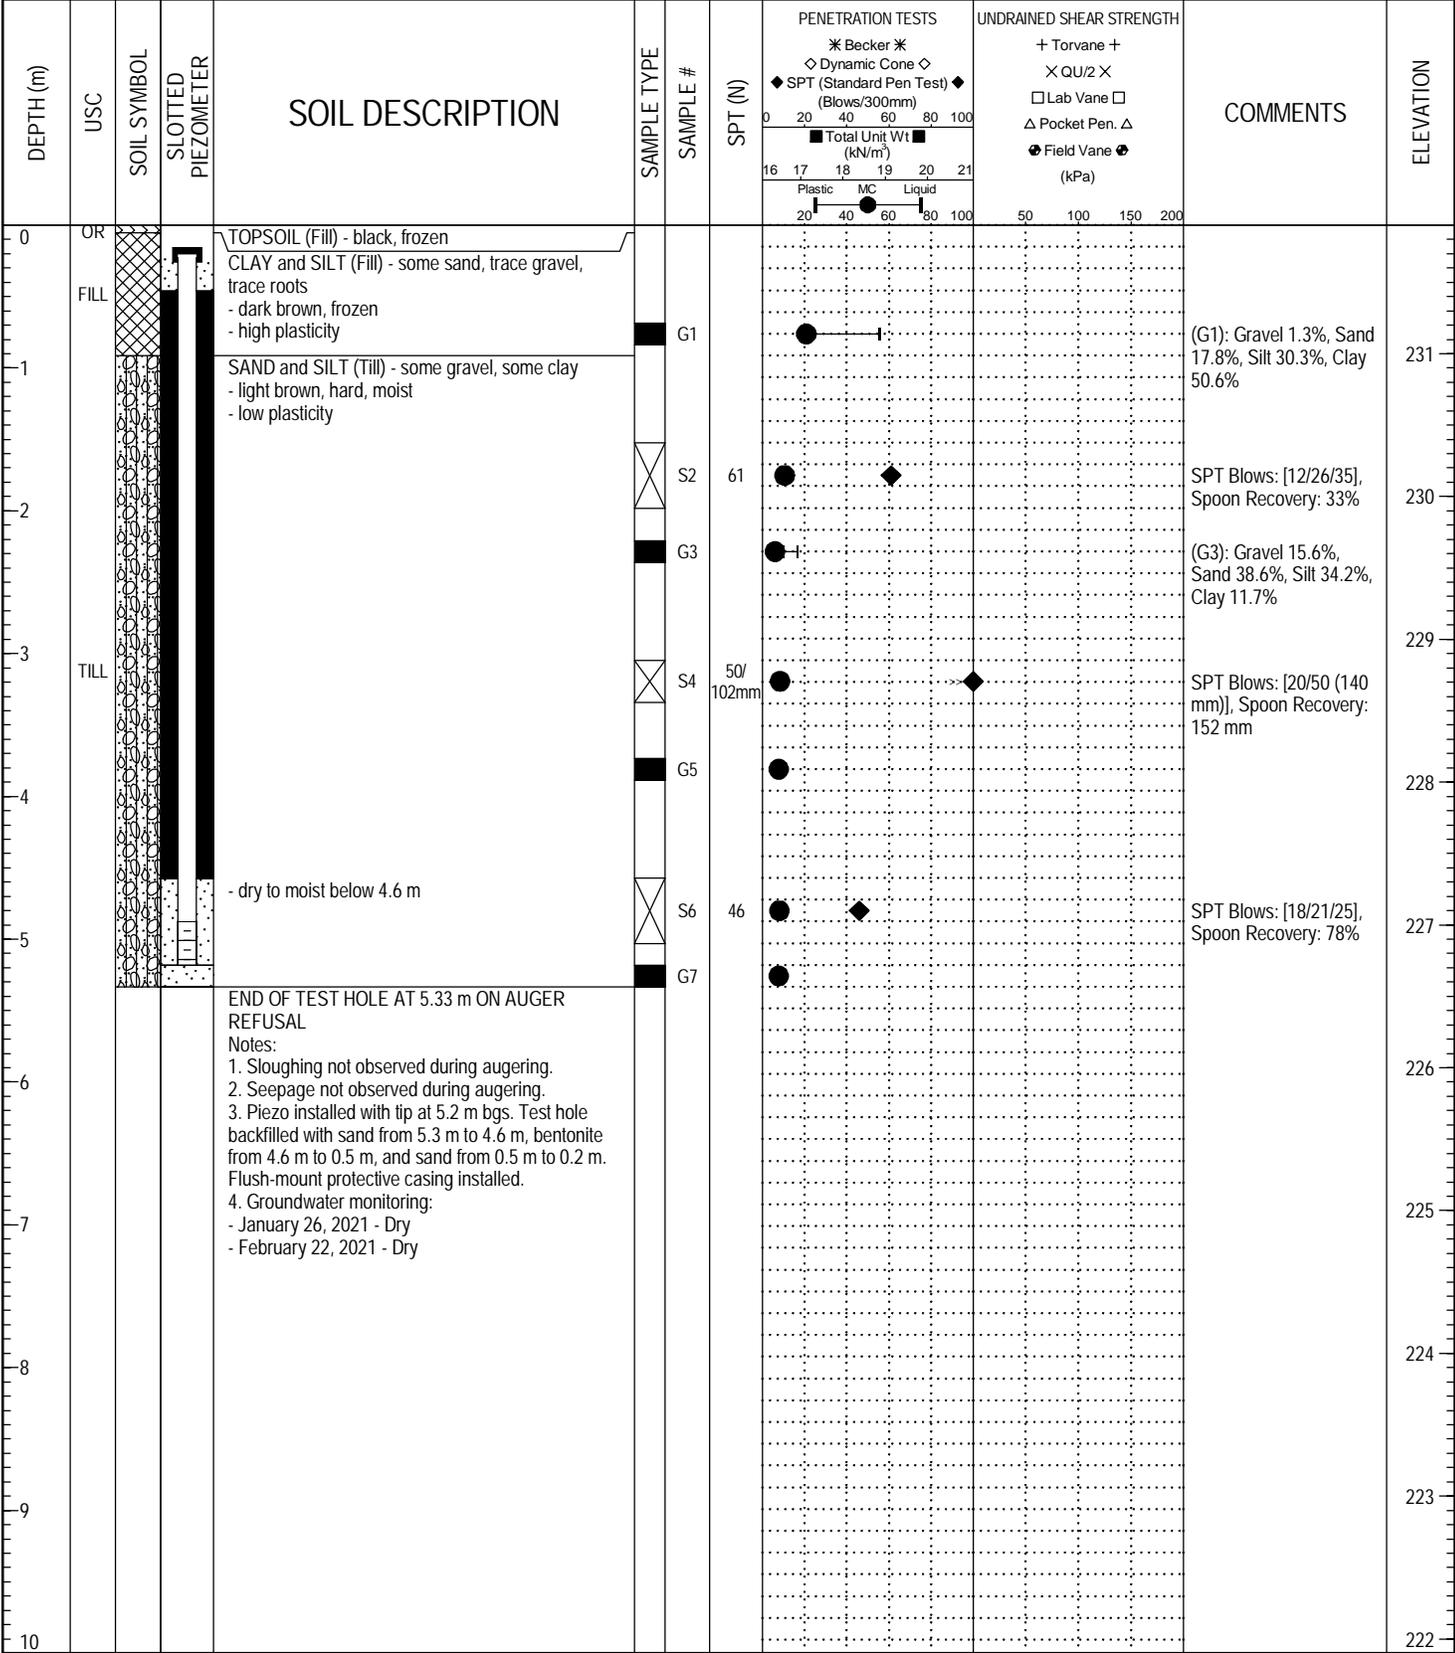
PROJECT: High Risk River Crossing Phase 3		CLIENT: City of Winnipeg		TESTHOLE NO: TH21-03		
LOCATION: Site 10 - North Bank (5525903 m N, 624809 m E)				PROJECT NO.: 60645745		
CONTRACTOR: Maple Leaf Drilling			METHOD: Track-Mounted - 125 mm SSA		ELEVATION (m): 231.90	
SAMPLE TYPE	GRAB	SHELBY TUBE	SPLIT SPOON	BULK	NO RECOVERY	CORE
BACKFILL TYPE	BENTONITE	GRAVEL	SLOUGH	GROUT	CUTTINGS	SAND

LOGGED BY: Ryan Harras	COMPLETION DEPTH: 5.33 m
REVIEWED BY: Elliott Drumright	COMPLETION DATE: 1/26/21
PROJECT ENGINEER: Marv McDonald	Page 1 of 1

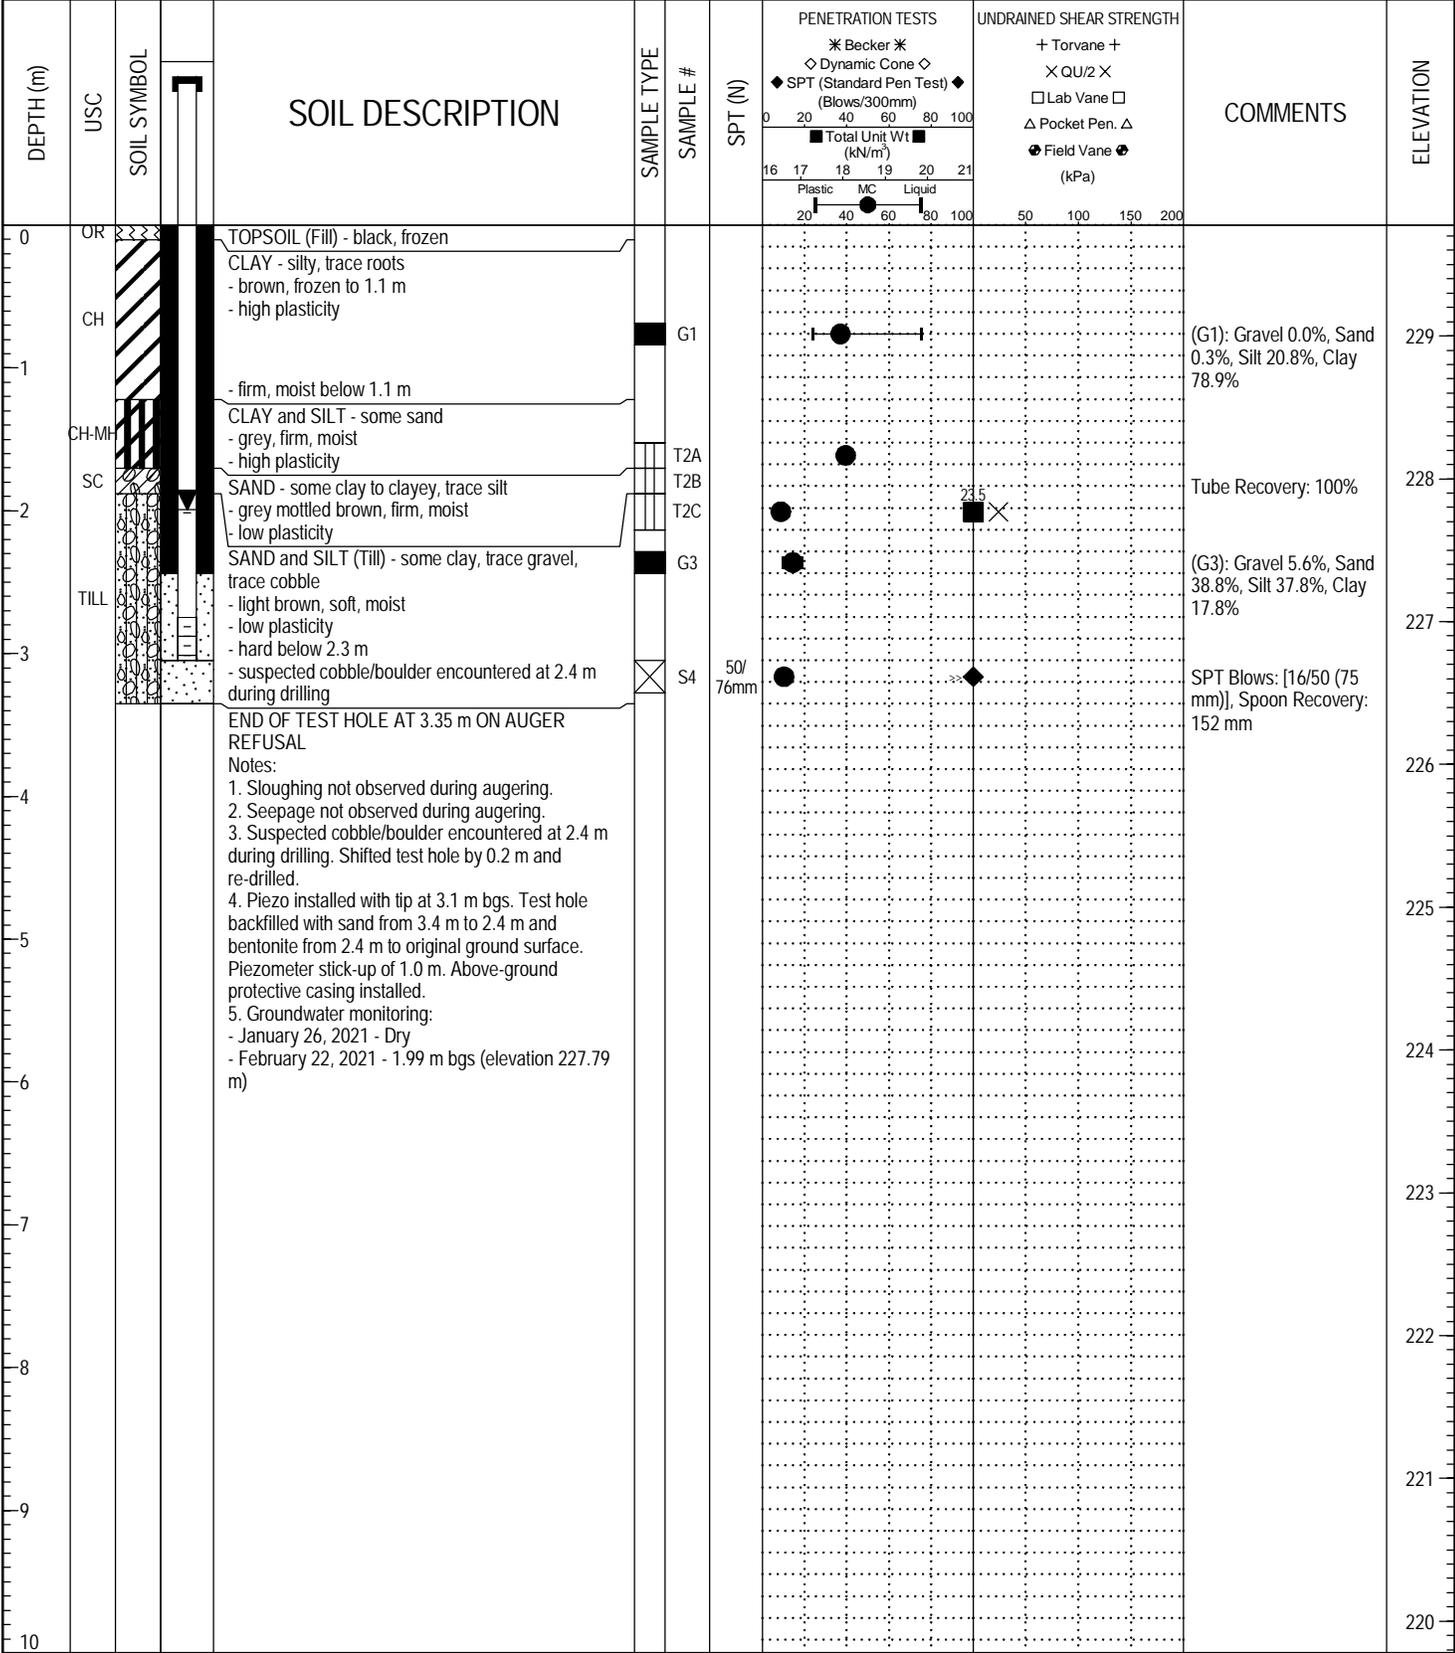
PROJECT: High Risk River Crossing Phase 3	CLIENT: City of Winnipeg	TESTHOLE NO: TH21-04
LOCATION: Site 10 - South Bank (5525799 m N, 624792 m E)		PROJECT NO.: 60645745
CONTRACTOR: Maple Leaf Drilling	METHOD: Track-Mounted - 125 mm SSA	ELEVATION (m): 229.78
SAMPLE TYPE	<input checked="" type="checkbox"/> GRAB <input type="checkbox"/> SHELBY TUBE <input checked="" type="checkbox"/> SPLIT SPOON <input type="checkbox"/> BULK <input type="checkbox"/> NO RECOVERY <input type="checkbox"/> CORE	
BACKFILL TYPE	<input checked="" type="checkbox"/> BENTONITE <input type="checkbox"/> GRAVEL <input type="checkbox"/> SLOUGH <input type="checkbox"/> GROUT <input type="checkbox"/> CUTTINGS <input type="checkbox"/> SAND

LOGGED BY: Ryan HARRAS	COMPLETION DEPTH: 3.35 m
REVIEWED BY: Elliott Drumright	COMPLETION DATE: 1/26/21
PROJECT ENGINEER: Marv McDonald	Page 1 of 1

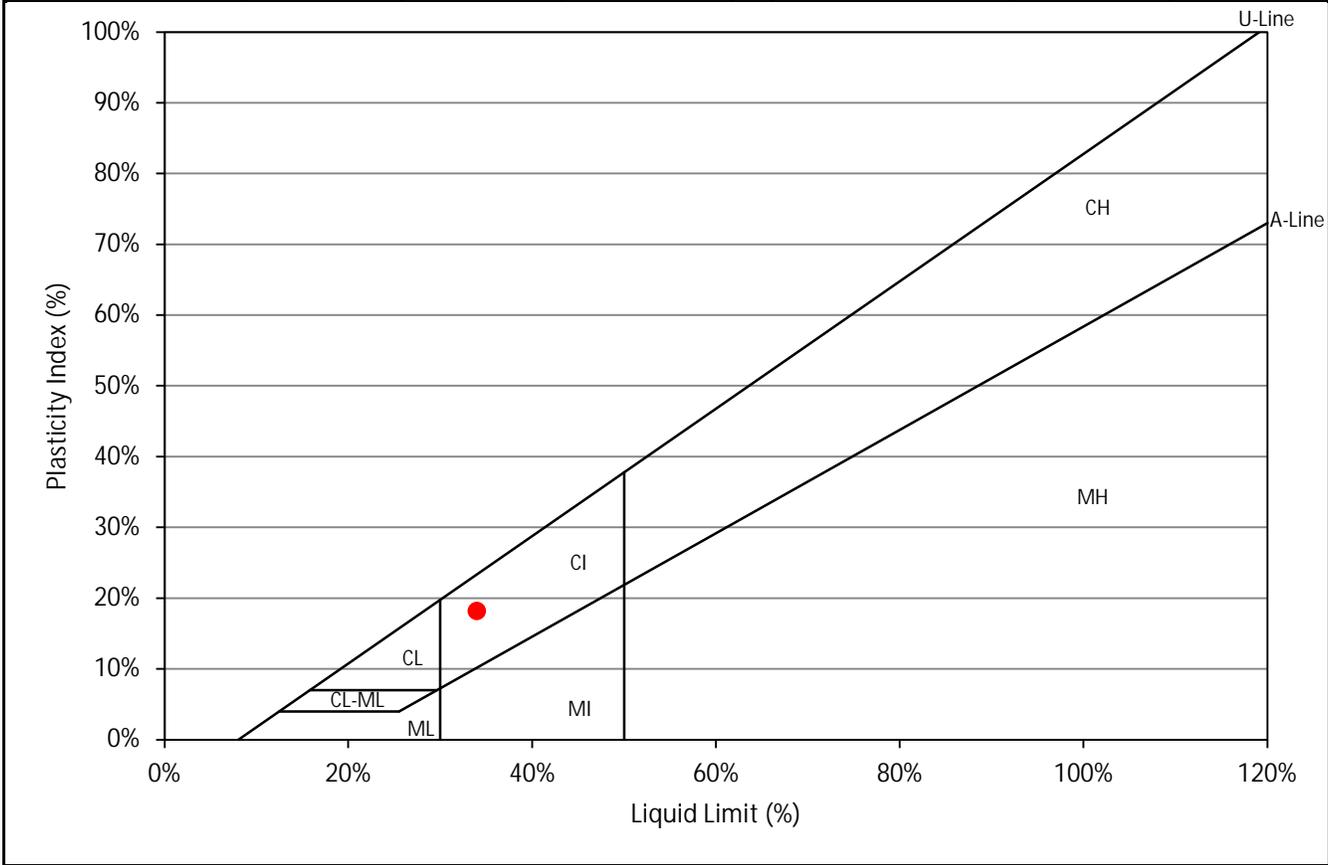
Liquid Limit			
Blows	29	20	18
Wet Sample (g)	9.1	10.1	8.6
Dry Sample (g)	6.8	7.5	6.4
Water Content (%)	33.3%	34.8%	35.2%

Plastic Limit		
Trial	1	2
Wet Sample (g)	6.3	6.2
Dry Sample (g)	5.4	5.3
Water Content (%)	16.1%	15.5%

Liquid Limit (%): 34.0%      Plastic Limit (%): 15.8%      Plasticity Index (%): 18.2%

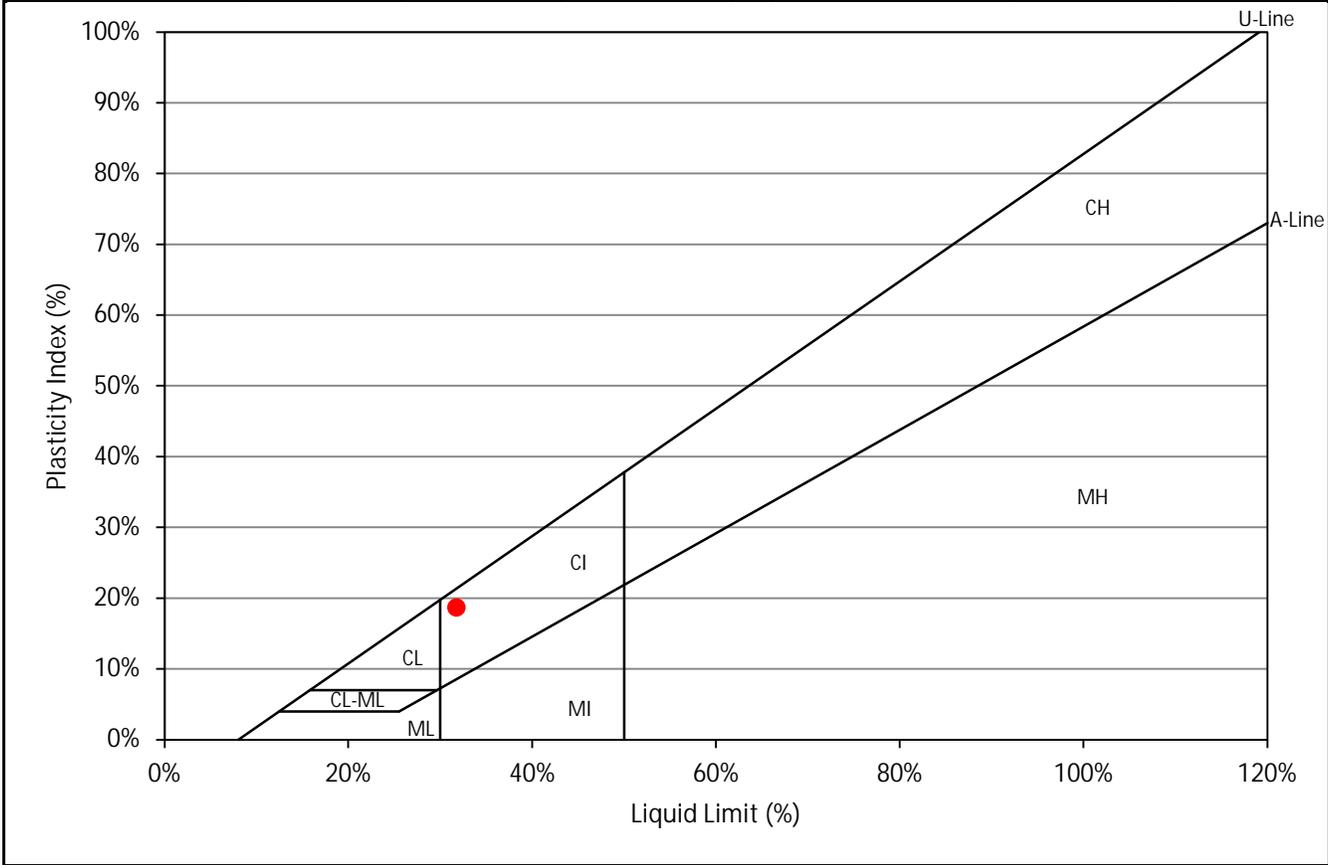
Liquid Limit			
Blows	34	25	17
Wet Sample (g)	8.4	11.0	9.2
Dry Sample (g)	6.4	8.4	6.9
Water Content (%)	30.4%	31.7%	33.0%

Plastic Limit		
Trial	1	2
Wet Sample (g)	7.2	6.9
Dry Sample (g)	6.4	6.1
Water Content (%)	13.0%	13.2%

Liquid Limit (%): 31.8%	Plastic Limit (%): 13.1%	Plasticity Index (%): 18.7%
-------------------------	--------------------------	-----------------------------

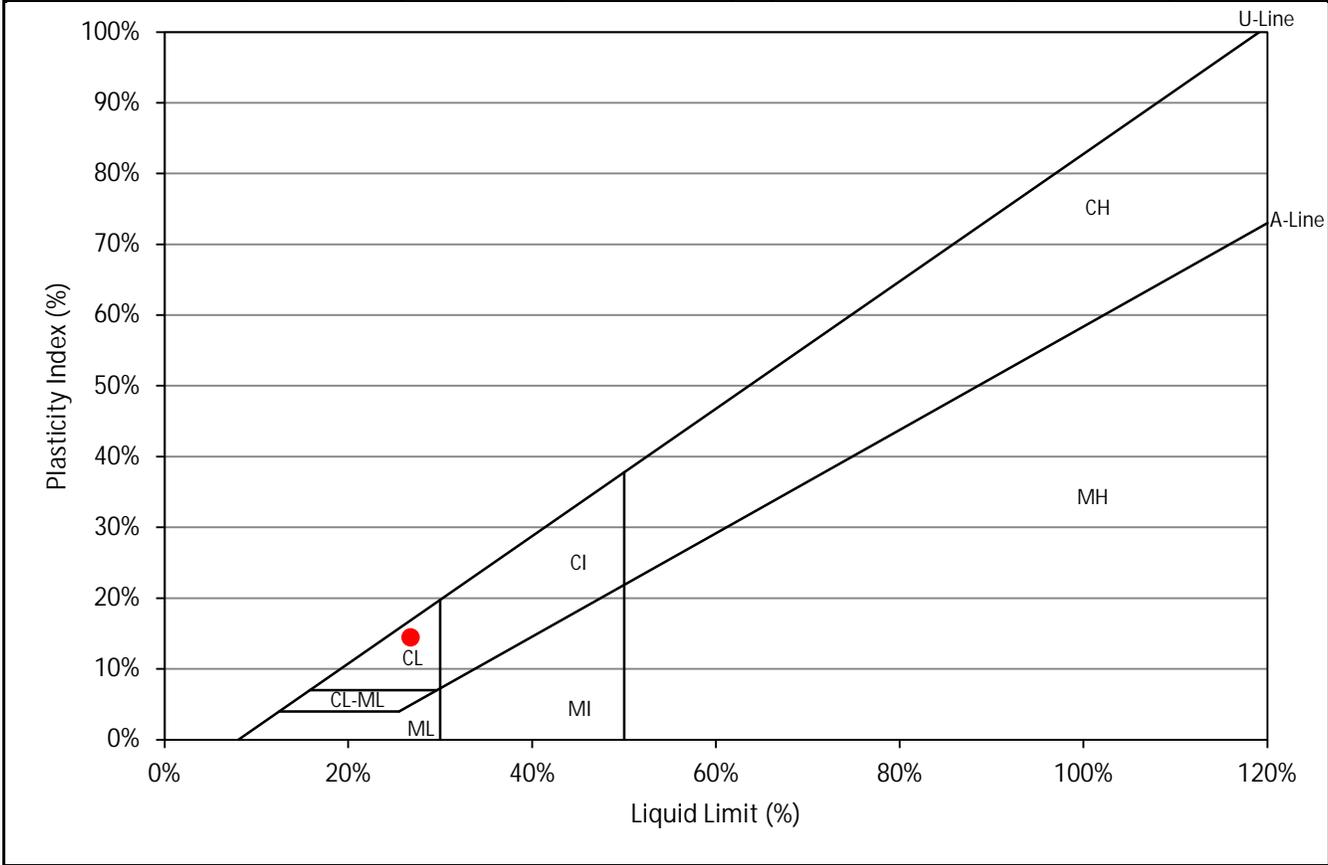
Liquid Limit			
Blows	35	26	21
Wet Sample (g)	10.5	11.4	11.7
Dry Sample (g)	8.4	9.0	9.2
Water Content (%)	25.6%	26.7%	27.5%

Plastic Limit		
Trial	1	2
Wet Sample (g)	6.7	6.8
Dry Sample (g)	6.0	6.0
Water Content (%)	12.4%	12.2%

Liquid Limit (%): 26.8%	Plastic Limit (%): 12.3%	Plasticity Index (%): 14.4%
-------------------------	--------------------------	-----------------------------
