# Replacement of the FGSV Siphon

Geotechnical Baseline Report  
FINAL

City of Winnipeg

May 2025

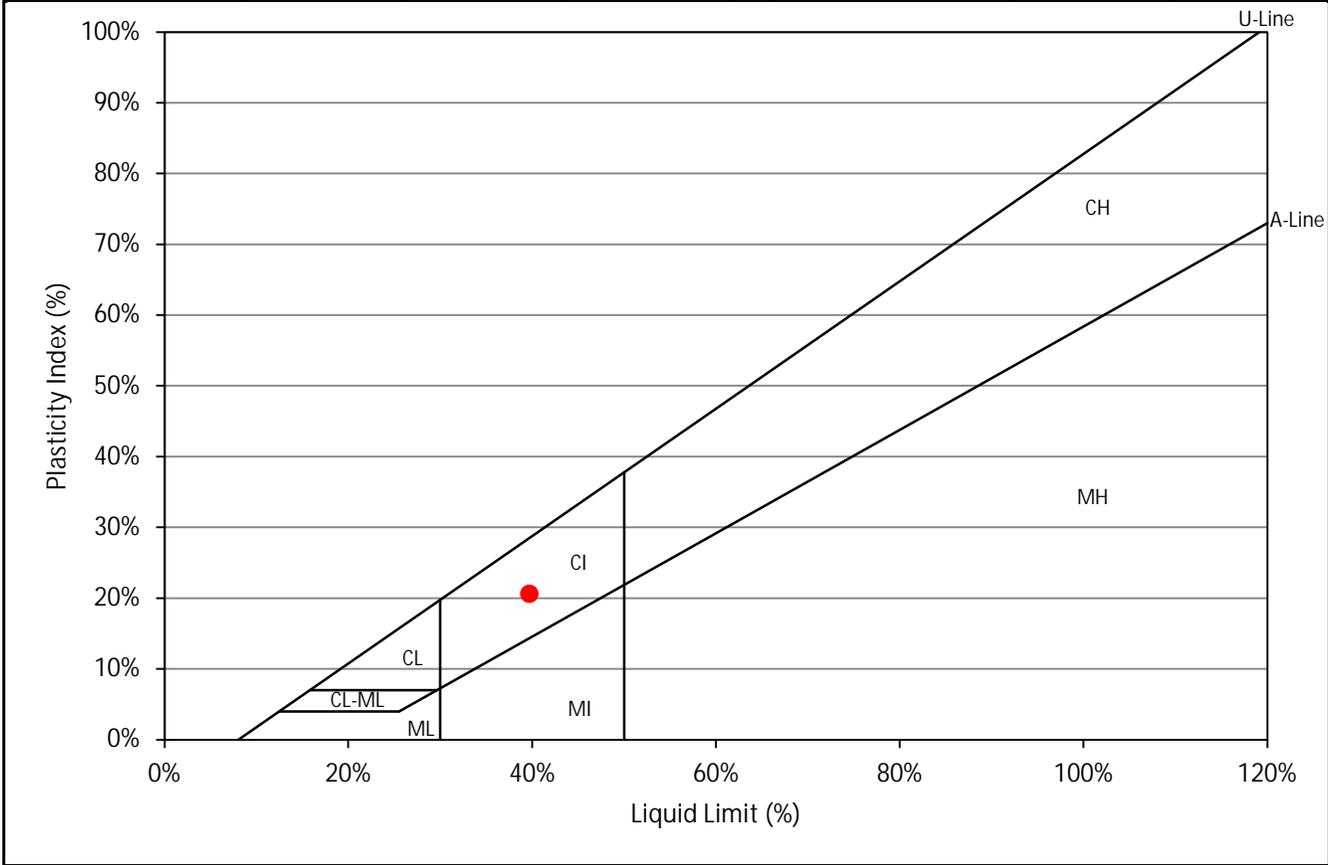
Liquid Limit			
Blows	32	26	21
Wet Sample (g)	9.4	10.7	10.7
Dry Sample (g)	6.8	7.6	7.6
Water Content (%)	39.0%	39.5%	40.1%

Plastic Limit		
Trial	1	2
Wet Sample (g)	6.1	6.4
Dry Sample (g)	5.1	5.4
Water Content (%)	19.2%	19.0%

Liquid Limit (%): 39.7%      Plastic Limit (%): 19.1%      Plasticity Index (%): 20.6%

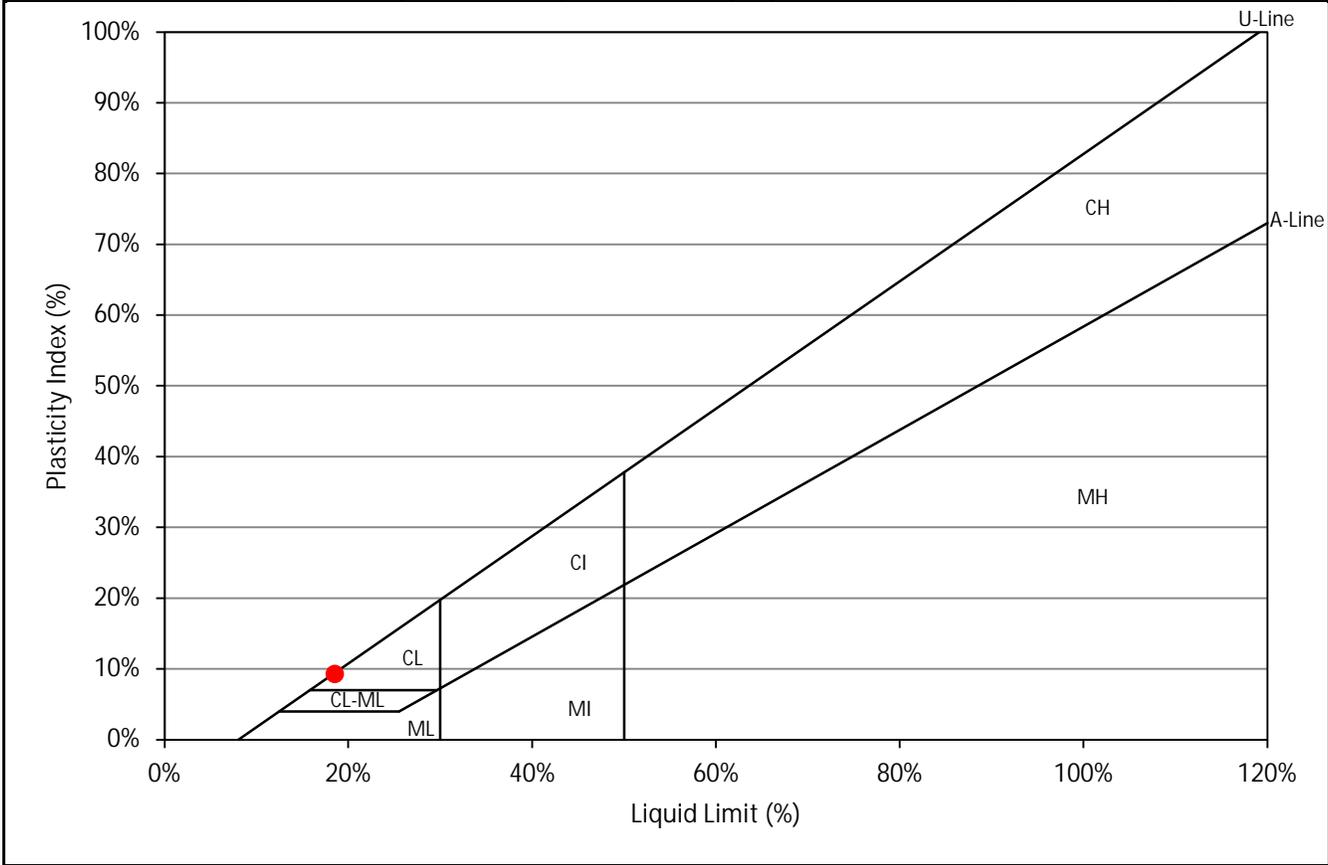
Liquid Limit			
Blows	34	25	16
Wet Sample (g)	11.9	11.4	13.0
Dry Sample (g)	10.1	9.7	10.9
Water Content (%)	17.7%	18.4%	19.3%

Plastic Limit		
Trial	1	2
Wet Sample (g)	6.1	6.4
Dry Sample (g)	5.6	5.8
Water Content (%)	9.2%	9.3%

Liquid Limit (%): 18.5%      Plastic Limit (%): 9.2%      Plasticity Index (%): 9.3%

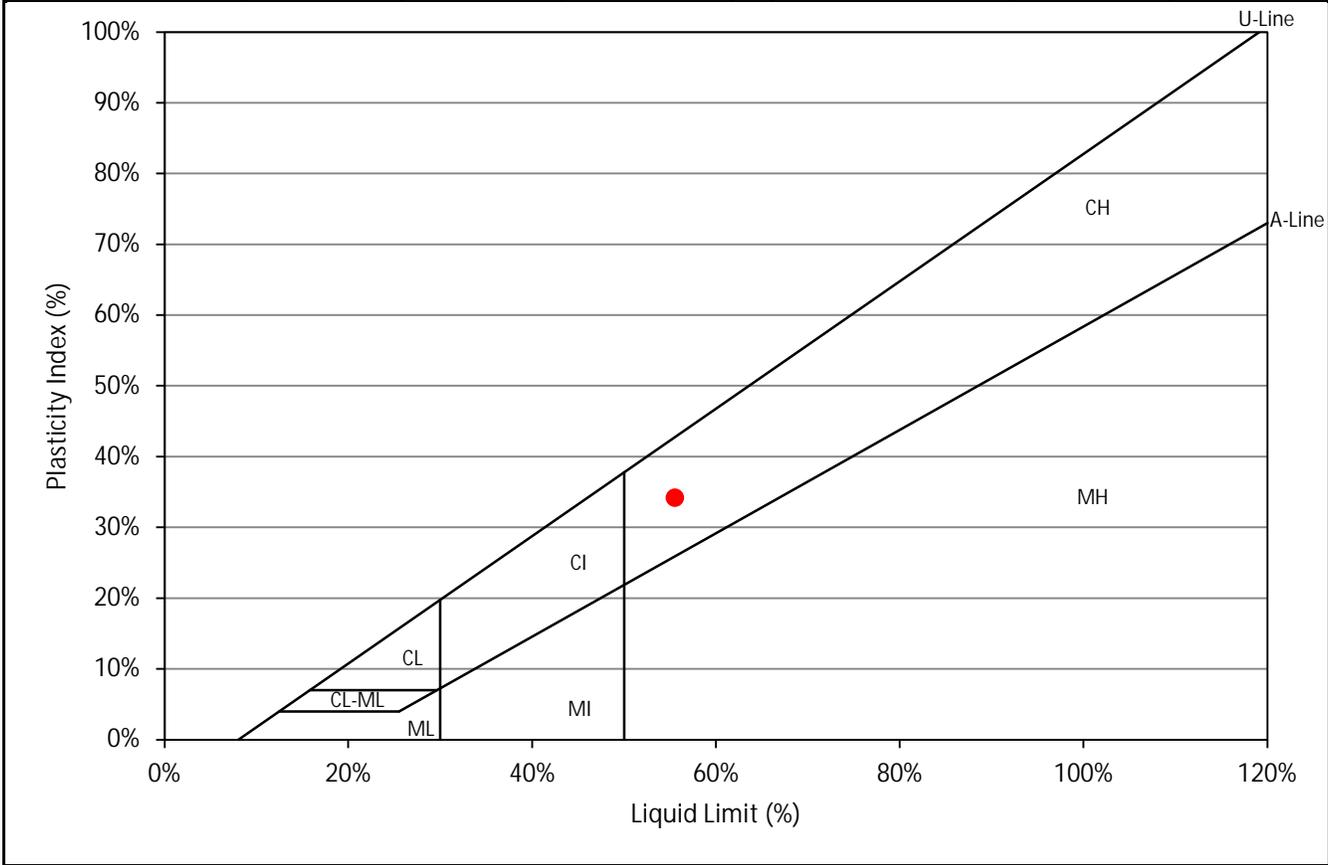
Liquid Limit			
Blows	27	21	17
Wet Sample (g)	8.6	8.7	8.4
Dry Sample (g)	5.6	5.6	5.3
Water Content (%)	55.1%	56.5%	57.8%

Plastic Limit		
Trial	1	2
Wet Sample (g)	6.2	5.9
Dry Sample (g)	5.1	4.9
Water Content (%)	21.4%	21.3%

Liquid Limit (%): 55.5 Plastic Limit (%): 21.3 Plasticity Index (%): 34.2

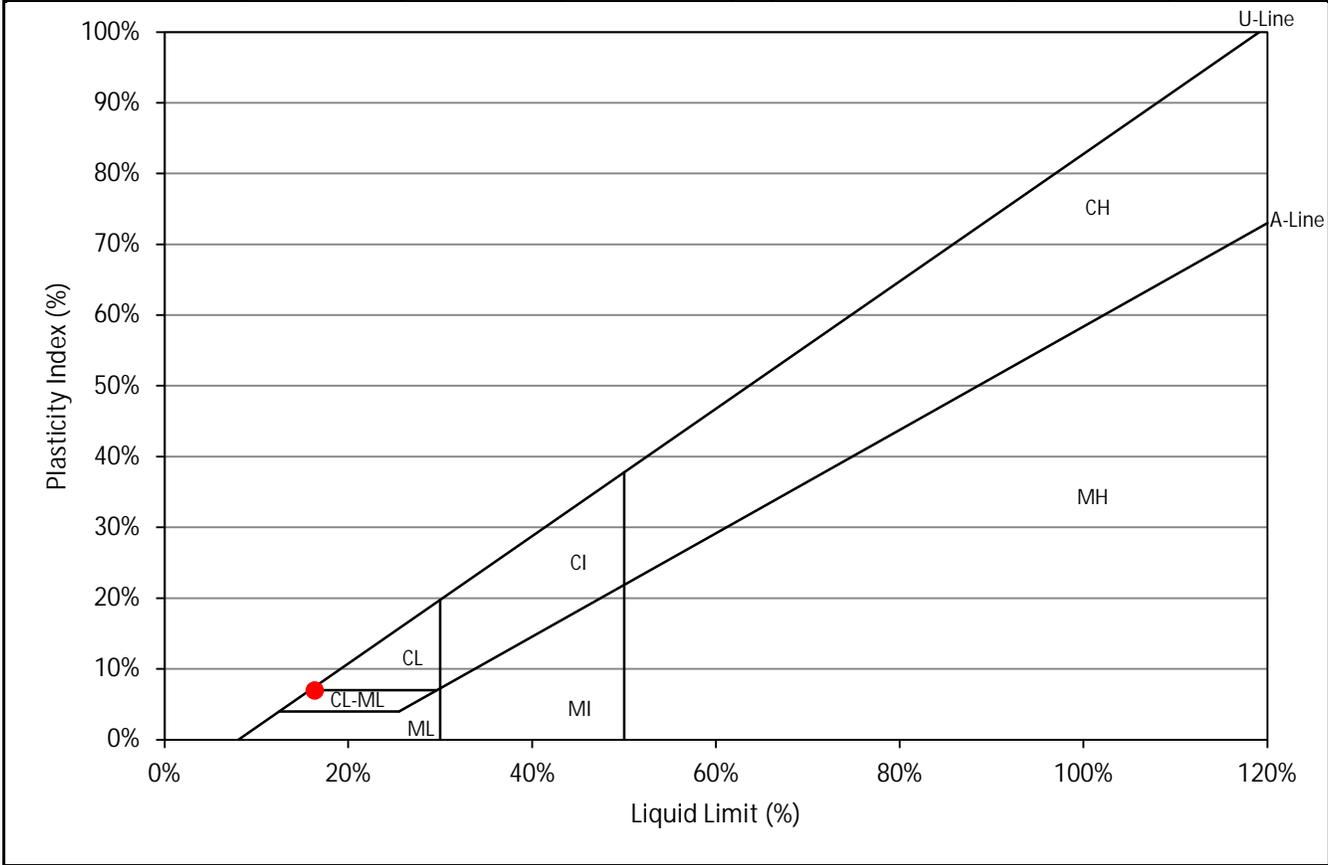
Liquid Limit		
Blows	32	21	15
Wet Sample (g)	10.9	12.1	11.1
Dry Sample (g)	9.5	10.4	9.4
Water Content (%)	15.4%	16.9%	18.3%

Plastic Limit	
Trial	1	2
Wet Sample (g)	6.6	6.2
Dry Sample (g)	6.0	5.7
Water Content (%)	9.3%	9.5%

Liquid Limit (%): 16.3%      Plastic Limit (%): 9.4%      Plasticity Index (%): 7.0%

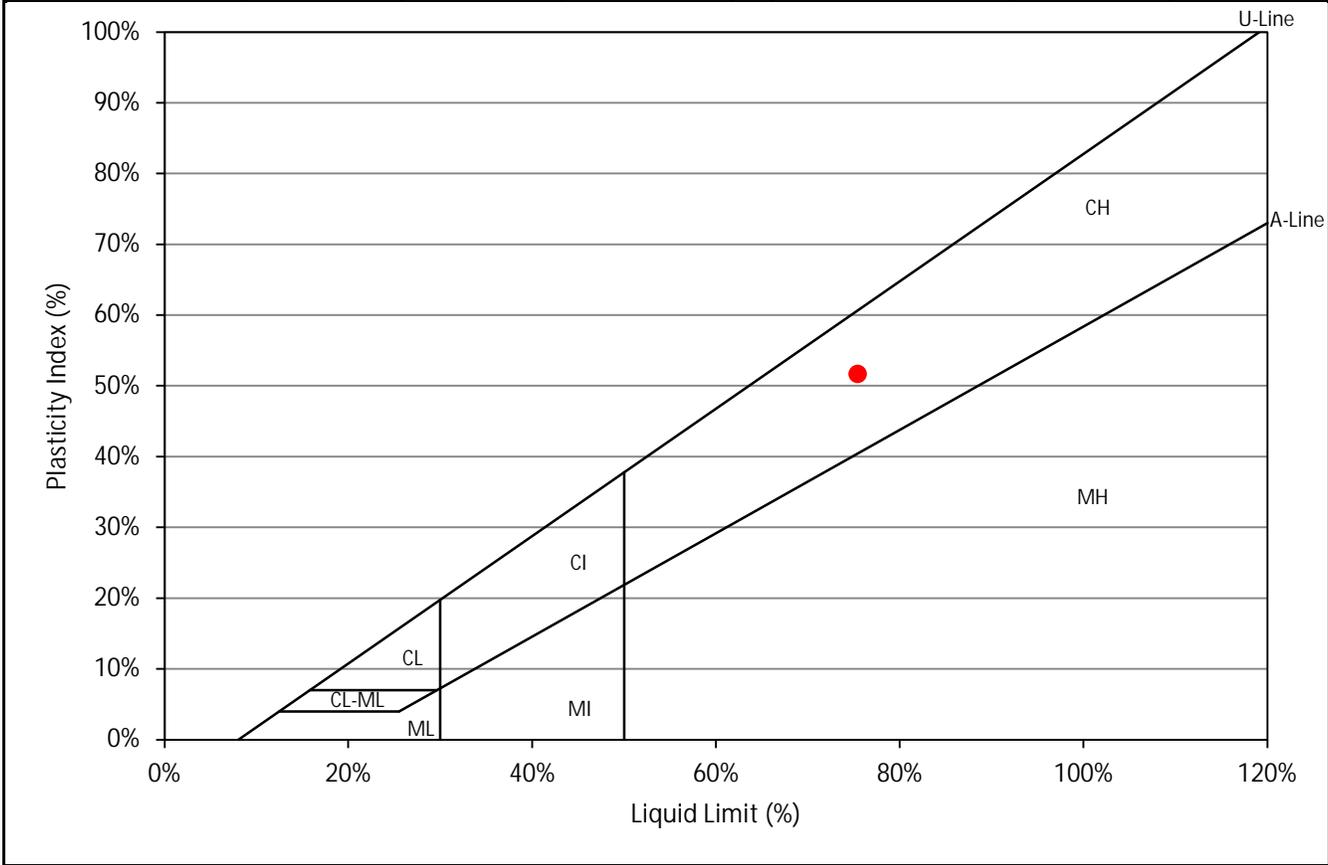
Liquid Limit			
Blows	33	27	18
Wet Sample (g)	8.9	8.6	7.9
Dry Sample (g)	5.2	4.9	4.4
Water Content (%)	72.7%	74.8%	78.6%

Plastic Limit		
Trial	1	2
Wet Sample (g)	6.0	6.3
Dry Sample (g)	4.9	5.1
Water Content (%)	23.6%	23.9%

Liquid Limit (%): 75.4%      Plastic Limit (%): 23.8%      Plasticity Index (%): 51.7%

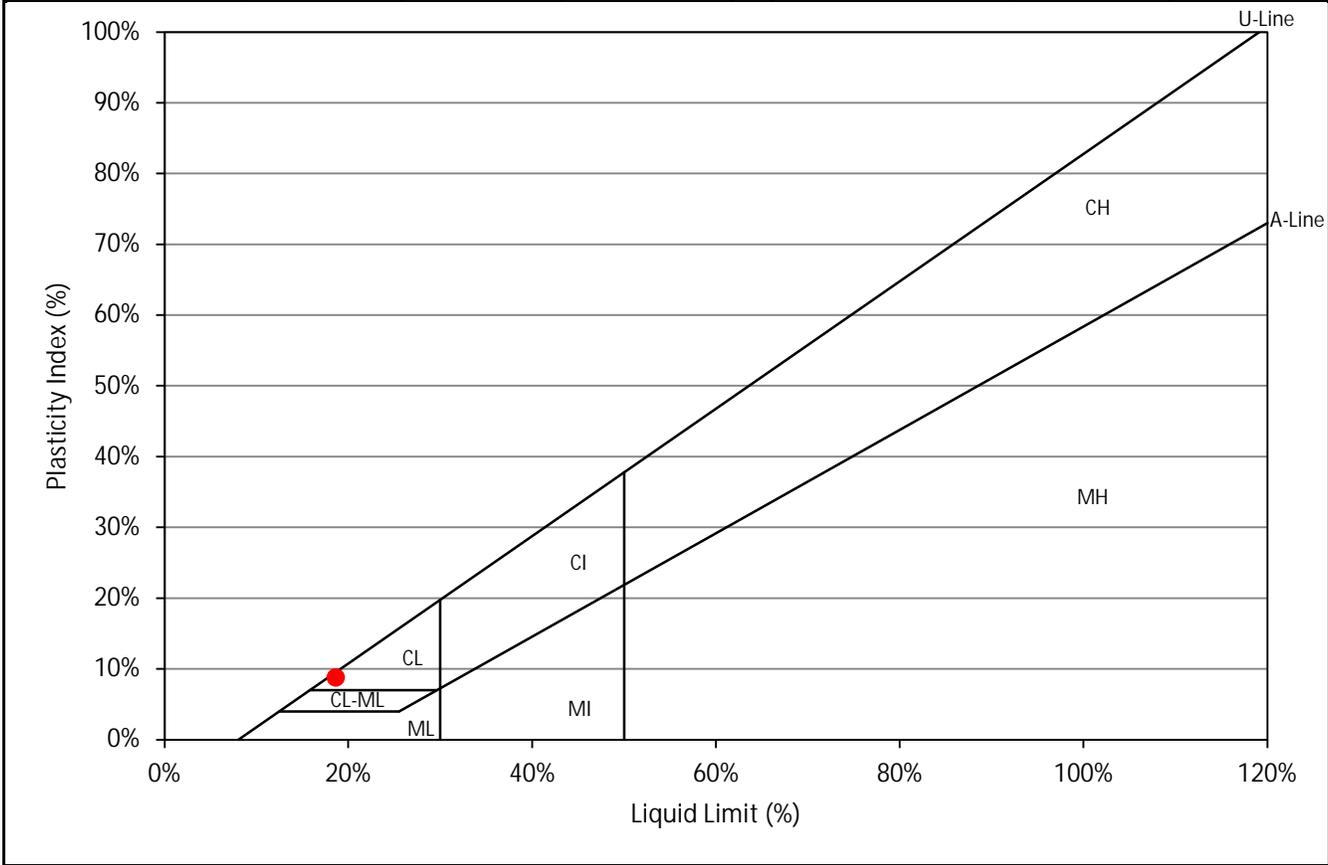
Liquid Limit			
Blows	34	22	15
Wet Sample (g)	9.5	12.0	11.8
Dry Sample (g)	8.0	10.1	9.9
Water Content (%)	18.0%	18.7%	19.4%

Plastic Limit		
Trial	1	2
Wet Sample (g)	6.2	6.2
Dry Sample (g)	5.7	5.7
Water Content (%)	9.6%	10.1%

Liquid Limit (%): 18.6%      Plastic Limit (%): 9.9%      Plasticity Index (%): 8.8%

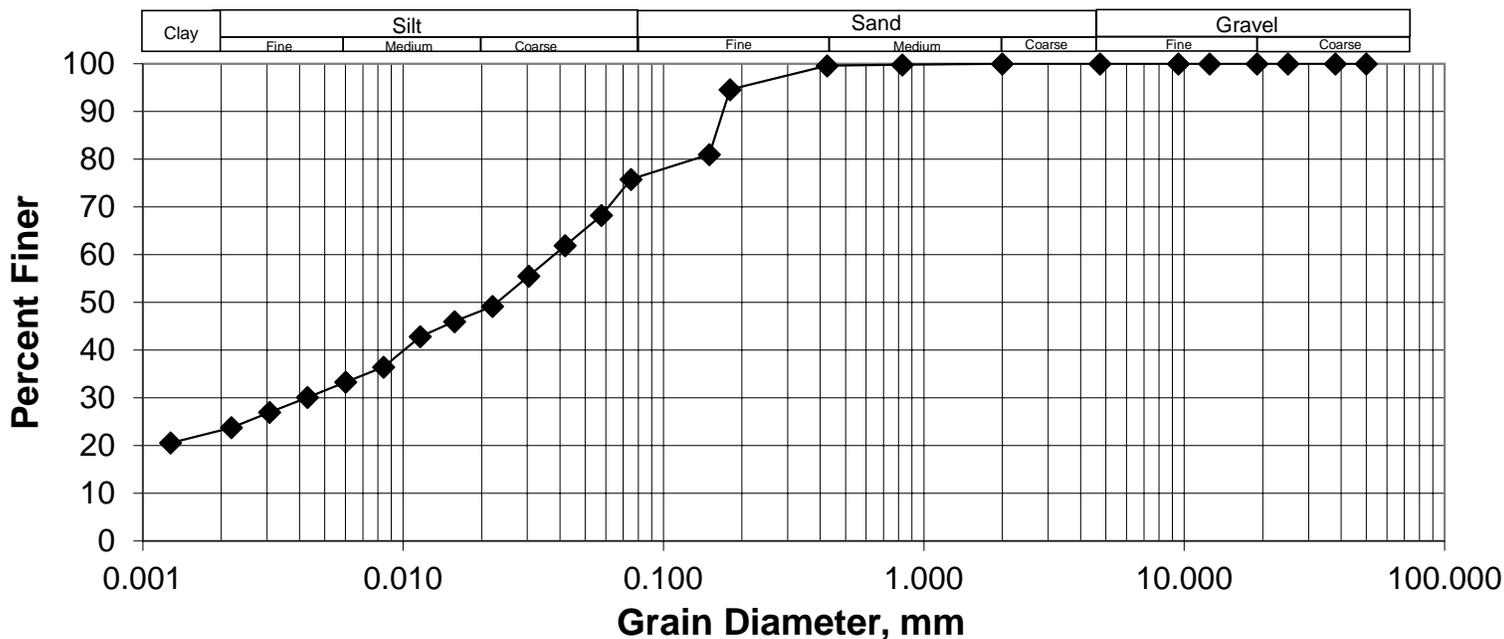
**GRAIN SIZE DISTRIBUTION CURVE**

GRAVEL SIZES		SAND SIZES		FINES	
Grain Size (mm.)	Total Percent Passing	Grain Size (mm.)	Total Percent Passing	Grain Size (mm.)	Total Percent Passing
50.0	100.0	4.75	100.0	0.0750	75.8
38.0	100.0	2.00	100.0	0.0577	68.2
25.0	100.0	0.825	99.8	0.0419	61.9
19.0	100.0	0.425	99.6	0.0304	55.5
12.5	100.0	0.18	94.6	0.0220	49.2
9.5	100.0	0.15	81.0	0.0157	46.0
4.75	100.0	0.075	75.8	0.0116	42.8
				0.0084	36.5
				0.0060	33.3
				0.0043	30.1
				0.0031	26.9
				0.0022	23.8
				0.0013	20.6

Gravel	0.0%	Silt	52.7%
Sand	24.2%	Clay	23.1%

**GRAIN SIZE DISTRIBUTION**  
(ASTM D422-63)

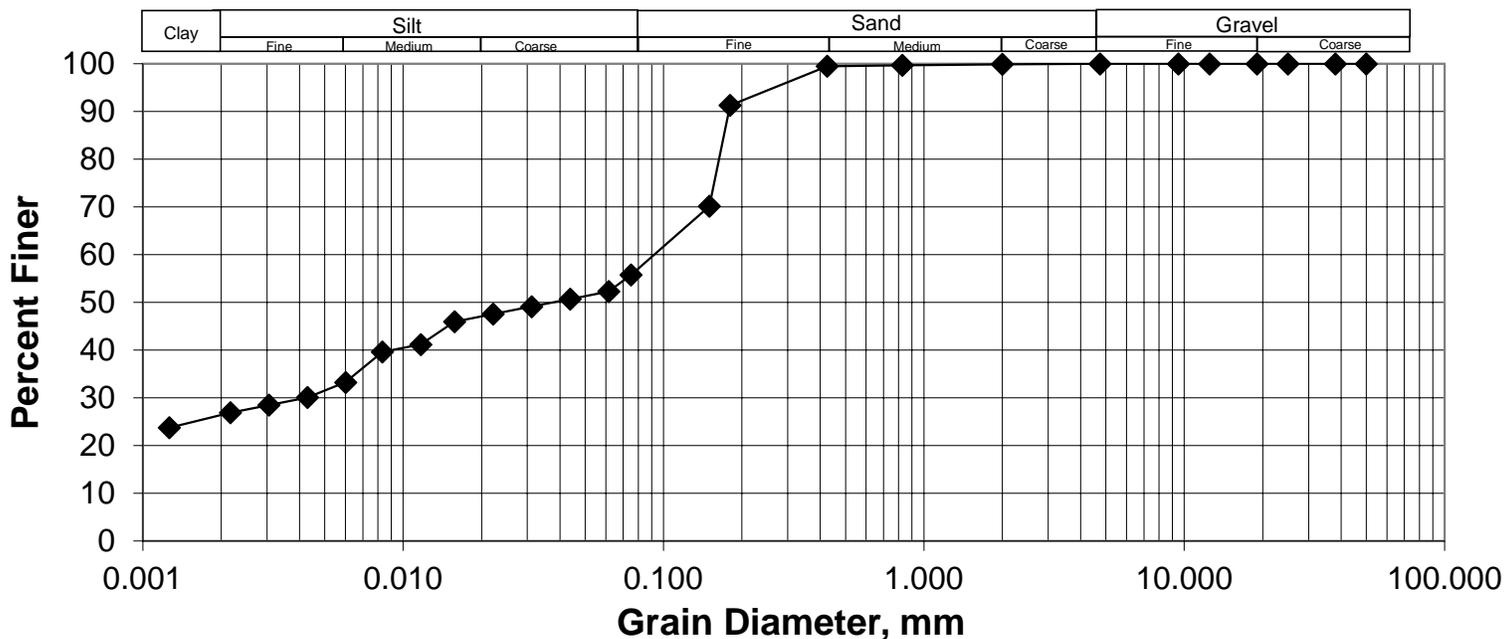
**GRAIN SIZE DISTRIBUTION CURVE**

GRAVEL SIZES		SAND SIZES		FINES	
Grain Size (mm.)	Total Percent Passing	Grain Size (mm.)	Total Percent Passing	Grain Size (mm.)	Total Percent Passing
50.0	100.0	4.75	100.0	0.0750	55.8
38.0	100.0	2.00	99.9	0.0615	52.3
25.0	100.0	0.825	99.7	0.0437	50.7
19.0	100.0	0.425	99.5	0.0311	49.1
12.5	100.0	0.18	91.3	0.0221	47.5
9.5	100.0	0.15	70.1	0.0157	46.0
4.75	100.0	0.075	55.8	0.0117	41.2
				0.0083	39.6
				0.0060	33.3
				0.0043	30.1
				0.0030	28.5
				0.0022	26.9
				0.0013	23.7

Gravel	0.0%	Silt	29.6%
Sand	44.2%	Clay	26.2%

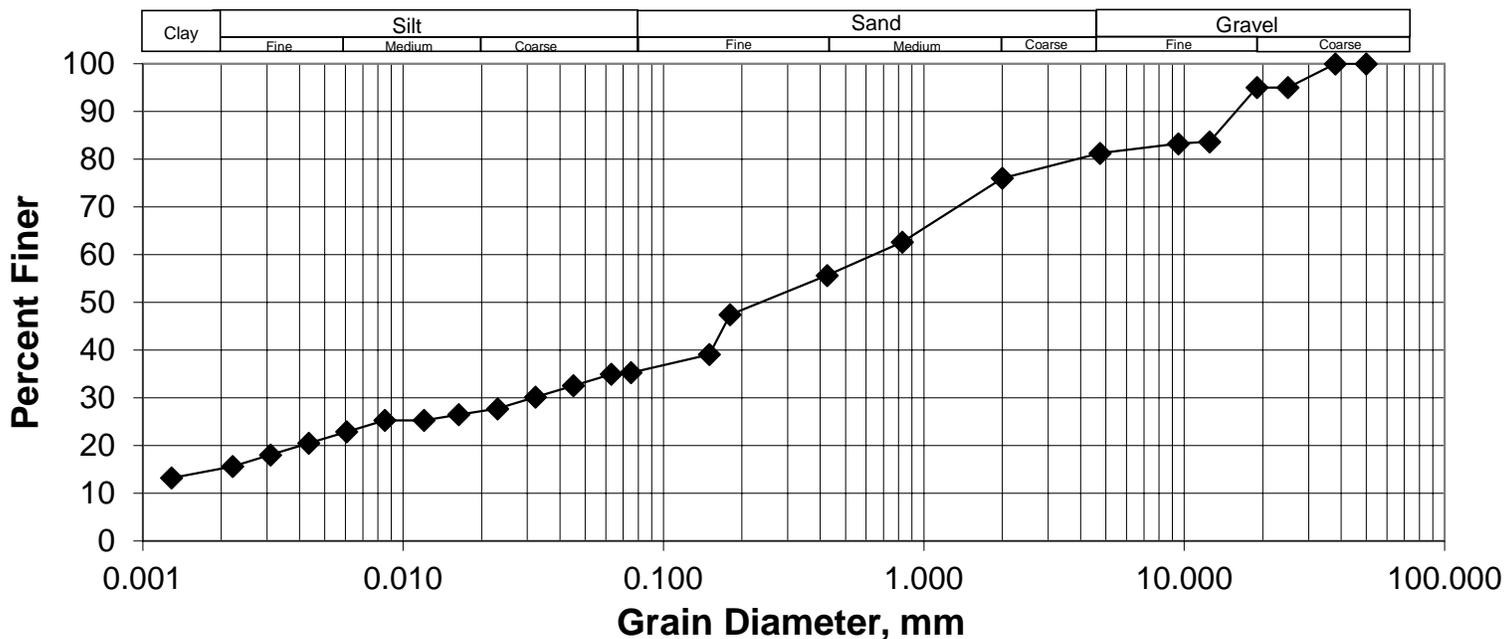
**GRAIN SIZE DISTRIBUTION CURVE**

GRAVEL SIZES		SAND SIZES		FINES	
Grain Size (mm.)	Total Percent Passing	Grain Size (mm.)	Total Percent Passing	Grain Size (mm.)	Total Percent Passing
50.0	100.0	4.75	81.3	0.0750	35.3
38.0	100.0	2.00	76.0	0.0629	35.0
25.0	95.0	0.825	62.7	0.0450	32.6
19.0	95.0	0.425	55.7	0.0322	30.1
12.5	83.7	0.18	47.4	0.0230	27.7
9.5	83.3	0.15	39.1	0.0164	26.5
4.75	81.3	0.075	35.3	0.0120	25.3
				0.0085	25.3
				0.0061	22.9
				0.0043	20.5
				0.0031	18.1
				0.0022	15.7
				0.0013	13.2

Gravel	18.7%	Silt	20.2%
Sand	46.0%	Clay	15.1%

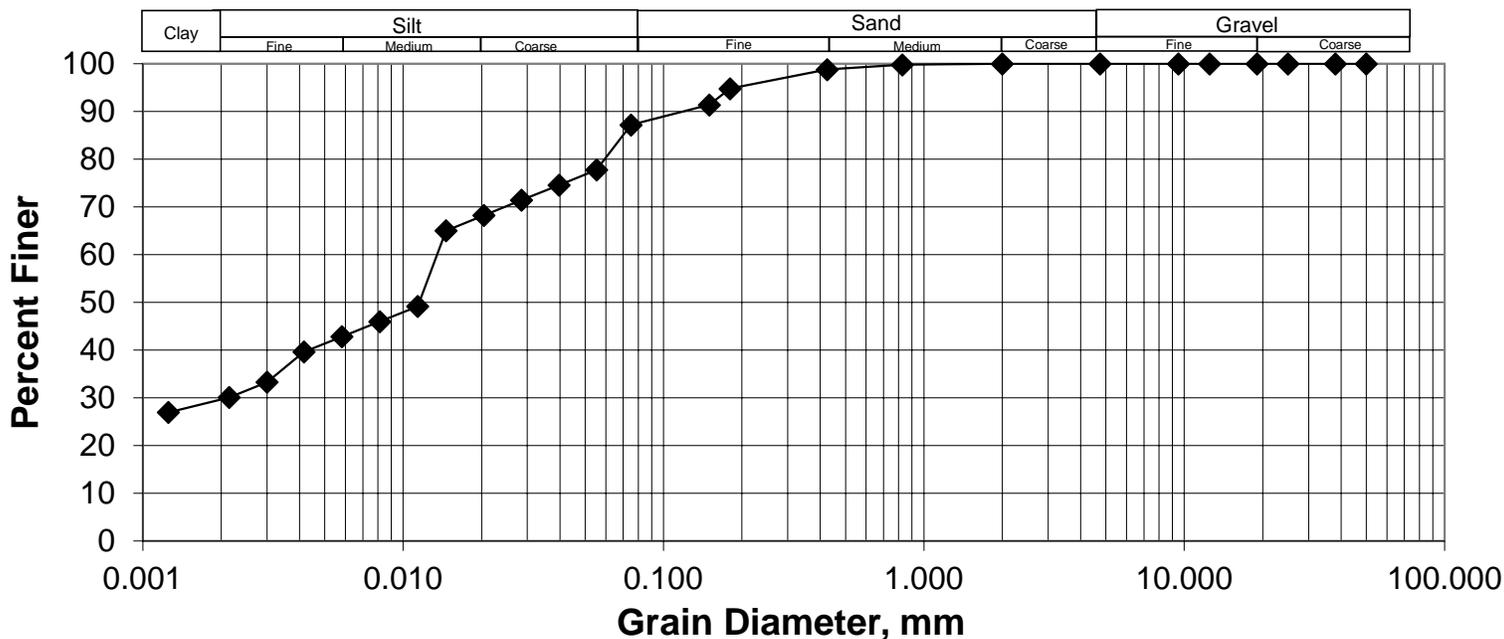
**GRAIN SIZE DISTRIBUTION CURVE**

GRAVEL SIZES		SAND SIZES		FINES	
Grain Size (mm.)	Total Percent Passing	Grain Size (mm.)	Total Percent Passing	Grain Size (mm.)	Total Percent Passing
50.0	100.0	4.75	100.0	0.0750	87.2
38.0	100.0	2.00	100.0	0.0552	77.8
25.0	100.0	0.825	99.8	0.0396	74.6
19.0	100.0	0.425	98.8	0.0284	71.4
12.5	100.0	0.18	94.8	0.0204	68.2
9.5	100.0	0.15	91.4	0.0146	65.1
4.75	100.0	0.075	87.2	0.0114	49.2
				0.0081	46.0
				0.0058	42.8
				0.0042	39.6
				0.0030	33.3
				0.0021	30.1
				0.0013	26.9

Gravel	0.0%	Silt	57.5%
Sand	12.8%	Clay	29.7%

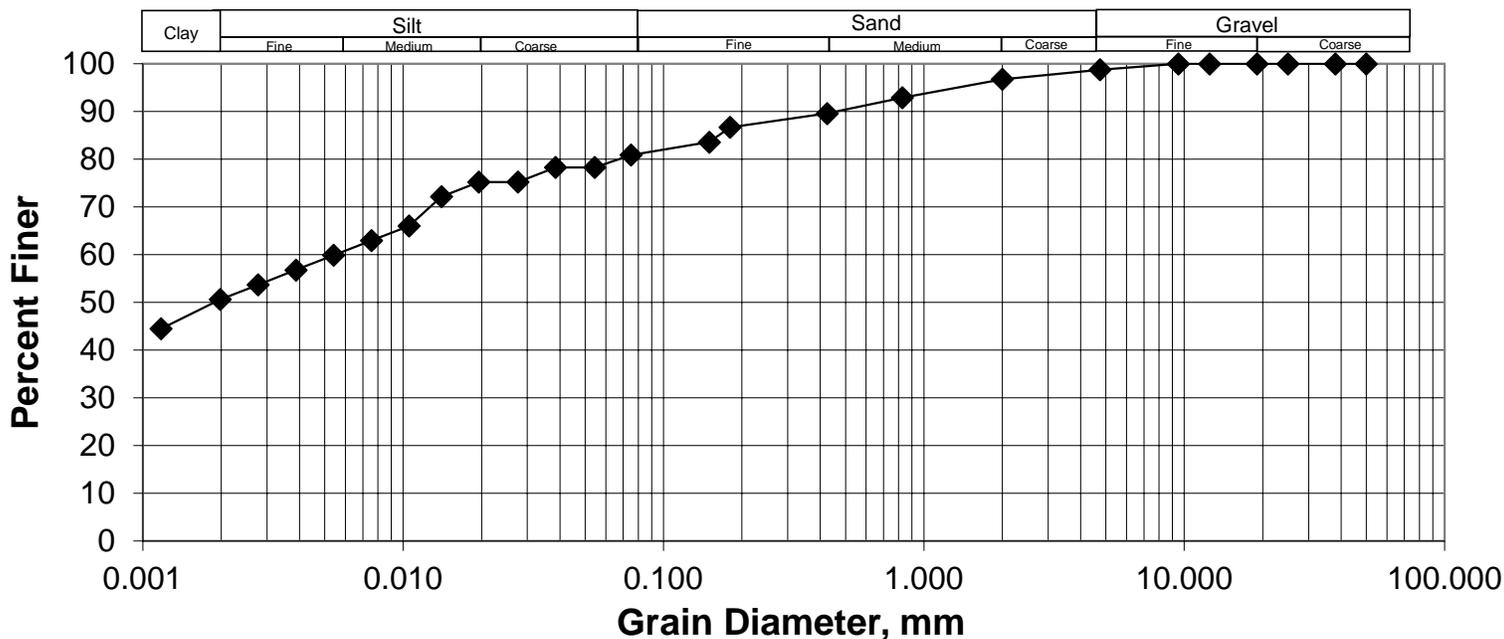
**GRAIN SIZE DISTRIBUTION CURVE**

GRAVEL SIZES		SAND SIZES		FINES	
Grain Size (mm.)	Total Percent Passing	Grain Size (mm.)	Total Percent Passing	Grain Size (mm.)	Total Percent Passing
50.0	100.0	4.75	98.7	0.0750	80.9
38.0	100.0	2.00	96.8	0.0544	78.3
25.0	100.0	0.825	92.9	0.0385	78.3
19.0	100.0	0.425	89.6	0.0276	75.2
12.5	100.0	0.18	86.7	0.0195	75.2
9.5	100.0	0.15	83.6	0.0140	72.2
4.75	98.7	0.075	80.9	0.0105	66.0
				0.0075	62.9
				0.0054	59.9
				0.0039	56.8
				0.0028	53.7
				0.0020	50.6
				0.0012	44.5

Gravel	1.3%	Silt	30.3%
Sand	17.8%	Clay	50.6%

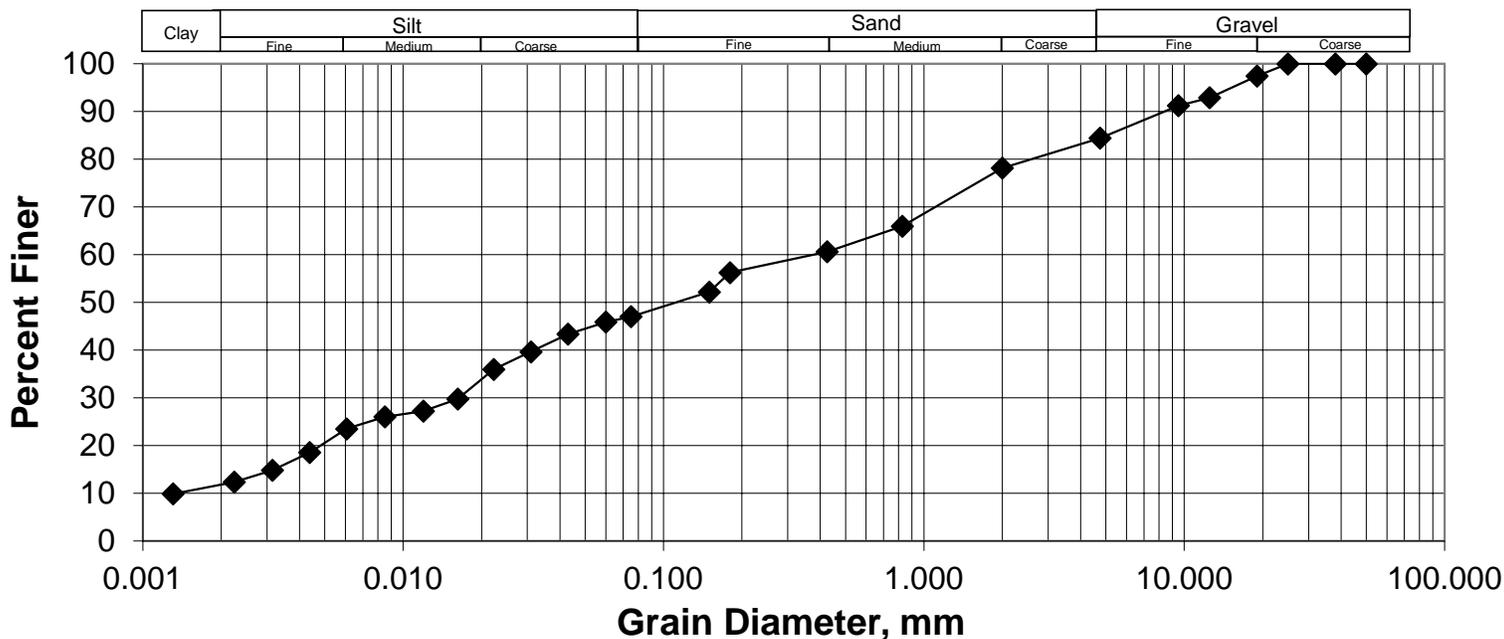
**GRAIN SIZE DISTRIBUTION CURVE**

GRAVEL SIZES		SAND SIZES		FINES	
Grain Size (mm.)	Total Percent Passing	Grain Size (mm.)	Total Percent Passing	Grain Size (mm.)	Total Percent Passing
50.0	100.0	4.75	84.4	0.0750	47.0
38.0	100.0	2.00	78.1	0.0600	45.9
25.0	100.0	0.825	65.9	0.0429	43.4
19.0	97.4	0.425	60.6	0.0309	39.7
12.5	92.9	0.18	56.3	0.0223	35.9
9.5	91.2	0.15	52.2	0.0162	29.7
4.75	84.4	0.075	47.0	0.0119	27.3
				0.0085	26.0
				0.0061	23.5
				0.0044	18.6
				0.0031	14.8
				0.0022	12.4
				0.0013	9.9

Gravel	15.6%	Silt	35.2%
Sand	37.4%	Clay	11.8%

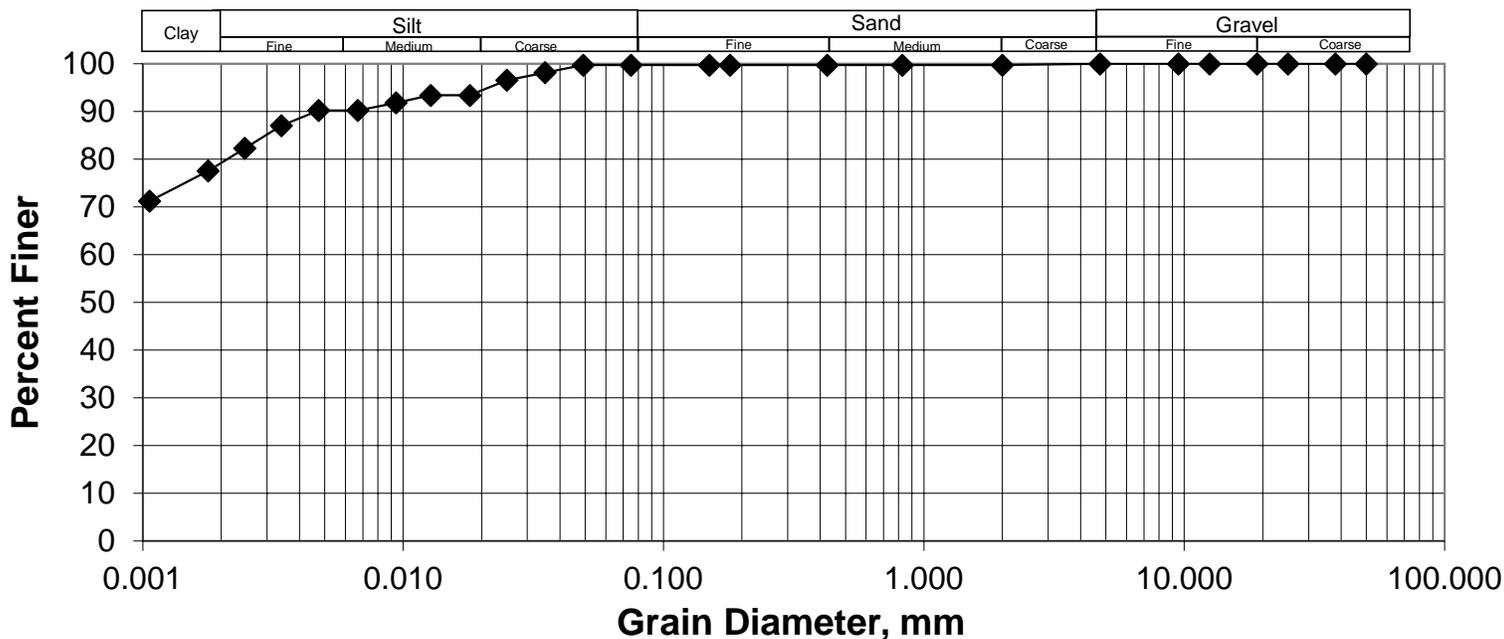
**GRAIN SIZE DISTRIBUTION CURVE**

GRAVEL SIZES		SAND SIZES		FINES	
Grain Size (mm.)	Total Percent Passing	Grain Size (mm.)	Total Percent Passing	Grain Size (mm.)	Total Percent Passing
50.0	100.0	4.75	100.0	0.0750	99.7
38.0	100.0	2.00	99.7	0.0491	99.7
25.0	100.0	0.825	99.7	0.0351	98.1
19.0	100.0	0.425	99.7	0.0250	96.6
12.5	100.0	0.18	99.7	0.0180	93.4
9.5	100.0	0.15	99.7	0.0127	93.4
4.75	100.0	0.075	99.7	0.0094	91.8
				0.0067	90.2
				0.0047	90.2
				0.0034	87.1
				0.0025	82.3
				0.0018	77.5
				0.0011	71.2

Gravel	0.0%	Silt	20.8%
Sand	0.3%	Clay	78.9%

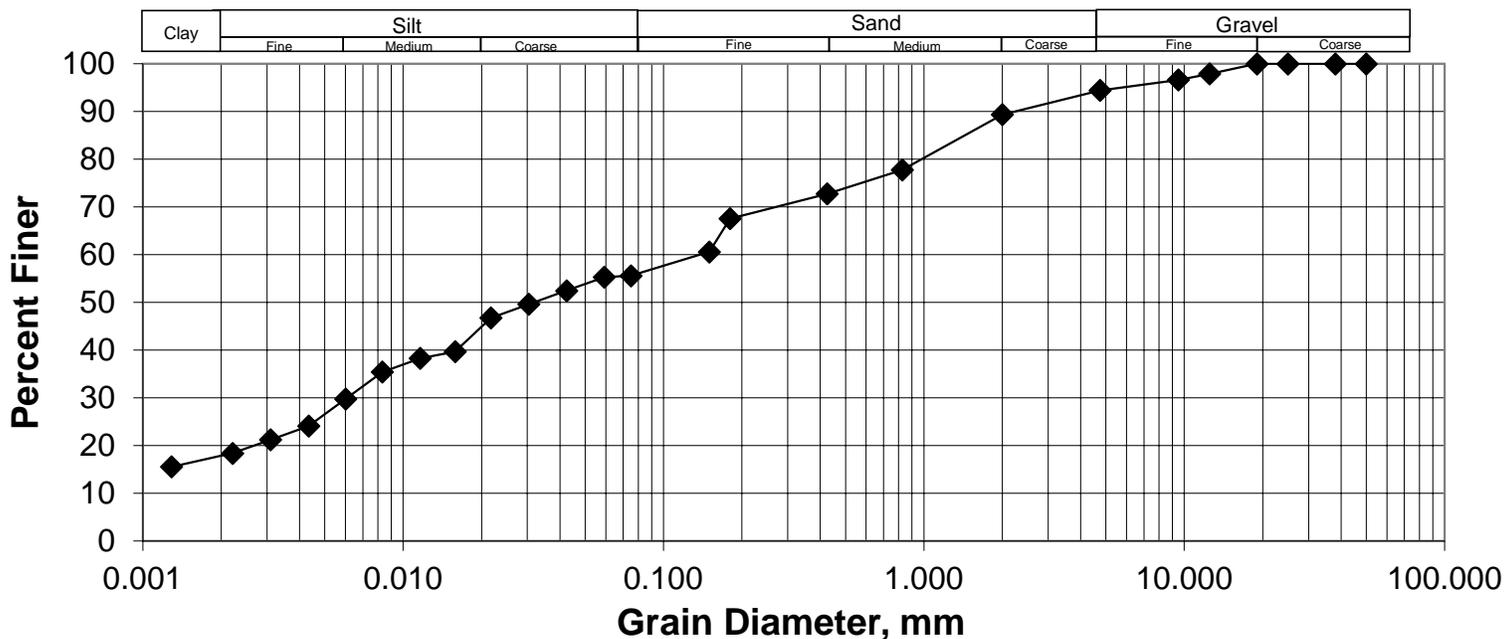
**GRAIN SIZE DISTRIBUTION CURVE**

GRAVEL SIZES		SAND SIZES		FINES	
Grain Size (mm.)	Total Percent Passing	Grain Size (mm.)	Total Percent Passing	Grain Size (mm.)	Total Percent Passing
50.0	100.0	4.75	94.4	0.0750	55.6
38.0	100.0	2.00	89.4	0.0592	55.3
25.0	100.0	0.825	77.8	0.0424	52.5
19.0	100.0	0.425	72.8	0.0304	49.6
12.5	97.9	0.18	67.6	0.0217	46.8
9.5	96.6	0.15	60.6	0.0158	39.7
4.75	94.4	0.075	55.6	0.0116	38.3
				0.0083	35.4
				0.0060	29.8
				0.0043	24.1
				0.0031	21.2
				0.0022	18.4
				0.0013	15.6

Gravel	5.6%	Silt	37.8%
Sand	38.8%	Clay	17.8%

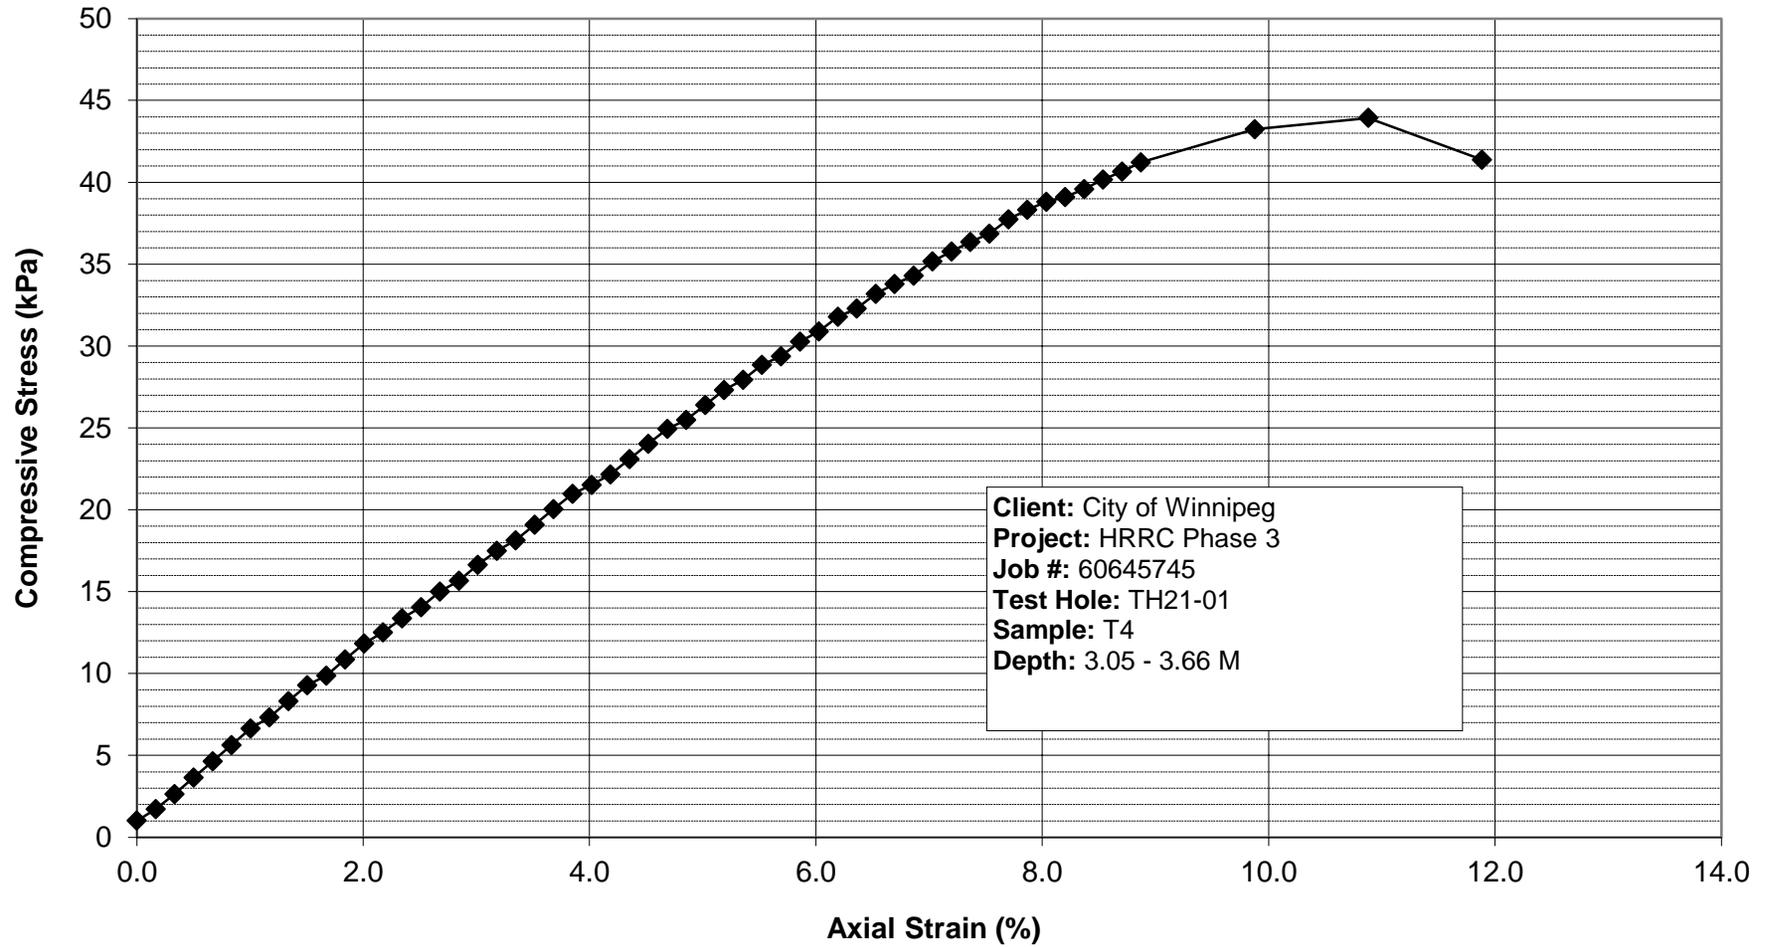
**AECOM**  
**UNCONFINED COMPRESSIVE STRENGTH OF COHESIVE SOILS**  
**(ASTM D2166)**

Length 1 (cm)	15.20
Length 2 (cm)	15.20
Length 3 (cm)	15.30
<b>Avg. Length (cm)</b>	<b>15.23</b>
Volume (cm <sup>3</sup> )	626.0
Moisture content (%)	24.8
Bulk Density (g/cm <sup>3</sup> )	1.943
<b>Bulk Density (kN/m<sup>3</sup>)</b>	<b>19.1</b>
<b>Bulk Density (pcf)</b>	<b>121.3</b>
<b>Dry Density (kN/m<sup>3</sup>)</b>	<b>15.27</b>

<b>SOIL DESCRIPTION:</b>	
CLAY - silty, trace to some sand, brown	
moist, firm, intermediate to high plasticity	
<b>MOISTURE CONTENT:</b>	24.8

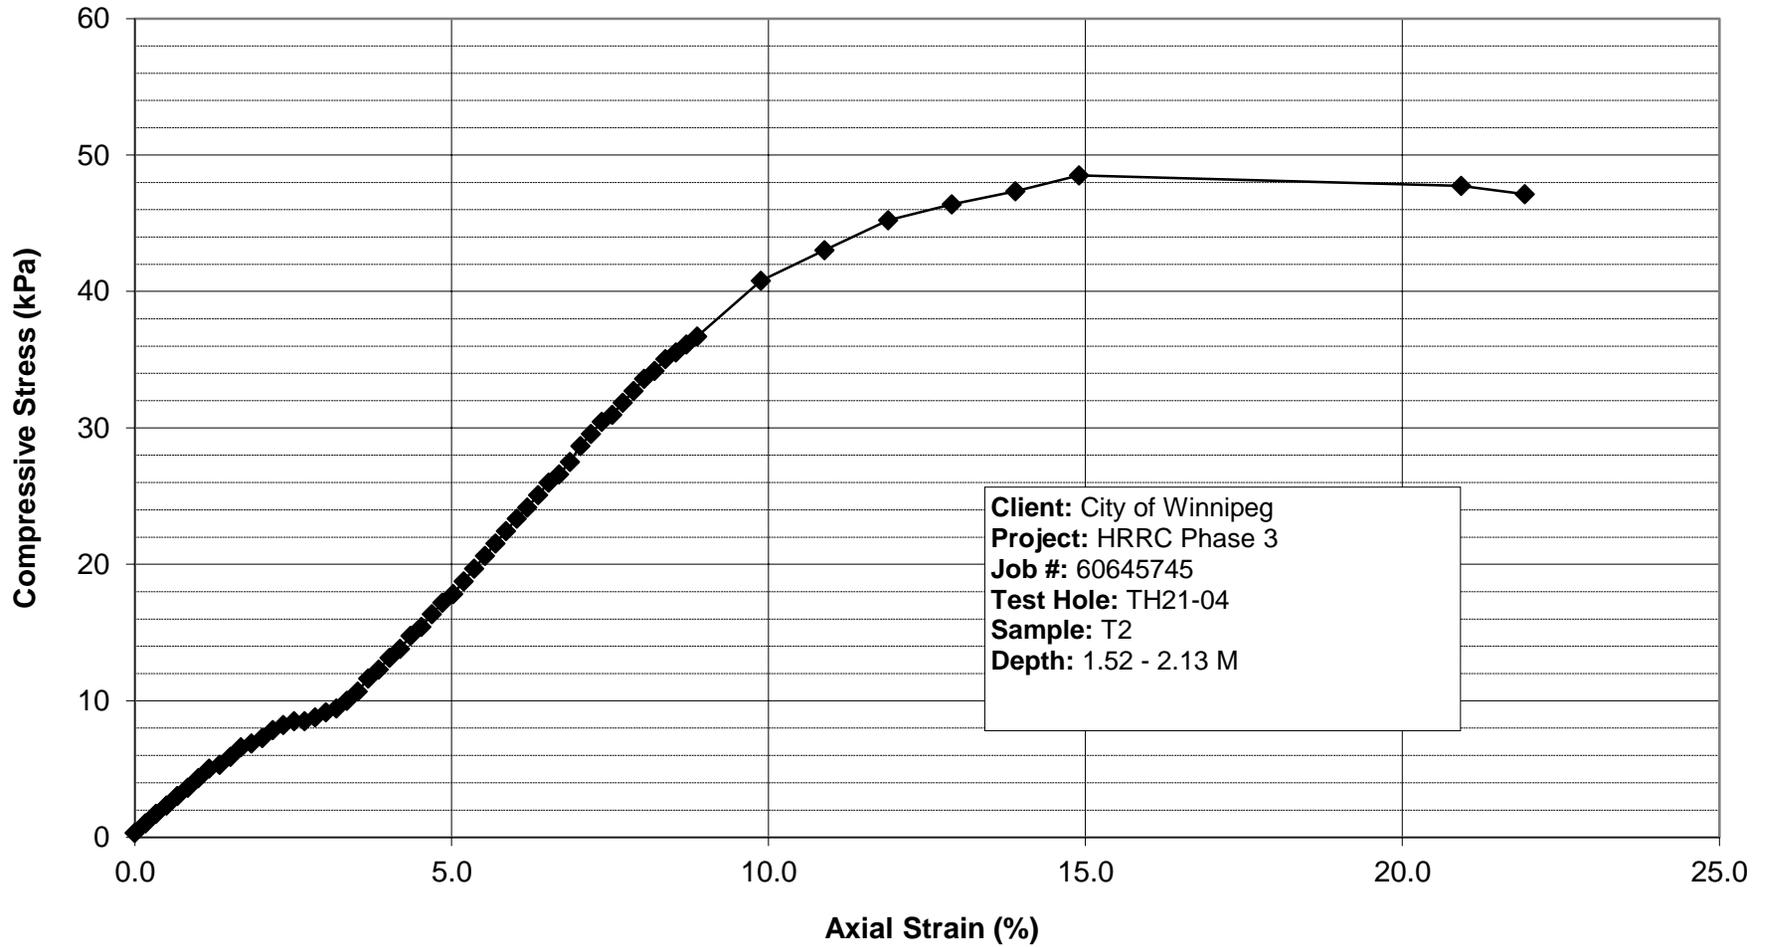
AECOM  
UNCONFINED COMPRESSIVE STRENGTH OF COHESIVE SOILS  
(ASTM D2166)

<b>Avg. Diameter (cm)</b>	<b>7.23</b>
Length 1 (cm)	15.20
Length 2 (cm)	15.20
Length 3 (cm)	15.30
<b>Avg. Length (cm)</b>	<b>15.23</b>
Volume (cm <sup>3</sup> )	626.0
Moisture content (%)	8.7
Bulk Density (g/cm <sup>3</sup> )	2.396
<b>Bulk Density (kN/m<sup>3</sup>)</b>	<b>23.5</b>
<b>Bulk Density (pcf)</b>	<b>149.6</b>
<b>Dry Density (kN/m<sup>3</sup>)</b>	<b>21.63</b>

<b>SOIL DESCRIPTION:</b>	
SILT (Till) - Some clay, some sand, trace to some gravel, light brown, moist, soft to firm, intermediate plasticity	
<b>MOISTURE CONTENT:</b> 8.7

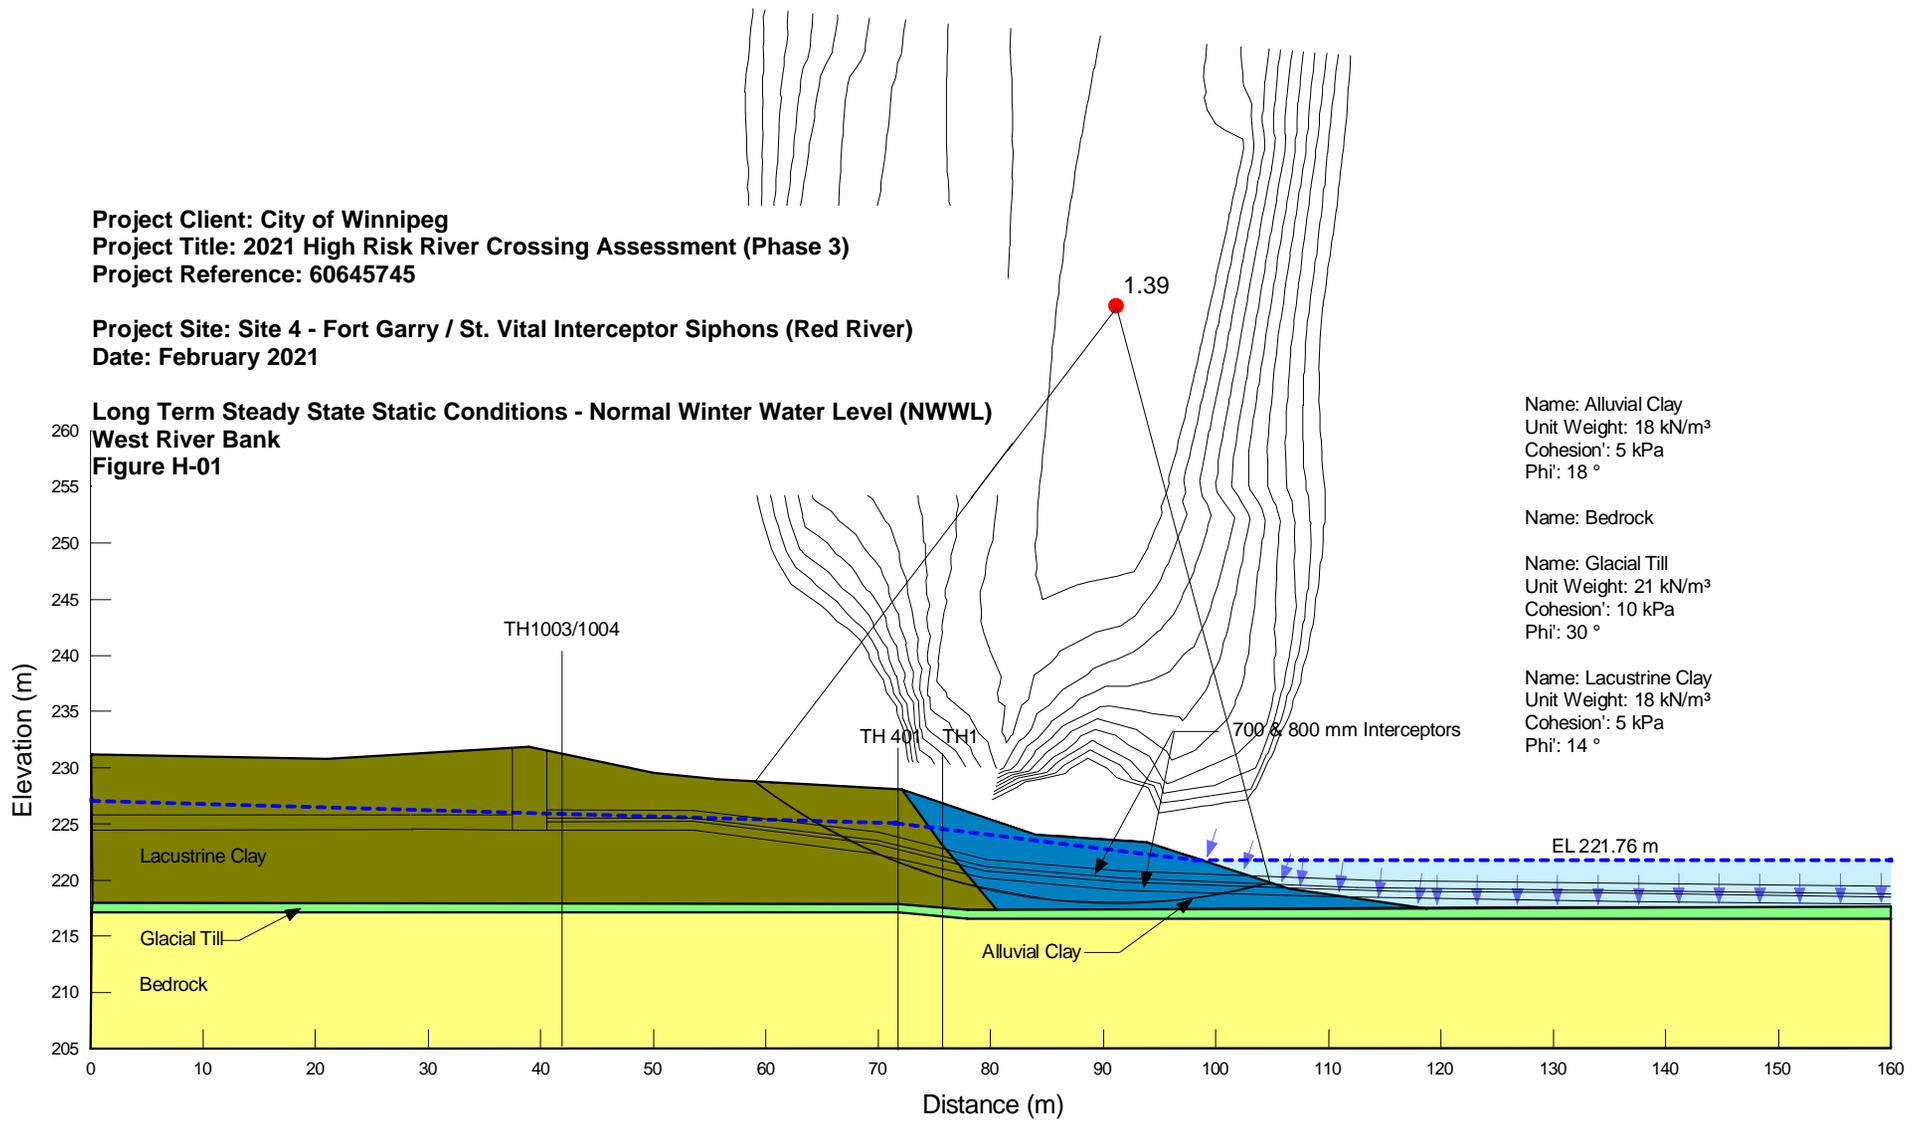
**Project Site: Site 4 - Fort Garry / St. Vital Interceptor Siphons (Red River)**  
**Date: February 2021**

**Long Term Steady State Static Conditions - Normal Winter Water Level (NWWL)**  
**West River Bank**  
**Figure H-01**
