# Replacement of the FGSV Siphon

Geotechnical Baseline Report  
FINAL

City of Winnipeg

May 2025

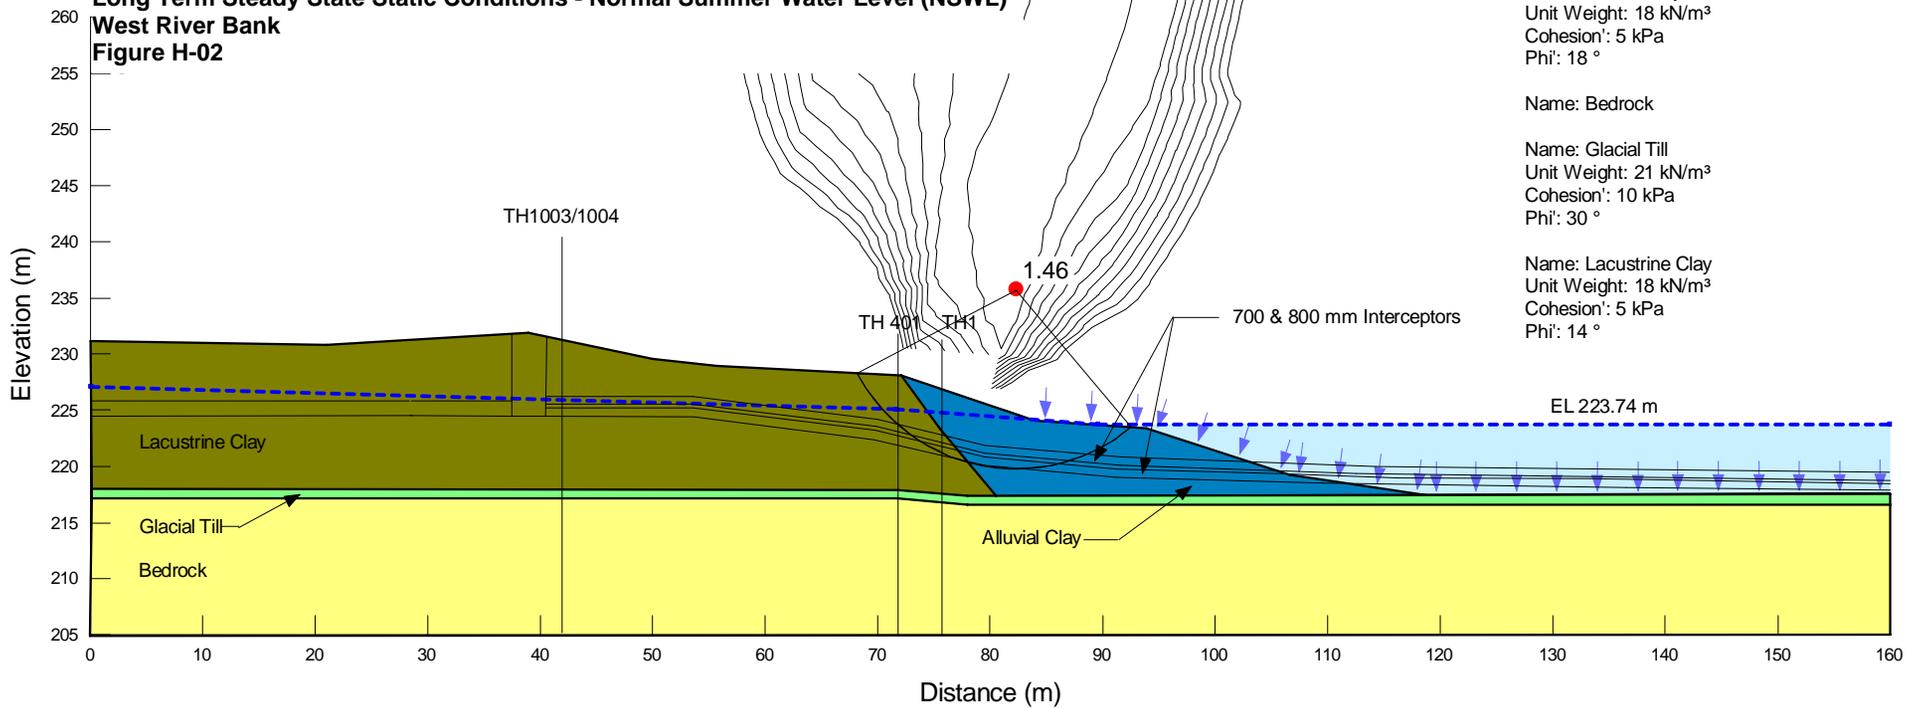
**Long Term Steady State Static Conditions - Normal Summer Water Level (NSWL)**

**West River Bank**  
**Figure H-02**

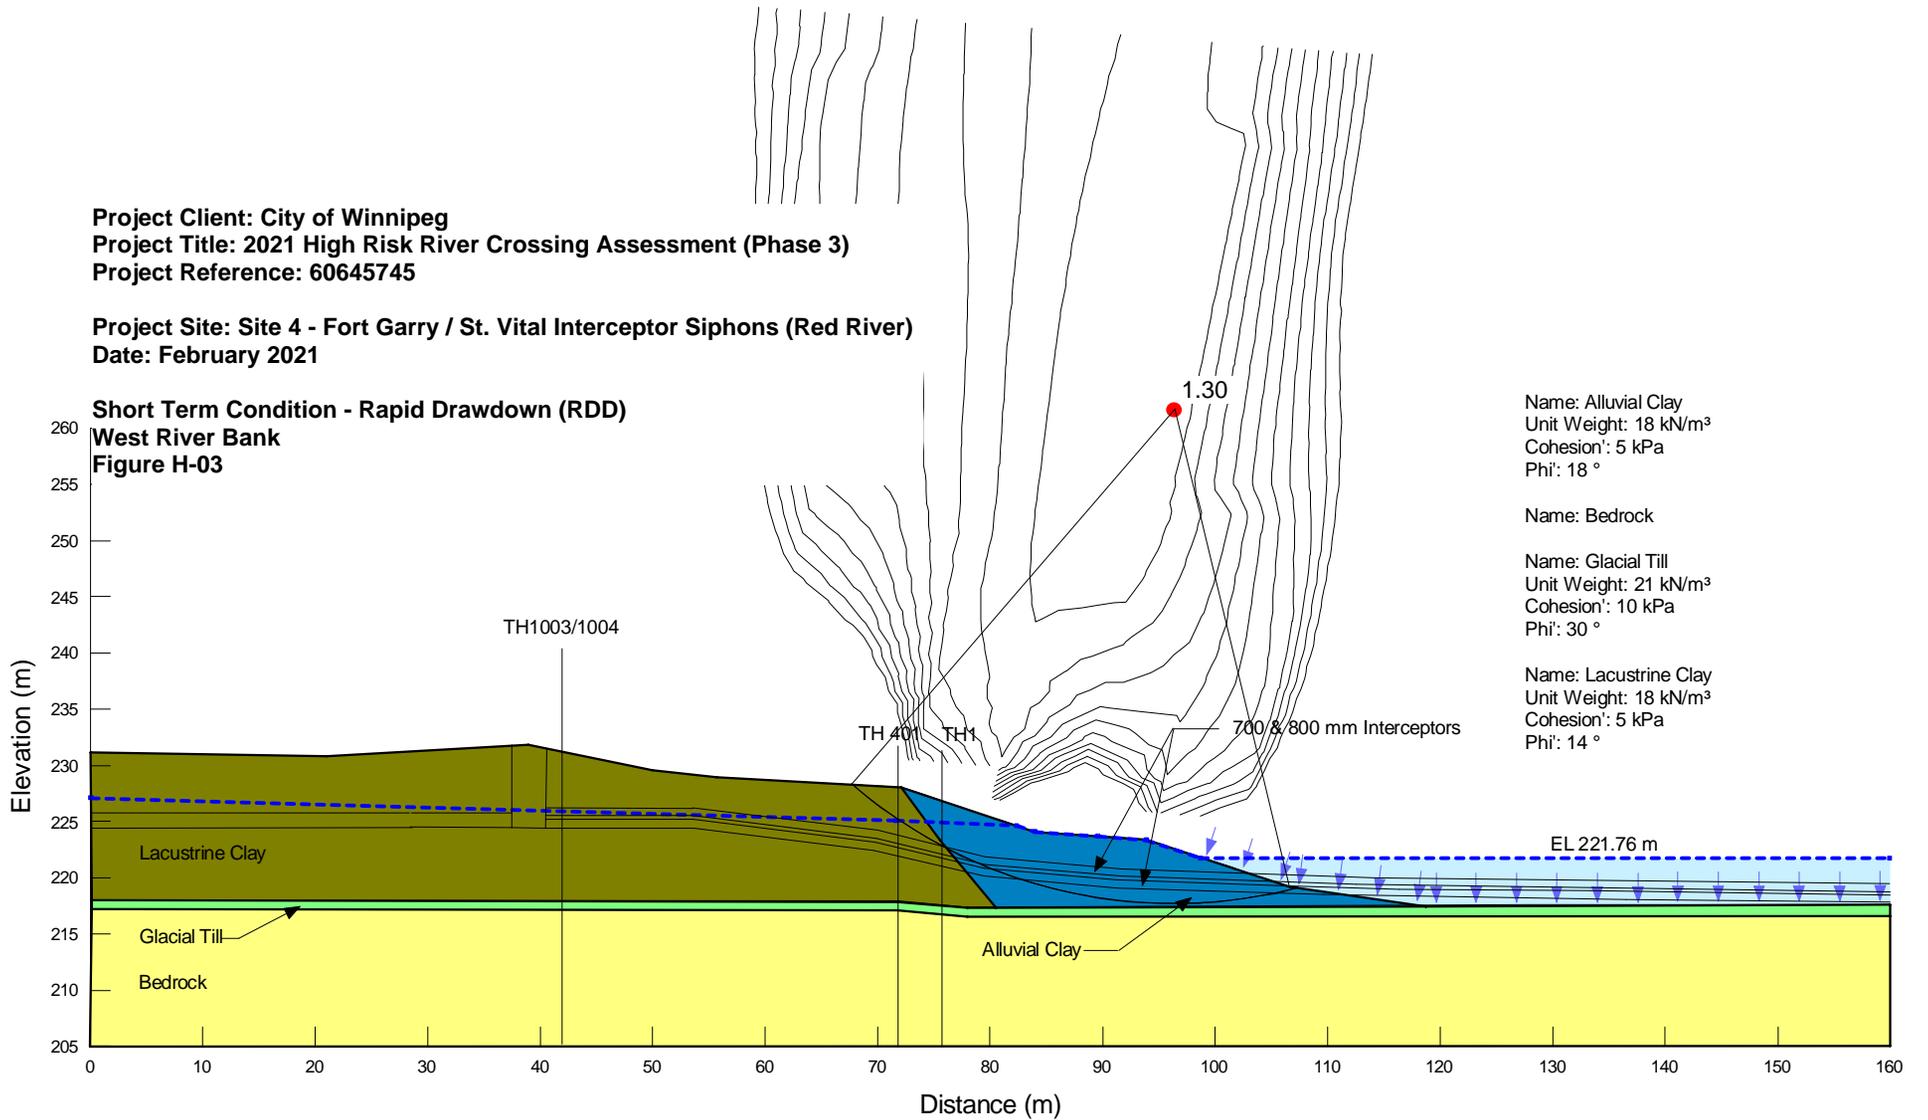
**Short Term Condition - Rapid Drawdown (RDD)**  
**West River Bank**  
**Figure H-03**

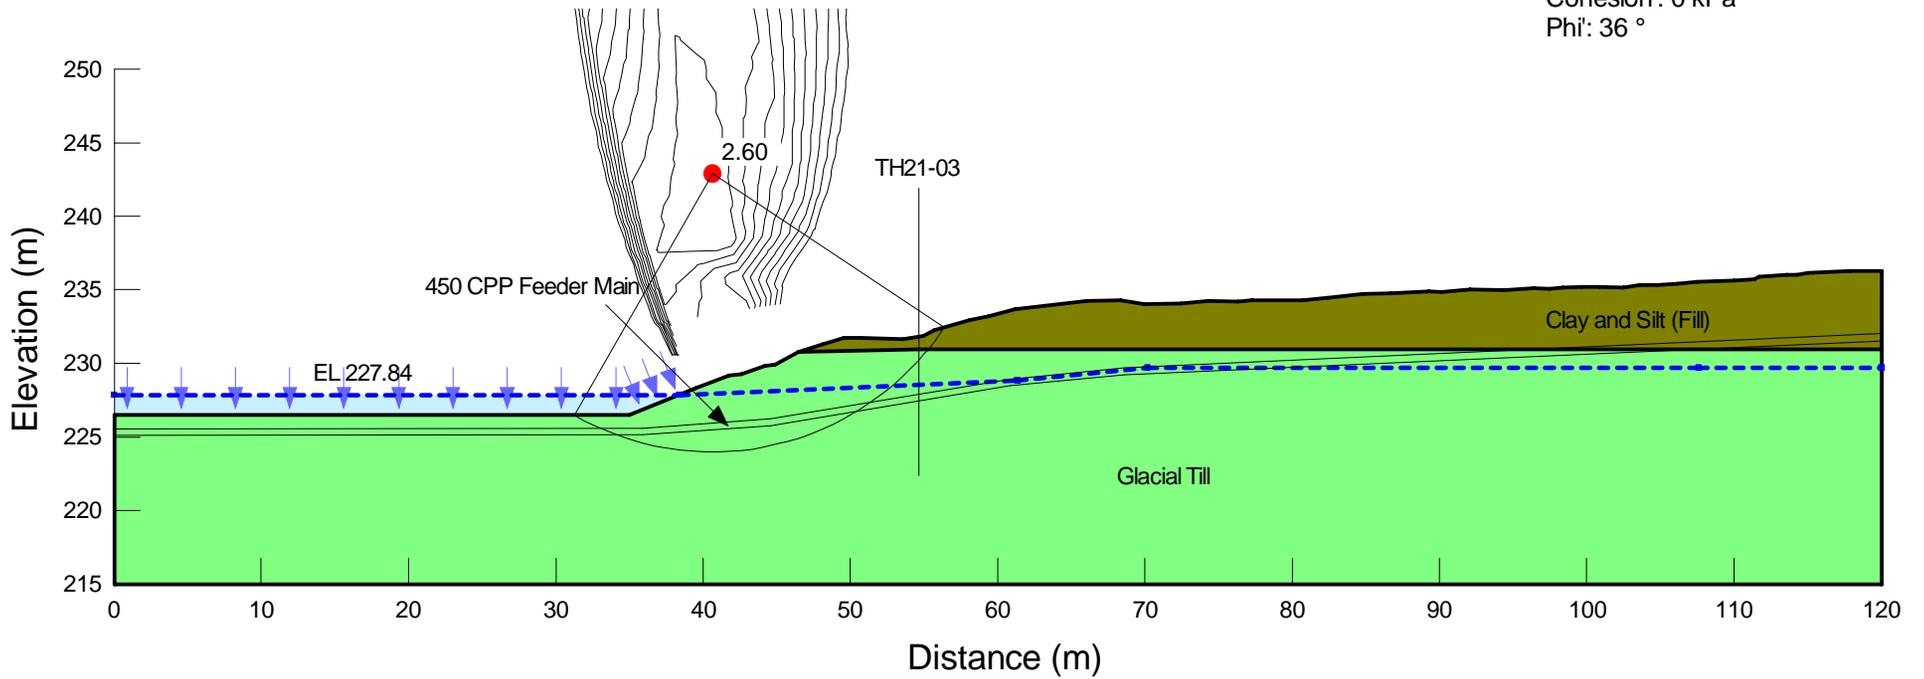
**Long Term Steady State Static Conditions - Normal Winter Water Level (NWWL)**  
**North River Bank**  
**Figure H-04**

Name: Clay and Silt (Fill)  
Unit Weight: 18.5 kN/m<sup>3</sup>  
Cohesion: 2 kPa  
Phi: 18 °

Name: Glacial Till  
Unit Weight: 21 kN/m<sup>3</sup>  
Cohesion: 0 kPa  
Phi: 36 °

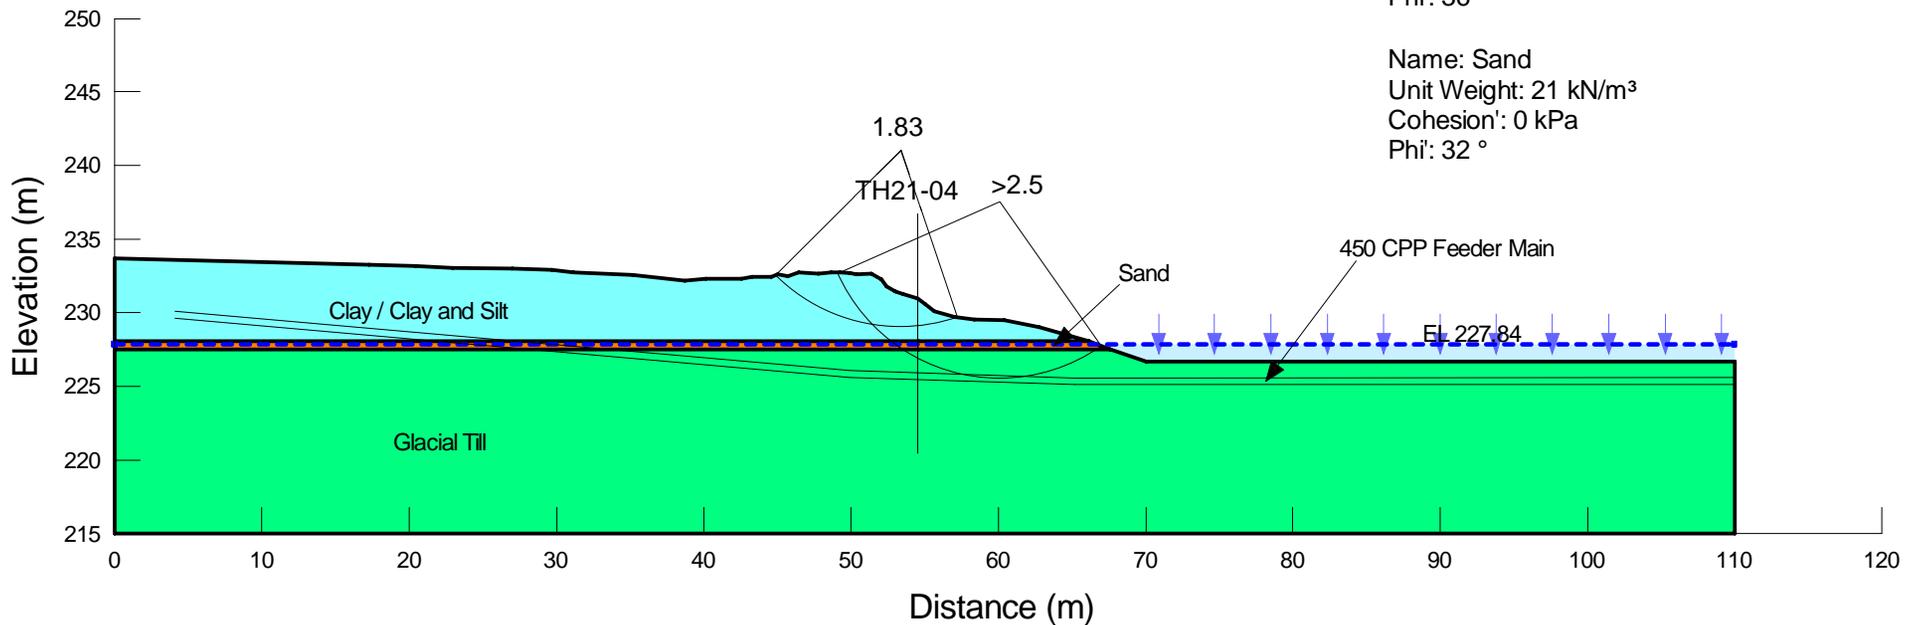
**Long Term Steady State Static Conditions - Normal Winter Water Level (NWWL)**  
**South River Bank**  
**Figure H-05**

Name: Glacial Till  
Unit Weight: 21 kN/m<sup>3</sup>  
Cohesion': 0 kPa  
Phi': 36 °

Name: Sand  
Unit Weight: 21 kN/m<sup>3</sup>  
Cohesion': 0 kPa  
Phi': 32 °

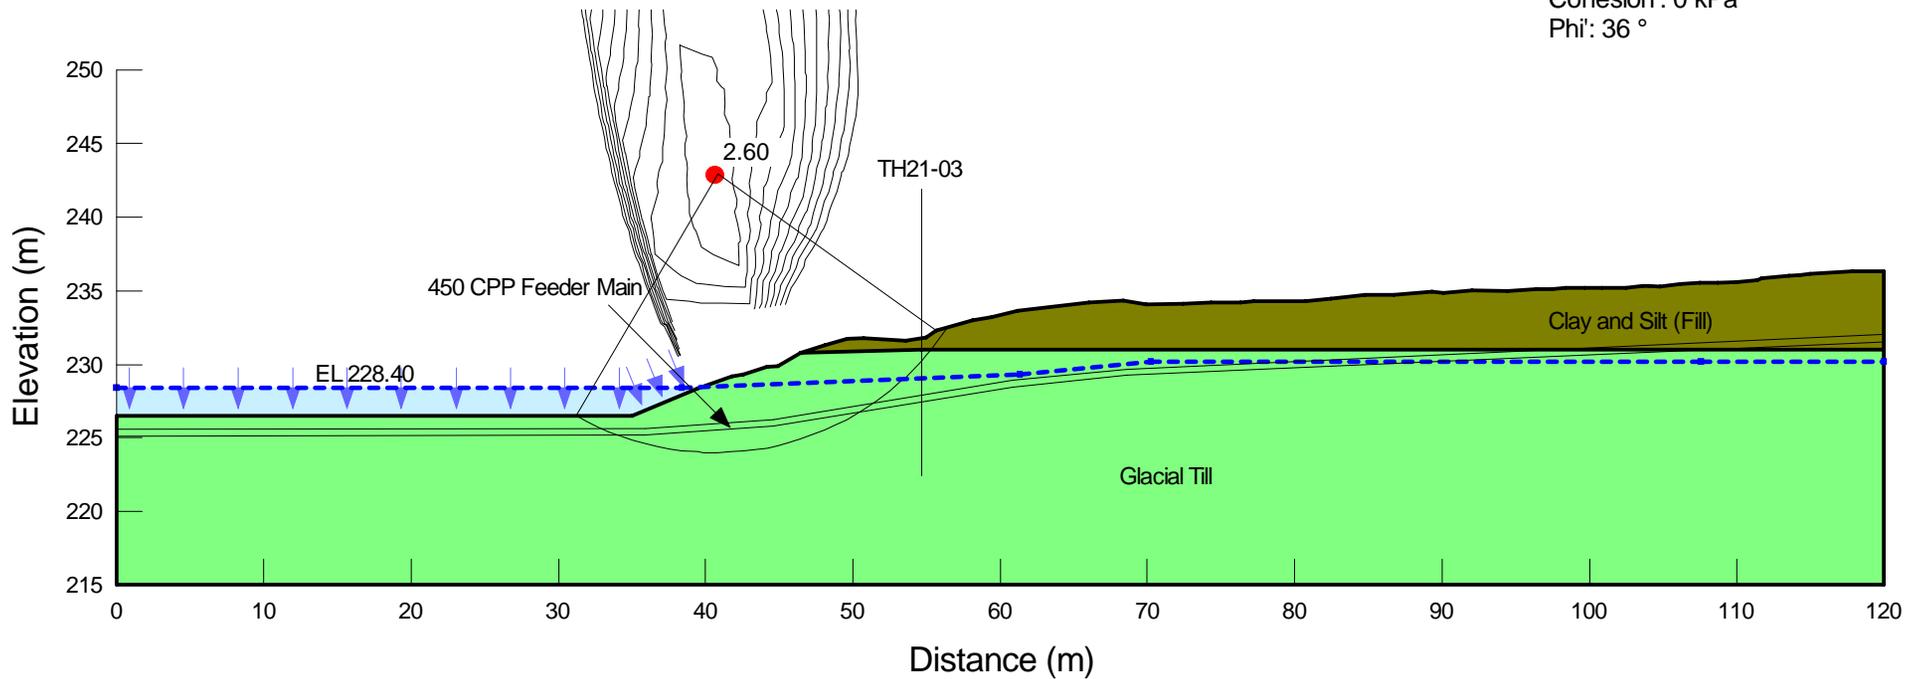
**Long Term Steady State Static Conditions - Normal Summer Water Level (NSWL)**  
**North River Bank**  
**Figure H-06**

Name: Clay and Silt (Fill)  
Unit Weight: 18.5 kN/m<sup>3</sup>  
Cohesion: 2 kPa  
Phi: 18 °

Name: Glacial Till  
Unit Weight: 21 kN/m<sup>3</sup>  
Cohesion: 0 kPa  
Phi: 36 °

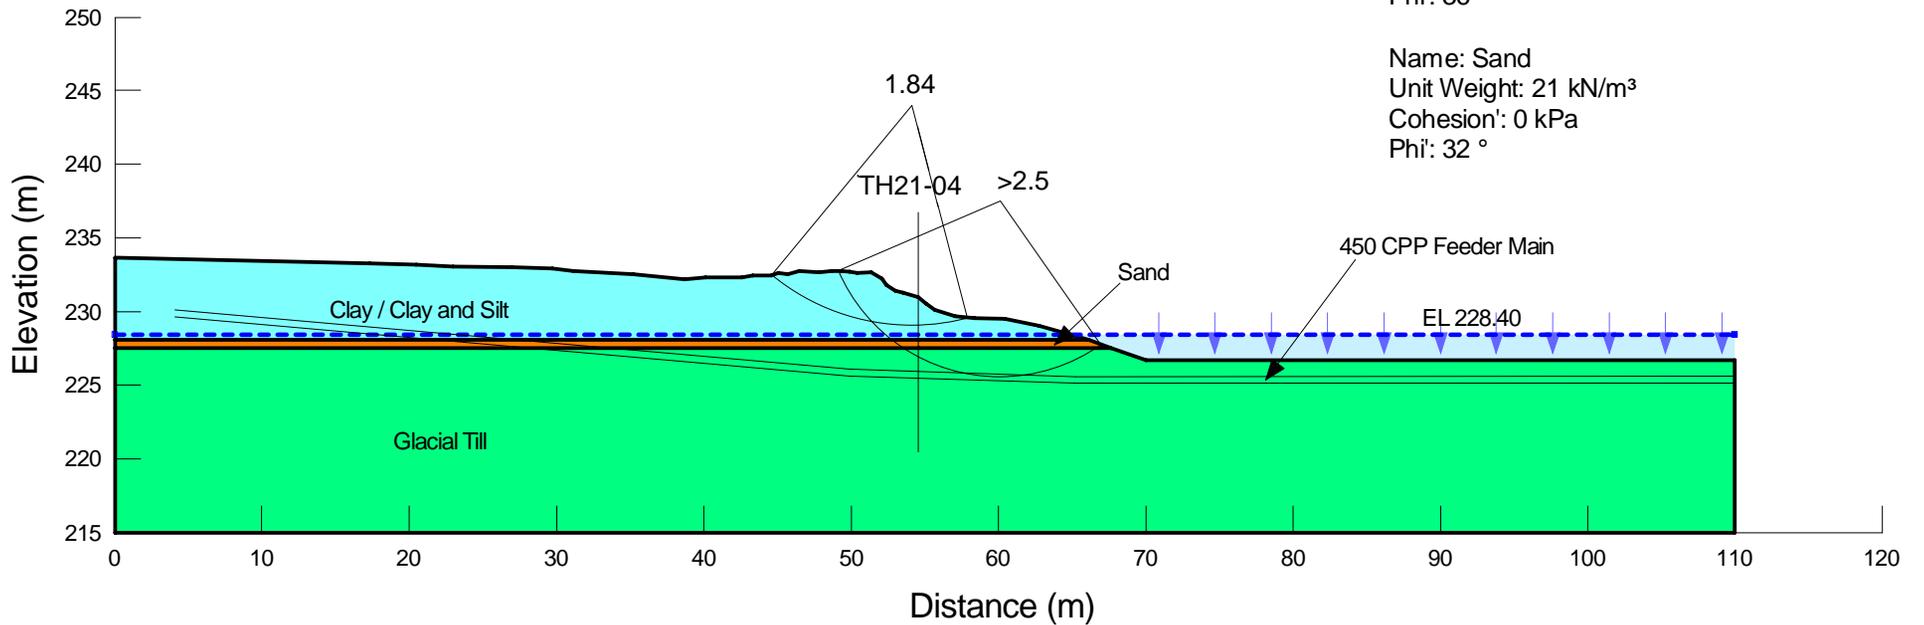
**Long Term Steady State Static Conditions - Normal Summer Water Level (NSWL)**  
**South River Bank**  
**Figure H-07**

Name: Glacial Till  
Unit Weight: 21 kN/m<sup>3</sup>  
Cohesion: 0 kPa  
Phi: 36 °

Name: Sand  
Unit Weight: 21 kN/m<sup>3</sup>  
Cohesion: 0 kPa  
Phi: 32 °

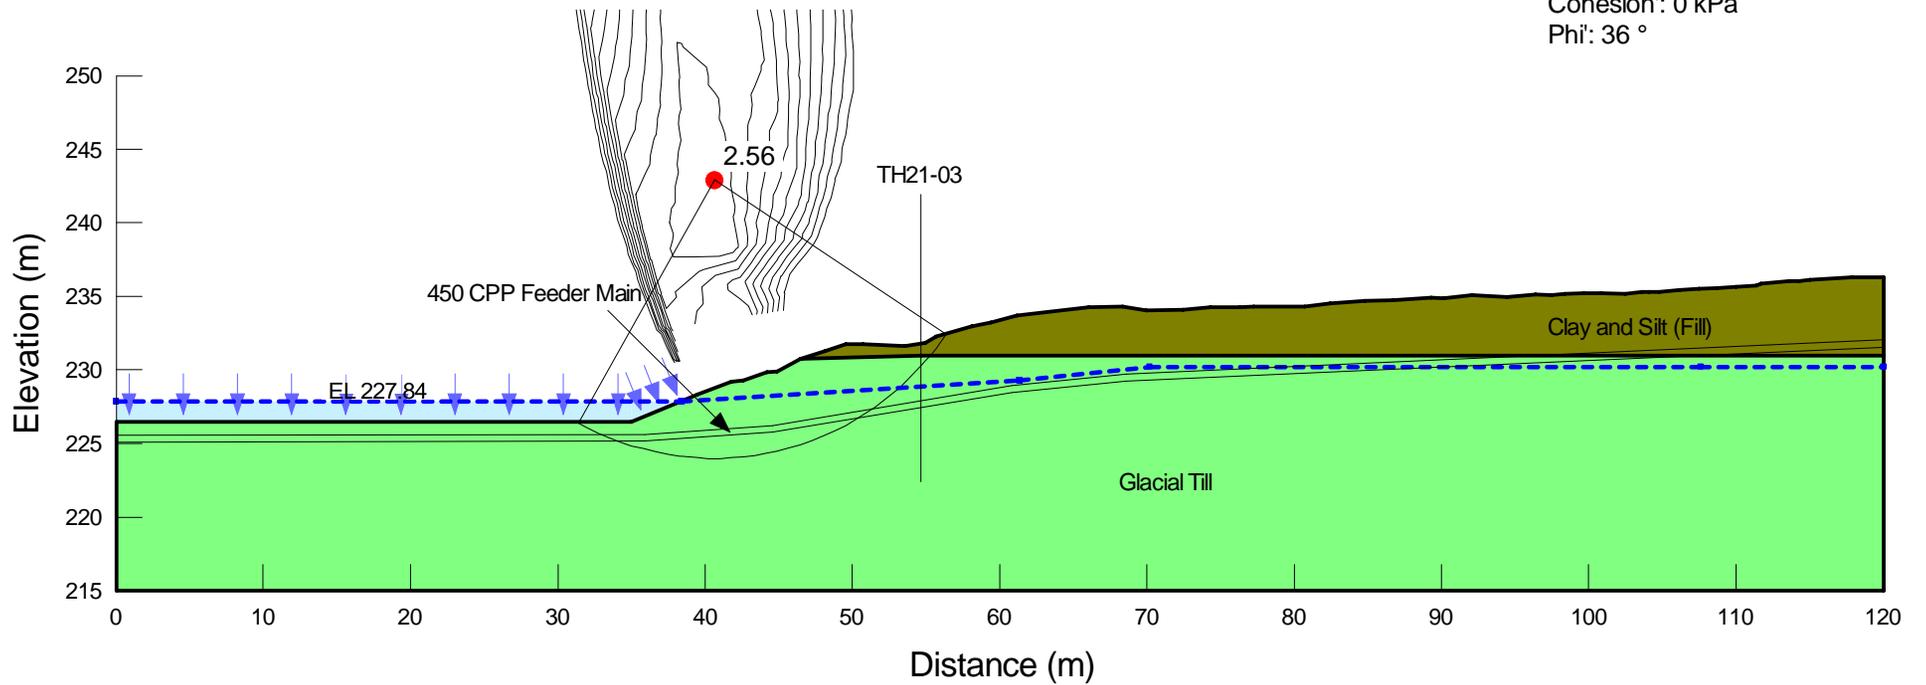
**Short Term Conditions - Rapid Drawdown (RDD)**  
**North River Bank**  
**Figure H-08**

Name: Clay and Silt (Fill)  
Unit Weight: 18.5 kN/m<sup>3</sup>  
Cohesion: 2 kPa  
Phi: 18 °

Name: Glacial Till  
Unit Weight: 21 kN/m<sup>3</sup>  
Cohesion: 0 kPa  
Phi: 36 °

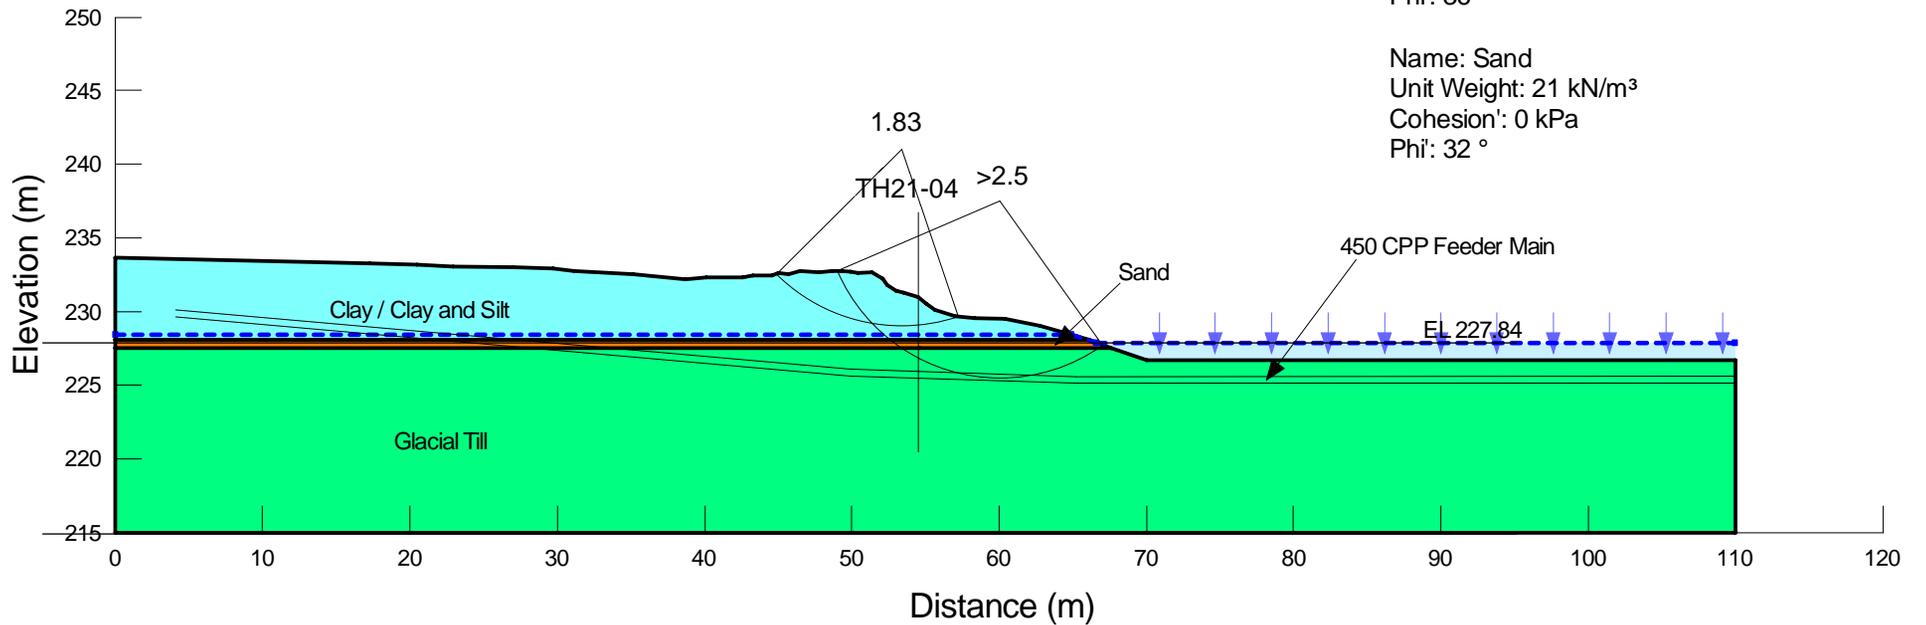
**Short Term Conditions - Rapid Drawdown (RDD)**  
**South River Bank**  
**Figure H-09**

Name: Glacial Till  
Unit Weight: 21 kN/m<sup>3</sup>  
Cohesion': 0 kPa  
Phi': 36 °

Name: Sand  
Unit Weight: 21 kN/m<sup>3</sup>  
Cohesion': 0 kPa  
Phi': 32 °

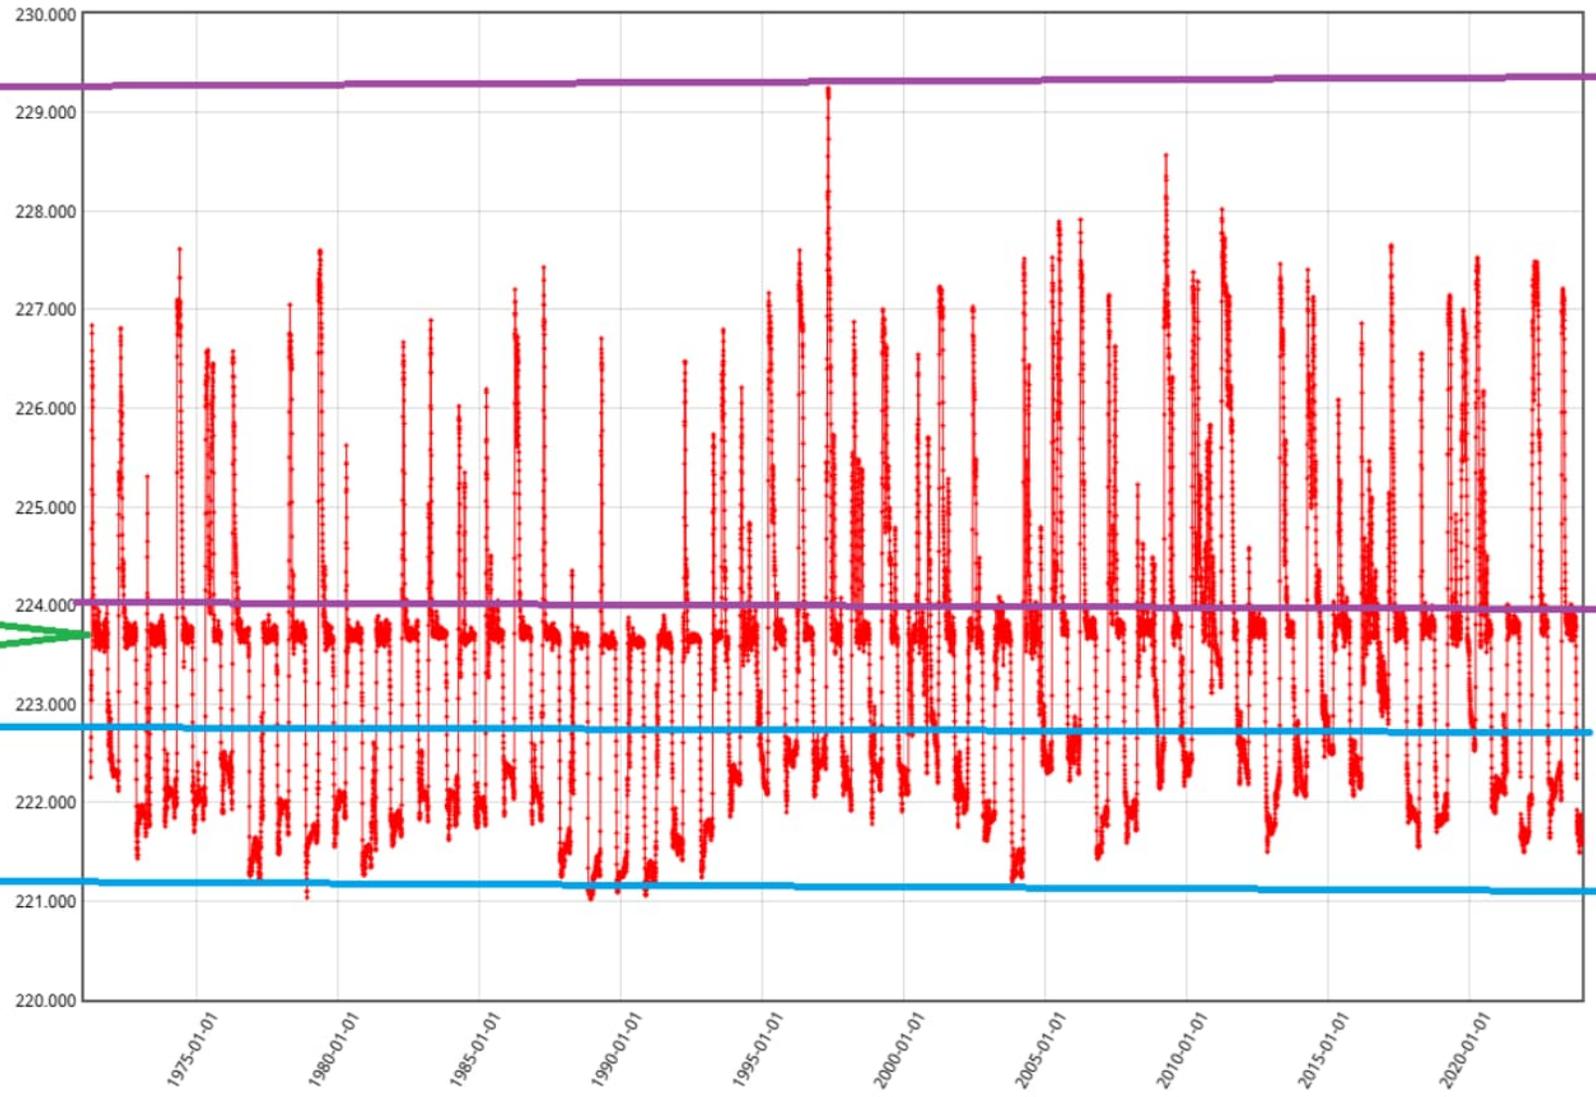
Level (m)

High variability  
in Spring  
Spring

Summer levels very  
consistent. Controlled  
by St. Andrews Lock  
and Dam
