THE CITY OF WINNIPEG PUBLIC WORKS DEPARTMENT ENGINEERING DIVISION		CITY DRAWING NUMBER B123-25-2206	
LAGIMODIERE TWIN OVERPASSES OVER CPKC KEEWATIN REHABILITATION AND RELATED WORKS		SHEET 6 OF 48	
NORTHBOUND STRUCTURE NORTH ABUTMENT N-5 - DEMOLITION AND REPAIR DETAILS		2206

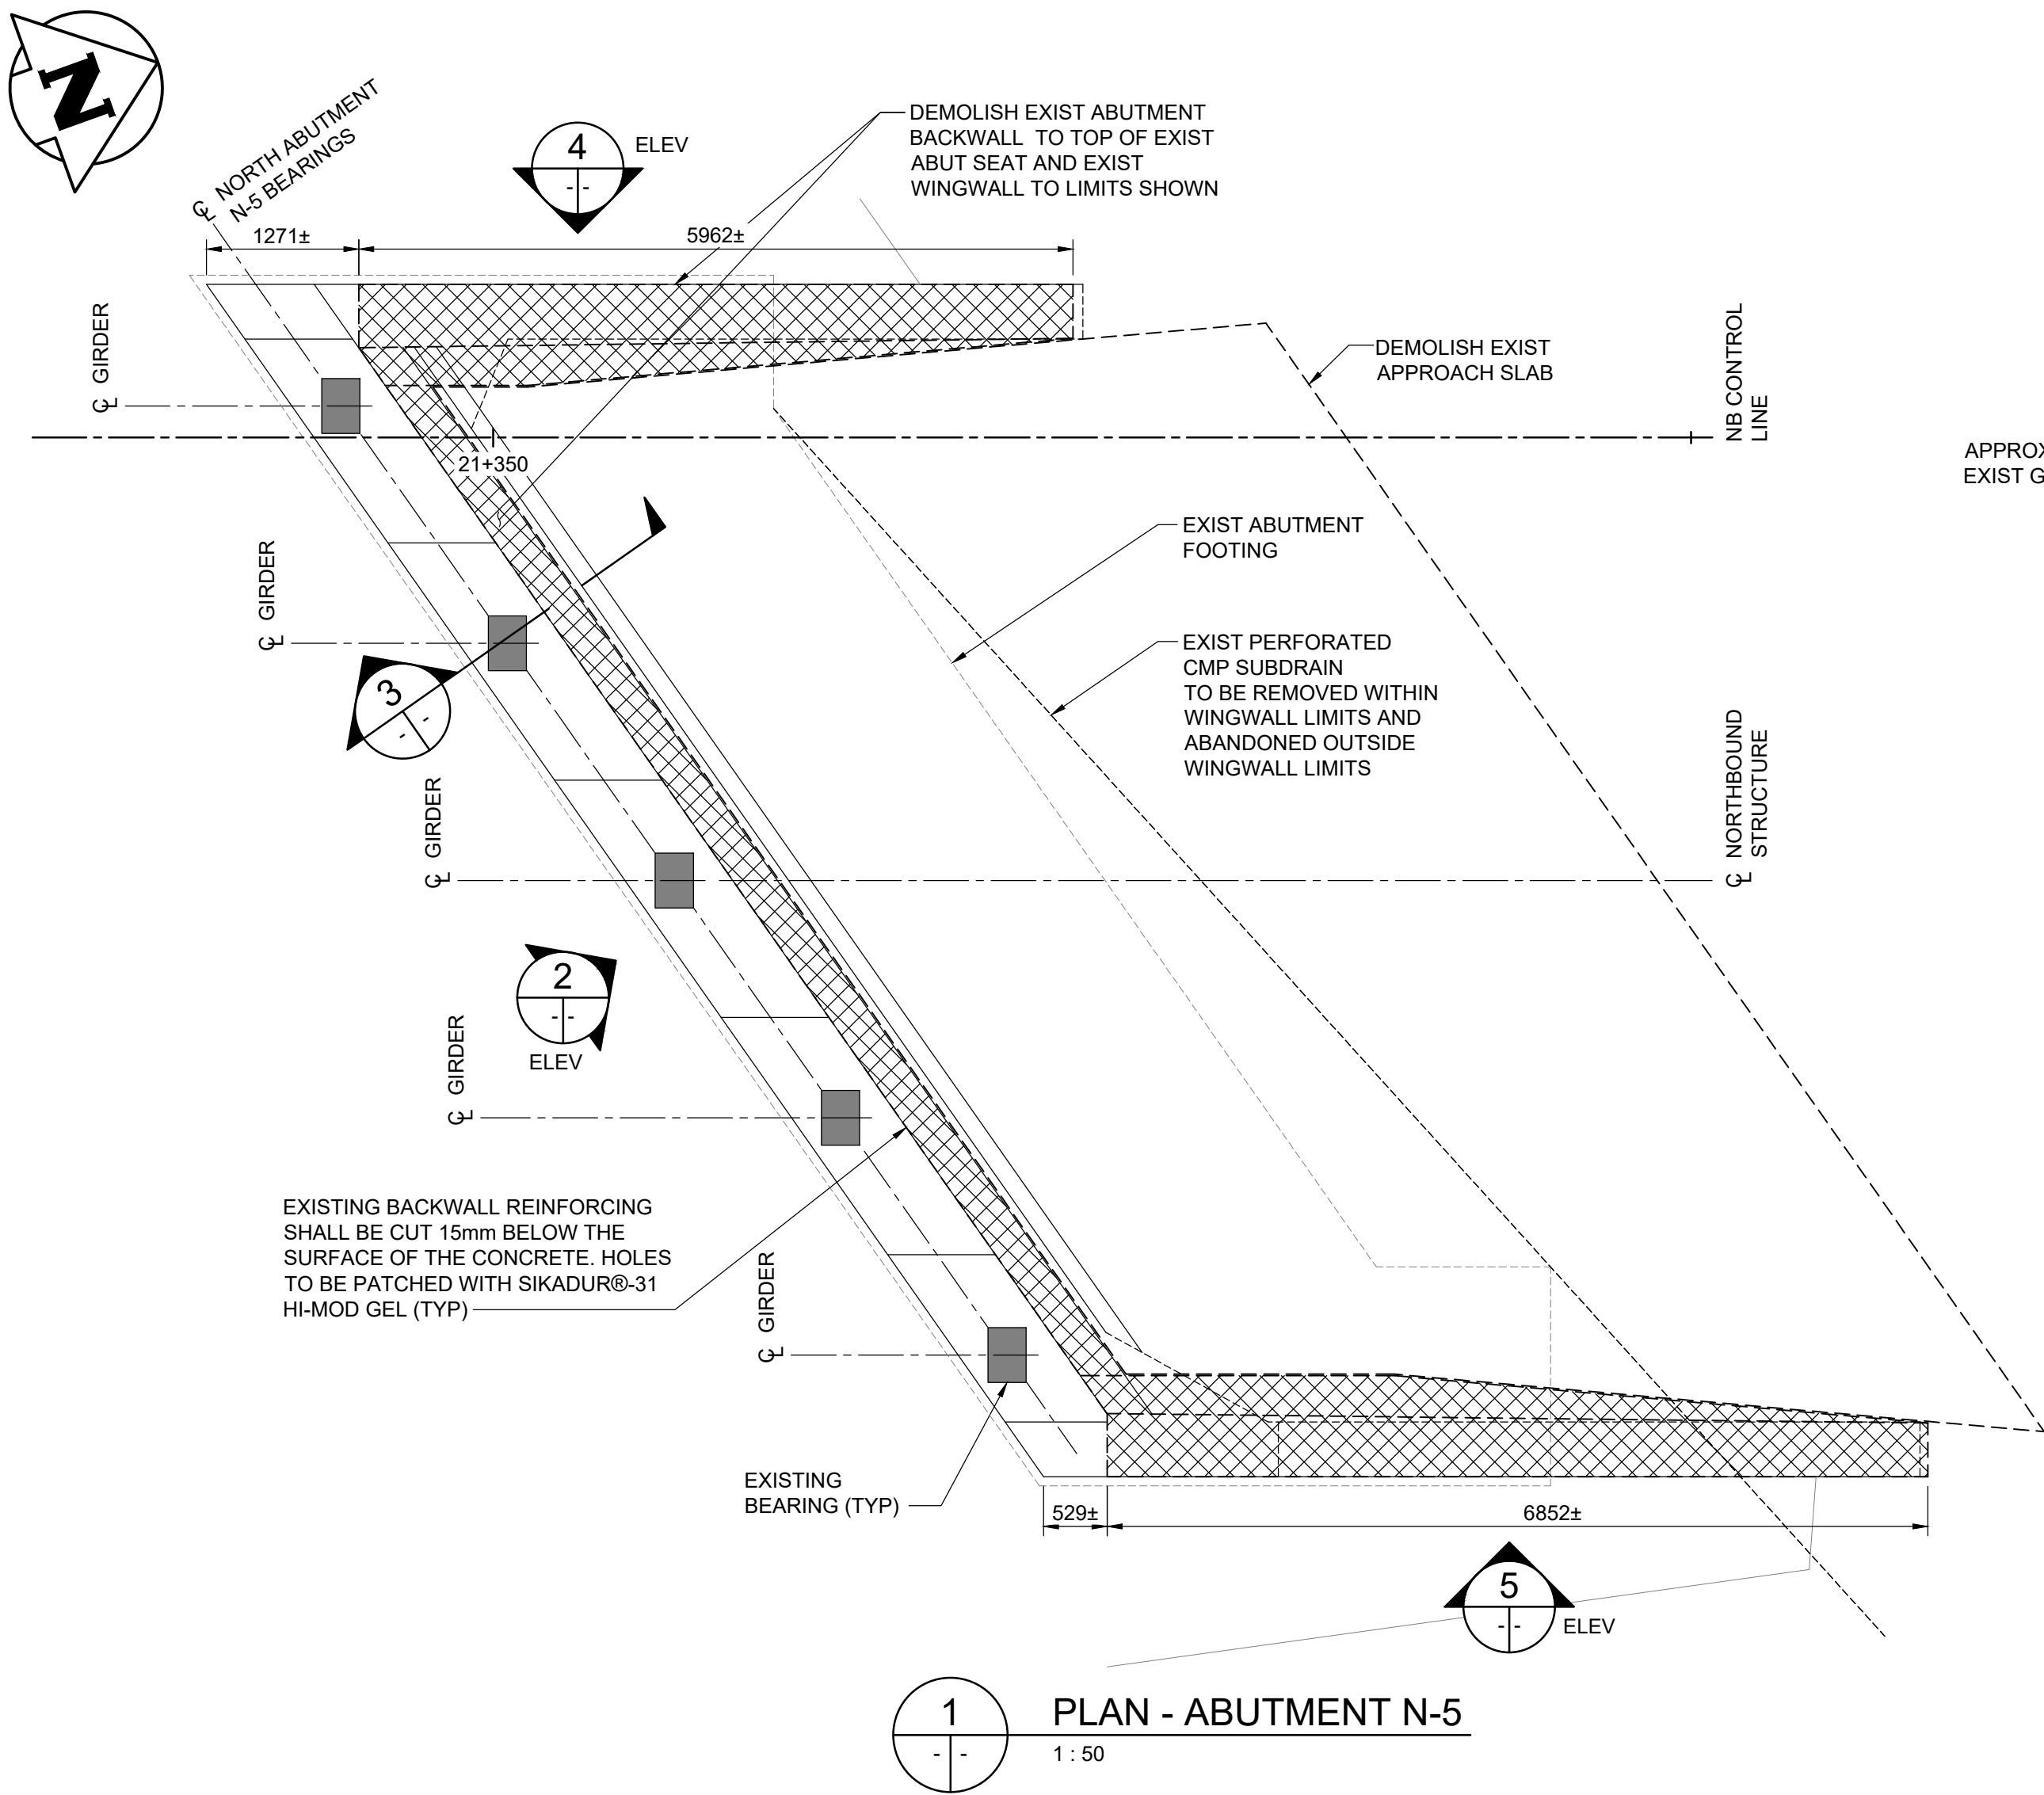
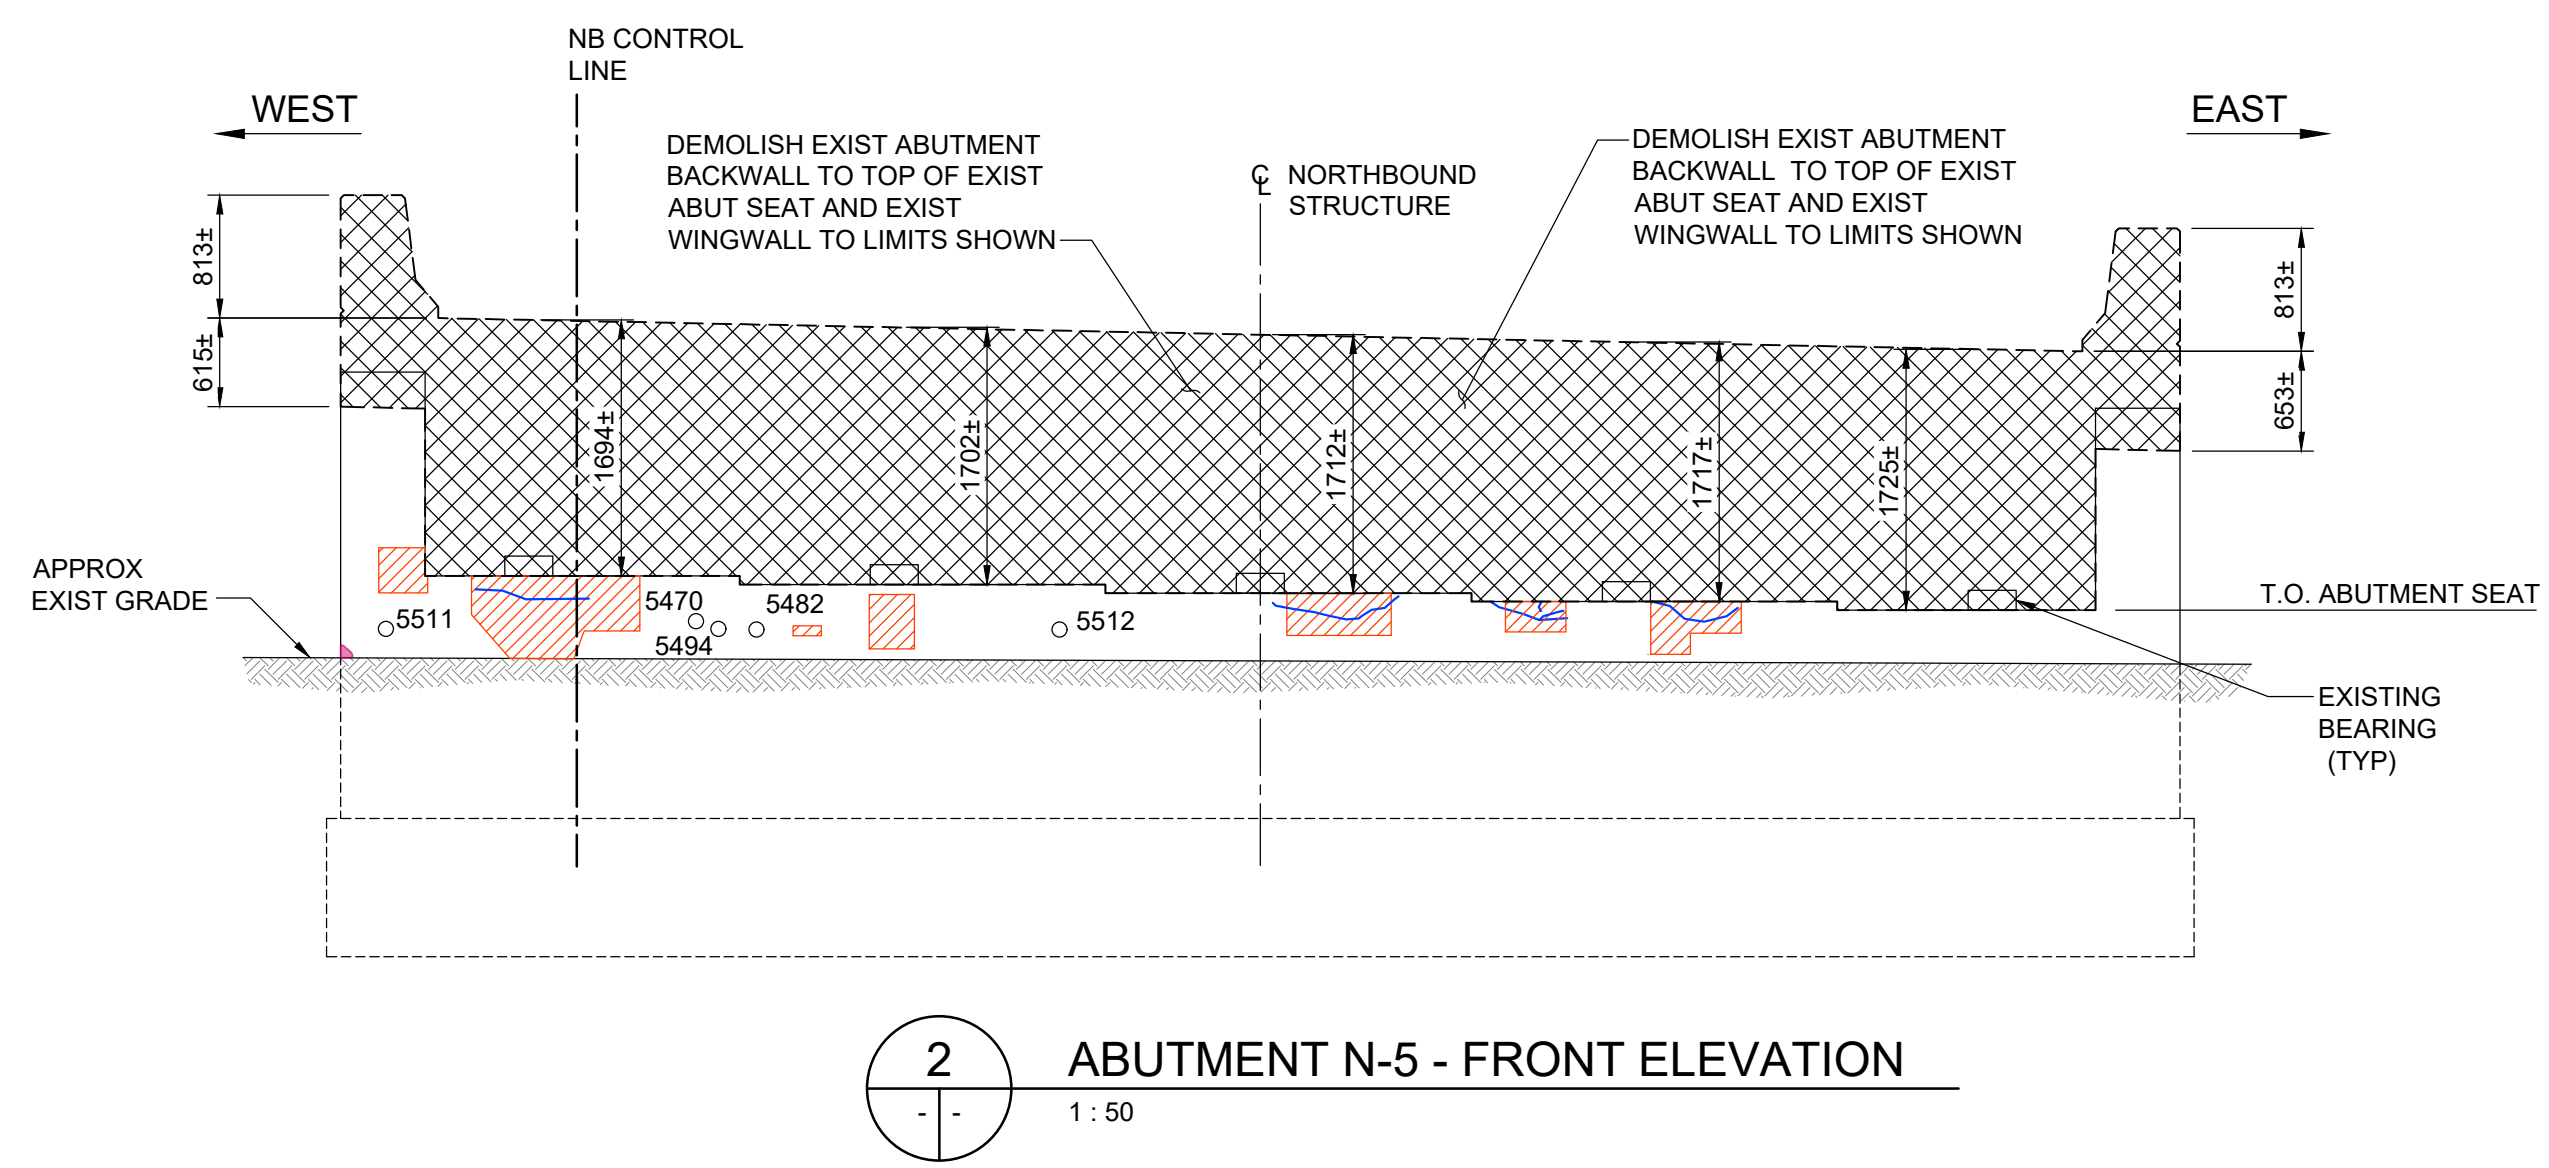
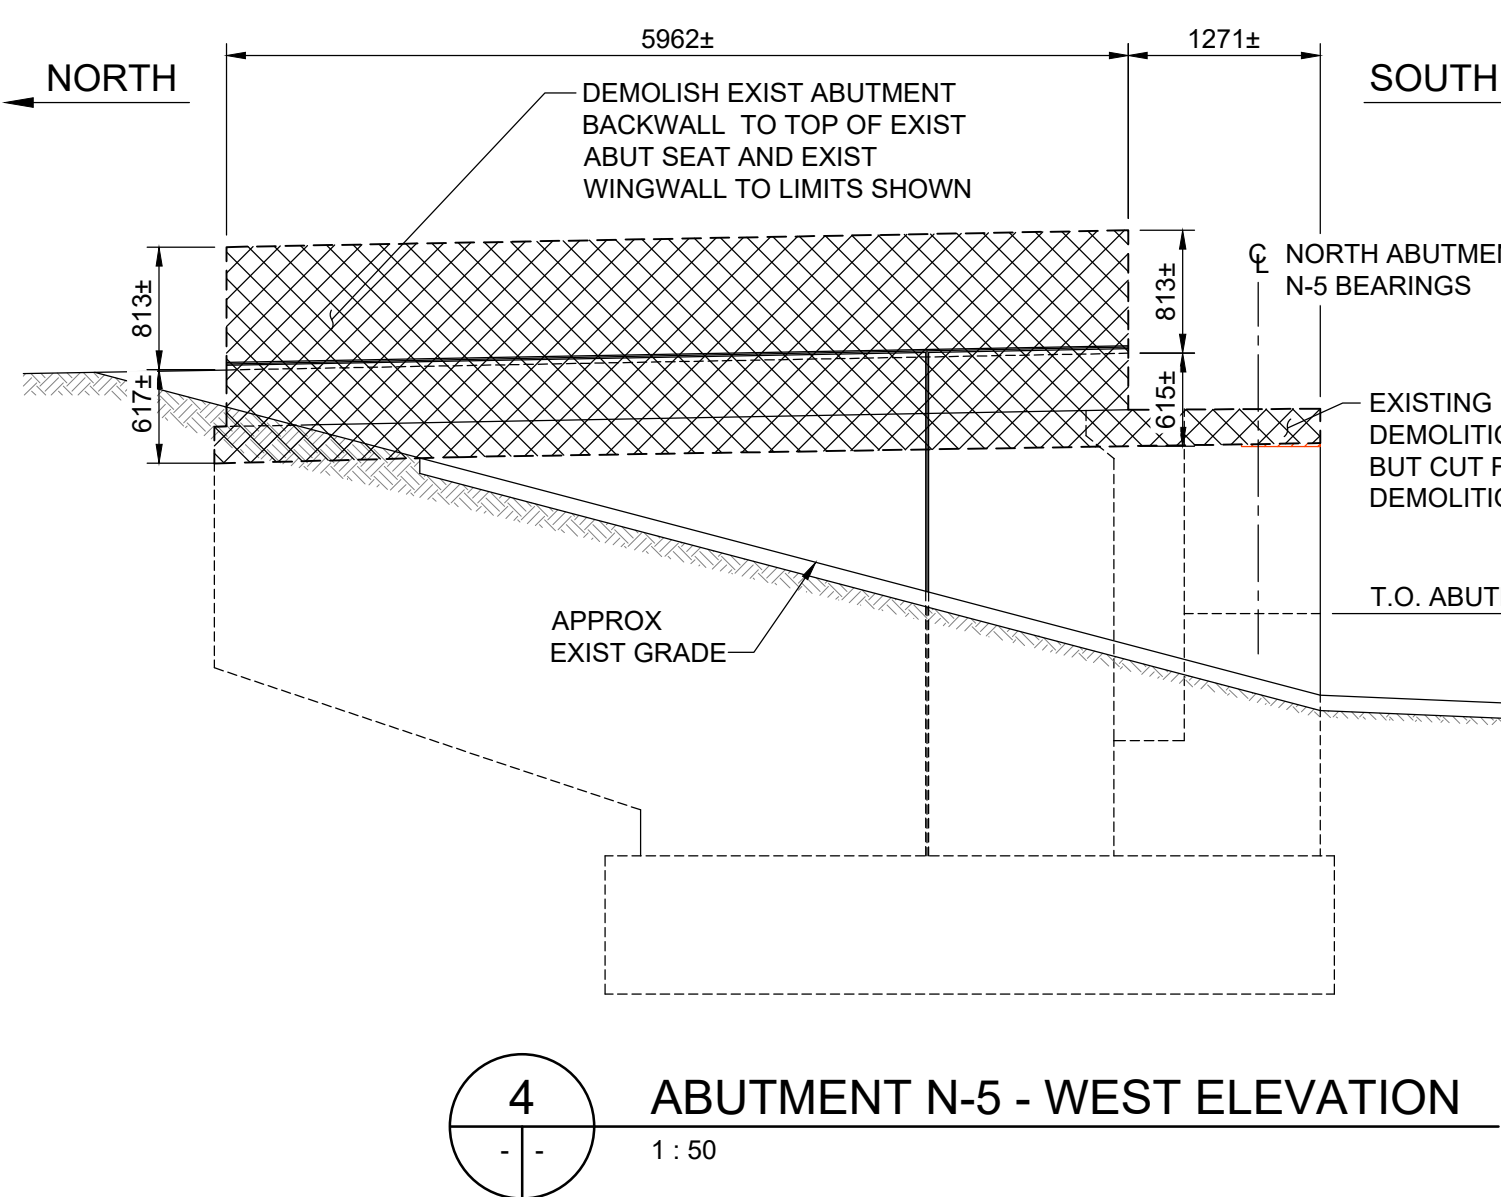
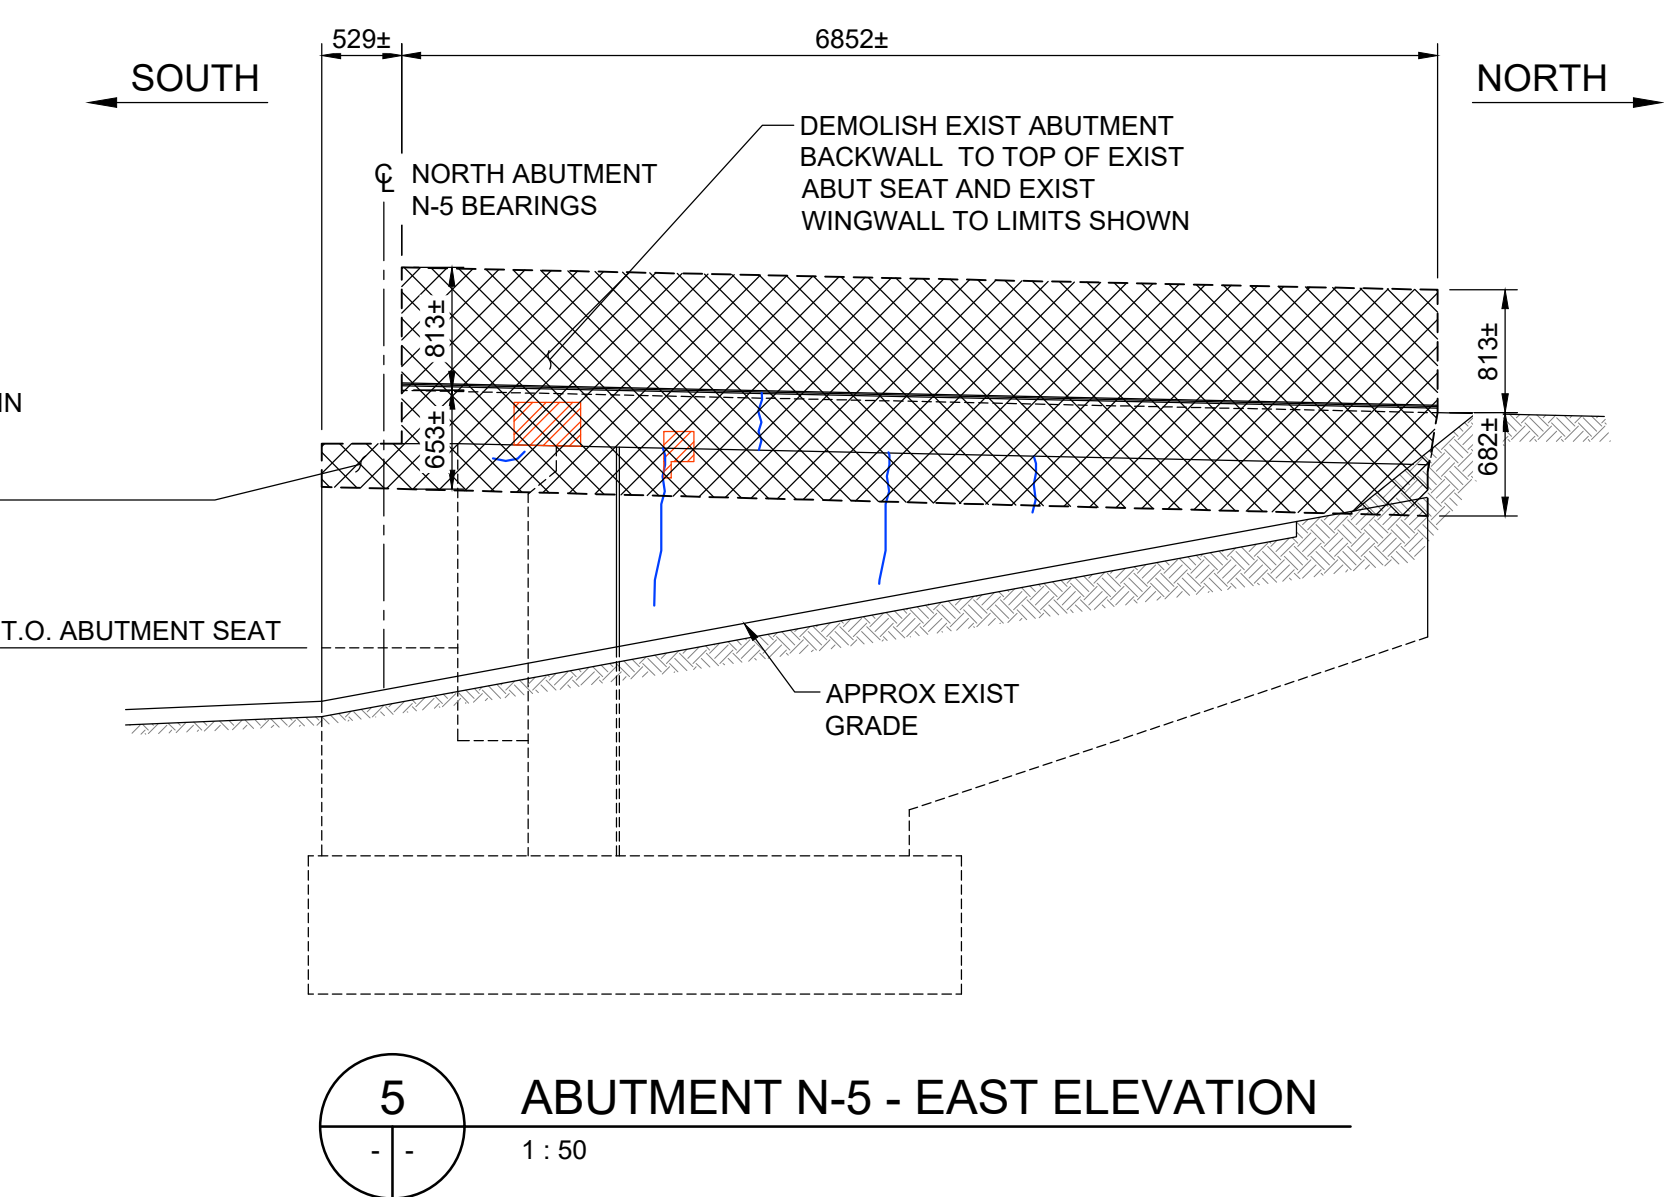
- CRACK
- ▨ DELAMINATION
- SPALL
- CORE
- ABANDONED CORE (HIT REINFORCING STEEL)

1. EXISTING ABUTMENT N.0 SHOWN, REFER TO CONDITION ASSESSMENT REPORT FOR N.5, S.0, AND S.5.
2. CRACK LOCATIONS ARE APPROXIMATE. CRACK WIDTH VARIED
3. THIS DRAWING DEPICTS SELECT FINDINGS/AREAS OF CONCERN. ACTUAL REPAIR AREAS MAY BE DIFFERENT AND WILL BE IDENTIFIED ON SITE BY THE CONTRACT ADMINISTRATOR. REPAIR AREAS TO BE MARKED OFF TO SQUARE OR RECTANGULAR SHAPES.
4. ASSUMED REPAIR AREAS ARE PROVIDED IN TABLE 1.
5. REFER TO SHEET 1004 FOR TYPICAL REPAIR NOTES.
6. REFER TO SHEET 2203 FOR DELAMINATION REPAIR DETAIL.
