NORTH WALL DETAILS

PAN AM POOL BLDG ENVELOPE RETROFIT PHASE 1

25 Poseidon Bay, Winnipeg, Manitoba

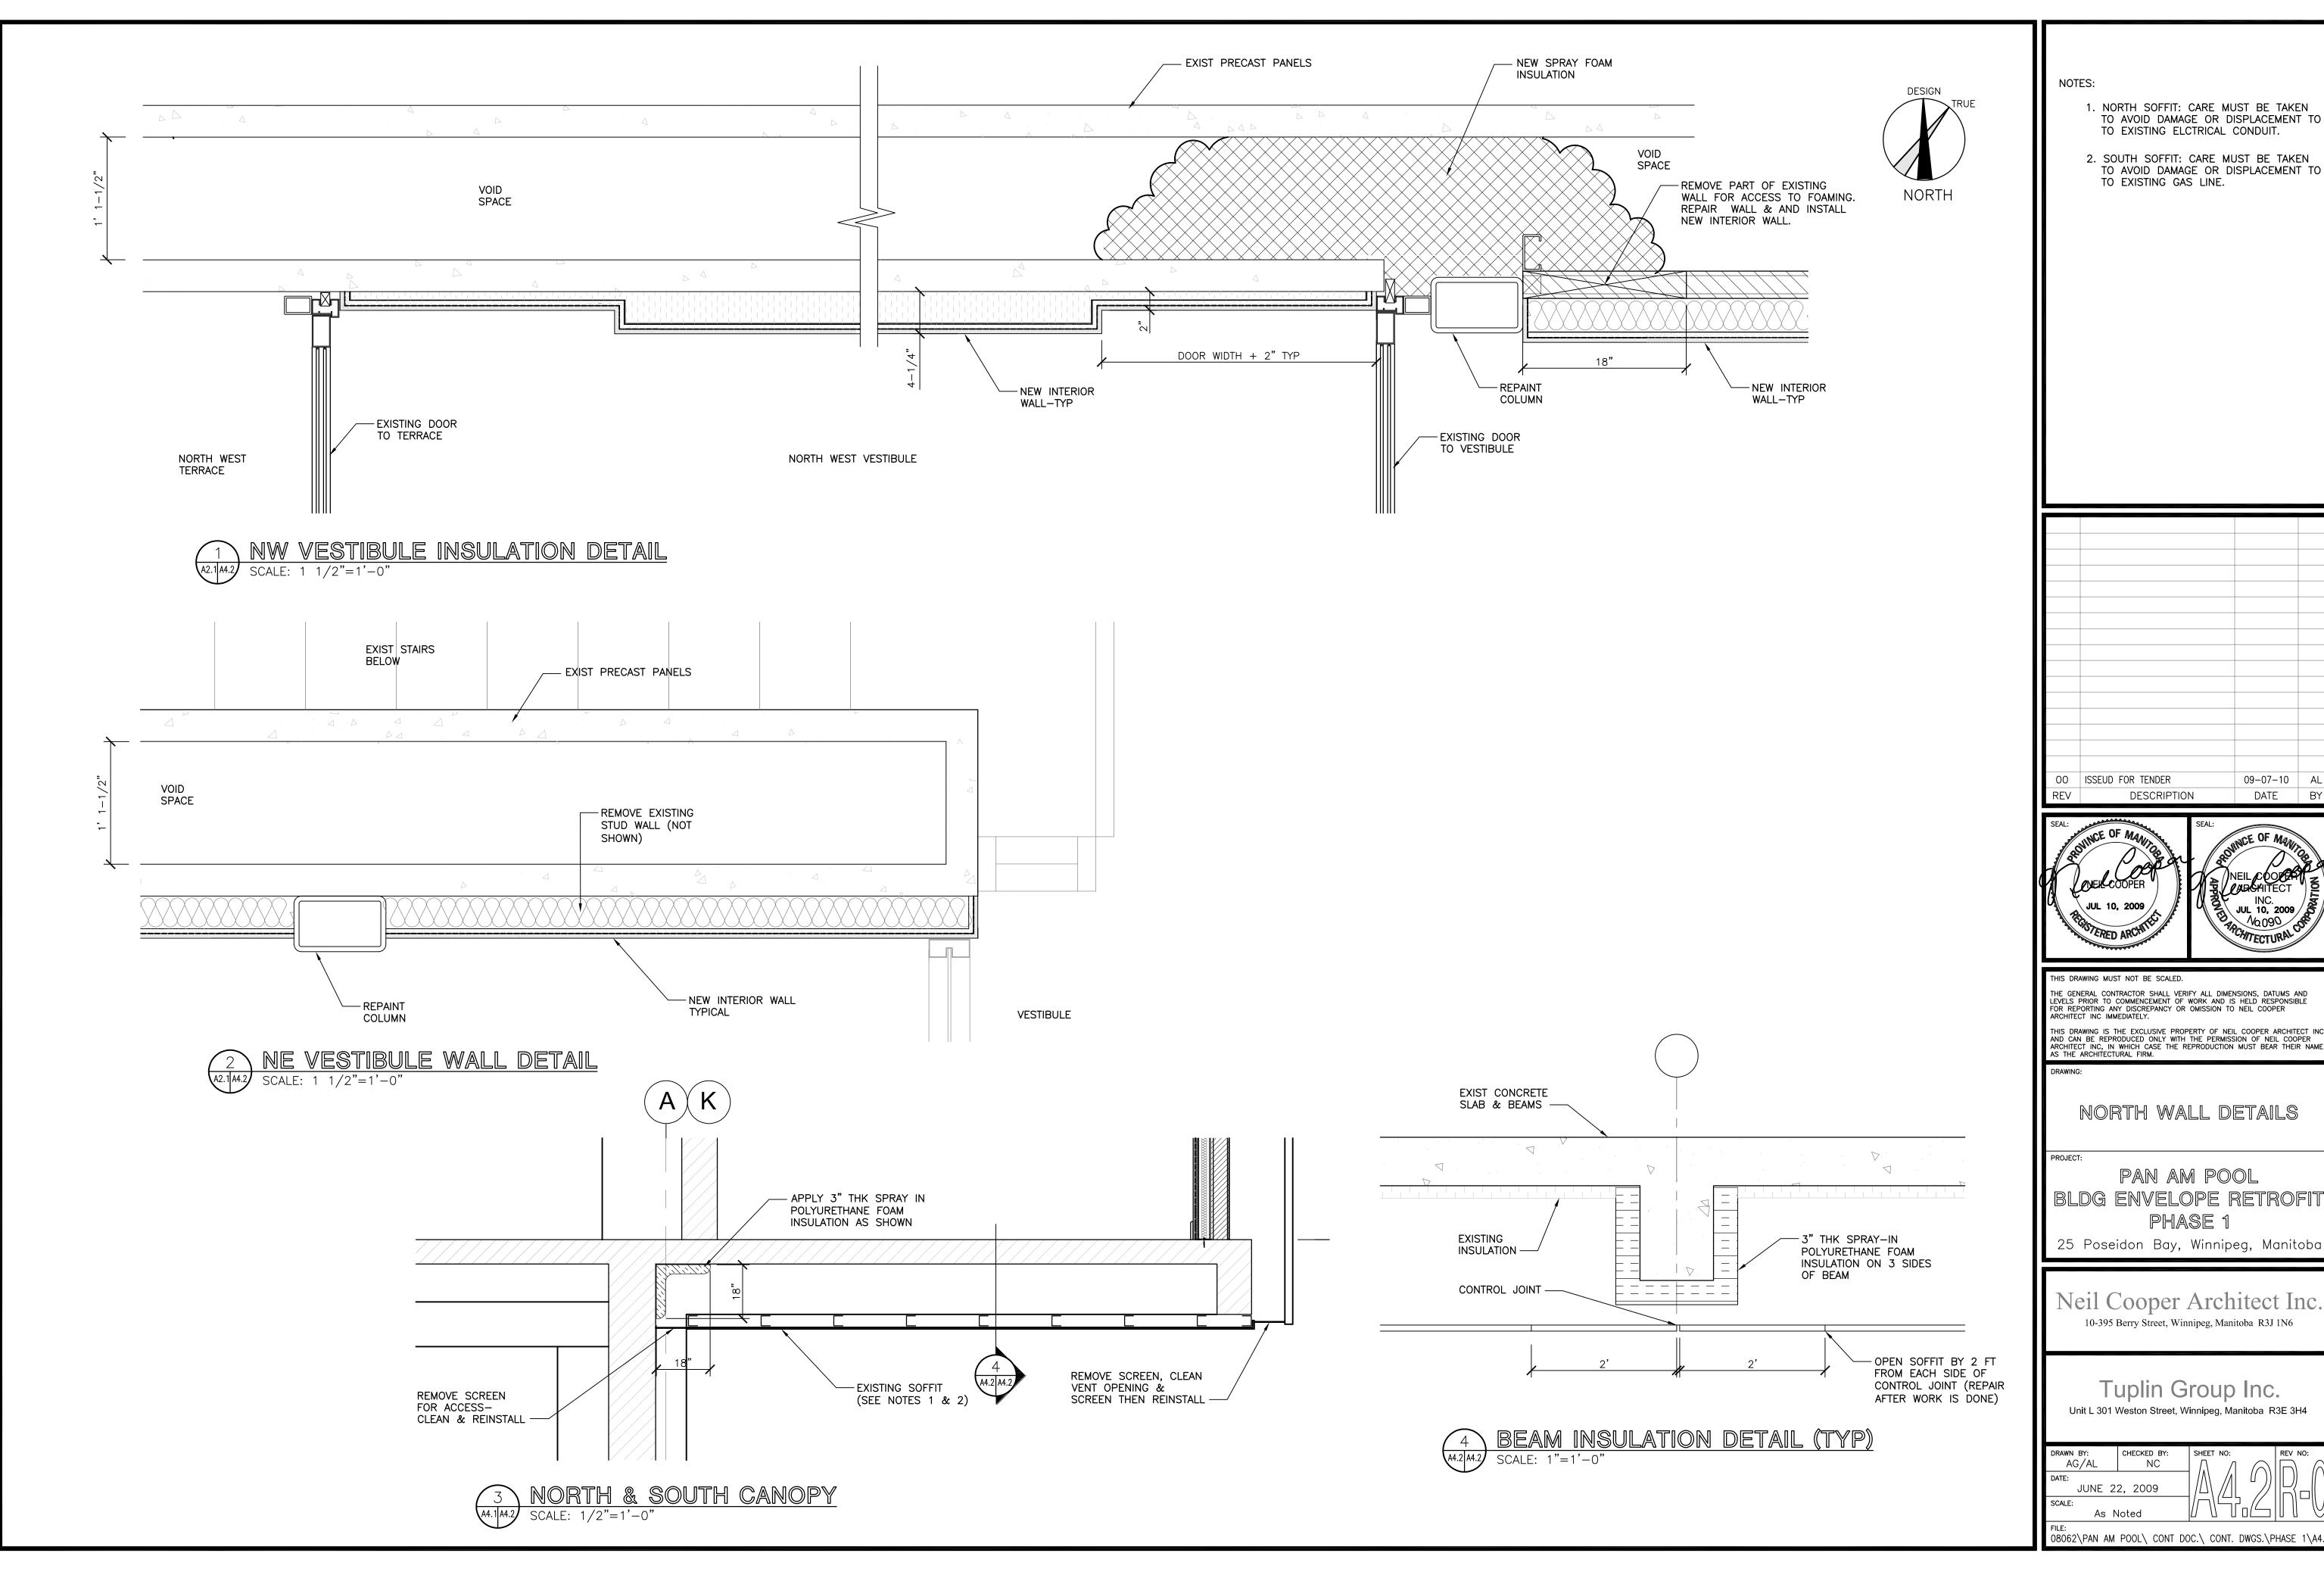
- 1. NORTH SOFFIT: CARE MUST BE TAKEN TO AVOID DAMAGE OR DISPLACEMENT TO TO EXISTING ELCTRICAL CONDUIT.
- 2. SOUTH SOFFIT: CARE MUST BE TAKEN TO AVOID DAMAGE OR DISPLACEMENT TO TO EXISTING GAS LINE.
