NO.	DATE	DESCRIPTION	BY
01	SEPT. 13, 2017	FOR CONSTRUCTION	NK

I.D.
SYNERGY INTERIOR DESIGN INC
13 Rosewarne. Avenue WINNIPEG, MB Canada R2M 0V8
204 233 9159
malvine@synergyinteriors.com
DATE JULY 2017 SCALE AS SHOWN REVISIONS
DRAWN BY CHECKED BY
PEMBINA TRAILS LIBRARY RENOVATIONS

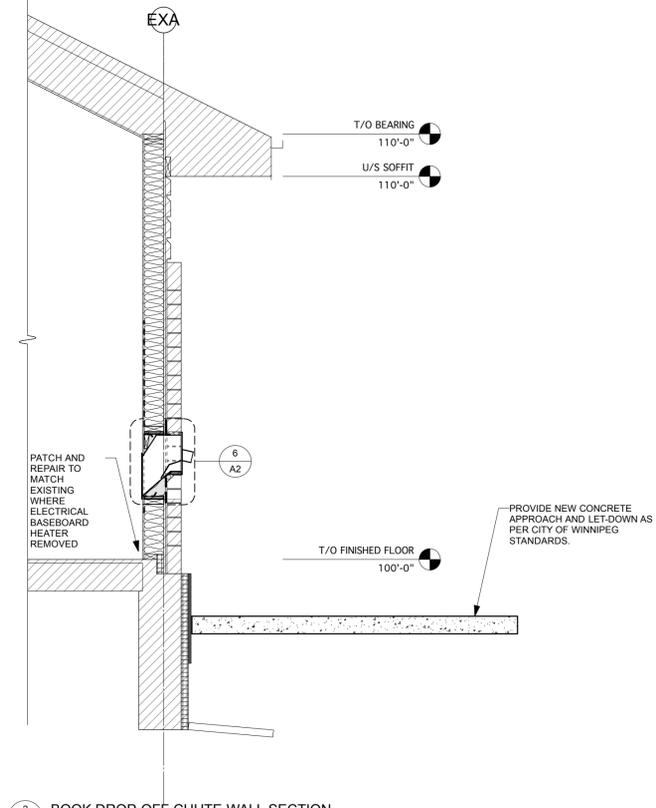
2 BOOK DROP-OFF CHUTE WALL SECTION
1/2" = 1'-0"
EXISTING BUILDING INFO SHOWN FOR GENERAL REFERENCE ONLY. CONTRACTOR TO VERIFY EXISTING CONDITIONS ON-SITE.
