THE CITY OF WINNIPEG WATER AND WASTE DEPARTMENT

2010 HVAC REPLACEMENT AND ASSOCIATED WORKS WEWPCC

1-0103G-M0026-001 AREA H — HEADWORKS GRIT/SCREENING RECEIVING VENTILATION - NEW CONDITIONS

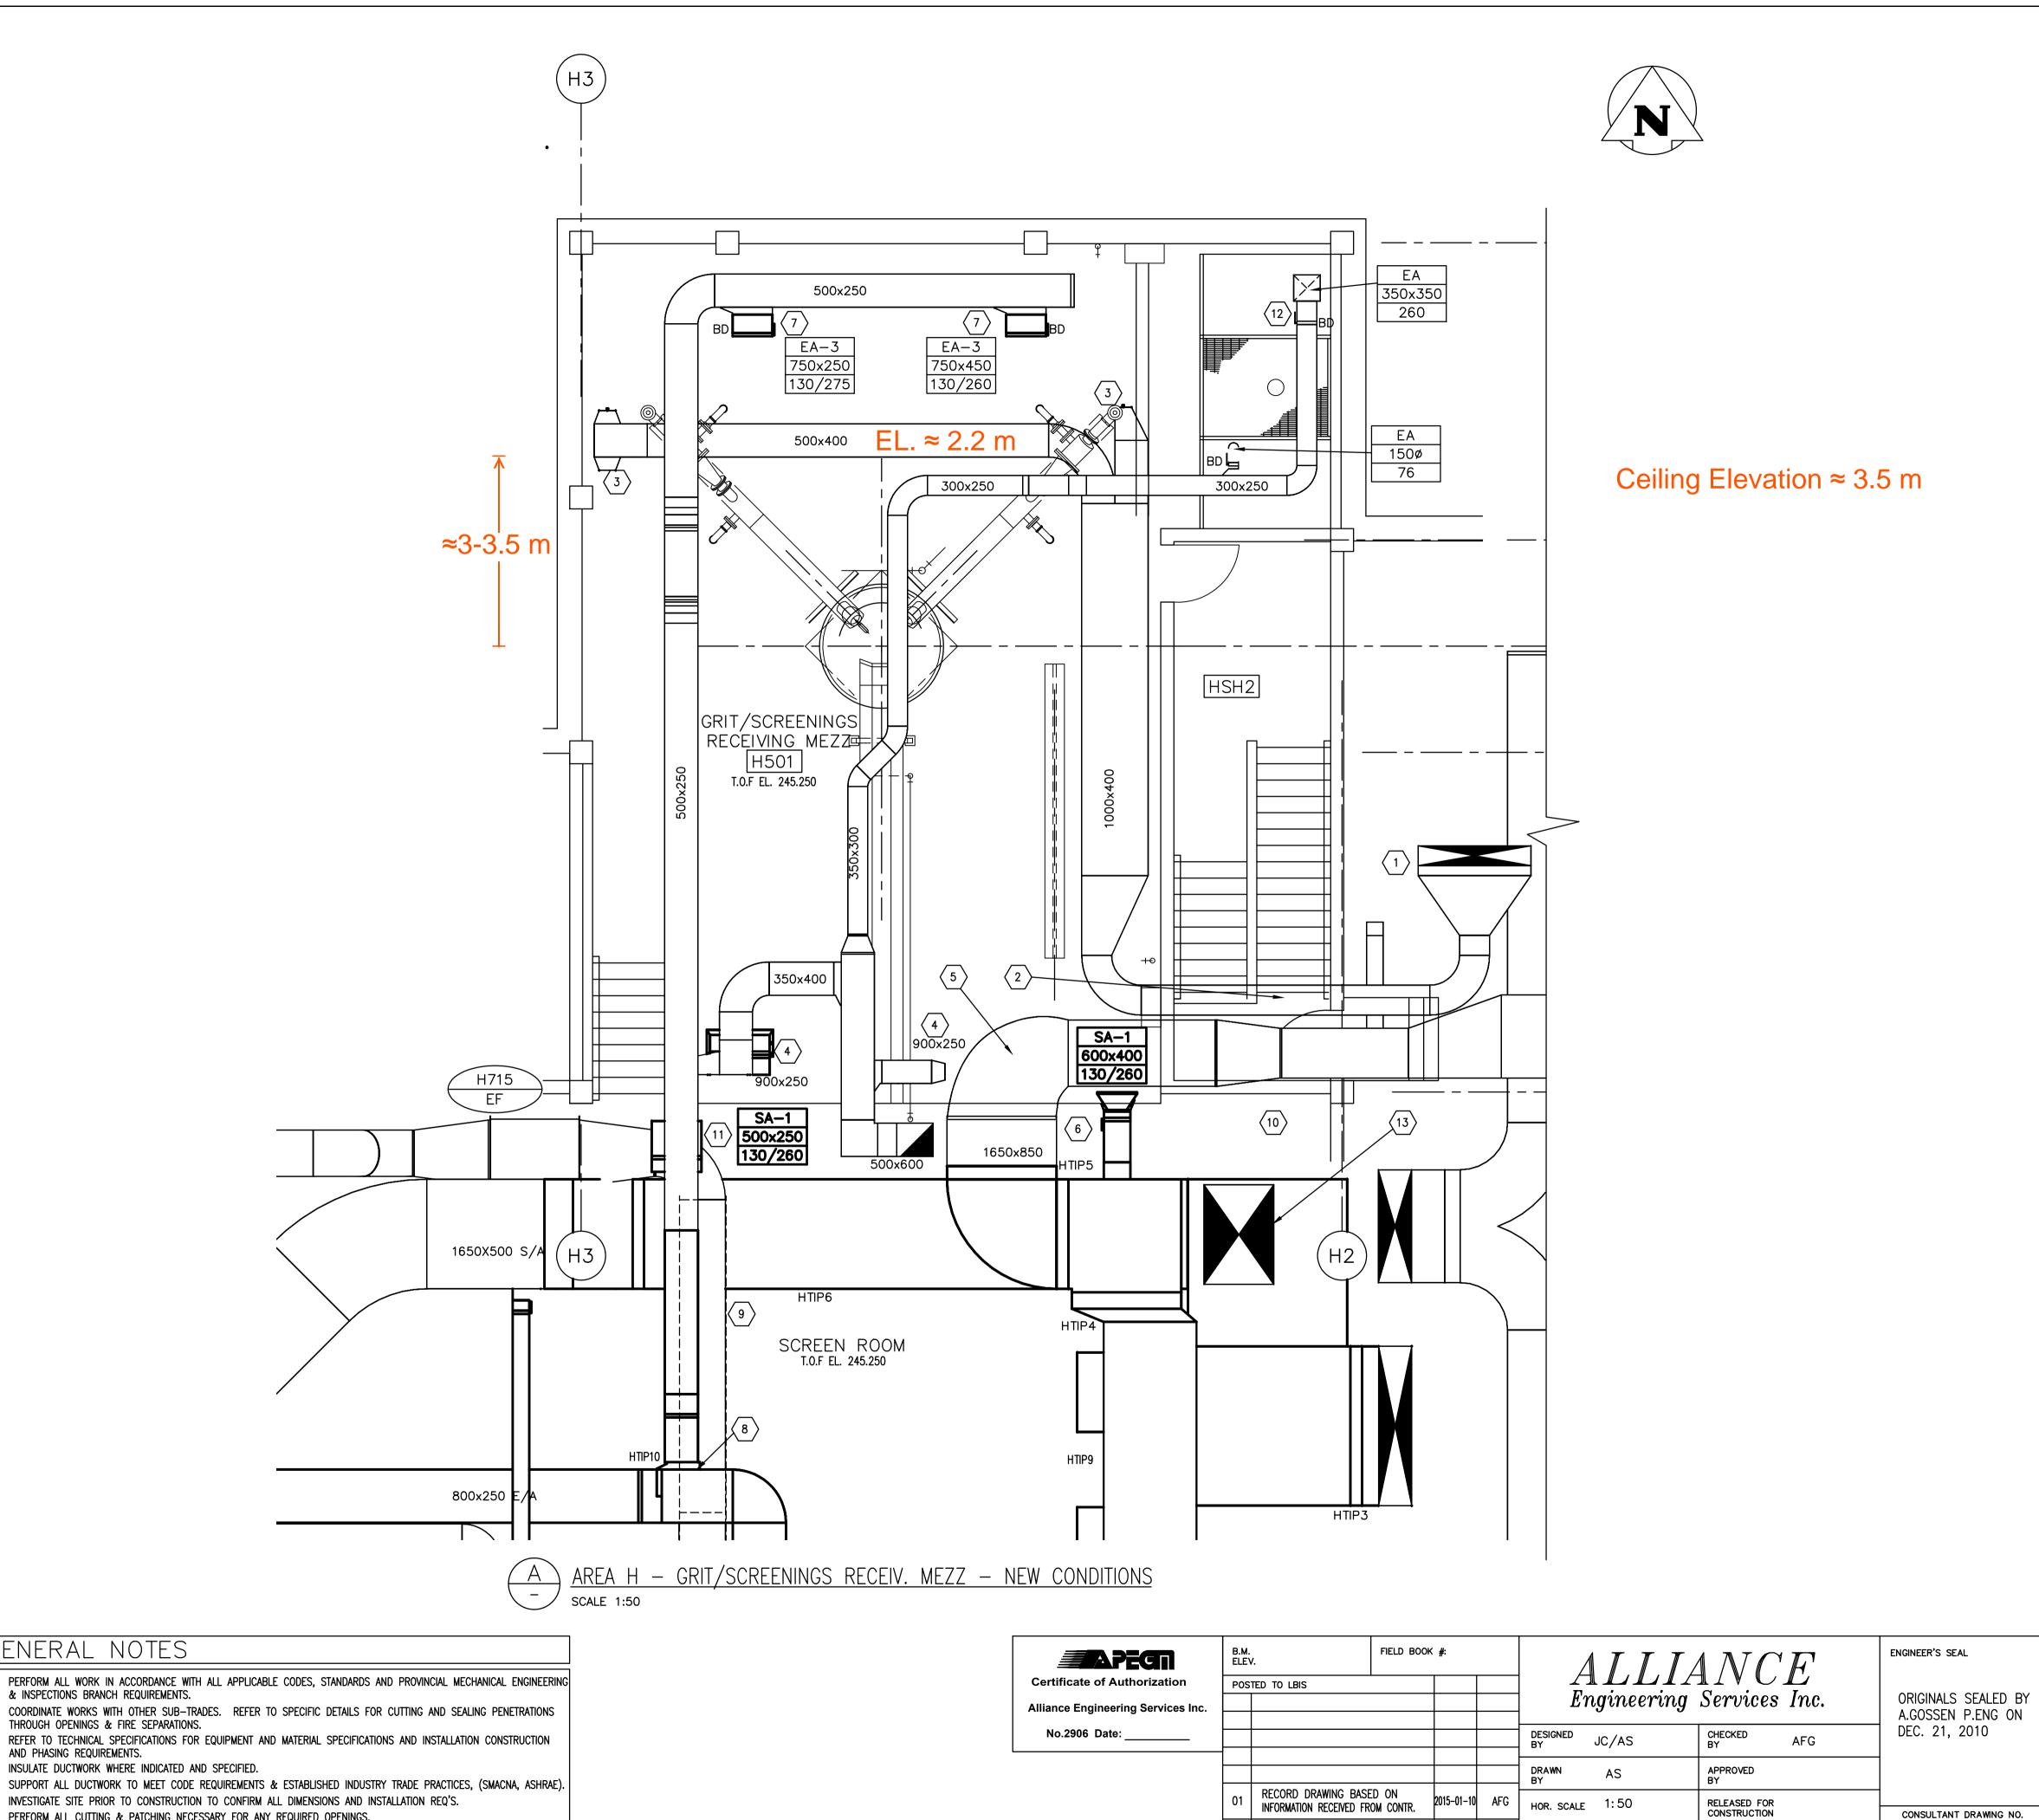
HM2.10

- $\left\langle 1 \right\rangle$ EXISTING 1700x300 S/A DUCT FROM H725, THRU SLUDGE TRUCK BAY CEILING
- SPACE, TO REMAIN IN SERVICE. 2 EXISTING S/A DUCT THRU STAIRWELL S2, IN FIRE RATED ENCLOSURE, C/W FIRE DAMPERS AT WALL PENETRATIONS, TO REMAIN IN SERVICE.

- 3 EXISTING INSULATED 250x900 S/A THRU FLOOR TO GRIT TRUCK BAY C/W FIRE DAMPER; DUCT TO BE EXTENDED U/S FLOOR
- 4 EXISTING 900x250 E/A RISERS FROM GRIT TRUCK BAY, C/W FIRE DAMPERS, TO REMAIN IN SERVICE; LOWER AND RELOCATE EXHAUST GRILLES IN GRIT LOADING

- 5 SLUDGE TRUCK BAY EXHAUST MAIN, TO MAIN EXHAUST RISER, TO REMAIN IN SERVICE.
- 6 EXISTING 1650x850 MAIN EXHAUST RISER TO REMAIN IN SERVICE
- 7 EXISTING BOOTS, GRILLES AND BALANCING DAMPERS; BALANCE TO AIR FLOW SHOWN.

- $\left\langle 8 \right\rangle$ EXTEND EXISTING 500X250 EXHAUST AIR DUCT TO NEW EXHAUST DUCT RUNNING E/W.
- 9 EXISTING 7500 GENERAL EXHAUST FROM DAF BUILDING, N.I.C.

- 10 NEW 4000 S/A DUCT C/W BALANCING DAMPER AND S/A GRILLE, TO SERVICE MEZZ. FLOOR.
- NEW 500x250 S/A BOOT, C/W BALANCING DAMPER AND S/A GRILLE, TO SERVICE MEZZ. FLOOR; BALANCE TO AIRFLOW SHOWN.

- EXISTING 350x300 E/A DUCT, WITH 1 E/A GRILLE AND ONE PICK-UP POINT BELOW GRATING TO REMAIN IN SERVICE; INSTALL BALANCING DAMPER ON 1500
- 13 EXISTING PURGE MODE AIR INTAKE DUCT SLEEVE, FROM INTAKE PENTHOUSE ON PROCESS AREA ROOF; 1800x1050, TO REMAIN IN SERVICE; REPLACE EXISTING MOTORIZED DAMPER, NEW DAMPER INSULATED BLADES AND FRAME.
