Cornish Library Renovation

Demolition Plans

A-101

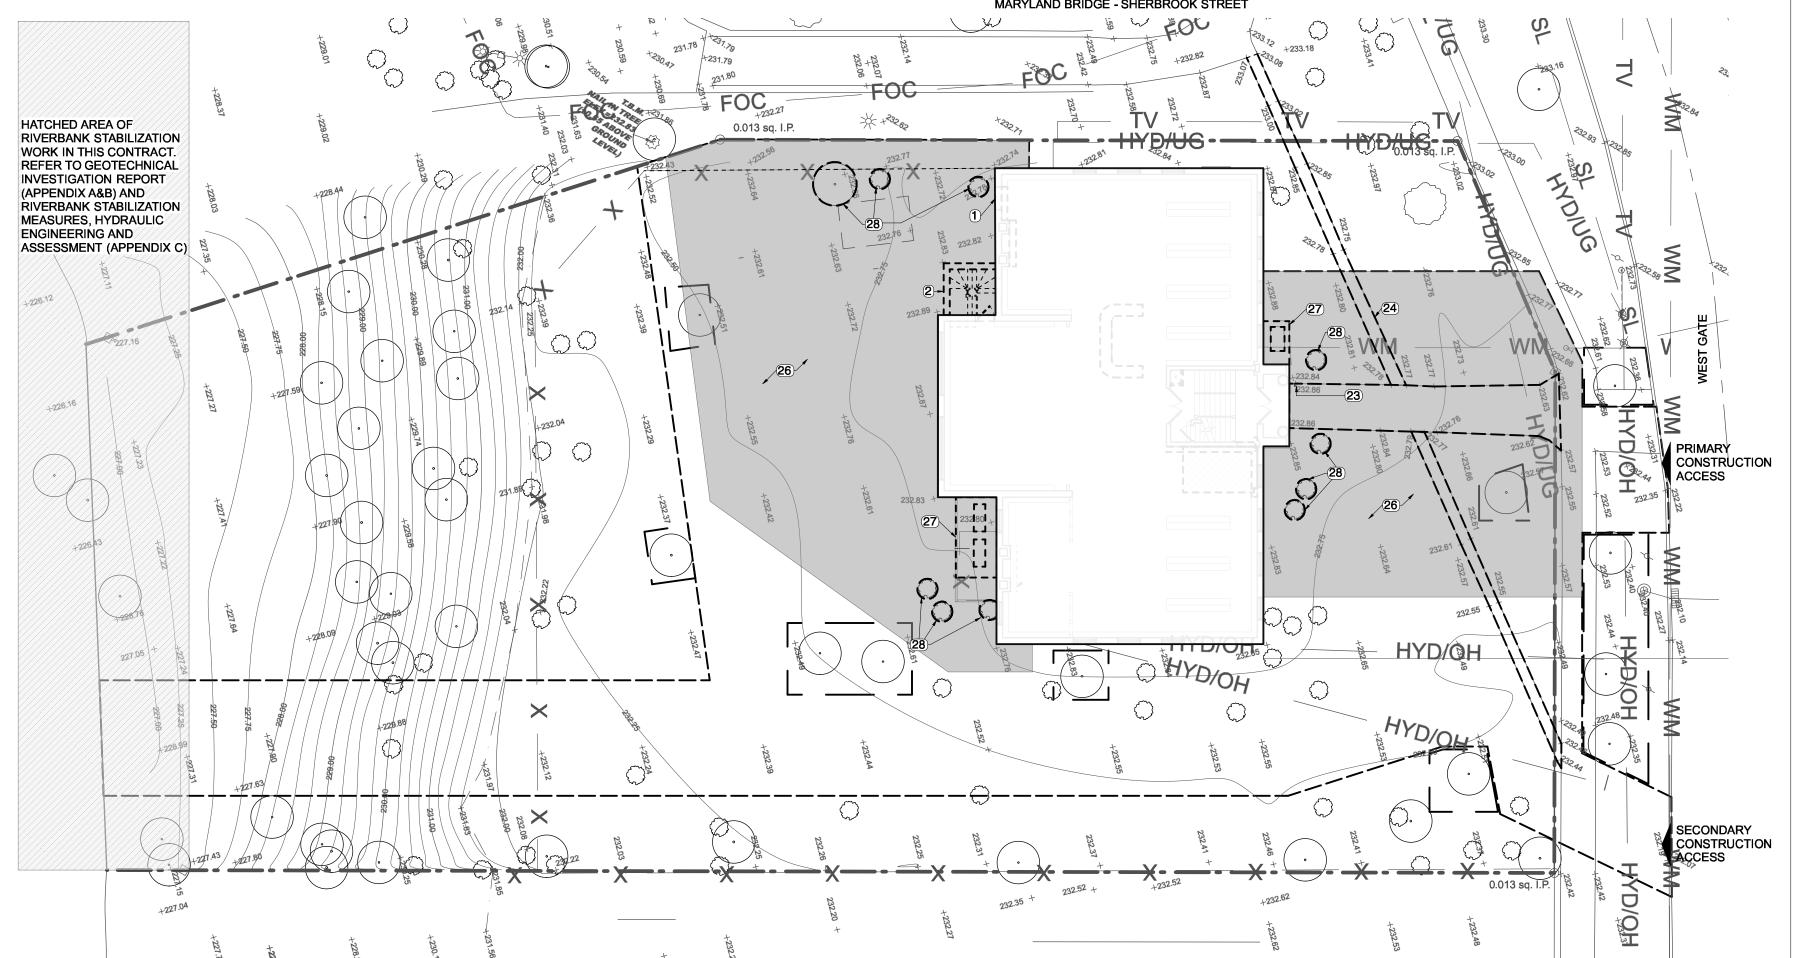
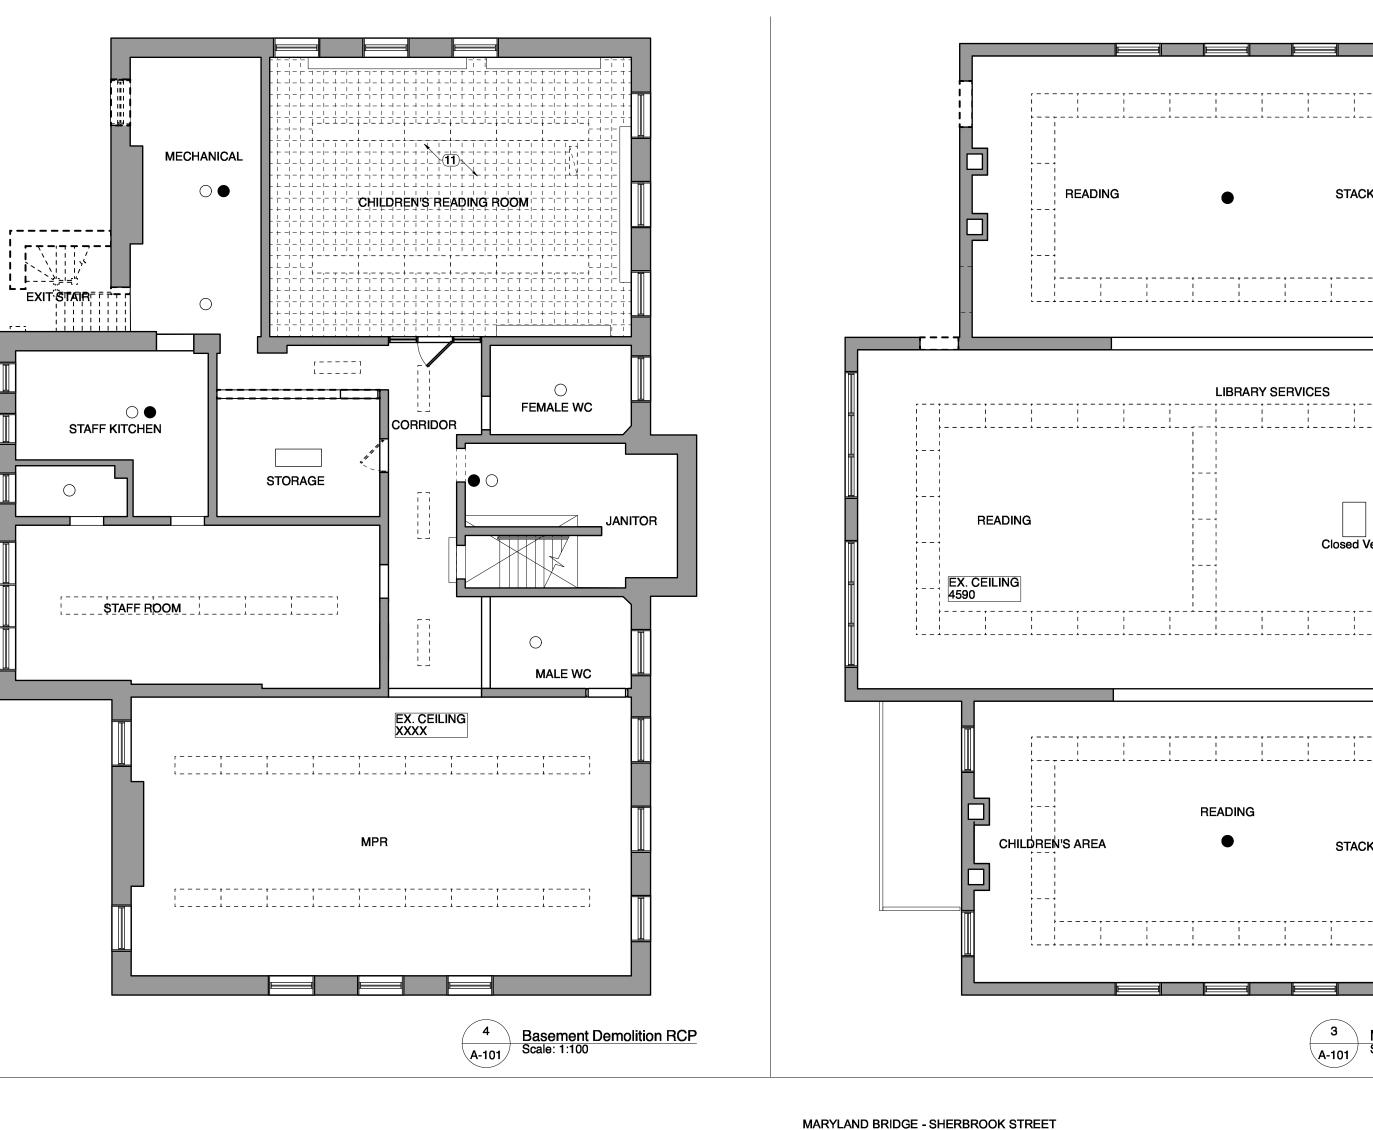
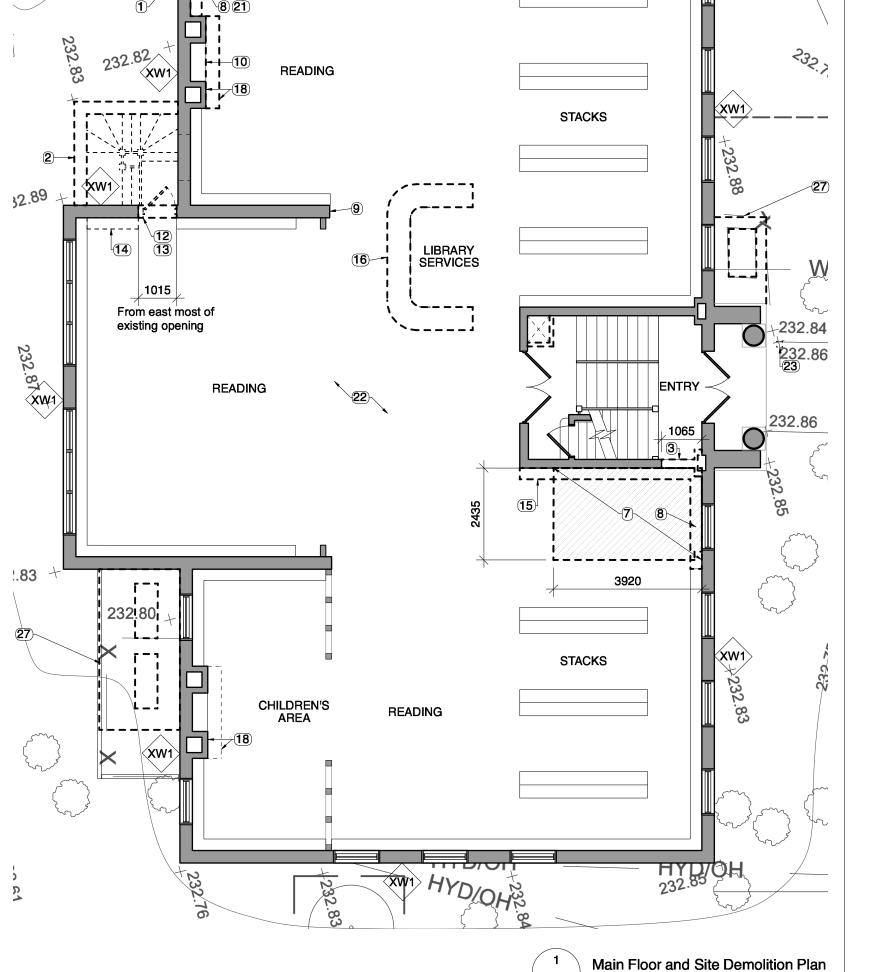
Main Floor and Site Demolition Plan A-101

- Existing window to be removed and salvaged. Wall below window to be demolished to top of structural floor.
- 2. Existing exit stair structure to be demolished. Salvage wood railings

- 3. Existing wall to be demolished to extend entry landing for lift access. Refer to elevations for extents.
- 4. Existing plumbing fixture to be demolished. Coordinate with

- 5. Existing ceramic tile floor and base to be removed.
- 6. Existing vinyl tile to be removed.
- 7. Extent of existing floor structure to be demolished to accomodate

- 8. Existing radiator to be removed. Coordinate with Mechanical.
- 9. Existing water fountain to be relocated. Coordinate with
- (10.) Existing gas fireplace and associated lines to be removed. Coordinate with Mechanical.

- Existing ACT, including fixtures, to be demolished. Coordinate removals of fixtures, devices, ductwork, etc. with Mechanical and
- 12. Existing opening to be widened. Existing door, trim and hardware to be removed and turned over to Owner.

- (13.) Existing exit sign, fire alarm pull station, and exit alarm to be removed. Coordinate with Electrical.
- 14. Existing bookshelves to be modified to suit new opening.

- 15. Existing bookshelves to be removed.
- (16.) Existing circulation desk to be demolished. Coordinate removal of wiring with Electrical. (17) Existing upper and lower cabinets to be demolished including kitchen style sink and associated plumbing. Coordinate with

- 18. Existing tile to be removed from floor and face of fireplace. (19.) Existing wood door, frame and original wood trim to be removed
- and salvaged for reinstallation in this project. (20.) Existing janitor's sink to be removed. Relocate associated plumbing lines. Coordinate with Mechanical.

- 21. Existing section of shelving above rad to be removed and salvaged. 22. Existing carpet and underlying vinyl tile to be removed. Refer to Demolition Notes for areas with asbestos containing materials.

- 23. Existing door actuator and pedestal to be removed. Maintain wiring to be connected to new actuator in similar location. Coordinate with
- 24. Existing concrete patio blocks to be removed back to City sidewalk,

- 25. Existing bookshelves to be removed and reinstalled to suit other
- 26. Site removals within shaded area to suit L-102 Grading and Layout

- 27. Demolish mechanical equipment and surrounding fence enclosure. Coordinate with Mechanical demolition drawings
- 28. Tree or shrub to be removed
- 30. Patch and make good wall transition at ends demolished wall
