Drawing Title
MAIN FLOOR AND ROOF PLAN -
TRACK 13-24 - DEMOLITION -
PLUMBING

1	M1.1	1 of 12
Revision Number	Drawing Number	Sheet Order
AS NOTED	NOVEMBER, 2018	18-240-01
Scale	Date	Project No.
JC/AS	XZ	JH
a,	0.1001104 = 7	, .pp. 0 . 0 a = j

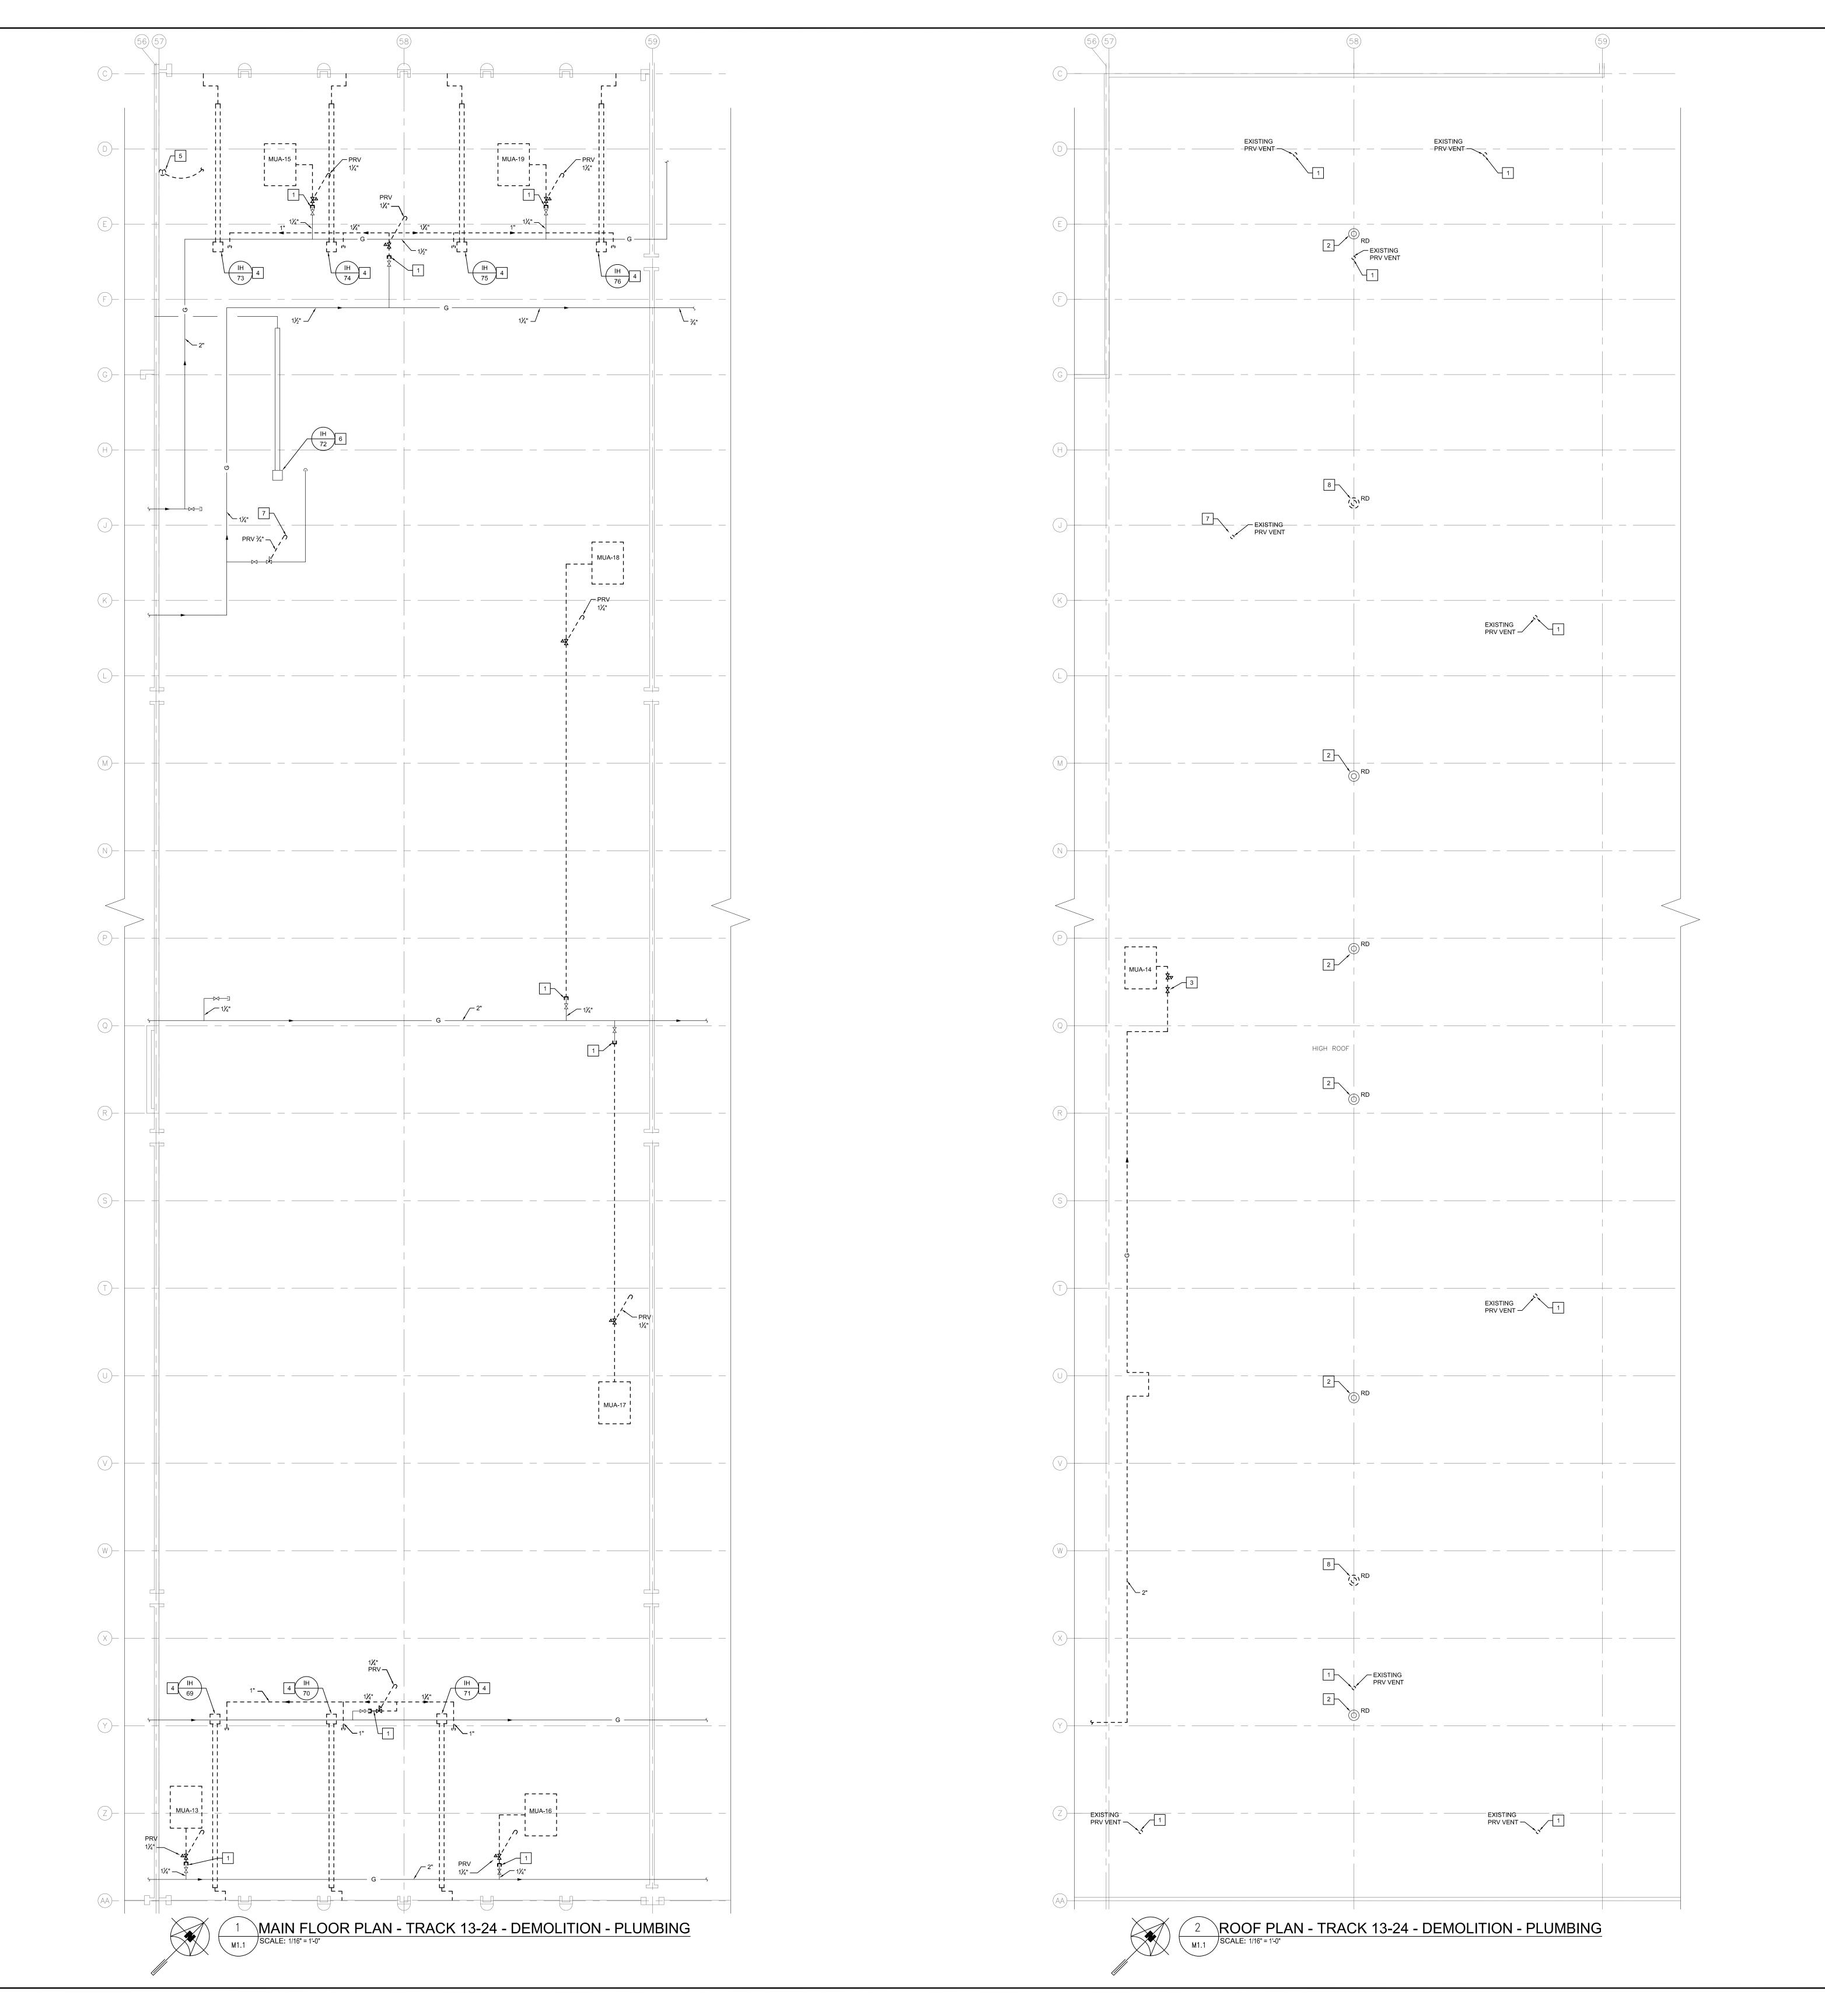
- DEMOLISH AND REMOVE NATURAL GAS PIPING AND VENT BACK TO ISOLATION VALVE AS SHOWN. REPAIR AND SEAL PRV VENT ROOF OPENING (REFER TO STRUCTURAL AND ROOFING SPECIFICATION / DETAILS).
- EXISTING ROOF DRAINS TO REMAIN.
 REMOVE EXISTING NATURAL GAS LINE SERVING MUA-14 C
- 3. REMOVE EXISTING NATURAL GAS LINE SERVING MUA-14 ON THE ROOF BACK TO SOURCE IN MECHANICAL ROOM 004 (REFER TO DRAWING M1.2 FOR CONTINUATION). REPAIR AND SEAL ROOF OPENINGS (REFER TO STRUCTURAL AND ROOFING SPECIFICATION/DETAIL.
- CONTROLLER AND THERMOSATAT.

5. REMOVE EXISTING THERMOSTAT SERVING INFRARED HEATERS.

4. REMOVE EXISTING INFRARED HEATER AND ASSOCIATED

- EXISTING INFRARED HEATER TO REMAIN.
 RELOCATE EXISTING PRV VENT THROUGH THE ROOF AWAY FROM LOCATION OF NEW HRU. REFER TO DRAWING M2.1.
- 8. RELOCATE EXISTING ROOF DRAIN AWAY FROM LOCATION OF NEW HRU STEEL PLATFORM STANDS. REFER TO M2.1 NEW CONSTRUCTION DRAWING.
