APPENDIX D

**ARCHIBALD OUTFALL – 2012 CORING AND COMPRESSION
TEST INFORMATION**

Project: Mission Outfall

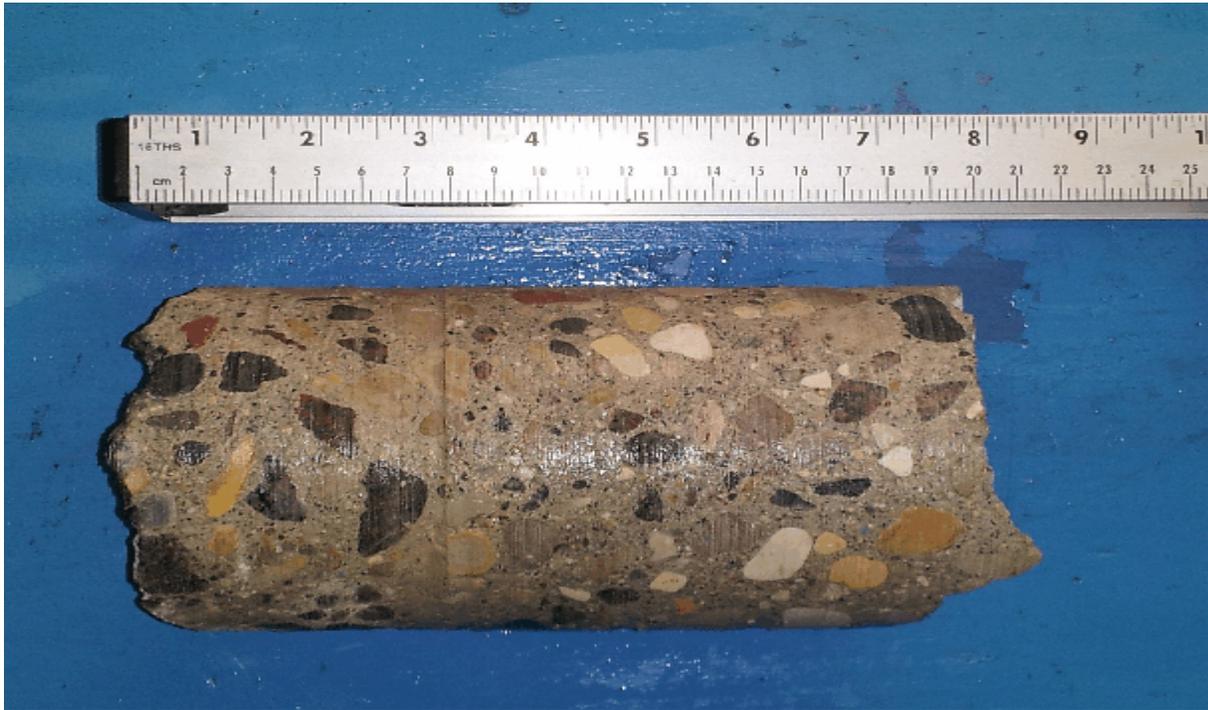
Core No. 1

- Core no. 1 - floor, 20 m upstream from manhole
- Core no. 2 - south wall, 20 m upstream from manhole, 1 m above floor
- Core no. 3 - floor, 9 m upstream from manhole

Based upon the visual examination of the core samples, it was determined that core nos. 1 to 3 are considered to be relatively sound concrete.

Core No.	Compressive Strength (MPa)
1	16.1
2	14.4
3	27.8
