Project
ST. JAMES CIVIC CENTRE
 ARENA CRAWLSPACE RESTORATION

Sheet Title
CRAWLSPACE DETAILS

Revision 1 Sheet No. S4.2

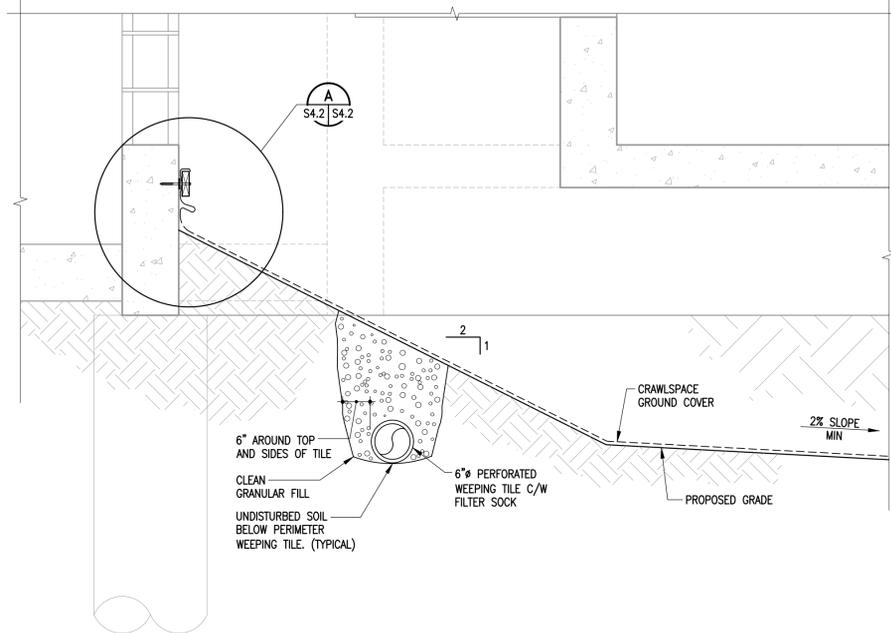
1 WEeping TILE DETAIL
 S4.1 | S4.2 1" = 1'-0" (BASE BID)

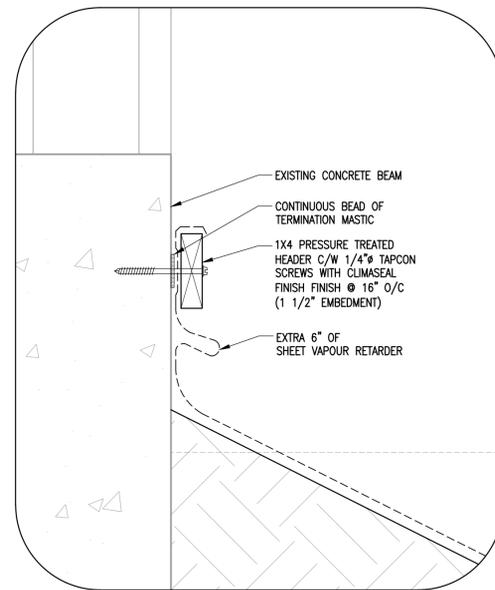
A LEDGER BOARD DETAIL
 S4.2 3" = 1'-0"

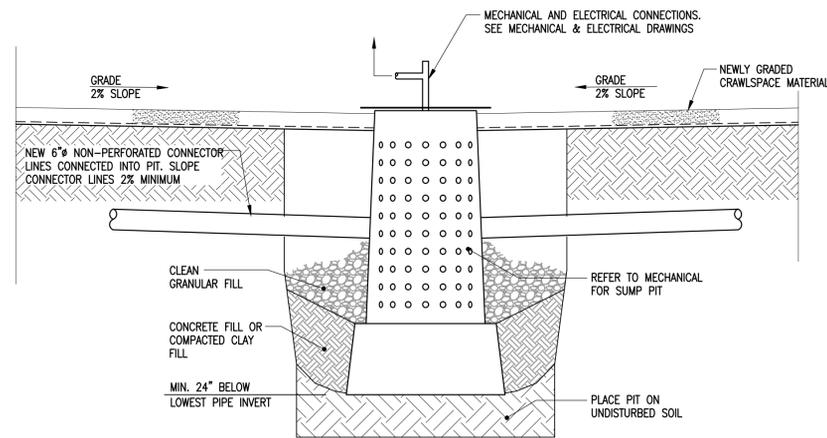
2 TYPICAL SUMP PIT DETAIL
 S4.2 N.T.S. (FIXED PRICE)

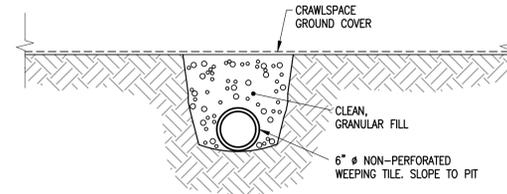
3 NON-PERFORATED COLLECTOR DETAIL
 S4.2 N.T.S.

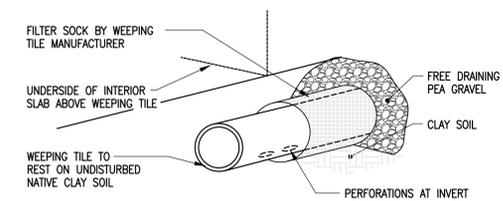
4 WEeping TILE INSTALLATION DETAIL
 S4.2 N.T.S.
 • INVERT OF WEeping TILE MUST BE AT OR BELOW UNDERSIDE OF VOID BELOW GRADE BEAM.

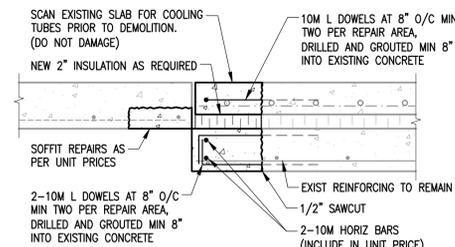
6 RINK SLAB REPAIR DETAIL
 S2.2 | S4.2 SCALE : 1"=1'-0" (UNIT PRICE)

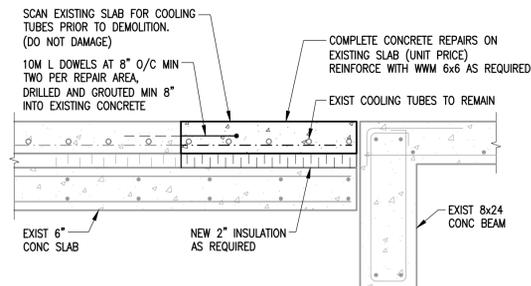
7 RINK SLAB REPAIR DETAIL
 S2.2 | S4.2 SCALE : 1"=1'-0" (UNIT PRICE)
