B.M. ELEV.				TETRA TECH				THE CITY OF WINNIPEG PUBLIC WORKS DEPARTMENT ENGINEERING DIVISION	
				DESIGNED BY RL	REVIEWED BY SA			LAGIMODIERE TWIN OVERPASSES OVER CPKC KEEWATIN REHABILITATION AND RELATED WORKS	
				DRAWN BY EV	APPROVED BY KA			SOUTHBOUND STRUCTURE PIER S-2 - REPAIR DETAILS	
				SCALE: AS NOTED	ACCEPTED BY DATE CAM WARD, P.ENG. 25.08.07	CONSULTANT DRAWING NO. 704-INF-MBI03007.01-DWG-S2110		CITY DRAWING NUMBER B123-25-2110	
0	ISSUED FOR TENDER	25.08.07	SA					SHEET 10 OF 47	
NO.	REVISIONS	DATE	BY	DATE	25.08.07			2110

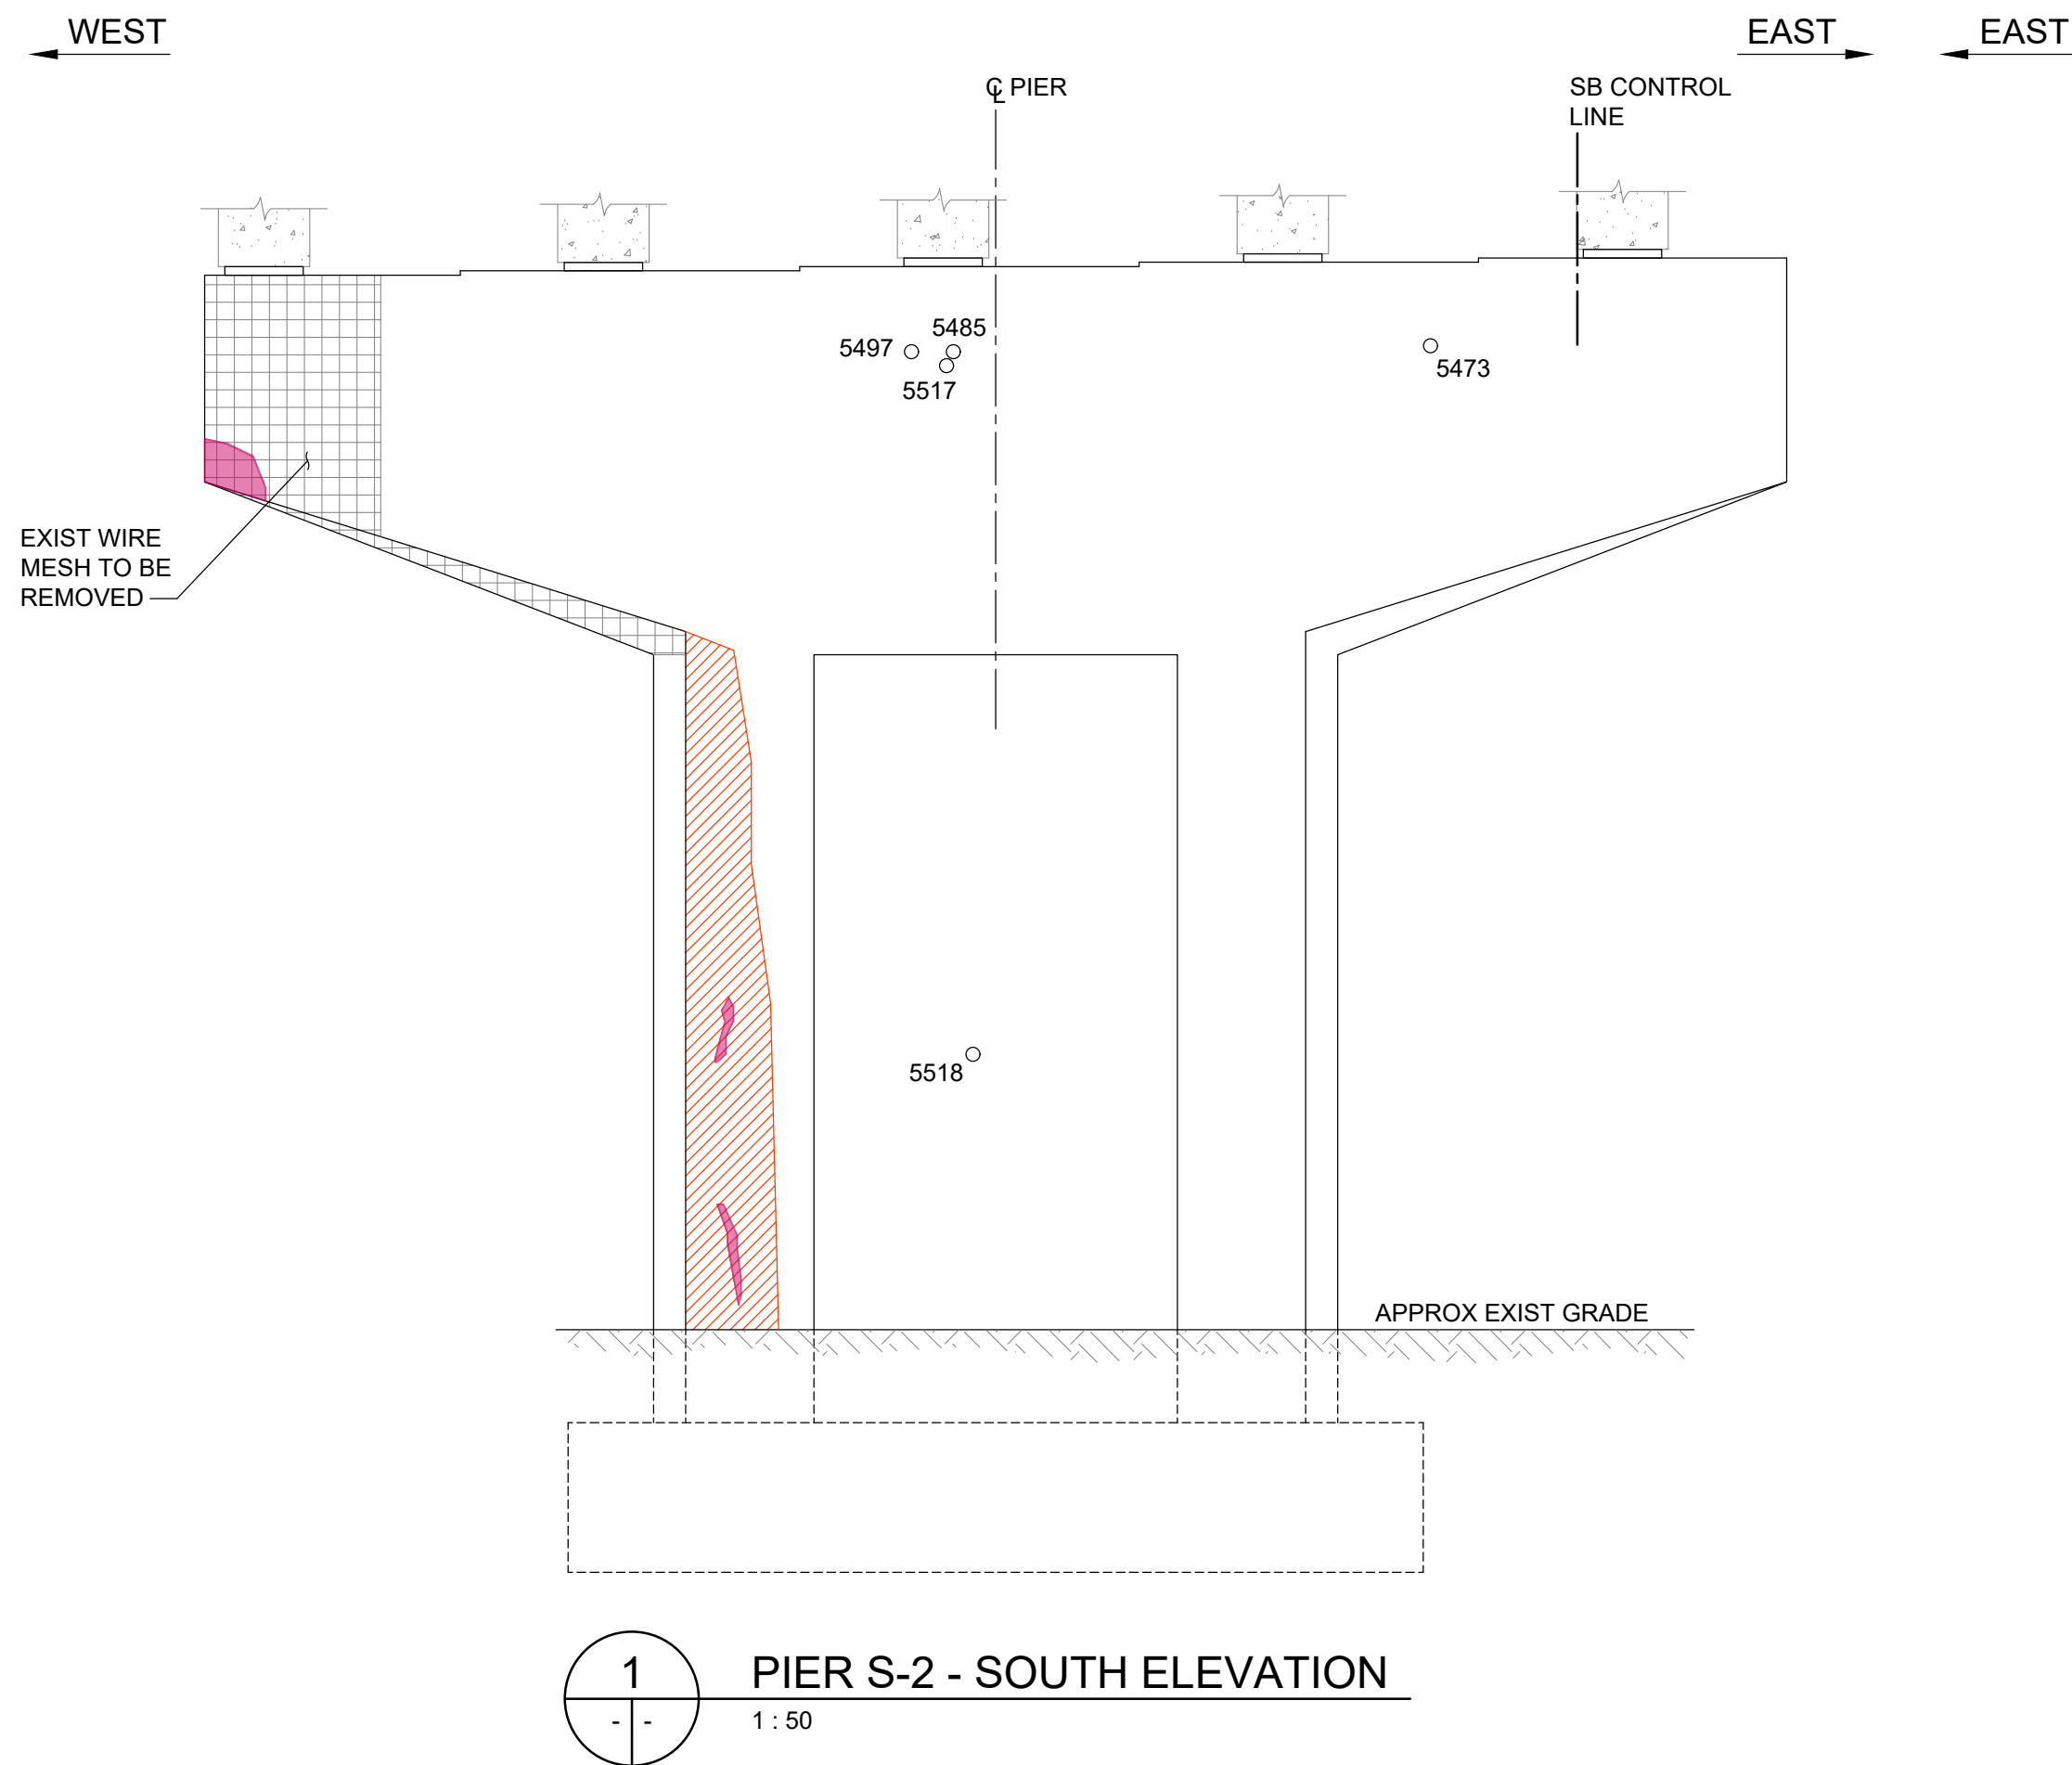
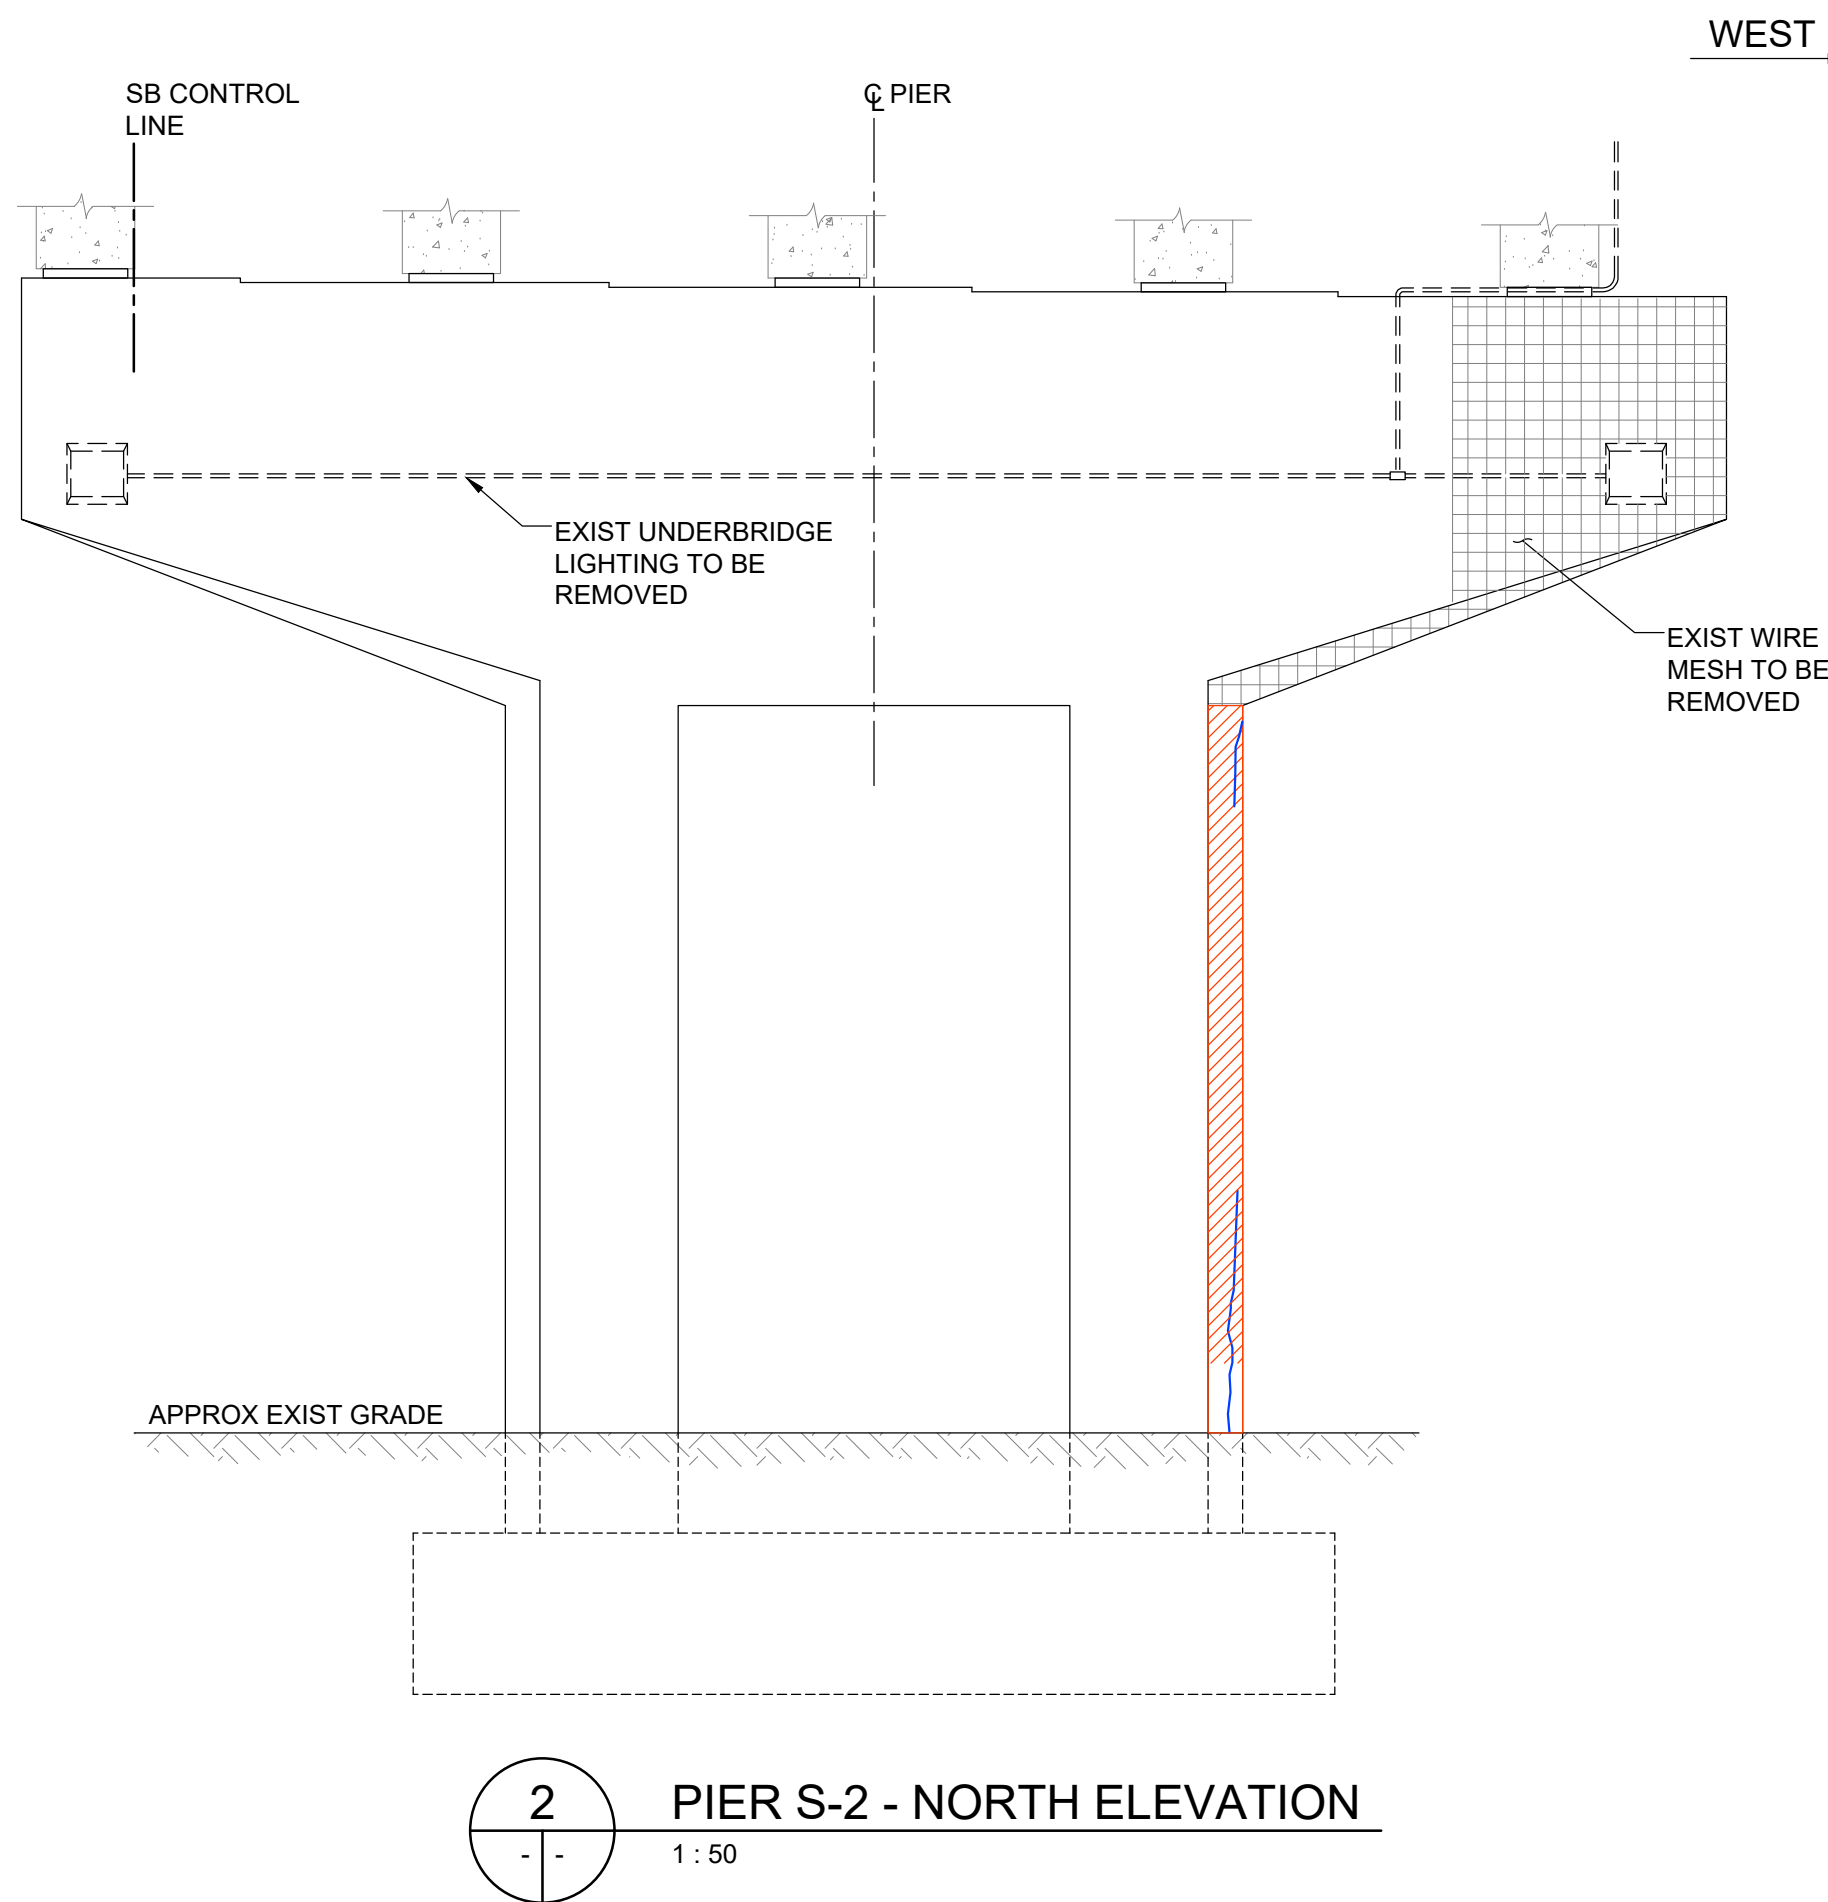
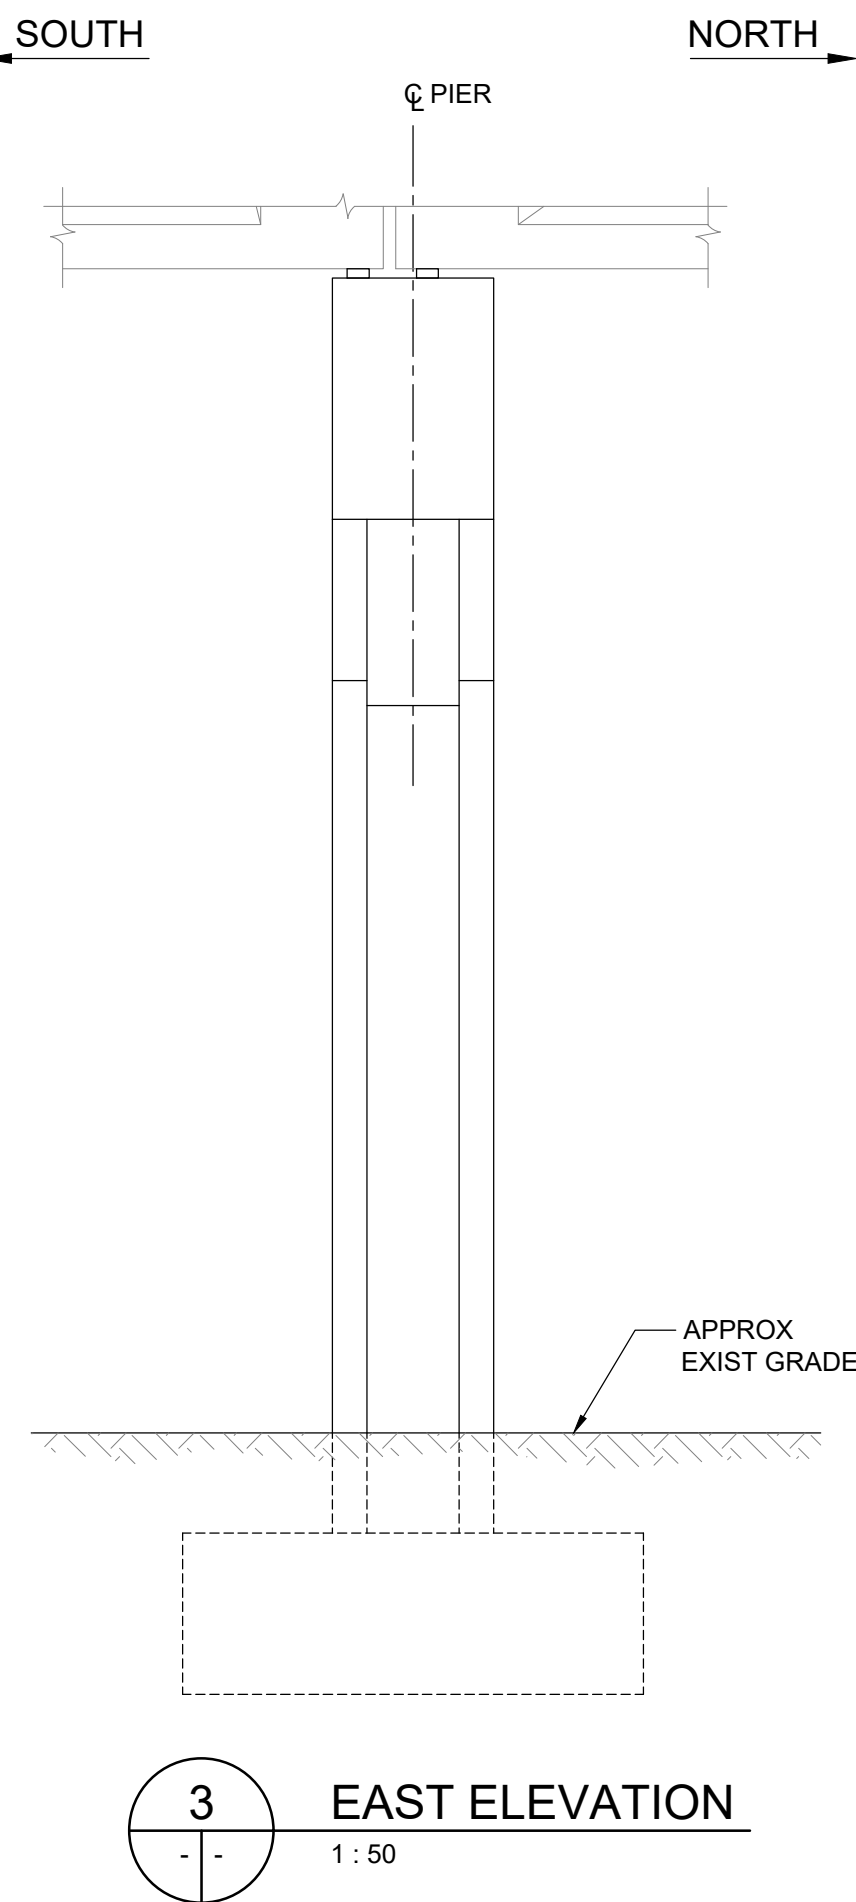
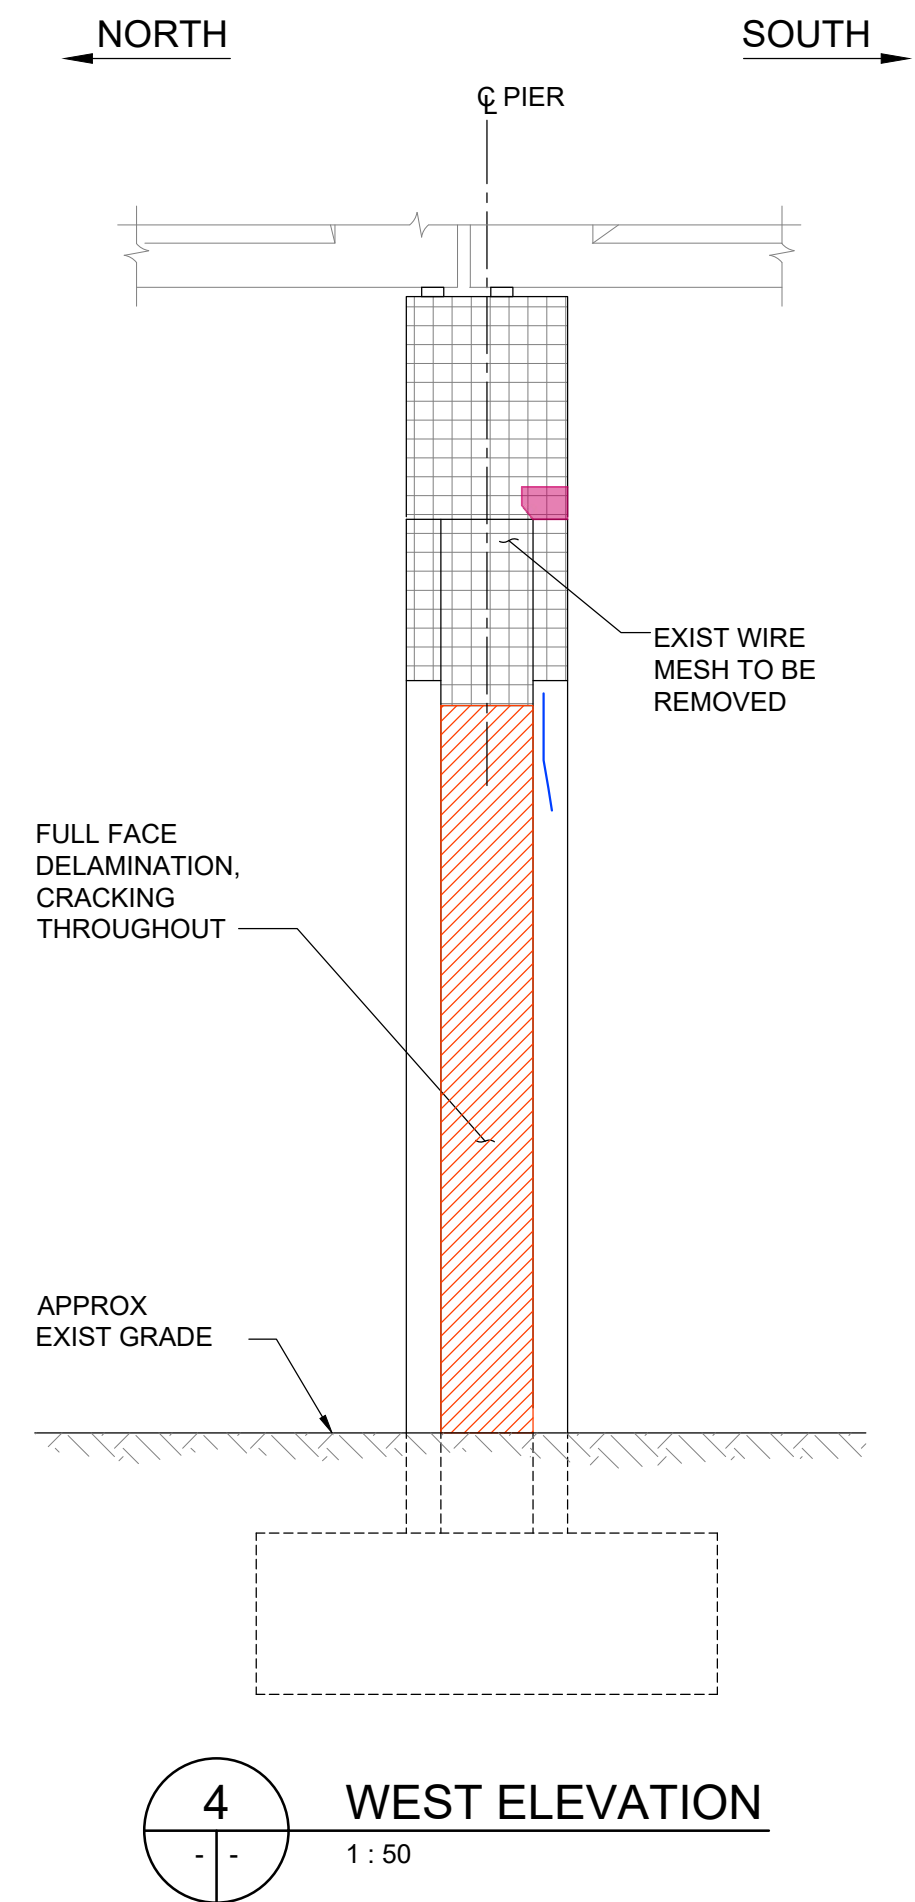
- CRACK LOCATIONS ARE APPROXIMATE. CRACK WIDTH VARIED
- THIS DRAWING DEPICTS SELECT FINDINGS/AREAS OF CONCERN. ACTUAL REPAIR AREAS MAY BE DIFFERENT AND WILL BE IDENTIFIED ON SITE BY THE CONTRACT ADMINISTRATOR. REPAIR AREAS TO BE MARKED OFF TO SQUARE OR RECTANGULAR SHAPES.
- ASSUMED REPAIR AREAS ARE PROVIDED IN TABLE 1.
- REFER TO SHEET 2109 FOR TYPICAL REPAIR DETAILS AND NOTES.
- AREAS NOTED WITHIN CAP MODIFICATION AREA ARE TO BE POURED MONOLITHICALLY WITH PIER CAP MODIFICATION CONCRETE.

TABLE 1: REPAIR QUANTITIES	
	APPROX REPAIR UNITS
S-2	SUBSTRUCTURE REPAIRS - 14.0 m ² MONOLITHIC WITH SUBSTRUCTURE MODIFICATIONS - 10.0 m ²
